Persistence and Effectiveness of Livewood as Large Wood in River Restoration

Danielle Charleston, Melissa Hassler, Kelsey Wilson  
University of California Berkeley  
Professor Matt Kondolf  
River Restoration  
Fall 2018

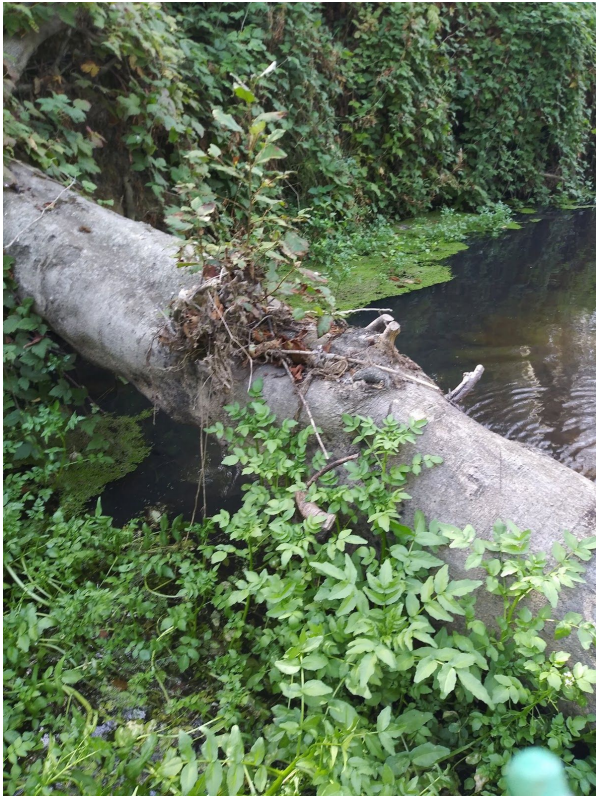
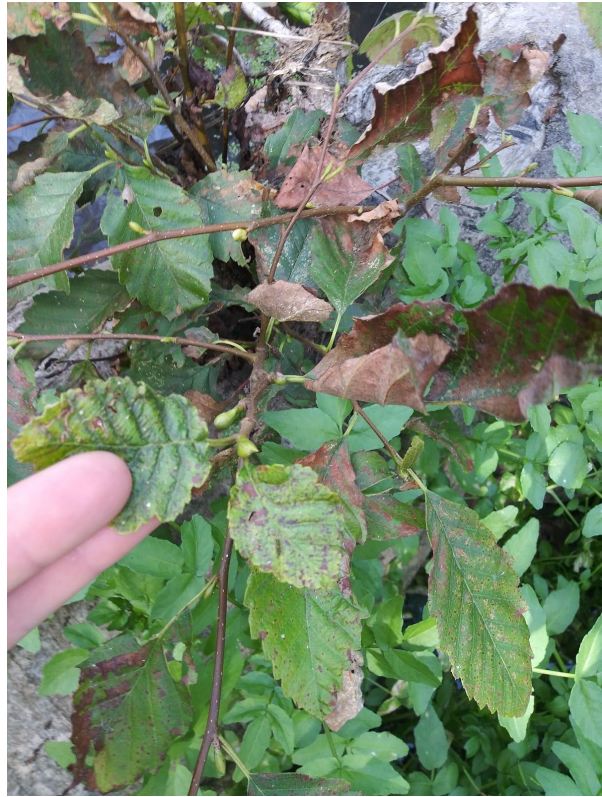
**Figure 7: Site 3 Butano Creek**

Area of new growth on one bole.  
 Photographs by Kelsey Wilson

Close up of new growth at site 3.

Two years after installation, the Butano Creek project has two Alders (Figure 7) that are partially alive, see Table 2. On site 4, a total of three root wads with six boles were used to create the LWC. Of those six boles, two showed signs of sprouting, the remaining four appeared dead with no growth. On site 3 there are two root wads with four boles. The first root wad did not appear alive, the second root wad showed some signs of sprouting on one bole.

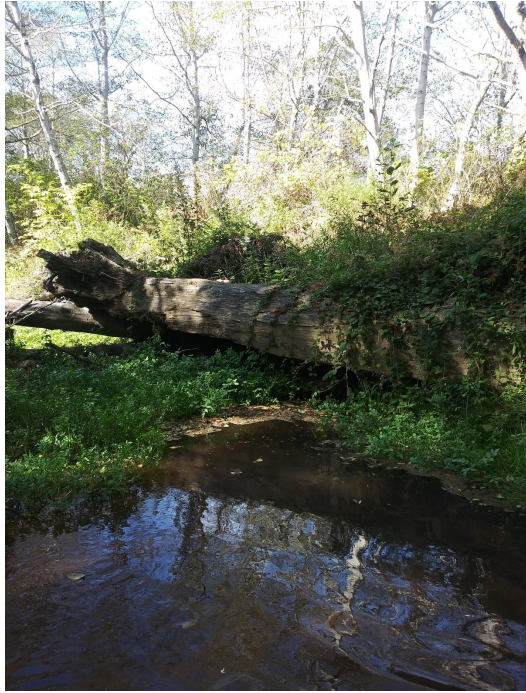
**Figure 8: Butano Creek Site 3**

A large redwood log on the bank of the creek that accumulated upstream of the LWC at site 3 in Butano Creek.  
Photograph by Kelsey Wilson

At Butano and Scotts Creek we visually confirmed that the livewood LWCs are accumulating small woody debris during storm events. We observed livewood that is no longer living has accumulated small debris. In Butano Creek, a large redwood trunk and stump have been recruited by LWCs on site 4 and 3, respectively ( Figures 8 and 9).

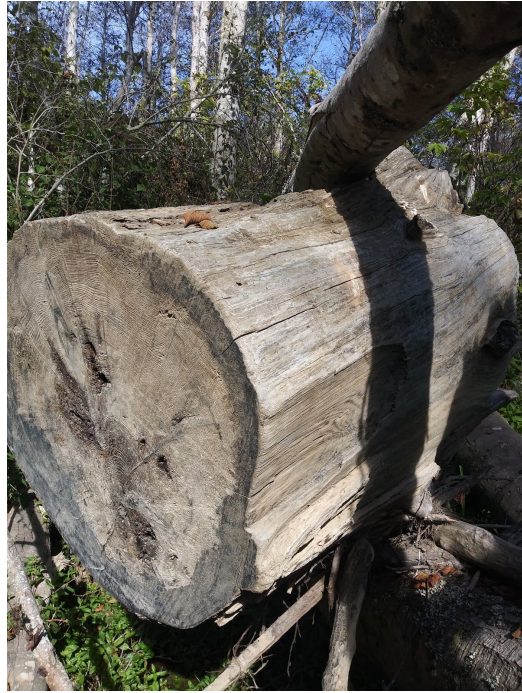
**Figure 9: Butano Creek Site 4**

A large stump accumulated between the two alder boles at site 3 in Butano Creek.  
Photograph by Kelsey Wilson

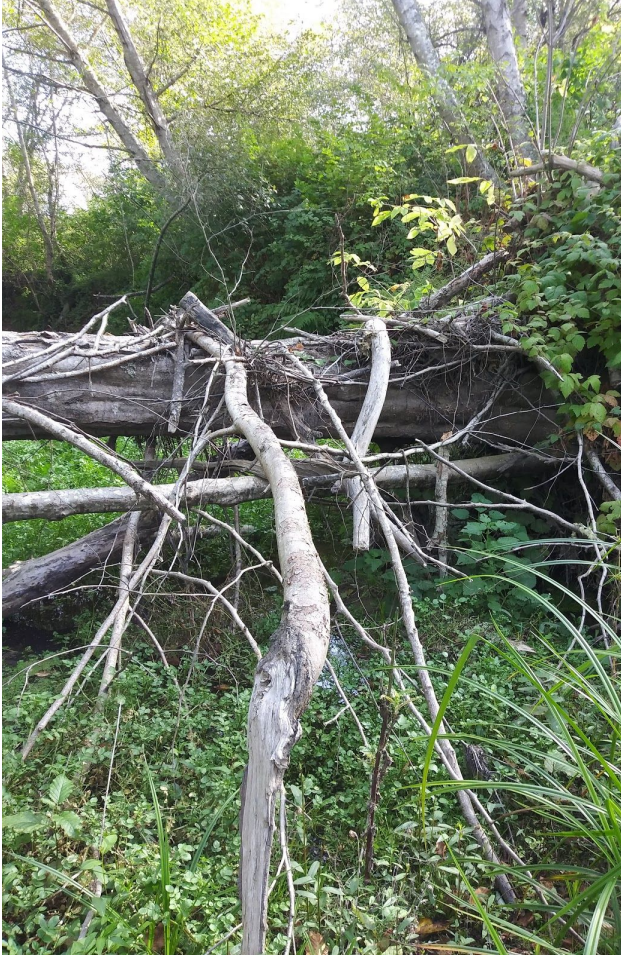
**Figure 10: Butano Creek Site 4**

Small debris has accumulated on top of the alder on site 4.

There is also small debris accumulation on site 3 (Figure 10). Phase 1 of Scotts Creek has naturally recruited additional alders as well as small debris (Figure 11). Phase 2 of Scotts Creek has accumulated small woody debris (Figure 12).

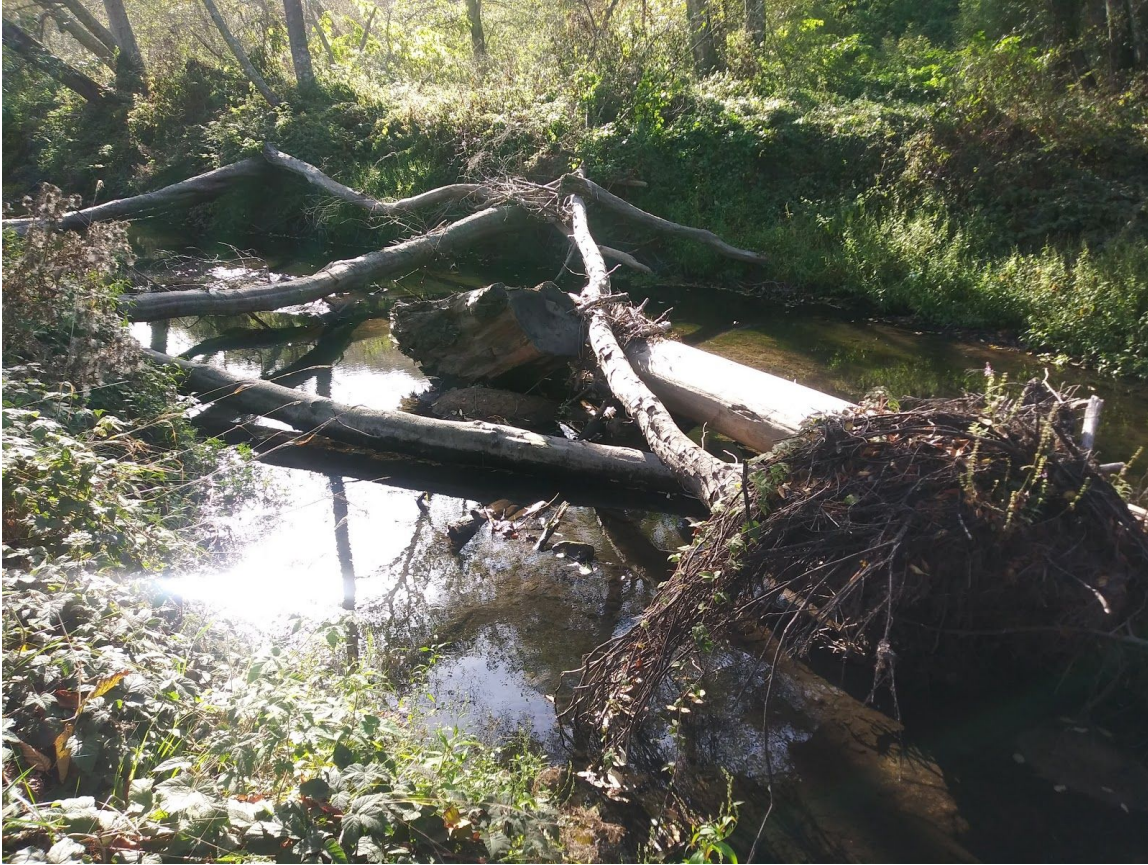
**Figure 11: Scotts Creek Phase 1**

Small debris has accumulated on the alders on Scotts Creek phase 1 LWC installation.  
Photograph by Kelsey Wilson

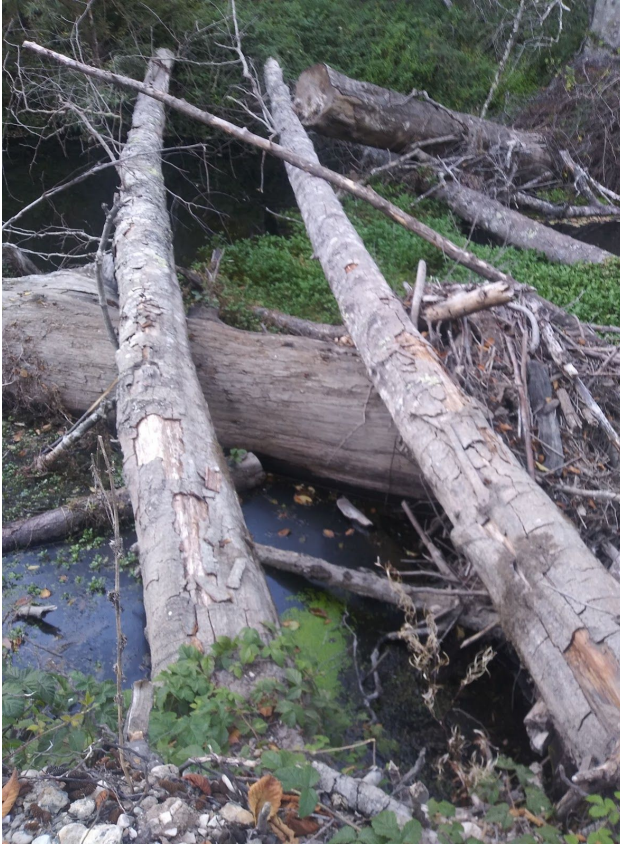
**Figure 12: Scotts Creek Phase 2**

Small debris has accumulated along the alders on Scotts Creek phase 2 LWC installation.

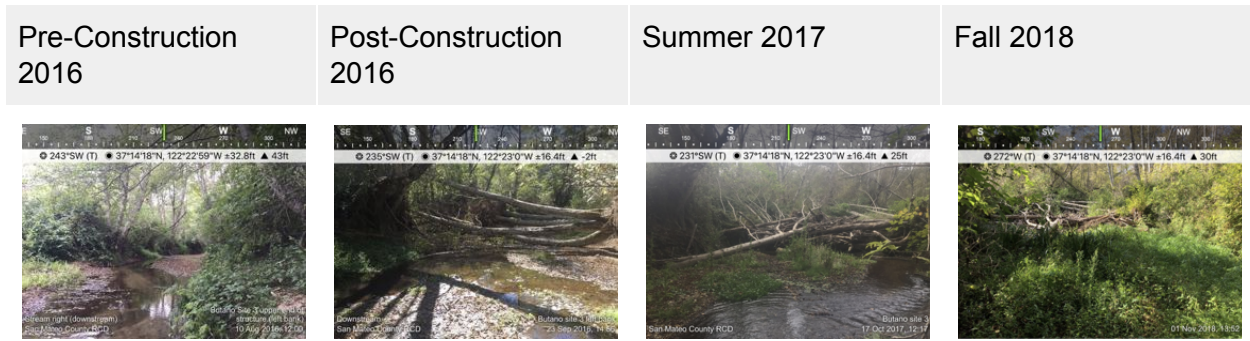
**Figure 13: Butano Creek Site 3**

A series of georeferenced photographs taken by Jared Fisher, at site 3, to track the changes of the creek before and after the restoration project.

At Butano Creek, before the LWCs were constructed, the reach was mostly planar bed with straight widening channels (Fisher, 2018). After the restoration project the reach has become more hydraulically dynamic with pools as well as a more sinuous channel. This is reflected in the project photo series for site 3 (Figure 13) and for site 4 (Figure 14).

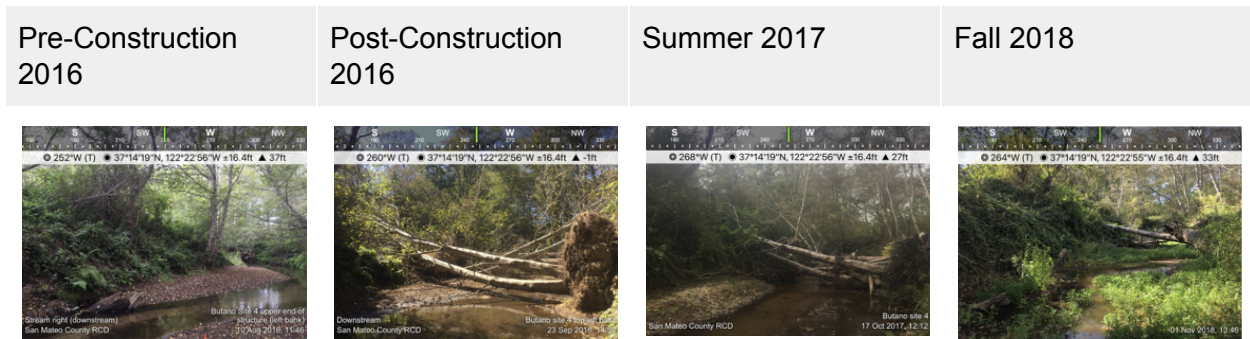
**Figure 14: Butano Creek Site 4**

A series of georeferenced photographs taken by Jared Fisher, at site 4, to track the changes of the creek before and after the restoration project.

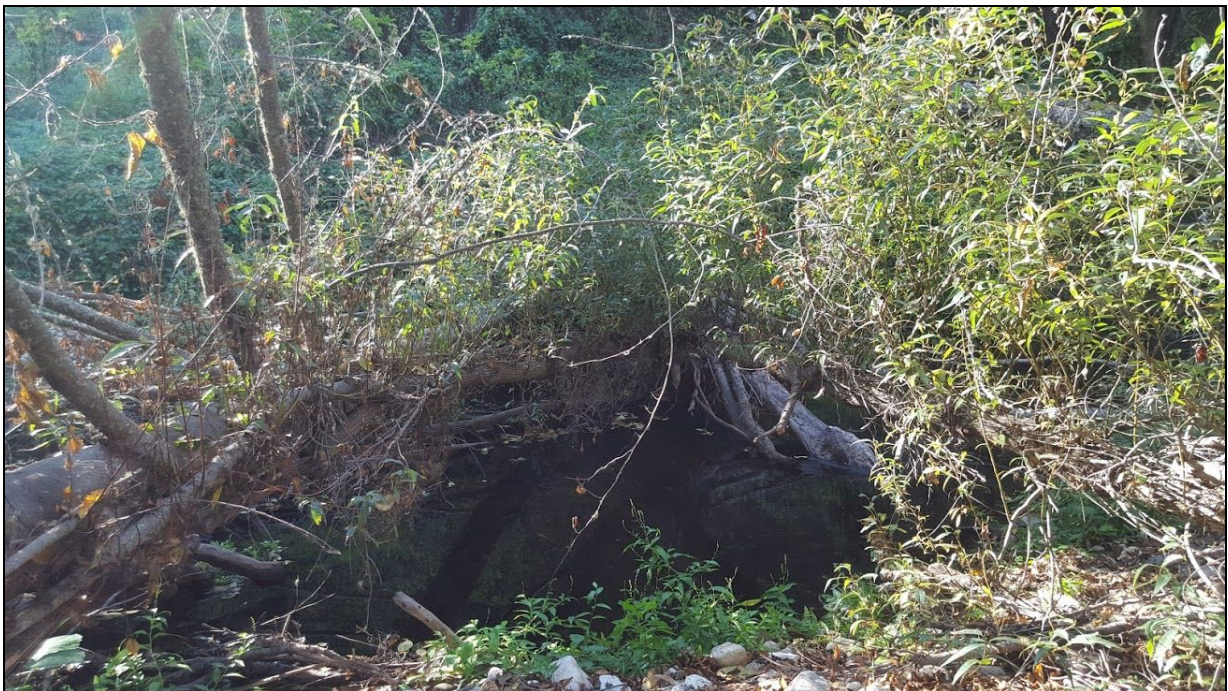
**Figure 18: Live willow recruitment**

A live willow tree has been recruited on one of the alder installation at Scotts Creek.  
Photograph by Melissa Hassler

Although the recruited alders did not have high survivorship, an interesting phenomenon we observed was that willows had taken root on some of the alder features (Figure 18). In addition to continued research on alder survivorship, an area for future investigation could involve combination installations that involve more resilient species like willow.
