Assessment of Maintenance Strategies for Bio-stabilization of Mudslides on Wildfire-affected Slopes

Ingrid Tomac, Ph.D., Assistant Professor, Structural Engineering
Department, University of California, San Diego
Jonathon Chavez de Rosas, MS Student, Structural Engineering
Department, University of California, San Diego

1. Report No. UC-ITS-2021-48		2. Government Accession No. N/A		3. Recipient's Catalog No. N/A	
4. Title and Subtitle Assessment of Maintenance Strategies for Bio-stabilization of Mudslides on Wildfire-affected Slopes				5. Report Date August 2022

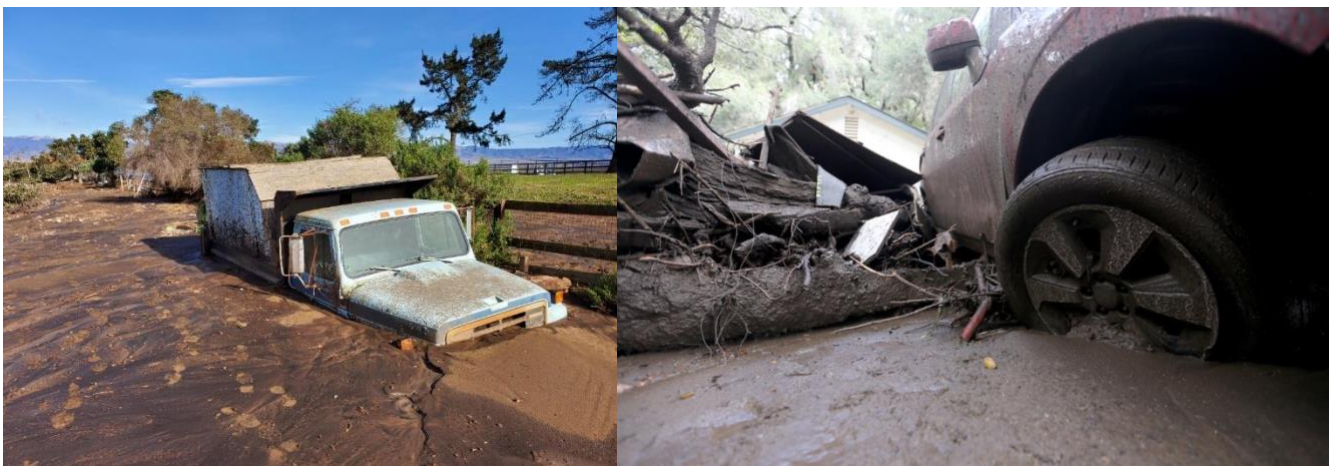
Figure 1. Mudflow damage a) along River Road in Monterey County, CA following the January 26-27 storm (Image courtesy of Matthew Thomas from USGS) and b) Silverado, CA following the January 28-29 storm (Luis Sinco / Los Angeles Times)

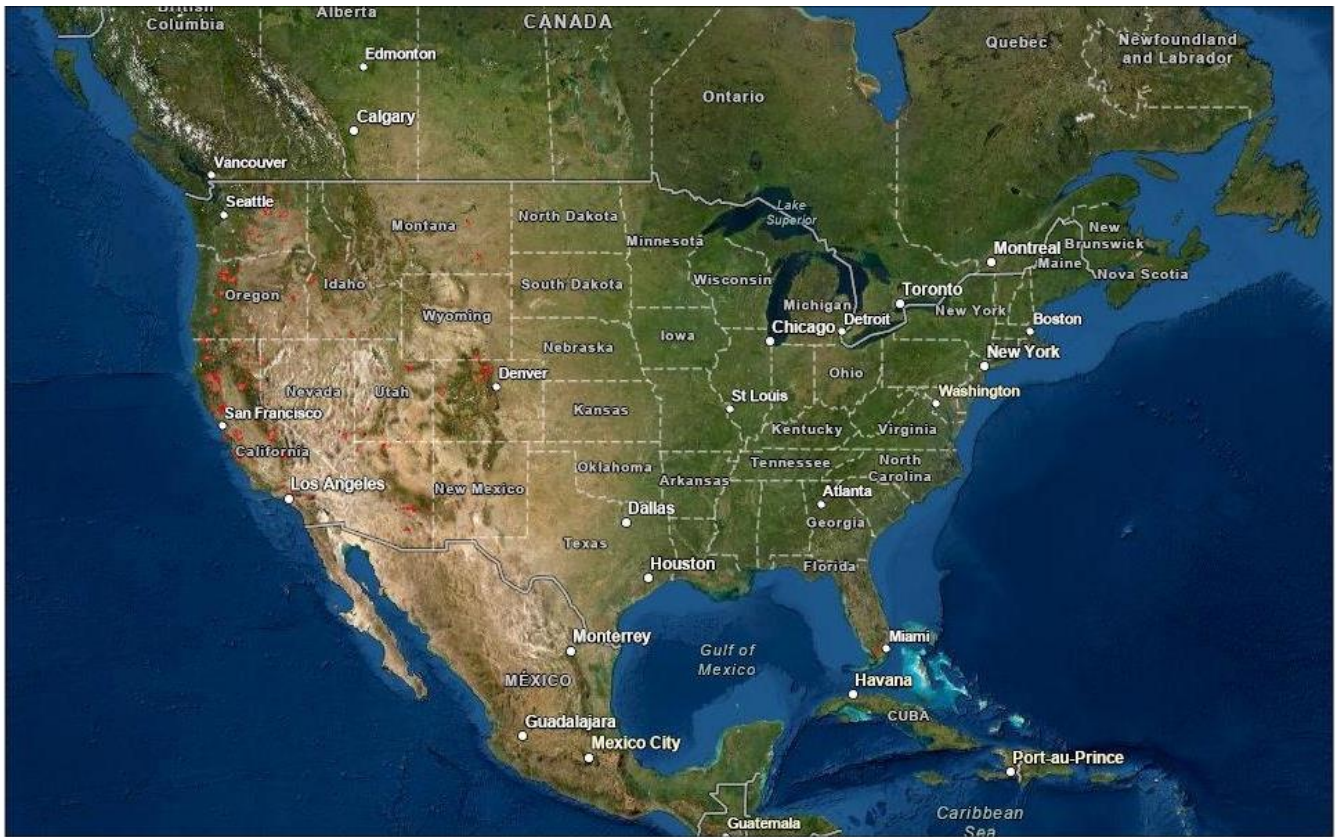
Figure 3. Burn scars in the US as of March 12, 2021 (Image obtained courtesy of US Wildfire reports by Esri Disaster Response Program)

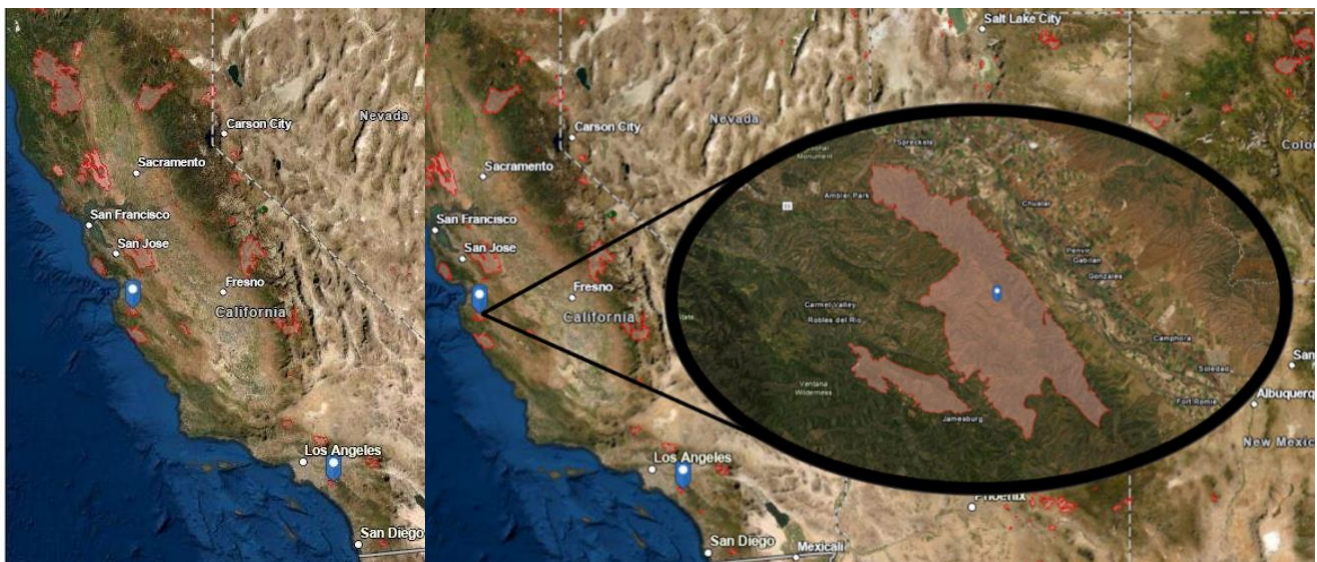
Figure 5. a) Two Southwestern U.S. burn scars focused on to gather more rain intensity data (Image obtained courtesy of US Wildfire reports by Esri Disaster Response Program) and b) River Fire burn scar in Monterey County, CA. The fire burned on August 16, 2020

While higher rainfall intensity rates were found for 15-minute intervals, the average hourly rainfall intensity rates are consistent with the average hourly rates found during this research for various post-wildfire mudflows that occurred late January of 2021. Figure 5 shows the two mudflows within California focused on to gather more rain intensity data. Through the California Nevada River Forecast Center, precipitation maps and hourly precipitation summaries for their rain station network was acquired. The text files containing the precipitation summaries were each edited to make the files readable within MATLAB. A code was created to read and extract precipitation data from the files according to the station being analyzed, and the data was then converted to metric units and plotted. Figure 5a shows the first of the two mudflows, which is a flow that occurred in Monterey County, CA along River Road in the early hours of January 27, 2021. The rain gauge station location is within the burn scar in Figure 6.

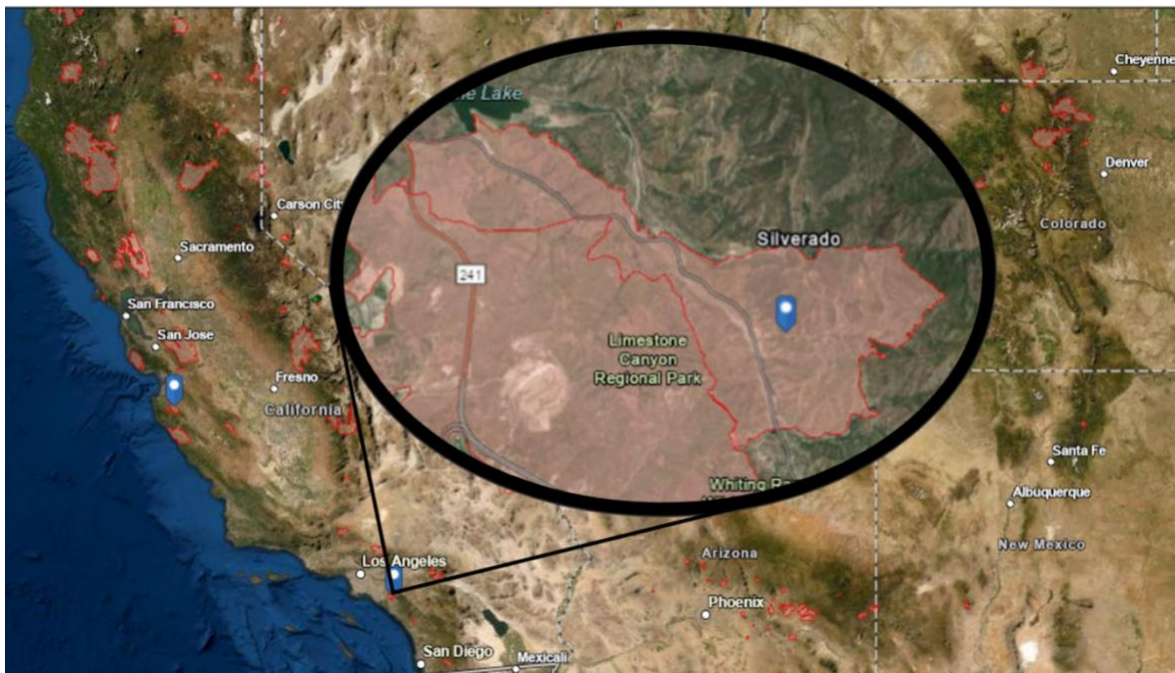
Figure 8. Bond Fire burn scar in Silverado, CA. The fire burned on December 3 through December 10, 2020

Figure 8 shows the second of the two mudflows, which is a flow that occurred in Silverado, CA in the last hour of January 28, 2021. The rain gauge station location is within the burn scar and can be found in Figure 9. As seen in Figure 10, the maximum hourly rainfall intensity was 12.19 mm/hr at 11 PM PST on January 27, which was around the time the flow is thought to have started. The cumulative rainfall after the storm was 39.4 mm.

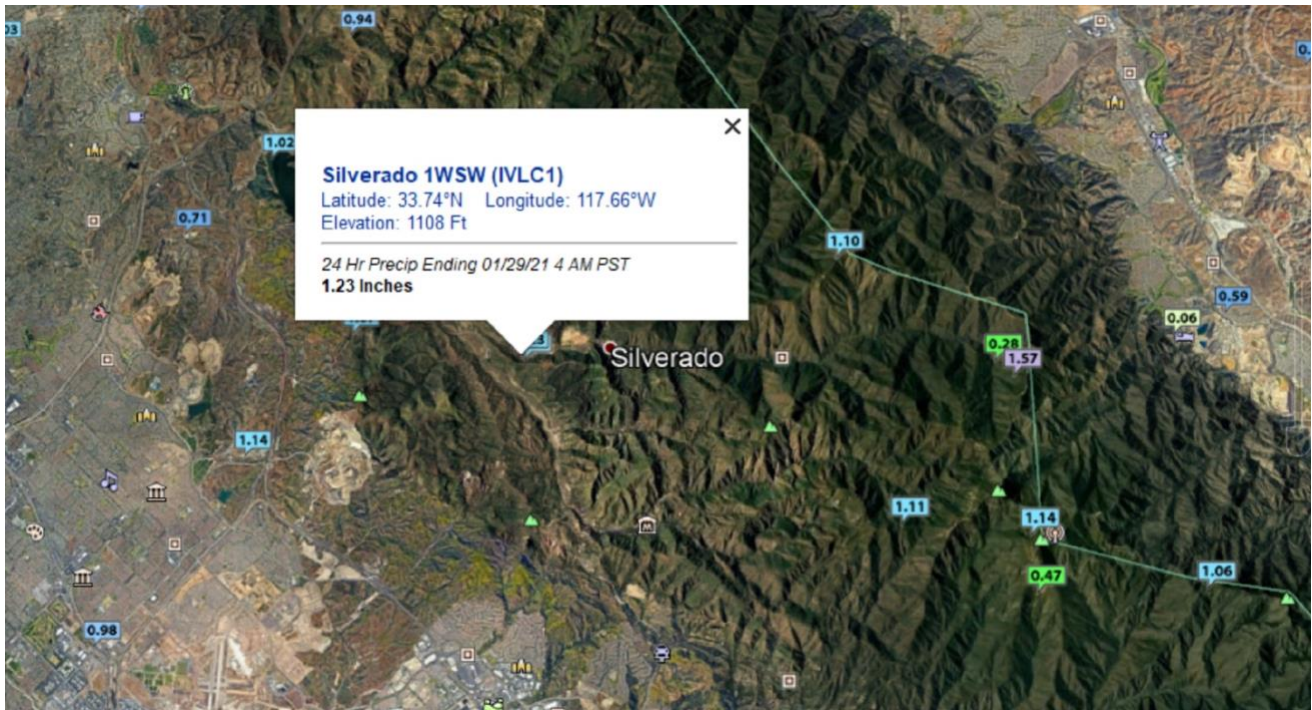
Figure 9. Rain gauge station location within the Bond Fire burn scar (Image obtained courtesy of NOAA)

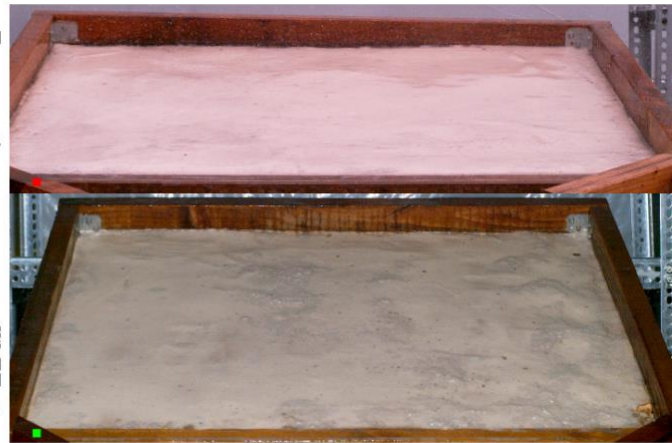
b. 24h cured 3% XG fine sand. Top: 10° Bottom: 25°

Figure 18. Water runoff with 24h cured XG percentage for varying slope angles

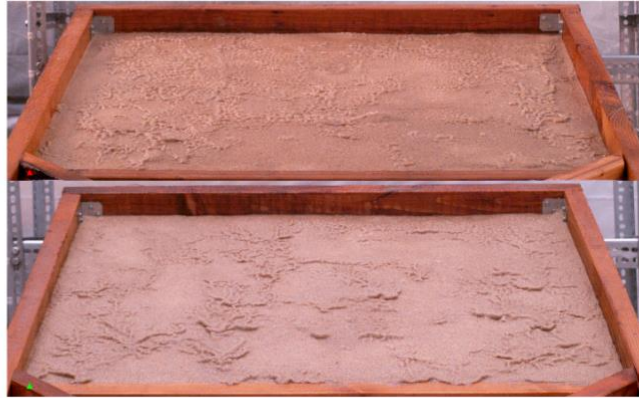
b. 24h cured 3% XG medium sand. Top: 15° Bottom: 20°

Figure 19. Water runoff with slope angle for varying 24h cured XG percentages

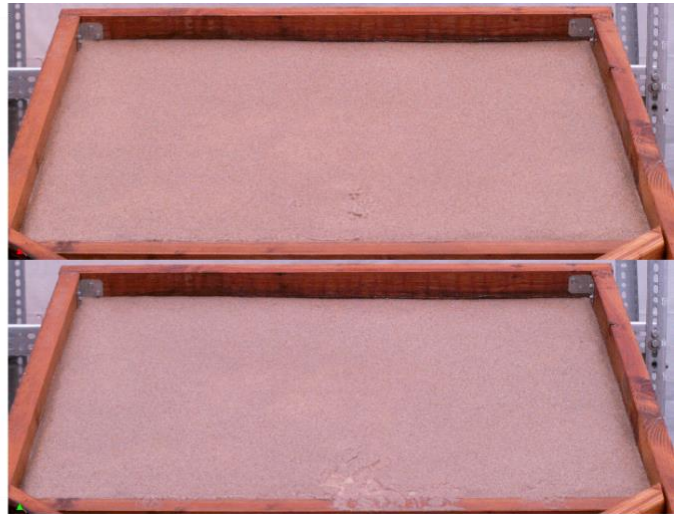
b. 24h cured 1% X.G. medium sand at 25°. Top: 15 min Bottom: 20 min

Figure 22. Sand runoff with time for rain intensities of 15 mm/hr at a 25° angle

Raining duration changes surfaces morphology, erosion, and water runoff. Looking at Figure 22, the lower intensity of the 20 mm/hr experiment is without erosion after the initial 15 minutes. Still, between 15 and 30 minutes, there is erosion, and a few sliding patches fail in both the 1% medium and the 3% fine sand, while the 1% fine and 3% coarse and medium remain uneroded. Figure 22b shows how the surface morphology could change as the rain duration increases. The example shows that the erosion stems from the developed ridge, even though it is small. Much like seen in the previous section, when the surface morphology type changes from ridges to another kind, there is an increase in sand runoff. On the contrary, Figure 23 shows that the water runoff for the lower rain intensity of 15 mm/hr remained consistent with little change in slopes for the duration of the experiment. The higher the XG percentage, the lower the water runoff for cured medium sand. For cured fine sand, the higher the XG percentage, the higher the water runoff, and the most water runoff comes from cured coarse sand with 3% XG.

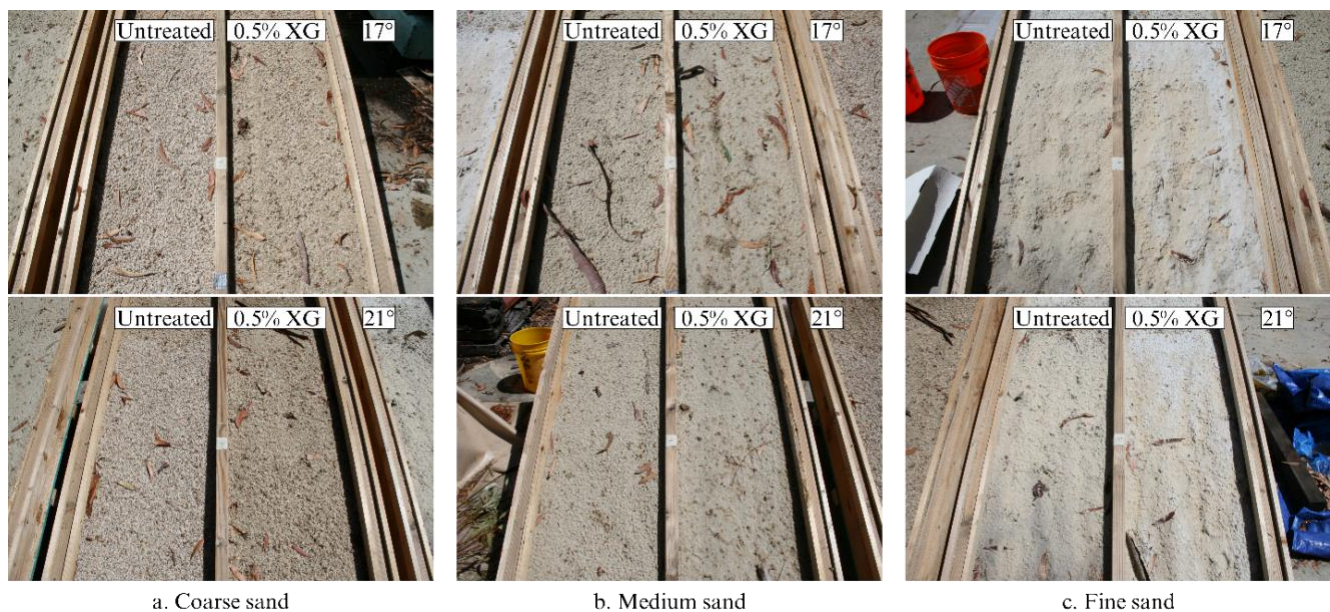
Figure 26. Surface morphology after RE 3 on September 10, 2021

The first two REs did not cause significant changes to the slopes as the rain durations were short and the rain intensities were low. The initial RE 1 rain wetted the XG coating on the sand particles and formed a hardened crust layer. After RE 2, raccoons walked along the surface of two slopes: the treated coarse slope, and the untreated fine slope, both at 17°. The treated coarse sand was not largely affected by animal footprints. Still, the untreated fine sand contained a section of the displaced hydrophobic layer, exposing the less hydrophobic layer underneath. However, this did not affect the overall trends of the erosion, as the 17° fine slopes data in Table 6 reveal that the 0.5% XG flume still experienced higher erosion than its untreated counterpart during RE 3 and the treated coarse sand had less erosion.

RE 3 with a max. 15-min rain intensity of 9.14 mm/hr caused the first significant change in surface morphology, leading to a larger erosion yield for each slope and sand type. Figure 26a, Figure 26b, and Figure 26c depict the surface morphology changes when comparing the sand types. Coarse slopes showed minor changes. Some channels began to form on medium slopes, while deep channels already formed on fine slopes. As the rain events continued, the channels seen in the fine sand slopes became more prevalent and extremely large (Figure 27a). With a cured layer from the XG after continuous rain, more raccoon activity broke apart the surface layer and created more drastic surface conditions exposing the hydrophobic layers susceptible to mudflows (Figure 27b).
