Baxter Creek Gateway Park Restoration: A Post-Project Appraisal

A Post-project appraisal

LD ARCH 227 - Restoration of Rivers and Streams

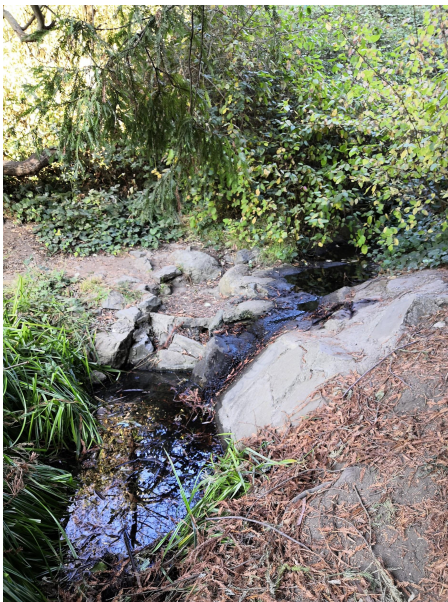
Figure 2.4.1: Baxter Creek Site Reference Map

During the dry season, the midstream and downstream of the channel was dried out (figure 3.1.3), only the part of upstream have still water but most of which are covered by aquatic vegetation. Some parts of the creek bed are higher and intended to create the lateral connection (Figure 2.4.1). But as a result, these engineered weirs stop water flowing and create a small pond in the dry season (Figure 3.1.4).

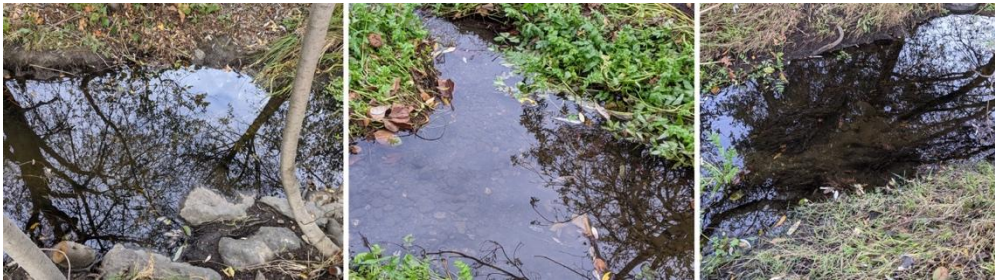
The material of the channel contains silt, cobbles, gravel and boulders, and they have different composition in different segments initially (Figure 3.1.6). In the bed material from 13 years later, we still can see the different size of the bed material in the channel (Figure 3.1.5), but the materials are not distributed regularly as the boulders were expected to be.

Figure 3.1.5 different creek bed material (base on the field visit on Dec.3rd)

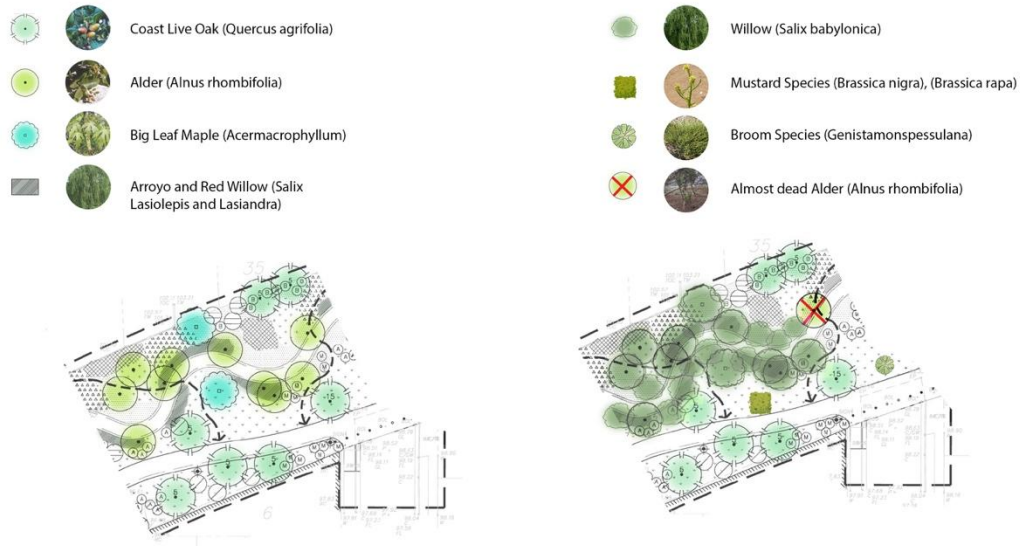
The trees shown in the planting plan (Figure 3.3.1) have some are in good condition, and some are not. The Oak grows in good shape, but the Alder and big leaf maple are hard to recognize, most of them are dead and not functional anymore (Figure 3.3.2). Moreover, the "container stock" bushes were hard to discover in the selected area, where there was just bare soil and some covered with grass. According to species studies, we found several invasive species in our chosen field, such as Mustard Species, which grows along the road, and Broom Species, which grow flourishingly in our site. Another significant issue is the expansion of willows, which take over space and shading large amounts of area, thus competing for the sun and nutrition with other riparian plants and blocked the creek view.

Figure 3.3.1: Plant species evolution

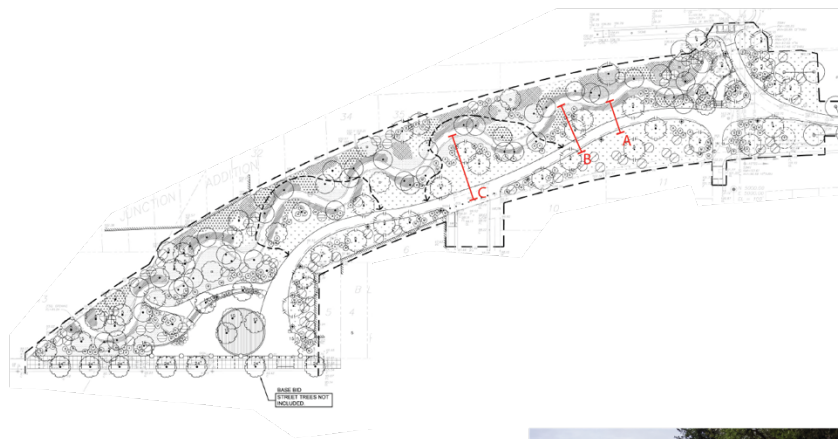
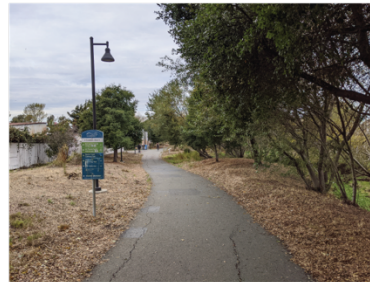
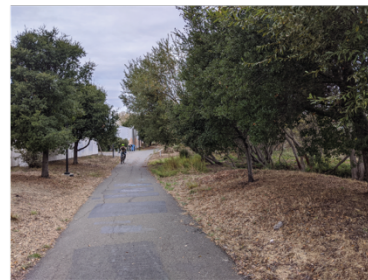
For the longitudinal accessibility, there are many activities, such as walking, biking, running, walking the dog, etc. The space experience is changing along the path via the distance from the channel and the topography changes. The crown of trees frame the edge of the space, from the photo and section, we can see there are three typical space ratio, 1:1, 1:2, 1:3, so when people walking through the park, the feeling of space are changing, bring people a good experience (Figure 3.5.2).

Figure 3.5.2 Section and space

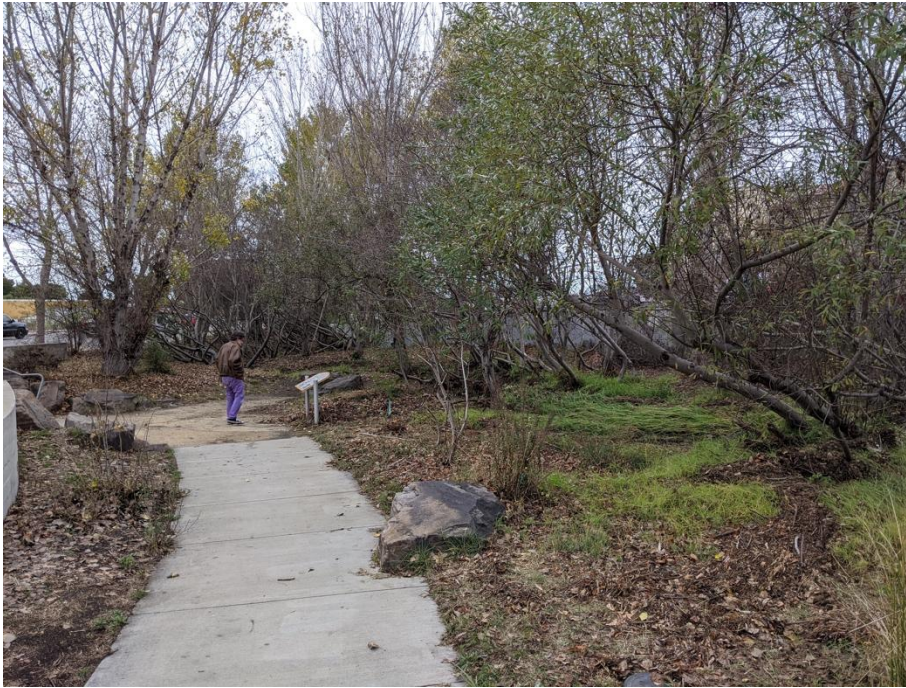
Figure 3.5.6 sitting chair of the park

We also found that there are not so many people staying in the park. Even though there are some people attracted by the creek or read the information boards, there are few people choosing to sit in the park and spending longer time there. The park has a lack of sitting elements, there are only two chairs placed in the entrance of the park (figure 3.5.6), but when I

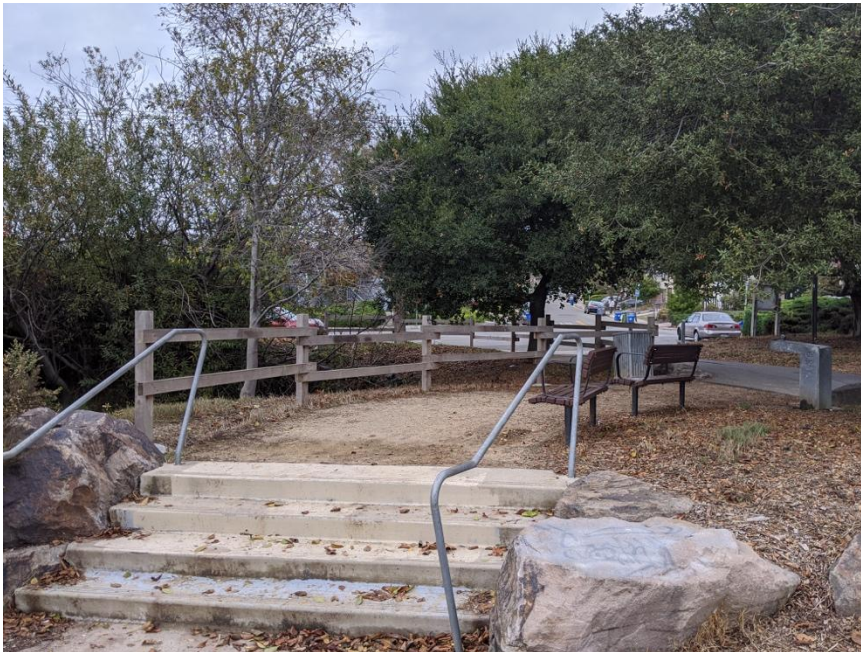
sit on the chair, I can only see the crown of the trees but not the channel. On the other end of the park, some stones are providing sitting possibilities, but the height of rocks is not comfortable to sit on it (Figure 3.5.7)

the west end of the trail, the way intersects with the channel, but nothing happens there, I think it will be much more helpful if putting a deck or steps into the water. For the lateral accessibility, the proposed small path has already covered by vegetation, and engineered weirs are also flooded by water during the wet season, make people hard to cross the channel. And the weir stop water flowing during the dry season, cause the water stagnant, lead to the channel covered by the aquatic plants. And the place also lacks water activities. The park doesn't have a place for people to play with water or access to water. Moreover, the park has not enough place for people to sit and lean, which also explains why there have few people stay in the site for a more extended period.

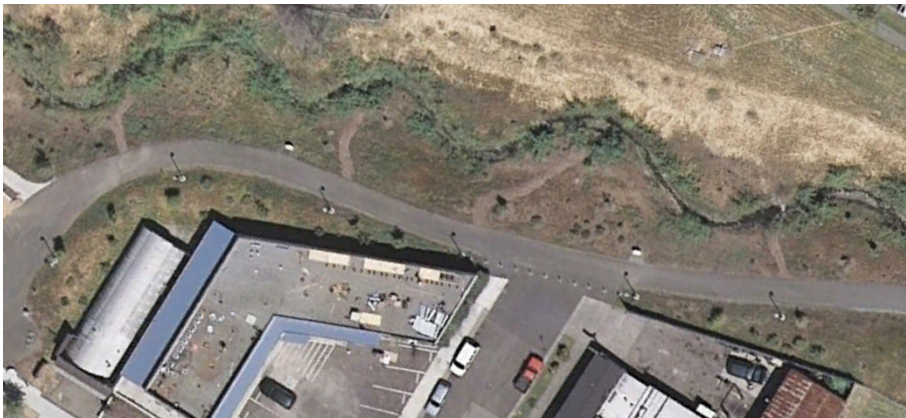
Figure 5.1

Vegetation: For the planting design, the project didn't plant so many trees in the channel, some parts of the channel are in the shading area and some parts are not shaded (Figure 5.5). Most of the trees grow in the floodplain and upland (Figure 5.1, Figure 5.2). The area of the upper channel is planted by wet plants (Figure 5.2).

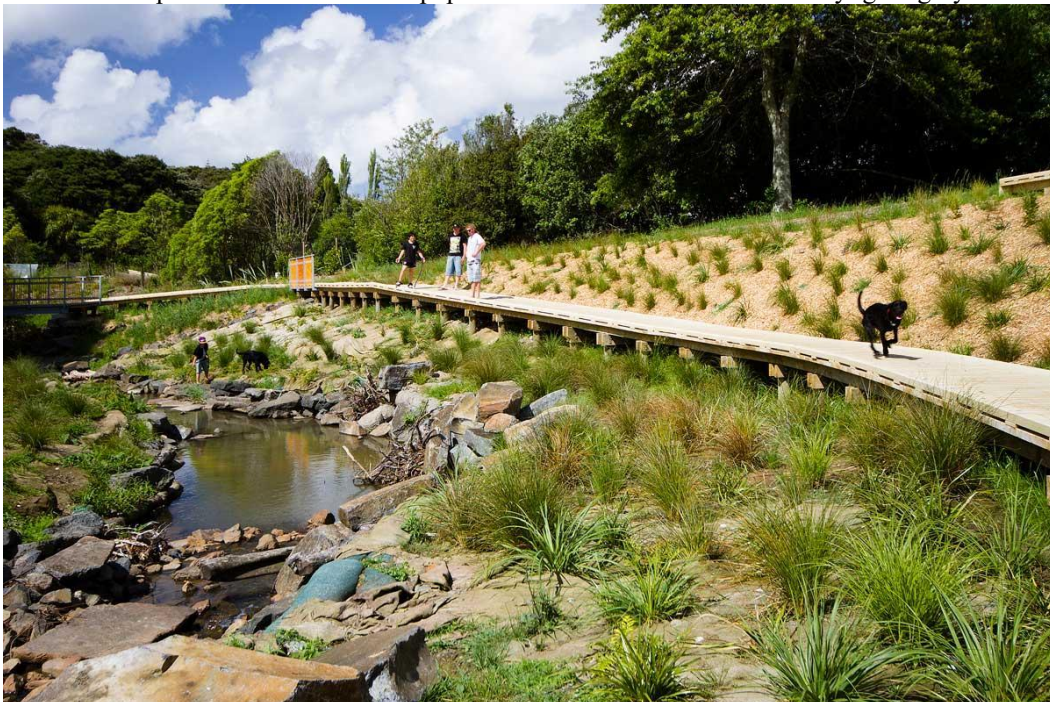
Figure 5.3

Creek bed and bank: The material of the stream channel is gravel, boulders, and debris of woodchucks and branches, and the upper bank material is clay and silt covered by vegetation (Figure 5.3). Boulders and debris create step pools not only slow down the speed of water flow, create habitat for water creatures but also provide users a place to rest (Figure 5.3, Figure 5.4).

Public accessibility: From the point of longitude accessibility, the project using wood piers as the pathway along the creek, not only has an aesthetic value and not blocking the water flow on the surface. The path sometimes far away from the channel and sometimes close to the channel and sometimes cross through the channel by bridges (Figure 5.1, Figure5.2), create a variable walking experience for the users. For the lateral connections, the open channel area encourages people to contact to the water, the boulders and debris also create a possibility to cross the channel and can be used as sitting elements for users (Figure5.5 figure 5.3, Figure 5.4).
