Performance of Drained and Undrained Flexible Pavement Structures Under Wet Conditions
Test Data From Accelerated Pavement Test Section 543-Drained

UCD-ITS-RR-04-6

April 2004

Draft Report Prepared for
California Department of Transportation

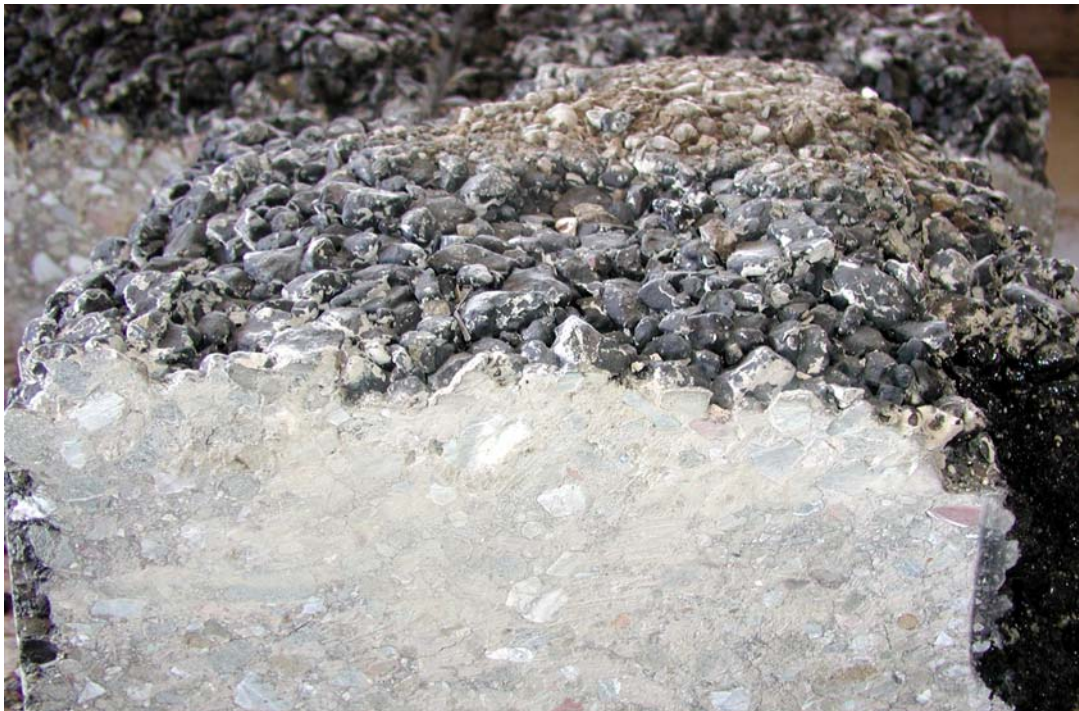
Note: Sample is shown upside-down (ATPB at top of image).

Figure 40b. ATPB slab from another HVS test section demonstrating appearance of ATPB without fines infiltration.

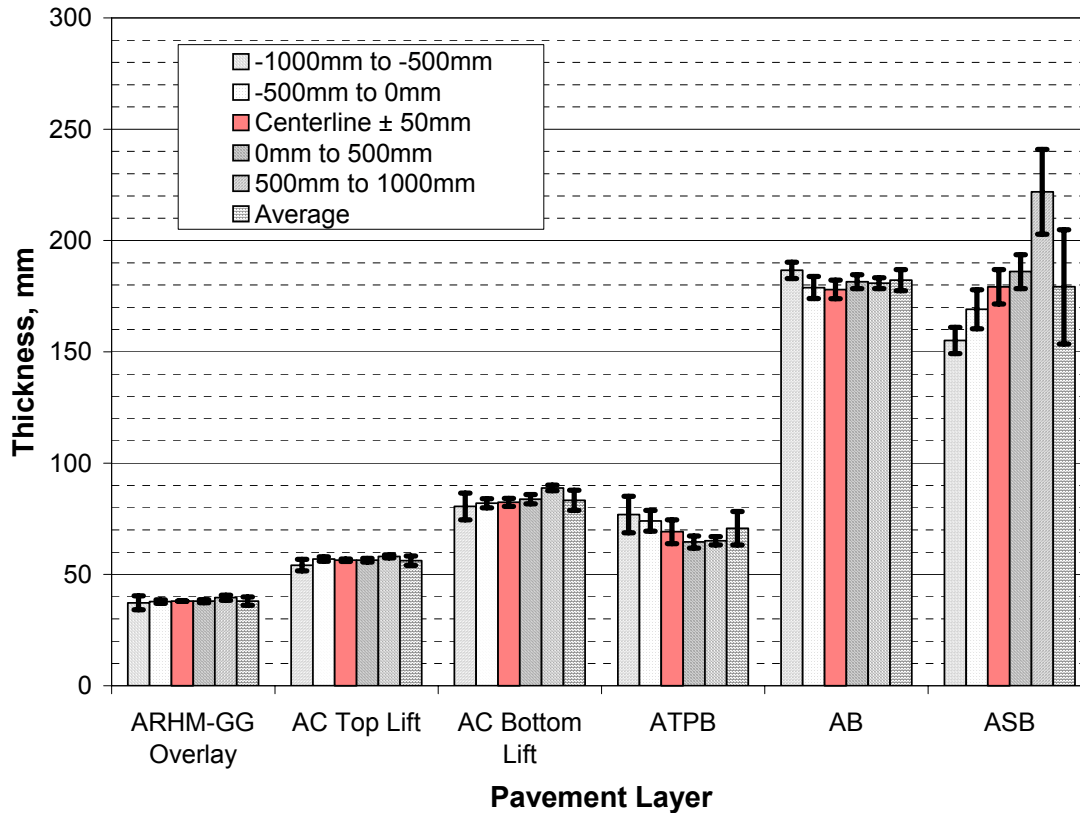
Figure 50. Summary of layer thicknesses across transverse distance of trench.

Larger variability was found for the ATPB and aggregate base and subbase layers. Data from outside the trafficked area (between –1000 and –500 and between 500 and 1000) indicate thickness variability of the ATPB during construction. On average, the difference between the two non-trafficked areas was between 12 to 17 mm. Standard deviation for the ATPB layer across the two faces was 8 mm. Centerline thicknesses for the ATPB are thinner than the thicknesses across the non-trafficked area between –1000 to –500 and thicker than the
