Construction and Test Results on Dowel Bar Retrofit HVS Test Sections 556FD, 557FD, 558FD, and 559FD: State Route 14, Los Angeles County at Palmdale

Research Report: UCPRC-RR-2006-02

Yi Bian, John Harvey, and Abdikarim Ali

This work was completed as part of Partnered Pavement Research Program Strategic Plan Item 4.8 “Dowel Bar Retrofit of Rigid Pavements”

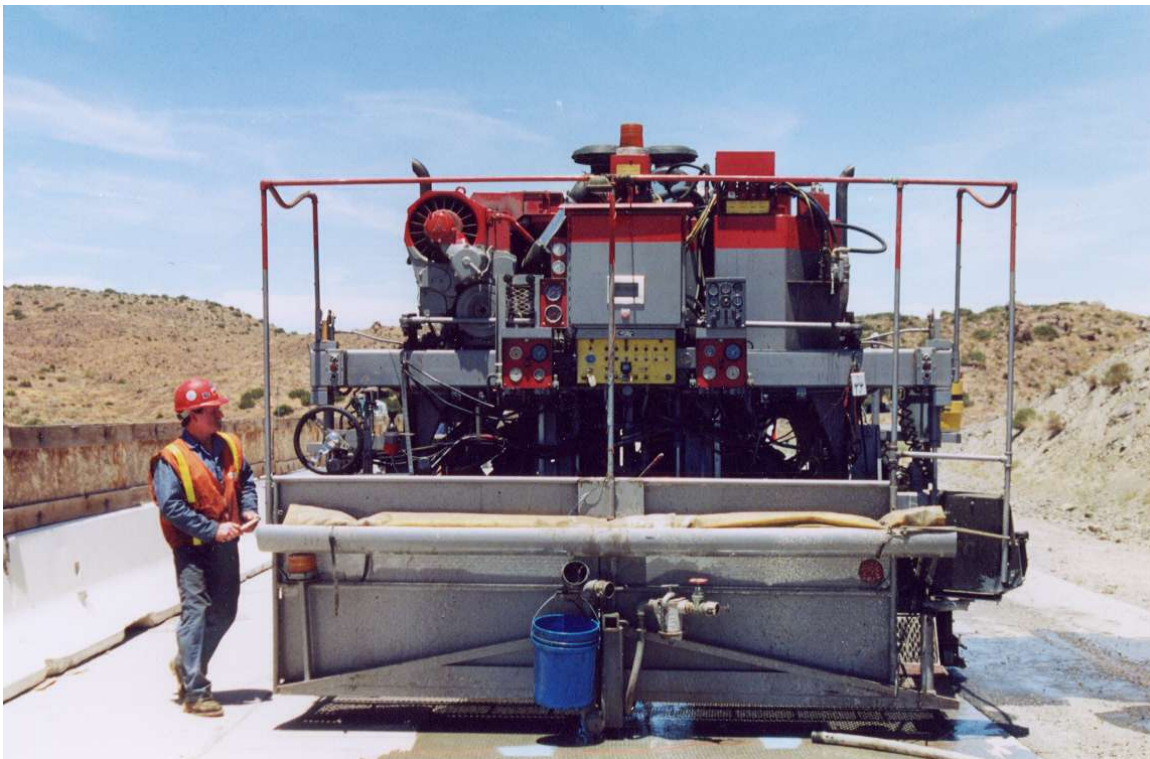
Figure 2.7. Dowel bar slot cutting machine (rear view).

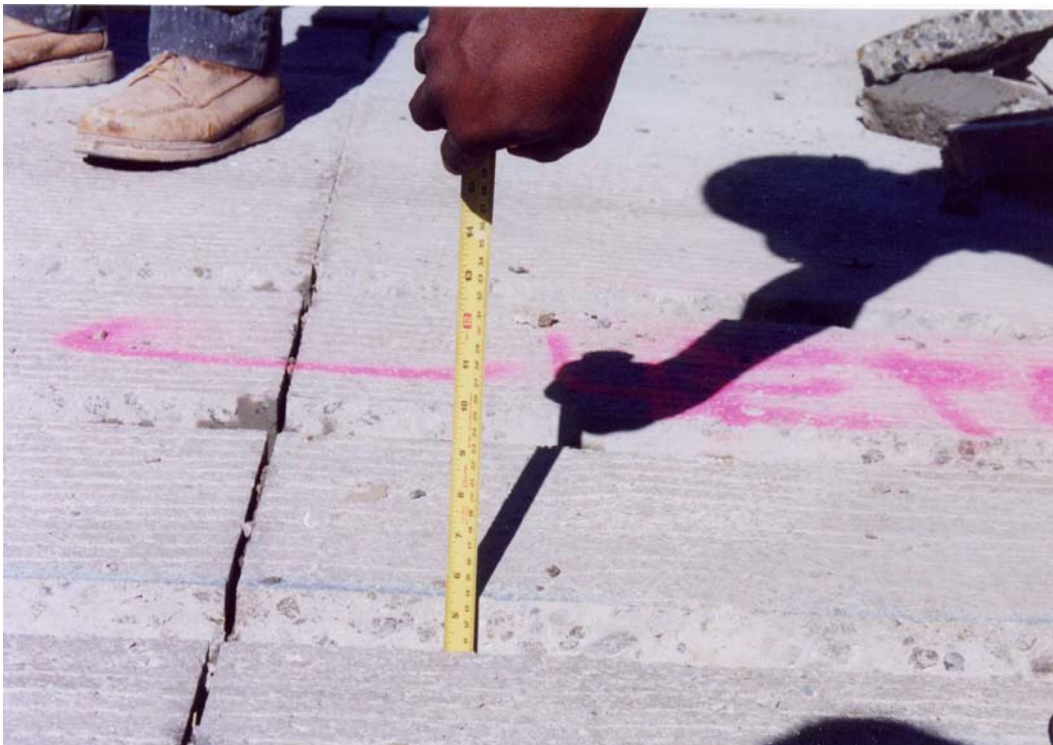
Figure 2.20. Checking dowel bar depth and uniformity of depth.

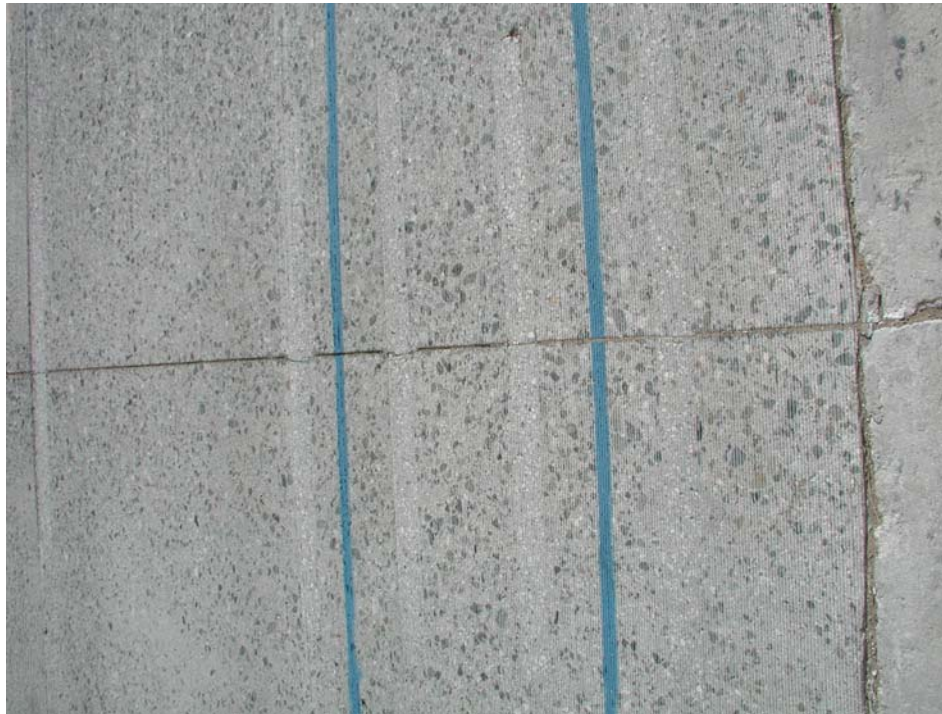
Figure 2.34. Photograph of Joint 38, Section 556FD, in March 2002, showing generally good condition. (Blue line painted on surface shows HVS wheelpath).

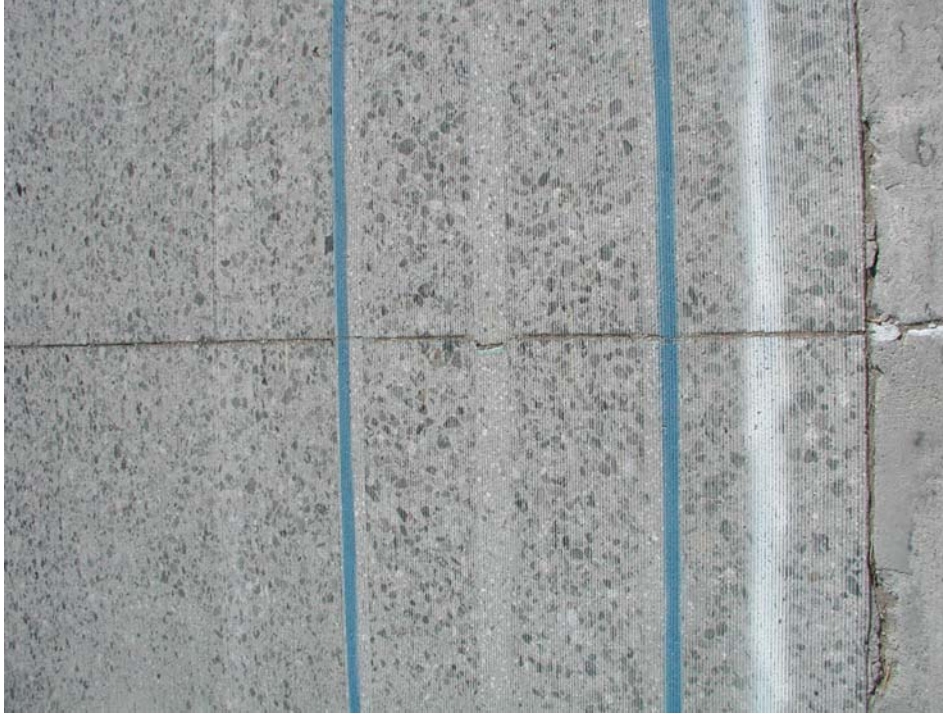
Figure 2.35. Photograph of Joint 36, Section 557FD, in March 2002, showing generally good condition.

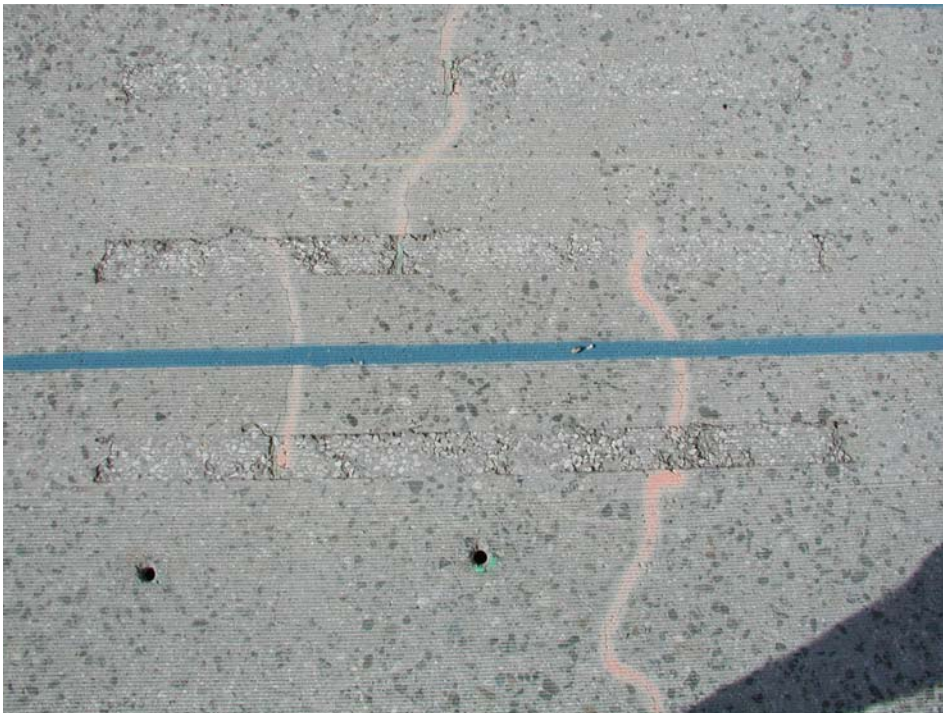
Figure 2.36. Photograph of Crack 1, Section 559FD, in March 2002, showing lack of fines, transverse cracking, and separation at edges.

Grout appearance. Some slots showed what appeared to be a lack of fine materials in the grout. Inspection two years after construction and after all HVS testing was completed showed some transverse cracking in the grout in the dowel slots. The grout did not come out of any of the slots, and the cracks remained tightly interlocked.

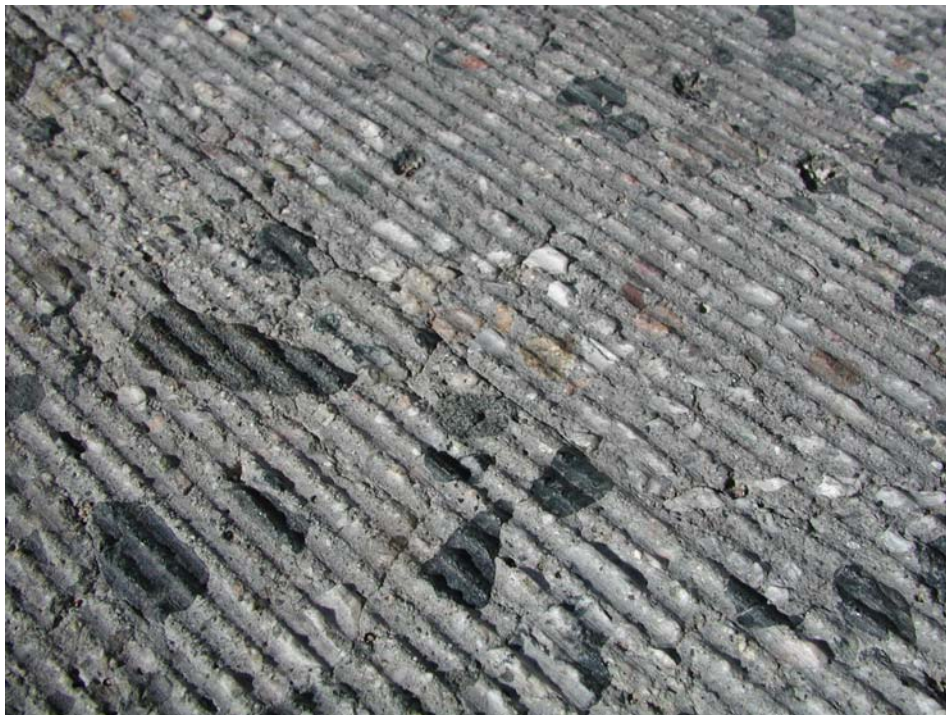
Figure 2.38. Photograph of DBR slot, Section 557FD, in June 2003, showing tight transverse cracks in grout and slab.

Photographs taken in June 2003, two years after construction and after HVS testing was completed on all sections, showed some transverse cracking in the grout in the dowel slots. The grout did not come out of any of the slots, and the cracks remained tightly interlocked. This can be seen in Figure 2.38, which shows transverse cracking in the grout and slab and a very small amount of separation of the grout from the slab. Figure 2.39 shows another slot with some separation of grout and slab. Figure 2.40 shows transverse cracks in the grout.

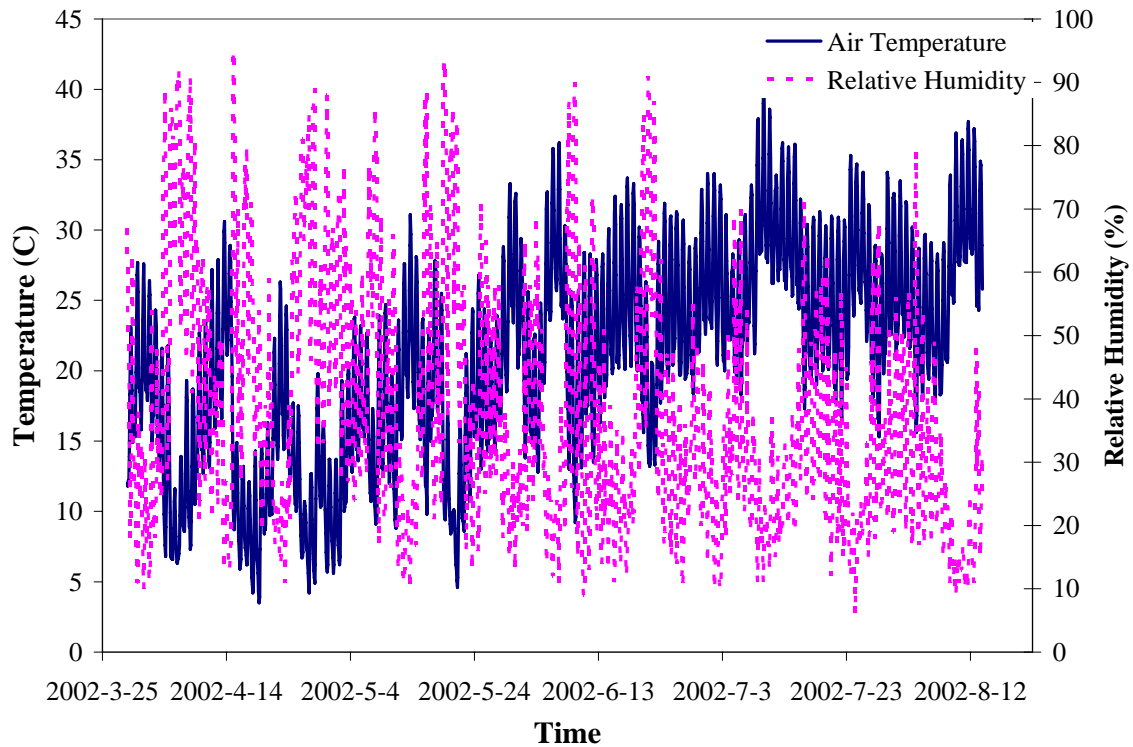
Figure 6.6. Air Temperature and relative humidity on Section 556FD during HVS testing.

Air temperature and relative humidity during testing of 556FD are shown in Figure 6.6. Extreme environmental conditions for 556FD are summarized in Table 6.2. The environmental conditions during this test can be summarized as warm and continuously dry. Only 6 days out of the total 137 testing days had measurable rainfall. Mid-slab temperatures and slab temperature gradients are summarized in Figure 6.7 and Figure 6.8, respectively.

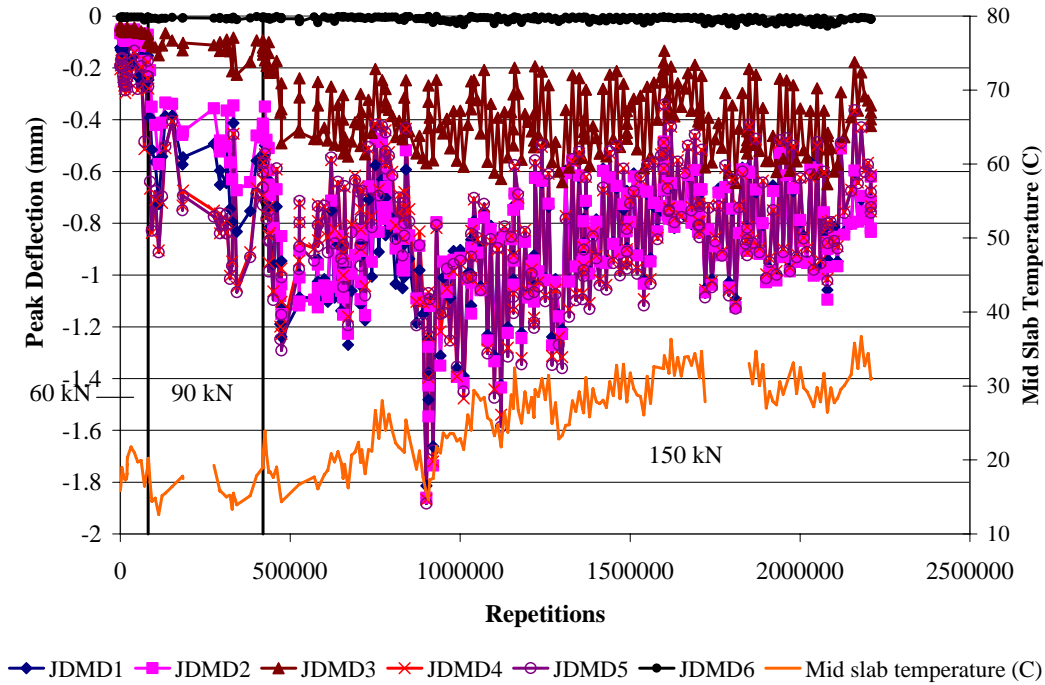
Figure 6.9. Maximum joint deflections under HVS trafficking load on Section 556FD.

From both Figure 6.9 and Figure 6.10, the horizontal deflections (JDMD 6) remain fairly constant throughout the whole HVS test. Vertical deflections midway along the longitudinal edge of the slab (JDMD 3) follow the same trend with the other vertical deflections at the transverse joints, and they also change with fluctuating mid-slab temperature: they increase with lower temperature and decrease with higher temperature.

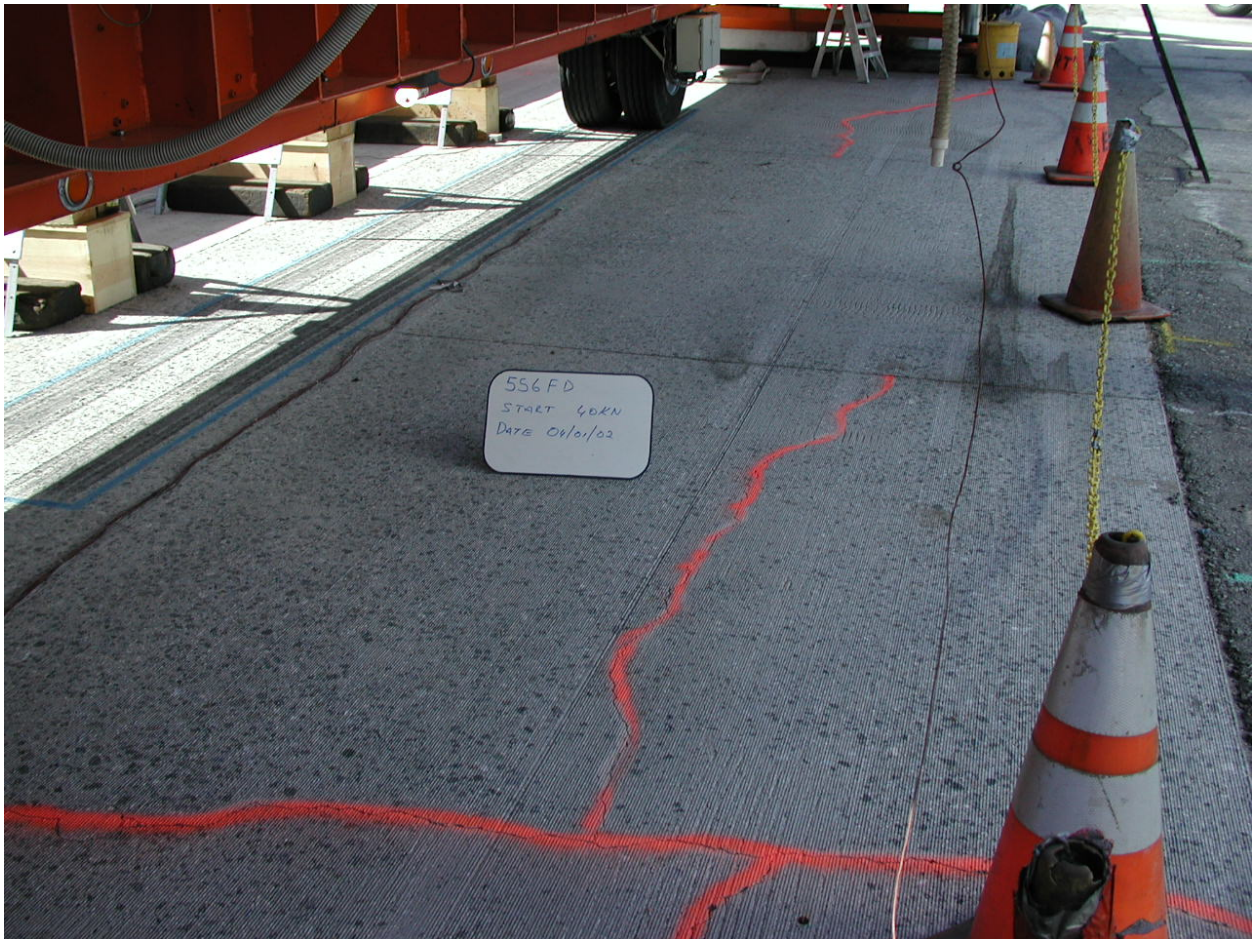
Figure 6.21. Initial condition of slabs in Section 556FD with existing cracking in adjacent slabs marked in red.

The initial condition of Section 556FD is shown in Figure 6.21. The existing cracks in Slabs 38 and 40, the slabs on either end of the center slab, can be seen in the photograph. Figure 6.22 shows the transverse crack that appeared on the surface of Slab 40 at the end of the wheelpath after 1.291 million load repetitions. Figure 6.23 shows the transverse crack that appeared on the surface of the center slab (Slab 39) after 1.759 million repetitions, indicating fatigue failure of the concrete slab. Figure 6.24 shows propagation of the transverse crack towards the transverse joint with additional loading to 2.064 million repetitions. This turning of the transverse crack towards the joint with additional propagation occurred on all other prior HVS test sections at Palmdale and is due to the use of a half axle as opposed to a full axle (24). The final state of cracking in the section is shown in Figure 6.25, and the final state of Joint 39 is shown in Figure 6.26. Final condition of Slabs 38, 39, and 40 is shown in overhead photos in Appendix B.

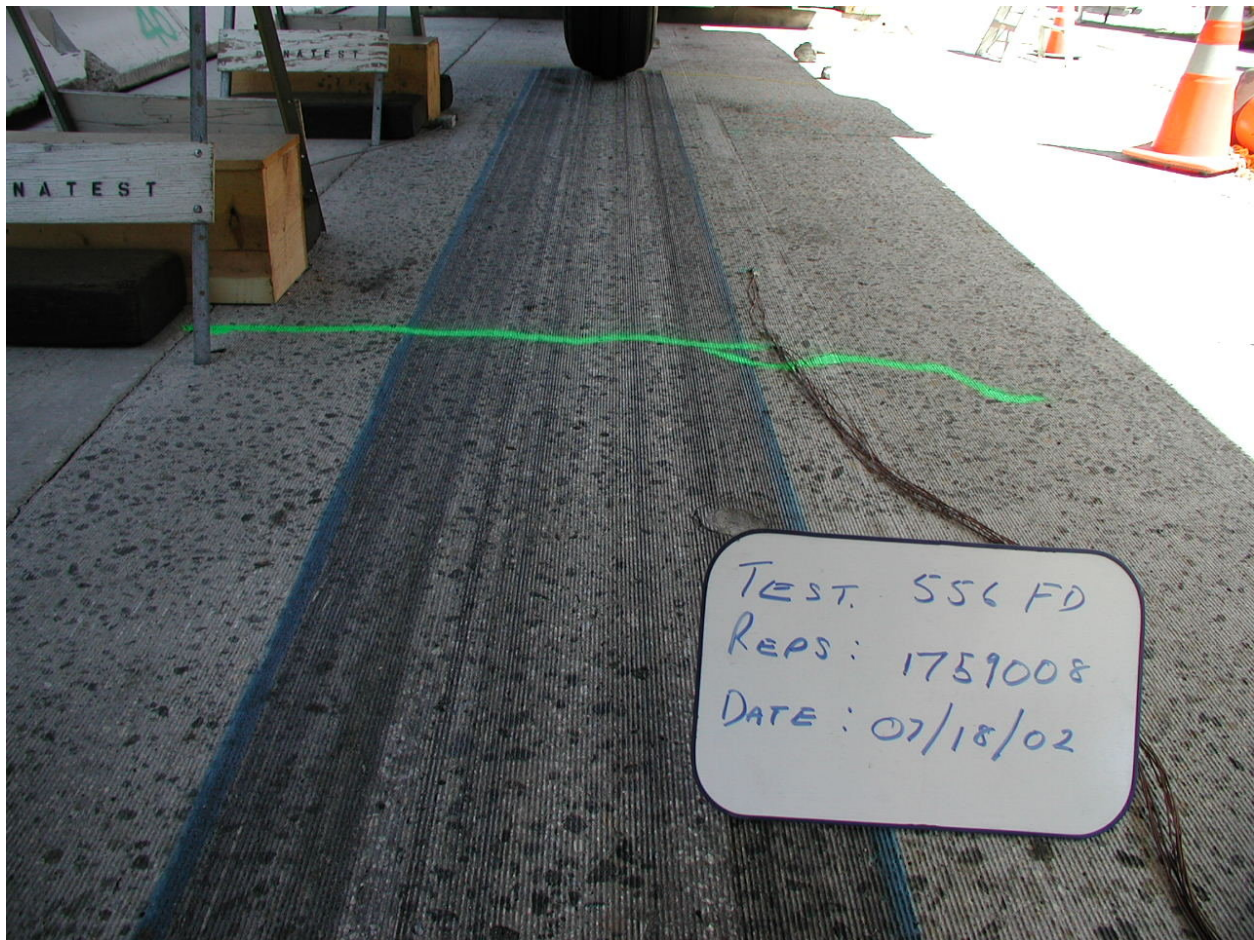
Figure 6.23. Cracking in the center slab (Slab 39) after 1.759 million repetitions.

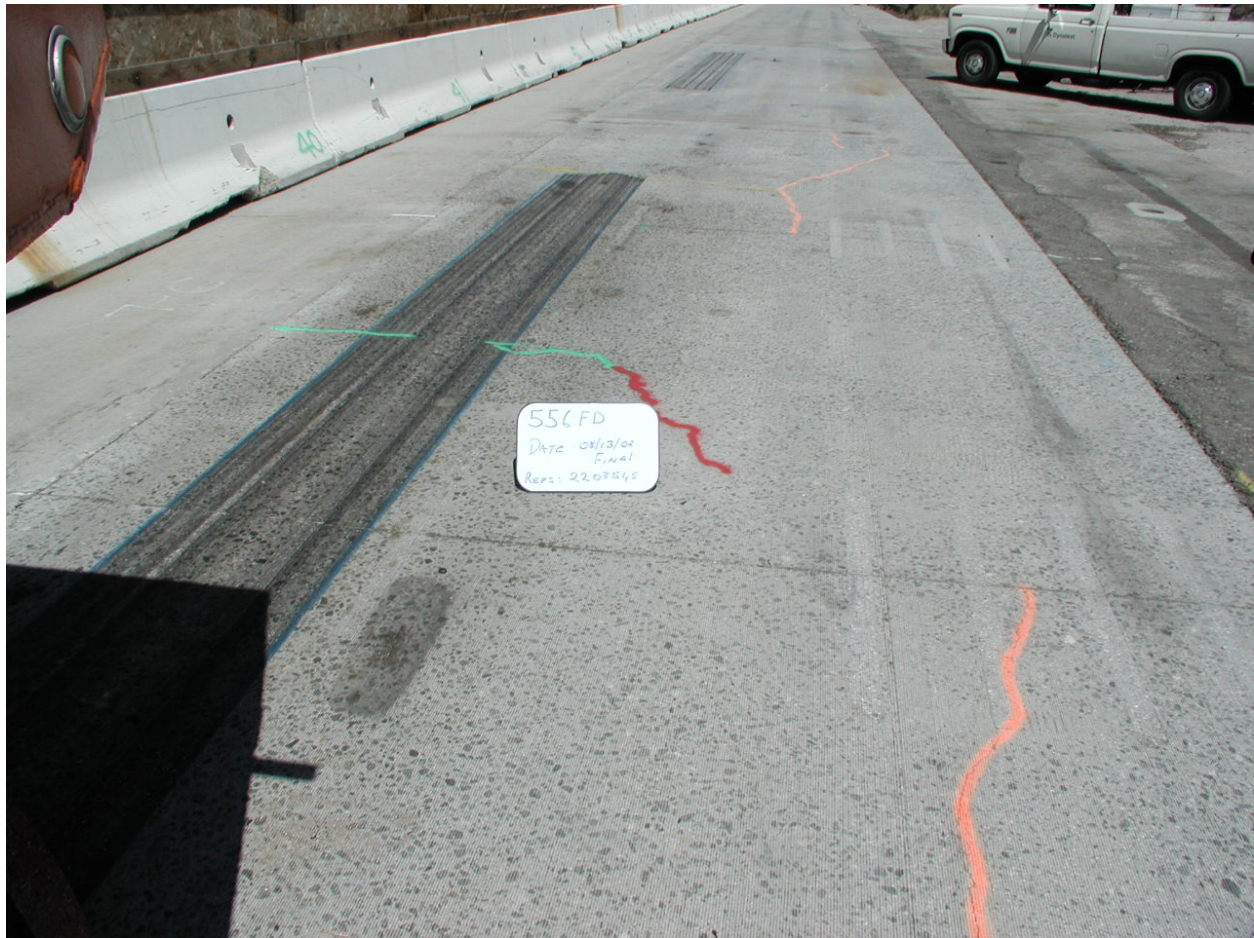
Figure 6.25. Cracking in all slabs at end of HVS loading on Section 556FD after 2.209 million repetitions.

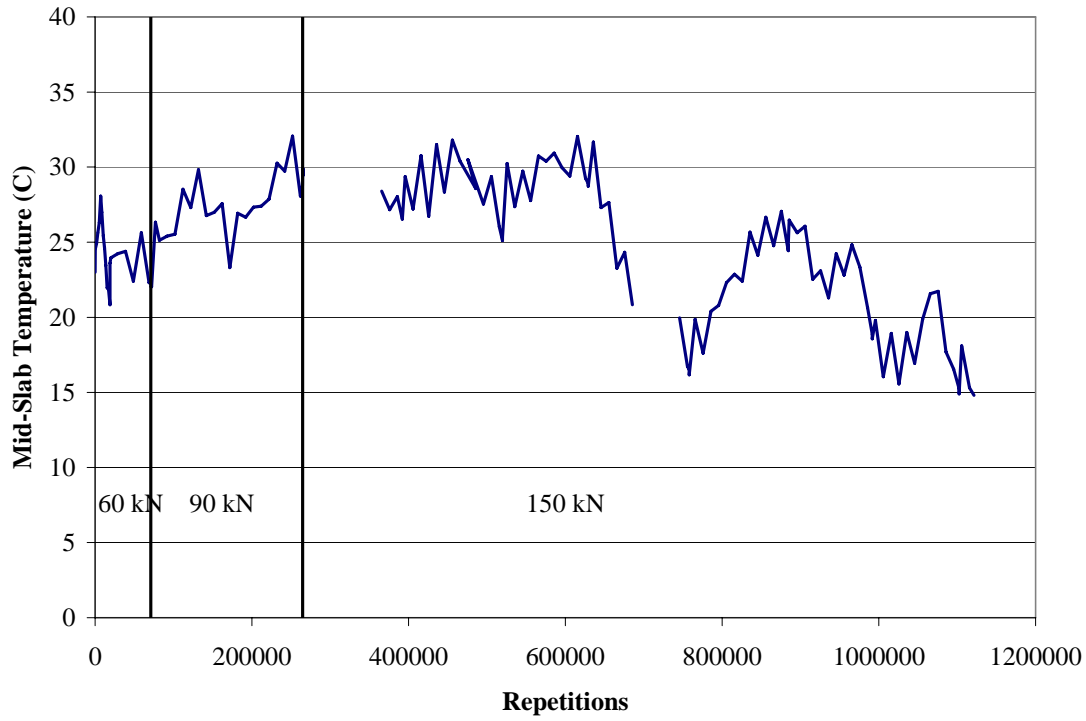
Figure 6.32. Mid-slab temperature for HVS Test Section 557FD.

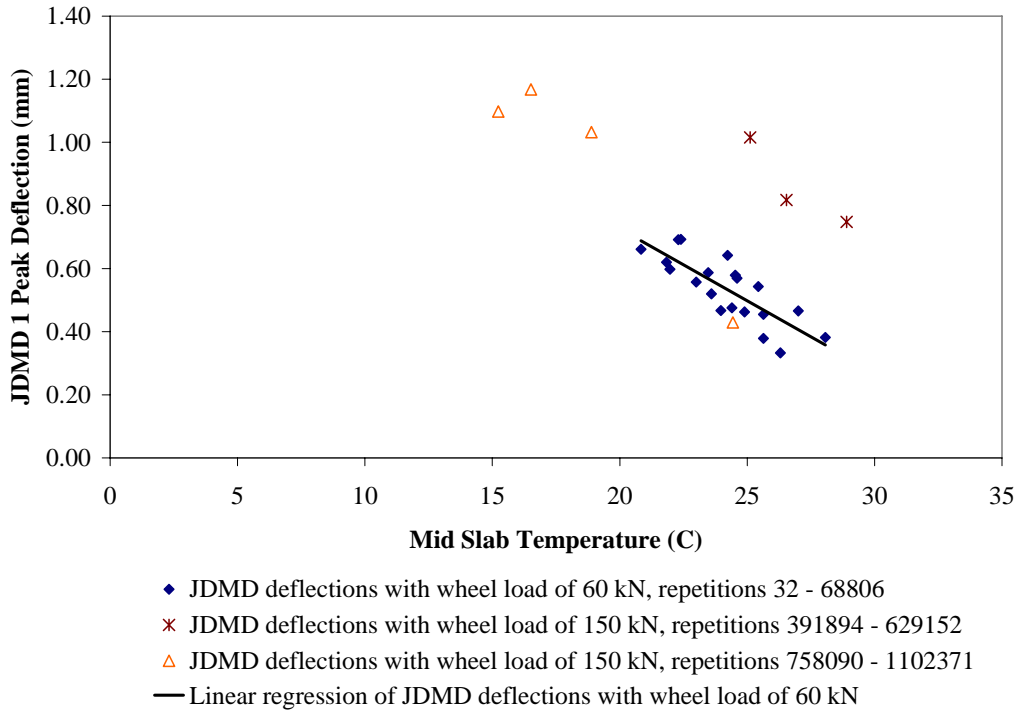
Figure 6.36. JDMD 1 peak deflection vs. mid-slab temperature on Section 557FD with measuring load of 60 kN (Joint 36, epoxy-coated steel dowel, 3/wheelpath).

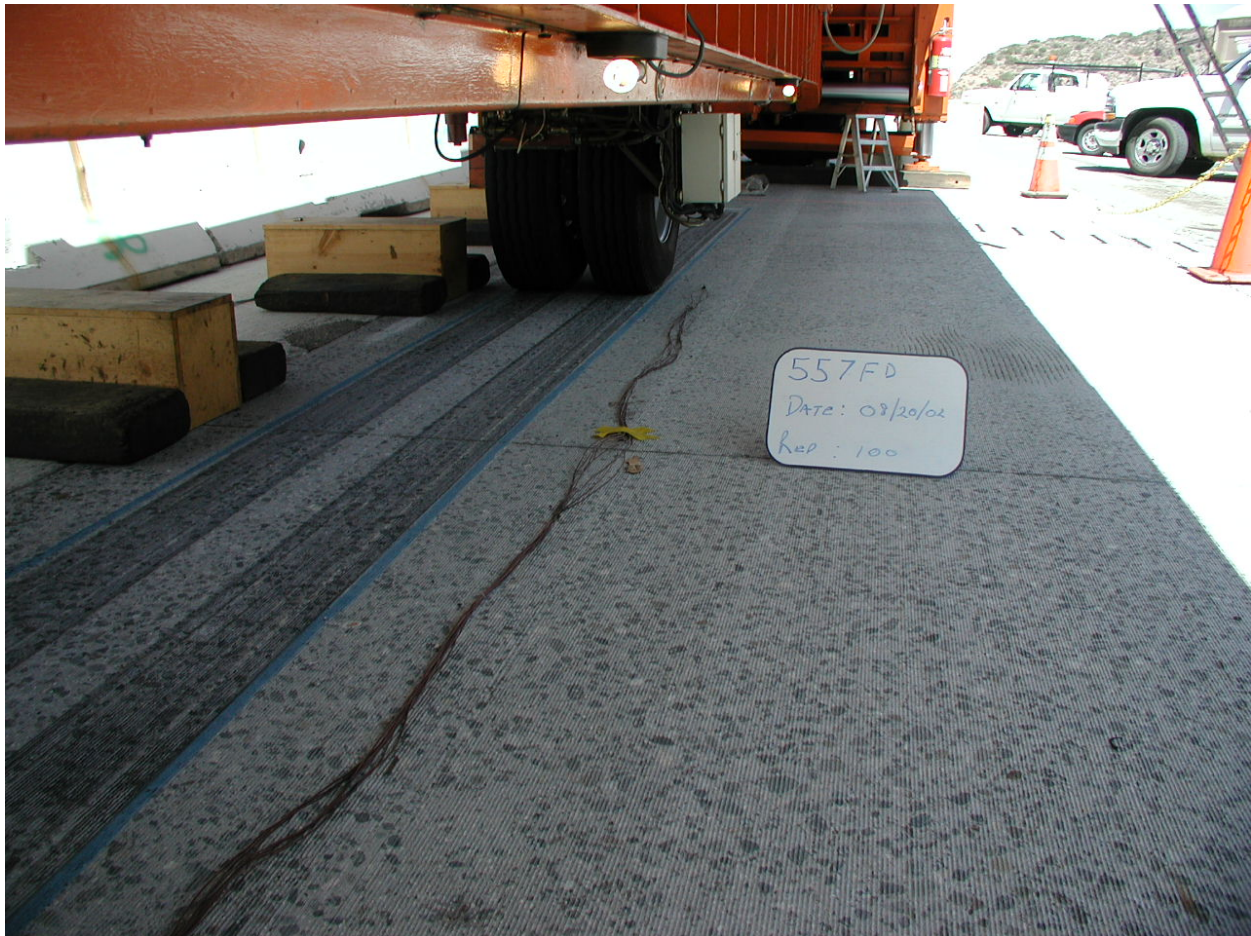
Figure 6.46. Initial condition of slabs in Section 557FD showing no existing cracking.

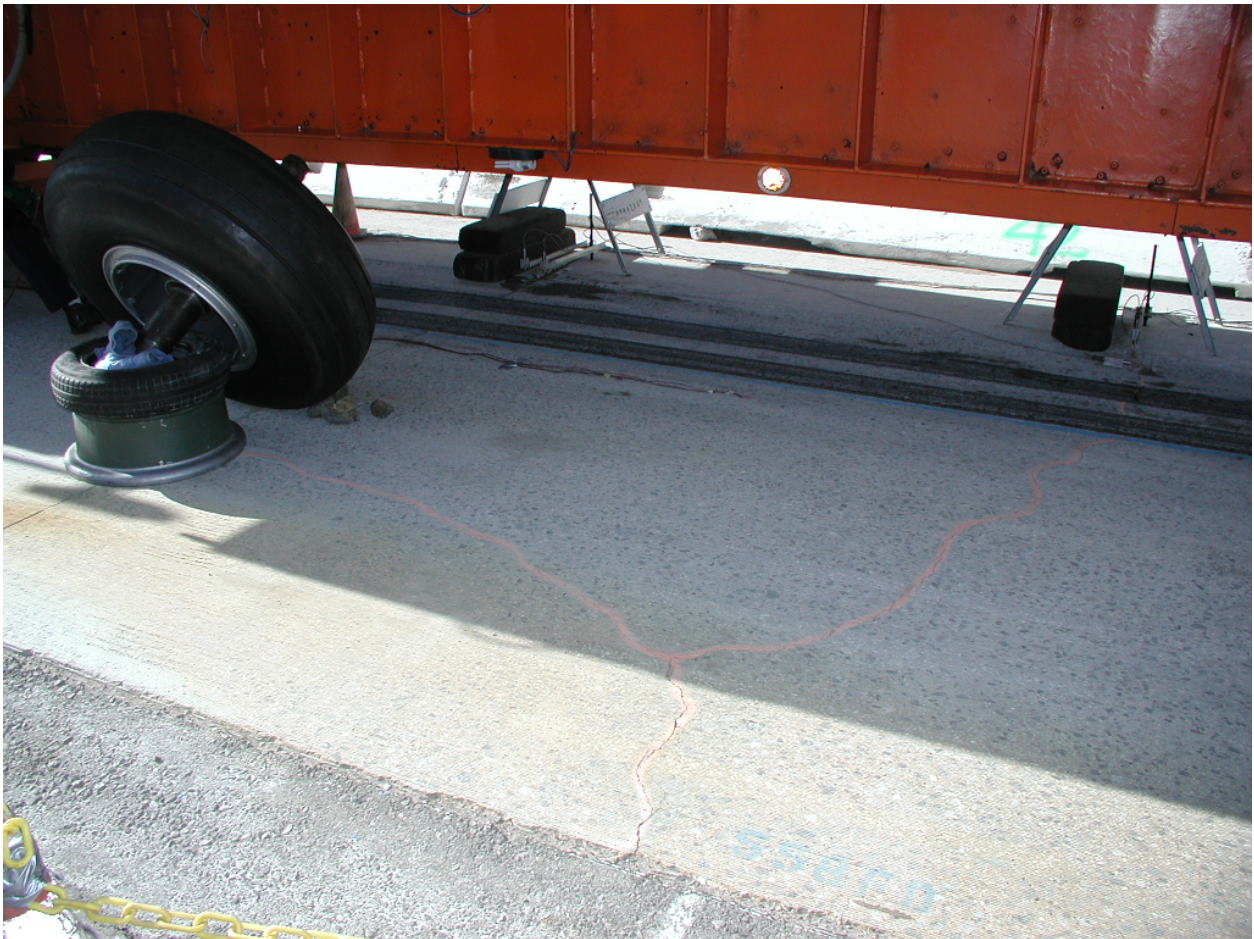
Figure 6.50. Slab 42 near Joint 41 on Section 558FD after 2.002 million repetitions.

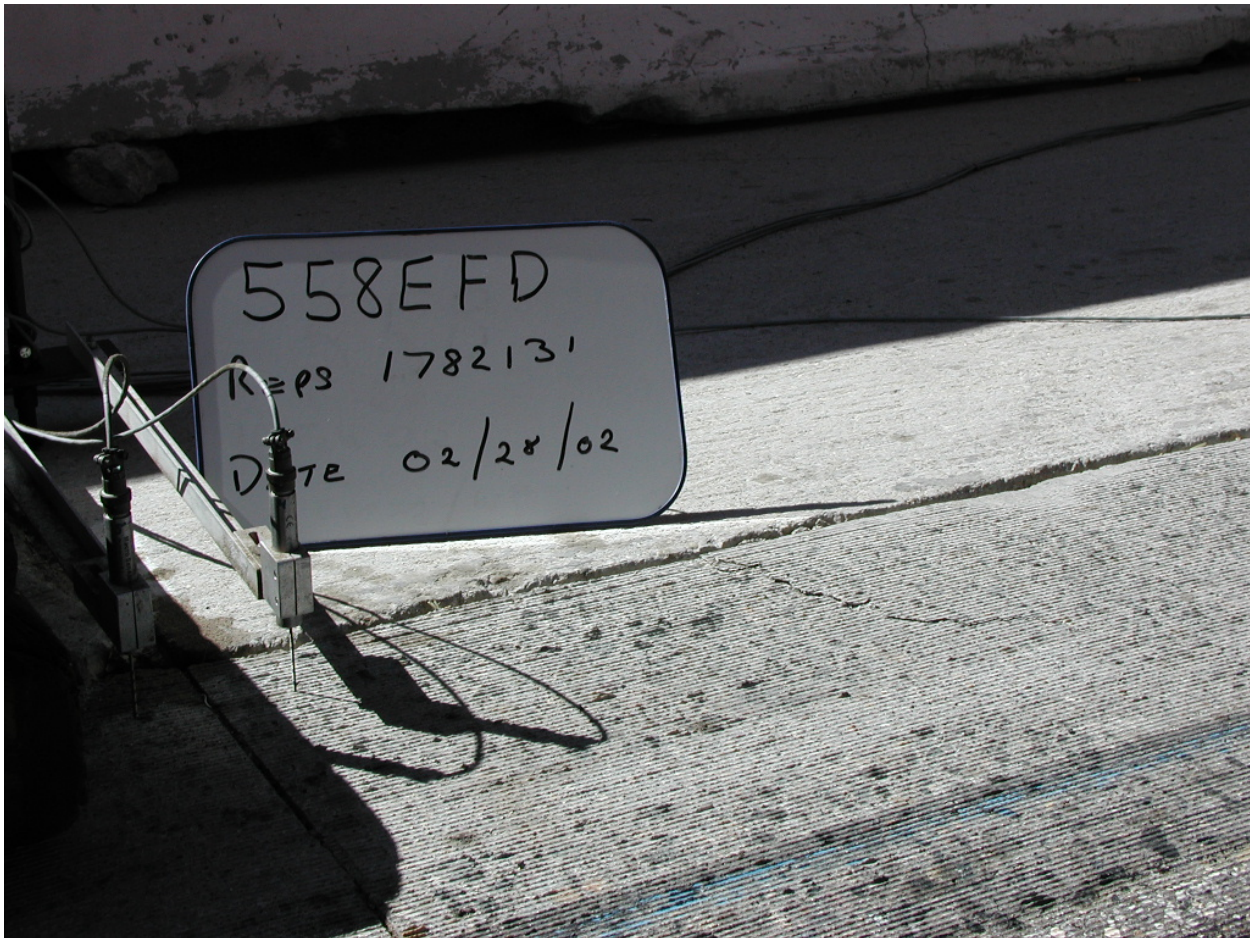
Figure 6.71. First new crack on Section 558FD from slab edge to back of outside dowel bar slot on Joint 41 at 1.782 million load repetitions.

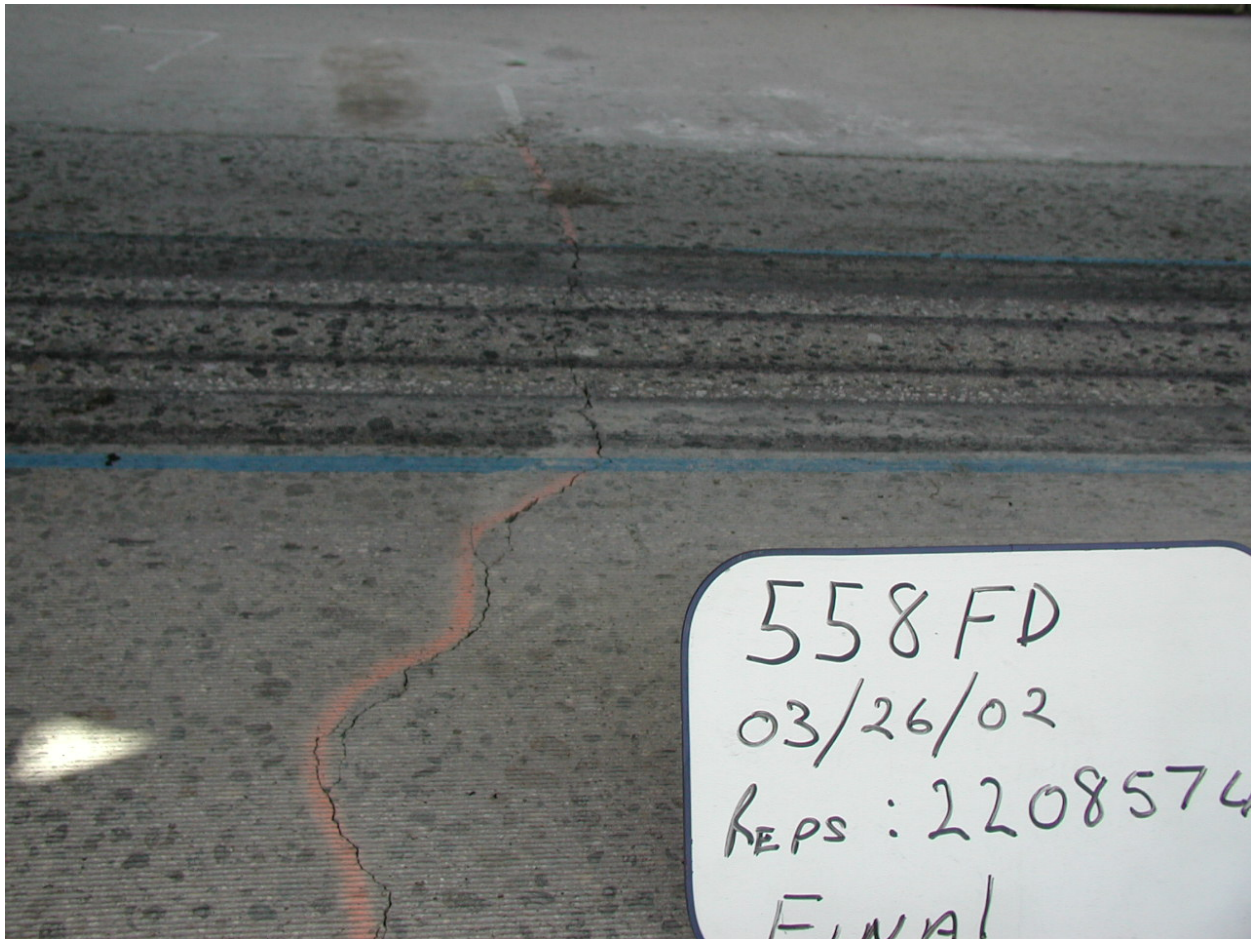
Figure 6.75. Close-up of final condition of Crack 2 at end of HVS loading after 2.209 million repetitions.

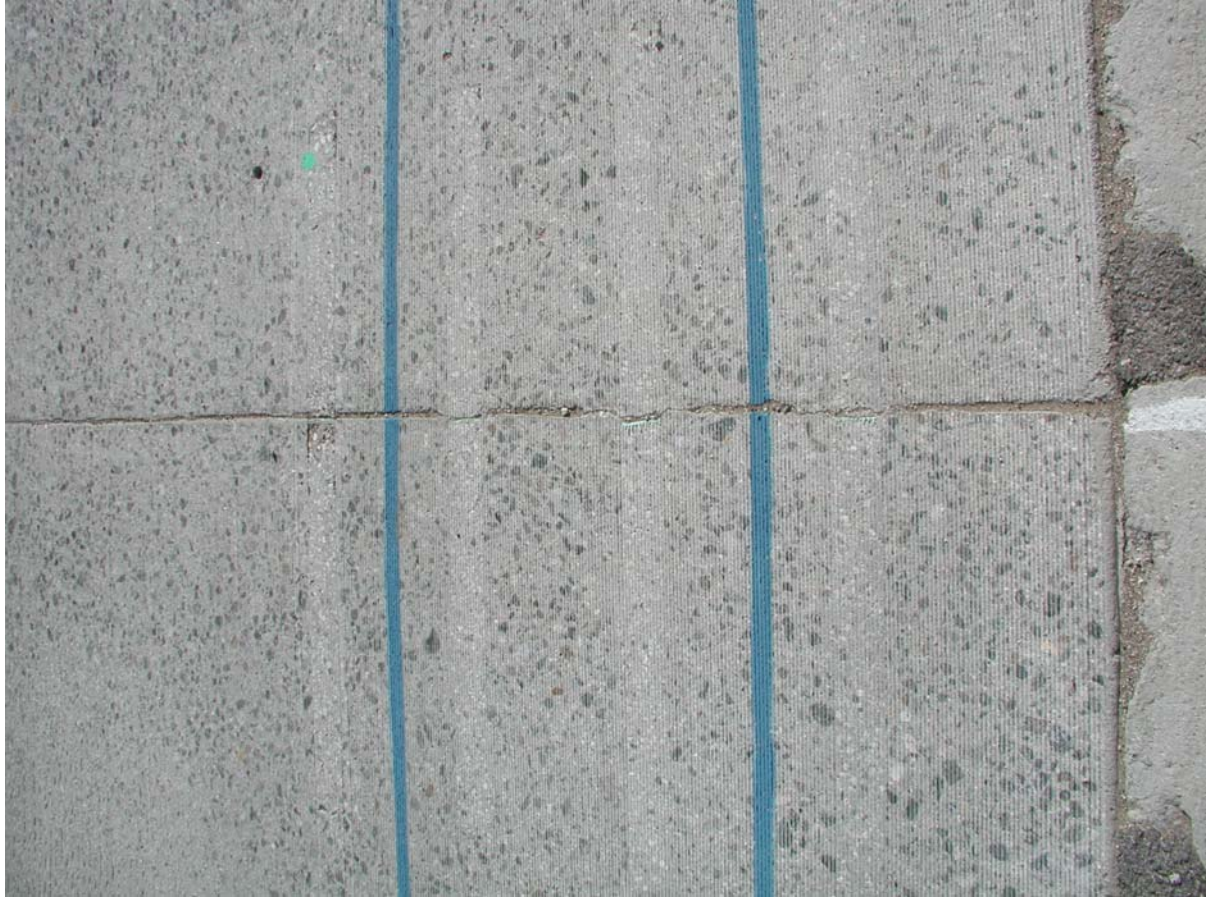
Figure 6.79. HVS Test Section 559FD, Joint 33, prior to HVS testing.
