ELEVATED TEMPERATURE COMBINED EROSION-CORROSION OF STEELS

A. Levy, E. Slamovich, and N. Jee

April 1985

LBL-19156
c.2

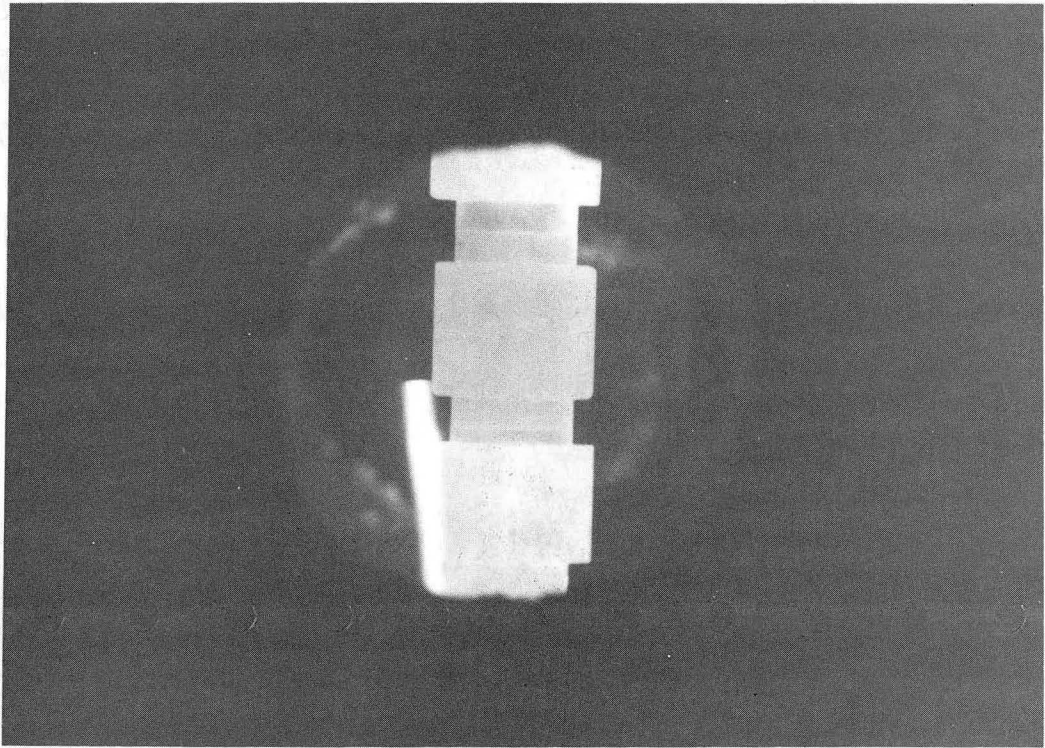
Fig. 1. Two cube shaped specimens in burner duct during testing separated by alumina washers.

oxygen was not determined. The specimens were 1.25cm on a side cubes with a small hole through their center for mounting on an alumina rod that extended into the 10cm dia. duct perpendicular to its wall. The specimens were exposed so that two of their sides were at 45° angles to the exhaust gas and the other two sides were shielded from direct gas-particle impingement, thus providing two surfaces that were eroded-corroded and two surfaces that were only corroded on the same specimen. The ACES exhaust gas simulator at the Sandia Livermore National Laboratory Combustion Research Center was used for the tests. Figure 1 shows two test cubes in place on the rod with smaller alumina washer spacers between them during a test.

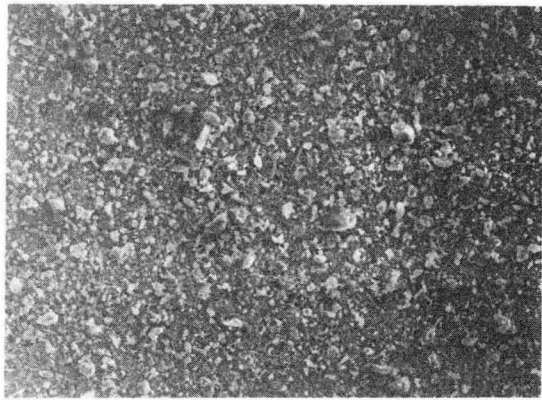
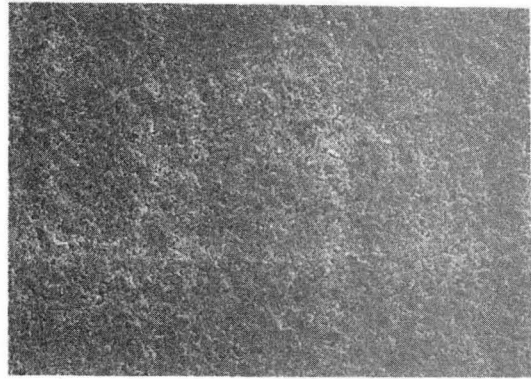
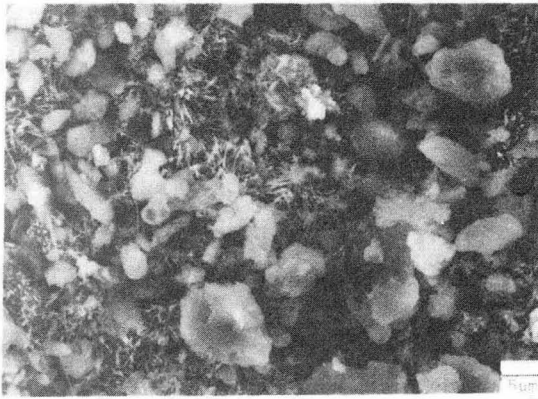
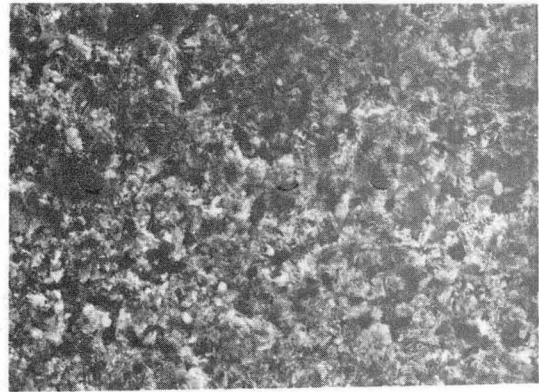
Fig. 2. Corroded and eroded-corroded surfaces of 1018 steel at 700°C

Figure 2 shows the surfaces of the corroded and the eroded-corroded sides of a single specimen after exposure to the oxygen rich, methane-air combustion gases and 5 μ m dia coal ash particles at 700°C. The observed surface on both sides consisted of iron oxide, Fe₂O₃. [6] The morphology of the scale on the corroded side consisted of a fine network of small needles with nodules of Fe₂O₃ penetrating up through them. A few coal ash particles from eddys in the flow behind the impingement sides of the specimen were also identified (the larger, light nodules). The eroded-corroded side had the same fine needle network as the corroded side, but the larger Fe₂O₃ nodules were not present. As can be seen, corrosion was the dominant mechanism on both sides. The fine needles that occurred on the eroded side did not appear to be vulnerable to the impact force of the impinging coal ash particles.

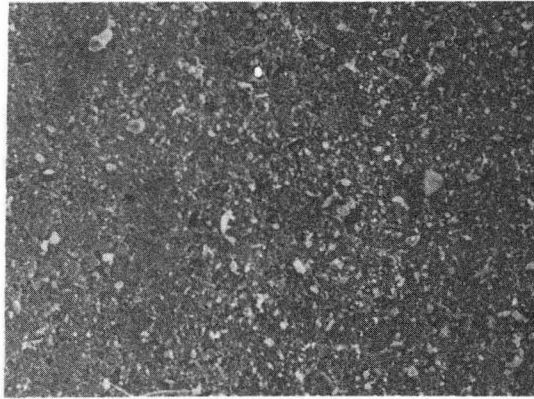
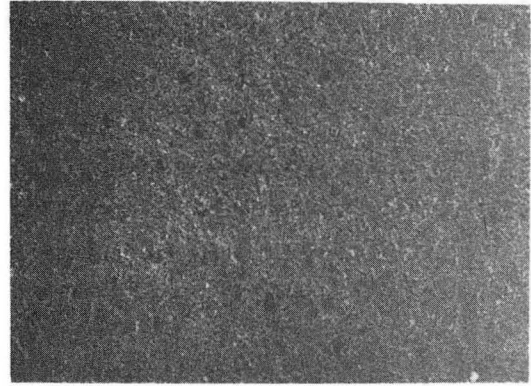
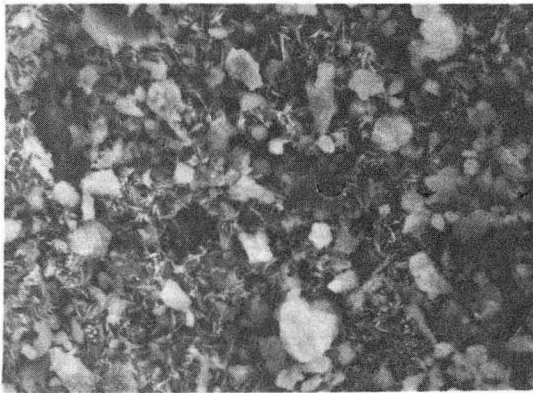
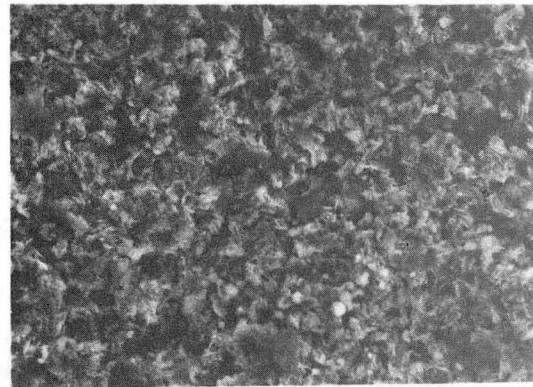
Fig. 3. Corroded and eroded-corroded surfaces of 2 1/4 Cr 1Mo steel at 700°C

Figure 3 shows the surfaces of this alloy after the 700°C test. The appearance of the surface is essentially the same as was seen on the 1018 steel specimen. Figure 4 shows the same alloy after the 800°C test. The morphology of both surfaces has changed somewhat. On the corroded side the Fe₂O₃ needles have formed into an interlaced network with some individual needles of larger diameter also occurring. Very few nodules of Fe₂O₃ are observed along with a very few coal ash particles (the larger, light grey particles in the lower photo).

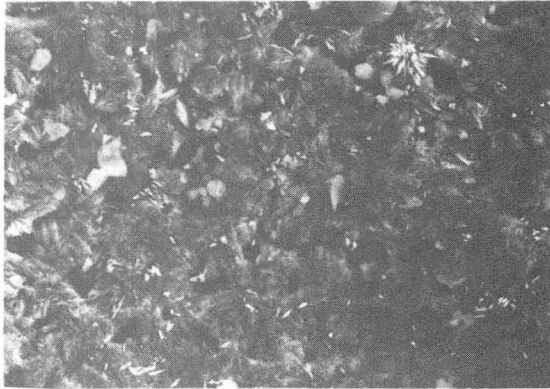
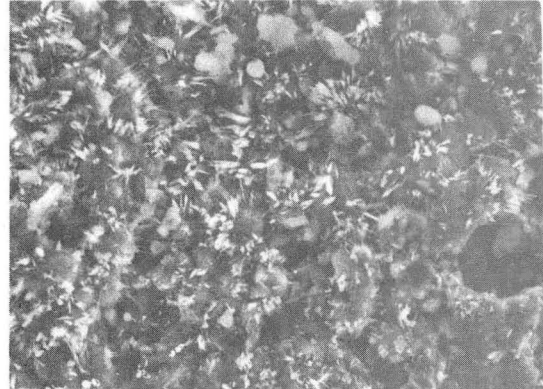
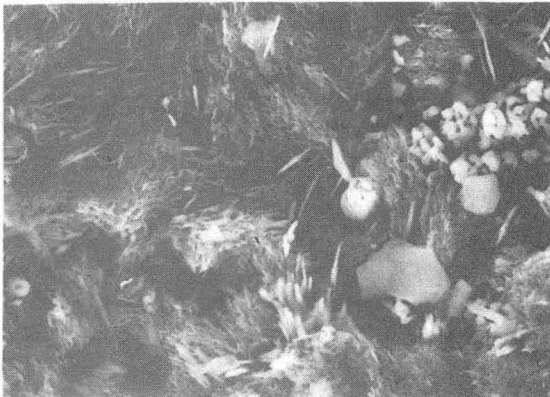
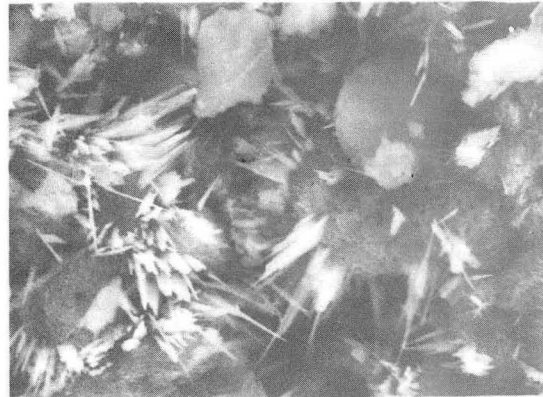
Fig. 4. Corroded and eroded-corroded surfaces of 2 1/4 Cr 1Mo steel at 800°C

On the eroded-corroded side, the morphology is somewhat different. The fine needle network appears to have condensed and a number of quite long comparatively large diameter, individual needles of oxide are seen growing out of the scale. Again, a few coal ash particles can be seen in the lower right photo. The delicacy of the long, individual needles on the eroded-corroded side is quite remarkable, considering that this side is being struck by coal ash particles. Note that the two lower photos are at the same magnification. The dynamic corrosion plus erosion that is occurring on the exposed side appears to be enhancing the growth of the oxide needles at this higher test temperature.

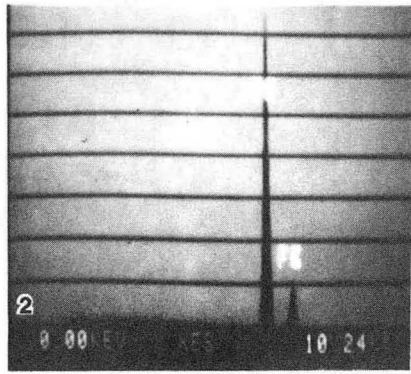
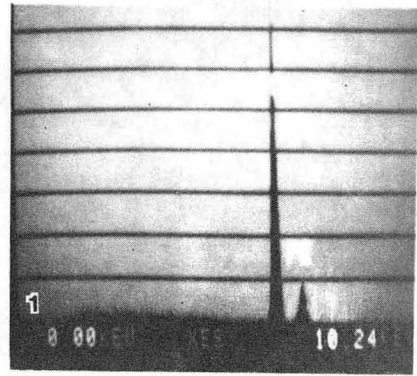
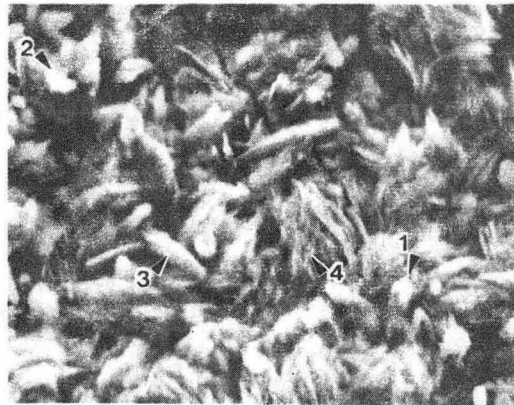
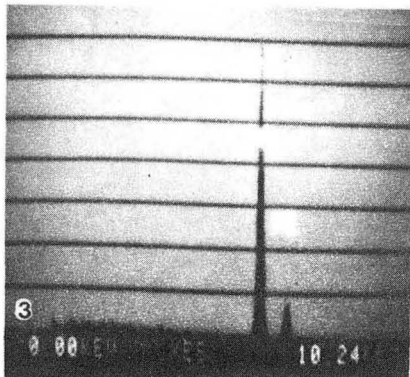
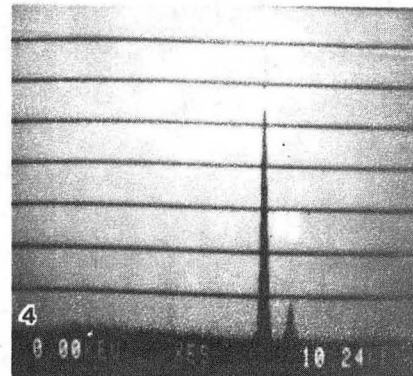
Fig. 5. SEM-KEVEX analysis of scale surface on eroded-corroded side of the 2 1/4 Cr 1Mo steel at 800°C

Figure 5 shows the SEM-REVEAL analysis of the surface scale on the eroded-corroded side of the specimen tested at 800°C. It can be seen that only iron oxide is present. The occurrence of only iron oxide on the surface with no chromium was observed for all of the alloys tested, except for the 304SS.

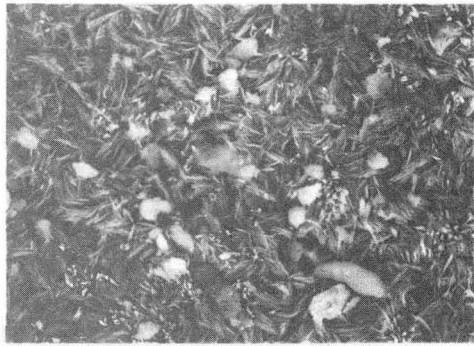
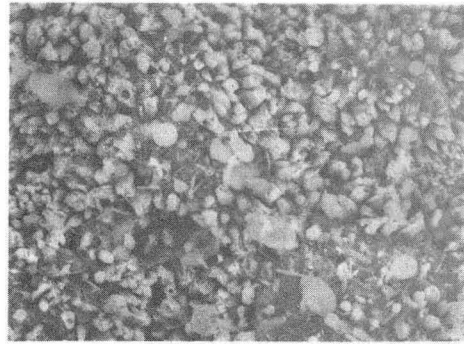
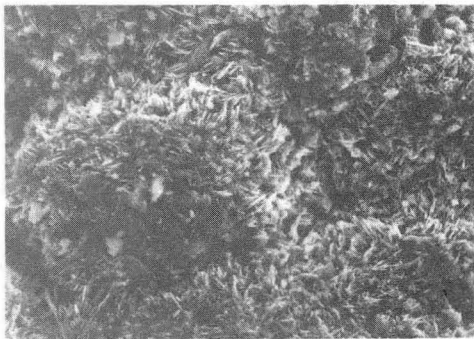
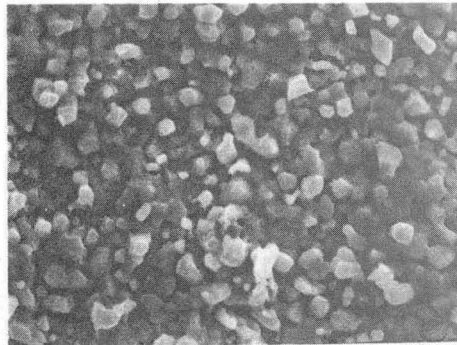
Fig. 6. Corroded and eroded-corroded surfaces of 5 Cr 1/2Mo steel at 800°C and 875°C

As the chromium content of the alloys increased the morphology of the oxide scale surface changed. The beginning of dramatic differences between the corroded side and the eroded-corroded side began with the 5Cr 1/2Mo Steel. Figure 6 shows the corroded (above) and eroded-corroded (below) surface at two test temperatures, 800°C and 875°C.

At the 800°C test temperature, the needle-like network of the scale can be seen on both the corroded and eroded-corroded sides. A few nodules appear on the corroded side; none on the eroded-corroded side. The same thing occurred on the 1018 and 2 1/4Cr1Mo steels at the lower, 700°C temperature (Figures 2 and 3). It appears that test

At the 875°C test temperature, the next major change in the morphology occurred. The needles are almost non-existent on the corroded side (upper right photo) and they are replaced by nodules and columns of Fe_2O_3 . The columns are different from the nodules in that their tops appear to be somewhat pointed and porous or wrinkled on the corroded side. The great difference in the morphology between the corroded and eroded-corroded sides first occurs on the eroded-corroded surface of this alloy. It consists entirely of crystalline columns of significantly greater cross section than the pointed-porous topped columns on the corroded side and their tops do not show any porosity. This behavior was observed on the higher chromium content alloys at higher test temperatures to an even greater degree, as will be seen.

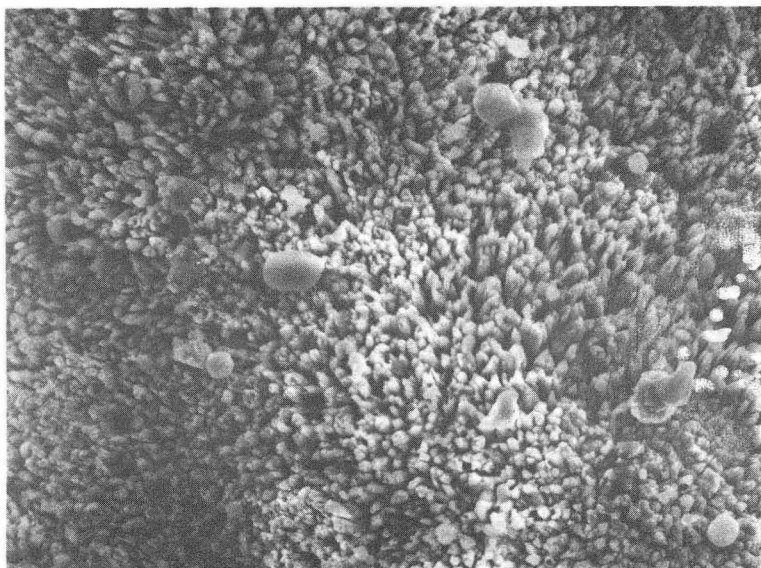
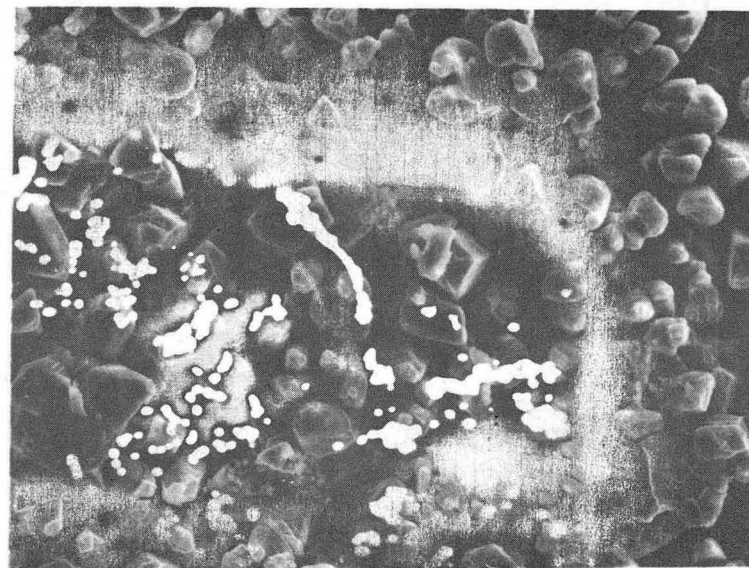
Fig. 7. Corroded and eroded-corroded surfaces of
9 Cr 1Mo steel at 925°C XBB 820-9329

Figure 7 shows the extent to which the great difference occurred in the morphology of the 9Cr1Mo steel between the corroded and eroded-corroded sides of the same test specimen. On the left side of the figure is the corroded side with a myriad of small diameter pointed-porous or wrinkled topped columns extending up perpendicular from the metal surface. The few gray globules are coal ash particles. On the right photo is the eroded-corroded surface. The well defined crystalline columns of iron oxide (no chromium was determined) are many

times the size of the columns on the corroded side and are no where near as numerous. Many of their tops have been chiselled away to form more or less points and no porosity or wrinkling can be observed at the tops of the columns. The action of the eroding coal ash particles can be seen to affect individual columns, but do not result in an overall eroding away of the surface. The relatively low density of the columns and their large size seems to reflect a selective thinning of the columns compared to the density of those that occurred on the corroded only side so that the remaining columns could grow to a much larger size. This phenomenon appears to be similar to the selective thinning of trees in a forest to promote the growth of the remaining ones.

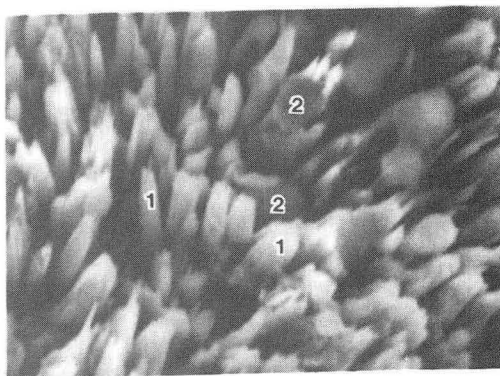
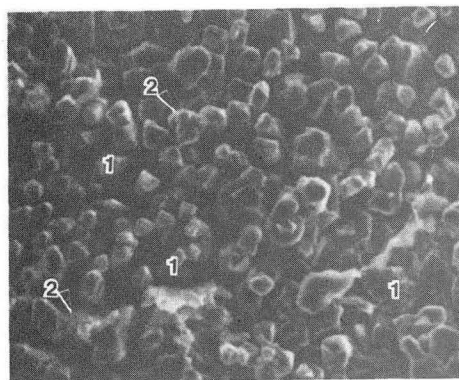
Fig. 8. SEM-KEVEX analyses of the oxide column composition of the 9 Cr 1Mo steel at 950°C

The determination of the composition of the columns on both the corroded and eroded-corroded sides of the 9Cr1Mo steel specimens was made by SEM-KEVEX analysis. Figure 8 shows the analyses of the scales that formed on the 9Cr1Mo steel. It can be seen that both types of columns are iron oxide with no chromium present. The presence of some coal ash is shown by the presence of such elements as Si, Ca, Al and Mg. The reason that the corroded side has more coal ash present is that the velocity of the particles on the back side of the specimens in the flow eddy is much slower than on the front side that directly receive the impact of the coal ash at the full 5 m/s. The wafting particles on the back side can more readily get caught in the forest of columns that exists there.

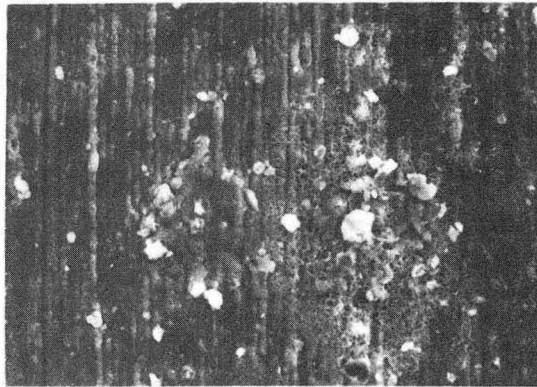
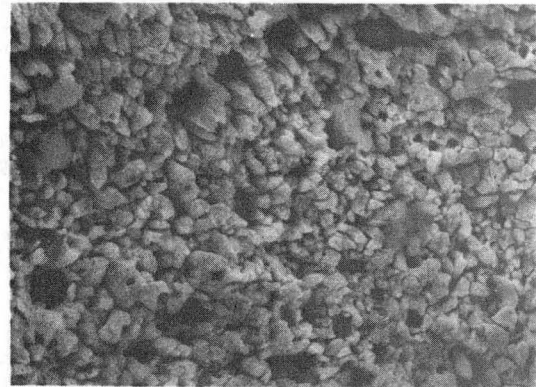
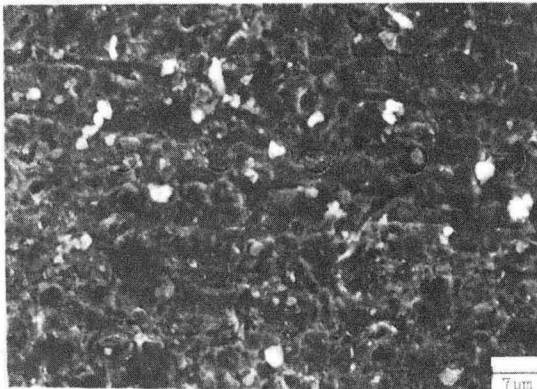
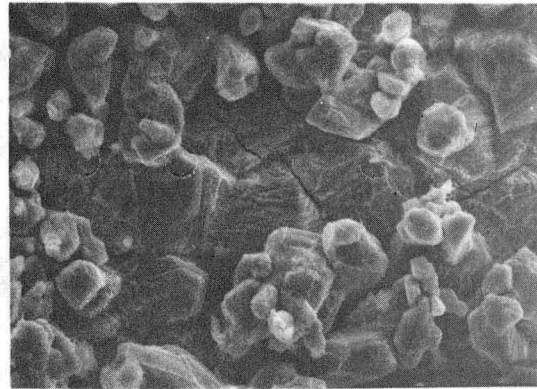
Fig. 9. Corroded and eroded-corroded surfaces of 9 Cr 1Mo steel at 800°C and 950°C

continuous Cr_2O_3 scale with some nodules of Fe_2O_3 and a few coal ash particles on the surface. The eroded-corroded side shows a slightly eroded Cr_2O_3 surface. At this lower temperature, compared to the 950°C exposed specimen shown in Figure 8, the chromium is present in sufficient quantity to form a typical protective barrier-type scale. The eroded-corroded side is still a mild enough overall condition to enable the alloy to maintain the protective scale.

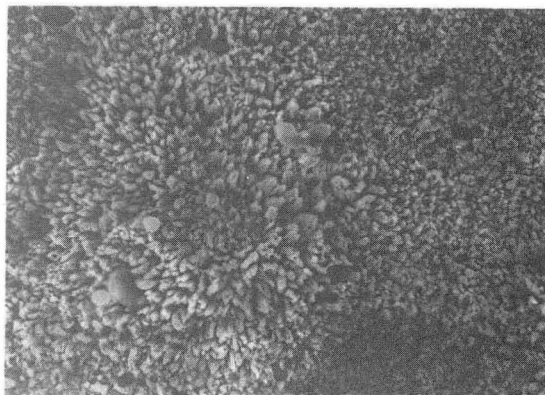
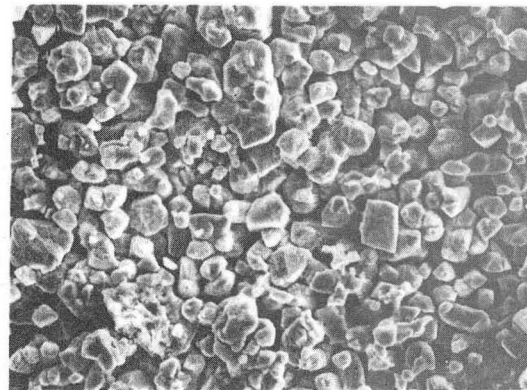
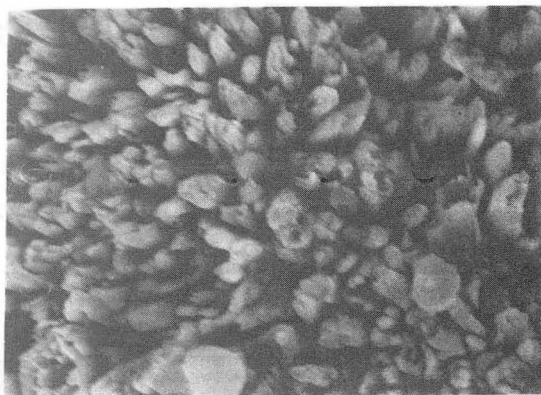
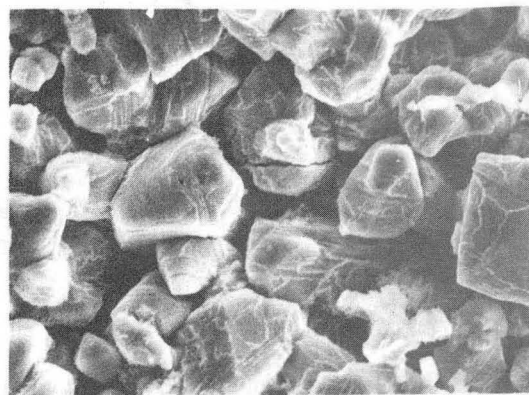
Fig. 10. Corroded and eroded-corroded surfaces of 410SS at 950°C XBB 820-9325

The 410SS specimens showed the same type of behavior as the lower chromium content, ferritic steels that formed columns. Figure 10 shows the two surfaces after testing at 950°C . The chiselled tops of the eroded-corroded side columns toward pointed shapes are clearly evident as are their greatly increased size over the corroded side columns. Note the difference in magnification at both the lower and the higher magnifications. At least one of the columns (lower right side photo)

is cracked, providing a short circuit diffusion path.

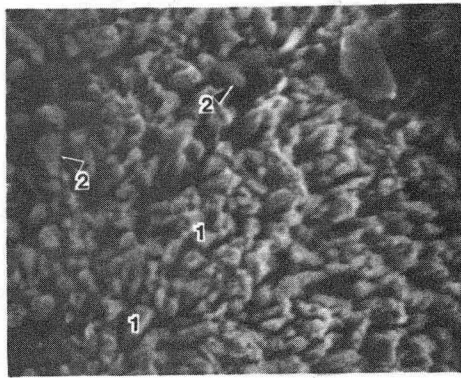
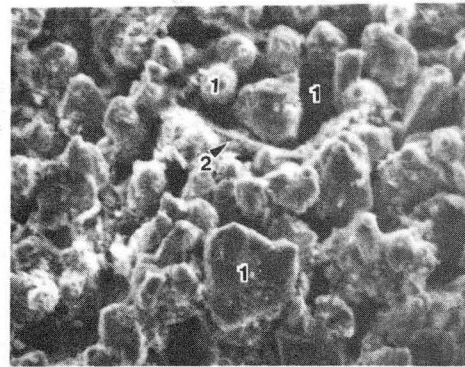
Fig. 11. SEM-KEVEX analyses of columns of scale on 410SS at 950°C

Figure 11 shows the SEM-REVEK peak analyses. Even with 12% Cr content in the alloy, the columns of oxide at the surface were determined to be iron oxide with no chromium. It is interesting to note, however, that the No. 2 peak on the eroded corroded side shows some chromium in a crystallite that appears to be below the general level of the columns. Some coal ash was retained on the corroded side of the specimen, peak 2, where the velocities are very low. The coal ash is composed of oxides of magnesium, aluminum, silicon, potassium and calcium as well as some additional, minor oxides and sulfides. Coal ash is known to be corrosive of itself. The ash particles are slowed down considerably in the wakes on the back sides of the specimens and can get caught in the columns of scale.

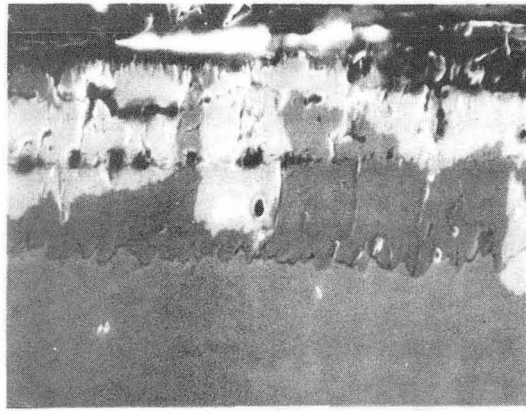
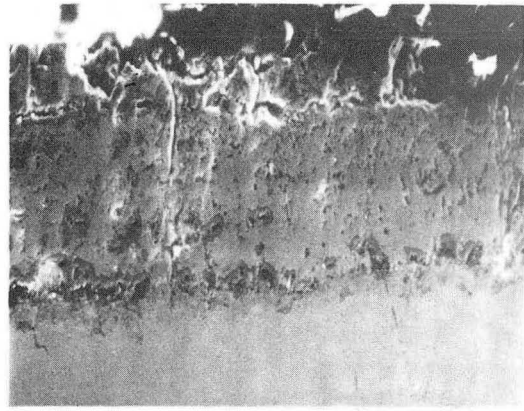
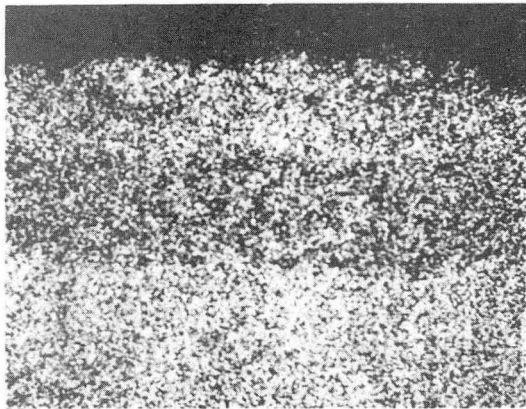
Fig. 12. Cross section of corroded and eroded-corroded surfaces of 410SS at 950°C

The 410SS specimens were cross sectioned to determine the nature of the scale down to the base metal. Figure 12 shows the morphology of the scales and the distribution of iron and chromium through them. Analysis of the photos indicates that combined erosion-corrosion not only changes the surface morphology of the scale compared to straight

On the corroded side (left side photos) the secondary electron image indicates that there is a duplex scale present with a line of porosity separating the two phases. Analyzing the x-ray maps shows that the top layer is iron oxide with no chromium in it, as has been discussed above. However, the second layer of the scale has substantial chromium content and is either Fe_2O_3 with chromium dissolved in it or an iron-chromium oxide spinel.[6] This layer has a scalloped, intimate bonded interface with the base metal. The cross sections of the small, pointed columns of surface scales described earlier can be readily seen in the upper left photo.

The morphology of the scale cross section on the eroded-corroded side of the specimen (right side photos in Figure 12) is quite different from that on the corroded only surface. The surface of the eroded-corroded side is made up of relatively large diameter columns of Fe_2O_3 with void areas between them that extend down to the iron-chromium oxide layer. It is for this reason that there is a chromium peak in Figure 11 on the eroded-corroded side. The cross sections of the columns on the surfaces of the corroded and eroded-corroded sides of the same specimen verify the observations made earlier concerning the morphological differences between the surfaces of the corroded and eroded-corroded scales.

Referring to the x-ray maps, it can be seen that the scale thicknesses of each of the constituents on the corroded and eroded-corroded sides as well as the distribution of the two phases on each side are markedly different.

On the corroded only side of the specimen, both the Fe_2O_3 and iron-chromium oxide layers have approximately the same thickness. The contact area between the lower scale layer and the substrate metal is intimate with no voids present. The outer, Fe_2O_3 scale is much thinner on the erosion-corrosion side, extending only to the base of the columns. The Fe-Cr oxide layer is much thicker on the eroded-corroded side, essentially constituting the main body of the scale. Also, the interface between the lower layer of the duplex scale and the base metal is quite porous on the erosion-corrosion side. The large increase in the iron-chromium oxide layer thickness apparently has depleted the substrate surface in chromium sufficiently to cause some Kirkendall type voids to occur at the scale-metal interface. The amount of voids between the upper and lower scales is near the same for both sides. Thus the occurrence of erosion in conjunction with corrosion, with the corrosion process dominant, changed the morphology and the composition distribution of the scale that was formed.

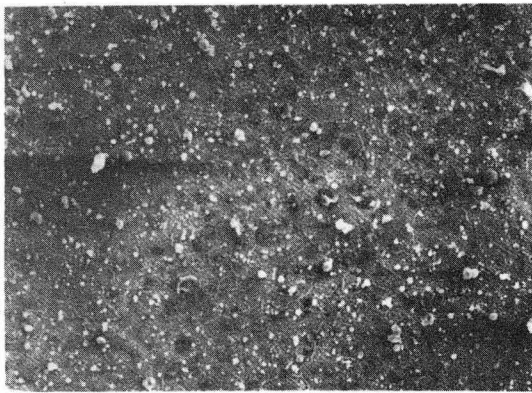
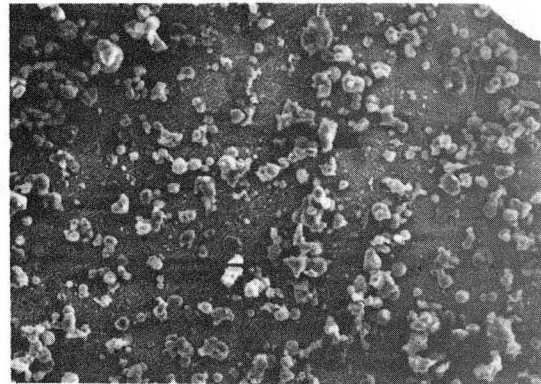
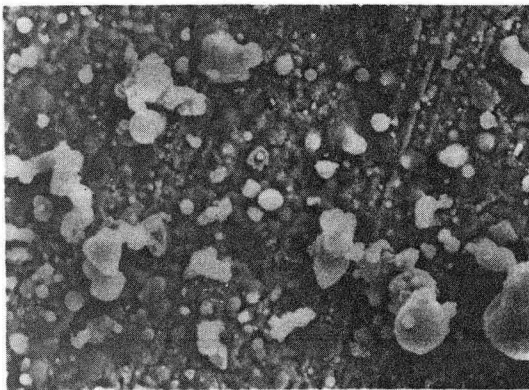
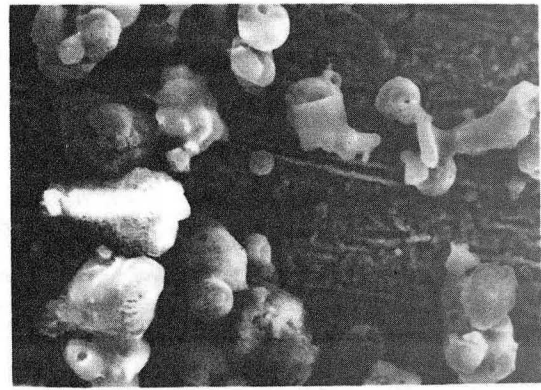
Fig. 13. Corroded and eroded-corroded surfaces of 304SS at 1000°C

The 304SS, an austenitic alloy with a significantly higher chromium content than any of the chromium containing ferritic alloys tested, behaved in a somewhat different manner than the other steels at temperatures higher than were used to test the other steels but still using $5\mu\text{m}$ coal ash particles. Figure 13 shows that the surfaces developed a continuous Cr_2O_3 scale on both the corroded and eroded-corroded surfaces and that the barrier scale was not penetrated by the eroding particles.

On both the corroded and eroded-corroded surfaces, nodules of iron-chromium spinel have penetrated up through the Cr_2O_3 scale layer. The size of the nodules is considerably larger on the erosion-corrosion surface than on the corroded surface. This follows the general trend throughout the test series of having combined erosion-corrosion enhance the growth of individual crystallites on the scale outer surface. Some of the nodules present on the surface are coal ash.

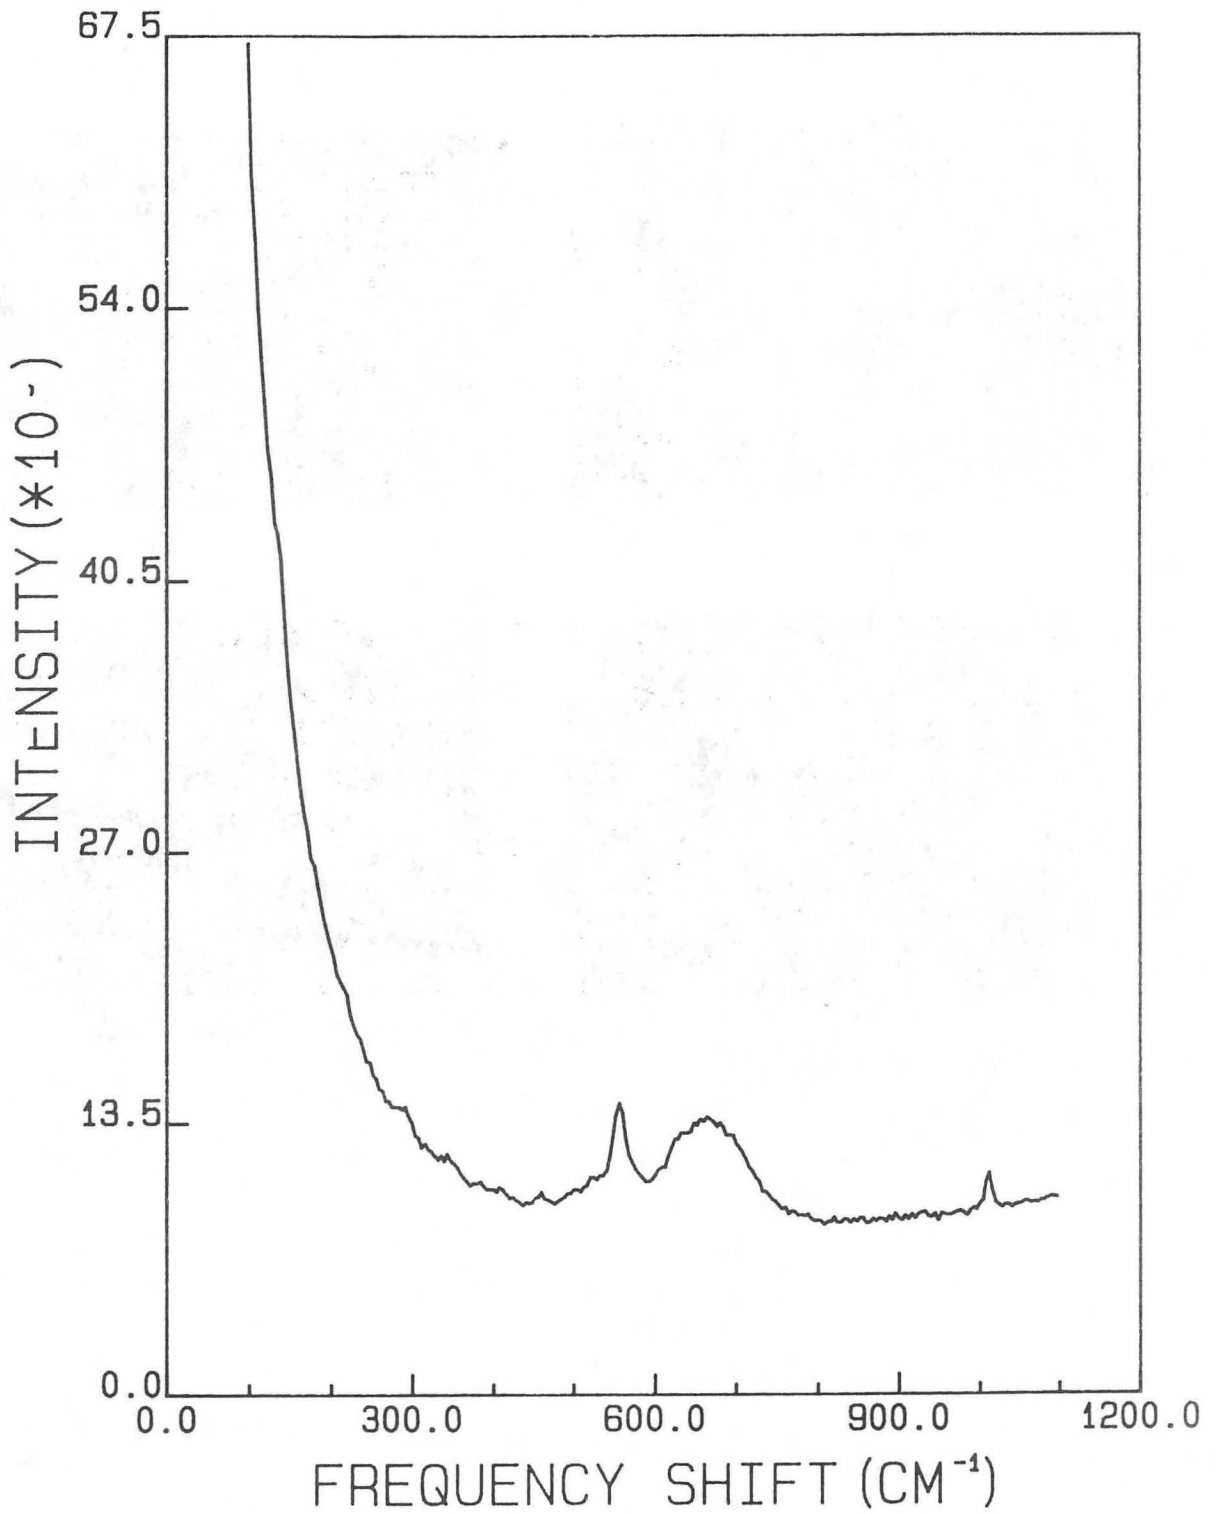
Fig. 14. Raman spectra of corroded surface of 304SS at 1000°C

Laser Raman spectroscopy was used to identify the phases that were present on the surface of the 304SS test samples. Figure 14 shows the Raman spectra for the corroded surface. The peak at 570 is Cr_2O_3 , the peak at 660 is spinel and the small peak at 1010 represents the compounds in coal ash. Figure 15 shows the Raman spectra of an area on the surface of the eroded-corroded side. The additional peaks over and above those that occurred in Figure 14 are due to coal ash particles adhering to the surface. These spectra indicate that individual nodules of iron-chromium oxide spinel formed on the iron-chromium-nickel 304SS rather than the iron oxide nodules that formed on the straight iron-chromium alloys.

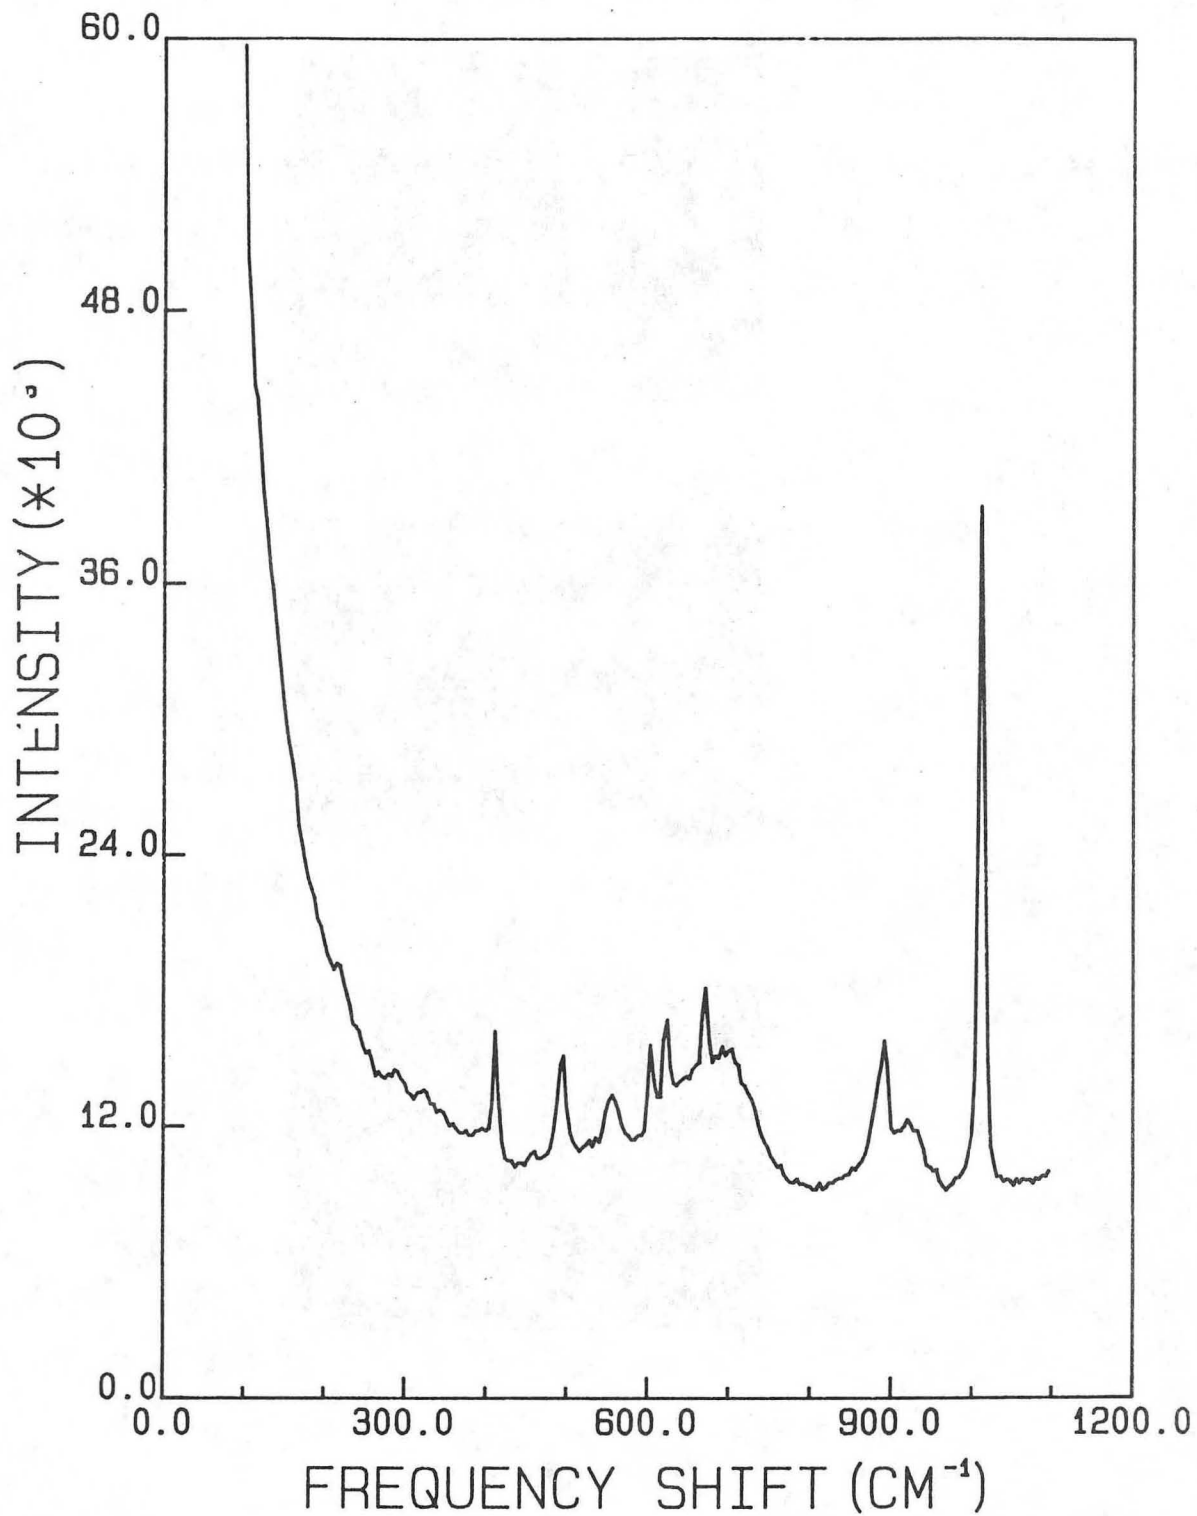
Fig. 15. Raman spectra of eroded-corroded surface of 304SS at 1000°C

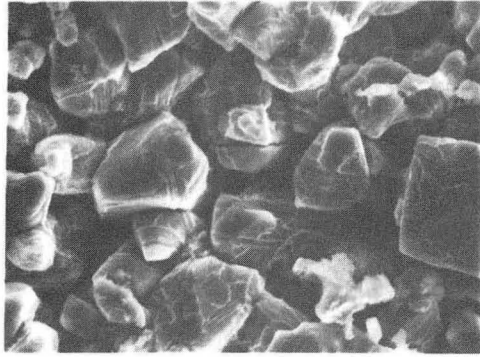
Fig. 16. Effect of eroding particle size on the surface morphology of the eroded-corroded surface of 410SS at 950°C

As the particle size of the erodent increased, major changes occurred in the morphology of the iron oxide scale surface. Figure 16 shows the surfaces of the erosion-corrosion side of 410SS eroded by 5 μ m flyash and 50 μ m and 100 μ m Al₂O₃. As the particle size increased from 5 μ m to 50 μ m diameter particles, the diameter of the iron oxide columns decreased and the number increased. The type of column caused by the 50 μ m particles reverts to that which occurred on the corrosion side of the specimens in the 5 μ m flyash test, Figure 10. A further increase in particle size to 100 μ m diameter Al₂O₃ caused a further major change in the topography of the scale surface, as can be seen in the lower photo in Figure 16. There are a minimum number of small nodules rising out of a cracked continuous iron oxide scale layer.

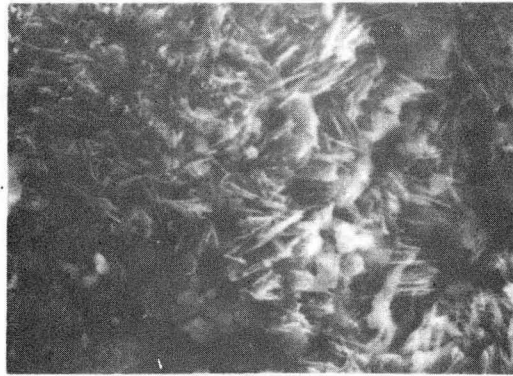
Fig.17. Morphology of surface scale on 5Cr1/2Mo steel eroded by 5µm, 50µm, 100µm particles.

The variation in surface morphologies as a function of erodent particle size followed a pattern found in all of the other chromium containing steels tested. For example, Figure 17 shows the effect of erodent particle size on the surface scale morphology of the 5Cr 1/2Mo steel. Note that the magnification of the scale on the 100 μ m Al₂O₃ is one-third that of the two photos above it. A major change in the diameter and shape of the needles or blades formed on the erosion-corrosion surface occurred between the 5 μ m flyash and the 100 μ m Al₂O₃ tests. The 50 μ m diameter particles resulted in a surface morphology that was similar to that found on the 410SS when it was eroded with 50 μ m diameter particles, see Figure 16. This small diameter column morphology was found on almost all of the alloys that were eroded with 50 μ m diameter particles.

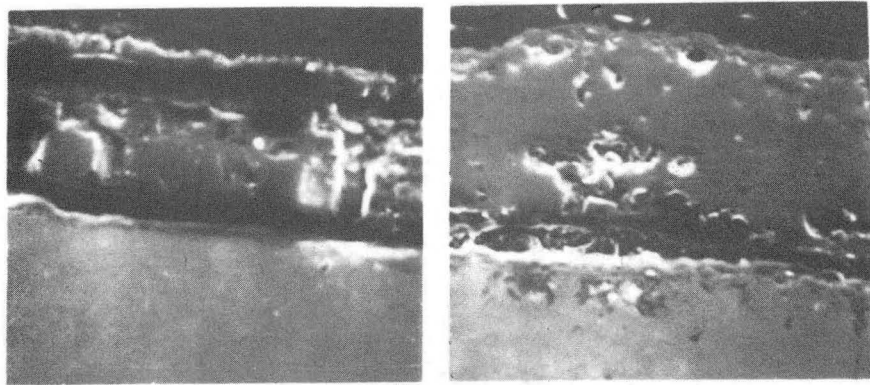
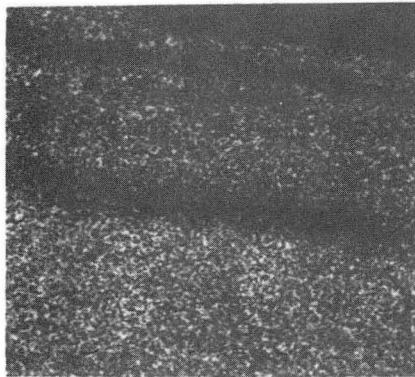
Fig. 18. Cross section of scales on 2 1/4 Cr1Mo steel from 100µm Al₂O₃ tests at 850°C.

Figure 18 shows the cross sections of the scales formed on the much lower chromium content 2 1/4 Cr1Mo steel when 100 μm particles were used at a lower test temperature than was used for the 410SS. The scale is essentially iron oxide. The chromium has concentrated in a thin iron-chromium oxide spinel layer at the scale-metal interface. The scale on the eroded-corroded side is significantly thicker than that on the corroded side, as occurred on 410SS. The scales that formed on both sides of the specimen were almost completely separated from the substrate, indicating a strong susceptibility to spalling.

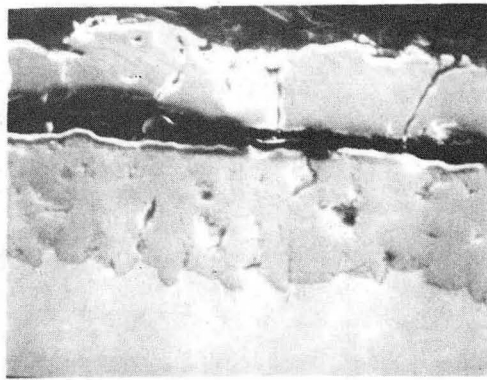
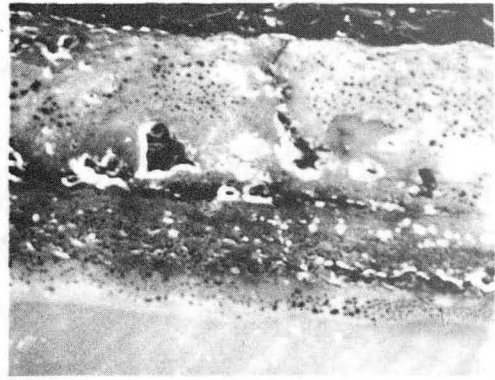
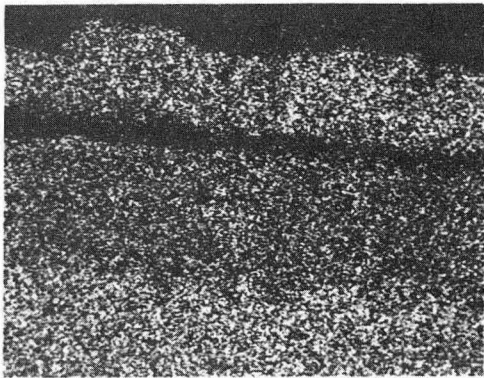
Fig.19. Cross section of scales on 410SS from 100μm Al₂O₃ tests at 950°C.

The distribution of the iron oxide and iron-chromium oxide scale layers on the 410SS was changed between the eroded-corroded scale in the 5 μm flyash test, Figure 12, and the 100 μm Al_2O_3 test shown in Figure 19. The iron oxide, upper layer, is now the thicker layer with not as much iron-chromium oxide spinel forming, relatively, as occurred in the 5 μm flyash test. Small diameter voids occurred throughout the scale layers on the eroded-corroded side but did not occur on the much

There is also an internal scale layer that has formed on the eroded-corroded side, below the voids at the scale-metal interface that does not contain chromium. Based on evidence in Reference 7, it is probably inward growing Fe_3O_4 . The much smoother surface of the 100 μ m particle test scale compared to the 5 μ m particle test scale is also indicated in Figure 19.

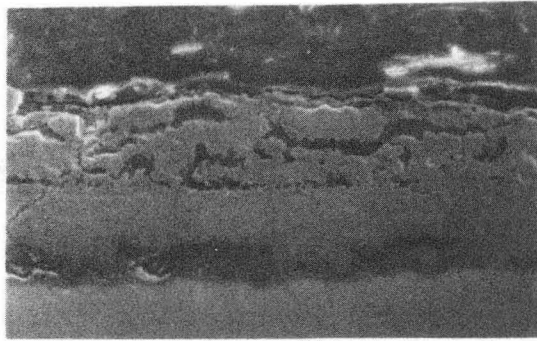
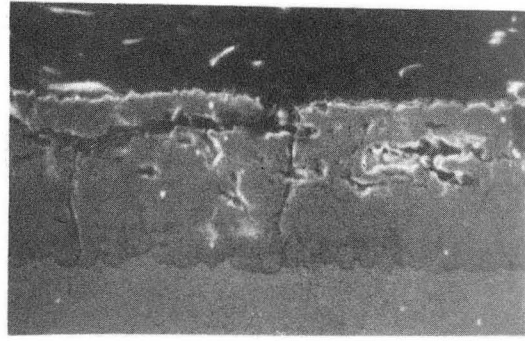
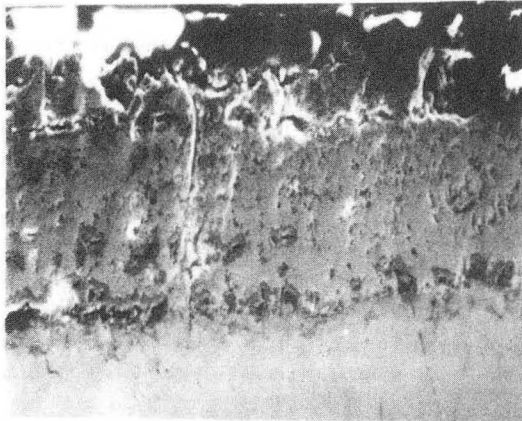
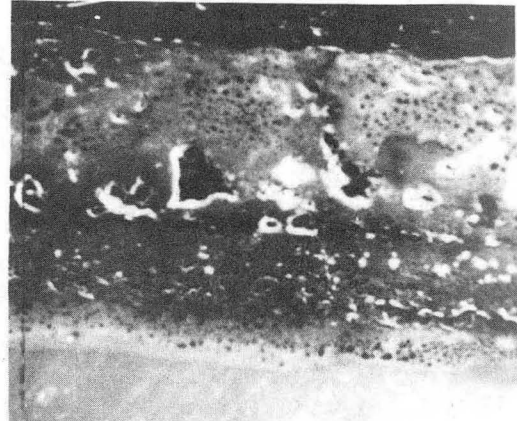
No particles
Static Corrosion
Scale Thickness=76 μm 20 μm

No particles
Dynamic Corrosion
Scale Thickness=82 μm 20 μm

5 μm Flyash
Erosion Corrosion
Scale Thickness=122 μm 20 μm

100 μm Al_2O_3
Erosion Corrosion
Scale Thickness=338 μm 50 μm

Fig. 20. Cross section of scales formed on 410SS at 950°C at different test conditions.

The consistent effect observed on all of the alloys for the eroding particles to increase the scale thickness on the erosion-corrosion side of the test specimen compared to the corrosion only side was checked against the dynamic corrosion obtained by testing specimens in the flowing gases of the ACES burner without injecting any particles. Figure 20 compares the scales formed and their thicknesses for a number of test conditions. It can be seen by comparing the top two photos that static corrosion on the back side of the specimen and dynamic corrosion on the front side (gas flow without particles) results in nearly the same scale thickness with approximately a 10% increase on the dynamic corrosion side. This compares with a 60% increase in the scale thickness on the erosion-corrosion side when 5 μ m particles are used and a 345% increase when 100 μ m particles are used, all compared to the static corrosion only side scale thickness.

Cross sections of the erosion-corrosion scales are seen in the lower two photos in Figure 20. While the morphology of the static and dynamic corrosion scales are similar, there is a major difference in the two eroded-corroded scales in addition to their thickness difference. This seemingly anomalous behavior of the more erosive

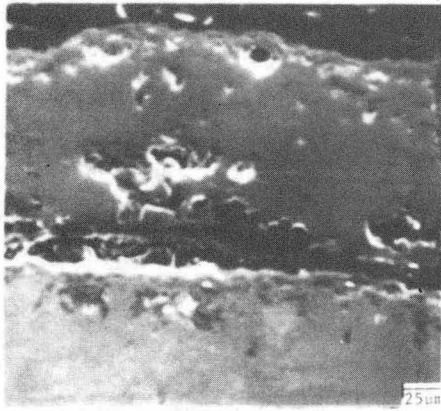
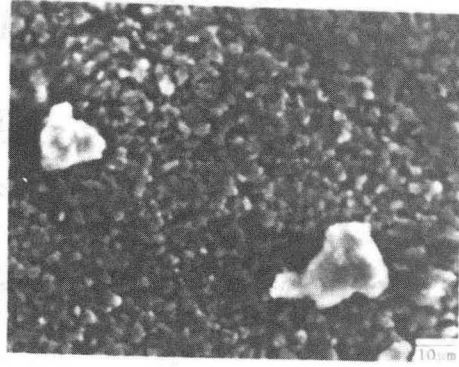
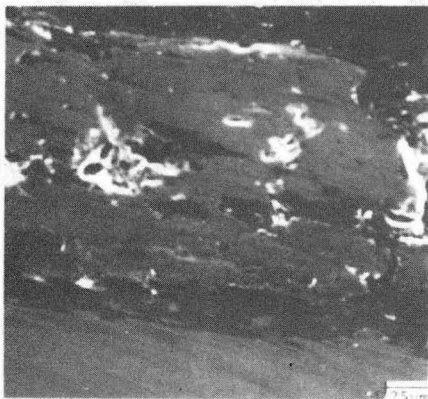
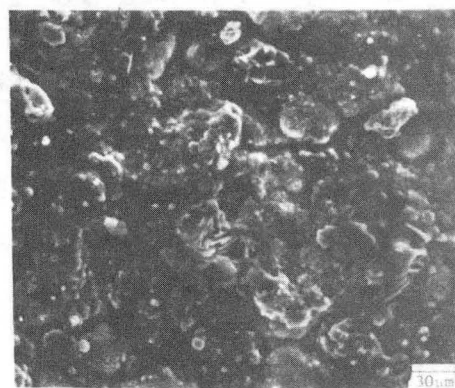
Fig. 21. Cross section and surface morphology of scales of 2 1/4, 9 and 12Cr steels eroded-corroded at 850°C using 100µm Al₂O₃.

The differences in the morphology of the cross section and surface of three of the chromium containing steels tested at the same conditions are shown in Figure 21. These steels were eroded by 100 μm Al_2O_3 particles. All three had iron oxide outer scales with the two higher chromium content steels having sizeable inner scales of iron-chromium oxide spinel.

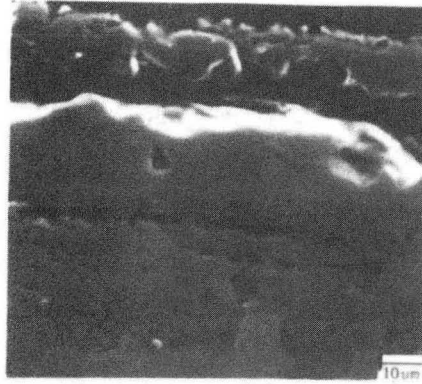
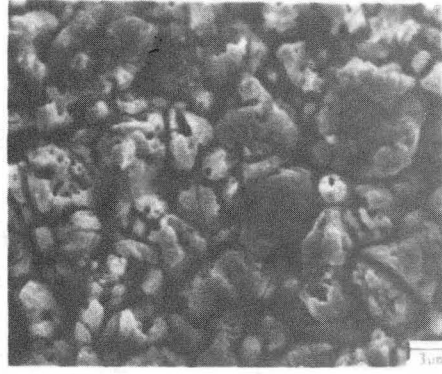
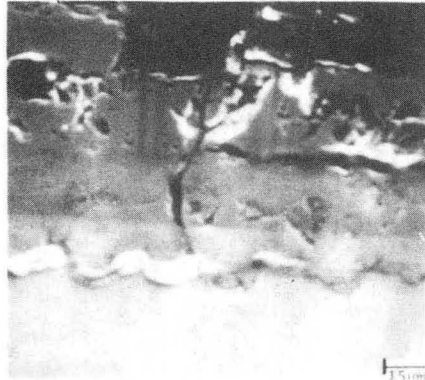
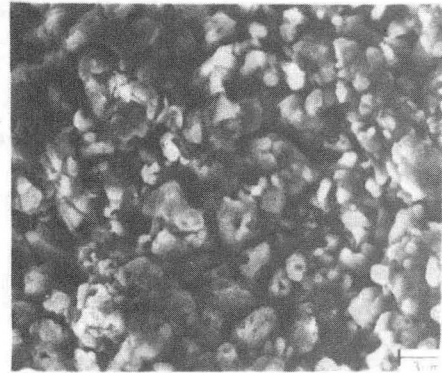
Fig. 22. Cross section and surface morphology of scales of 5, 9 and 12Cr steels eroded-corroded at 950°C using 50µm Al₂O₃. XBB 841-105

In contrast with the differences in the eroded-corroded surfaces that were shown in Figure 21 when the erodent was 100 μm Al_2O_3 the use of 50 μm Al_2O_3 erodent particles resulted in a very similar surface scale morphology for the three alloys of varying chromium content shown in Figure 22. The columns of iron oxide with wrinkled and porous tops are similar in size and shape to the corroded only side of the 410SS specimen that was tested with 5 μm flyash, see Figure 10. The scale morphologies of the three alloys shown in Figure 22 are completely

different from their eroded-corroded surfaces when tested using either 5 μ m or 100 μ m size particles, see Figure 10 and 21. The cross sections of the three scales are multi-layered and have generally similar morphologies. The scale thickness of the 9Cr and 12Cr steels was thinner when the 50 μ m particles were used than when the 100 μ m particles were used as can be seen by comparing Figures 21 and 22 (note magnification differences).
