ELEVATED TEMPERATURE COMBINED EROSION-CORROSION OF STEELS

A. Levy, E. Slamovich, and N. Jee

April 1985

LBL-19156
c.2

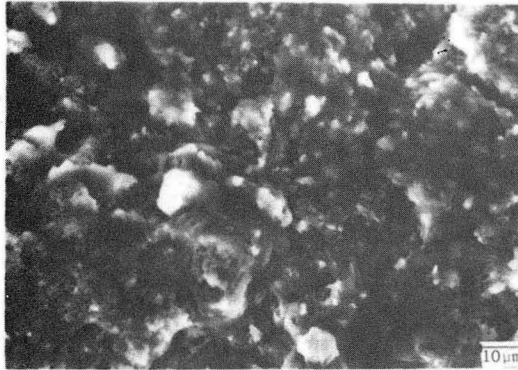
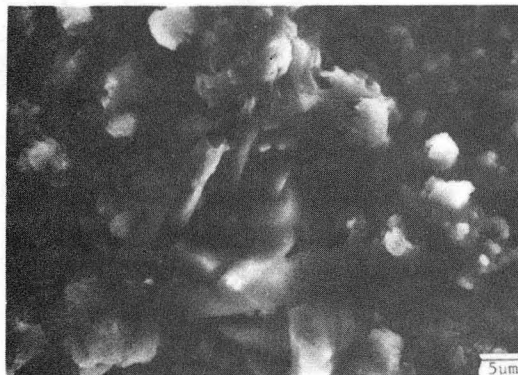
Fig.23. Surface morphology of eroded-corroded 9Cr1Mo steel at three different test temperatures using 100µm Al₂O₃.

The morphology of the surface iron oxide scale was also affected by the test temperature when 5 μ m flyash and 100 μ m Al₂O₃ erodents were used, but not when 50 μ m Al₂O₃ particles were used. Figure 23 shows the changes that occurred on the 9Cr1Mo steel specimens when the temperature was changed from 800° to 950°C and 100 μ m size particles were used. The large diameter needles or blades that grew at 950°C were very similar to those which grew at 800°C on the 5Cr1/2Mo steel shown in Figure 17. The increase in the size of the microstructural elements with increasing temperature was expected, but the delicacy of some of the iron oxide crystals on surfaces that were being impacted by 100 μ m size particles as they were growing was unexpected.

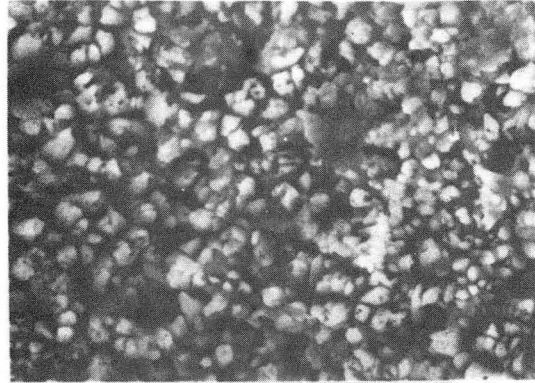
Fig.24. Surface morphology of eroded-corroded 9Cr1Mo steel at three different test temperatures using 50 μm Al₂O₃.
