OBSERVATIONS ON THE MECHANISMS OF FATIGUE IN EUTECTIC PB-SN SOLDER JOINTS

To be presented at the ASME Winter Annual Meeting, Chicago, IL, November 28, 1988, and to be published in the Proceedings

D. Tribula, D. Grivas, D.R. Frear,  
and J.W. Morris, Jr.

LBL-25831

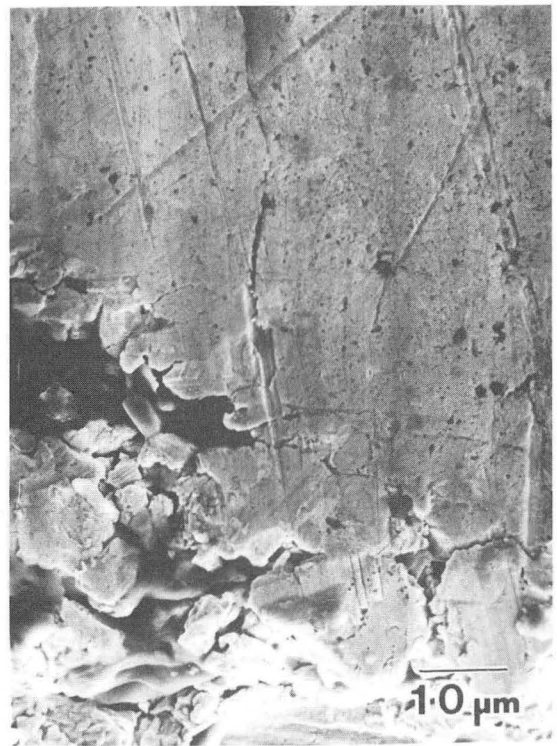
Figure 6

6. Optical micrograph of a coarsened band showing the coarse grain structure and intergranular fracture between Sn-rich grains.
7. Sample configuration used for isothermal creep experiments. Due to the slot configuration cut in in sample, when the sample is pulled in tension the solder regions between the slots are strained in nearly simple shear.

to form a growing thermal fatigue crack. The cracking mechanism, which is illustrated in Figure 6, involves the intergranular fracture of Sn-rich grains followed by the gradual failure of the intermediate Pb-rich material.

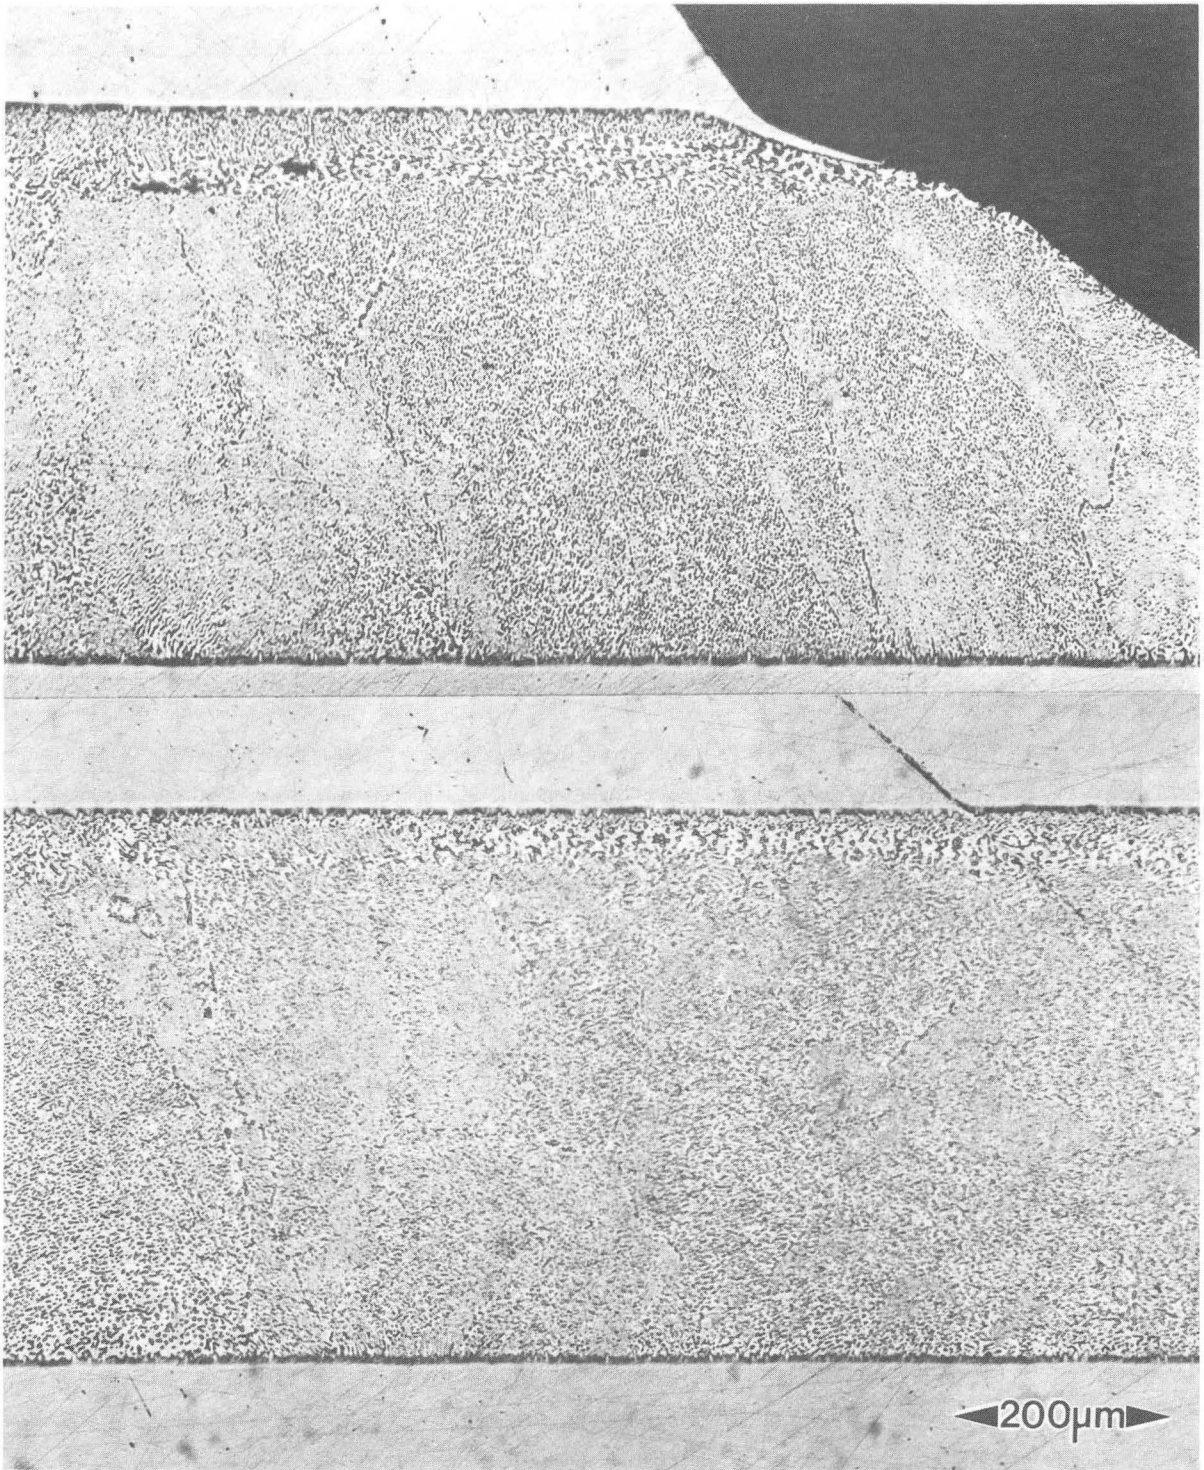
Figure 11

11. a. Optical micrograph showing initiation of the coarsened band at a free surface. b. The same coarsened band propagates along the length of the joint terminating within the solder.

In all cases the parallel deformation band originates at one side of the lateral surface of the solder joint. Finite element analyses [13] suggest that the point of origin is near the principal stress concentration point in the sample. The coarsened band that leads to fracture in the sample is always coincident with the parallel deformation band described above, and forms first at the terminus of the deformation band at the free surface, Figure 11a. It then slowly grows along the deformation band into the sample. Figure 11b, for example, shows the partly developed coarsened band of Figure 11a that terminates in the solder.
