Assessing channel morphology following a floodplain restoration project : Wildcat Creek, Richmond, CA

Assessing Channel Morphology Following a Floodplain Restoration Project: Wildcat Creek, Richmond, CA

*Ashley Holt and Charles F. Battaglia, University of California, Berkeley
LAEP222, Hydrology for Planners Term Project
May 17, 2004*

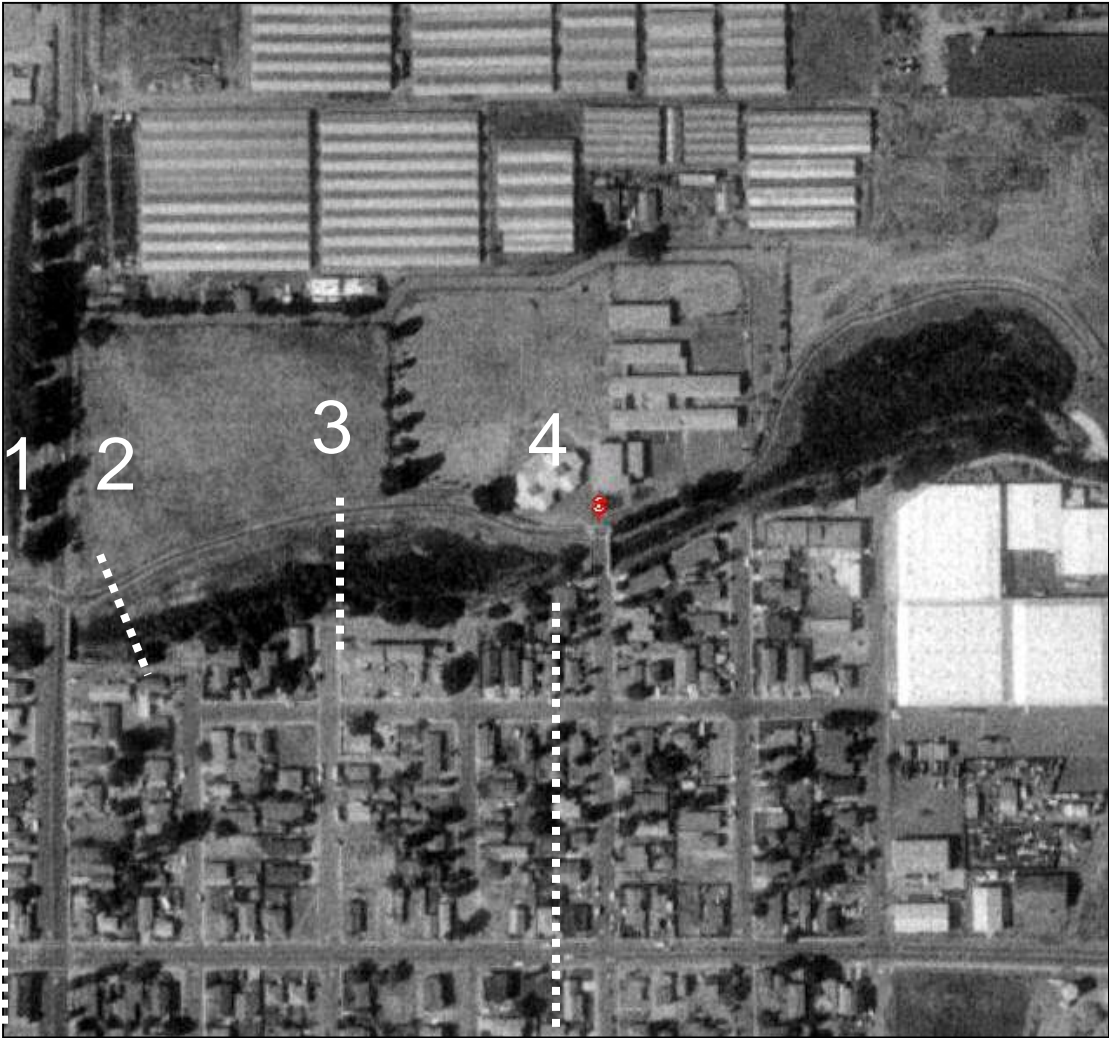
FIGURE 7: USGS AERIAL PHOTO OF RICHMOND, CA – 1993

- 1. 3rd Street
- 2. 83+00
- 3. 88+00
- 4. Giaramita Ave.

The papers by Bouitillier and White (2002, 2003) included aerial photography of Wildcat Creek in 1984, 1989, and 1996, and we used these images as a time series to track changes in channel morphology and surrounding vegetation.

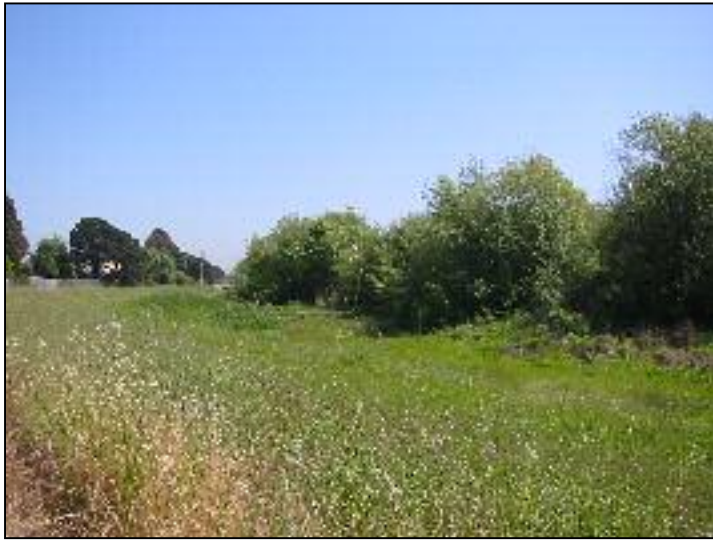
FIGURE 10: CROSS SECTION 83 + 00

View of floodplain looking upstream. Giaramita Ave. can be seen in the distance.

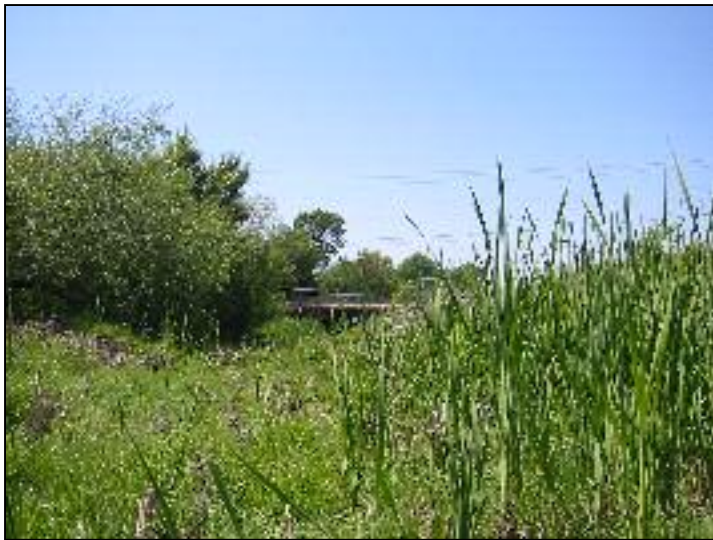
View of floodplain looking downstream. The Third St. bridge can be seen in the distance.

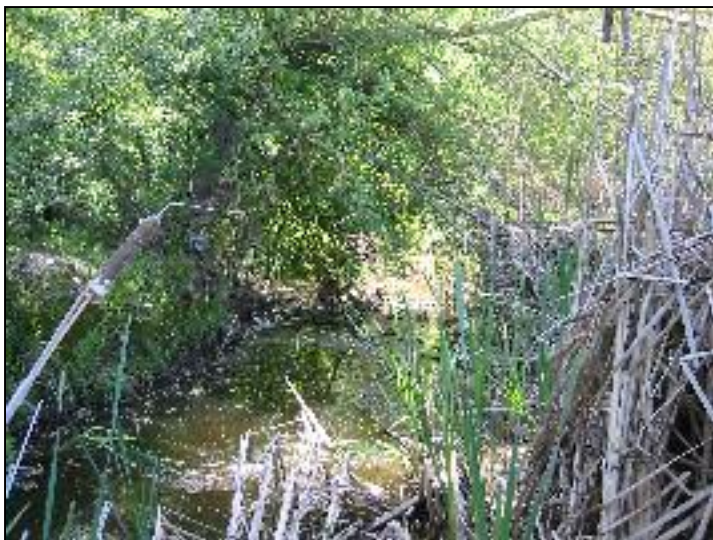
Downstream view of the main (low-flow) channel.

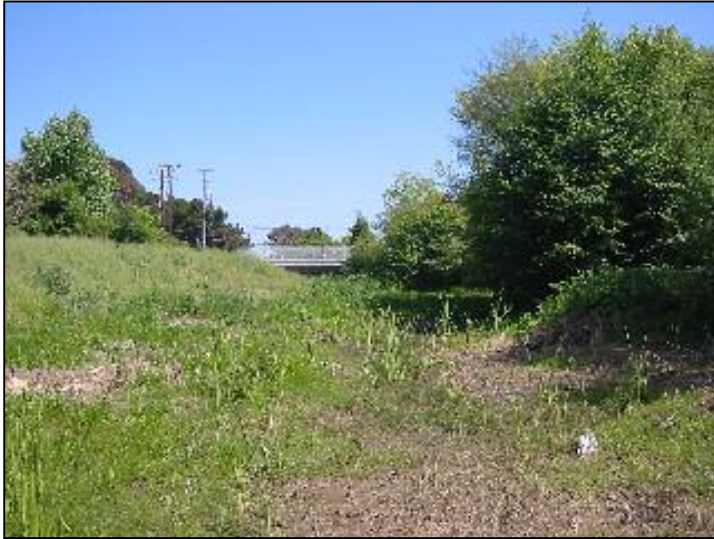
FIGURE 11: CROSS SECTION 88 + 00

View of floodplain looking upstream. Giaramita Ave. can be seen in the distance.

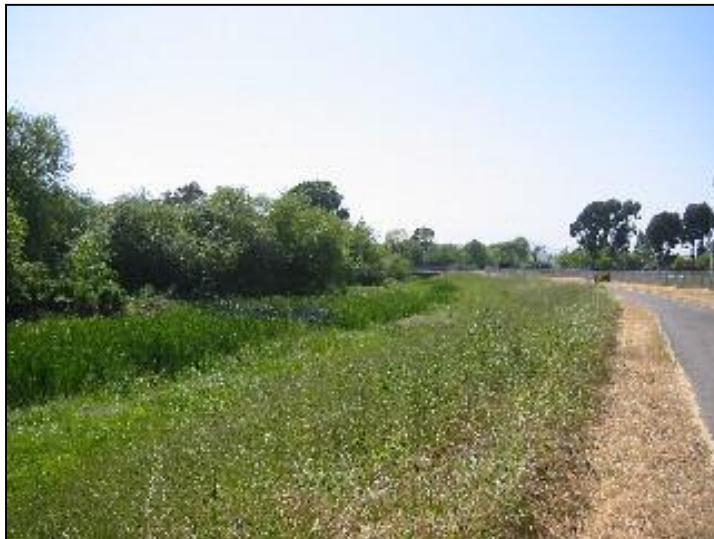
View of floodplain looking downstream. The Third St. bridge can be seen in the distance.

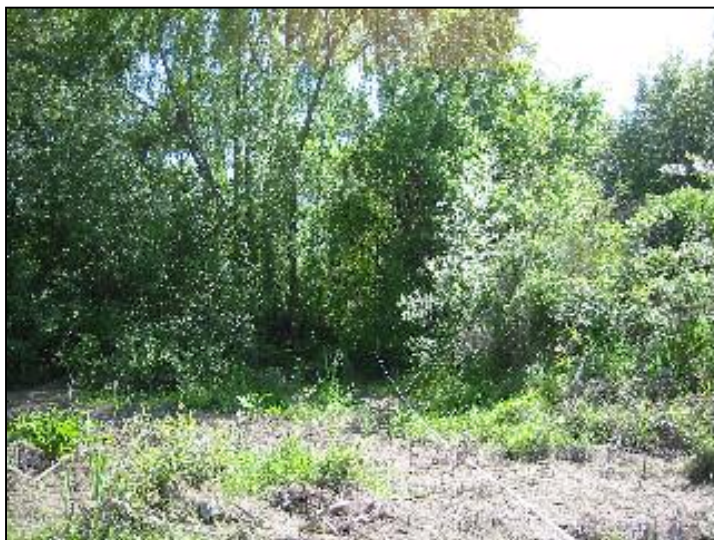
View of vegetation along the bank of the main (low-flow) channel.

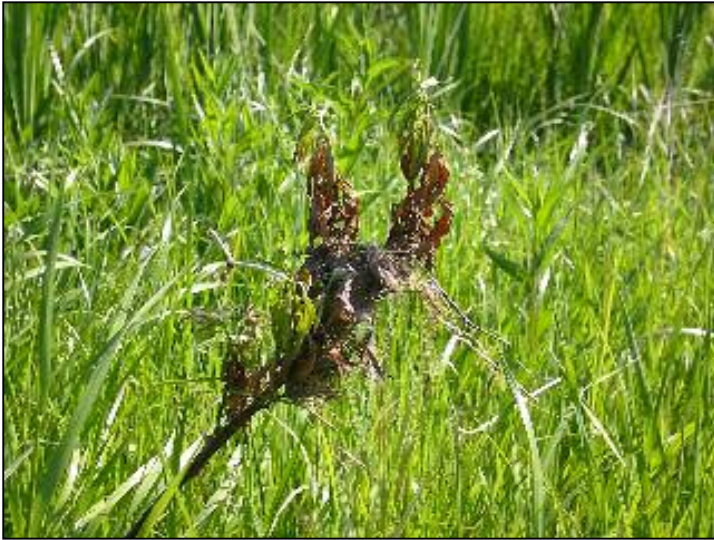
FIGURE 12: HIGH WATER MARKS

Debris caught in branch, along floodplain.

in the floodplain and identified additional high water marks from debris caught in small saplings and shrubs. With the level still in place, we surveyed these elevations and later used them to confirm the initial high water estimates from the upper edges of the floodplain.

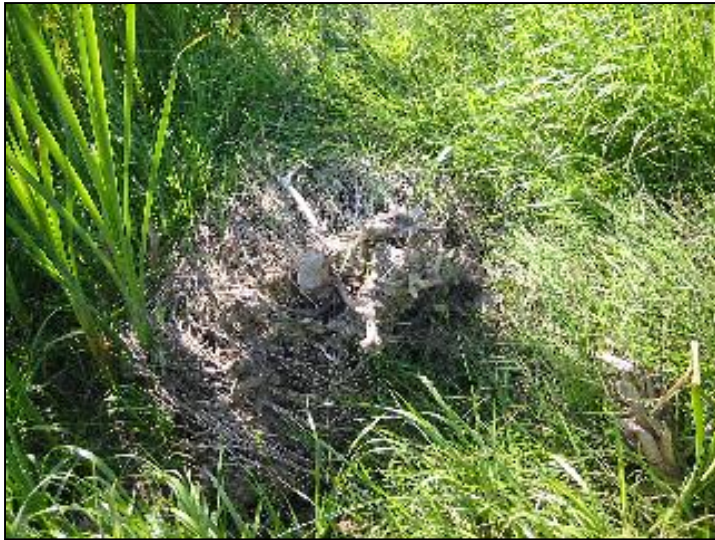
Debris built up along the edge of the floodplain.

For both cross sections (83+00, 88+00), we were only able to locate the survey pins on the northern side of the creek near the path. The southern ends of the cross sections were densely vegetated with blackberry bushes, inhibiting us from locating the pins. In both cases, however, a narrow clearing through the trees and otherwise dense riparian corridor marked a straight line from the north and south pins, and we conducted our cross-sectional surveys along this line. We surveyed the cross sections using a level and stadia rod, taking measurements along the cross section at intervals reflecting changes in topography, at high water marks, at inflection points, at the right and left edge of the water in the channel (REW & LEW), and at the thalweg of the main channel. For survey points located within the water, we also noted the height of the water above the channel substrate. Initial high water marks were located and recorded along the upper edge of the floodplain, where distinct changes in vegetation, debris, and soil existed.

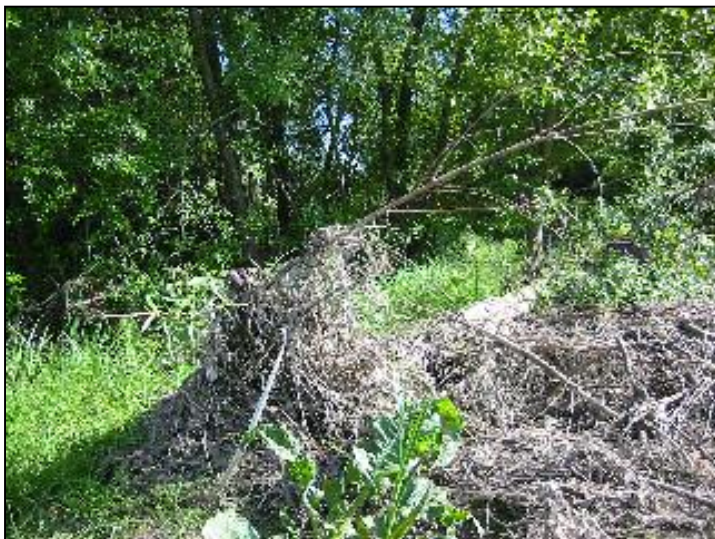
Debris caught in tree, near top bank of low-flow channel.
