Evaluating the effectiveness of wildlife accident mitigation installations with the wildlife accident reporting system (WARS) in British Columbia

# EVALUATING THE EFFECTIVENESS OF WILDLIFE ACCIDENT MITIGATION INSTALLATIONS WITH THE WILDLIFE ACCIDENT REPORTING SYSTEM (WARS) IN BRITISH COLUMBIA

Leonard E. Sielecki, Environmental Issues Analyst, British Columbia Ministry of Transportation, P.O. Box 9850, STN PROV GOVT, 4B - 940 Blanshard Street, Victoria, BC, Canada V8W 9T5. Phone: 250-356-2255. Fax: 250-387-3736. Email: Leonard.Sielecki@gems9.gov.bc.ca

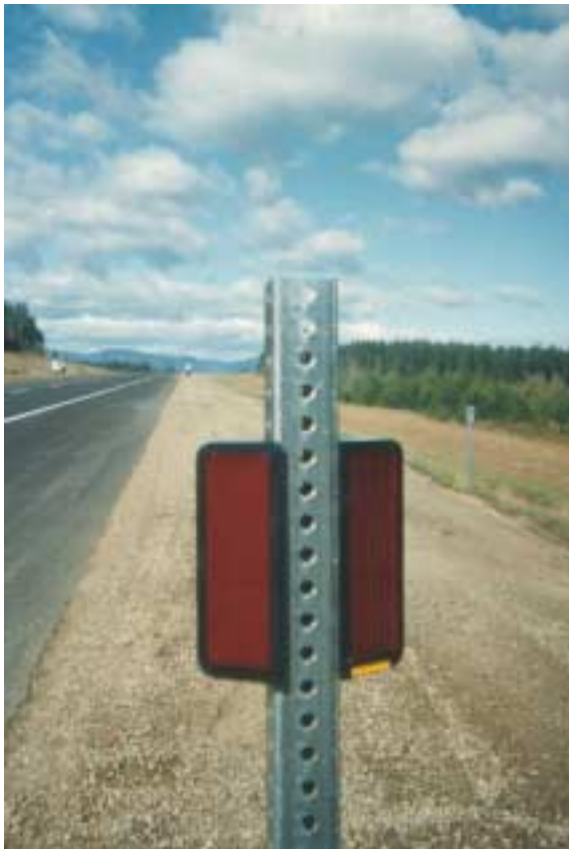
BC MoT has been installing wildlife warning reflectors since the late 1980s as the largest component of its continued effort to reduce wildlife-related accidents. The reflectors are prisms mounted on posts and installed along the sides of the highway as a means of deterring animals from entering the highway when vehicles are present (figure 1).

Fig. 1. Swarflex reflectors installed on a highway shoulder

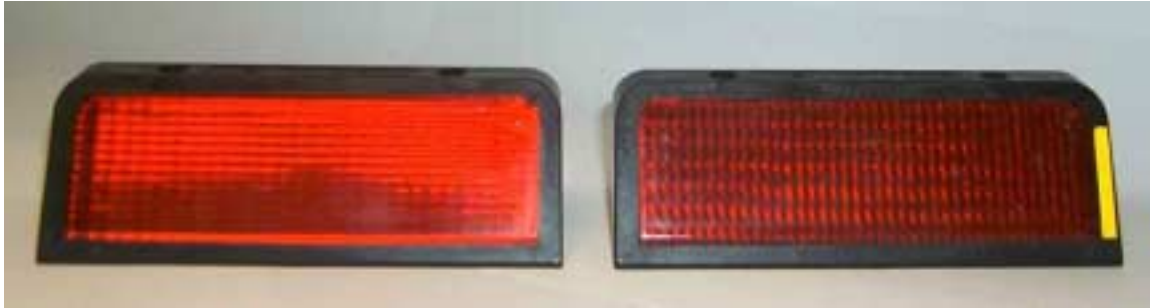
In addition to field tests, BC MoT is examining how wildlife warning reflectors may influence the roadside behavior of deer. BC MoT has traditionally used red coloured Swarflex ("old" style, level terrain and slope terrain models) and Strieter-Lite reflectors ("new" style models) (figures 5 and 6) because the manufacturer indicated deer responded to the colour red. "In a long series of experiments conducted by scientists in the field of behaviourism it was established that red light exerts a warning effect on deer." (Swarovski AG 2001) As a first step toward understanding how wildlife warning reflectors operate, BC MoT conducted tests on different coloured Swarflex and Strieter-Lite reflectors to determine their fundamental spectrometric and photometric properties (Sivic and Sielecki 2001) (figure 7). The tests were designed to measure the reflected light spectrum, luminous intensity and light distribution in a horizontal and vertical plane. Several spectrometric and photometric characteristics were found.

Fig. 5. Swarflex wildlife warning reflectors ("old" style) (Models 7172 and 7182)

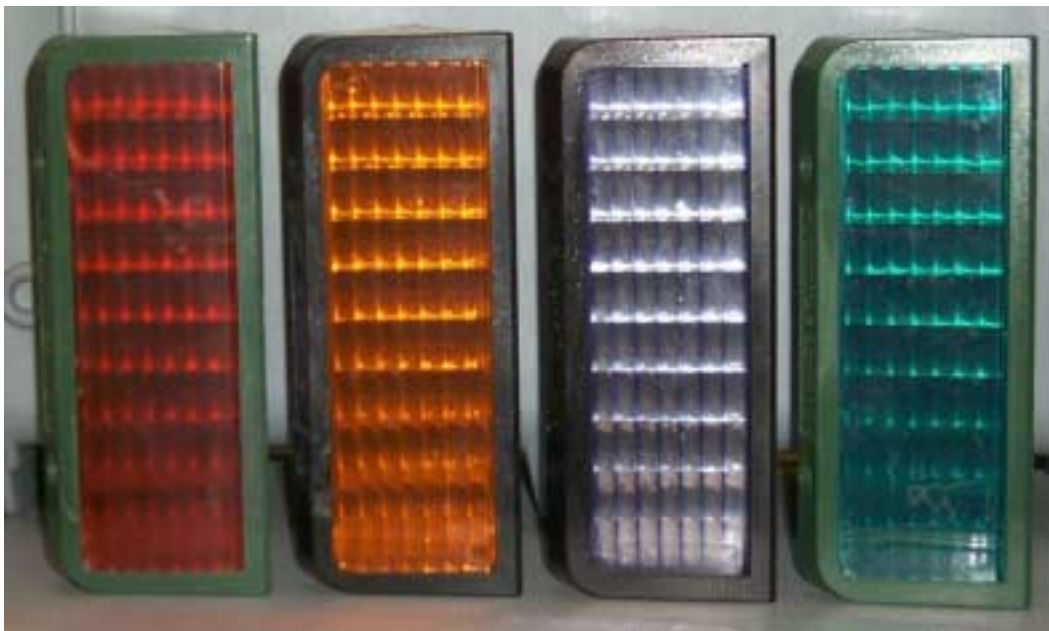
Fig. 7. Strieter-Lite wildlife warning reflectors (Model 7176)

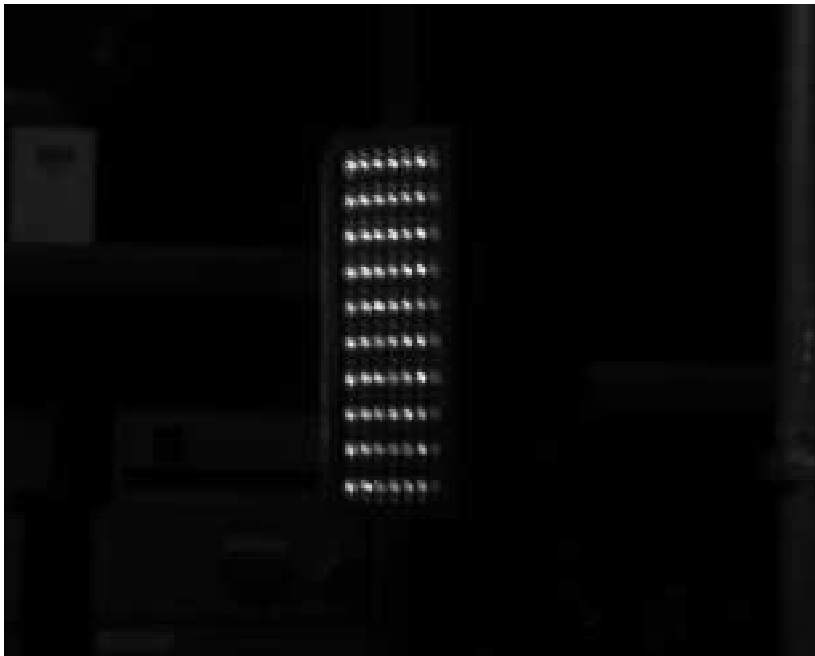
The Swarflex "old" style models appear to have five to ten times higher light reflection intensity compared to the Strieter-Lite new style models (figures 8 and 9). The functional design of the Swarflex "old" style level terrain model (Model 7172) appears better suited for reflecting light from motor vehicle headlights on a horizontal plane than the Strieter-Lite "new" style reflector (Model 7176).

Fig. 9. Strieter-Lite wildlife warning reflector ("new" style) (Model 7176) illuminated

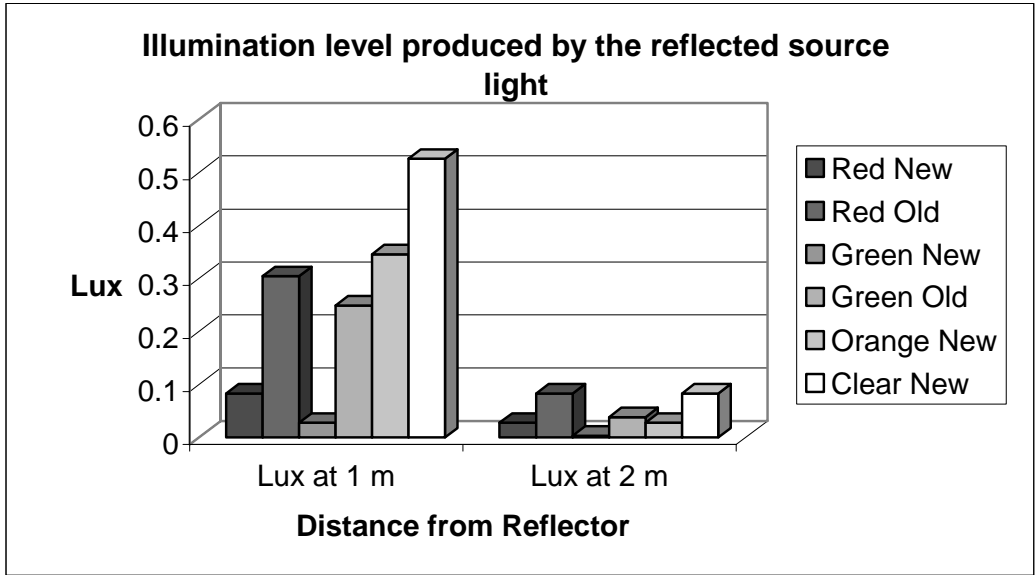
The function design of the Swarflex "old" style slope terrain model (Model 7182) appears better suited for reflecting light from motor vehicle headlights at an angle than the Strieter-Lite "new" style reflector (Model 7176). Generally the coloured reflected light intensity readings are very low. The reason for this appears to be the small size of the reflector. The reflector reflects only a small portion of the incoming light from the car headlight. The readings at the distance of two meters from the reflectors are below 0.1 lux, which indicates the intensity at greater distances will be negligible (figure 10).

Fig. 10. Illumination levels produced by the reflected source light

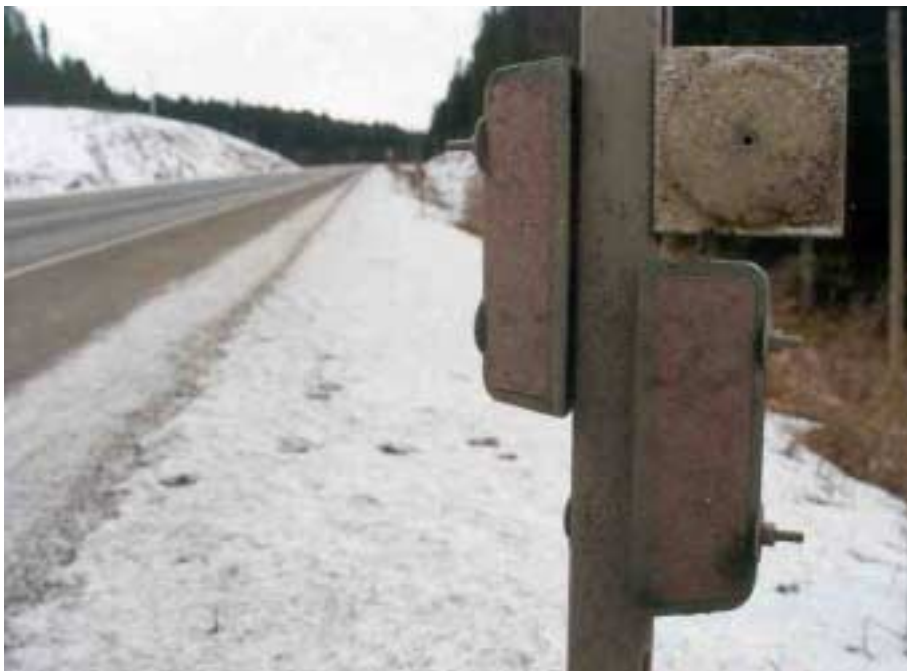
Fig. 12. Wildlife warning reflectors operating under winter roadside conditions

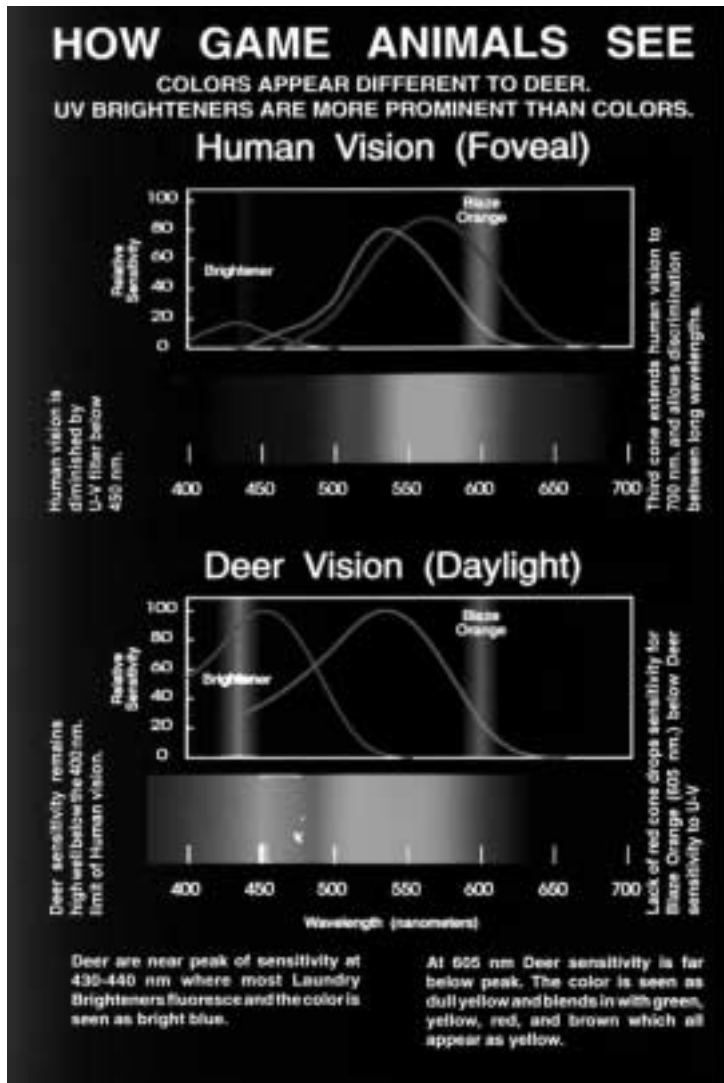
To fully understand how reflectors may influence the behavior of ungulates, the effects of white first surface reflection should be investigated. The white first surface reflection may be a more significant feature of the reflectors than the internal reflections from a coloured or uncoloured lens. However, deer vision research conducted by Jacob et al. (1994), raises serious questions about what colour of reflectors may be best suited for highway purposes. Apparently, deer do not see well in the red end of the light spectrum (figure 14).

Fig. 14. Comparison of human and deer colour vision

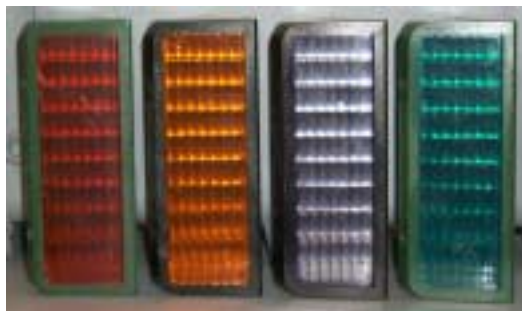
If one applies the concept of deer having limited red colour vision to the examination of the effectiveness of wildlife warning reflectors, it appears red coloured reflectors may not be the most suitable for highway applications to reduce deer related motor vehicle accidents. Given the properties of ungulate vision, the effectiveness of colour on should also be determined (Jacob et al. 1994; Zacks 1986).

Fig. 15. Wildlife reflectors (visible light spectrum)
