## Establishing a Baseline Surveying of Ackerman Creek (*Ya-mo-bida*) at Pinoleville Pomo Nation

Fall 2023

Elias Demosthenes & Kanani D'Angelo

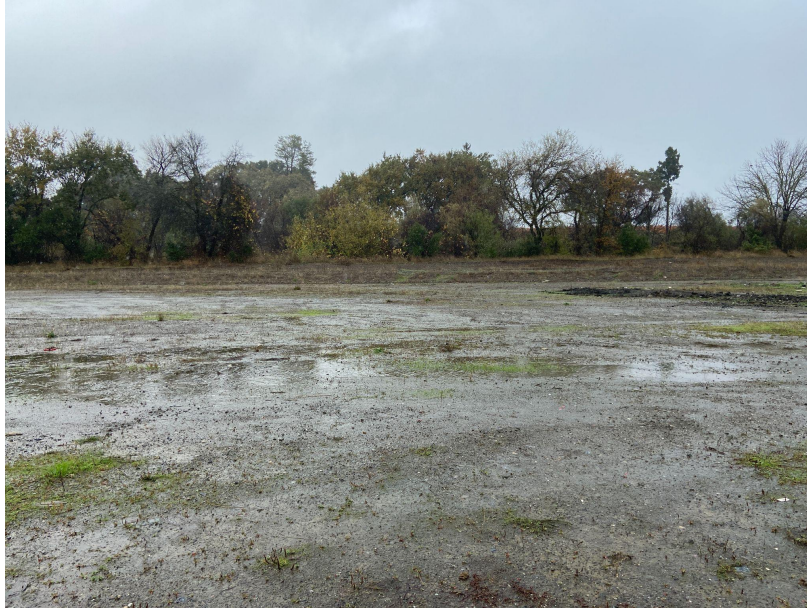
Figure 6. View of the North side of Rancheria. This is the site of the former auto wrecking yard. Ackerman creek lies beyond the constructed berm seen in the background.

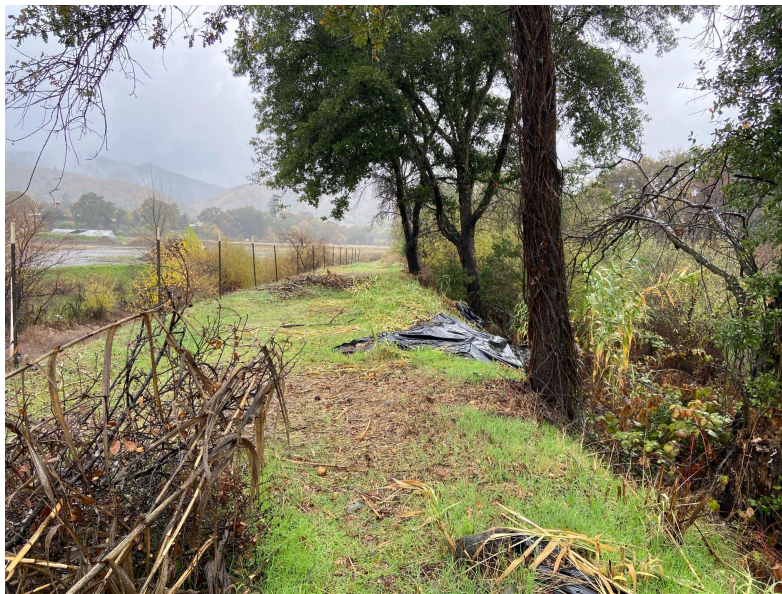
Figure 7. View looking upstream (west) from south berm. Ackerman creek on right and PPN on left.

*Figure 7.* View looking upstream (west) from south berm. Ackerman creek on right and PPN on left.

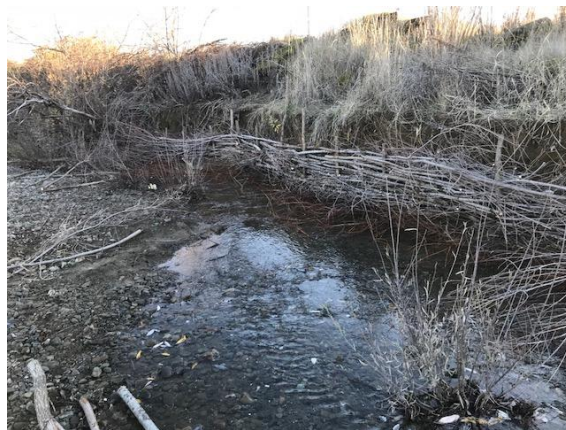
Figure 8. Willow wall installed in December 2017 for streambank stabilization<sup>37</sup>

The PPN's stewardship of Ackerman Creek centers around restoring the riparian area as a thriving space that supports both wildlife and cultural practice. The PPN EPA's efforts currently prioritize invasive species removal, water quality monitoring, and native species propagation and planting.<sup>33</sup> In 2009, the first pilot projects for in-stream restoration were installed upstream of our study area, and focused on Steelhead trout and Chinook salmon habitat creation with log and boulder structures.<sup>34</sup> Additional restoration utilized over 1,500 feet of bioengineered willow and log and boulder structures.<sup>35</sup> These efforts intended to “create scouring pools, increase depth, catch and remove sediment from the channel, improve bank stabilization and ultimately increase the amount of suitable spawning habitat for [PPN's] yo-sha (fish) relatives.”<sup>36</sup>

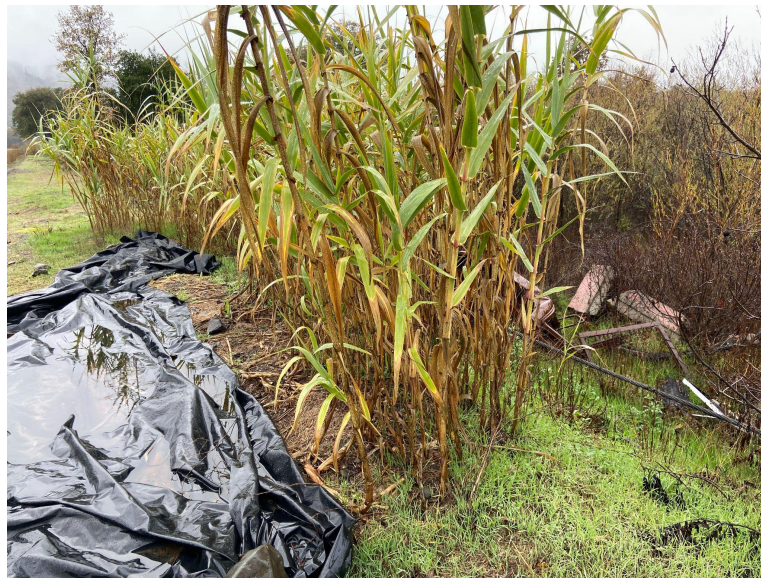
Figure 9. *Arundo* removal upstream of surveyed site, on south bank.

Ongoing restoration efforts emphasize the removal of invasive *Arundo donax* (Giant Reed) and *Rubus armeniacus* (Himalayan Blackberry). *Arundo* forms dense stands along riparian and wetland areas where it outcompetes willow and other native riparian species for water.<sup>38</sup> In the Russian River watershed, Ackerman creek has one of the largest *Arundo* infestations.<sup>39</sup> The PPN currently uses mechanical removal, burning, and tarping tactics to eradicate *Arundo*. Many

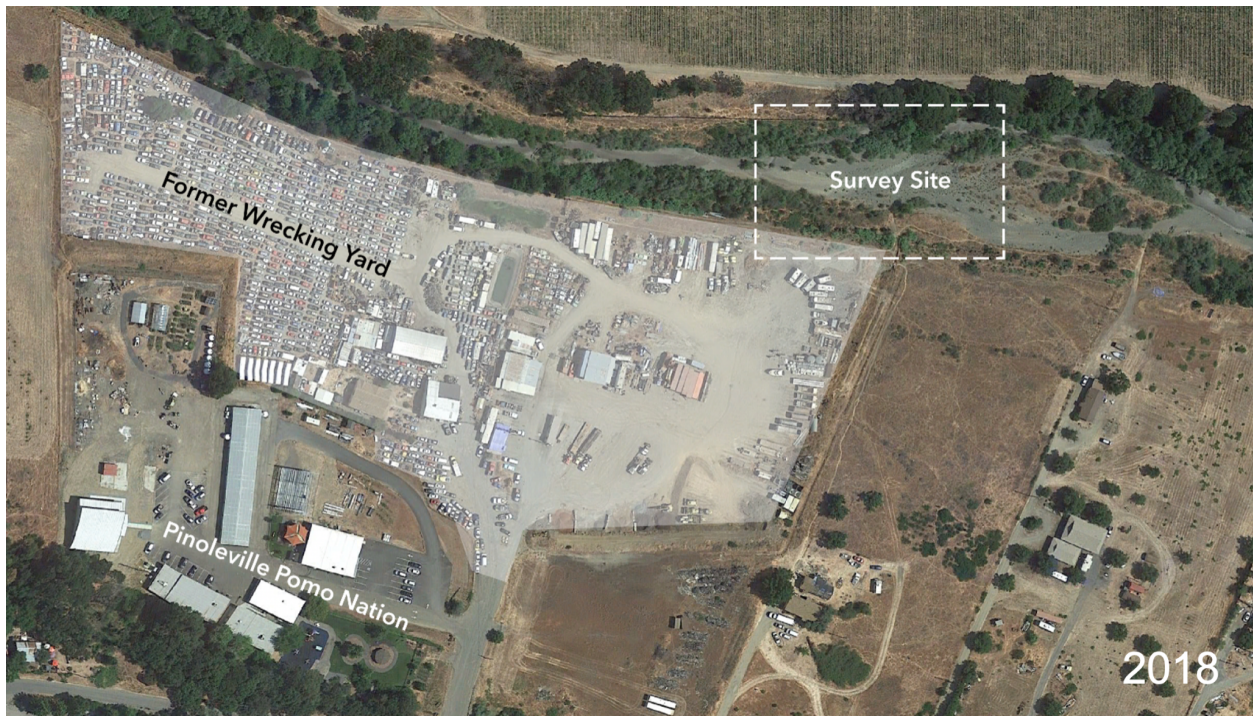
Figure 10. Wrecking yard within PPN rancheria in 2018, with noted survey site.

Ackerman Creek began in 2008.<sup>45</sup> As of 2021 the wrecking yard was cleaned up, with the physical debris and cars cleared from the site between the Rancheria offices and the creek.

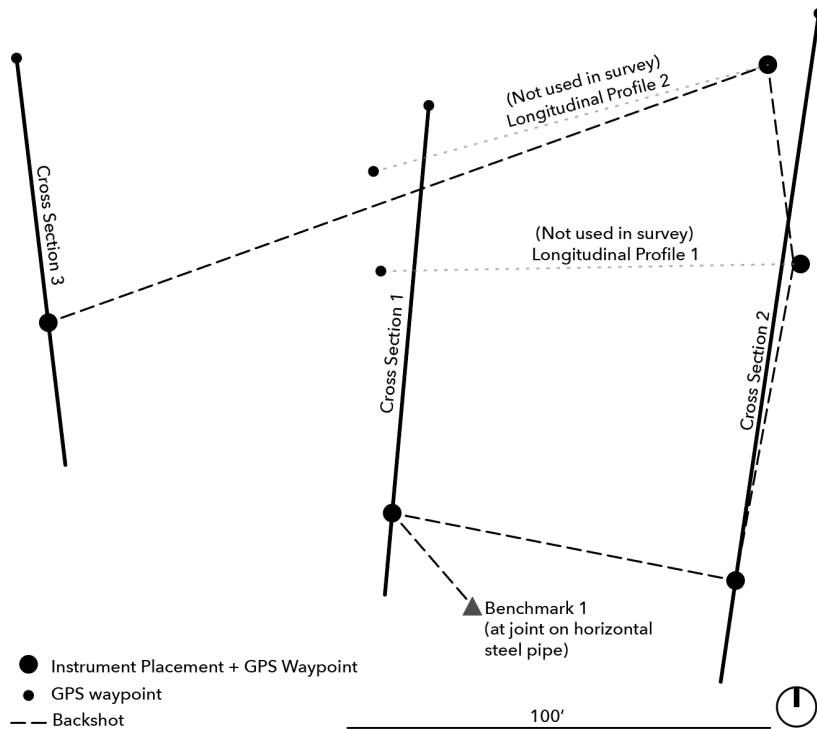
**Appendix B: Cross-Sections**

**Surveyed Cross Sections Ackerman Creek - November 18, 2023**

HI: Height of surveying Instrument

Cross-Section 1: Station 1A (39.18162 °N, -123.216533 °W), Station 1B (39.181891°N, -123.216501°W)

Cross-Section 2: Station 2A (39.181573 °N, -123.216231 °W), Station 2B (39.1819251°N, -123.216172 °W)

Cross-Section 3: Station 3A (39.181747 °N, -123.216827 °W), Section 3B (39.181896°N, -123.216851 °W)
