Ecological History of Los Laureles-Goat Canyon

Final Project

Ld Arch 227: River Restoration

Maria Lopez Vazquez

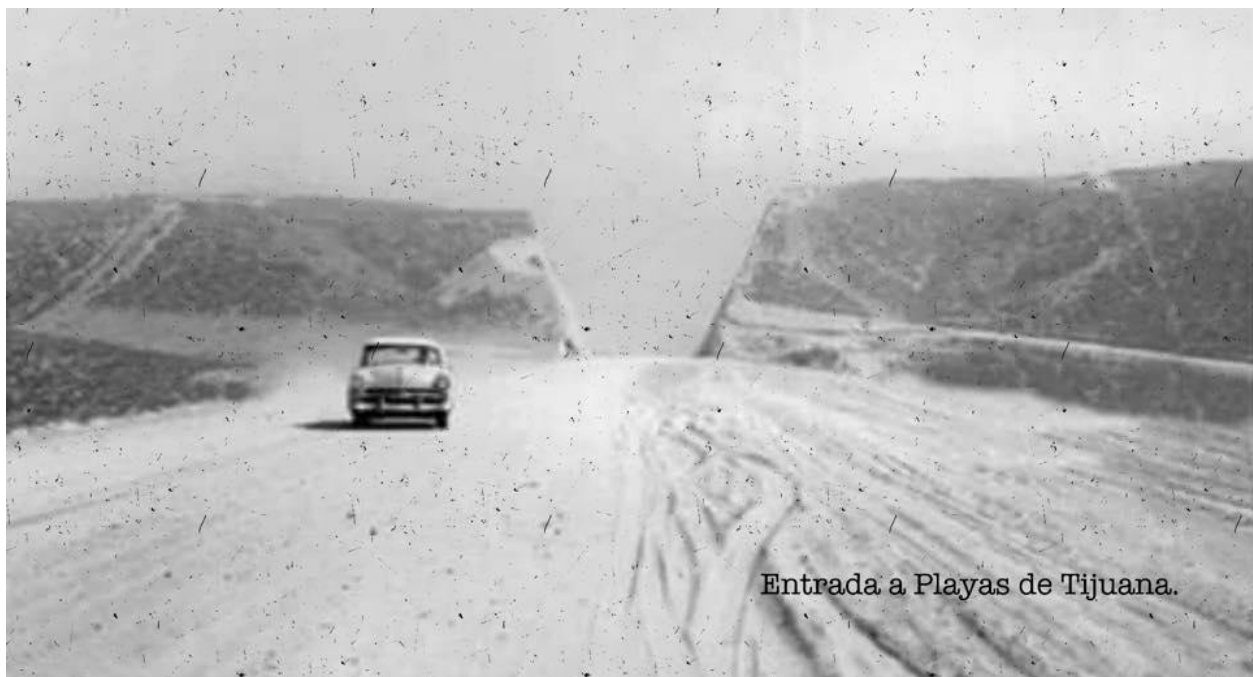
Figure 1-03 shows the slicing of the mesa in 1959. The picture was taken from Playas looking back to the east (Por las calles y colonias de Tijuana, 2002)

The modern development and ecological decay of the Los Laureles (Goat Canyon in the U.S.) region can be traced back to the construction of the “Playas Road” that connects the Tijuana beach area to the rest of Tijuana. In 1959 the administration of Governor Braulio Maldonado (the first governor of Baja California) started the construction of the road to connect Playas with the rest of the city. Dynamite was used to slice the hills and make the road (Por las calles y colonias de Tijuana, 2002). Figures 1-03 and Figure 1-04 clearly show the splice of the canyon to create the road.

There is no public record of the earthworks of the road, but one can speculate that the cut material from the splicing of the mesa served as fill material to elevate the road in Los Laureles-Goat canyon. Creating a barrier in the valley and forcing the hydrology that flows downstream from the south through pipes to connect to the estuary in the north.

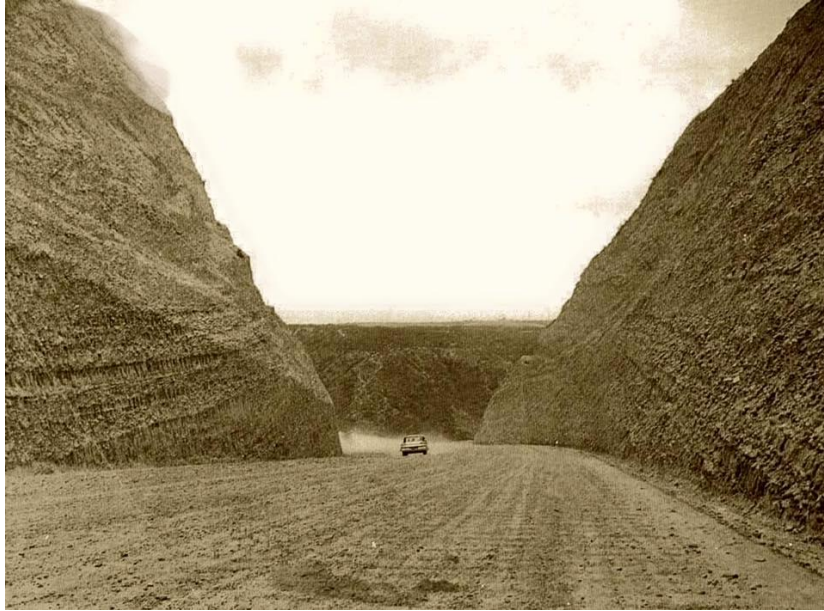
Figure 1-04 shows the cut of the mesa. The picture was taken within the cut area, looking back to the east (Por las calles y colonias de Tijuana, 2002).

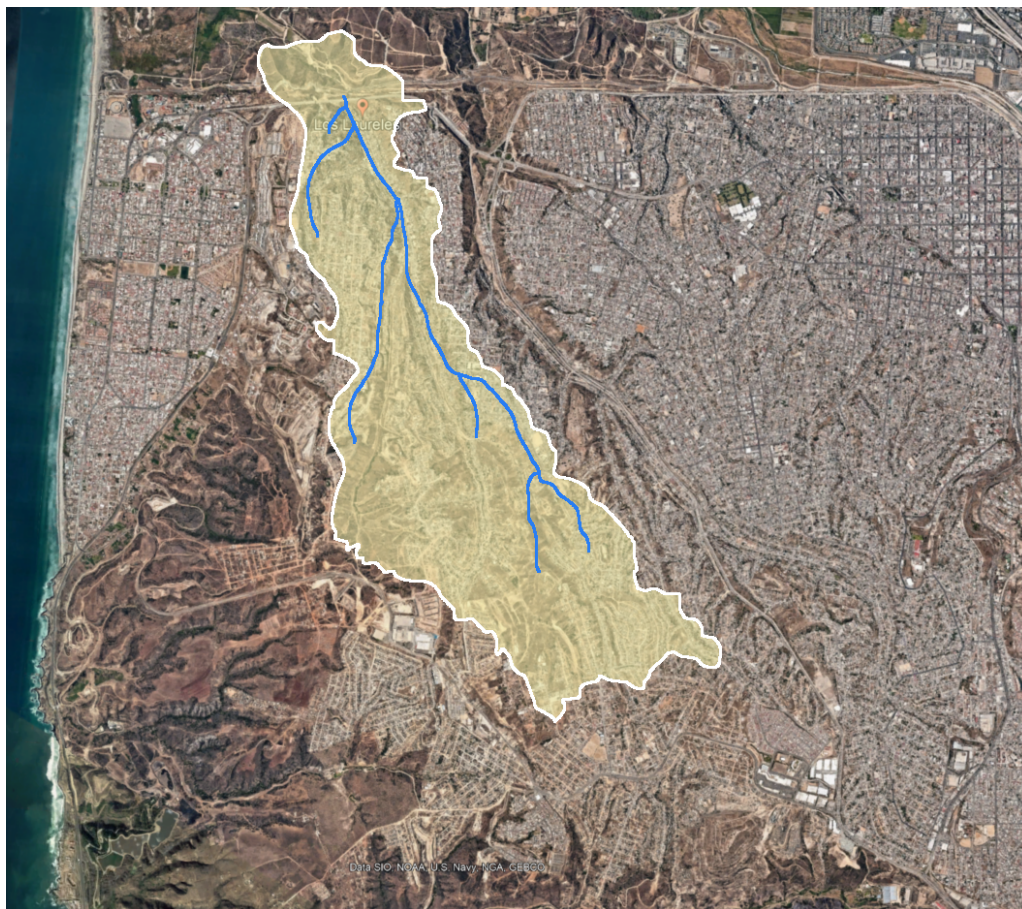
Figure 1-06 Outlines the extent of the Los Laureles subwatershed with the stream.

Los Laureles subwatershed is one of 31 subwatershed within the Tijuana River watershed (Atlas de Riesgos Naturales del Municipio de Tijuana, 2014). Los Laureles subwatershed is 4.69 square miles, in turn divided into seven micro watersheds. Figure 1-06 illustrate the location of the subwatershed Los Laureles and the stream.

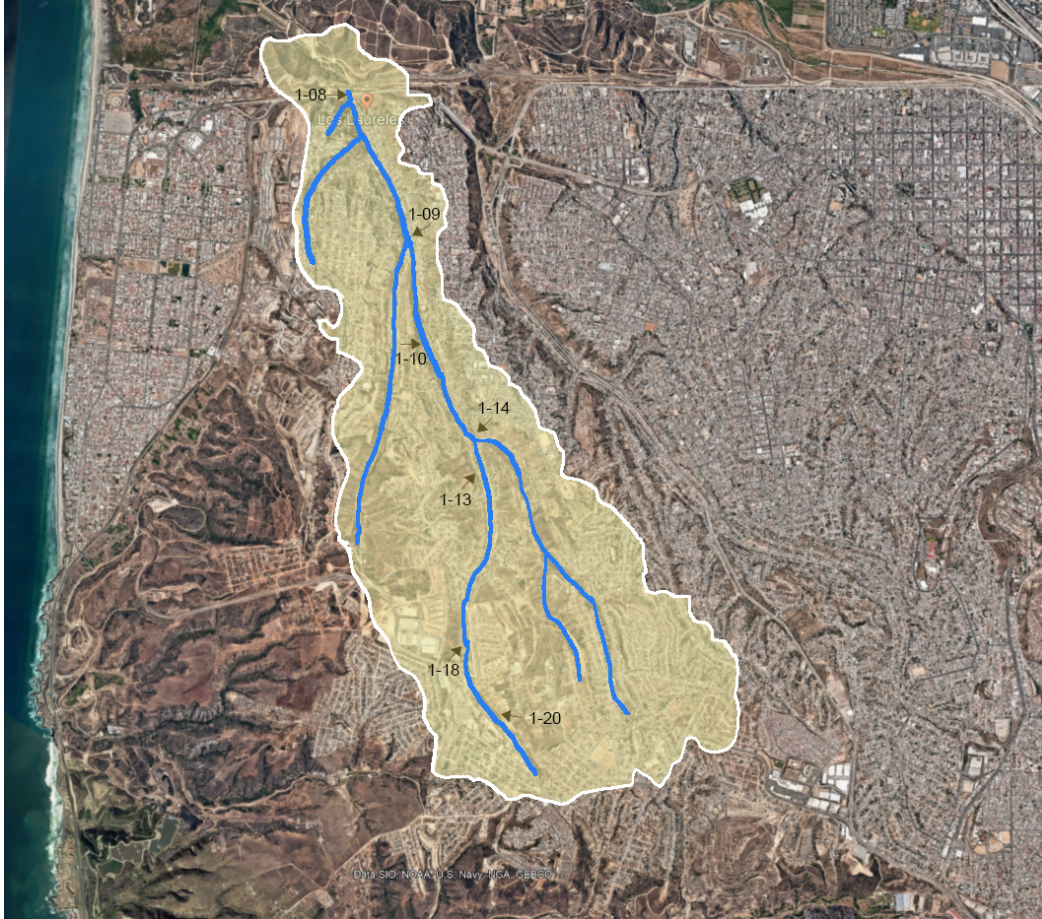
Figure 1-22 Identified the route along the west fork of the stream and marks the locations of the interactions along the stream with the context of an aerial map.)

Figure 1-22 illustrates the route taken in Los Laureles Basin and with arrows indicates where the photographs were taken.

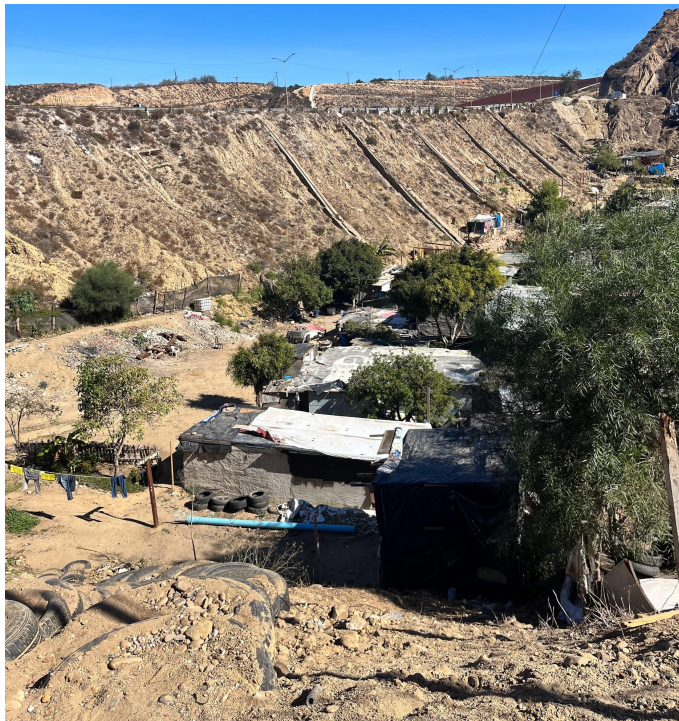
Figure 1-08 View of the informal settlement between Playas Road and the entrance of Los Laureles Community on the North (32.535358,-117.100402).

As I was documenting the entrance of Los Laureles from the North side, micro watershed G, Figure 1-08, Tito Corrales approached me. He has been a resident of this area for over 6 years and expressed concern for the lack of infrastructure in the region. The rest of the conversation revolved around marginalization by the government. There was an apparent lack of information about the official land use zoning from the land he inhabited. Misses Licha who lives in the canyon overlooking this portion of the stream recounts how the area was regarded as pure wilderness only a few feet away from her parents house. “[My brothers and I,] ...we would go exploring ”.

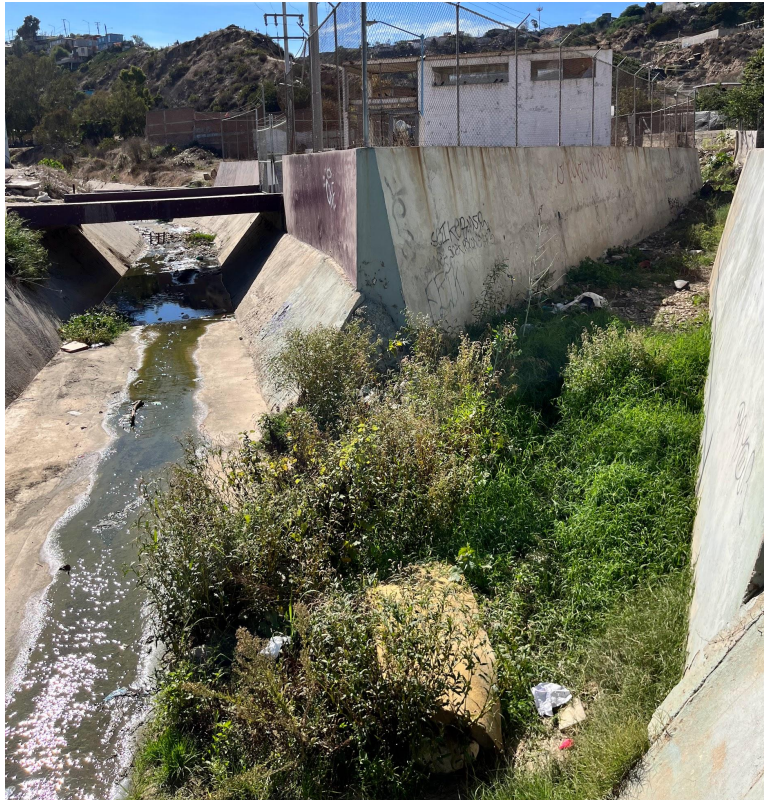
Figure 1-09 Culvert/Pumping station Los Laureles, (32.523478, -117.091621)

When documenting the culvert/ pumping facility Los Laureles II Figure 1-09 that pumps sewage from the vicinities to be transported through pipes to the nearest treatment center. This facility is located at the entrance of sub watershed D, a cleaning crew swept the northern section of the channel. Natario y Firo were tasked to clean that portion a few days ago by local CESPT (Commission Estatal de Servicios Publicos Tijuana/ The State Commission of Public Services of Tijuana) workers. They mentioned

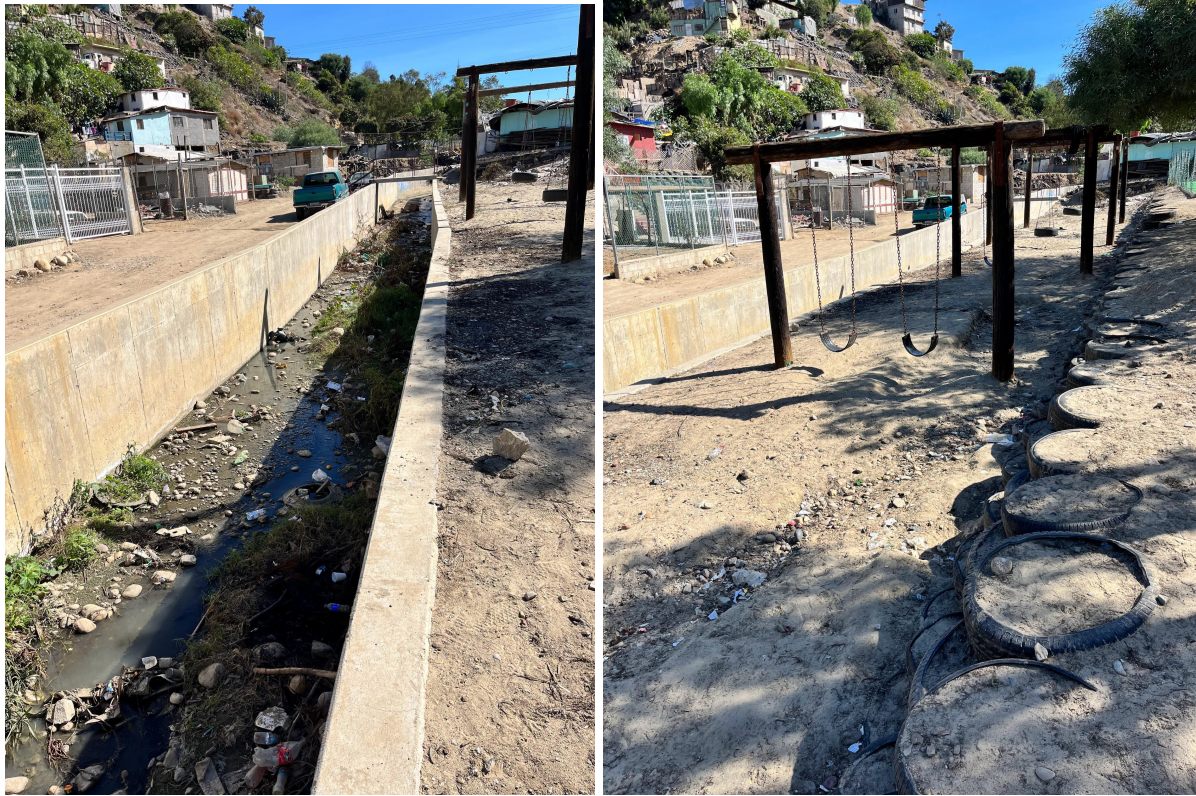
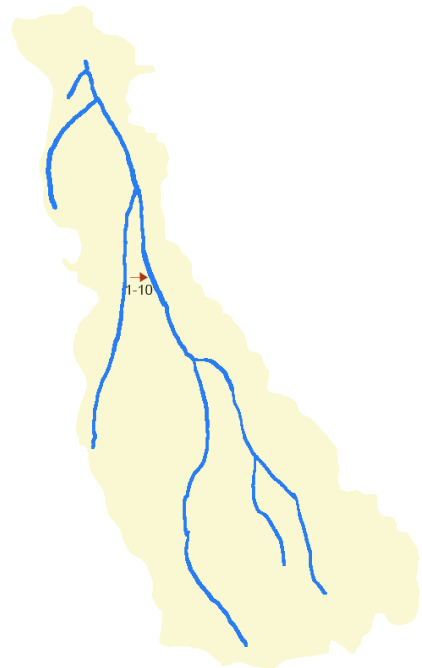
Figure 1-10 and 1-11 transit stop and local park next to the channel (32.511724,-117.086461)

Figure 1-10 and 1-11 are particularly interesting because it is a very active point since its the starting point for the local transit route. It is surrounded by convenience stores and churches. Carlo Perez parked his taxi in this location and waited for passengers to arrive. I asked about the recycle play structures, and he mentioned the project was a team effort between “some organization,” local churches, and community members, “we needed community spaces, we still do, and this is a good start.” When I asked about the channel, he seemed well-informed about community issues and had a informed opinion about the channel and the sources of pollution. He noted that most people see the waterway as a hazard more than a benefit since, most of the time the

water is dirty and smells bad. He recognizes the efforts the community plays in keeping it clean but notes that it's very hard to change people's habits.

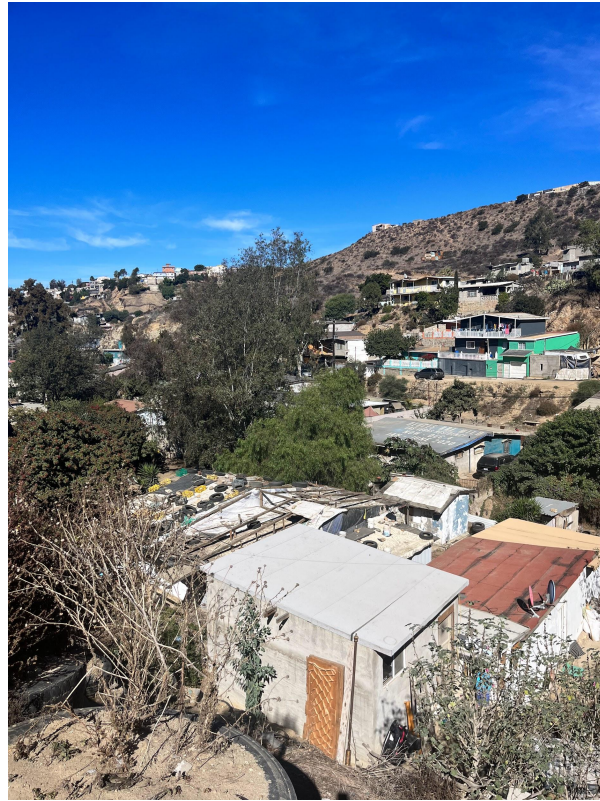
Figure 1-12 Aerial view showing dense vegetation. Figure 1-13 Above the channel looking down at the encroaching urban settlements (32.505925, -117.083453)

As I continued to track the stream upwards, there was a point where the channel changed direction and was no longer visible from the street, looking at an aerial view of the region, I realized the stream was not culvered because there was dense vegetation forming a corridor between houses Figure1-12.

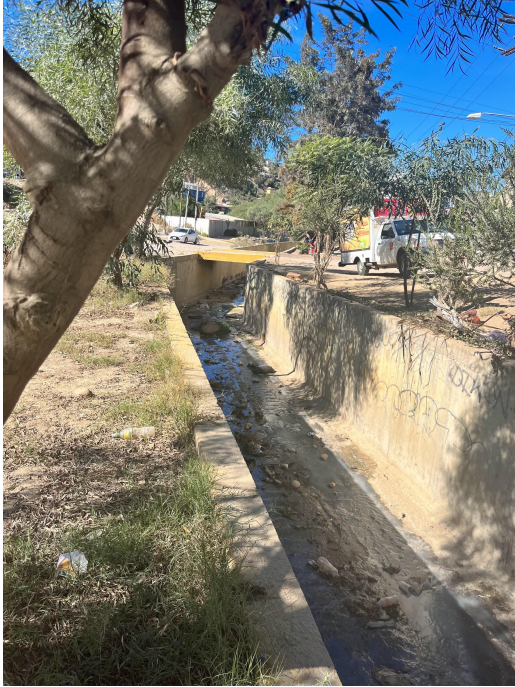
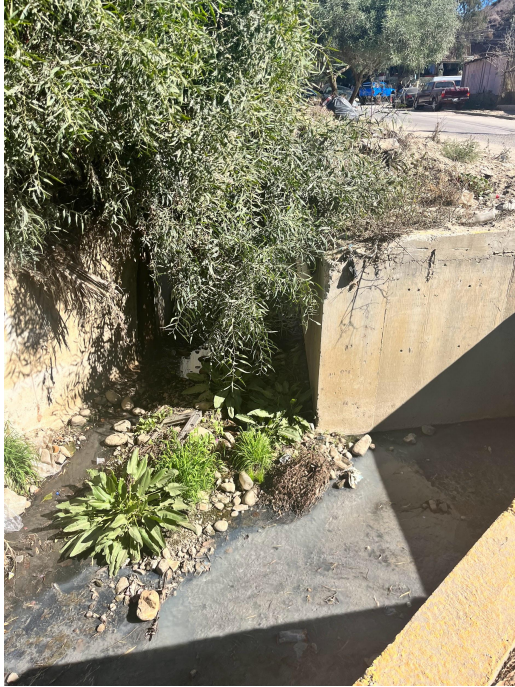
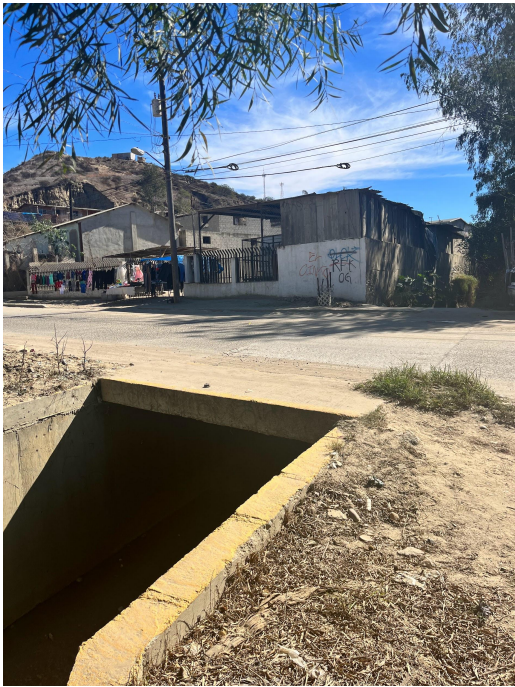
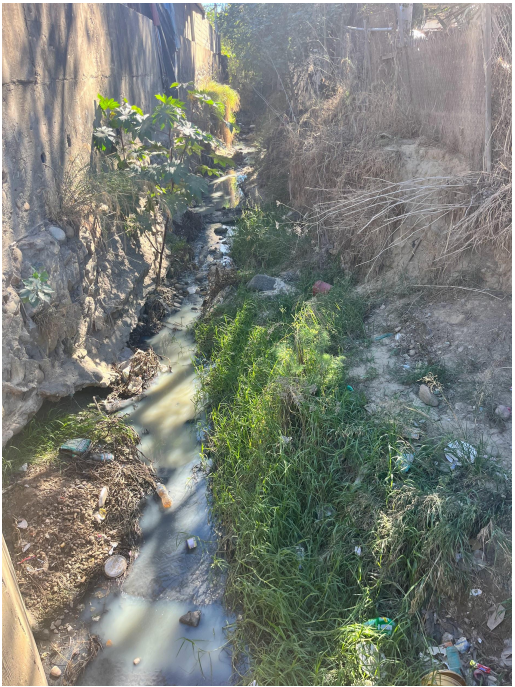
Figure 1-14 Upper left shows the formalized channel along the street (32.509399, -117.084495). Figure 1-15 Upper right shows the bifurcation of the channel. Figure 1-16 Lower left shows the channel running under the street. Figure 1-17 Lower right shows the channel between residential lots.

Taking a closer look at the point where the channel changes direction it is not clear up to what extent it is formalized. Comparing it to the adjacent section Figure 1-14 shows the formality of the channel a few feet before the bend. Figure 1-17 shows the channel between properties. Incision is apparent by the exposure of footings, pollution from household chemicals is also apparent. This marks the end of sub watershed D.

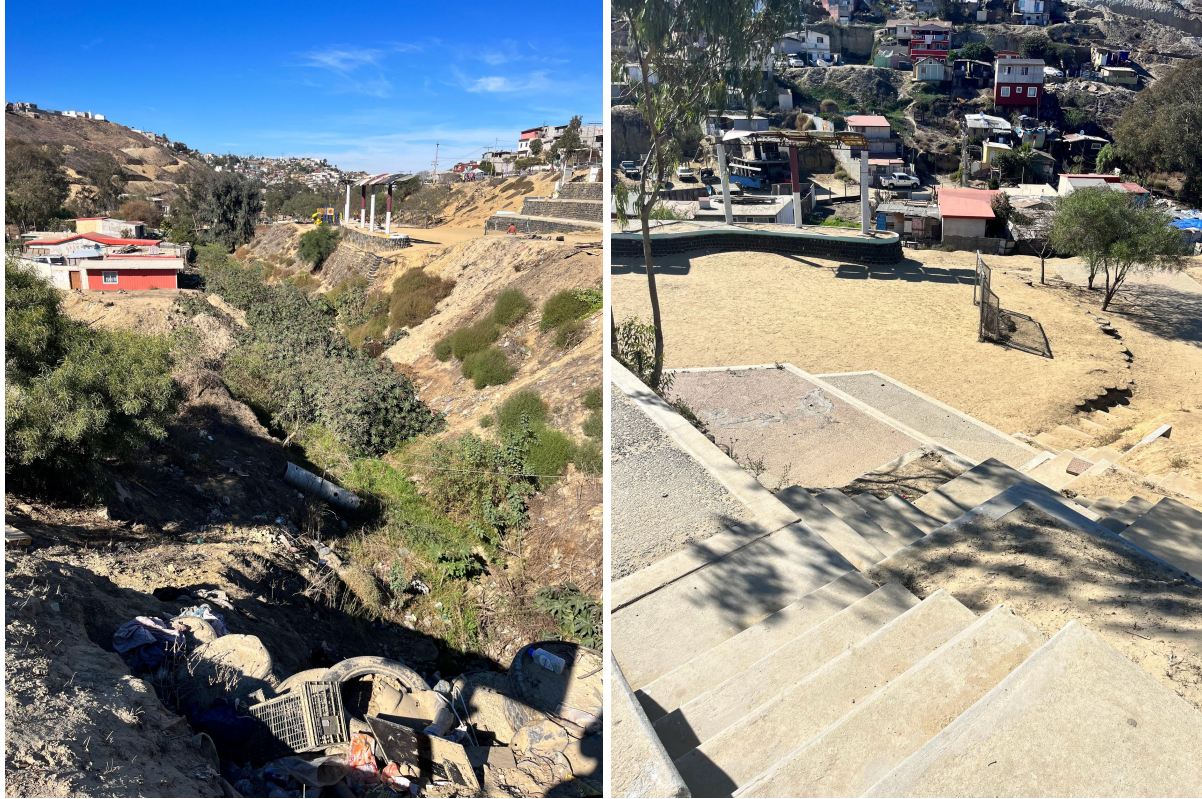
Figure 1-18 Taken from the road that cuts across the stream looking north into the riparian corridor of the stream. Noting the tires along the banks used to stabilize the bank from erosion. Figure 1-19 is taken from the street looking into the terraces of the Fronterizo park (32.491122, -117.082843.)

From this point on the stream runs between residential lots in sub watershed A, in and out of the streetscape until it emerges delineating a ranching area settled on the footsteps of a mesa. Further upstream following the westfork we find Parque Fronterizo. Figure 1-18 shows the stream unformalized and Parque Fronterizo in the right bank. And Figure 1-19 shows the amenities the park has (32.491122, -117.082843.)

Looking at the history of this park, Parque Fronterizo was inaugurated in 2012 as a solution for eroding terraces near the bank of the stream, Oscar Romo environmental activist and professor at UCSD in the urban planning department, worked with the community and several organizations to construct an eco friendly park for the community, where recycled materials were used in walls and retaining walls, also developed permeable pavers to let water seep in and reduce dust in the air (UCSD TV Los Laureles Canyon: Research in Action, 2009.)

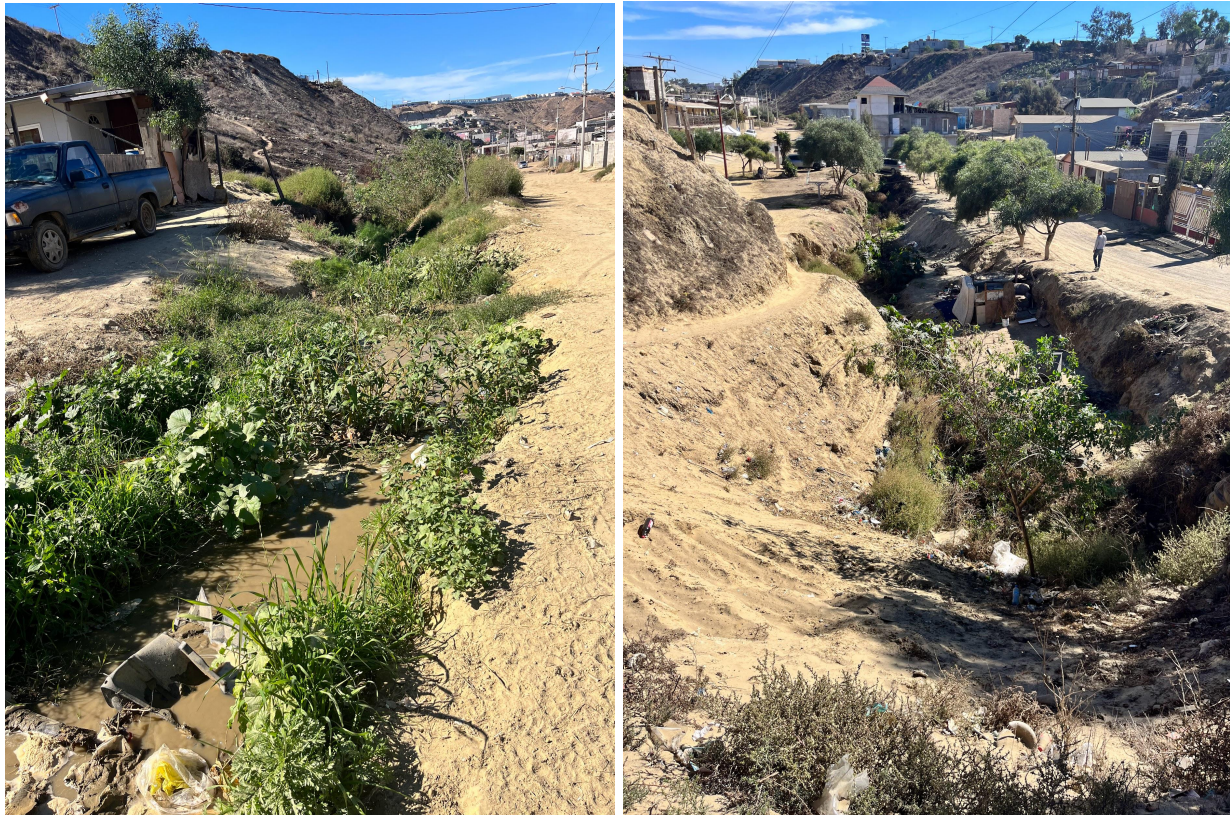
Figure 1-20 shows the streetscape of the region (32.487092,-117.078721). Figure 1-21 is taken from Calle Amanecer looking South into the stream. At this point the channel is not urbanized, Acacias were planted to line the banks of the stream.

On the other side of the road that divides the stream (Calle del Amanecer,) streetscape conditions change. The streets are not paved or leveled and its difficult to continue following the westfork of the sub watershed A. At this point I end my journey of the westfork of the sub watershed A within the subwatershed of Los Laureles (32.487092,-117.078721.)
