Pavement Recycling: Shrinkage Crack Mitigation in Cement-Treated Pavement Layers - Phase 1 Laboratory Testing

Research Report: UCPRC-RR-2016-07

Partnered Pavement Research Center (PPRC) Project Number 4.52a (DRISI Task 2708):  
Microcracking of Cement-Treated Pavement Layers

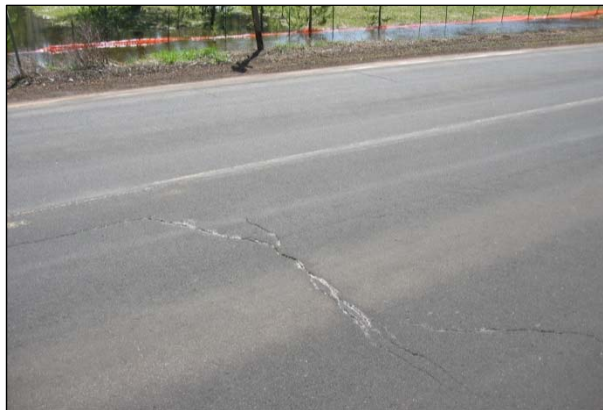
**Figure 2.1: Transverse crack.**

Transverse cracks in asphalt pavements over CTB (Figure 2.1) may be caused by the shrinkage associated with hydration and drying in the CTB after construction (3,5,6). Shrinkage cracking in CTBs begins soon after the completion of compaction as hydration reactions begin and the layer dries back. The rate of reflection of these cracks through the asphalt concrete layer is typically dependent on the thickness of that asphalt layer and the cement content of the base (higher cement contents typically result in wider cracks with higher associated stress fields).

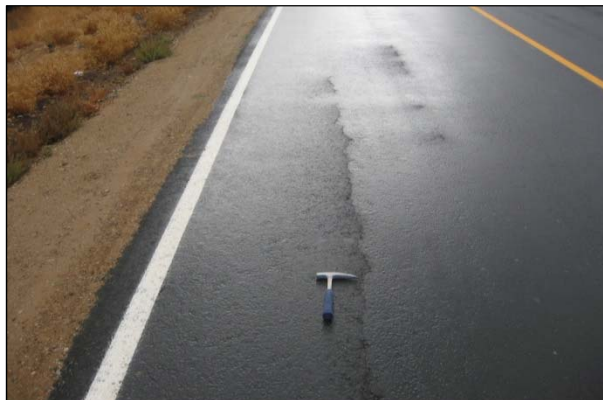
**Figure 2.2: Longitudinal crack.**

Longitudinal cracking in flexible pavements with CTB (Figure 2.2) have also been recorded (9,10). This distress, usually in the wheelpaths, is caused by the high shear/tension stress at the surface of the asphalt caused by high wheel loads and/or tire pressures (8). Longitudinal cracking outside the wheelpath is more commonly caused by expansive soils and construction effects (5).

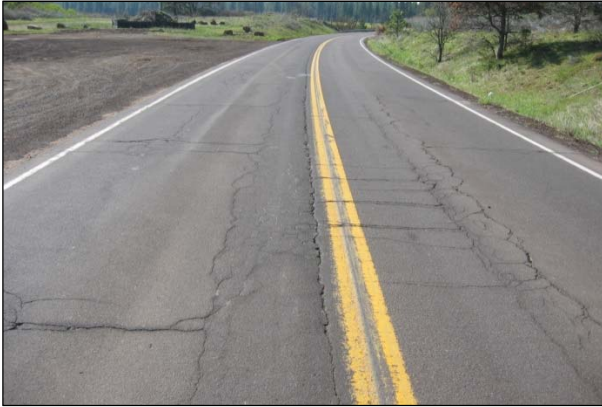
**Figure 2.3: Block cracking.**

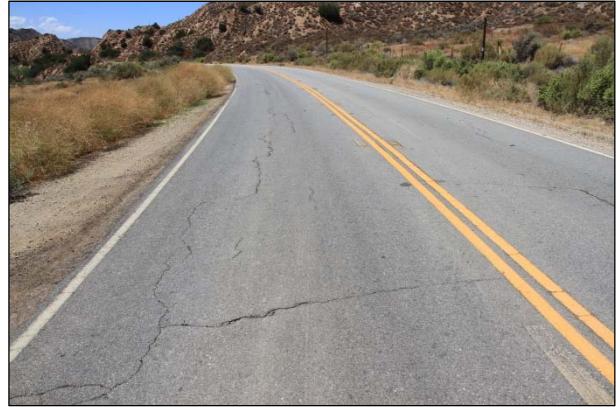
**Figure 2.4: Block crack progression.**

concrete surfacing (Figure 2.4) (11). Although block cracks will occur in both trafficked and untrafficked areas of the pavement, their formation is not necessarily dependent on traffic loading.

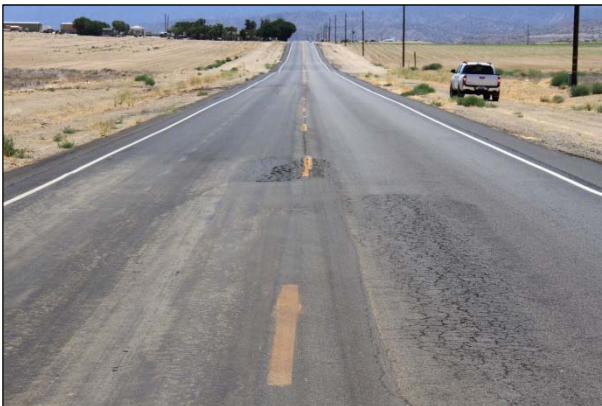
**Figure 2.5: Fatigue cracking.**

Fatigue cracking in asphalt surface layers over CTB (Figure 2.5) can result from the formation of weak areas at the top of the treated layer, caused by carbonation of the cement prior to the surfacing being placed (i.e., inappropriate curing procedures), laminations (i.e., due to inappropriate final leveling and final compaction procedures), or compaction outside of the specified time limits, which in turn can lead to fatigue and compression failures. These weak areas can lead to delamination in the CTB or to debonding between the top of the CTB and the bottom of the asphalt layer, which creates conditions of minimum friction between the different layers (12). The laminations and loss of friction are susceptible to erosion and loss of fines by pumping (Figure 2.6). The strain levels at the bottom of the asphalt surface layer increase as the surface of the base weakens, leading to the fatigue failure.

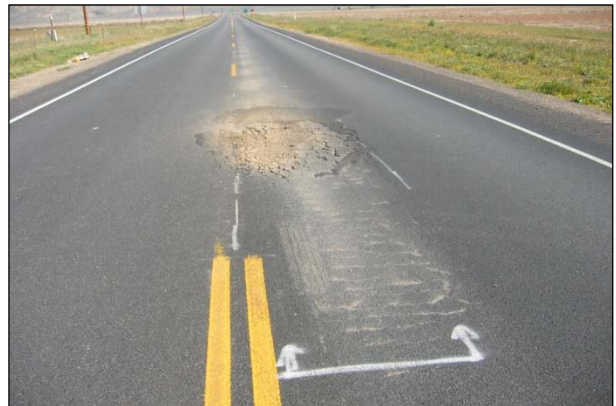
**Figure 2.6: Pumping through fatigue cracking.**

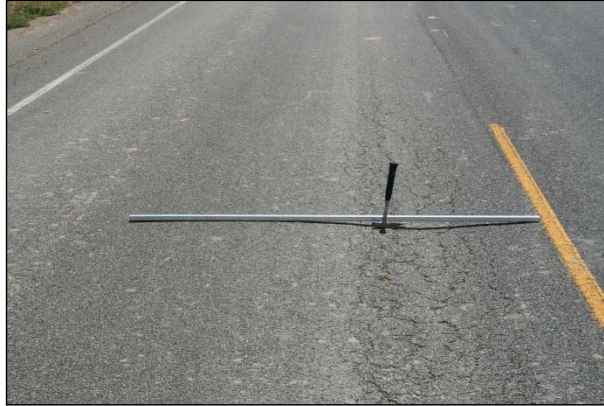
**Figure 2.7: Rutting caused by water ingress through cracks into the base.**

Rutting in well-constructed CTB layers is rare given their relatively high strengths and stiffnesses. However, on pavements with severe cracking that allows water to infiltrate into the base, rutting often occurs as a result of deformation of the softer base materials under traffic loading (Figure 2.7).

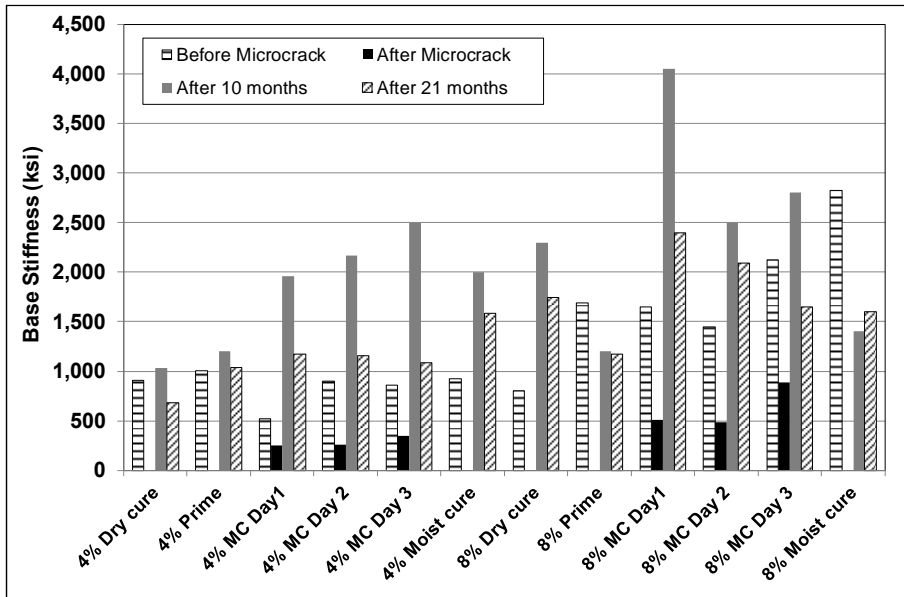
**Figure 2.9: Texas A&M Riverside Project: stiffness measurements.**

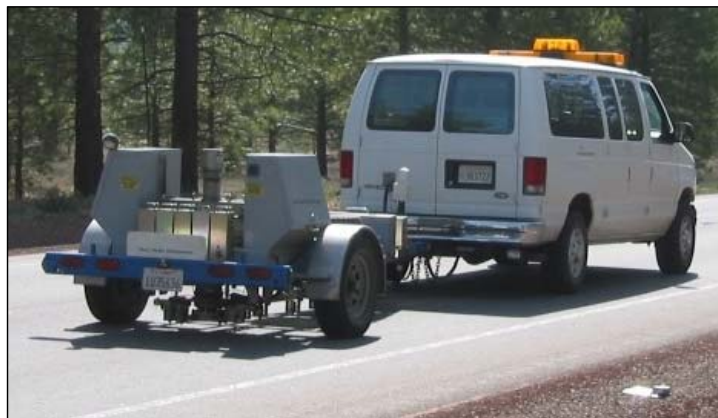
**Figure 2.11: Falling weight deflectometer.**

The FWD is the most commonly used instrument for measuring deflection on pavements (Figure 2.11). Deflection measurements can be backcalculated to determine layer stiffnesses. Concerns have been raised about using an FWD for measuring the effect of microcracking on base stiffness because the heavier falling weight could induce additional microcracking in the region of the drop zone. For this reason, stiffness gauge manufacturers usually recommend that gauge measurements be taken before FWD measurements (26). If percent of stiffness reduction is being used as a control measure for the number of roller passes applied during microcracking, the use of FWD measurements could be misleading because rolling would be stopped when stiffness had dropped to the required percentage of original stiffness in the FWD drop zone, which might not be representative of the stiffness change in the rest of the pavement.

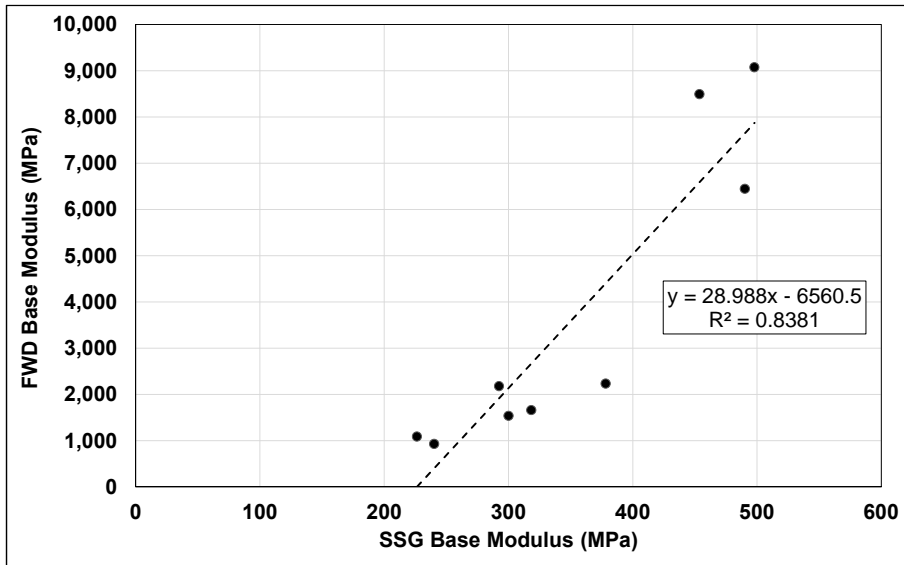
Figure 2.15: Relationship between FWD and SSG measured stiffness (11).

The data collected by Scullion on the City of College Station project in Texas (11) was used to compare measurements taken with a soil stiffness gauge to those taken with an FWD at the same location. Figure 2.15 shows the relationship between the stiffness measurements from the two devices. The stiffnesses measured with the FWD were substantially higher than those measured with the stiffness gauge. Similar findings were observed in experiments in New England (19). This was attributed to the much higher loading capacity of the FWD and its ability to measure the stiffness of the entire pavement structure compared to the lighter loading capacity of the stiffness gauge, which generally only measures the stiffness to a depth of 8 to 12 in. (200 to 300 mm). A better correlation (R-squared of 83.81) was achieved between these two instruments compared to the correlation between the stiffness gauge and light weight deflectometer. The FWD measured a two-fold reduction in stiffness compared to the stiffness gauge (Figure 2.16).

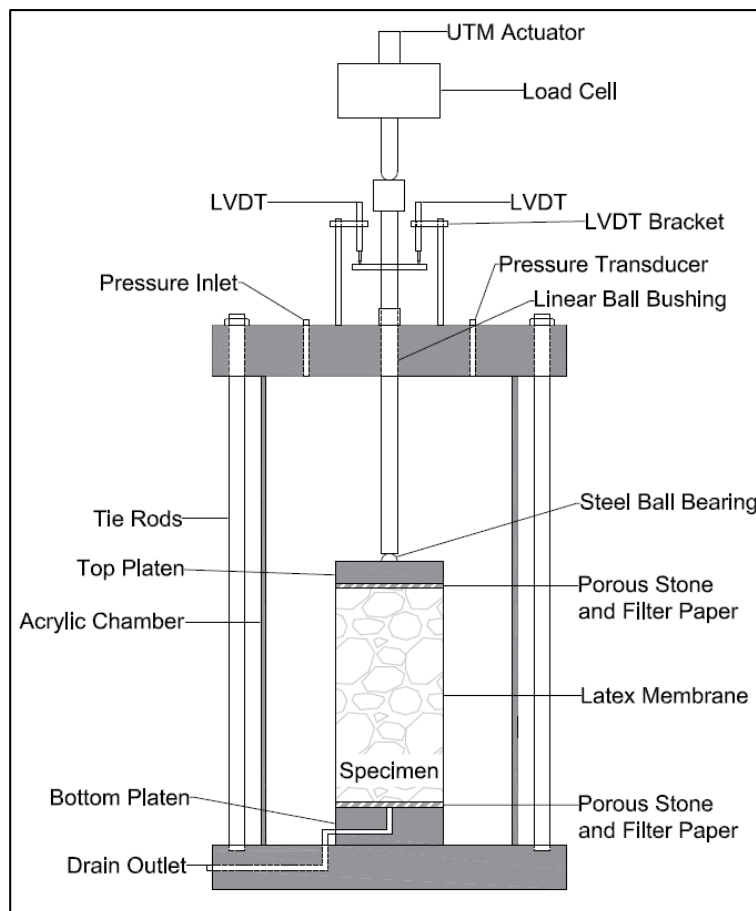
Figure 2.17: AASHTO T 307 resilient modulus test setup.

Testing the stiffness of stabilized materials in the laboratory is typically achieved by determining the resilient modulus of laboratory compacted specimens or field cores. Although resilient modulus can be measured in a number of different ways, triaxial testing is considered to be one of the most appropriate. The AASHTO T 307 method was designed and is commonly followed for testing the resilient modulus of soils and aggregate base materials and is often used to simulate the stress state of unbound materials in the base layer under traffic. It is a nondestructive test that measures the elastic stiffness of a specimen under different deviatoric stress conditions, from which the resilient modulus can be determined. The standard test setup is shown in Figure 2.17.

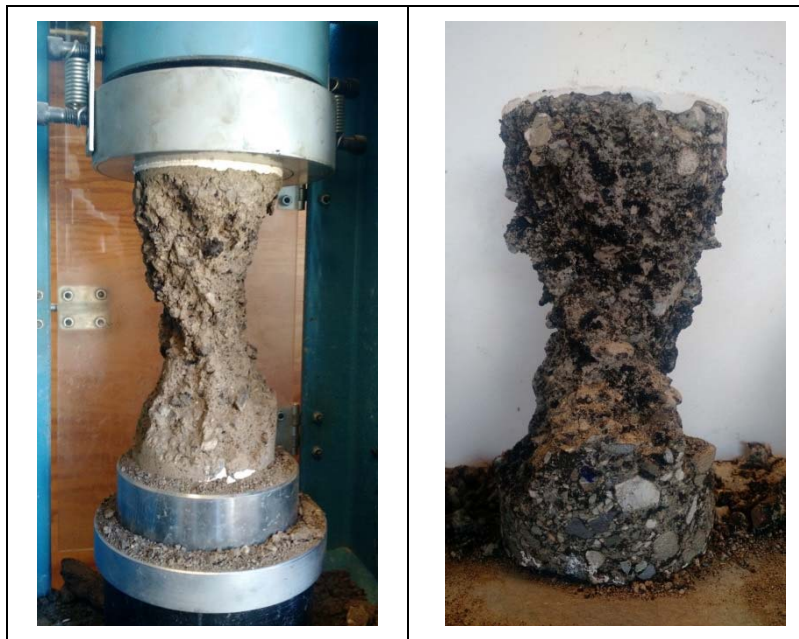
**Figure 2.18: Shear failure of FDR-PC and FDR-FA specimens after UCS testing.**

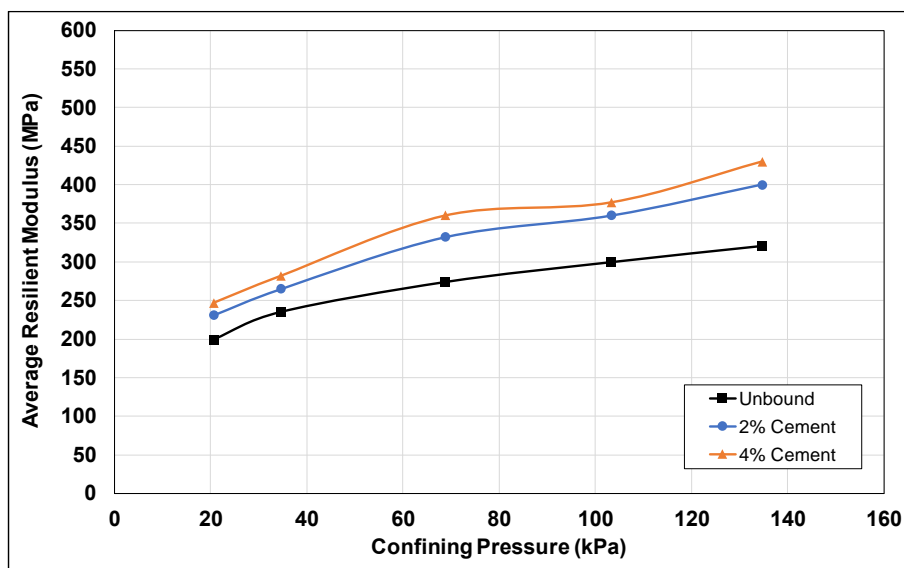
Figure 2.19: Resilient modulus of unstabilized and stabilized materials (29).

The resilient modulus of cement stabilized aggregate determined with AASHTO T 307 or similar methods is typically between 200 MPa and 1,000 MPa. Puppala (28) tested RAP stabilized with 2 percent and 4 percent cement. Resilient moduli of between 220 MPa and 450 MPa and between 250 MPa and 500 MPa were recorded for the stabilizer contents, respectively, equating to increases of 32 percent and 50 percent above that of the unstabilized RAP control. Potturi (29) compared unstabilized aggregates to aggregates stabilized with 2 percent and 4 percent cement (Figure 2.19). Cement stabilization increased the resilient modulus on average by 52 MPa (19 percent increase) with 2 percent cement and 74 MPa (28 percent increase) with 4 percent cement when compared to the unbound material.

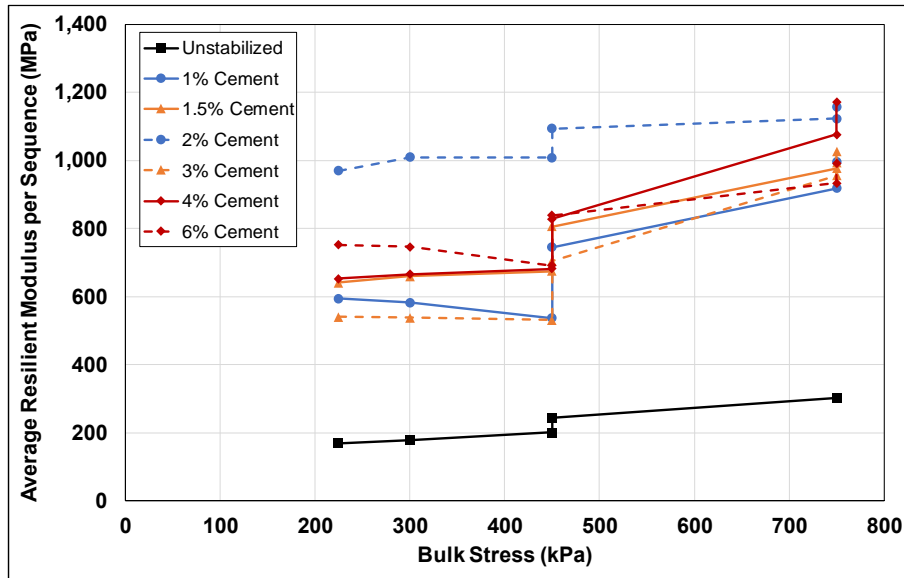
**Figure 2.20: Resilient modulus of cement stabilized materials tested under repeated loading (30).**

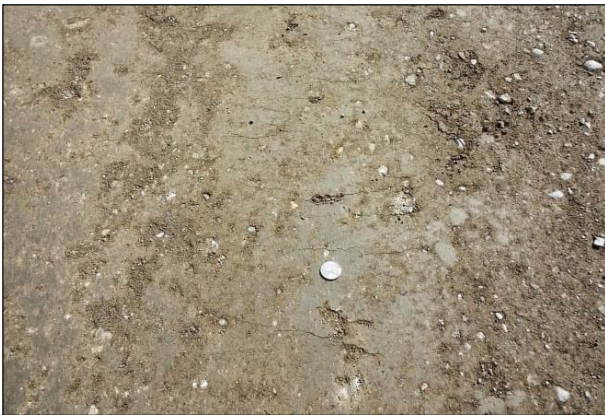
**Figure 3.2: CR32B: Transverse cracking after microcracking.**

The construction process generally followed standard FDR procedures, complying with the specifications. However, a number of distresses observed on the completed FDR-PC layer prior to surfacing were attributed to deviations from standard practice. In addition to the fine transverse cracks typically seen after microcracking (Figure 3.2), some block cracking was also observed on the base prior to surfacing (Figure 3.3). This block cracking was limited to a long, narrow zone along the length of the project and was attributed to shrinkage associated with a windrow of cement formed by dragging of the water pipe connecting the recycler and the water tanker (Figure 3.4).

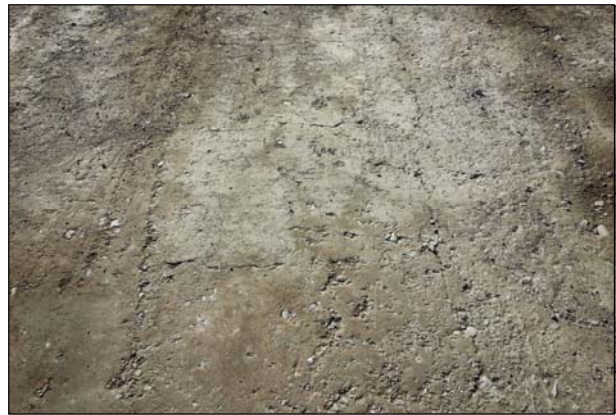
**Figure 3.3: CR32B: Block cracking on FDR-PC prior to surfacing.**

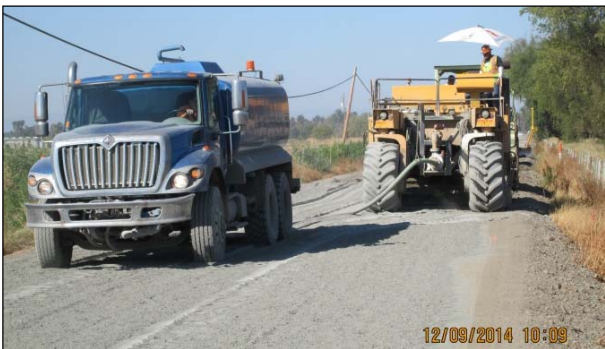
**Figure 3.4: CR32B: Water hose dragging on the spread cement.**

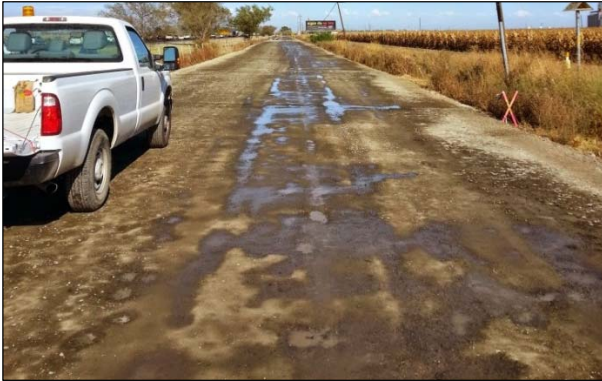
**Figure 3.5: CR32B: Surface raveling.**

Raveling of the surface was observed in the wheelpaths along most of the project. This was attributed to road users ignoring the closure and driving on the road before and after construction each day (CR32B is a frontage road to Interstate 80 and is used by East Davis residents to access Interstate 80 at the Chiles Road on-ramp). Water sprayed during curing accumulated in the low spots caused by this raveling (Figure 3.5). Wet, soft patches were also observed in a number of locations corresponding to areas where water was spilled onto the section during mixing (Figure 3.6 and Figure 3.7). Spills occurred either during switching of tankers (i.e., draining of water in the pipe) or when the dragged pipe got trapped underneath the recycler wheels, causing it to disconnect from the water truck and spill water until the valve was closed. The resident

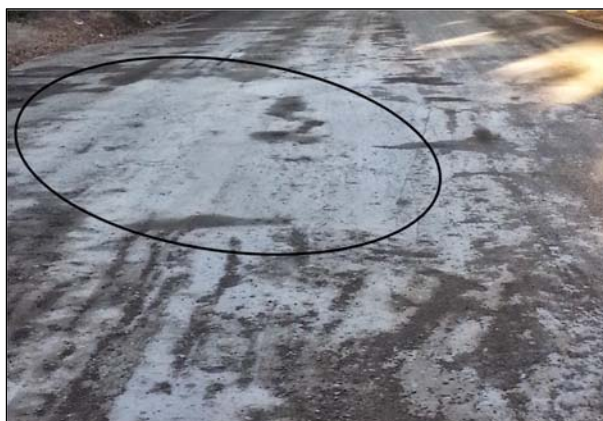
**Figure 3.8: CR32B: Wet section after repair.**

engineer required some of these areas to be reworked with an additional two percent cement and then recompacted (Figure 3.8, note the absence of absorbed water in the repaired area. Although the entire road was sprayed with water prior to taking the photograph, the higher cement content in the repaired area absorbed the available moisture faster than the surrounding previously stabilized material.). SSG measurements were taken on one of the wet areas that was not repaired (Figure 3.7), and compared to an adjacent drier area to quantify the effects on stiffness gain of not repairing overly wet areas.

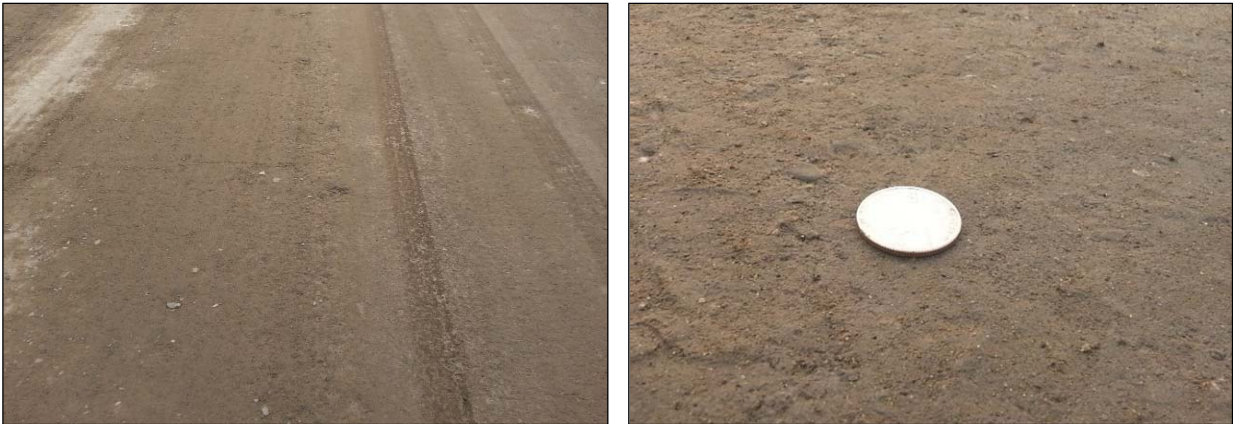
**Figure 3.10: CR27: Fine graded material near start of project.**

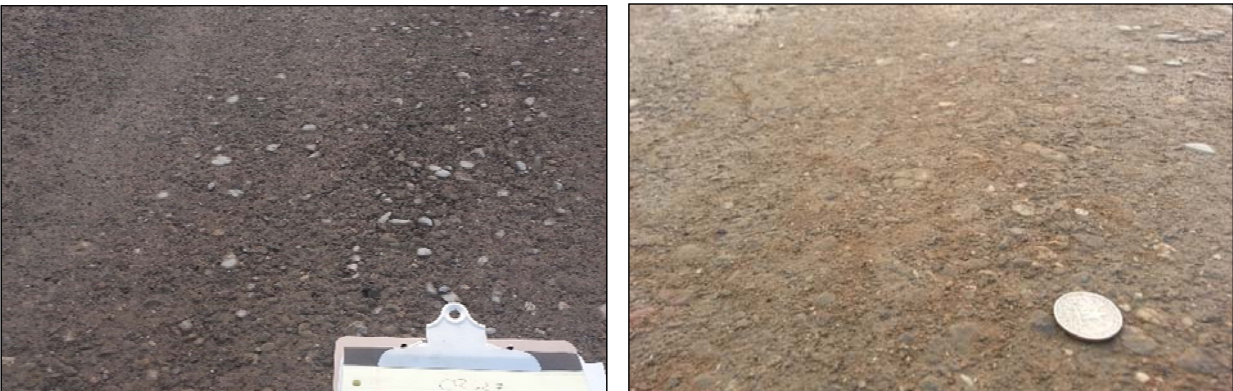
**Figure 3.11: CR27: Coarser material throughout majority of the project.**

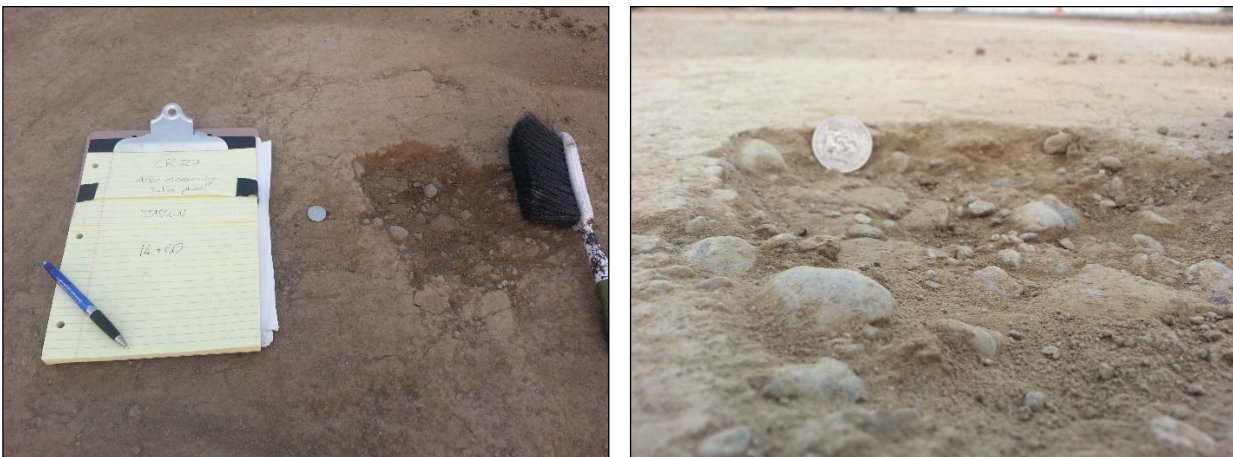
**Figure 3.12: CR27: Distressed surface of FDR-PC layer after microcracking near start of project.**

approximately 25 mm (1 in.) thick on top of the underlying coarser material. This fine material layer tended to break up and separate from the underlying material during microcracking (Figure 3.12).

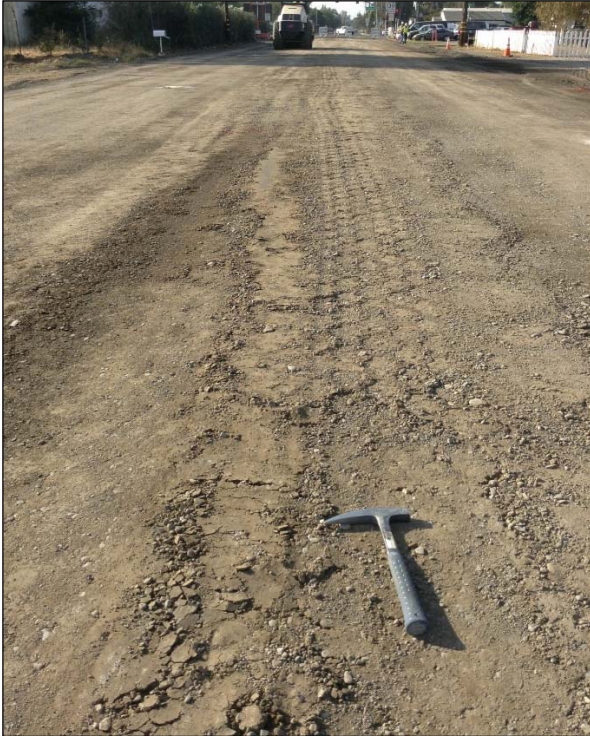
**Figure 3.13: CR99: Delamination after microcracking.**

grade requirements. The thickness of the loose layer was approximately 50 mm (2 in.). These areas were repaired by reworking the material, adding two percent cement, mixing by hand, and recompacting with the same 12-ton vibratory roller.

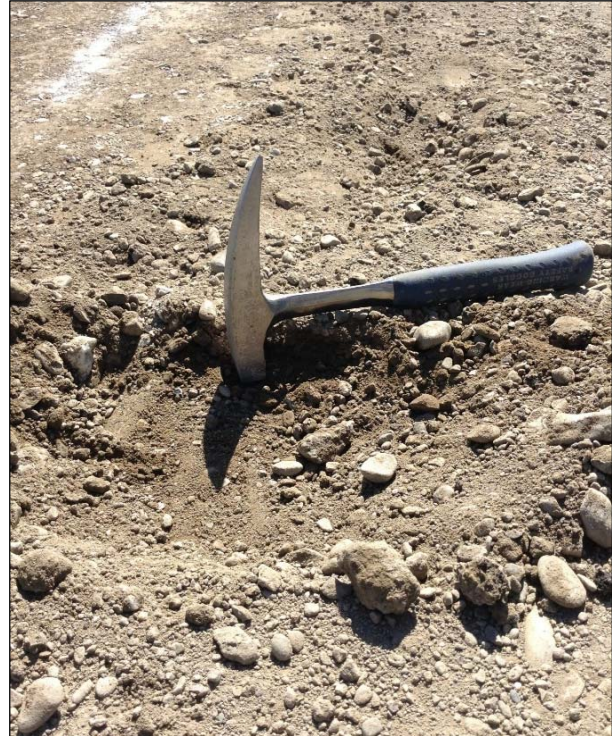
**Figure 3.14: CR99: Depth of delaminated material (50 mm [2 in.]).**

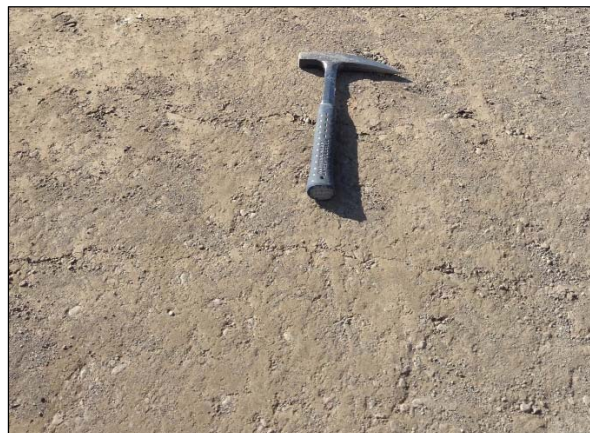
**Figure 3.15: CR99: Block cracking after microcracking.**

Block cracking (Figure 3.15) similar to that discussed in Section 3.4.1 was observed on sections of the FDR-PC layer prior to surfacing. The cause was attributed primarily to higher-than-design cement contents in these areas caused by accumulations of cement resulting from dragging of the water pipe connecting the recycler and the water tanker.

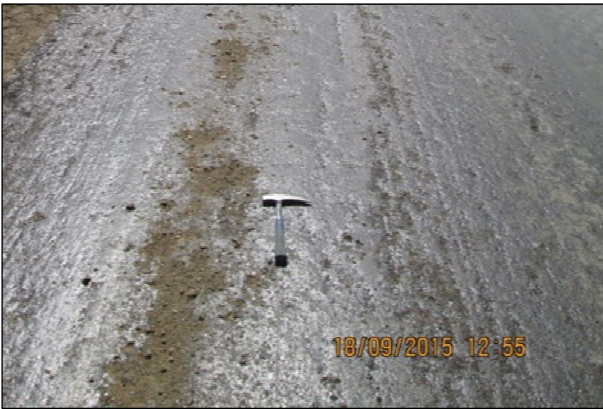
**Figure 3.16: PLU147: Prime coat stripped from FDR-PC layer after traffic.**

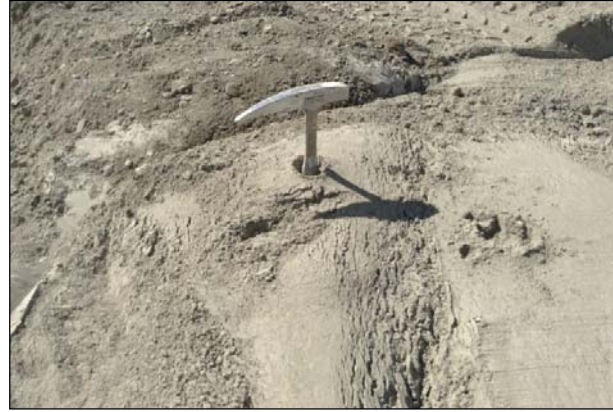
**Figure 3.21: PLU147: Depth of cement mound due to dragging of hose ( $\pm 200$  mm).**

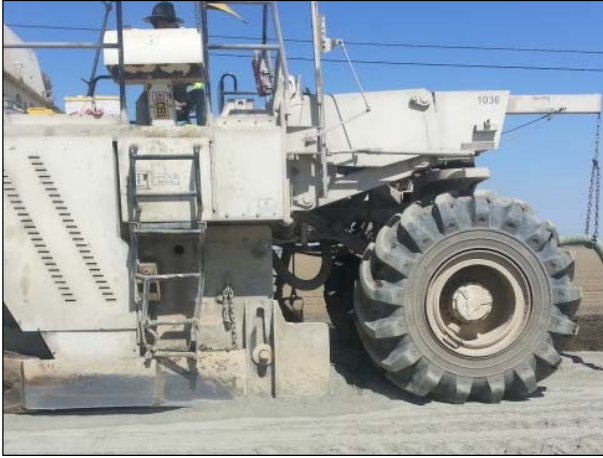
**Figure 3.22: Wave of cement in front of pulverizer skirt on mixing chamber.**

Section 30 of the Caltrans standard specifications does not have any requirements for preventing or dealing with these localized areas of cement accumulation. The specifications do, however, indicate that mixing on the following section should start at least 2 ft. (600 mm) behind the line where the pulverizer stopped mixing on the previous section. Consideration should be given to amending the specifications to require careful setting of the skirt on the pulverizer mixing chamber to prevent this accumulation at the end of the construction section and the resulting lower-than-design cement content along the section that has already been mixed.

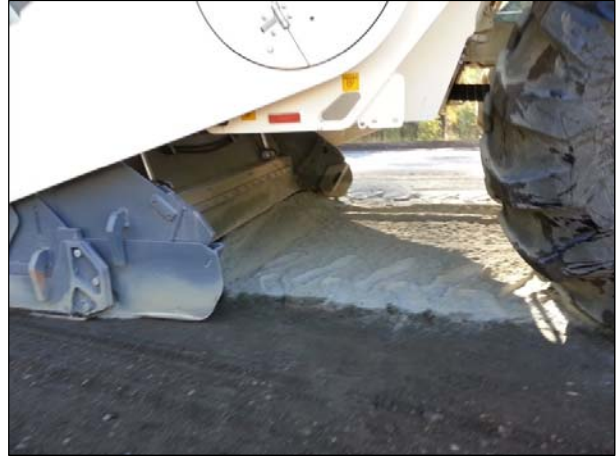
**Figure 3.23: End of pulverizer pass with no accumulated cement visible.**

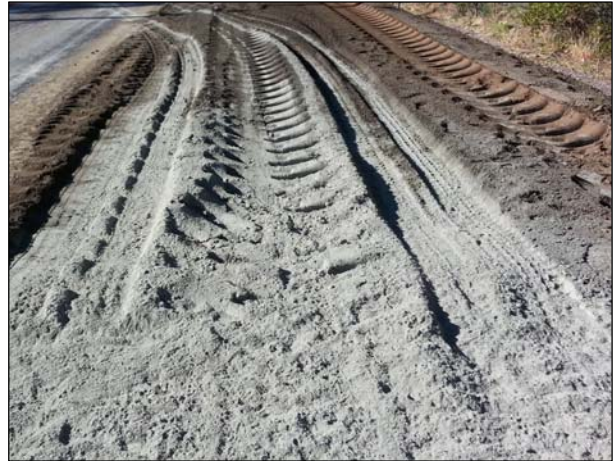
**Figure 3.24: Cement spreader spreading cement on already mixed section.**

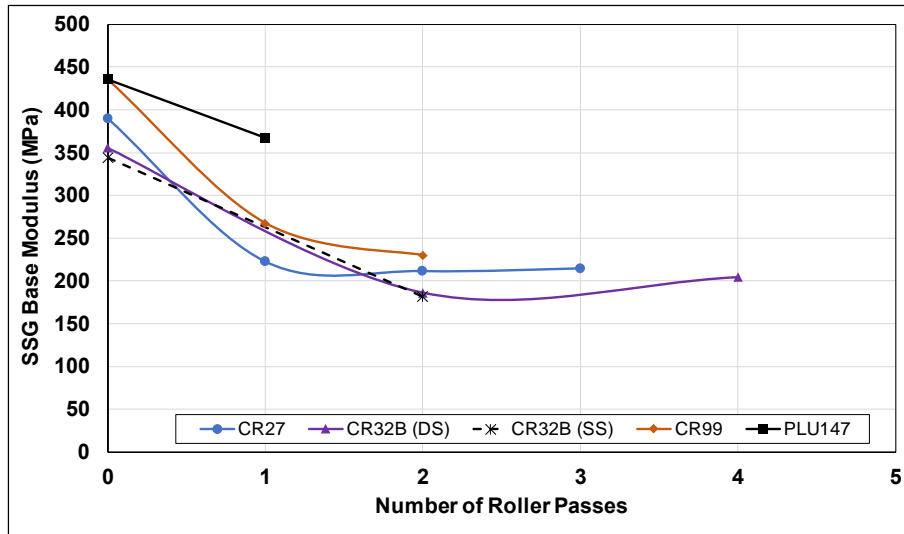
Figure 3.29: Effect of number of roller passes on stiffness change.

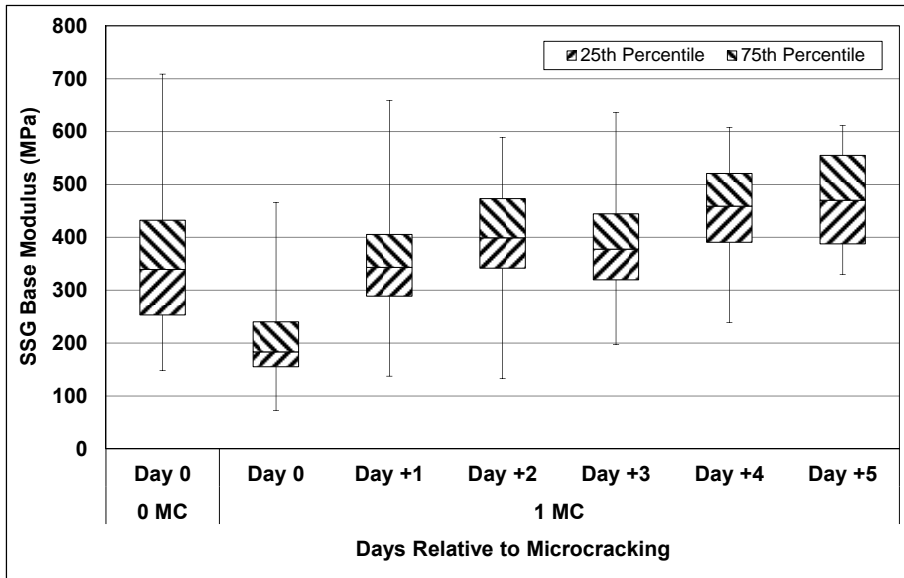
Figure 3.30: CR32B: Average SSG stiffness results after microcracking.

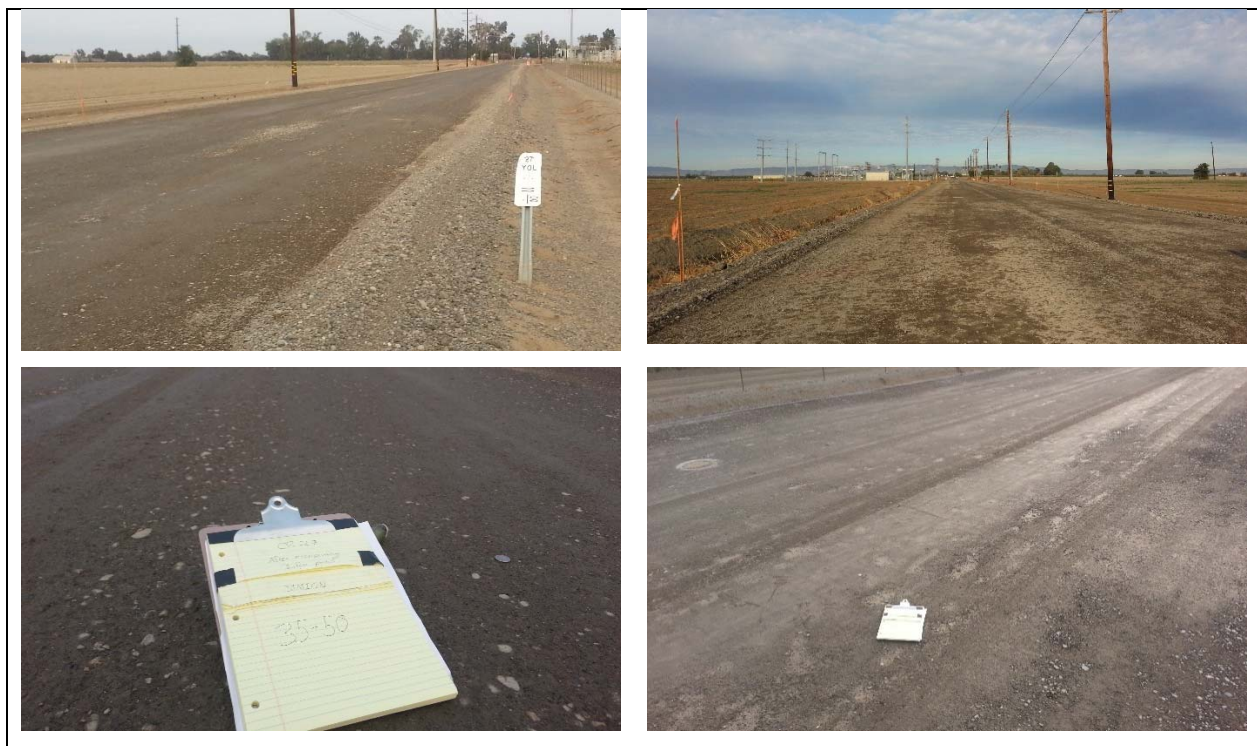
**Figure 3.32: CR27: Photographs showing wet surface.**

Regular water curing until paving was specified for the project, and photographs taken on the day of microcracking (Figure 3.32) indicate that this was carried out in the early stages of the project. Although a water tanker spraying the road was observed by the UCPRC crew during daily stiffness measurements, it is not clear whether sufficient water was sprayed since the UCPRC crew were only on site for a limited period and no records of watering were made available by the contractor or the county. Weather station records for the area show a mean ambient temperature of 27°C (81°F), a maximum temperature of 38°C (100°F), and low relative humidity during daylight hours. It is therefore possible that the amount water and frequency of spraying was unable to maintain sufficient moisture in the layer to sustain hydration and a corresponding stiffness increase.

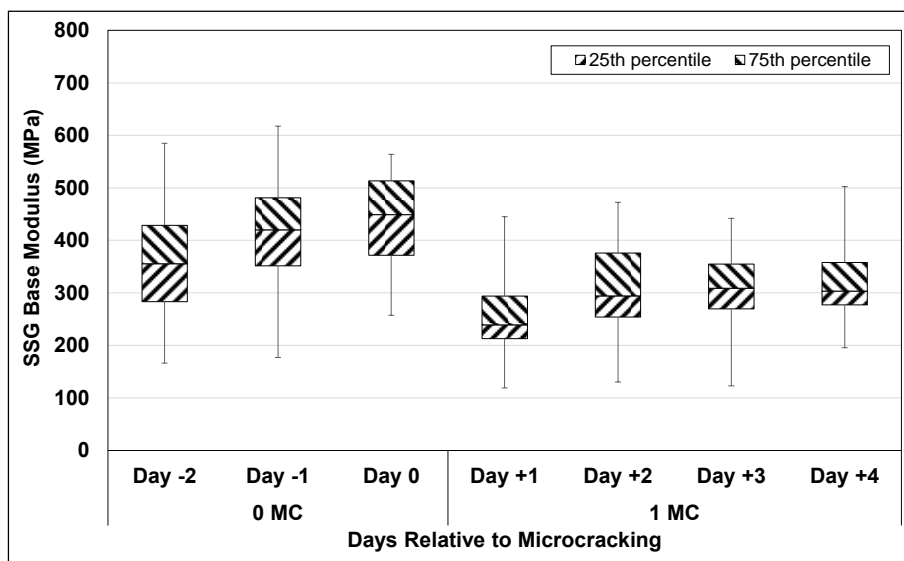
**Figure 3.33: CR99: Average SSG stiffness results after microcracking.**

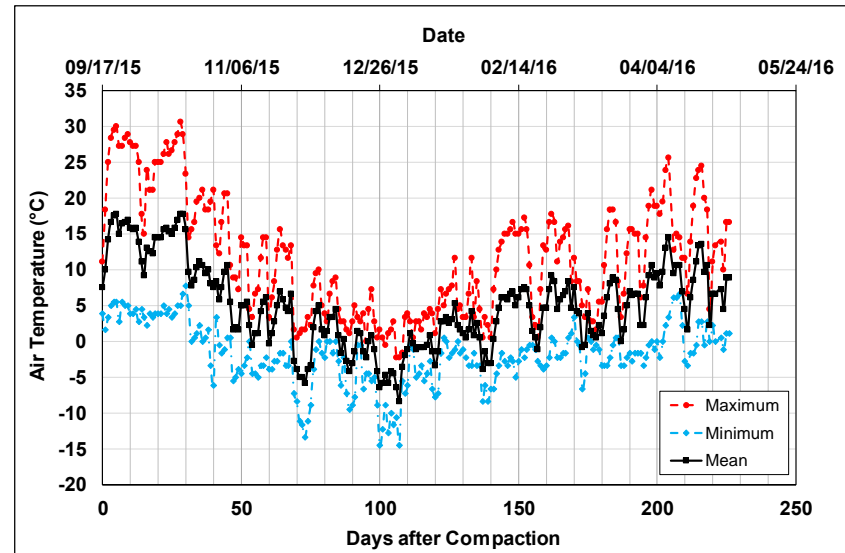
Figure 3.49: PLU147: Air temperatures during FWD testing.

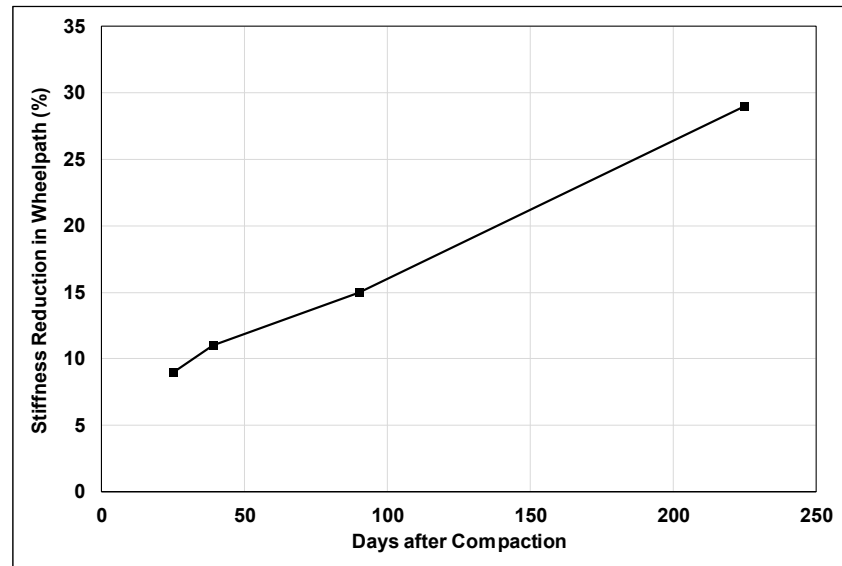
**Figure 3.51: PLU147: Stiffness reduction in the wheelpath compared to between the wheelpaths.**

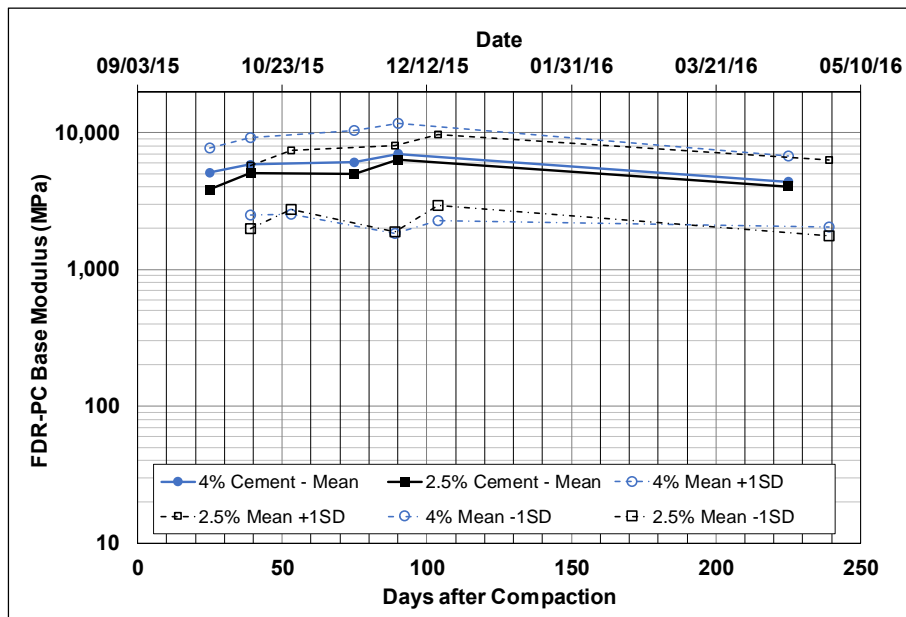
**Figure 3.52: PLU147: Mean FDR-PC base moduli for different cement contents over time.**

The mean FDR-PC layer moduli over the testing period between September 23, 2015 (25 days) and April 29, 2016 (225 days) for the first set of between-wheelpath tests is shown in Figure 3.52. Results for both the 2.5 percent and 4.0 percent design cement contents are shown. The results show that there was an initial increase in stiffness followed by a reduction in stiffness after December 16, 2015 (39 days).

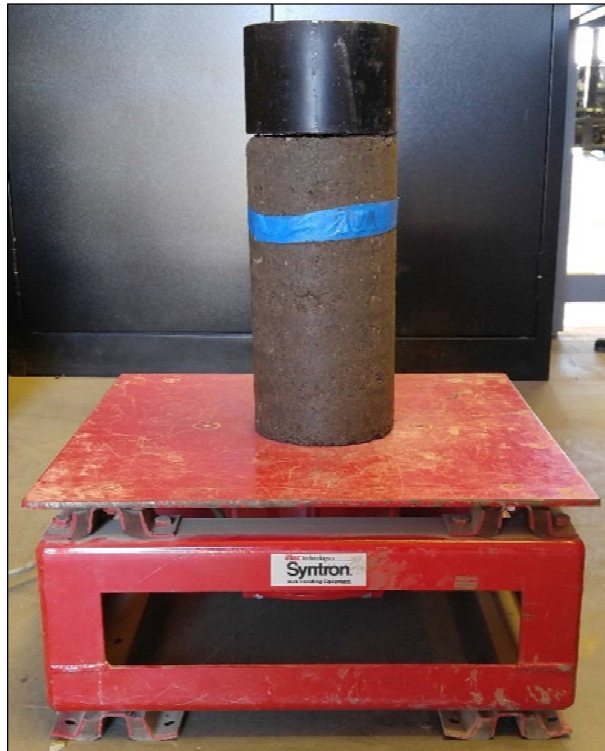
**Figure 5.3: Vibrating table.**

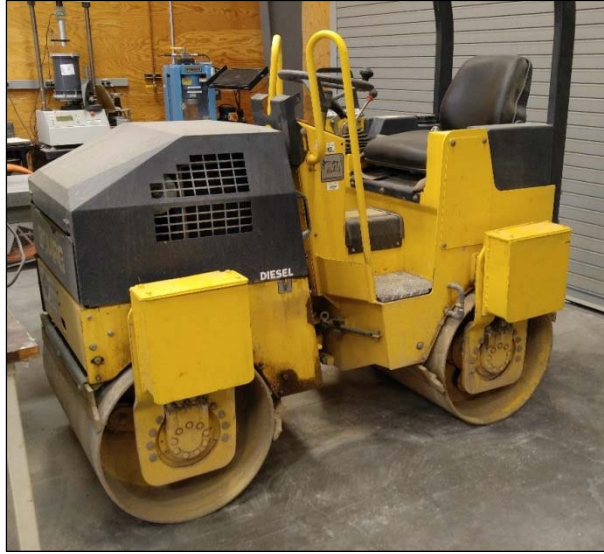
**Figure 5.4: Steel wheel vibrating roller.**

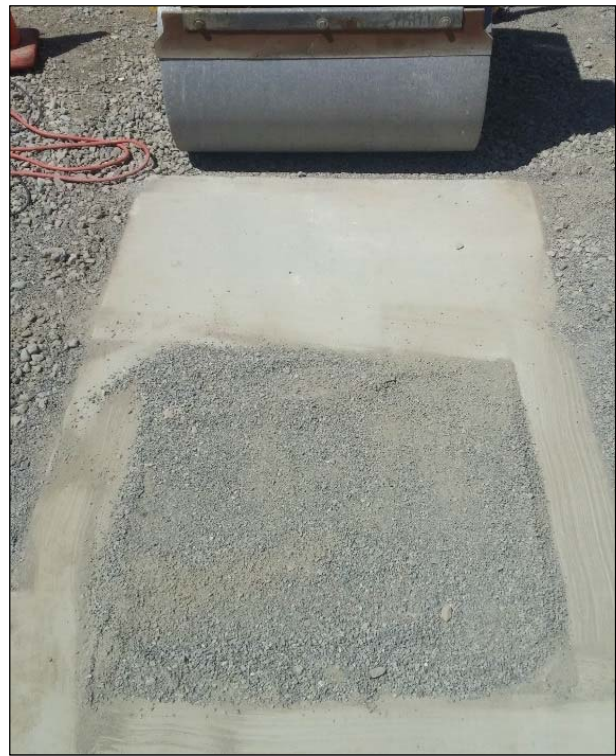
**Figure 5.6: Final setup before microcracking.**

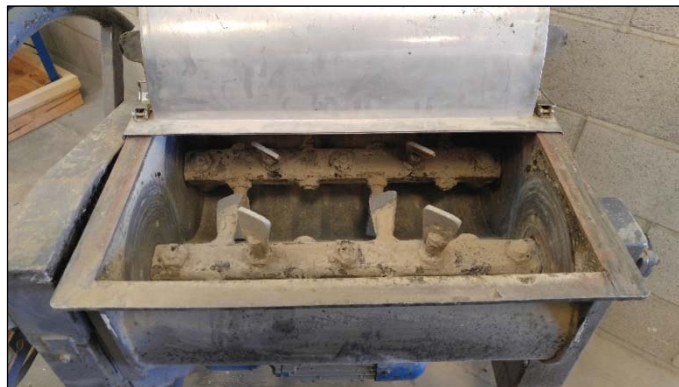
**Figure 6.2: Pug mill mixer.**

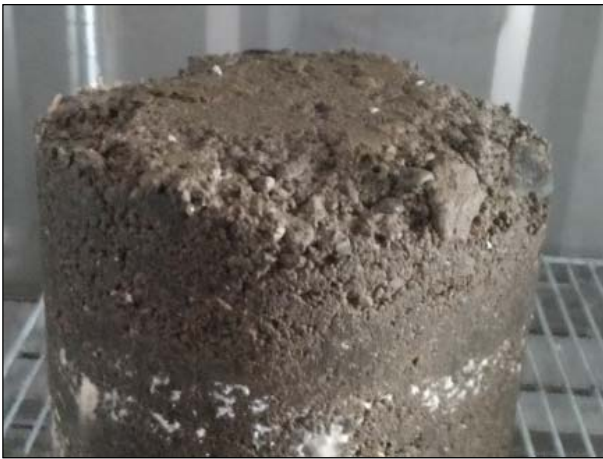
**Figure 6.14: Broken edges caused by brittle nature of stabilized material.**

- The brittleness of the laboratory-compacted FDR-PC samples caused the edges of the specimens to chip during handling and testing, which in turn led to tears in the latex membrane used for confining the specimen during testing. These tears led to a loss of confinement, which might also have contributed to the wide variation in the test results.

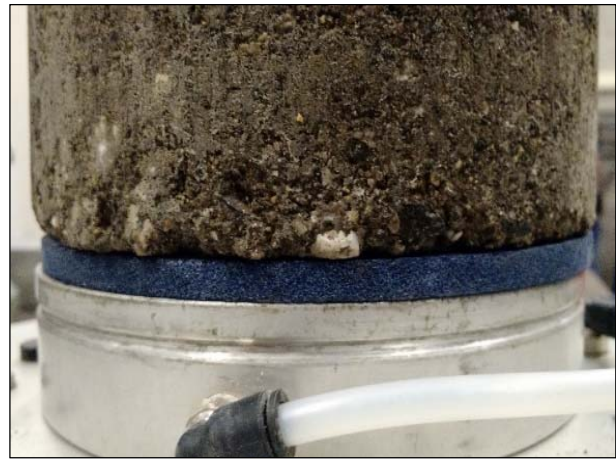
**Figure 6.15: Irregular specimen ends leading to poor contact.**

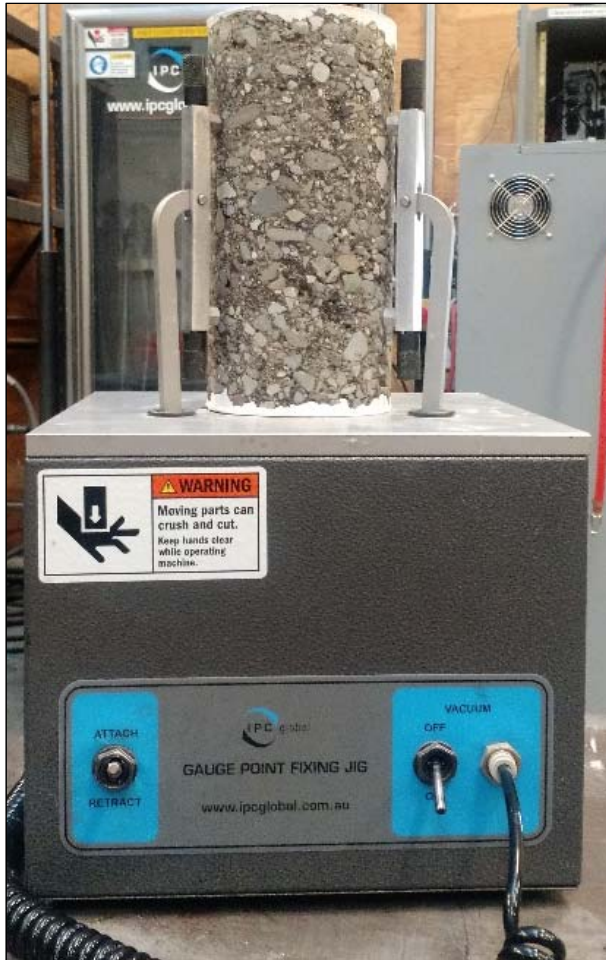
**Figure 6.16: Modified jig for mounting LVDTs on 200 mm × 100 mm specimens.**

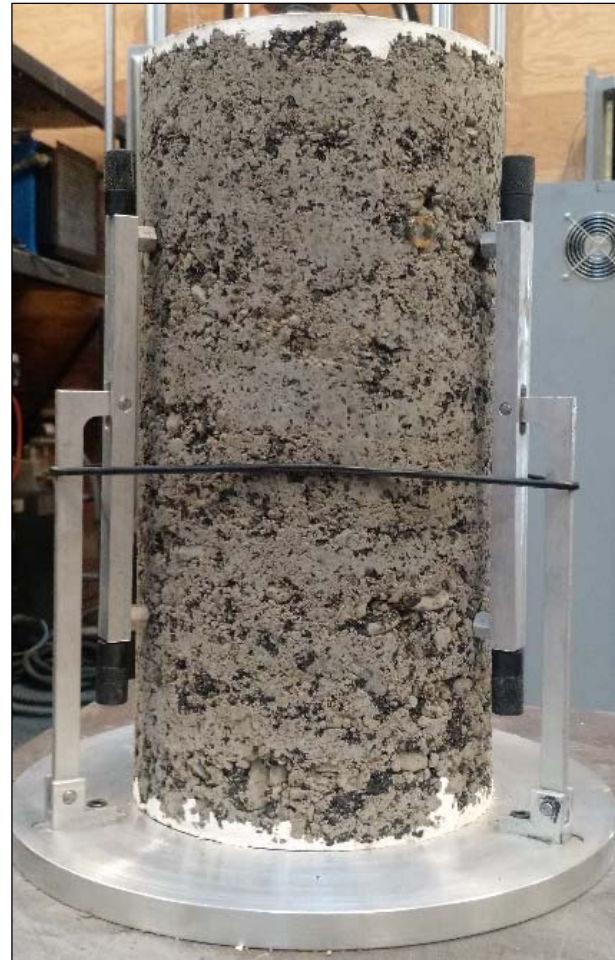
**Figure 6.17: Fabricated jig for mounting LVDTs on 300 mm × 150 mm specimens.**

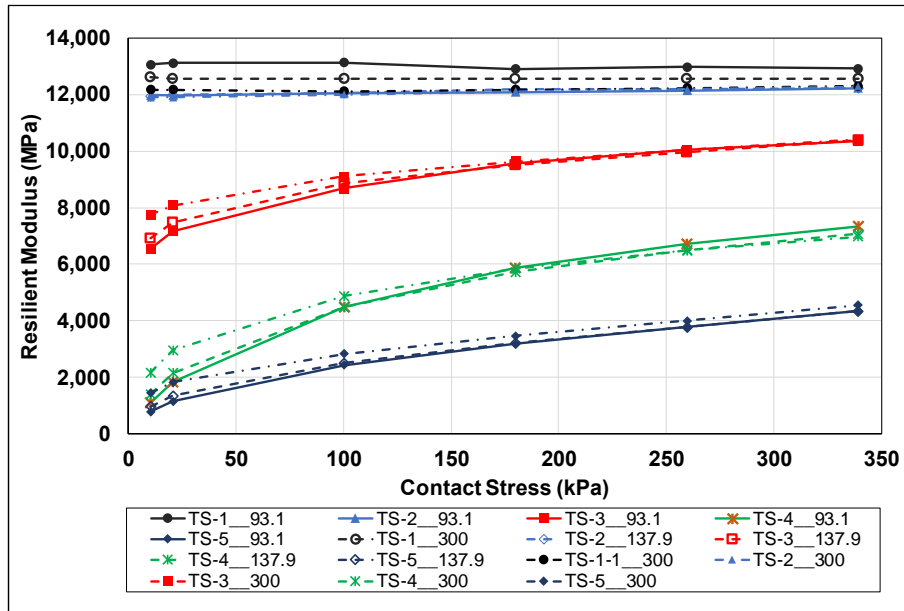
**Figure 6.20: Resilient modulus test results at each cyclic stress for FDR-PC specimens.**

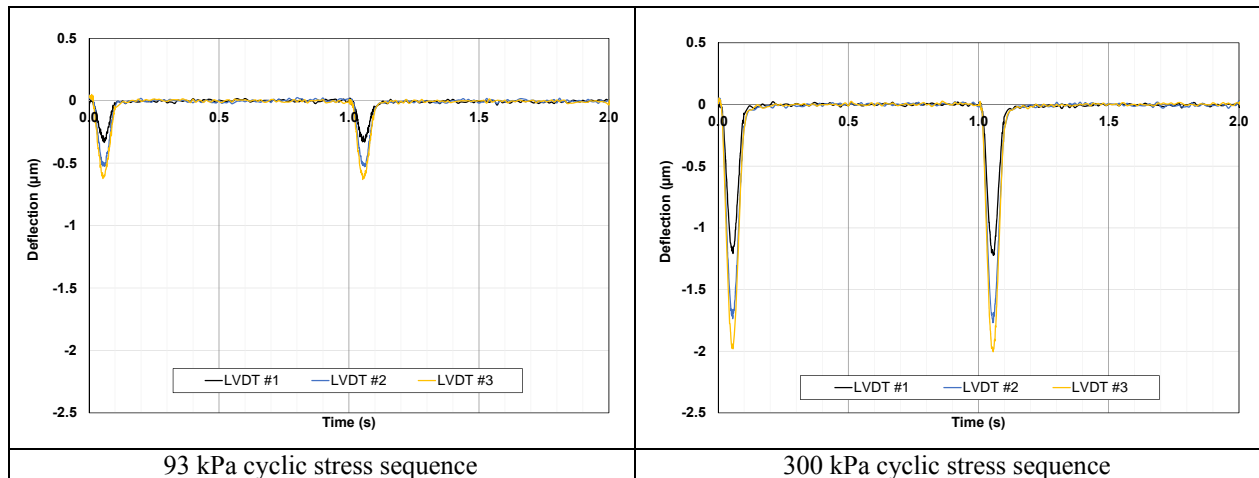
**Figure 6.23: LVDT responses measured using TS-1.**
