STUDY OF DEFECTIVE RCA 6810 MULTIPLIER PHOTOTUBES

F. Kirsten

June 10, 1956

STUDY OF DEFECTIVE RCA TYPE 6810
MULTIPLIER PHOTOTUBES

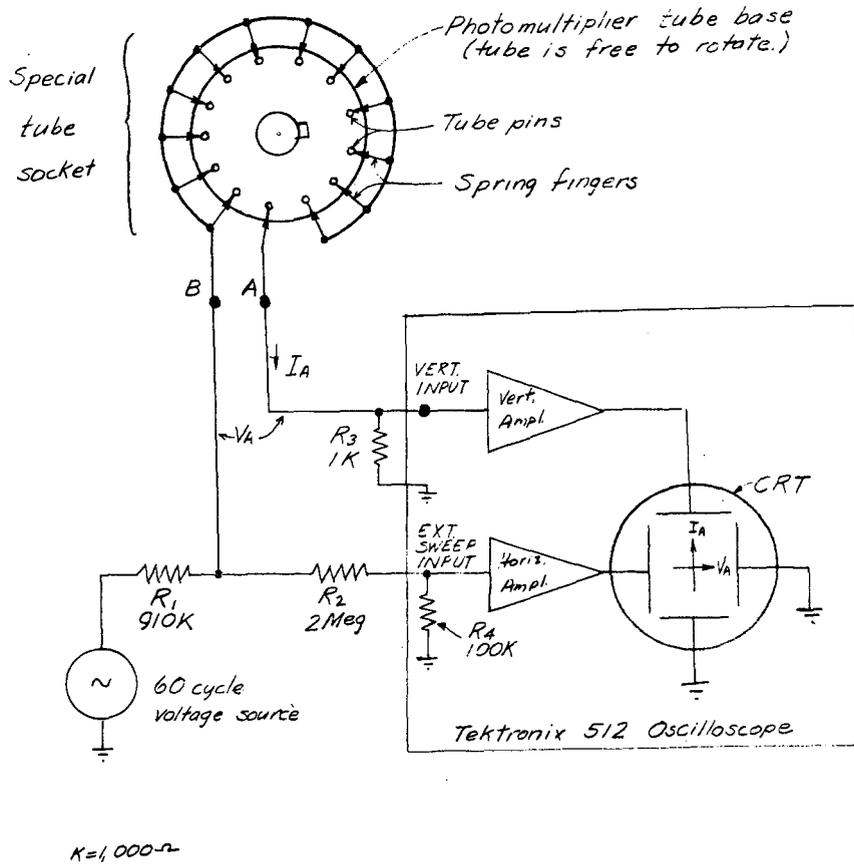
Fig. 1. Block diagram of equipment used to measure dynamic interelectrode impedances of multiplier phototubes.

Inasmuch as the routine tests indicated that many of the rejected tubes suffered from erratic or intermittent operation, a device was constructed to aid in finding the specific electrodes contributing to the intermittent condition. This device, referred to as an "interelectrode impedance checker," is similar in nature to the interelectrode short tester on a commercial tube tester, but is capable of indicating much more about the nature of the tube defects encountered. As shown on the block diagram of the instrument in Fig. 1, a 60-cycle alternating voltage, V_A , is applied between one of the electrodes (connected to terminal A) and all other electrodes (terminal B). As a result of the applied voltage, a current I_A flows through the impedance existing between the electrode connected to terminal A and all other electrodes. The voltage $I_A R_3$ is amplified and impressed on the vertical deflection plates, causing a deflection of the cathode-ray tube beam proportional to I_A . The horizontal deflection is proportional to V_A . The CRT beam, therefore, traces out the volt-ampere (v-i) characteristic of the electrode under test to all other electrodes sixty times a second. (For convenience, "all other electrodes" is abbreviated as X in this note. Thus, the v-i characteristic existing between dynode 1 and all other electrodes is called the dynode 1-X characteristic.) The patterns observed as terminal A of Fig. 1 is connected to the various electrodes in turn can be interpreted in terms of impedances, as is indicated in the sketches of Fig. 2, where some

A special tube socket was built to facilitate making the impedance observations at each of the 20 base pins. The tube under test is free to rotate within the socket, which has a ring of spring fingers to make connections to the base pins. The contact fingers are arranged so that all but one of the base pins are connected to terminal B, the remaining pin to terminal A. As the tube is rotated in the socket, each base pin in turn is connected to terminal A.

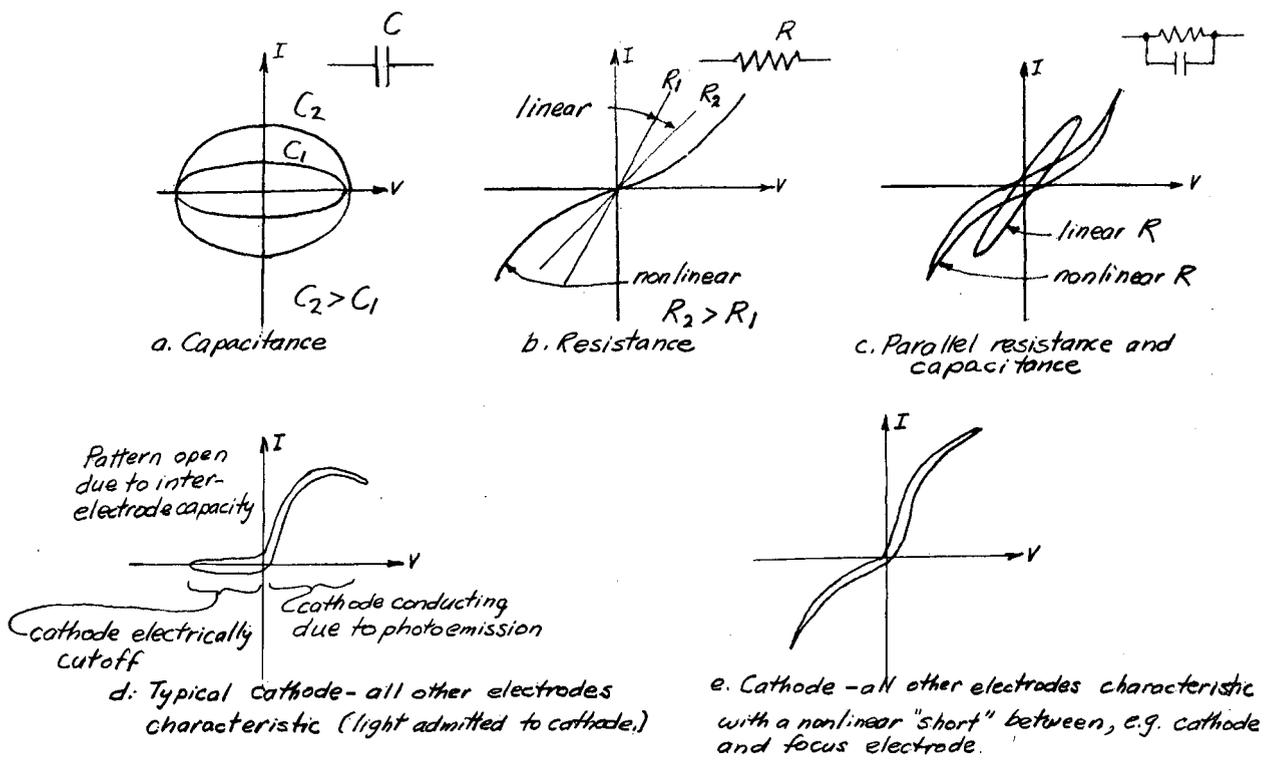
MU-11469

Fig. 2. Volt-ampere characteristics of certain electrical elements. These are included to aid in interpreting Photographs 1 through 8.

sample patterns and their interpretations are given. Note that it is possible to differentiate between linear and nonlinear resistances; the latter are typical of semiconductors.

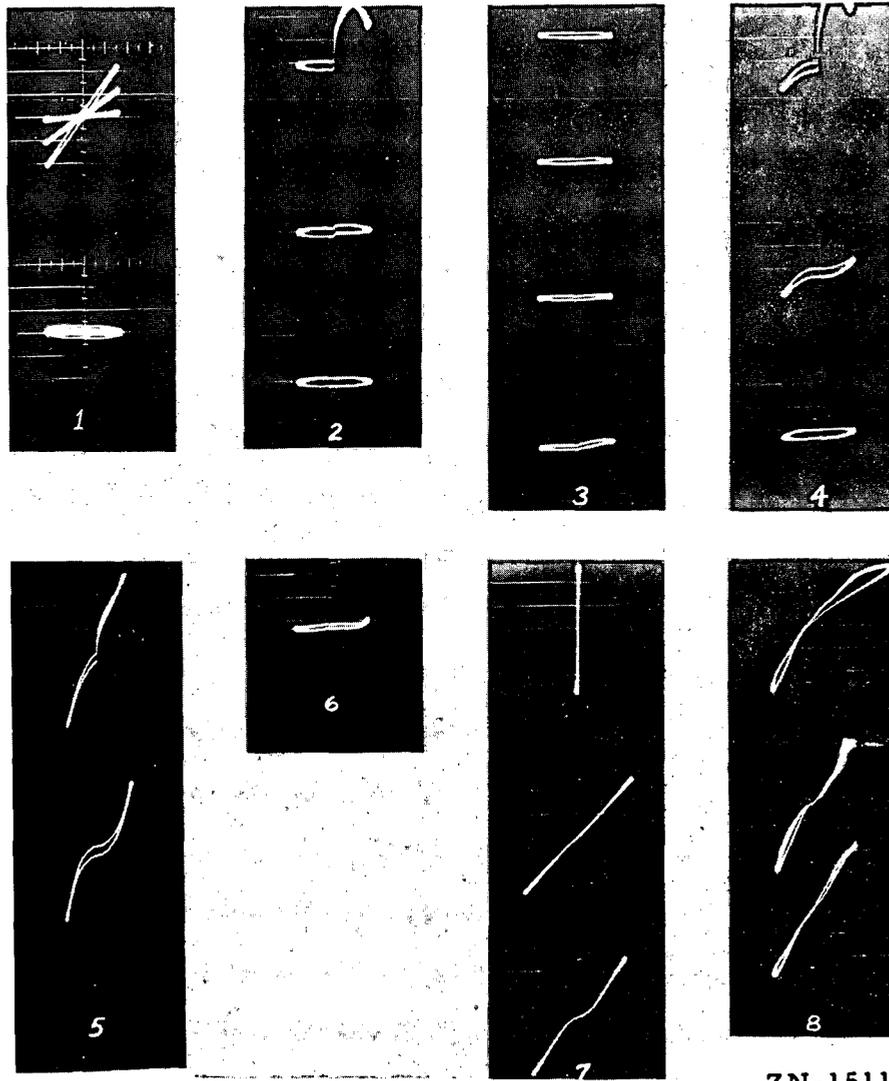
Photograph 1. Calibration of scope for conditions used in taking Photographs 2 through 7.

Top: The characteristics of three 0.5-watt resistors. A 100-megohm resistor gave the nearly horizontal trace; the others in counterclockwise order are 20 megohms and 10 megohms. The slight opening of the traces is owing to shunt capacity, most of which is contributed by the resistors themselves (cf. Fig. 2c)

Lower: Three values of capacity--0, 10, 30 μf ; the 30- μf trace is the largest ellipse.

Photograph 2. All three traces are of the cathode-X characteristic of a good tube. The amount of light admitted to the cathode decreases in order from full room light for the top trace to zero light for the bottom trace.

Photograph 3. The same (good) tube as in Photograph 2; the v-i characteristics between all other electrodes and dynodes Nos. 4, 3, 2, 1 from top to bottom, with the tube exposed to room light. Note that some of the cathode current flows to dynode No. 1, less to dynode No. 2, etc.

Photographs 1 through 8 show interelectrode volt-ampere characteristics of some 6810 multiplier phototubes. Details are given in Section IIA.

Photographs 4 and 5. The cathode-X v-i characteristic of rejected tube 1-6-21.

Top, No. 4: Room light admitted to cathode.

Middle, No. 4: No light admitted to cathode.

Bottom, No. 4: No light admitted to cathode, but the tube having been shaken since the middle picture was made.

Top No. 5: Light on cathode, tube shaken again.

Bottom No. 5: Same as Top No. 5, light blocked from cathode.

These pictures indicate the presence of a variable-resistance, vibration-sensitive semiconducting "short" between the cathode and some other electrode, in this case the focus electrode (shield between cathode and dynode structure). The "short" was found on the inner surface of the glass envelope between the extension on the internal aluminized shield, which is also used as the cathode lead, and one of the four focus electrode supports. The gap between the support and the aluminizing is abnormally small at this point--approximately 0.1 inch. There were evidences of a deposit of some material within this gap. With the tube in a dark room and with 300 to 500 volts applied between cathode and focus electrode, small bluish sparks could be seen in this gap when the tube was tapped.

Photograph 6. The dynode 1-X characteristic of tube 1-6-21. The upward tilt of the right-hand part of the trace indicates that conduction between dynode No. 1 and some other electrode takes place at the peak value (approx. 100 volts) of the applied voltage. In this tube, the clearance between the dynode No. 1 and dynode No. 3 support rods was rather small at the ceramic side insulators. In the darkroom, an application of dc voltage between dynodes Nos. 1 and 3 resulted in a bluish glow, visible to the dark-adapted eye, until the applied voltage was reduced below 200 volts. This glow was intense enough so that a clear photograph of it was obtained with an exposure at $f 1.9$ of 10 minutes, using a film with an ASA speed of 400.

Top: The dynode 1-X characteristic of tube 2-6-875, indicating a short of approximately 100 ohms between dynodes No. 1 and No. 3. In this tube also, the separation between the dynode No. 1 and No. 3 support rods was small. Application of voltage between these electrodes resulted at first in a yellowish glow between the support rods at the ceramic side insulator. This glow later disappeared, but a bluish discharge appeared at this point when the tube was tapped.

Middle and Bottom, No. 7: The dynode 13-X characteristic of tube 10-5-29, showing a tap-sensitive short between dynode No. 13 and the anode. When the tube was tapped, the short was found to change from a linear resistance to a nonlinear resistance, as the pictures show.

Photograph 8. The dynode 1-X characteristic of tube Z-6-840, with different scale factors than for Photographs 1 through 7. These three traces show an average slope corresponding to about 10,000 ohms. In this tube a small fragment of matter was seen lodged between the dynode No. 1 and No. 3 support rods. The three traces show the different volt-ampere characteristics assumed as the fragment was moved by tapping the tube. The tube was held stationary while each trace was photographed, but the middle trace shows that the v-i characteristic varied spontaneously.

1-6-21. Intermittent high-resistance (megohms) shorts between cathode and focus electrode, and between dynodes Nos. 1 and 3. (Photographs 4, 5, and 6) In darkroom, glow visible between dynodes No. 1 and No. 3 support rods at ceramic insulator (photos of this were taken) with dynode No. 1 to No. 3 voltages down to 200V. Tube has small spacing between cathode-potential aluminium coating and focus-electrode support.

2-6-840. Short of a 5K ohms between dynodes Nos. 1 and 3. (Photograph 8) A small fragment was seen lodged between these two dynodes. The fragment later fell out when tube was tapped. Erratic dark current. (Photograph 15)

2-6-875. Intermittent short of approx. 100 ohms between dynodes Nos. 1 and 3. (Photograph 7) Upon first application of voltage of approximately 300 volts between these electrodes, a yellowish glow was seen between dynodes Nos. 1 and 3 at the ceramic side insulator.

1. Intermittent interelectrode "shorts" due to particles captive within the tube.
2. Intermittent shorts due to voltage breakdown at points of high electrical stress.
3. Erratic dark currents, of up to saturation amplitudes, caused, in part, by light and ions generated within the tube by voltage breakdowns and by space current.

Too small a spacing between, and sharp points on, the support rods of dynodes No. 1 and No. 3 were the cause of many of the above defects. Point 3 above emphasizes the need for a good vacuum in the tube and an efficient light shield between the photocathode and multiplier structure.

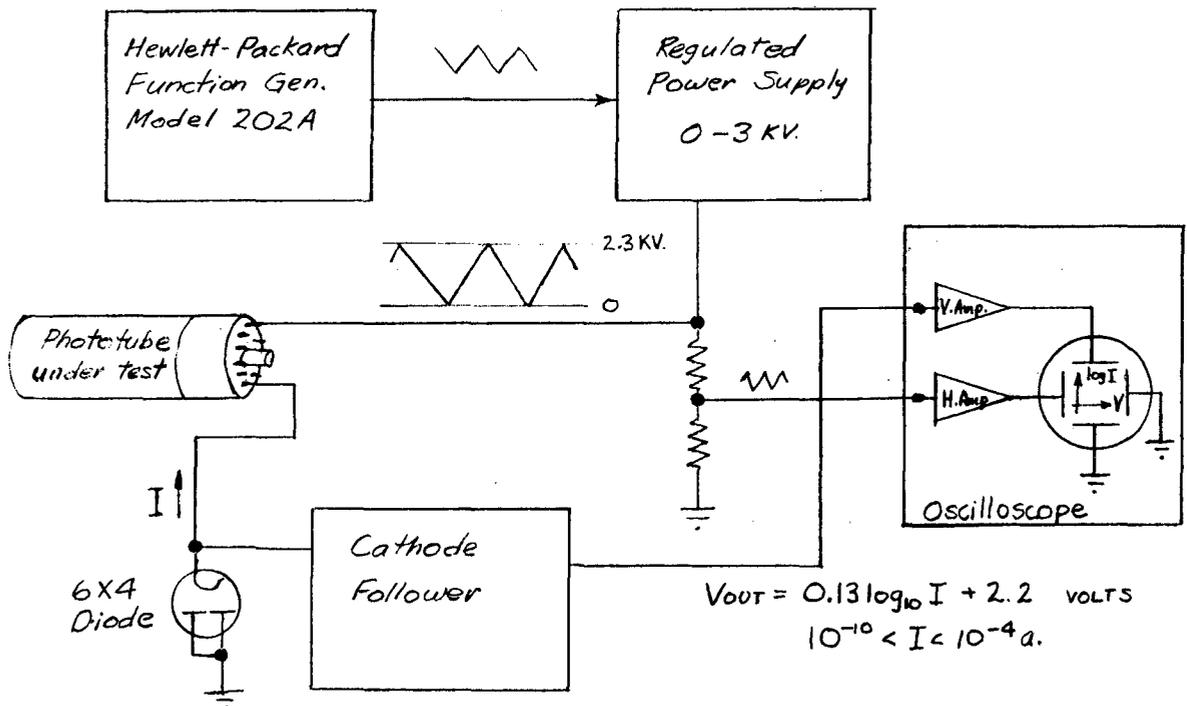
MU-11470

A block diagram of the equipment used in this test is shown in Fig. 3. An oscilloscope is used to obtain a plot of dark current vs voltage. A fraction of the supply voltage is impressed on the horizontal input of the scope, and a voltage proportional to the logarithm of the phototube anode current is impressed on the vertical input. This latter voltage is generated by passing the anode current through the nonlinear plate resistance of a thermionic diode. A cathode follower with grid current known to be less than 10^{-15} ampere is used to measure the voltage developed across the diode. The signal generator is used to generate a triangular wave, the period of which can be made as long as 10 seconds. The output of the regulated power supply is an amplified version of the triangular wave, with a peak amplitude of 2300 volts.

Fig. 3. Block diagram of equipment used in the swept-voltage dark current test. (Photographs 9 through 15.)

A series of representative patterns of dark current observed with this equipment is shown in Photographs 9 through 12, as described below. The voltage calibration on all the pictures is 250 volts per horizontal centimeter. (the three vertical lines are at 0, 5, and 10 cm) with zero volts on the left, 2500 volts at the right, 1250 volts in the center. The calibration of the vertical current scale is shown in Photograph 9. Each photograph was exposed for 30 seconds, this time corresponding to one cycle of the triangular wave form of the anode supply voltage.

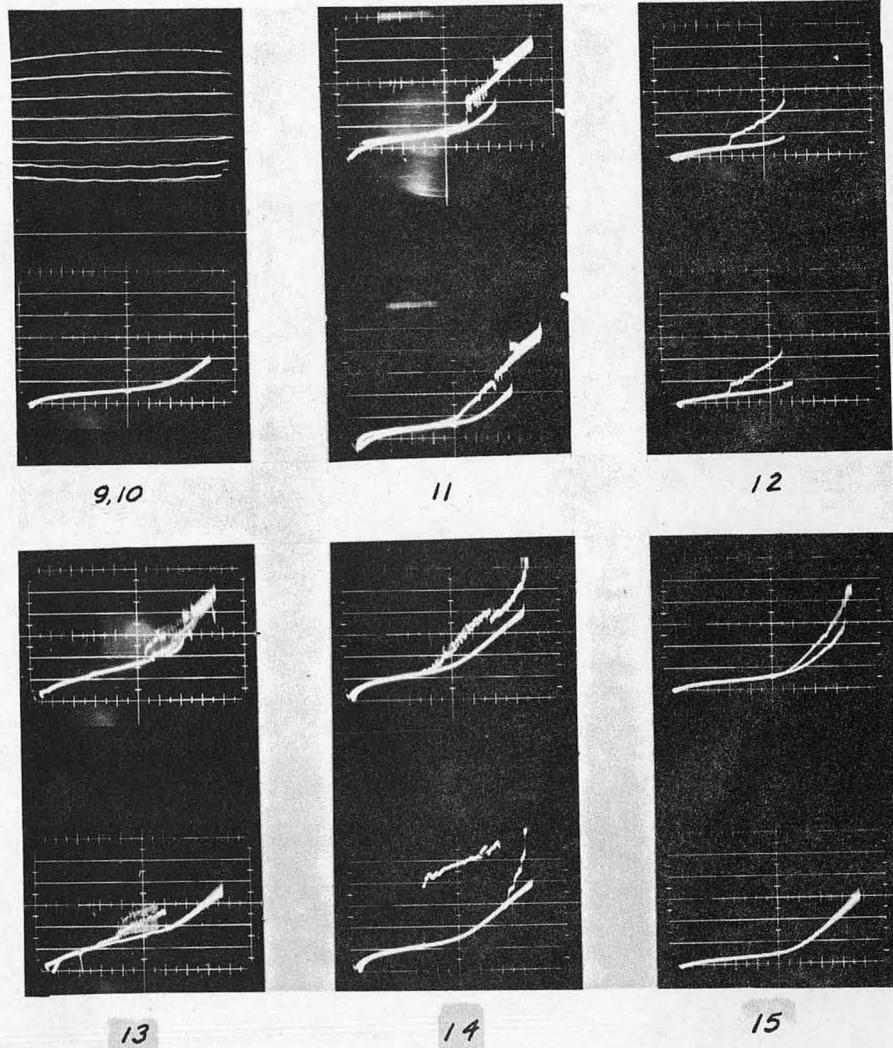
ZN-1512

Photograph 9. Current calibration traces are shown. Top to bottom, they record currents of 10^{-9} , 10^{-8} , 10^{-7} , 10^{-6} , 10^{-5} , 10^{-4} and 5×10^{-3} amp. Note that the scale is nearly logarithmic from 10^{-9} to 10^{-4} amp.

Photograph 10. Tube 1-6-643. The dark-current characteristic typical of a good tube. Note that the curve is smooth and that the portions for the increasing and decreasing parts of the triangular anode supply voltage waveform are coincident.

Photographs 9 through 15 show the relation between anode dark current and anode-cathode voltage of several 6810 multiplier phototubes. Voltage is plotted with a linear scale on the horizontal axis, zero volts on the left, 2500 volts on the right side of the graticule. The current calibration is shown in Photograph 9, where from top to bottom the traces shown correspond to $.5 \times 10^{-3}$, 1×10^{-4} , 10^{-5} , 10^{-6} , 10^{-7} , 10^{-8} and 10^{-9} amperes.

Photograph 11, Tube 2-6-233.

Top: As the supply voltage is raised, the dark current suddenly increases at 1800 volts by an order of magnitude. For decreasing supply voltages, the dark current suddenly decreases at 1500 volts. The hysteresis is typical of many discharge phenomena.

Bottom: The dark-current characteristic is slightly different each time the anode supply voltage is cycled. This one shows the characteristic observed several cycles after the top picture was taken.

Photograph 12, Tube 2-6-233. Supply voltage cycled between limits of 0 and 1500 volts.

Top: Dark-current jump occurred at the highest supply voltage.

Bottom: Dark current jumped after supply voltage had reached its peak and had started to decrease.

Photograph 13, Tube 1-6-687. Two very noisy traces. When the dark current is in its higher state, the instantaneous amplitude fluctuates rapidly.

Photograph 14, Tube 1-6-648.

Top: Dark-current jumps occurred when supply voltage reached 2300 volts, rose to more than 0.5 milliampere.

Bottom: After the tube was tapped, the dark-current characteristic changed slightly.

Photograph 15, Tube 2-6-840.

Bottom: This is the dark current observed for the first cycle of the triangular wave form of supply voltage when first turned on.

Top: After several cycles, the dark-current jumps occurred at about 2100 volts.

1-6-648. Intermittent operation observed. Small points of bluish light seen on ends of latter-dynode support rods. Observed to jump into condition of large dark current with 2 kv anode-cathode potential. (Photograph 14)

1-6-687. Dark current erratic. (Photograph 13)

2-6-233. Intermittent short of approximately 75K ohms between dynodes Nos. 1 and 3. As the voltage is raised, the dark current increases suddenly at 1000 to 1500 volts, decreases suddenly when the voltage is decreased to a lower value. Dark current is 10^{-4} to 10^{-3} amp at 2300v. (Photographs 11 and 12)
