Low Velocity Impacts of Variable Tip Radius on Carbon/ Epoxy Plates /

A Thesis submitted in partial satisfaction of the requirements  
for the degree of Master of Science

Structural Engineering

Mac P. Delaney

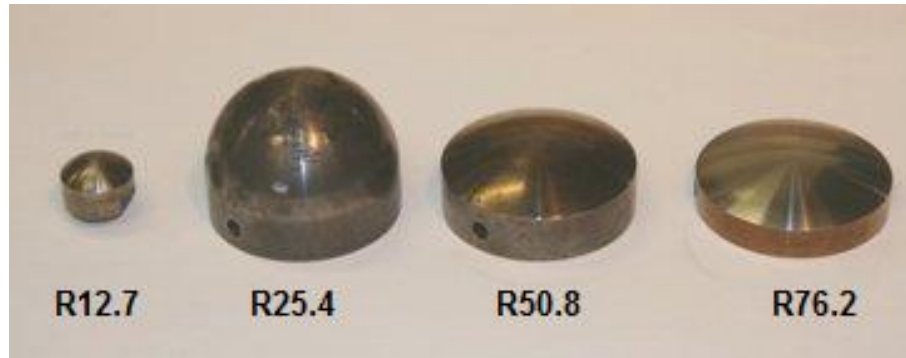
Four interchangeable impact tips made of hardened steel were used in this investigation. The tips had radii of 12.7, 25.4, 50.8, and 76.2 mm (Figure 3). These tips had masses of 23.5, 462.2, 262.3, and 168.4 grams respectively. The 12.7 mm radius tip was mounted to a DYTRAN 1050V6 force transducer which had a mass of 34.2 grams, and the other three tips were mounted to a DYTRAN 1060V5 force transducer which had a mass of 461.3 grams. This was due to the different size of the 12.7 mm radius tip in comparison to the other three (see Figure 3). Because the mass of the impact tip was not negligible compared to the mass of the entire pendulum head, the force measured by the transducer had to be corrected to accurately know the force at the face of the impact. This is primarily a function of the mass of the tip which sits between the load cell and target panel. This dynamic correction is further described in Appendix I. The force transducer's output was in volts and needed to be converted to units of force. The

**Figure 3. Impact tips of radii 12.7, 25.4, 50.8 and 76.2 mm from left to right**

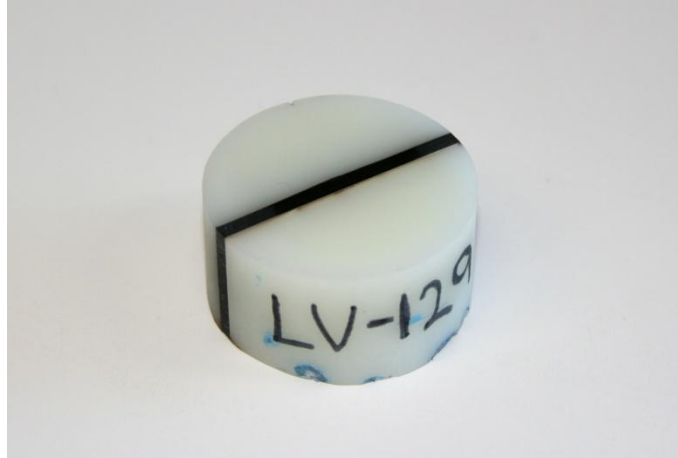
In order to further investigate the damage morphology within the panels, a few select specimens were sectioned for microscope inspection. This was done by cutting through the impact site in the zero degree direction. This section of panel was then mounted in epoxy (see Figure 34) and then polished using five levels of sand paper with a progressively finer grit, the final level being 14,000 grit.

**Figure 34. Panel section prepared for microscopy mounted in epoxy**
