To be presented at Windows in Building Design and  
Maintenance, Gothenburg, Sweden, June 13-15, 1984

OBSTACLES TO THE USE OF EXTERIOR FENESTRATION AND  
DAYLIGHTING CONTROL SYSTEMS IN THE U.S.

G. Sweitzer and R. Johnson

March 1984

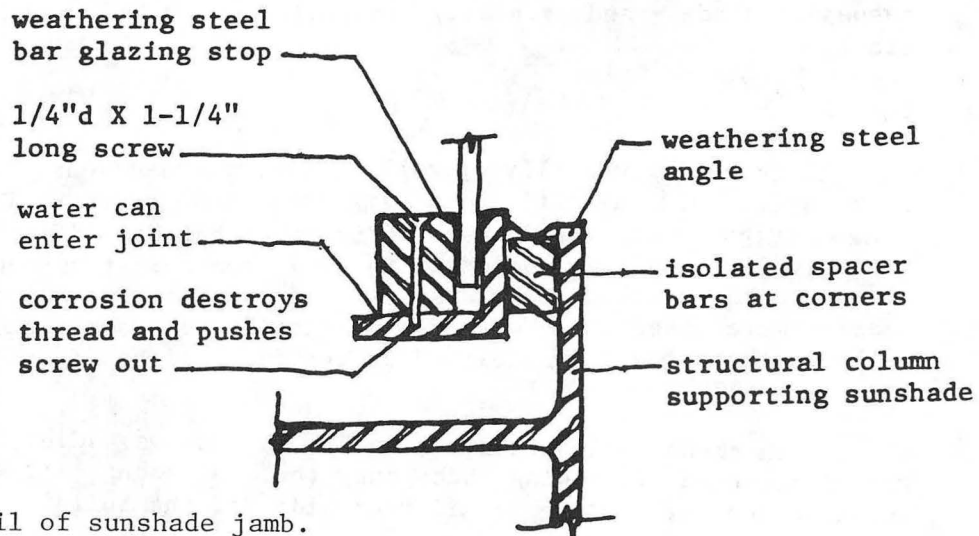
Fig. 4 Detail of sunshade jamb.

The original glass sunshade frames, hung from outside the catwalks, supported 3/8-inch-thick tinted glass panes measuring about 4 feet by 5 feet, and supported by welded angles and bar glazing stops, both made of weathering steel. The steel stops were fastened by screws to both vertical and top and bottom horizontal angles. The total shade frame was supported by a short weld at the top and bottom of each vertical angle (Fig. 4).

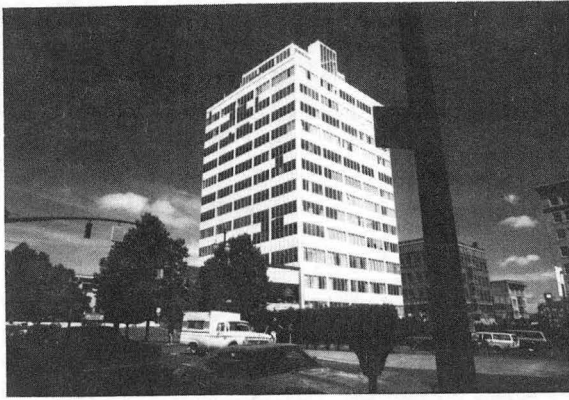
Fig. 6 Building view from southeast.

Case 2, involving manually operable exterior sunscreens, concerns a 13-story medical office building located in downtown Portland, Oregon (Figs. 6 and 7). This squarish-plan building features perimeter offices and was converted in 1959 from a 9-story department store. Horizontal window bands, each of 1-inch-thick insulating glass, were added along with new spandrels, both separated vertically by channel mullions extending the full height of the building.
