Graduate student research papers

Restoration Impacts on Lobos Creek: San Francisco's Last Free-Flowing, Perennial, and Unculverted Creek

Final Draft

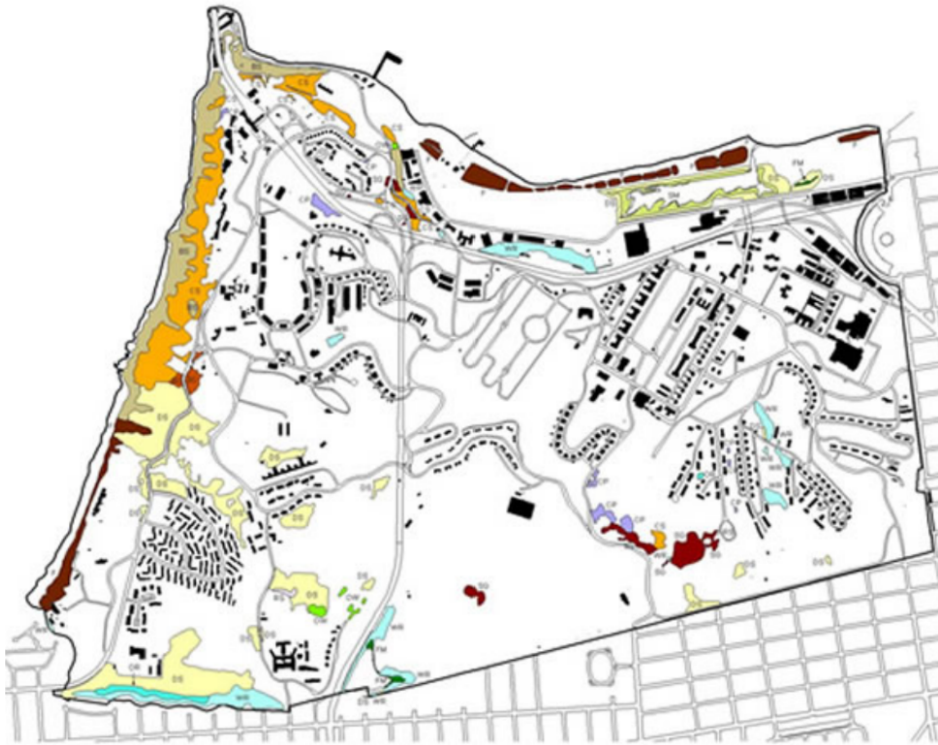
Figure 4: Probable Presidio Native Vegetation Prior to European Settlement (GGNRA et al., 2001).

Though we lack details on the exact distribution of plant species in pre-colonization Lobos Creek, the creek riparian area native vegetation consisted of arroyo willow and live oak riparian forests. The Lobos Creek Dunes hosted the dune scrub ecosystem, and the mouth of the creek at Baker Beach was a foredune ecosystem (Figure 4). Today, the Lobos Creek Valley dunes and riparian areas represent some of the last remaining native plant communities in the Presidio and San Francisco as a whole (Figure 5).

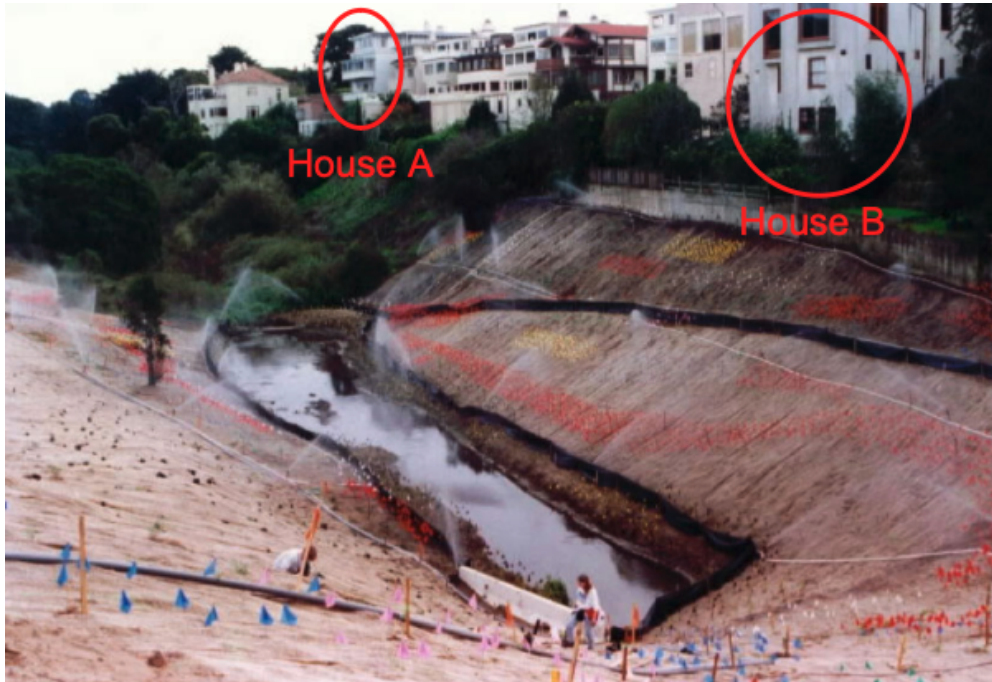
Figure 6: 1996 upstream view of Lobos Creek restoration project (Korotkin Associates, 2019)

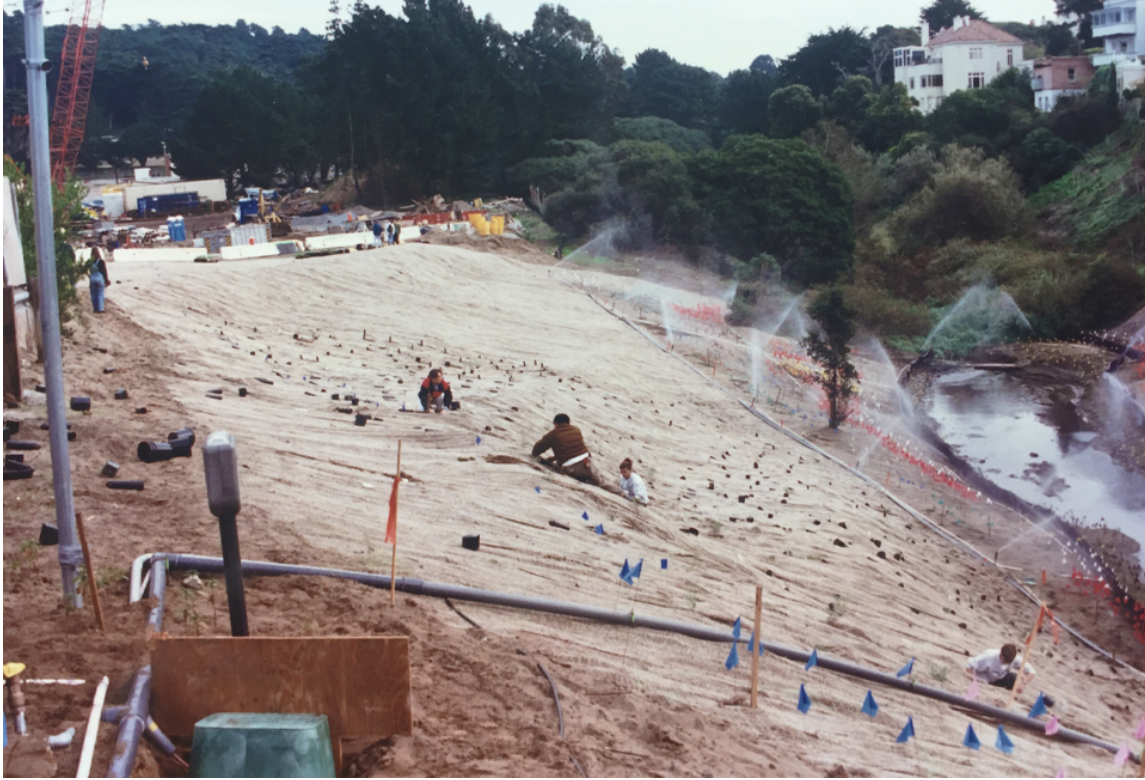
Figure 8: 1996 view of the north bank of the Lobos Creek during restoration (Korotkin Associates, 2019).

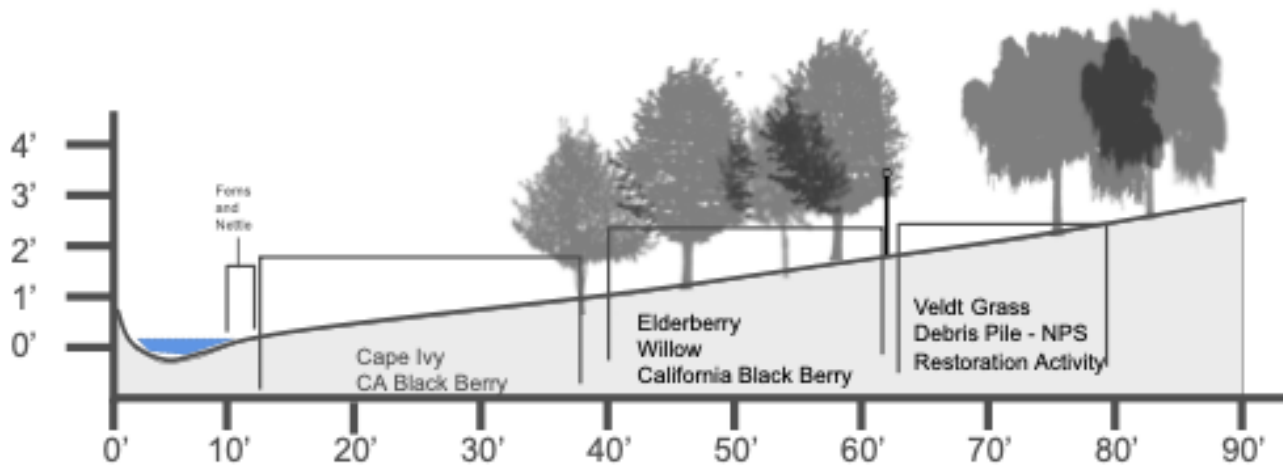
Figure 9: Vegetation transect #1. Headwaters of Lobos Creek between 16th and 17th Avenues.

Transect 1 was taken at the headwaters of the creek where the stream is a seep (Figure 9). From 10 to 40 feet, the vegetation assemblage includes lady fern (*Athyrium filix-femina* (L.) Roth), stinging nettle (*Urtica dioica*), California blackberry (*Rubus ursinus*) and Cape ivy (*Delairea odorata*). From 40 to 60 feet the planting includes willow, red elderberry (*Sambucus racemosa*) and California blackberry (*Rubus ursinus*). Past the fence at the 64-foot mark debris piles of cape

ivy from past restoration efforts can be seen. Plants include panic veldt grass (*Ehrharta erecta*) willow, and toyon (*heteromeles arbutifolia*).

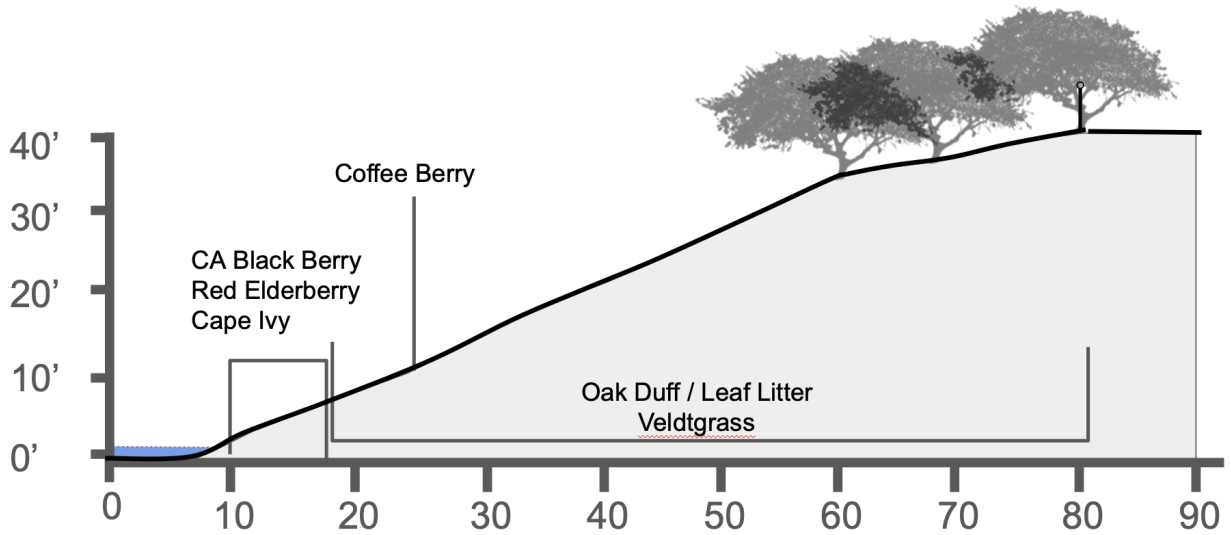
Figure 11: Vegetation Transect #3. Oak riparian habitat of Lobos Creek just east of restoration site.

Transect 3 was taken where there is a defined stream channel within a moderately steep ravine, compared to transect 2 (Figure 11). From the 10-foot to 20-foot mark, plants include California blackberry, red elderberry, and cape ivy. We found California coffeeberry (*Frangula California*) on this transect but did not see it in other reaches of the creek. The remaining 70 feet included coast live oak, panic veldt grass, and oak leaf litter.
