Numerical Analyses of Liquefaction-Induced Building Settlement

A dissertation submitted in partial satisfaction of the
requirements for the degree of
Doctor in Philosophy

Engineering – Civil and Environmental Engineering

University of California, Berkeley

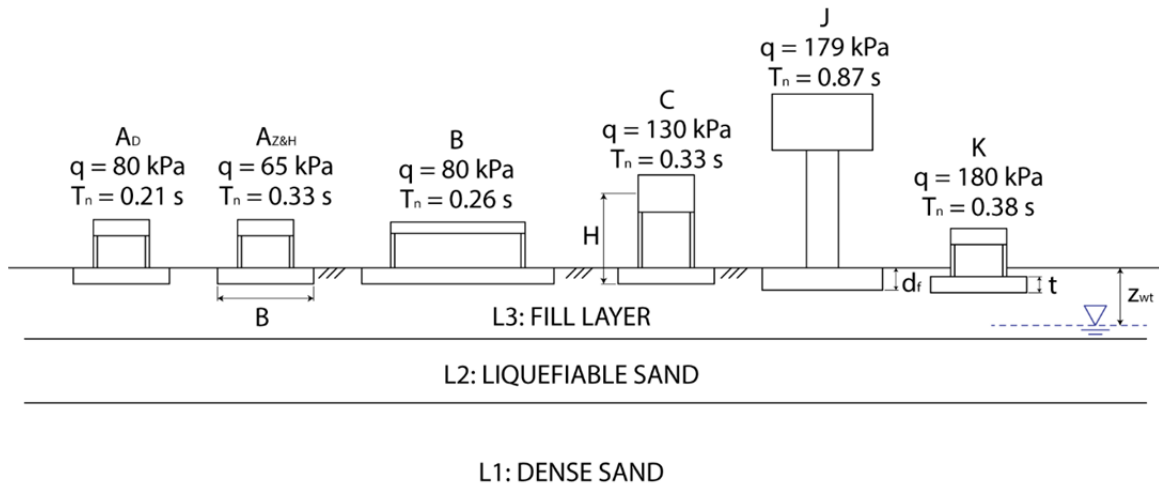
Figure 2.1. Different buildings modeled in this study with a typical soil configuration.

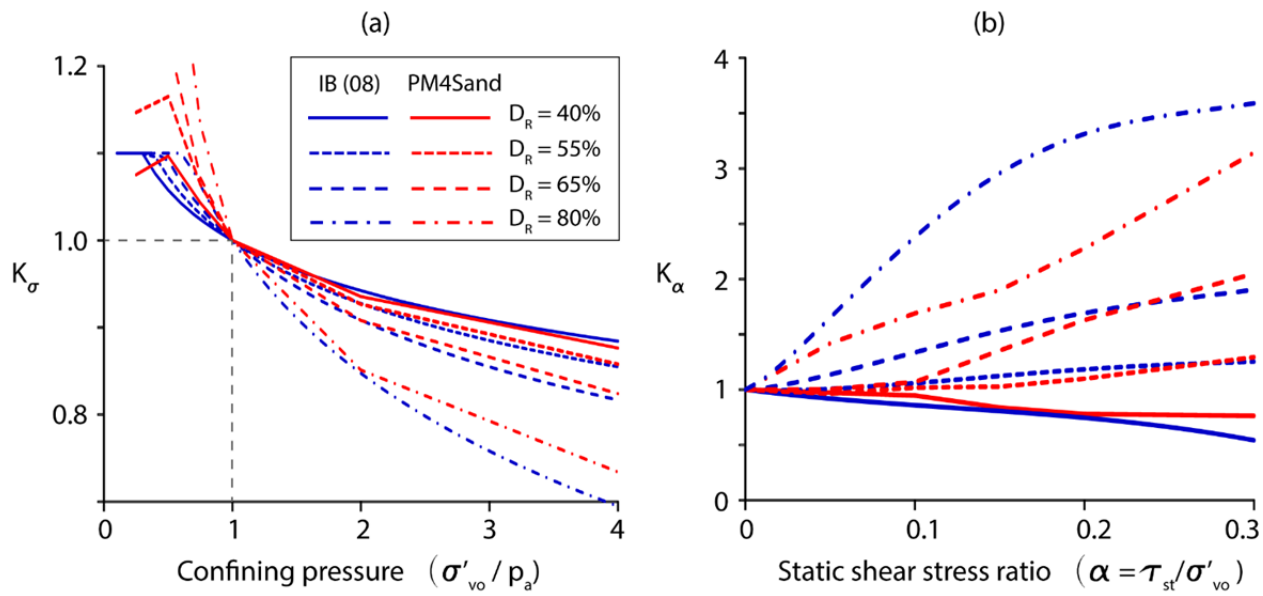
Figure 2.5. (a) K_σ and (b) K_α responses obtained from Idriss & Boulanger (2008) liquefaction triggering procedure (blue) and from the PM4Sand constitutive model (red) for different relative densities.

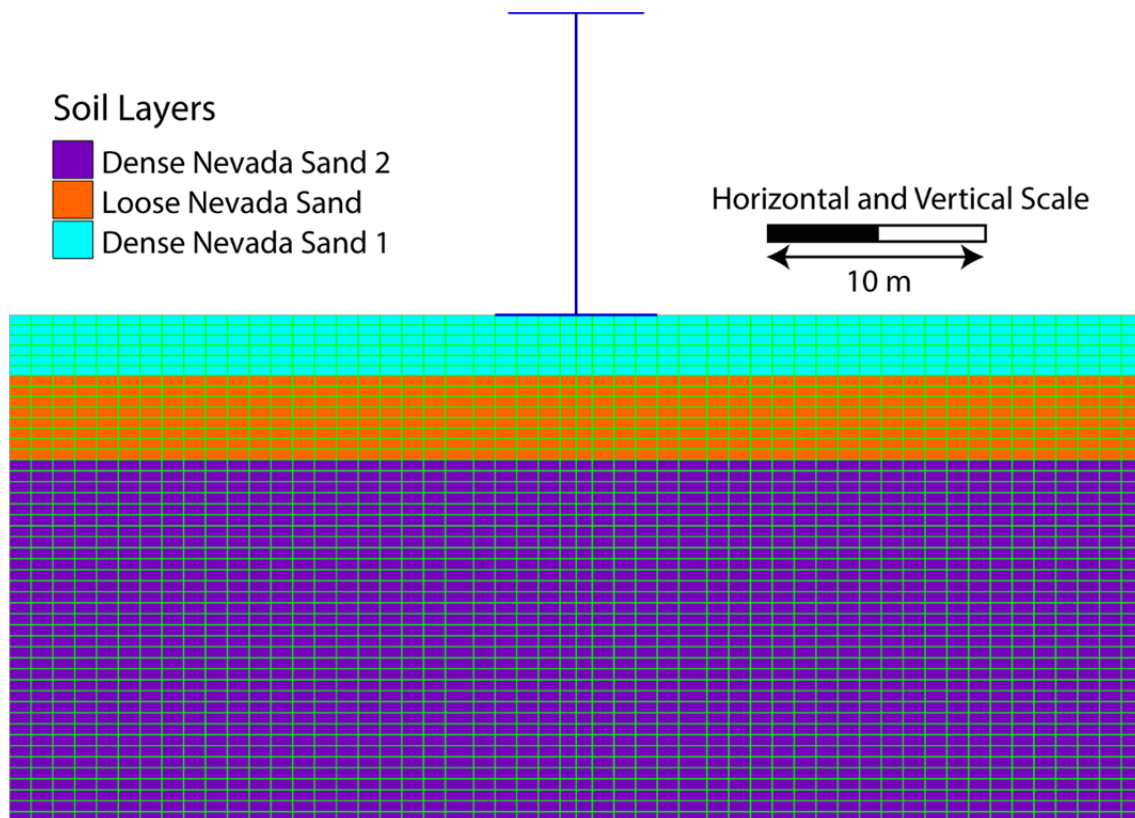
Figure 2.6. Finite difference mesh for configuration T3.9-50 and Building J_s

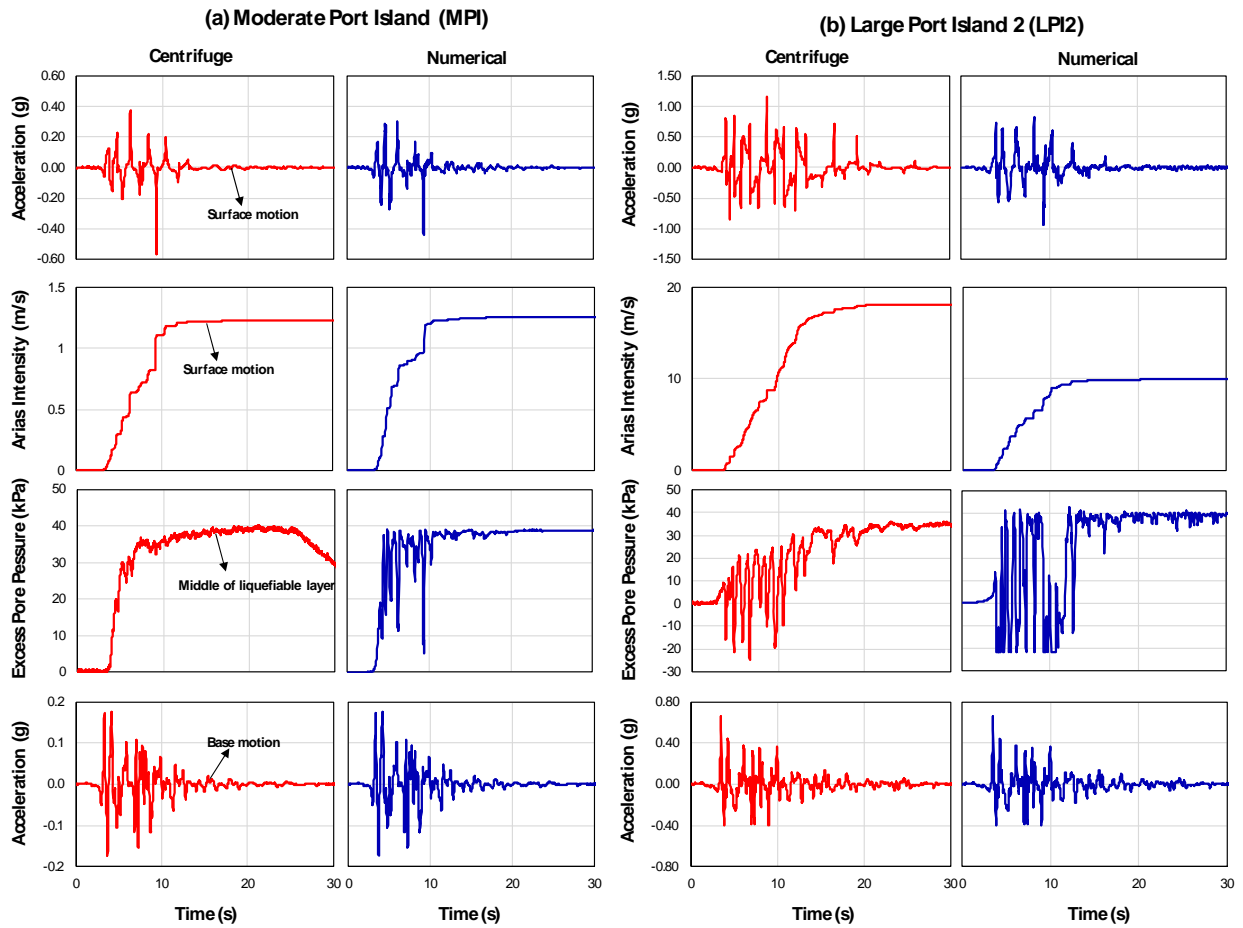
Figure 2.7. Free-field response comparison of centrifuge test and numerical simulations for the T3-50 experiment for: (a) the moderate Port Island event (MPI) and (b) the large Port Island event (LPI2)

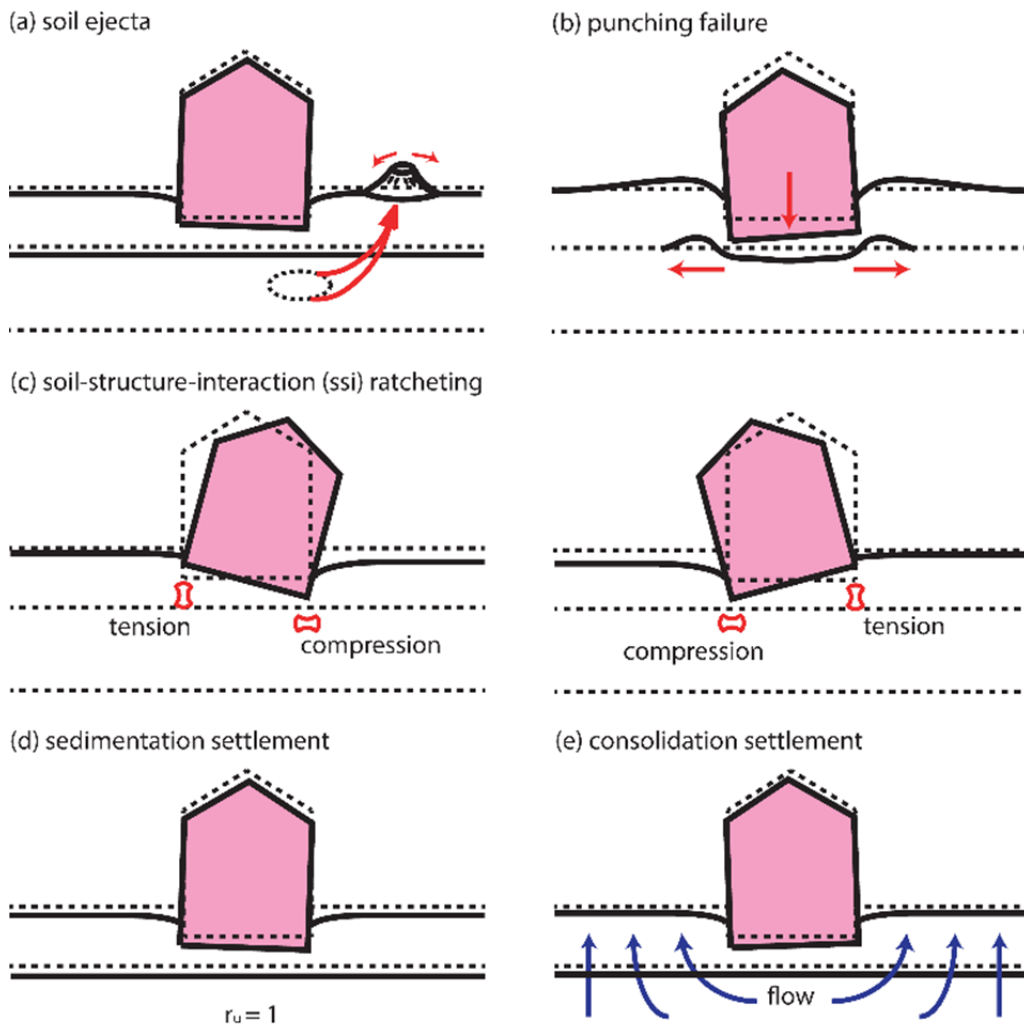
Figure 3.1. Liquefaction-induced displacement mechanisms: (a) ground loss due to soil ejecta; shear-induced settlement from (b) punching failure, or (c) soil-structure-interaction (SSI) ratcheting; and volumetric-induced settlement from (d) sedimentation, or (e) post-liquefaction reconsolidation (modified from Bray and Dashti 2014).

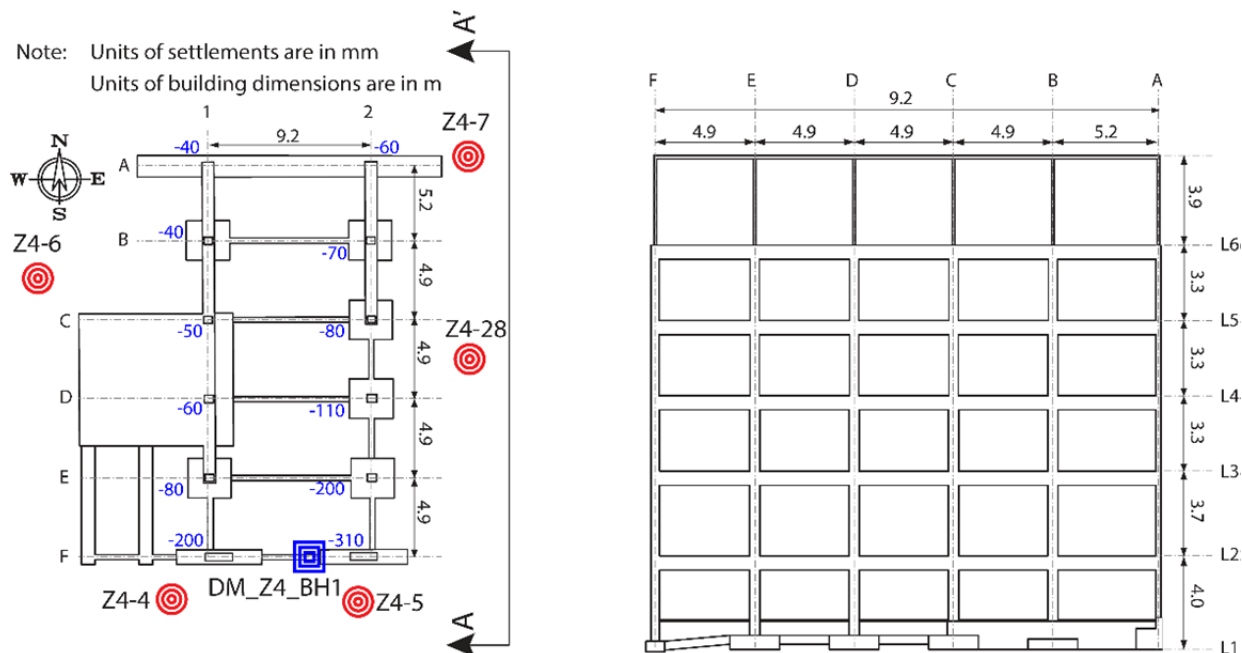
Figure 3.3. Foundation plan view of the CTUC building and elevation view of its eastern NS-oriented frame.

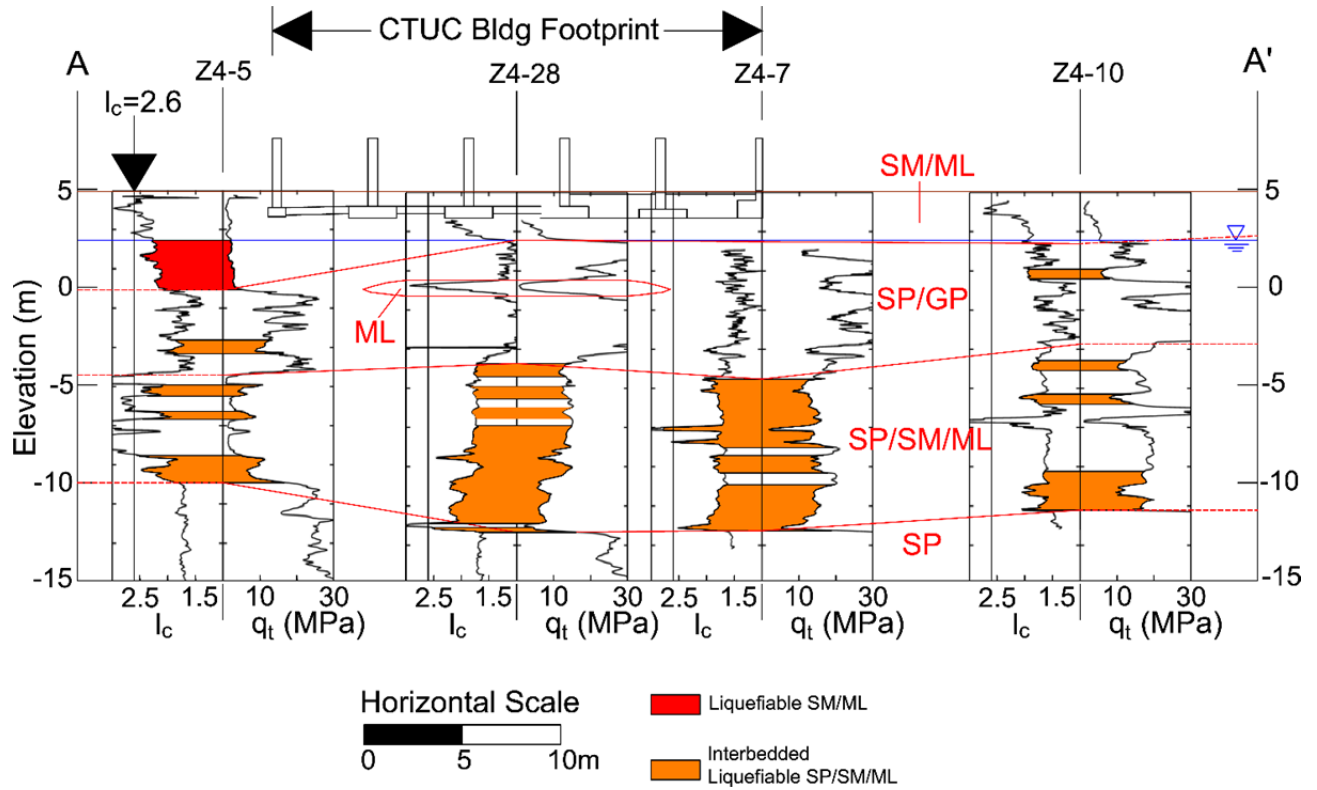
Figure 3.4. Subsurface conditions at the CTUC building site showing zones of materials with $FS_1 < 1.0$ based on the Robertson & Wride (1998) procedure using the median PGA from Bradley (2014) for the Christchurch earthquake (from Bray et al. 2014a).

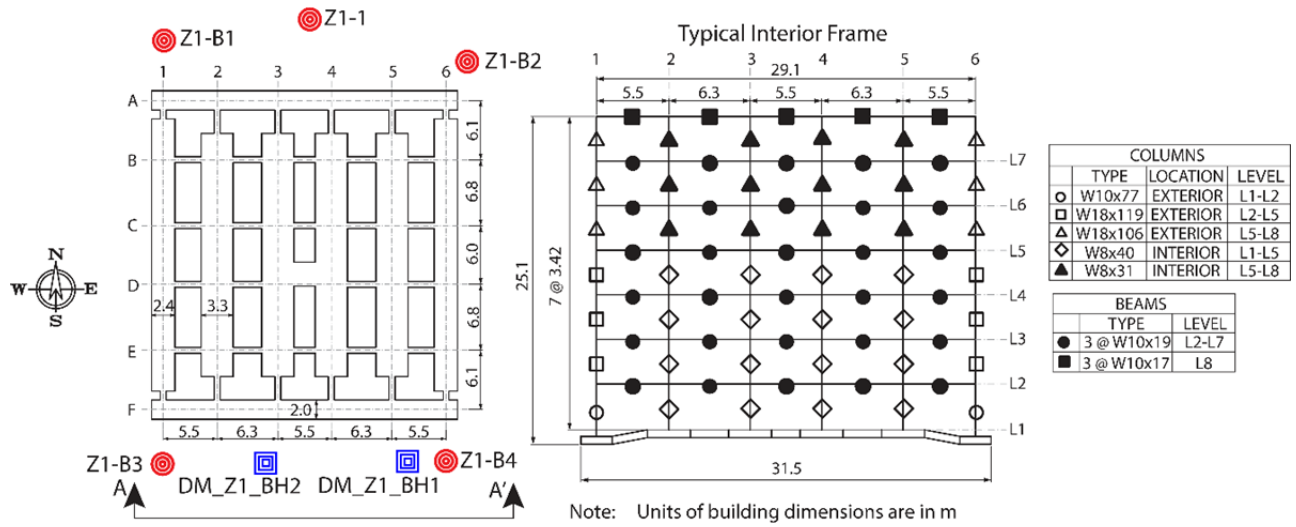
Figure 3.5. Foundation plan view of the FTG-7 building and elevation view of a typical interior frame in the EW direction.

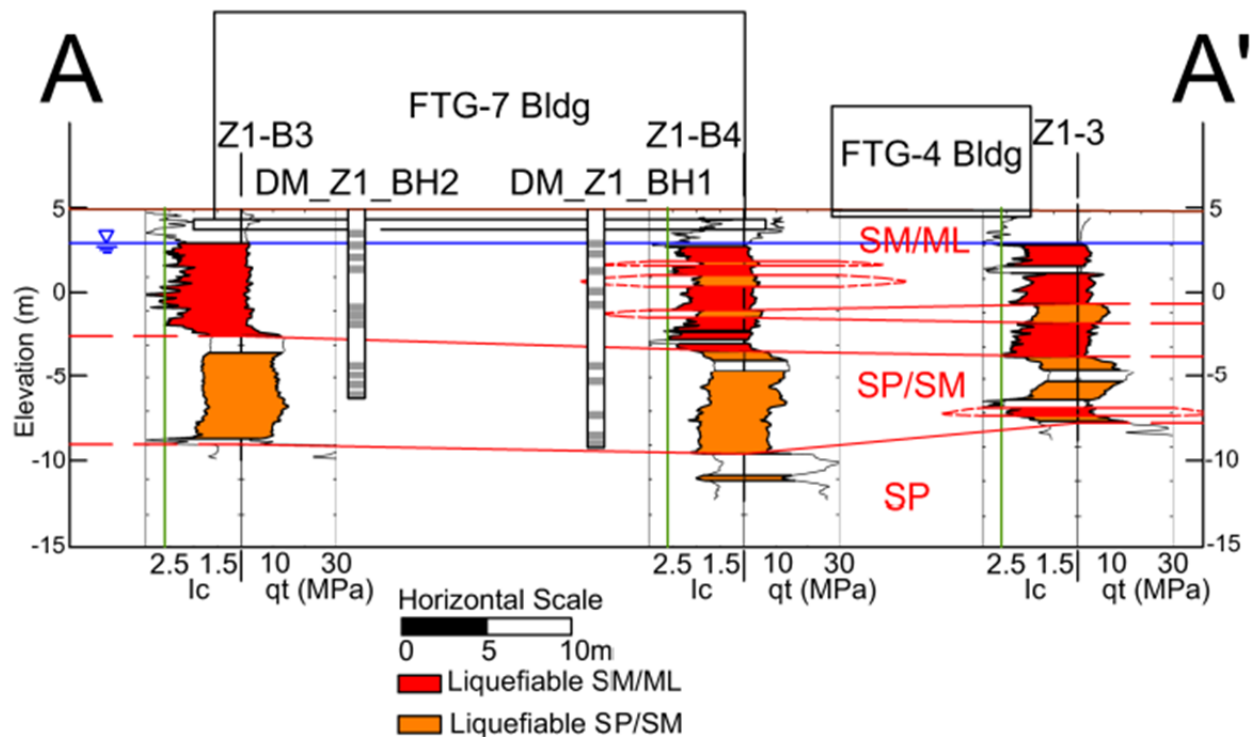
Figure 3.6. Subsurface conditions at the FTG-7 building site showing zones of materials with $FS_1 < 1.0$ based on the Robertson & Wride (1998) procedure using the median PGA from Bradley (2014) for the Christchurch earthquake (from Markham 2015).

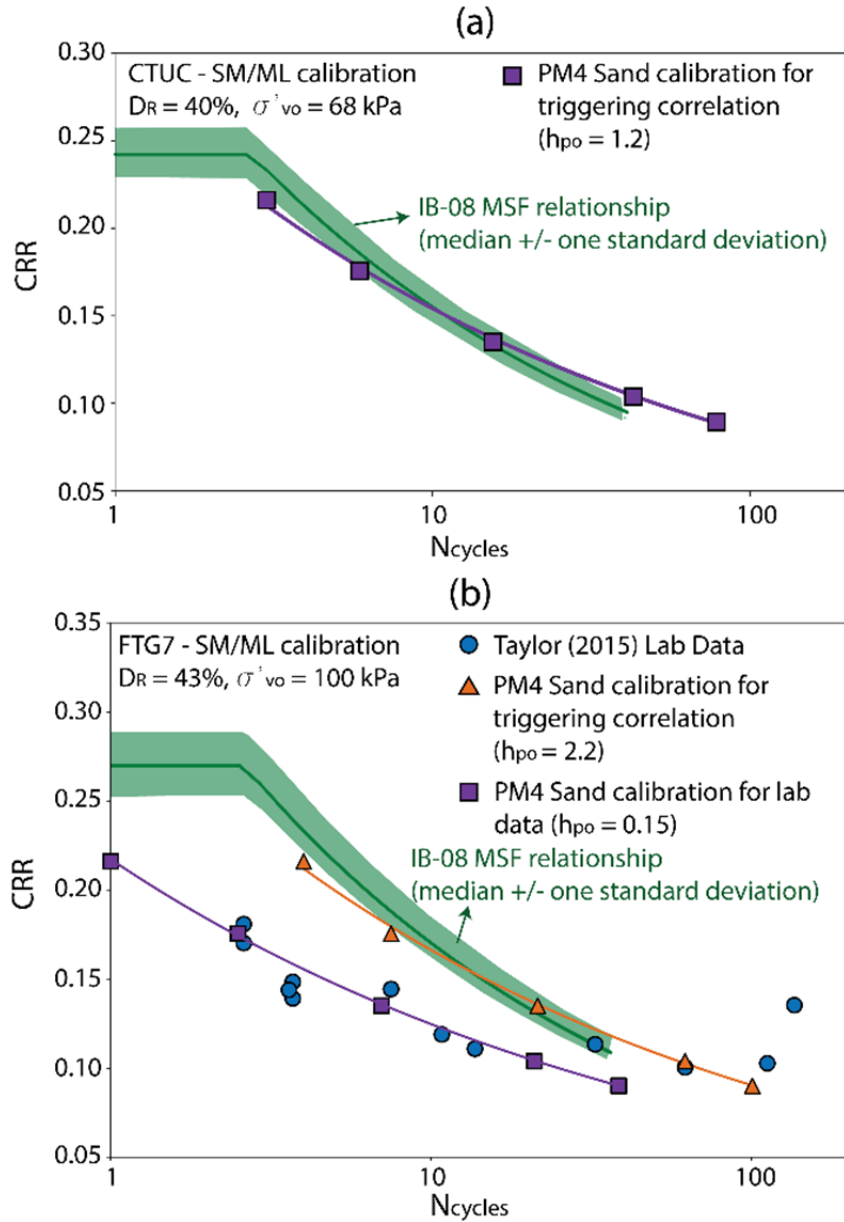
Figure 3.7. CRR- N_{cycles} curves for: (a) SM/ML soil at CTUC building and (b) SM/ML soil at FTG-7 building.

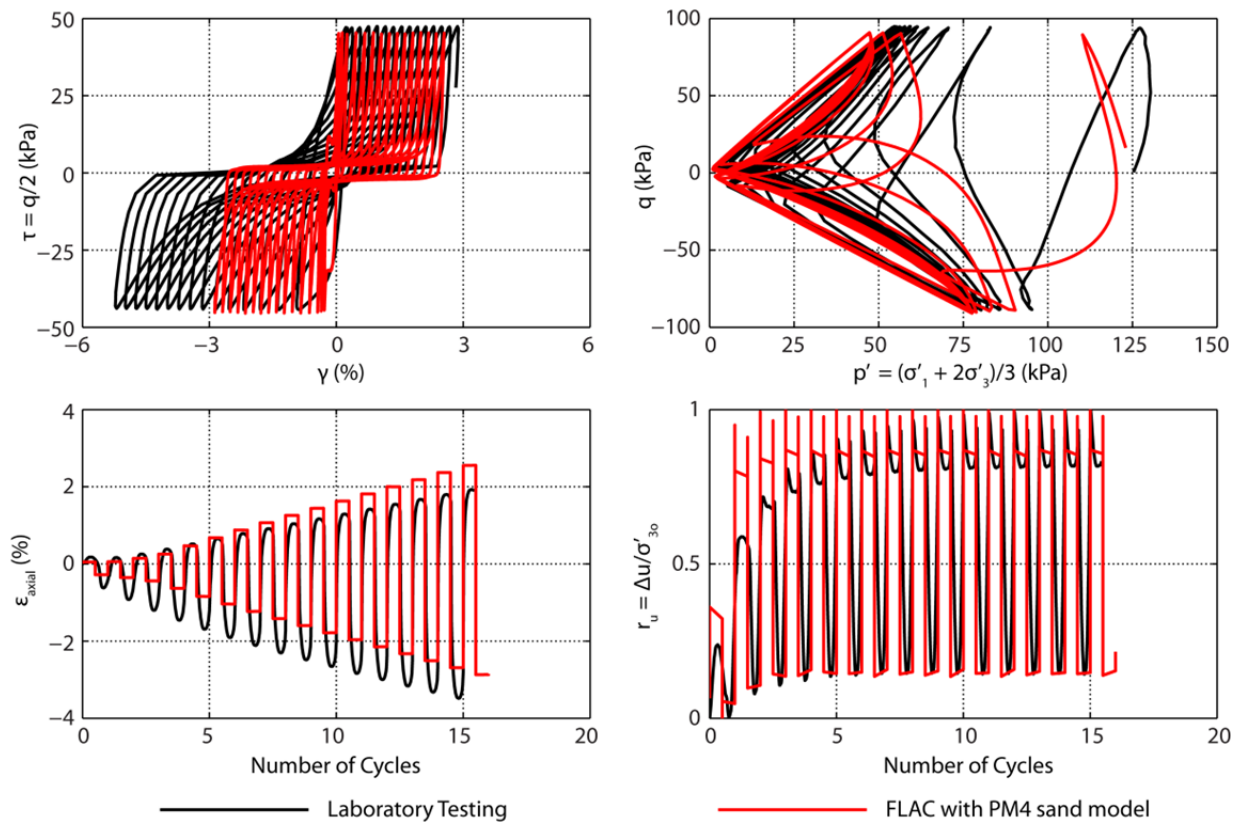
Figure 3.8. Comparison between laboratory cyclic triaxial test results (black) and FLAC simulated test (red) for a specimen from a depth of 10.97 m at the FTG-7 building site.

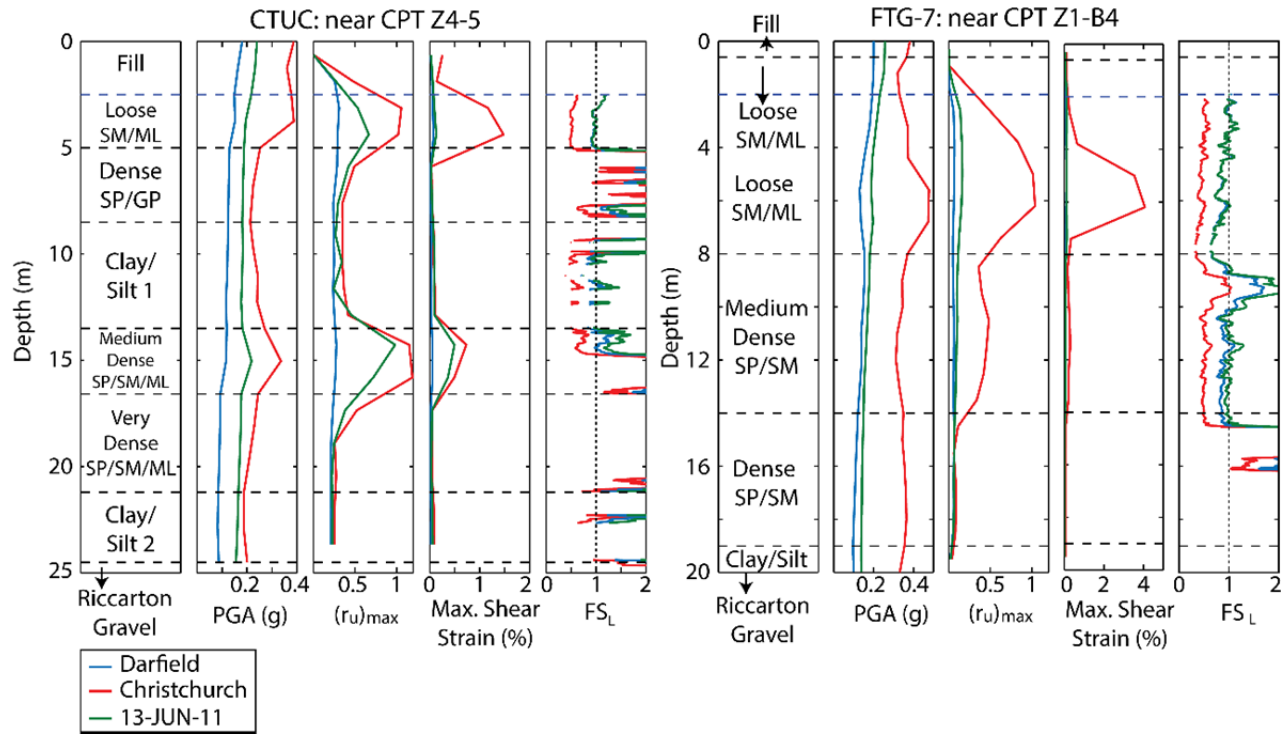
Figure 3.9. Seismic response of the free-field condition for the CTUC and FTG-7 building sites.

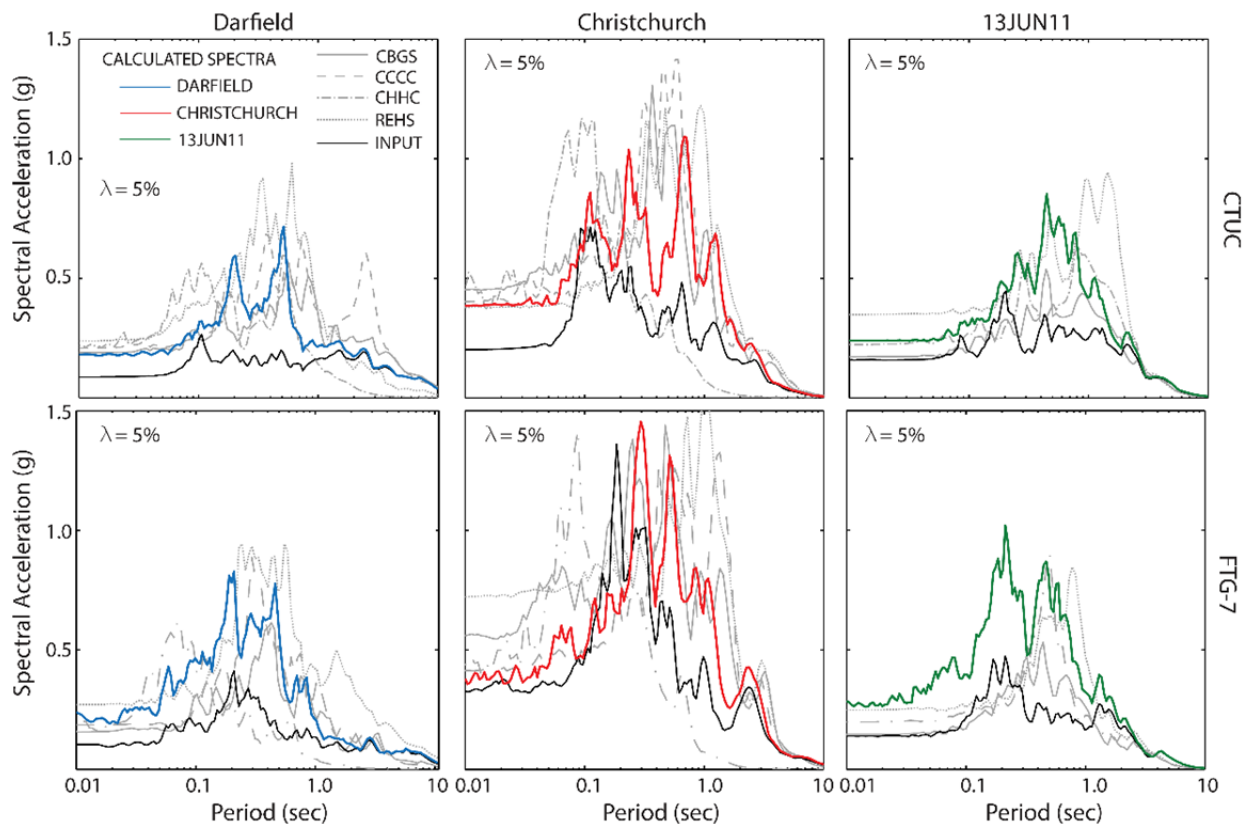
Figure 3.10. Acceleration response spectra (5% damped) calculated for the CTUC building site (top row) and FTG-7 building site (bottom row) compared to recorded response spectra at nearby recording stations.

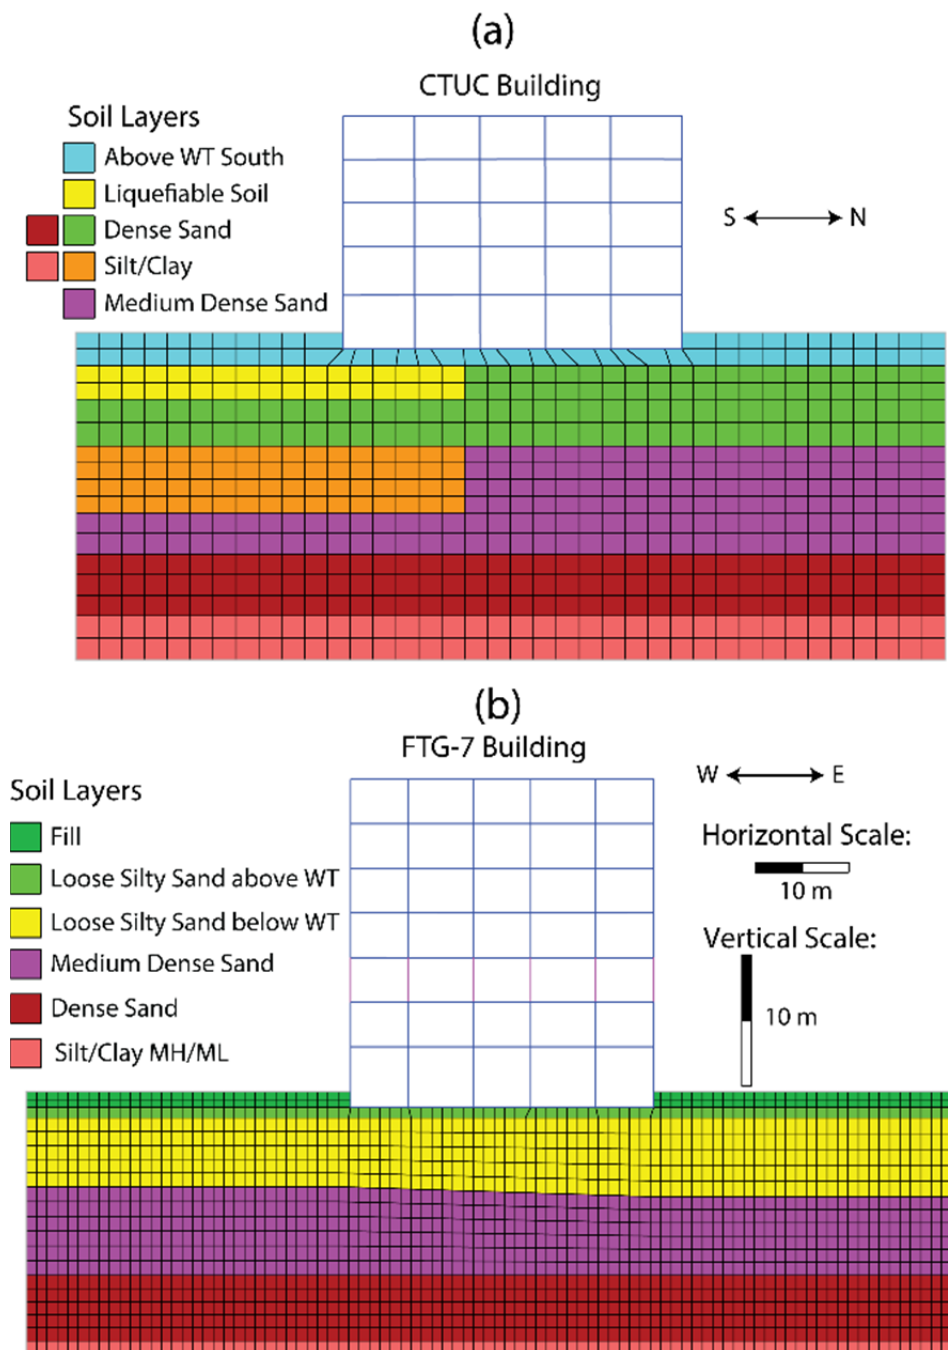
Figure 3.11. Geotechnical and structural model for the (a) CTUC and (b) FTG-7 buildings.

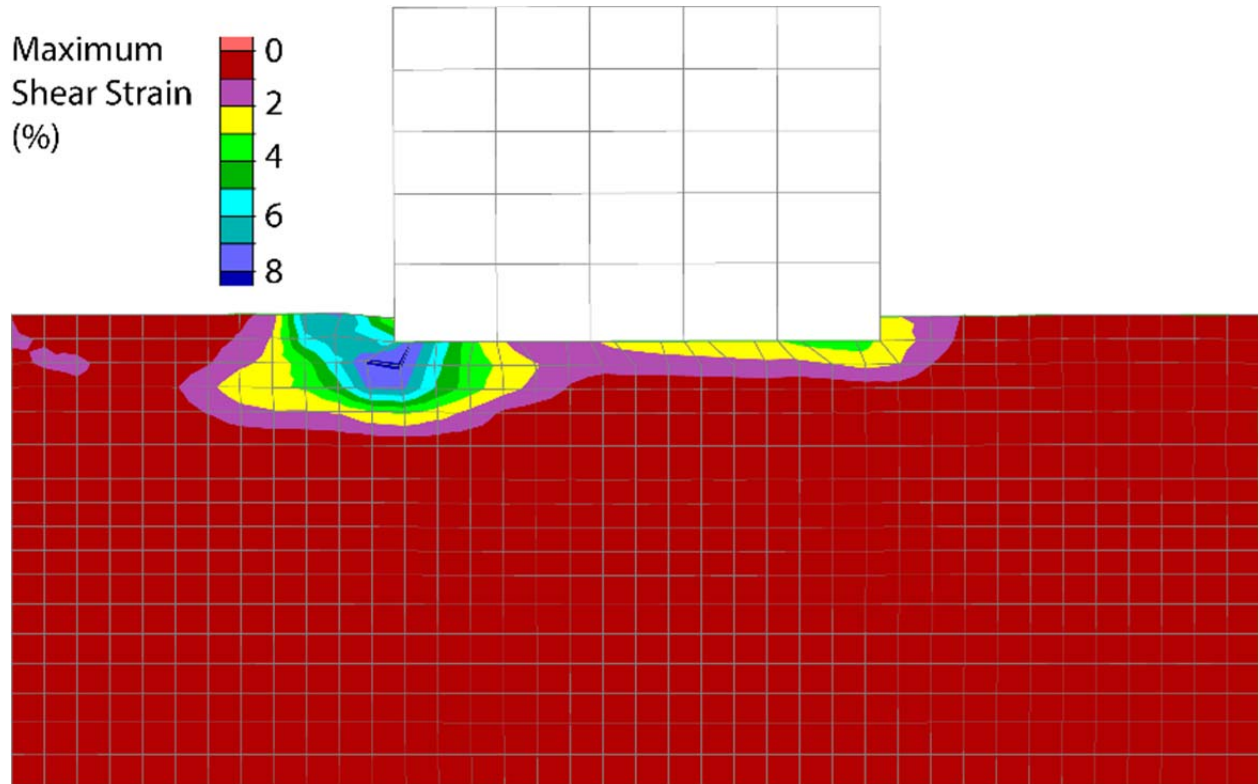
Figure 3.12. Shear strain contours for soils beneath the CTUC building at end of the Christchurch earthquake.

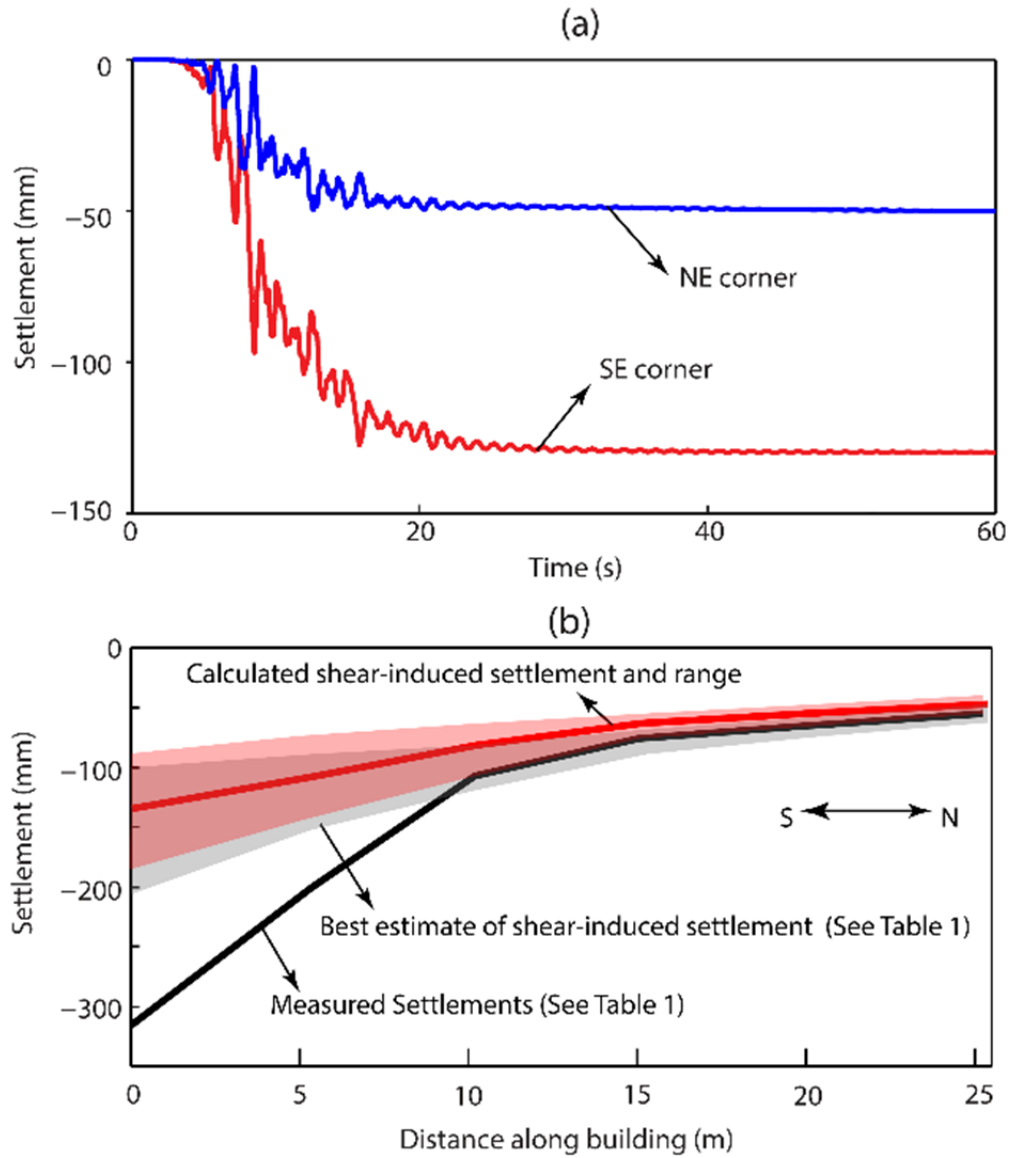
Figure 3.13. (a) Displacement time-history at the southern and northern columns of the CTUC building for the Christchurch earthquake, and (b) settlement profile along the building.

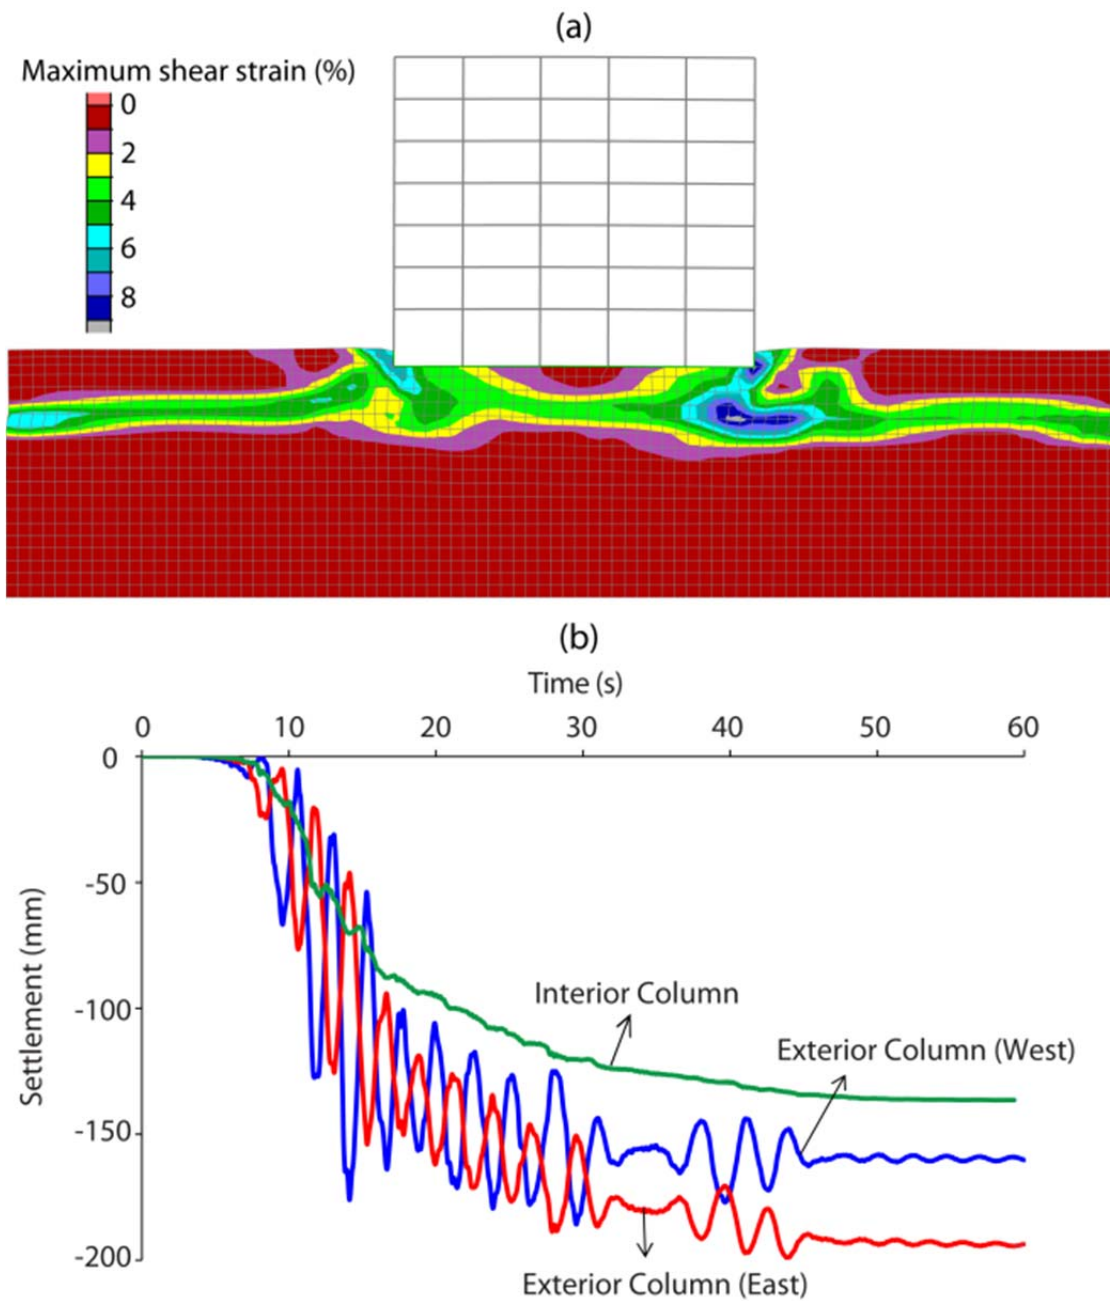
Figure 3.14. (a) Shear strain contours for soils beneath the FTG-7 building at the end of the Christchurch earthquake, and (b) displacement time-histories at western, eastern, and interior columns for the Christchurch earthquake.

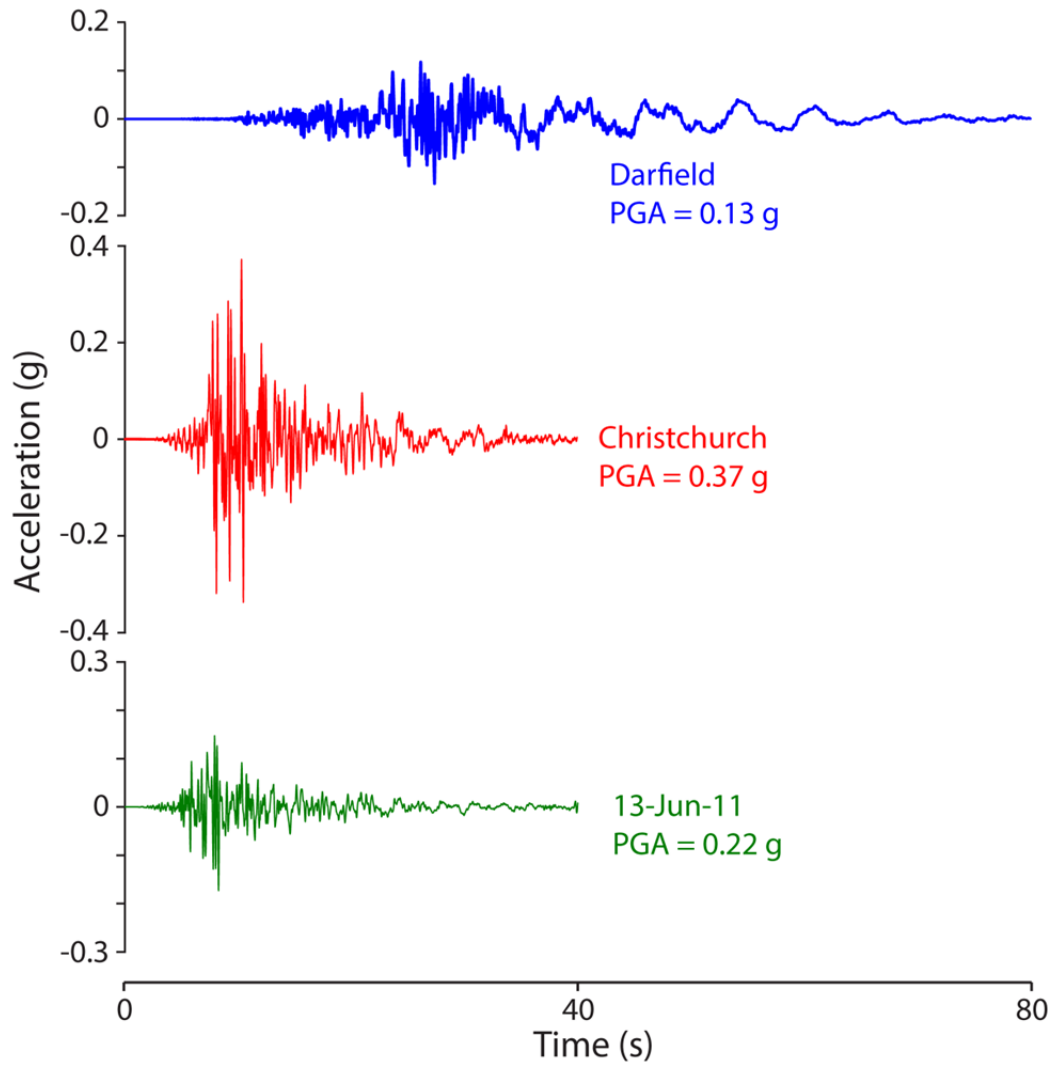
Figure 4.1. Input deconvolved “within” ground motions from the CACS station for the NS component for the three primary earthquakes of the Canterbury earthquake sequence scaled for the CTH site.

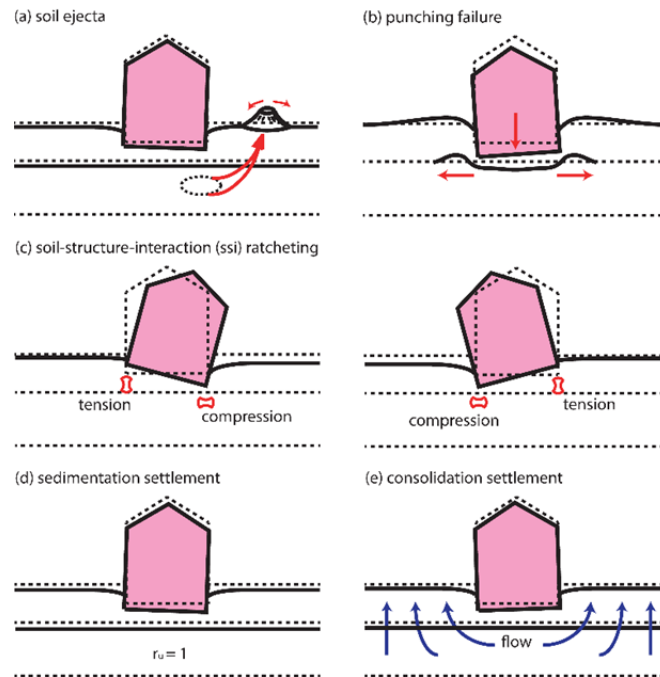
Figure 5.1. Liquefaction-induced displacement mechanisms: (a) soil ejecta; (b) punching failure, (c) soil-structure-interaction (SSI) shear-induced ratcheting; (d) sedimentation and (e) consolidation (modified from Bray and Dashti 2014).

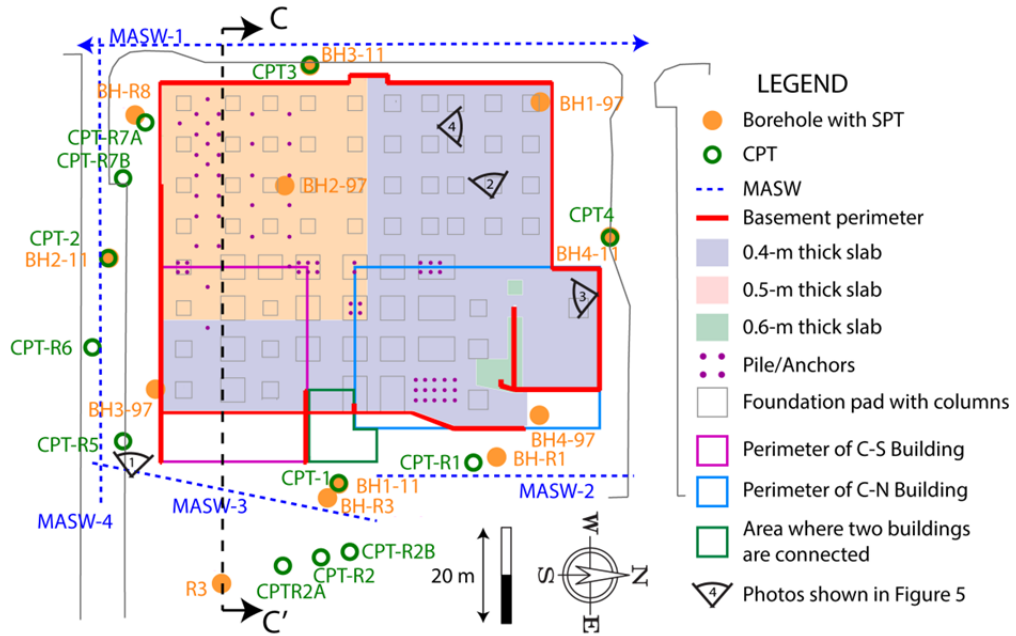
Figure 5.2. Building C basement and structure plan areas with geotechnical data.

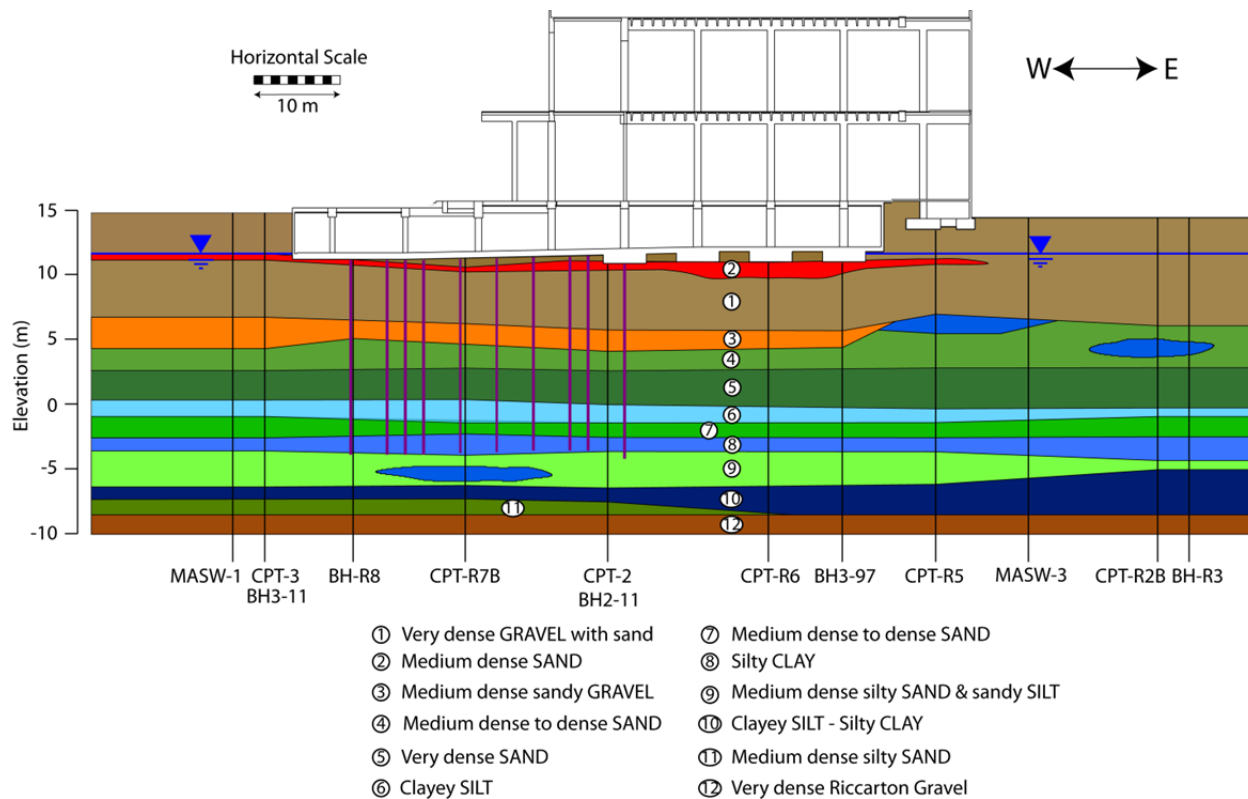
Figure 5.3. Subsurface conditions at Building C showing different geotechnical units and structural frame at cross section C-C'.

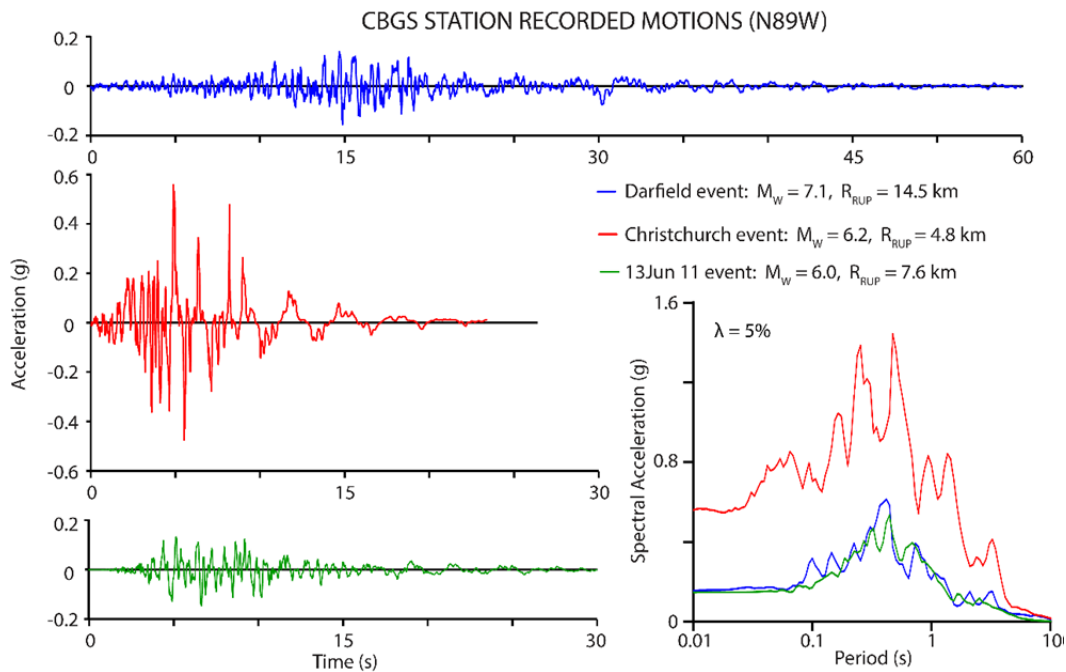
Figure 5.4. Recorded acceleration-time histories at the CBGS strong motion station for the three Canterbury earthquakes: Darfield, Christchurch, and 13JUN11

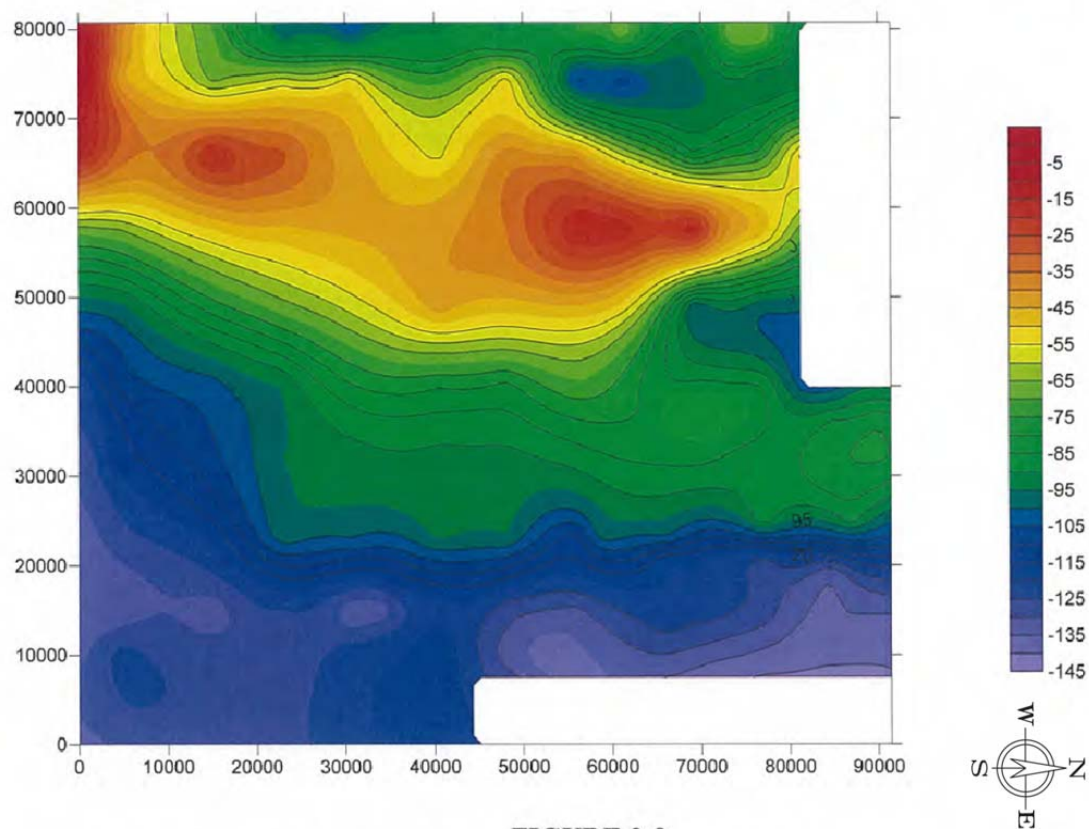
FIGURE 3-9
MEASURED RELATIVE POST-EARTHQUAKE SETTLEMENT CONTOUR PLOTS (MM)
Figure 5.5. Post-Canterbury earthquake sequence relative settlement contours on the foundation slab of the Building C from PCR (2013).
