Numerical Analyses of Liquefaction-Induced Building Settlement

A dissertation submitted in partial satisfaction of the
requirements for the degree of
Doctor in Philosophy

Engineering – Civil and Environmental Engineering

University of California, Berkeley

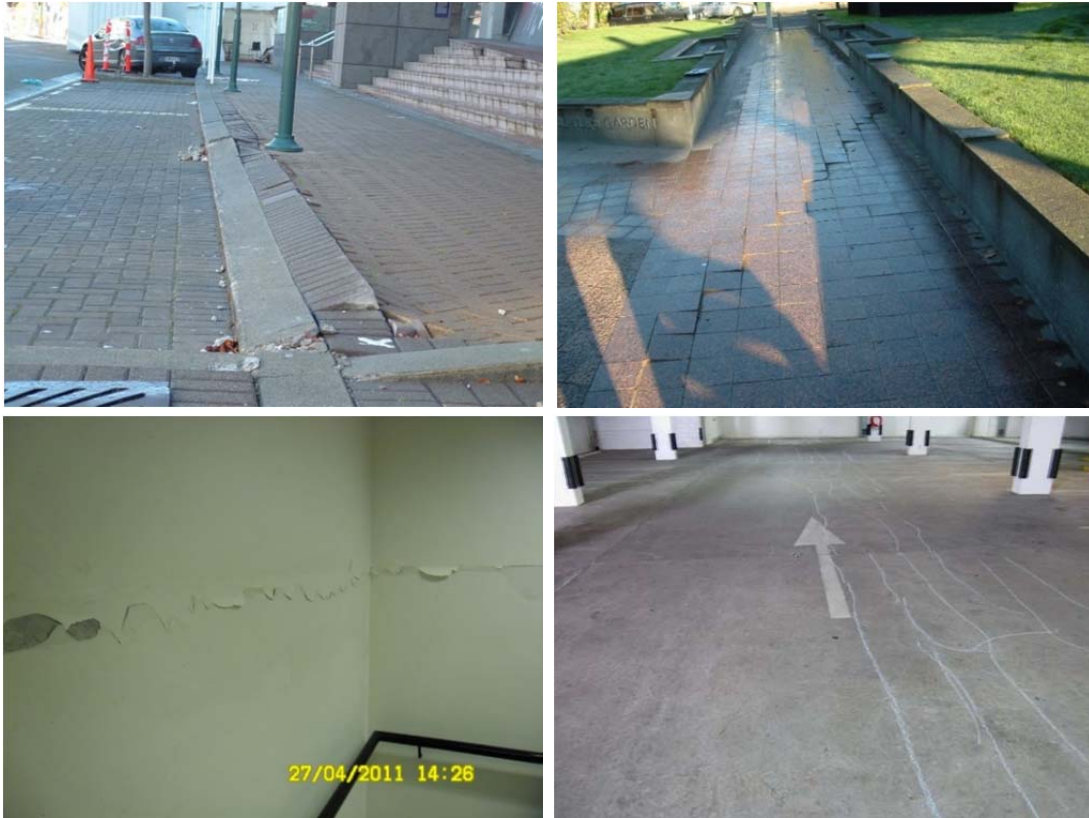
Figure 5.6. Post-Christchurch earthquake photographs of Building C: (upper-left) rolling of curb outside of building indicated area of cyclic softening-induced ground movement; (upper-right) deformation in tiled walkway and planter walls on west side of building above basement; (lower-left) cracking of wall in north corner stairway to car park; and (lower-right) cracking of garage basement RC mat (from CCC)

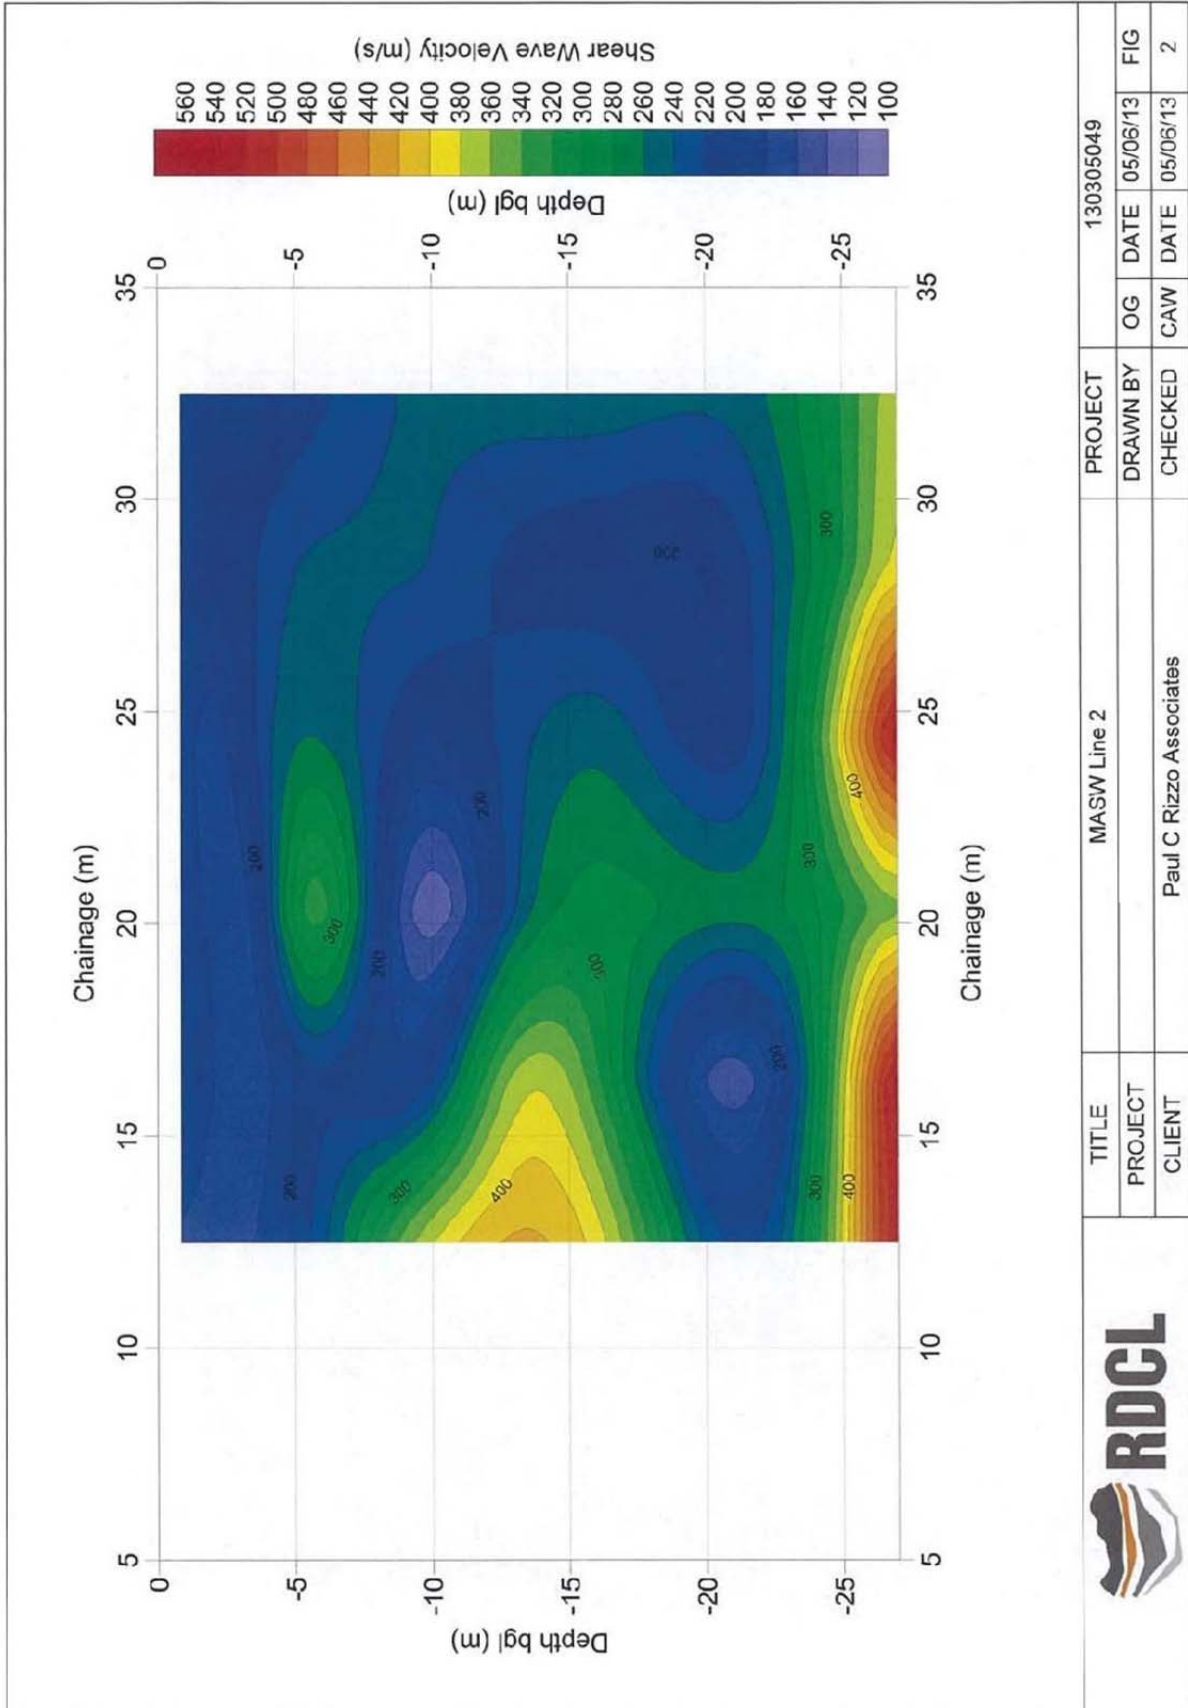
TITLE	MASW Line 2	PROJECT	130305049	
PROJECT		DRAWN BY	OG	DATE 05/06/13
CLIENT	Paul C Rizzo Associates	CHECKED	CAW	DATE 05/06/13
				FIG 2

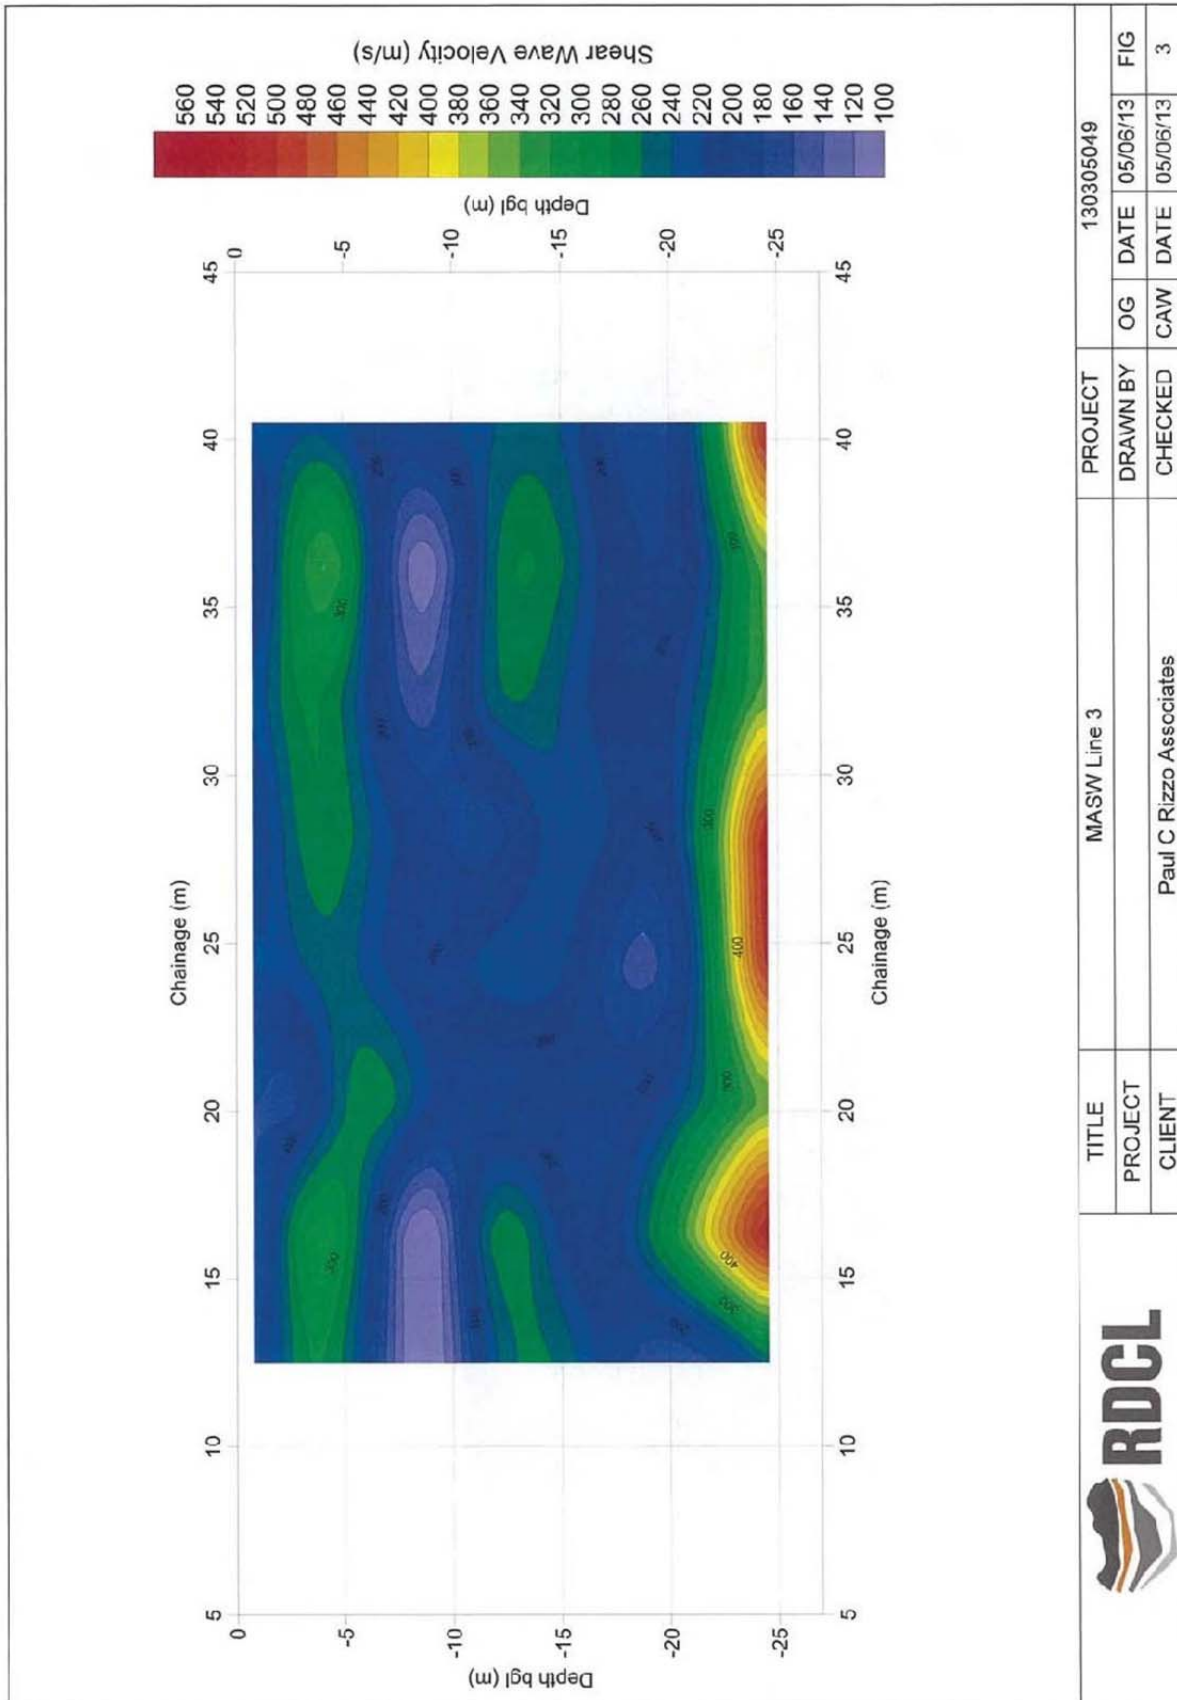
TITLE	MASW Line 3	PROJECT	130305049	
PROJECT		DRAWN BY	OG	DATE 05/06/13
CLIENT	Paul C Rizzo Associates	CHECKED	CAW	DATE 05/06/13
				FIG 3

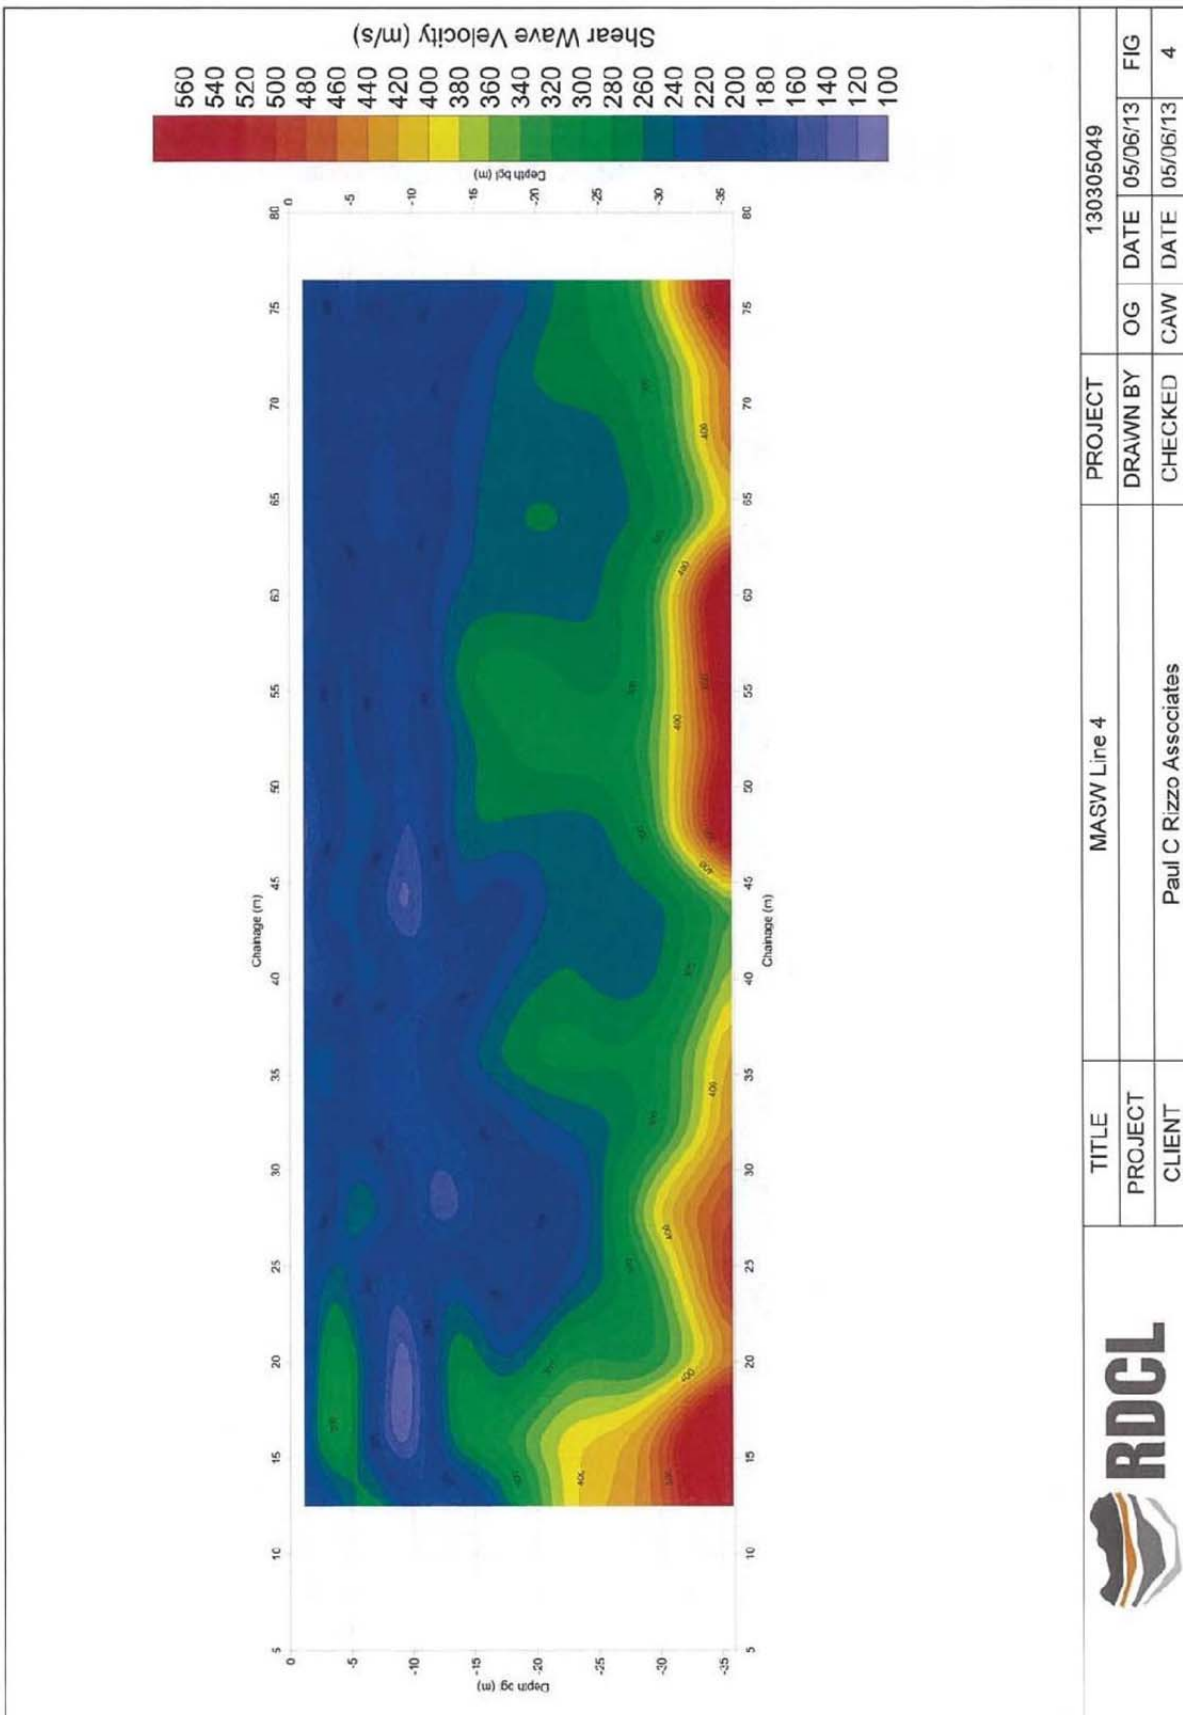
TITLE		MASW Line 4		PROJECT		130305049	
PROJECT				DRAWN BY		OG	
CLIENT		Paul C Rizzo Associates		CHECKED		CAW	
				DATE		05/06/13	
				DATE		05/06/13	
				FIG		4

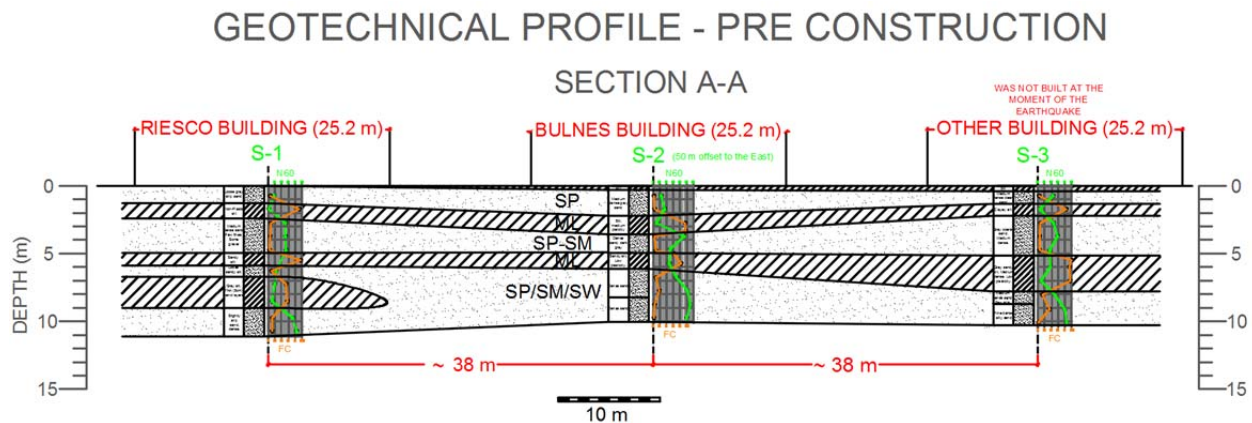
Figure B.5. Site conditions based on investigation performed prior to construction of the buildings during the design phase.

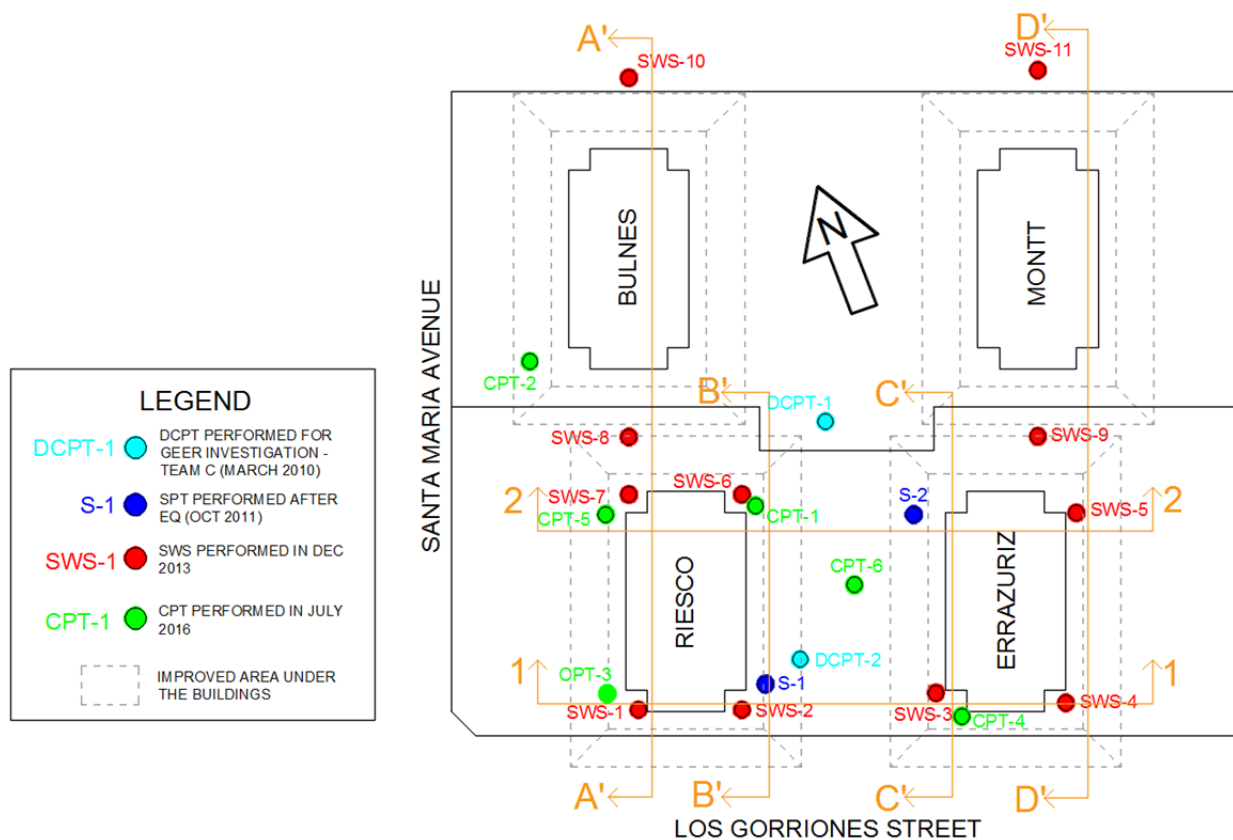
Figure B.6. Plan view of the four buildings together with the site investigation performed after the earthquake, showing also the area of replaced soil as specified in the geotechnical design report.

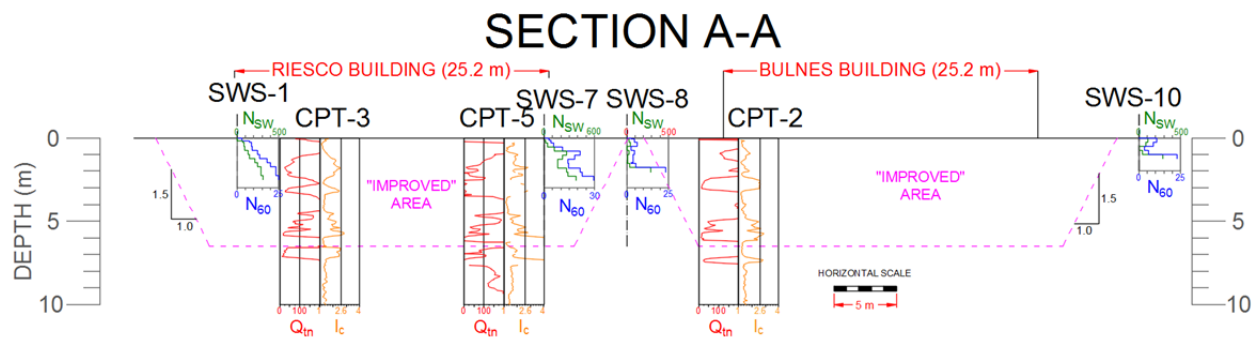
Figure B.7. Section A-A through the west side of buildings Riesco and Bulnes.

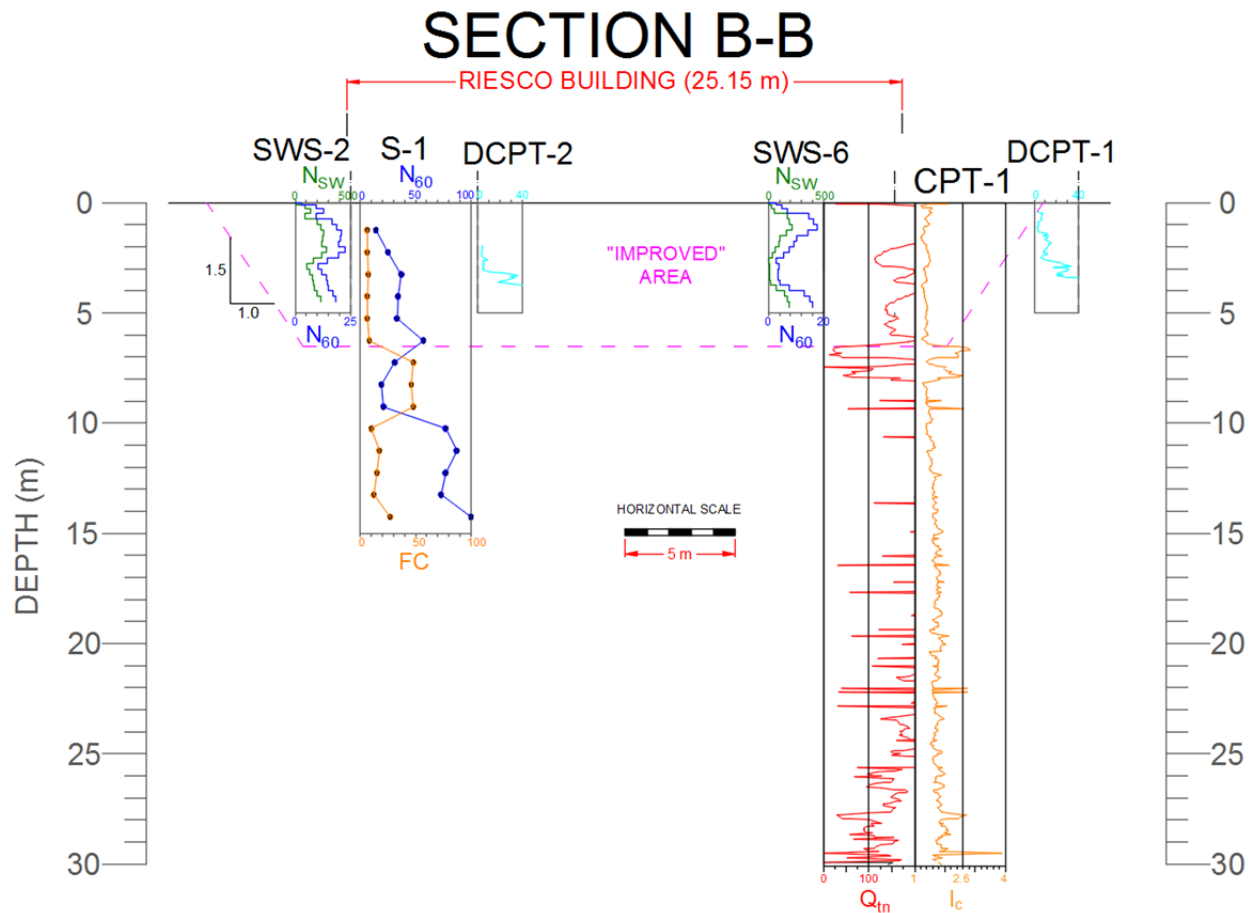
Figure B.8. Section B-B through the east side of Riesco Building.

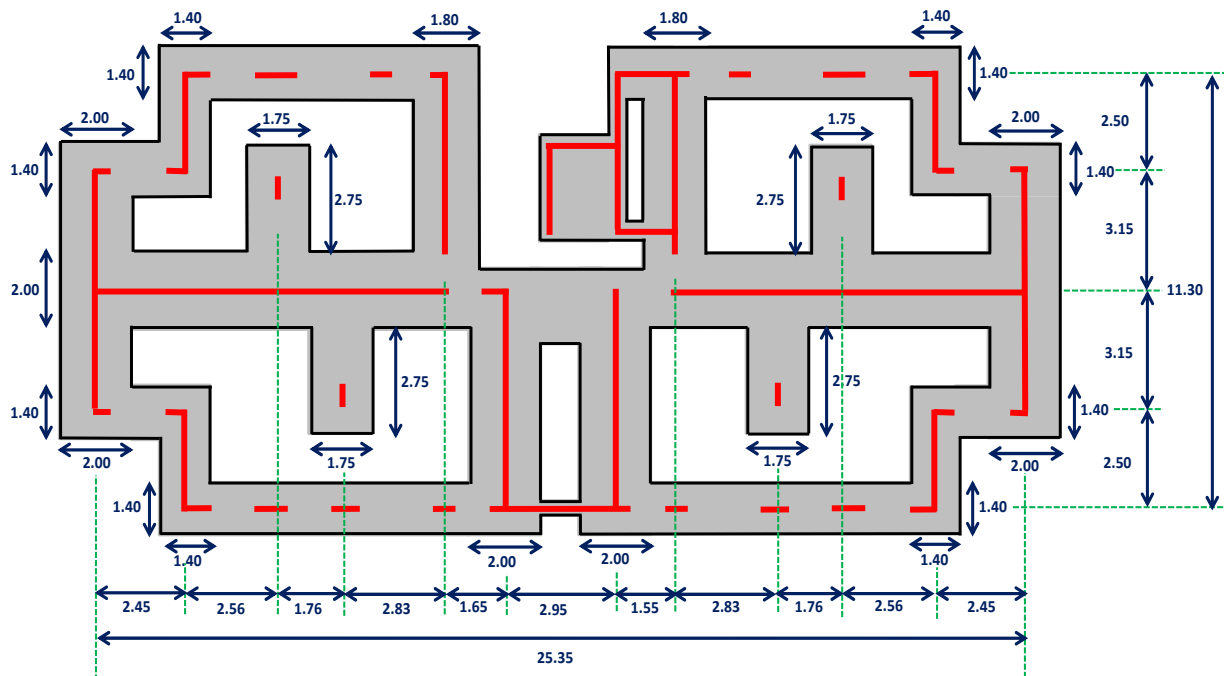
Figure B.13. Plan view of the foundation system of the four buildings.

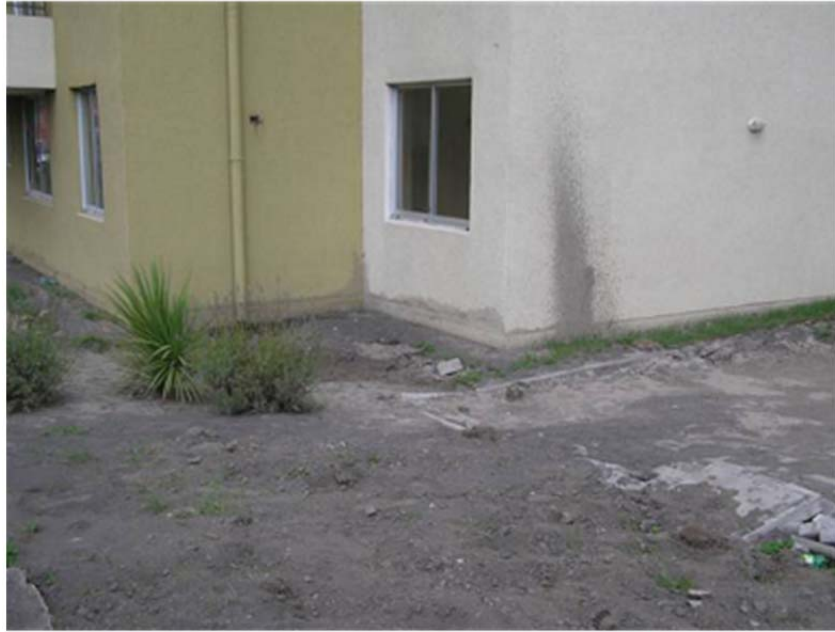
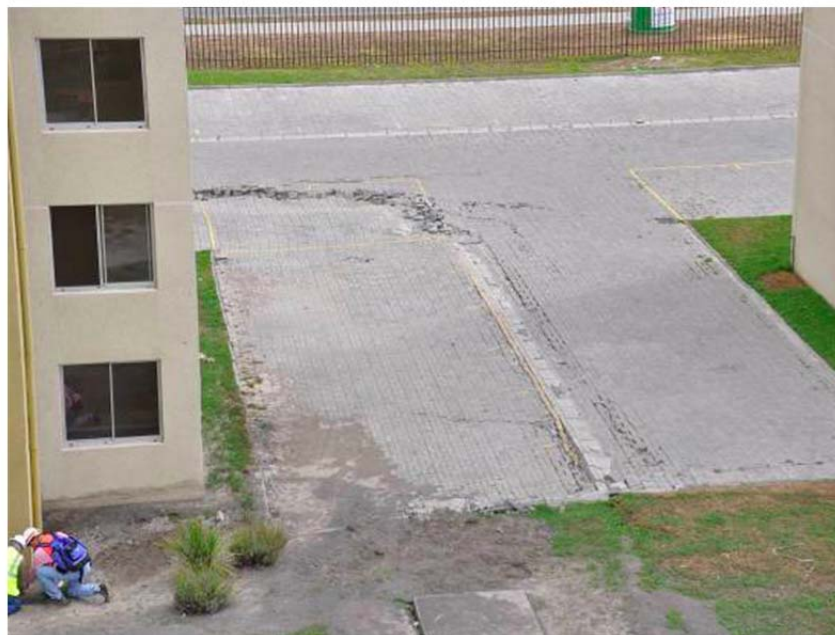
Figure B.14. Sediment ejecta and water stains in the wall located in the NE corner of the Riesco Building (From Bray et al., 2012)

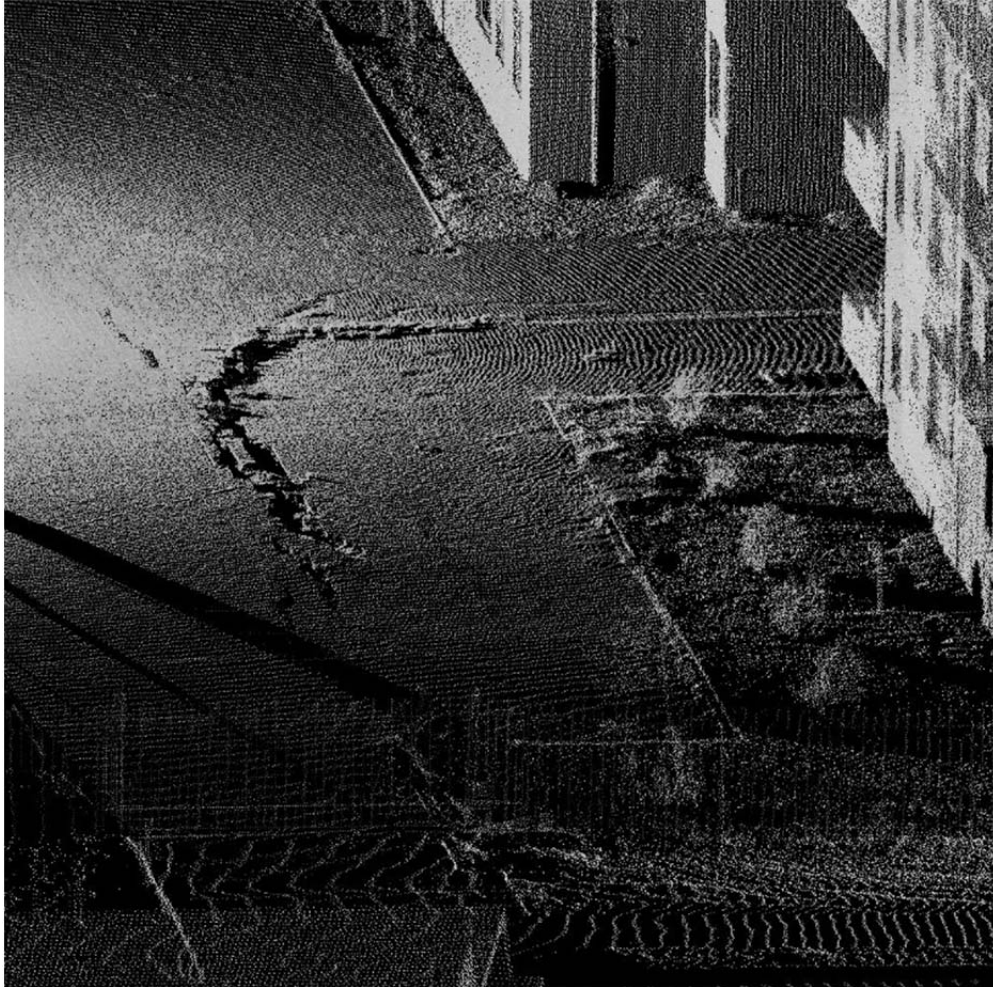
Figure B.16. LiDAR photography for Riesco Building from Kayen (2016), personal communication.
