Canasawacta Creek Project: Chenango County, New York

CANASAWACTA CREEK PROJECT: CHENANGO COUNTY, NEW YORK

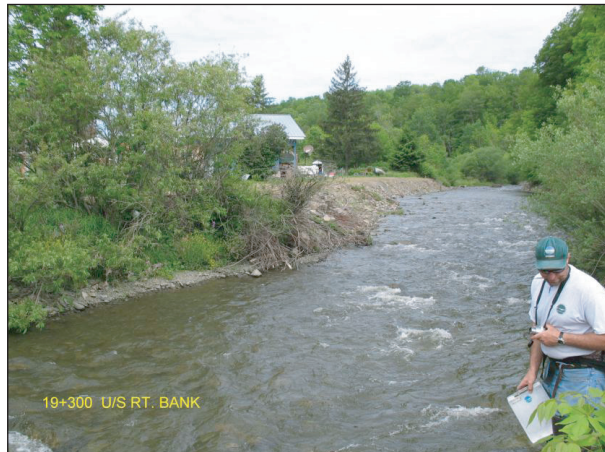
Figure 3. Looking upstream from the bridge at Moon Hill Road. The bridge is just out of the picture to the left. One of the houses located between Route 23 and Cansawacta Creek can be seen in the center of the photo.

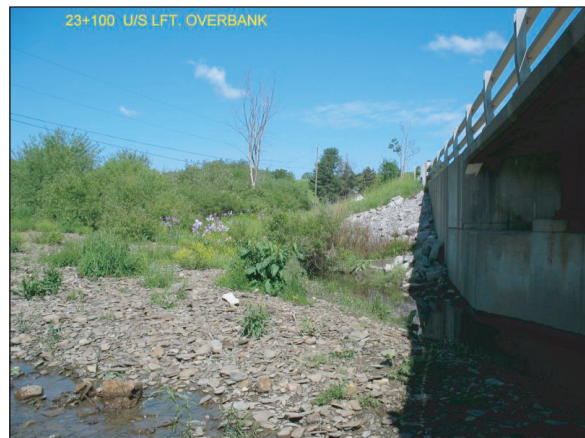
Figure 4. Looking upstream from the Chan Aldrich bridge. The utility pole is located between Route 23 on the right and Canasawacta Creek.

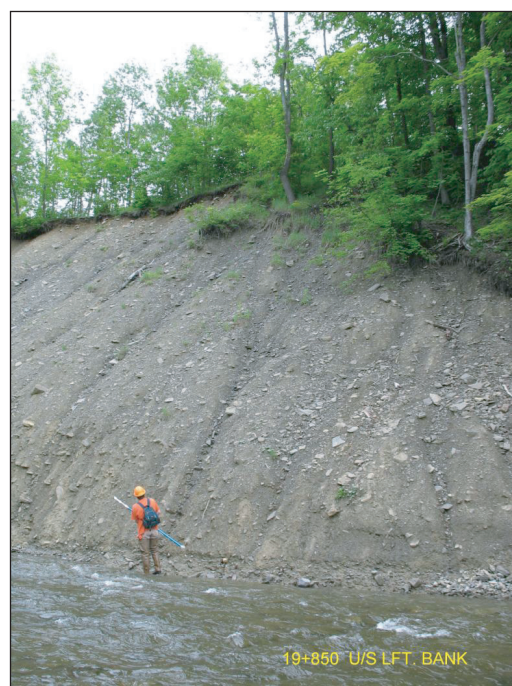
The bridge by Moon Hill Road is on the flood watch list which means that the regional hydraulics engineer checks the bridge after every flood. This bridge was built in 1931. There are scour problems at the footings, which are not supported by piles. The stream bank is armored upstream and downstream from the bridge, but NYSDOT has not done any work in the stream in the vicinity of this bridge for many years. There is a 50 foot high eroding embankment upstream from the bridge on private property (figure 5). In addition several of the properties upstream from the bridge have lost significant portions of their backyards due to erosion during high water. Several homes have been repeatedly flooded during the past ten years.

Figure 5. Eroding south bank of Canasawacta Creek just upstream of the Moon Hill Road bridge. Material is continually sloughing off into the creek.

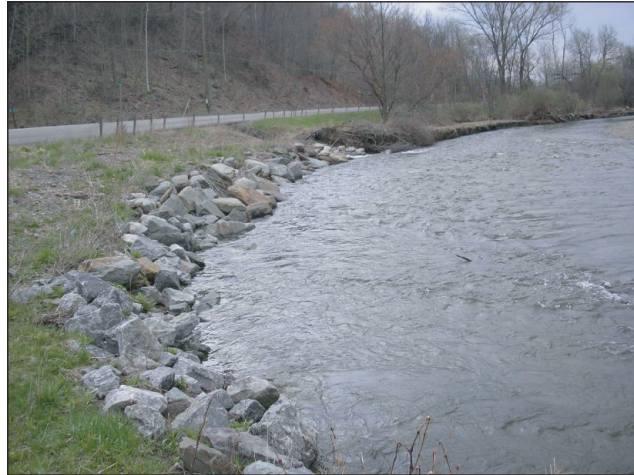
Canasawacta Creek was eroding the south shoulder of State Route 23 in 2004. In the summer of 2004, stream bank between the stream and the road was armored with heavy stone to prevent further encroachment onto the shoulder of Route 23. At that time placement of rock vanes was considered but rejected because it required work off the DOT right-of-way and permission to work on private property was not forthcoming (figure 6). During the flooding of June 2006 the bank reinforcement held, but there was extensive damage to the stream bank further downstream (figure 7). This damage now threatens State Route 23.

Figure 6. Looking downstream at the bank stabilization installed in 2004 before the June flooding. Route 23 is seen in the photo. Ashcraft Road intersects Route 23 just out of view to the left in the photo.

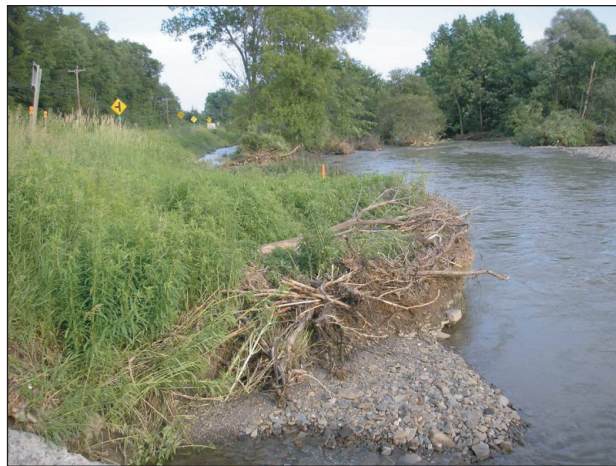
Figure 7. This photo was taken just upstream from the rip-rap shown in Figure 6 after the June flooding. The creek has cut a new channel closer to Route 23. The vegetation blocks a clear view of the road but the location of Route 23 can be surmised by guide rail and highway sign.

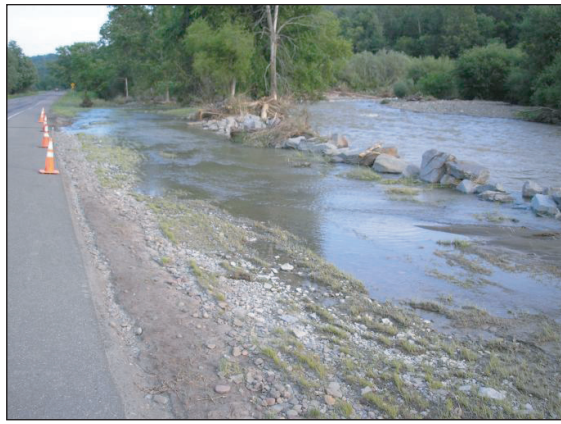
Record plans indicate that Canasawacta Creek was moved from the north to the south side of Route 23 during the 1931 construction project. This area of the road repeatedly floods during any high water event. The June 2006 flooding eroded the shoulder up to the edge of blacktop; the bed of the creek was almost at the same level as the top of the road (figure 8). NYSDOT personnel removed some of the sediment that was deposited in the bed of the creek. Further work is planned for the summer of 2007.

Figure 8. Canasawacta Creek is undermining Route 23. This is where the creek was moved from the north side of the road to its present location. Flooding occurs often in this location.

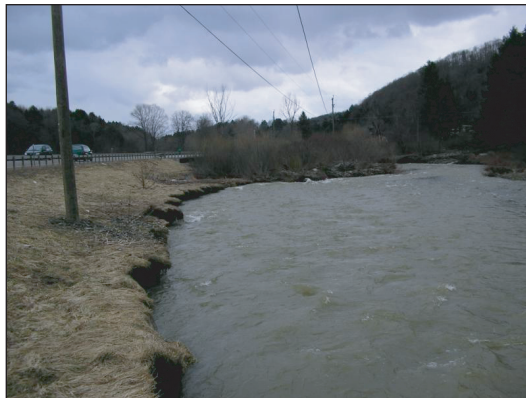
Upstream from the bridge the utility pole between the north side of the creek and the south side of the highway was moved repeatedly because of bank erosion. In addition to threatening the utility pole the creek also threatens State Route 23 upstream from the bridge. Figure 9 shows the location of the utility pole before the June 2006 flood, after the June 2006 flood. Figure 10 shows a view of the same area from the bridge before and after the June flooding. The creek moved closer to the highway and cut a new channel that was closer to the original 1931 channel.

Figure 9. Looking downstream just above of the Chan Aldridge bridge in March 2006. Notice that the utility pole is several feet from the creek. It had already been moved once so that it was not engulfed by the stream.

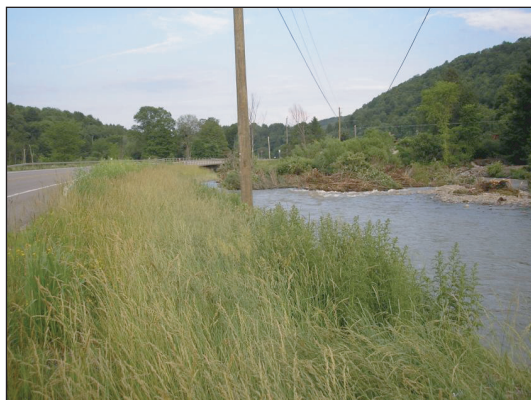
Figure 10. Looking downstream just above the Chan Aldridge bridge (same location as figure 9) just after the June 2006 flood. The utility pole is now on the bank of the creek.

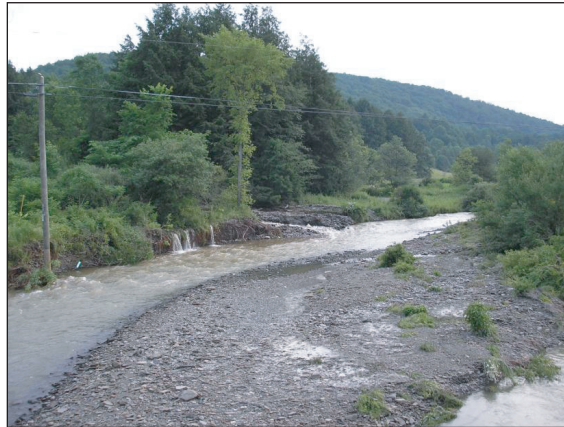
Figure 11 shows the south side of the creek near the Chan Aldridge bridge. A small tributary enters Canasawacta Creek from the south at this location. After the June flooding, the utility poles on the south side of the creek as well as a town road (Chan Aldrich) were also threatened.

Figure 11. South side of Canasawacta Creek looking upstream from the Chan Aldridge bridge after the June 2006 flooding.

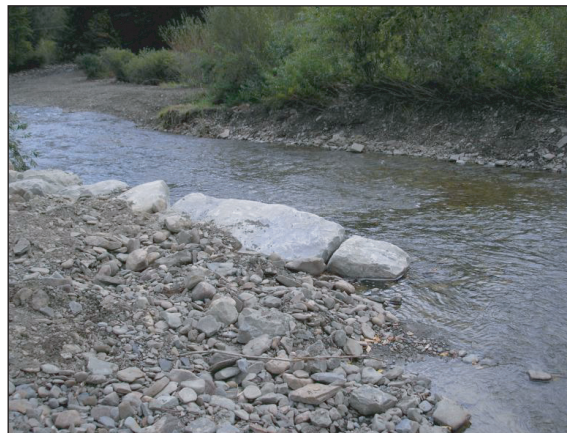
Figure 12. One of the rock vanes built on the north bank of Canasawacta Creek. The photo was taken looking downstream.

In September of 2006, NYSDOT installed rock vanes and one cross vane upstream from the bridge. The design originally included three rock vanes (figure 12), but four were actually installed. The design included building a bench to increase the distance between Route 23 and the creek. The bench also acts as an overflow area during high water. The cross vane was installed immediately upstream from the bridge to direct energy away from both banks of the creek and direct the main flow towards the center of the bridge. Willows that were plentiful at the location were used to stabilize the rock structures.

The Canasawacta Creek watershed experienced a second flood in November of 2006. Three of the rock vanes survived the flooding with minor damage; one had to be re-built. The cross vane was filled in with silt on one side.

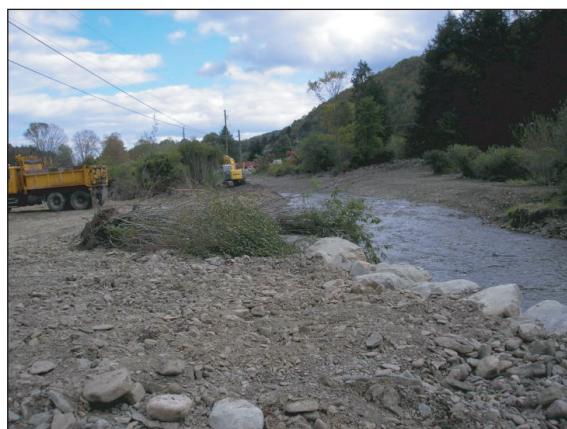
Figure 13. The bench provides an area for high water between the creek and Route 23. The willows were planted and they are doing quite well. The utility pole is not shown but the bench protects it from the creek.
