Reflective Cracking Study: First-Level Report on the HVS Rutting Experiment

Partnered Pavement Research Program (PPRC) Contract Strategic Plan Element 4.10:
Development of Improved Rehabilitation Designs for Reflective Cracking

California Department of Transportation
Division of Research and Innovation
Office of Roadway Research

University of California
Pavement Research Center
UC Davis, UC Berkeley

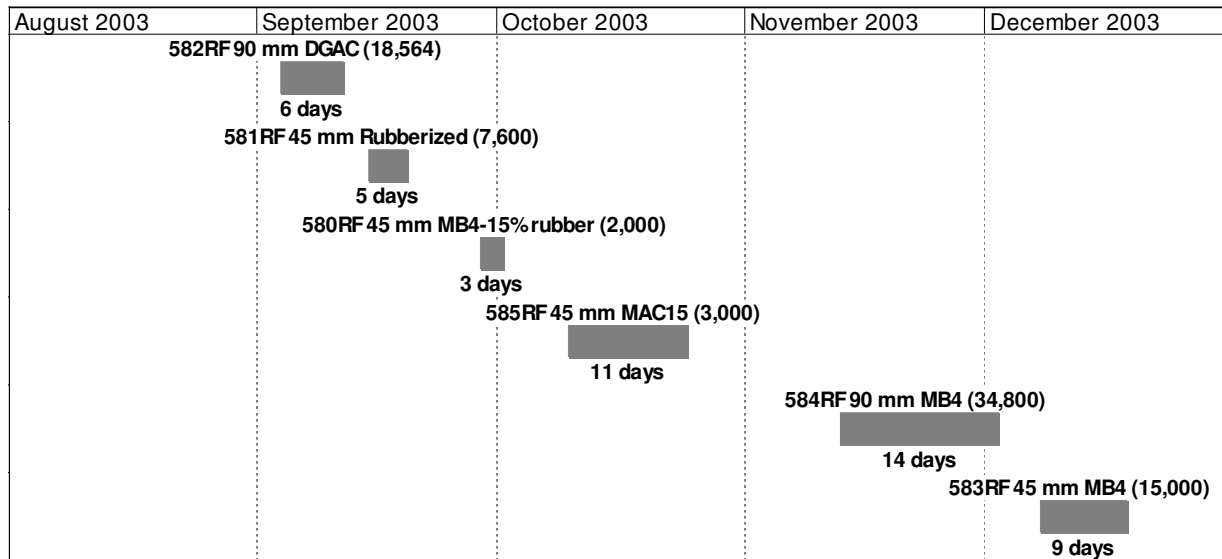
Figure 2.6: Trafficking schedule for the HVS rutting tests.

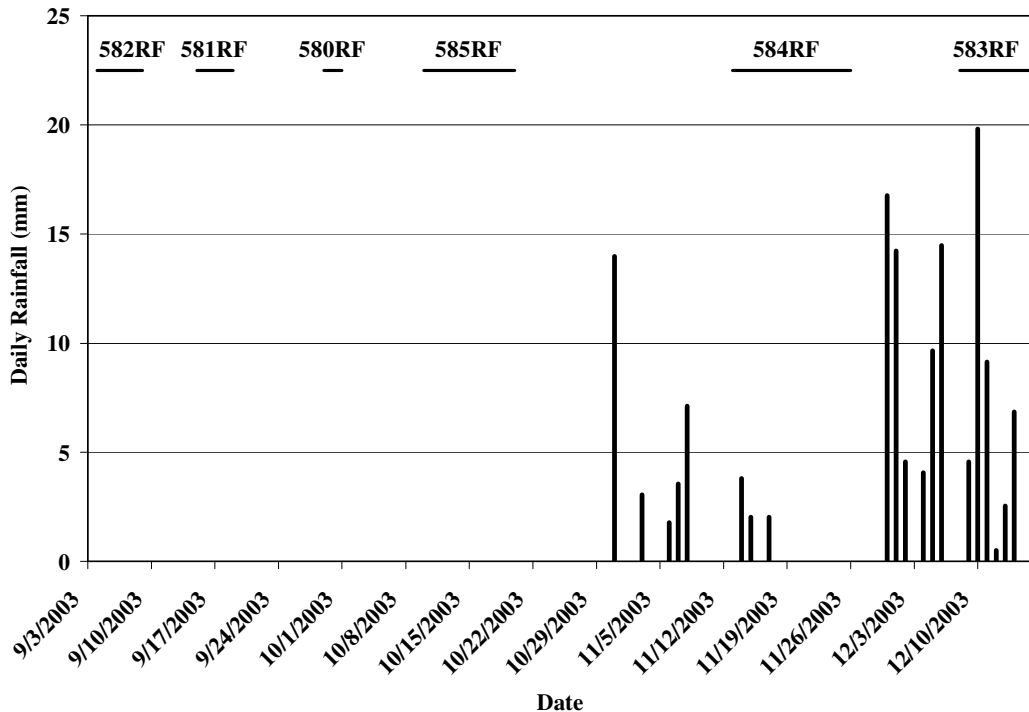
Figure 3.2: Measured rainfall at the Richmond Field Station during the HVS testing.

Figure 3. shows the monthly rainfall data from September 2003 to December 2003 as adapted from the weather station at the Richmond Field Station HVS site. The first four tests (582RF, 581RF, 580RF, and 585RF) were completed in dry conditions. During tests on Sections 583RF and 584RF, 144 mm (5.75 in) of rain was recorded.

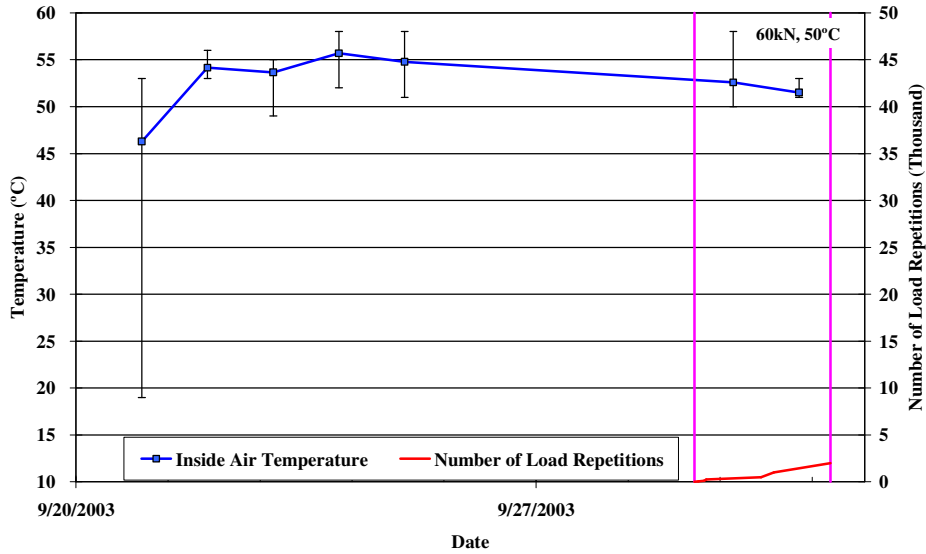
Figure 3.3: 580RF: Daily average air temperatures inside the temperature control chamber.

temperatures recorded in the temperature control unit, calculated from the hourly temperatures recorded during HVS operation, are shown in Figure 3.3. Vertical errors bars on each point on the graph show daily temperature range.

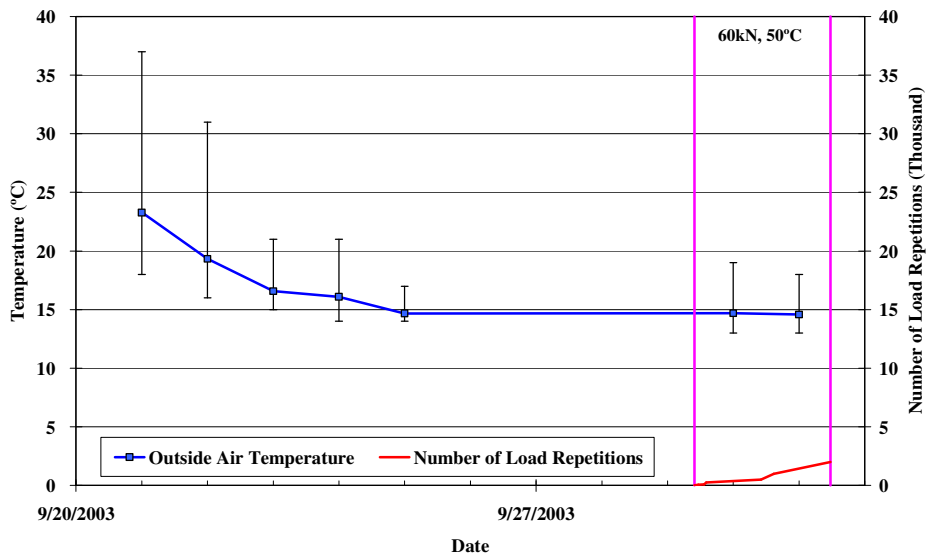
Figure 3.4: 580RF: Daily average air temperatures outside the temperature control chamber.

Outside air temperatures ranged from 13°C to 19°C with an average of 14.5°C and are summarized in Figure 3.4. Vertical error bars on each point on the graph show daily temperature range.

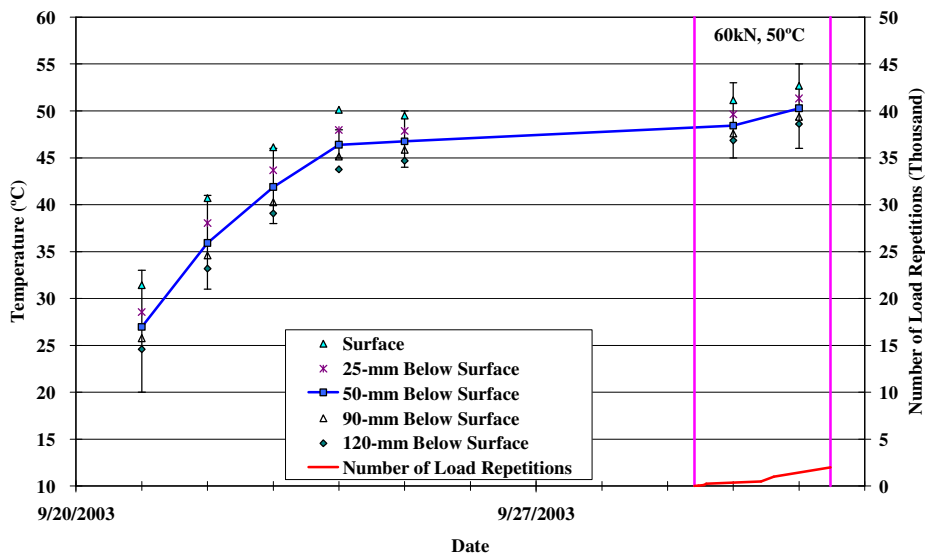
Figure 3.5: 580RF: Daily average temperatures at pavement surface and various depths.

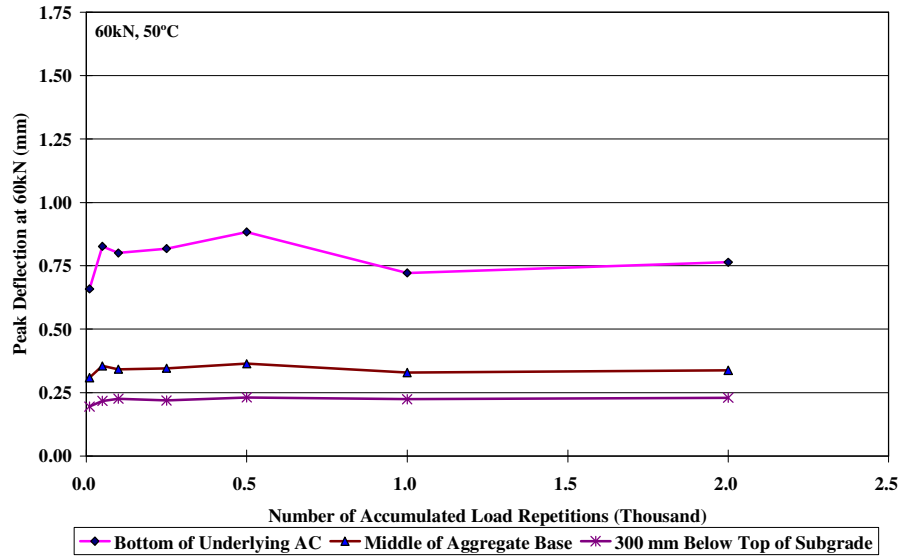
Figure 3.6: 580RF: Elastic deflections at MDD8 with 60 kN test load.

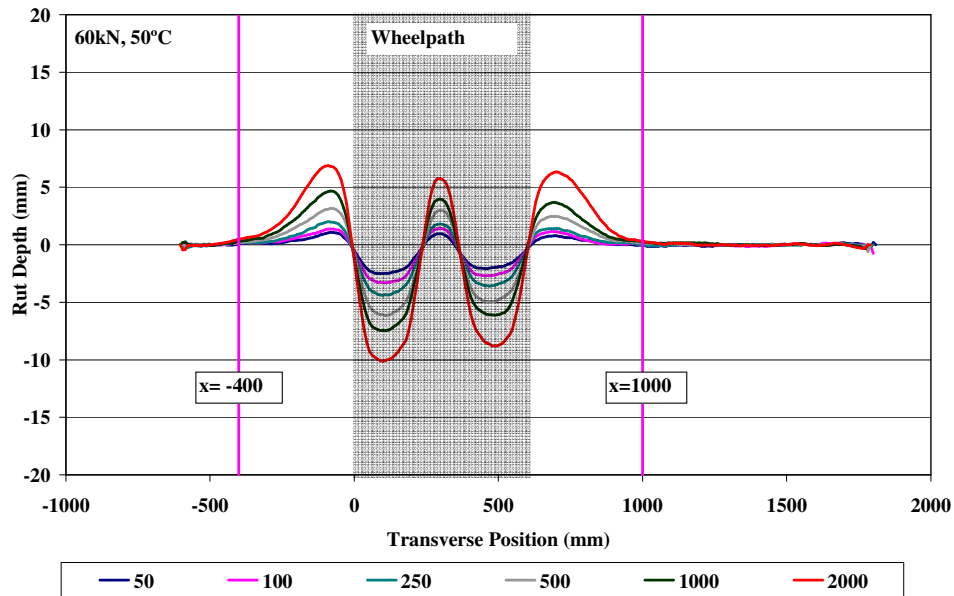
Figure 3.7: 580RF: Profiler cross section at various load repetitions.

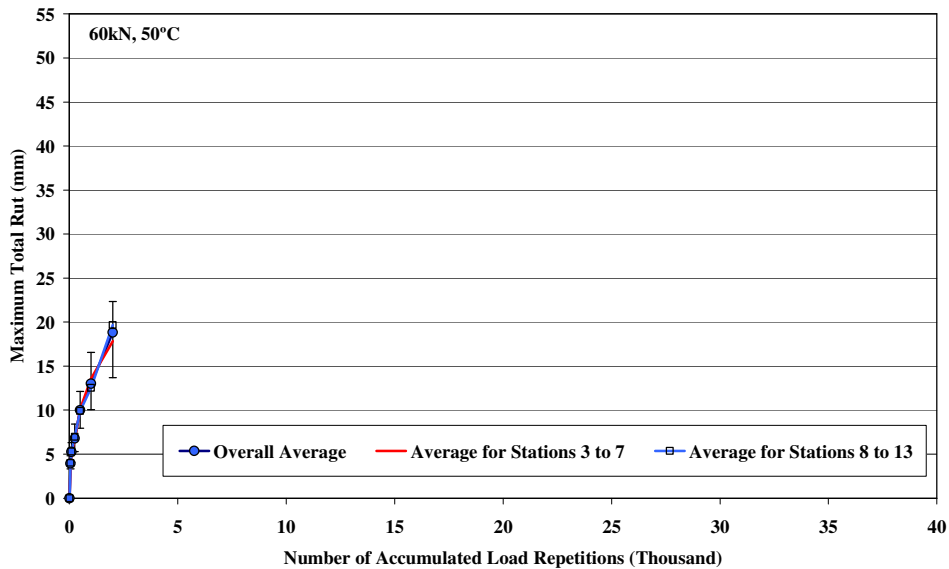
Figure 3.8: 580RF: Average maximum rut.

maximum rut depth and the average deformation were 18.8 mm and 7.1 mm, respectively. The maximum rut depth measured on the section was 22.3 mm. Rut development was rapid with the failure criteria of an average of 12.5 mm total rut depth reached after 914 load repetitions.

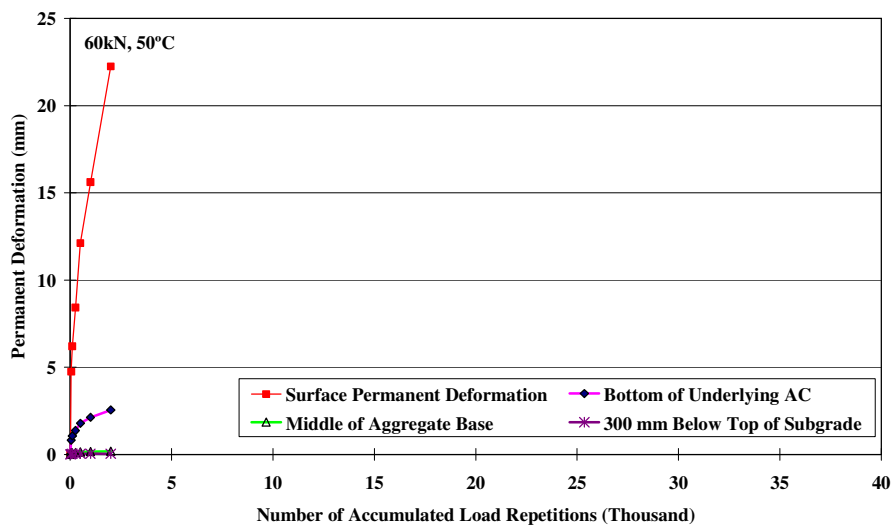
Figure 3.11: 580RF: Permanent in-depth deformation at MDD8.

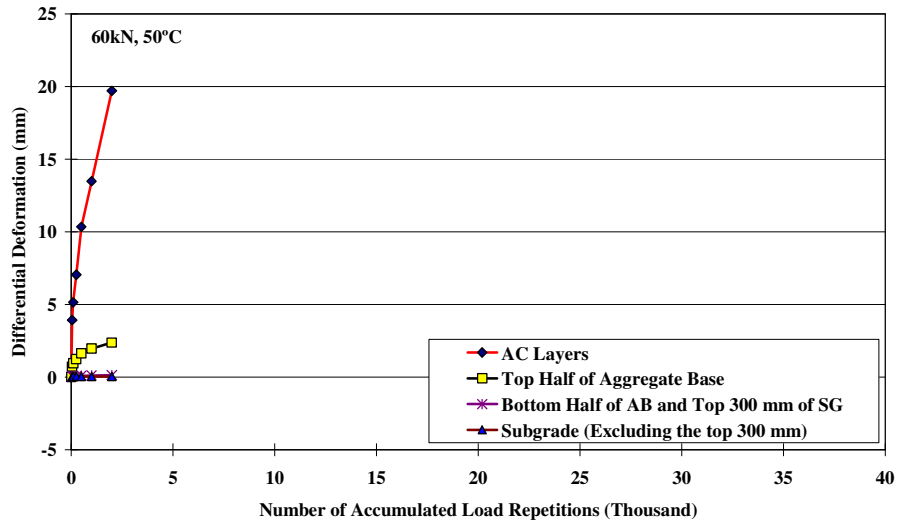
Figure 3.12: 580RF: In-depth differential deformation at MDD8.

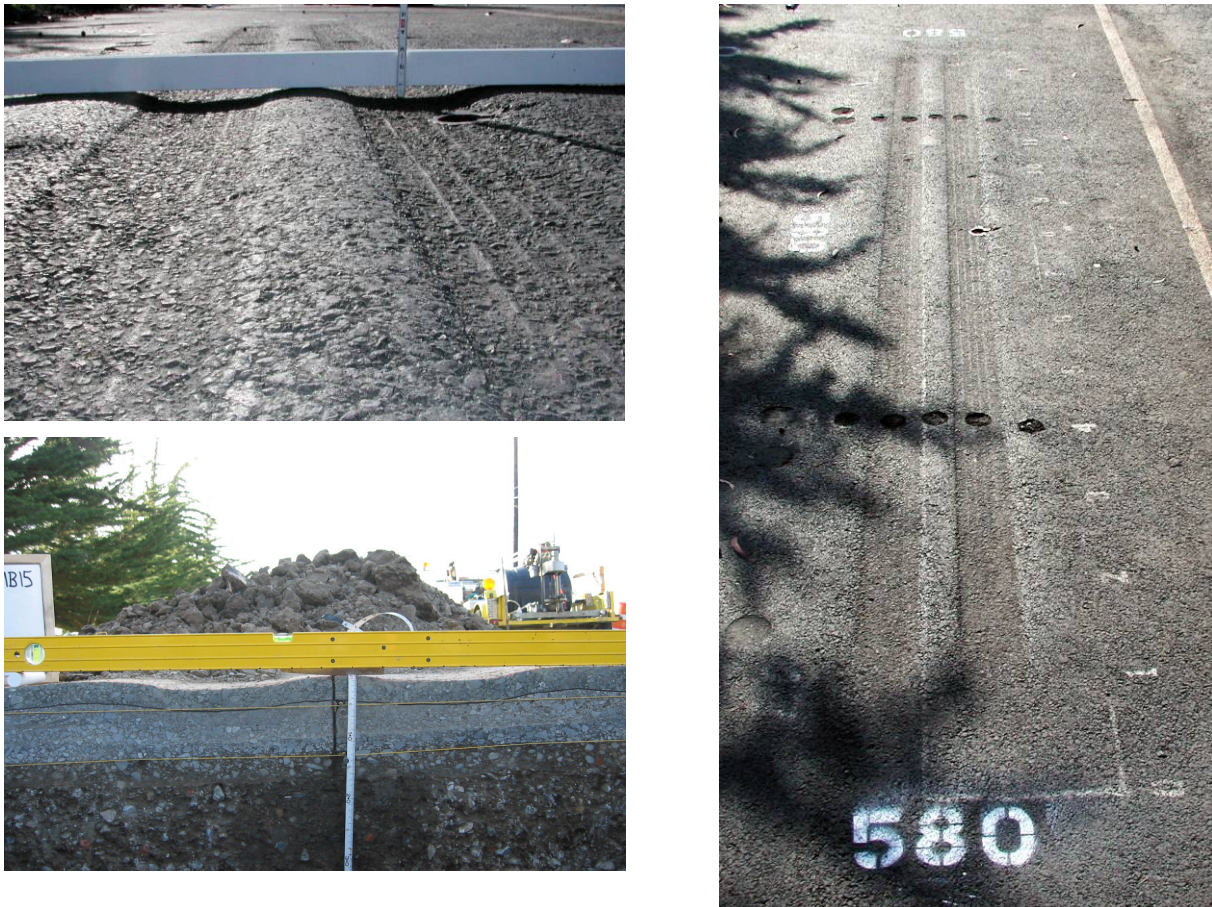
Figure 3.13: 580RF: Section photographs at the end of the test.

Apart from rutting, no other distress was recorded on the section. Figure 3.13 shows photographs taken of the surface at the end of the test.

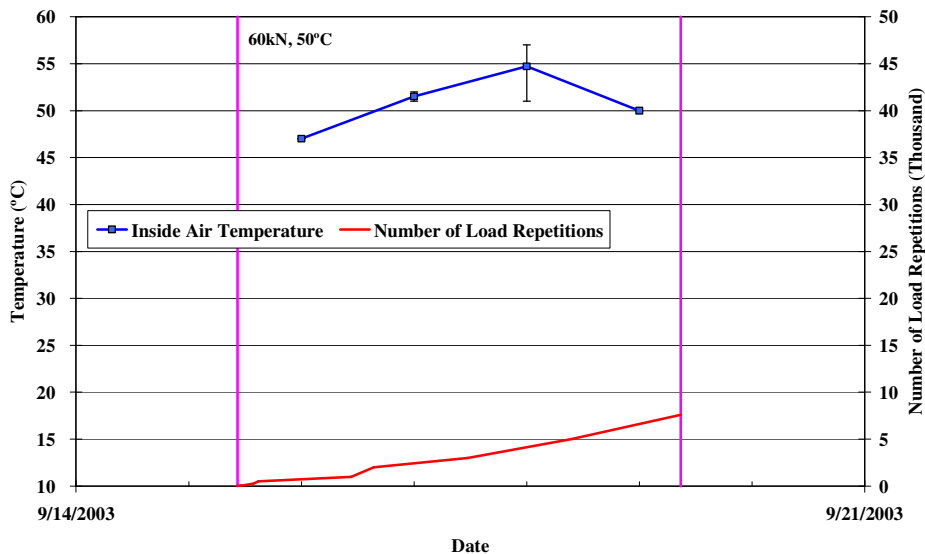
Figure 3.14: 581RF: Daily average air temperatures inside the temperature control chamber.

Air temperatures inside the temperature control chamber ranged from 51°C to 57°C, with an average of 53°C and standard deviation of 3.2°C. Air temperatures were adjusted to maintain a pavement temperature of 50°C±4°C. The daily average air temperatures recorded in the temperature control unit, calculated from the hourly temperatures recorded during HVS operation, are shown in Figure 3.14. Vertical errors bars show daily temperature range.

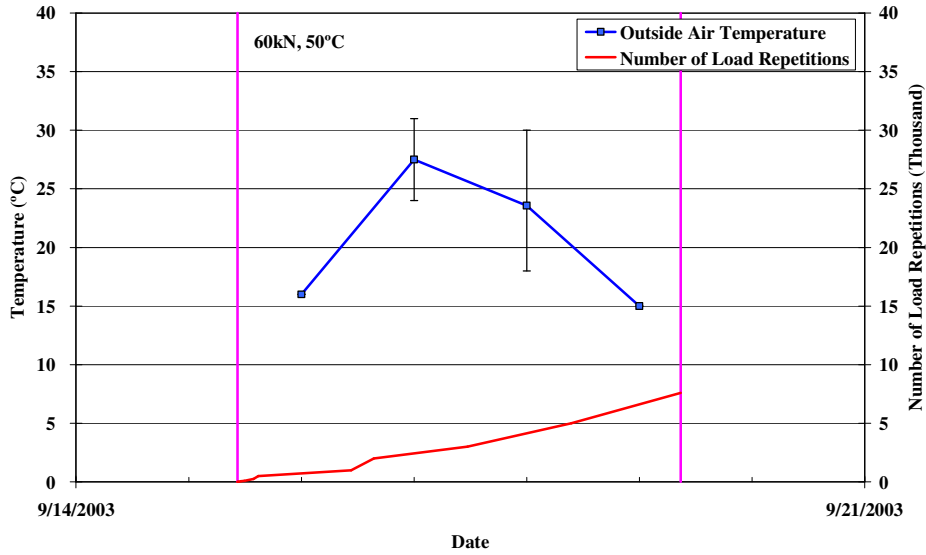
Figure 3.15: 581RF: Daily average air temperatures outside the temperature control chamber.

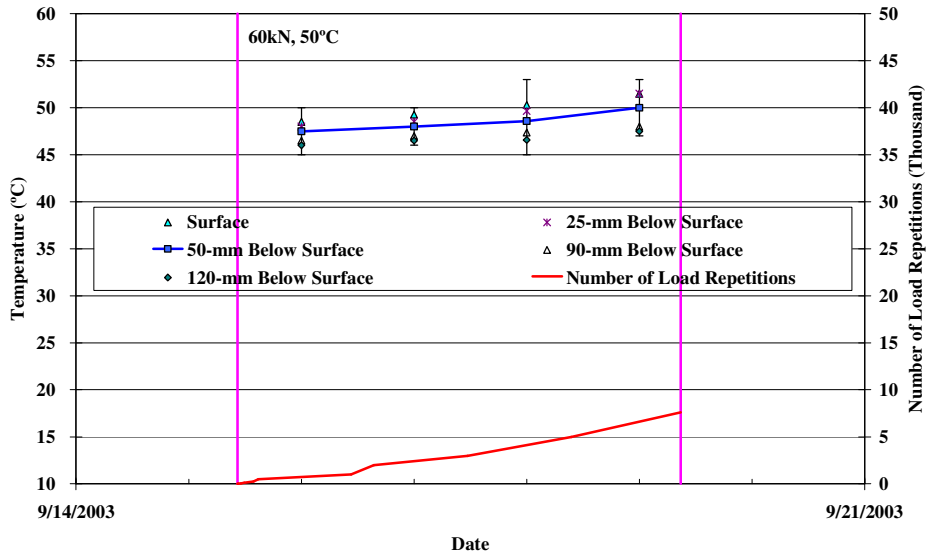
Figure 3.16: 581RF: Daily average temperatures at pavement surface and various depths.

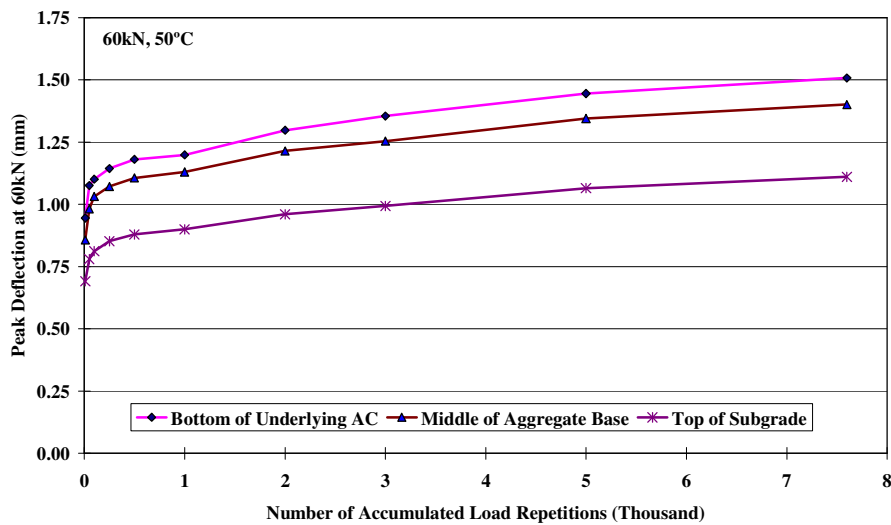
Figure 3.17: 581RF: Elastic deflections at MDD8 with 60 kN test load.

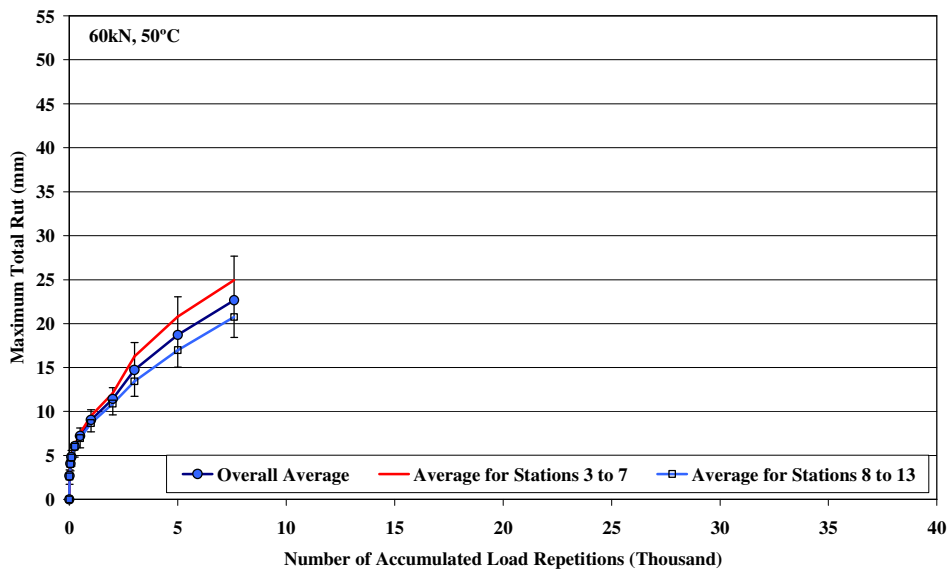
Figure 3.19: 581RF: Average maximum rut.

Figures 3.19 and 3.20 show the development of permanent deformation (average maximum rut and average deformation, respectively) with load repetitions as determined by the Laser Profilometer for the test section, with an embedment phase only apparent at the beginning of the experiment. Error bars on the average reading indicate variation along the length of the section. Figure 3.21 shows a contour plot of the pavement surface at the end of the test (7,600 repetitions). After completion of trafficking, the average maximum rut depth and the average deformation were 22.7 mm and 10.3 mm, respectively. The maximum rut depth measured on the section was 27.6 mm. Rut development was rapid with the failure criteria of an average of 12.5 mm total rut depth reached after 2,324 load repetitions.

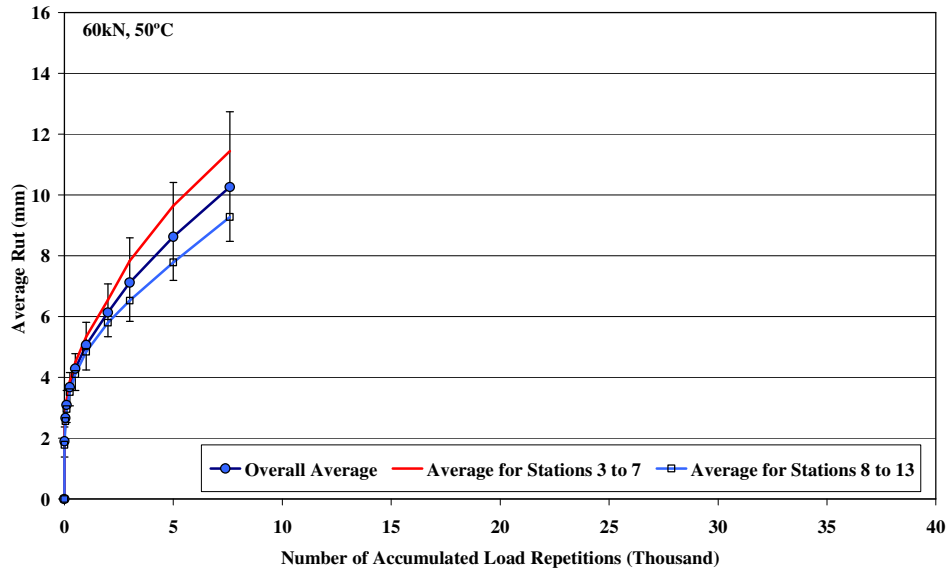
Figure 3.20: 581RF: Average deformation.

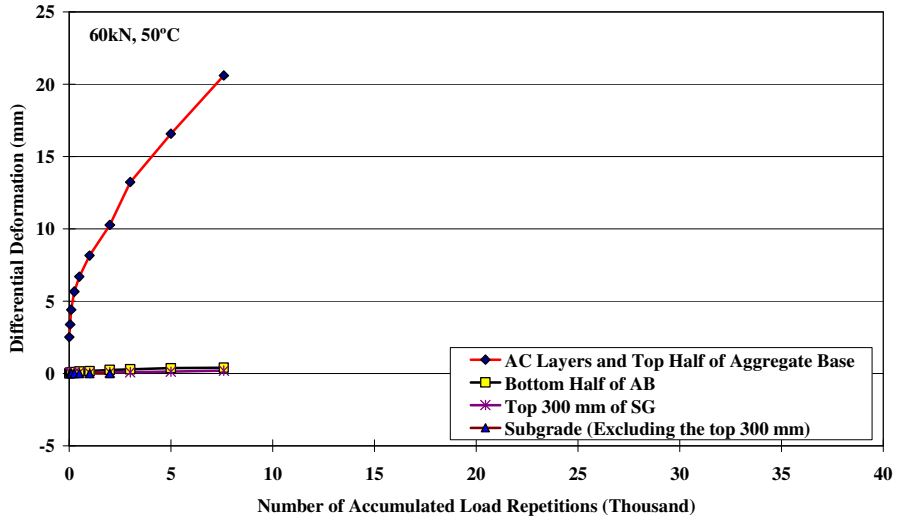
Figure 3.23: 581RF: In-depth differential deformation at MDD8.

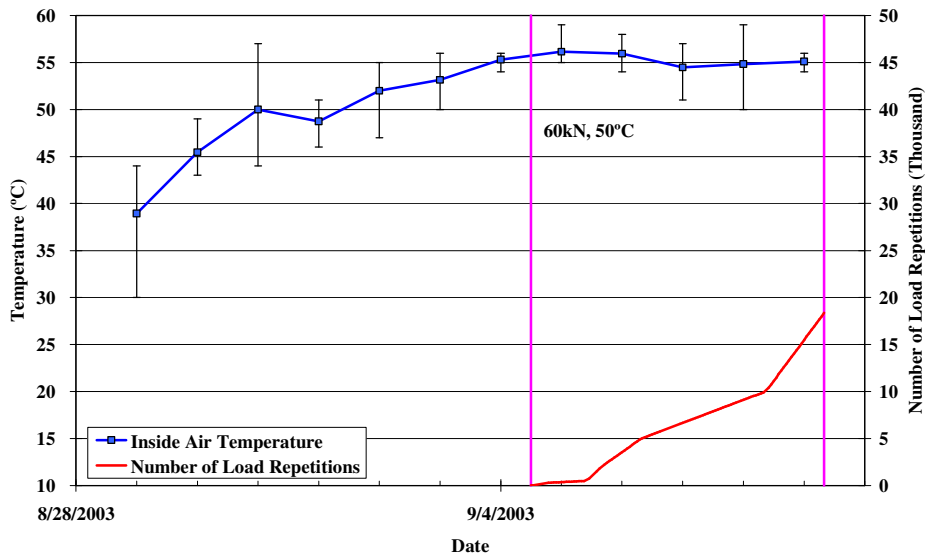
Figure 3.25: 582RF: Daily average air temperatures inside the temperature control chamber.

The daily average air temperatures recorded in the temperature control unit, calculated from the hourly temperatures recorded during HVS operation, are shown in Figure 3.25. Vertical errors bars on each point on the graph show daily temperature range.

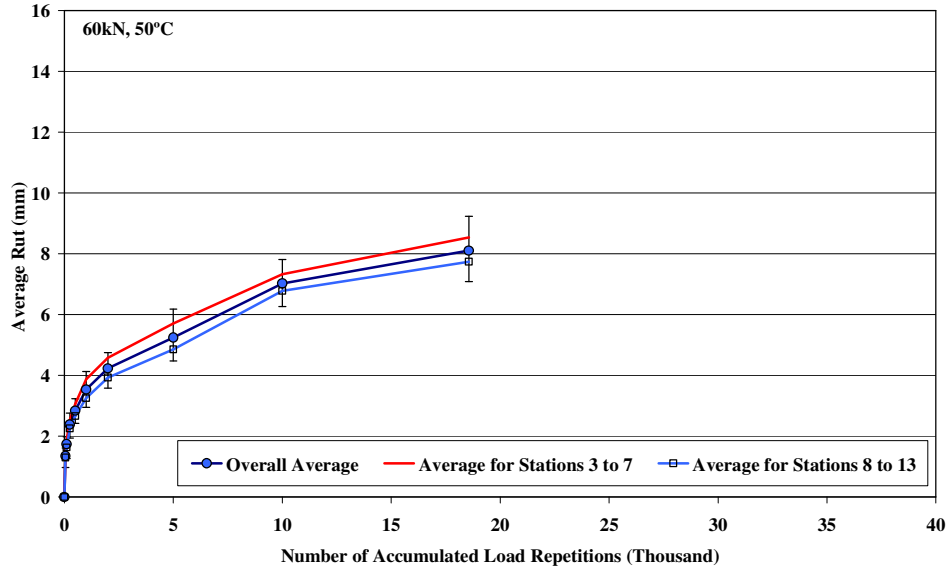
Figure 3.31: 582RF: Average deformation.

Figures 3.30 and 3.31 show the development of permanent deformation (average maximum rut and average deformation, respectively) with load repetitions as determined by the Laser Profilometer for the test section, with an embedment phase only apparent at the beginning of the experiment. Error bars on the average reading indicate variation along the length of the section. Figure 3.32 shows a contour plot of the pavement surface at the end of the test (18,564 repetitions). After completion of trafficking, the average maximum rut depth and the average deformation were 15.6 mm and 8.1 mm, respectively. The maximum rut depth measured on the section was 20.0 mm. Rut development was rapid with the failure criteria of an average of 12.5 mm total rut depth reached after 8,266 load repetitions.

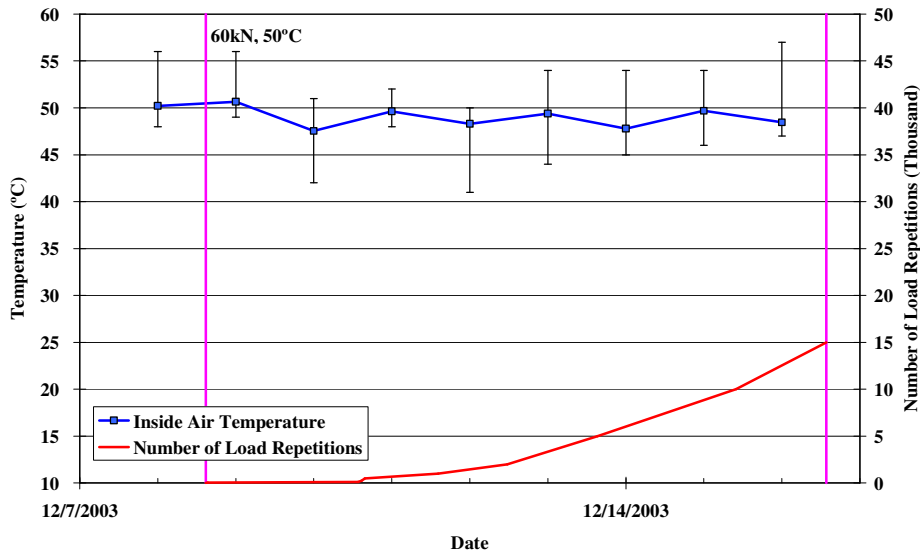
Figure 3.36: 583RF: Daily average air temperatures inside the temperature control chamber.

Air temperatures inside the temperature control chamber ranged from 41°C to 57°C, with an average of 49°C and a standard deviation of 3.9°C. Air temperatures were adjusted to maintain a pavement temperature of 50°C±4°C. The daily average air temperatures recorded in the temperature control unit, calculated from the hourly temperatures recorded during HVS operation, are shown in Figure 3.36. Vertical errors bars on each point on the graph show daily temperature range.

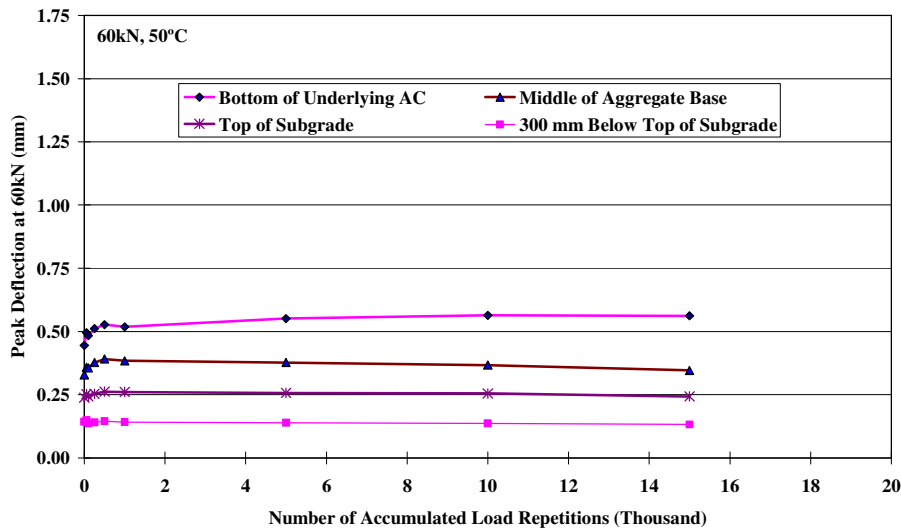
Figure 3.39: 583RF: Elastic deflections at MDD8 with 60 kN test load.

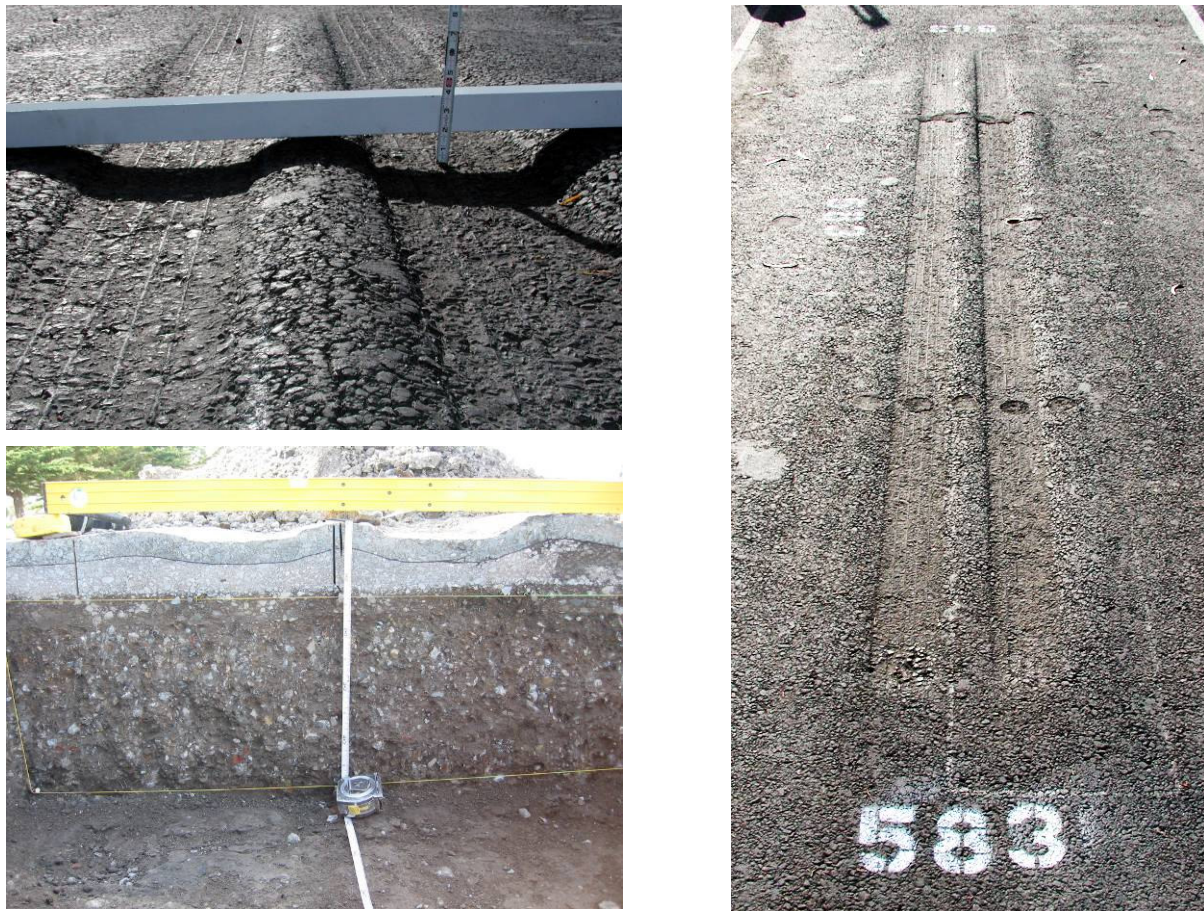
Figure 3.46: 583RF: Section photographs at the end of the test.

Apart from rutting, no other distress was recorded on the section. Figure 3.46 shows photographs taken of the surface at the end of the test.

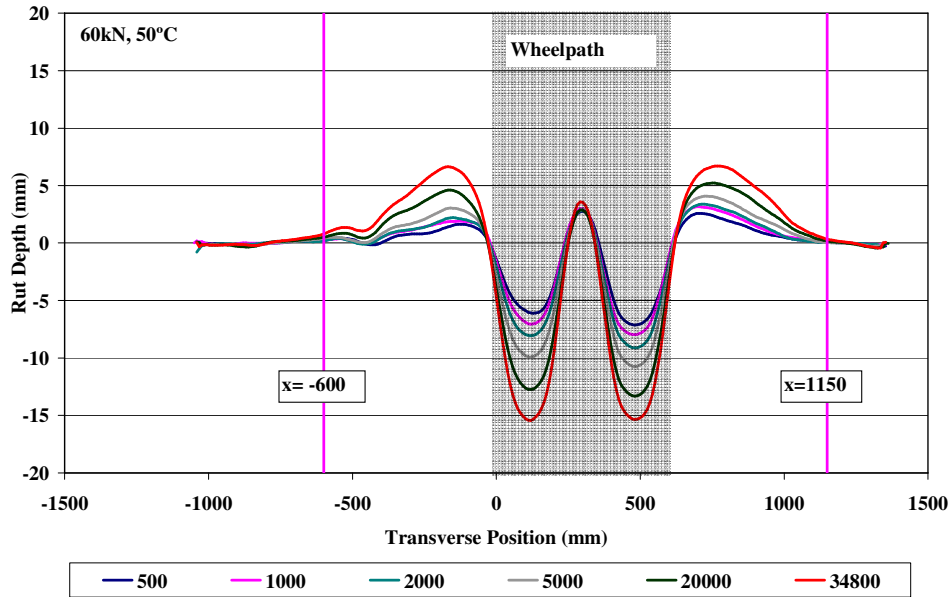
Figure 3.51: 584RF: Profilometer cross section at various load repetitions.

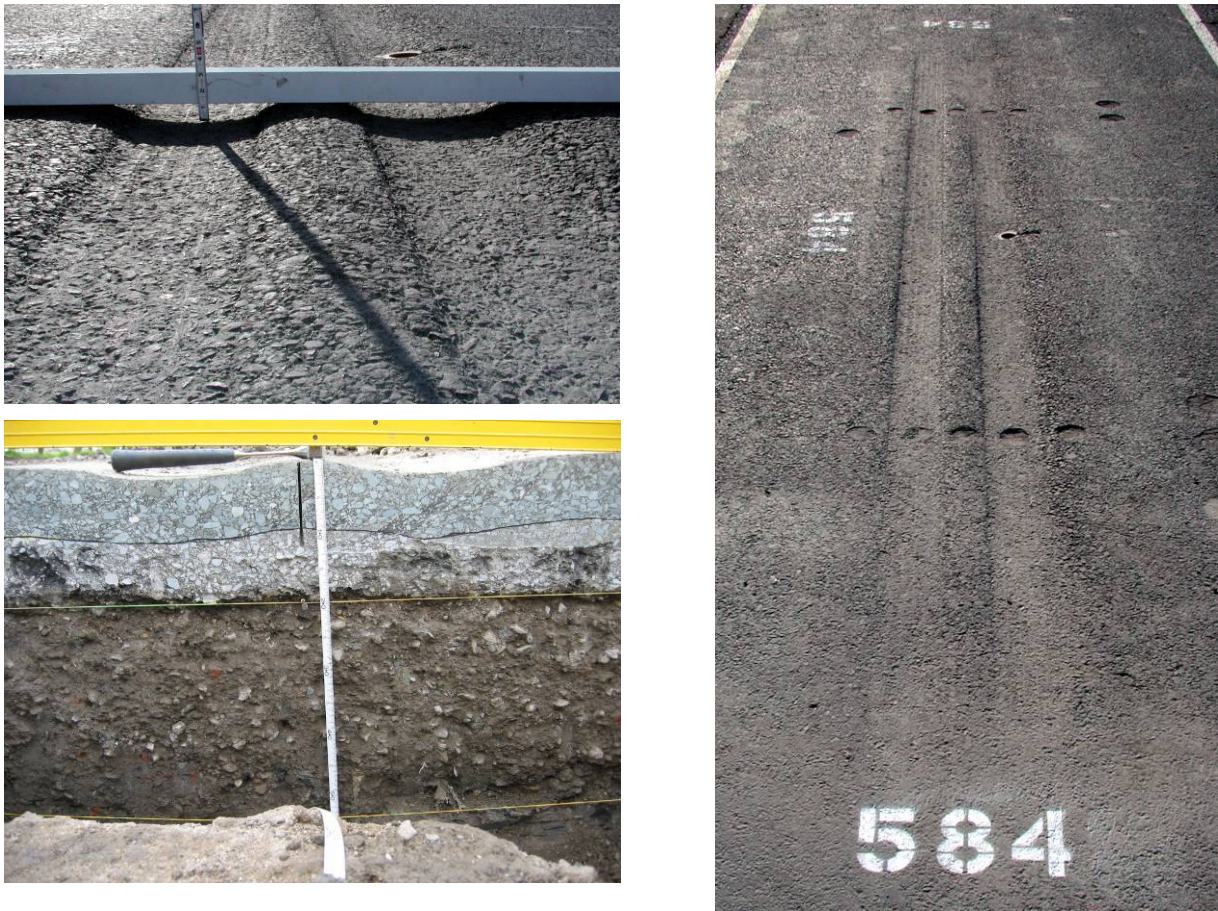
Figure 3.57: 584RF: Section photographs at the end of the test.

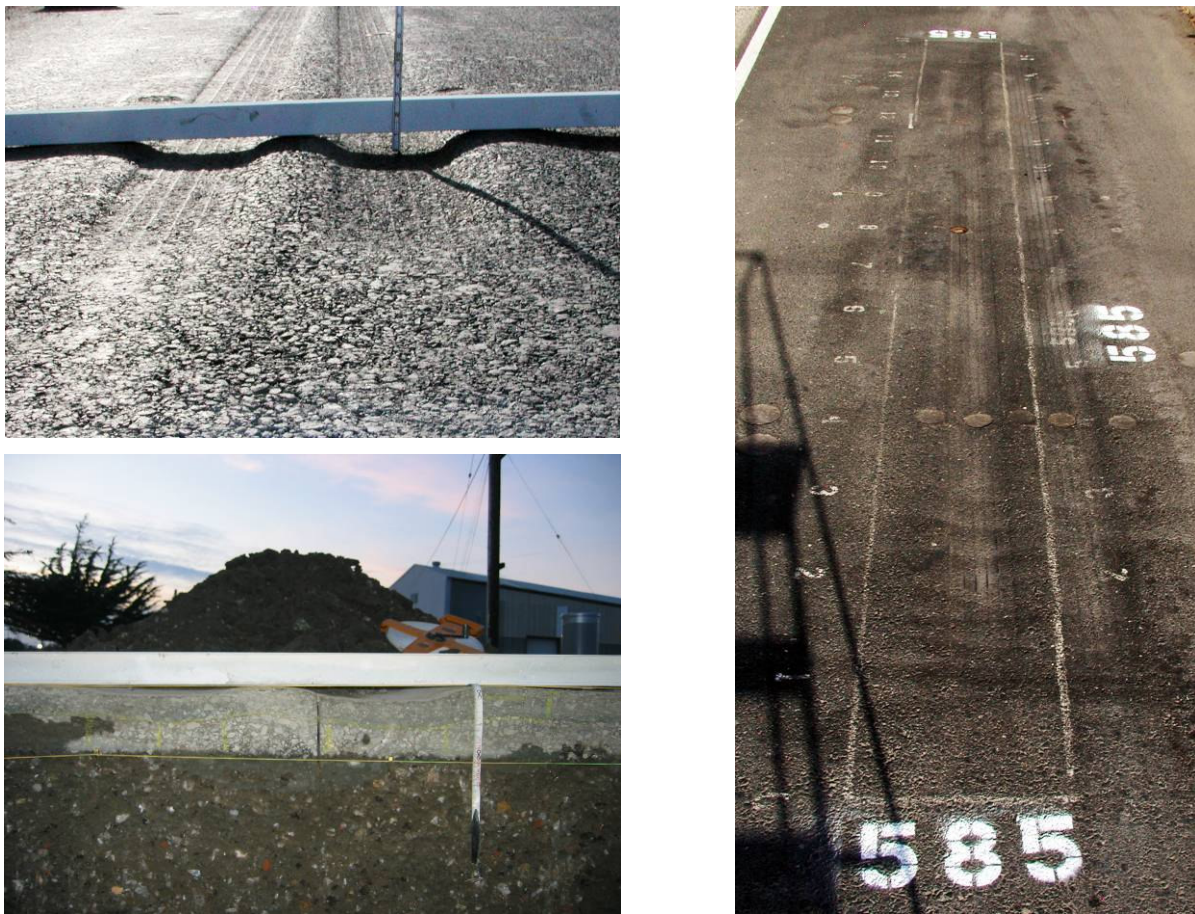
Figure 3.68: 585RF: Section photographs at the end of the test.
