REGROWTH BEHAVIOR OF THREE DIFFERENT DAMAGE STRUCTURES IN P+ IMPLANTED AND SUBSEQUENTLY LASER ANNEALED Si

To be published in the Proceedings of the Electrochemical Society, Inc.,  
Los Angeles, CA, October 14-19, 1979

D. K. Sadana, M. C. Wilson, G. R. Booker, and J. Washburn

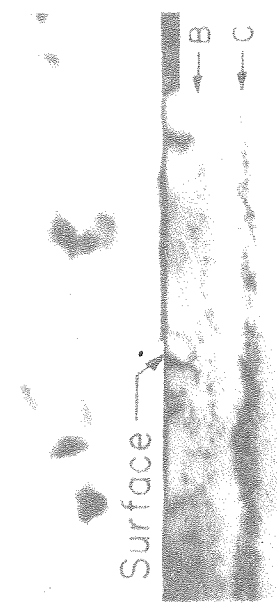
XBB790-14333

- Fig. 1. TEM 'cross-section' micrographs showing the laser annealing sequence for P<sup>+</sup> implanted (111) Si. (Ti = RT, N<sub>P<sup>+</sup></sub> = 5X10<sup>14</sup>/cm<sup>2</sup>, E<sub>i</sub> = 120 KeV)
- Fig. 2. TEM 'cross-section' micrographs showing the laser annealing sequence for P<sup>+</sup> implanted (111) Si. Ti = 150°C, N<sub>P<sup>+</sup></sub> = 10<sup>15</sup>/cm<sup>2</sup>, E<sub>i</sub> = 120 KeV)
- Fig. 3. TEM 'cross-section' micrographs showing the laser annealing sequence for P<sup>+</sup> implanted (111) Si. (Ti = 350°C, N<sub>P<sup>+</sup></sub> = 5X10<sup>15</sup>/cm<sup>2</sup>, E<sub>i</sub> = 120 KeV)

a. Buried Amorphous Layer. For the specimen implanted to a dose of  $5 \times 10^{14}/\text{cm}^2$ , the TEM 'cross-section' micrograph showed a  $\sim 1150 \text{ \AA}$  wide buried amorphous layer 'A' located at a mean depth of  $\sim 850 \text{ \AA}$  from the surface (Fig. 1a). The region between the surface and the top edge of damage layer 'A' had sparsely distributed clusters.

After the specimen had been laser annealed at  $0.7 \text{ J}/\text{cm}^2$ , the region between the surface and  $\sim 1600 \text{ \AA}$  depth, marked as 'B' in Fig. 1b, consisted of dislocation loops (mean diameter  $\sim 100 \text{ \AA}$ ) and clusters. The density of dislocation loops obtained from 'plan' view micrograph (not included in the text) was  $\sim 6 \times 10^{10}/\text{cm}^2$ . The regrown region 'B' was followed by a second damage layer 'C'  $\sim 250 \text{ \AA}$  wide, consisting of dense fine structure and was located at a depth immediately below the bottom edge of layer 'A' in the as implanted specimen (Fig. 1b).

After the specimen had been laser annealed at  $1.5 \text{ J}/\text{cm}^2$ , the first damage layer 'B' in the previous specimen was no longer present. The previous second layer 'C' was much less in evidence and consisted mainly of small damage clusters in the layer 'D' (Fig. 1c). Occasionally, single dislocations extending from the surface to the clusters layer were observed.

For the as implanted specimens with buried damage layers (Fig. 1a and Fig. 3a), the near-surface region although damaged, is still single crystal as shown by TEDs (not included in the text). However, for the  $10^{15} \text{P}^+/\text{cm}^2$  specimen, the near-surface region is amorphous. As a result, the energy absorption in the 'buried layer' specimens occurred over a larger volume as compared to the 'continuous amorphous layer' specimen. This is because of different absorption coefficients for amorphous and single crystal Si. Therefore, at lower energies, i.e.,  $0.7\text{J}/\text{cm}^2$  the 'buried damage layers' either partially recover in solid phase (Fig. 1b) or remain unaffected (Fig. 3b) depending on the thickness and the extent of damage in the near-surface region. However, for 'continuous amorphous layers' strong absorption of energy nearer to the surface causes melting of the surface layer, but the deeper lying damage still anneals in the solid phase. The
