Materials & Molecular Research Division

To be presented at the International Conference
on Wear, Reston, VA, April 11-14, 1983

THE NATURE AND ORIGIN OF SLIDING WEAR DEBRIS
FROM STEELS

W.J. Salesky, R.M. Fisher, R.O. Ritchie, and
G. Thomas

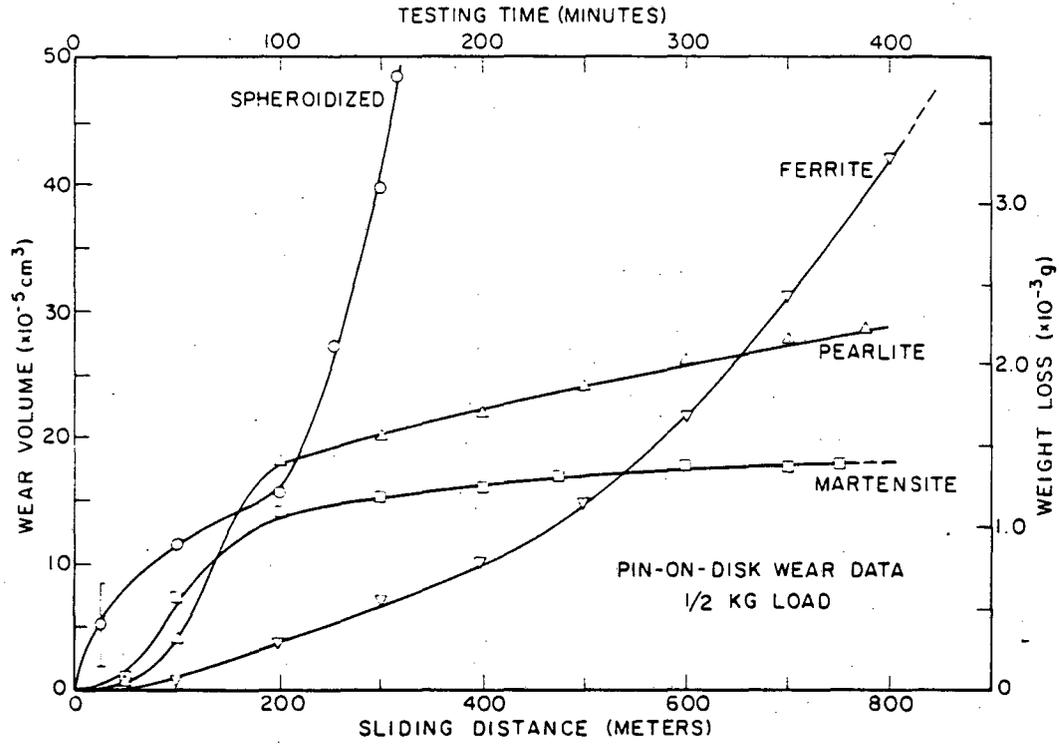
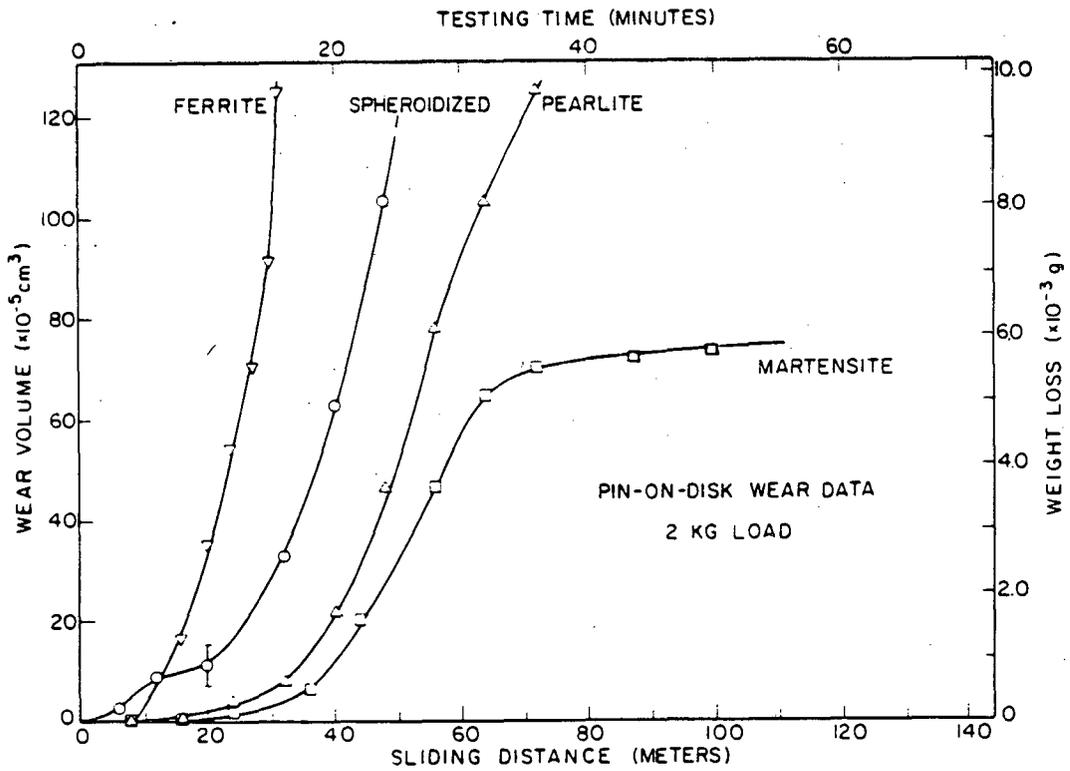
XBL 826-5947A

Figure 1: Total pin on disk wear versus sliding distance for several steel microstructures. a) 0.5 kg load b) 2.0 kg load.

Representative wear data for unlubricated sliding of the steels are plotted in Fig. 1. Three wear tests were averaged for each datum point. Although considerable scatter occurred (10%) especially with light loads, it was quite apparent that the martensitic structures wear less than either ferritic, pearlitic, or spheroidized structures. Pearlite rubbed with small loads reaches a constant wear rate above that of martensite, yet at higher loads, the wear rate steadily increases such that a constant rate is not reached. The wear rate of ferrite, however, increases approximately linearly with time at all loads. Spheroidized structures exhibit a rate of wear similar to that of ferrite, except that, at small loads, spheroidized steel wears faster. Clearly, microstructure plays a significant role in determining the degree of wear under particular conditions.

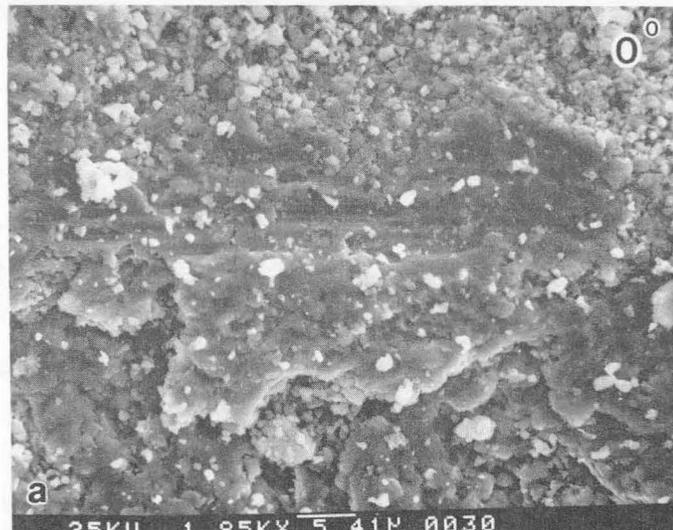
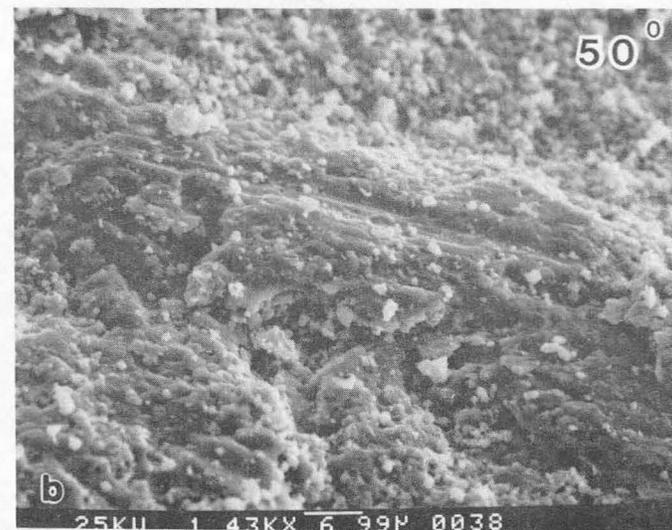
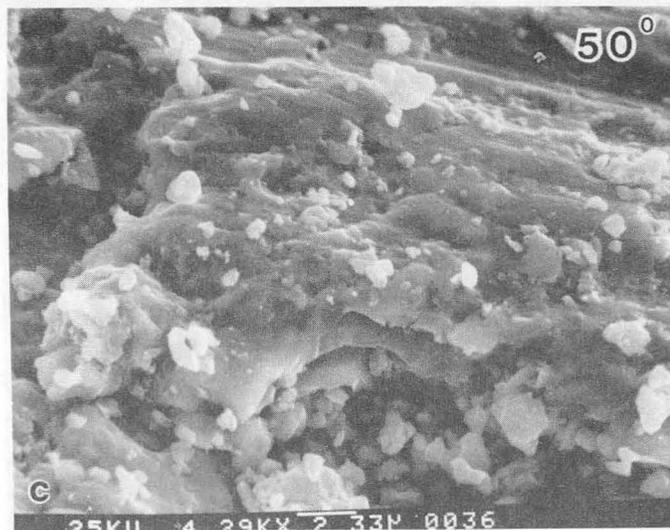
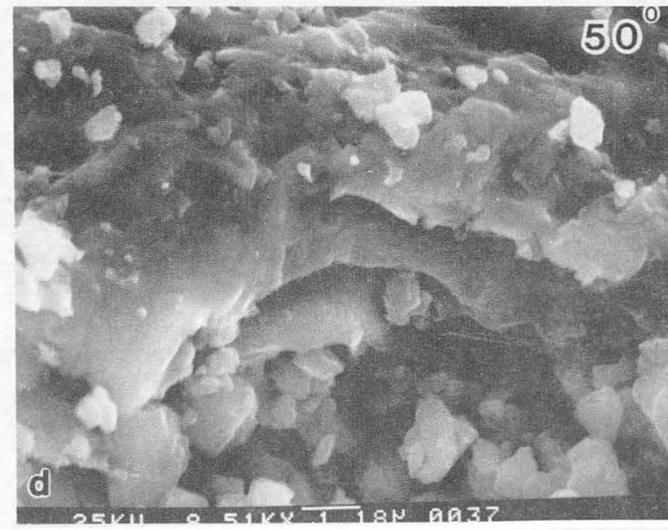
XBB 826-5042

Figure 2: Representative SEM micrographs showing appearance of surface craters and debris particles. a) Typical area on the worn pin b) area in (a) after tilting 50° c) Enlargement of (b) d) enlargement of (c) showing that the layered nature of the worn surface is comparable to the debris thickness (150-300nm).

The appearance of the worn surface of a Ferrovac E pin is illustrated for several magnifications and tilt angles in Fig. 2. Individual debris particles, a few nm in diameter, as well as aggregates are visible. A layered structure with a thickness spacing of 150-300 nm may be noted in the large central crate.

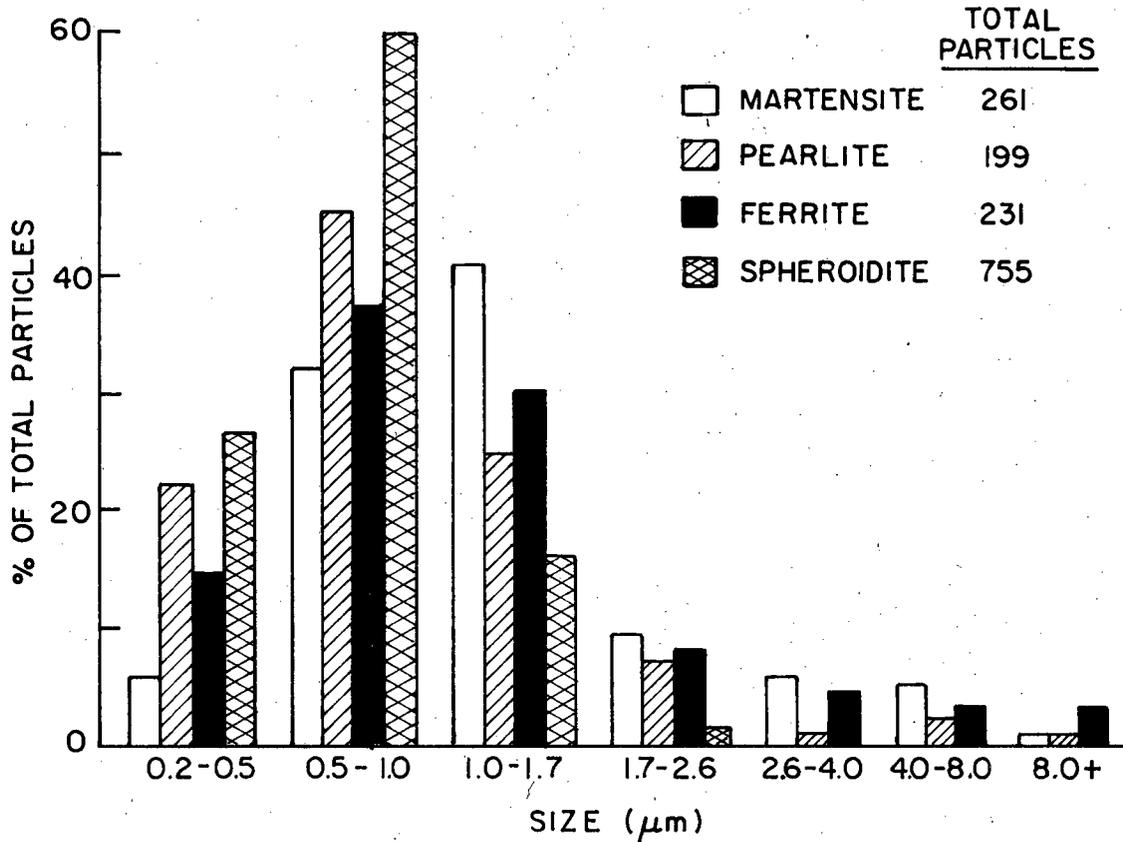
XBL 822-5147A

Figure 3: Histogram of particle sizes obtained by computer controlled electron microscopy. a) influence of microstructure b) influence of load

typically plate-like having an average aspect ratio of 1:2. For most of the materials examined, the size distribution peak ranged from 0.5 to 1.0 μm . Notably, the spherodized structures formed a large number of small ($< 1\mu\text{m}$ mean diameter) particles, whereas martensite specimens were observed to form many larger (1.0 to 1.7 μm) particles.

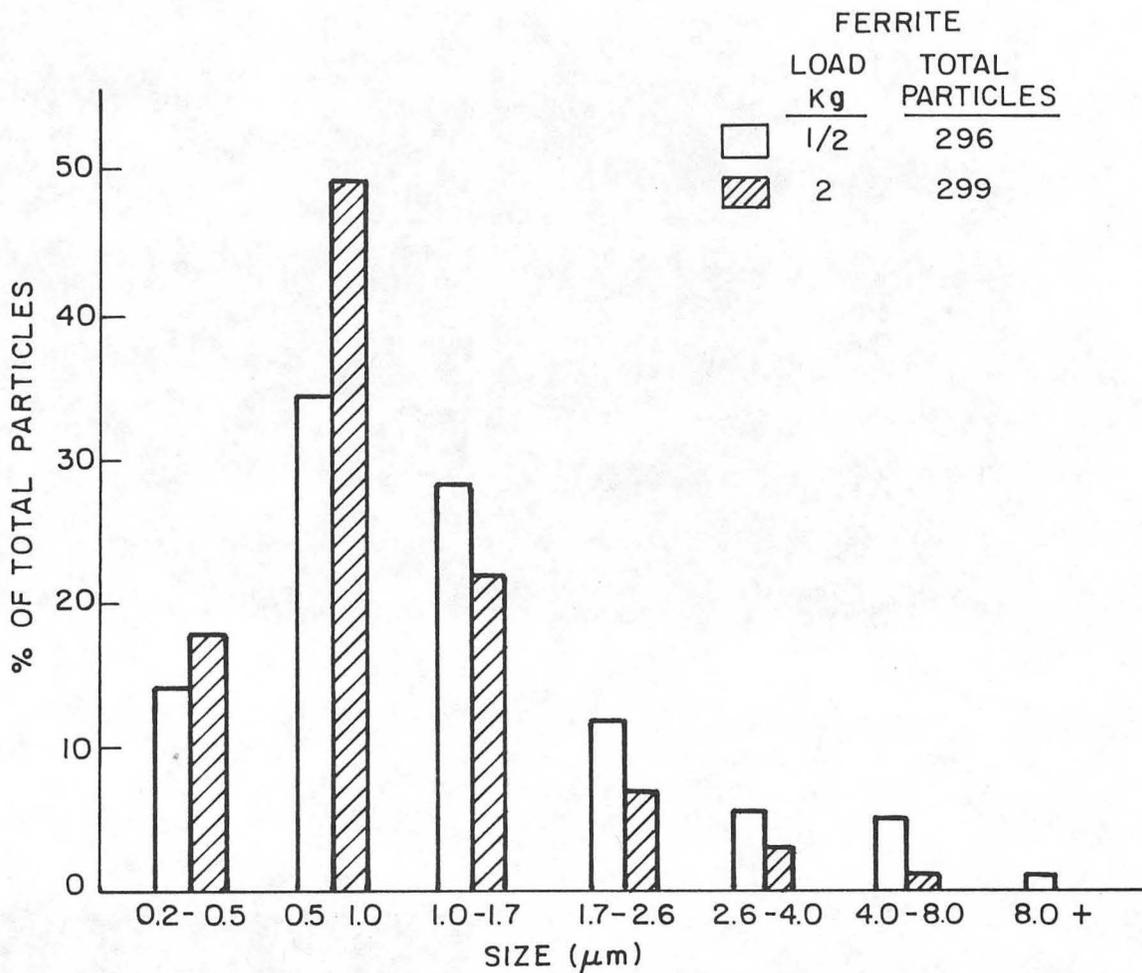
XBL 822-5148

Figure 3: Histogram of particle sizes obtained by computer controlled electron microscopy. a) influence of microstructure
b) influence of load

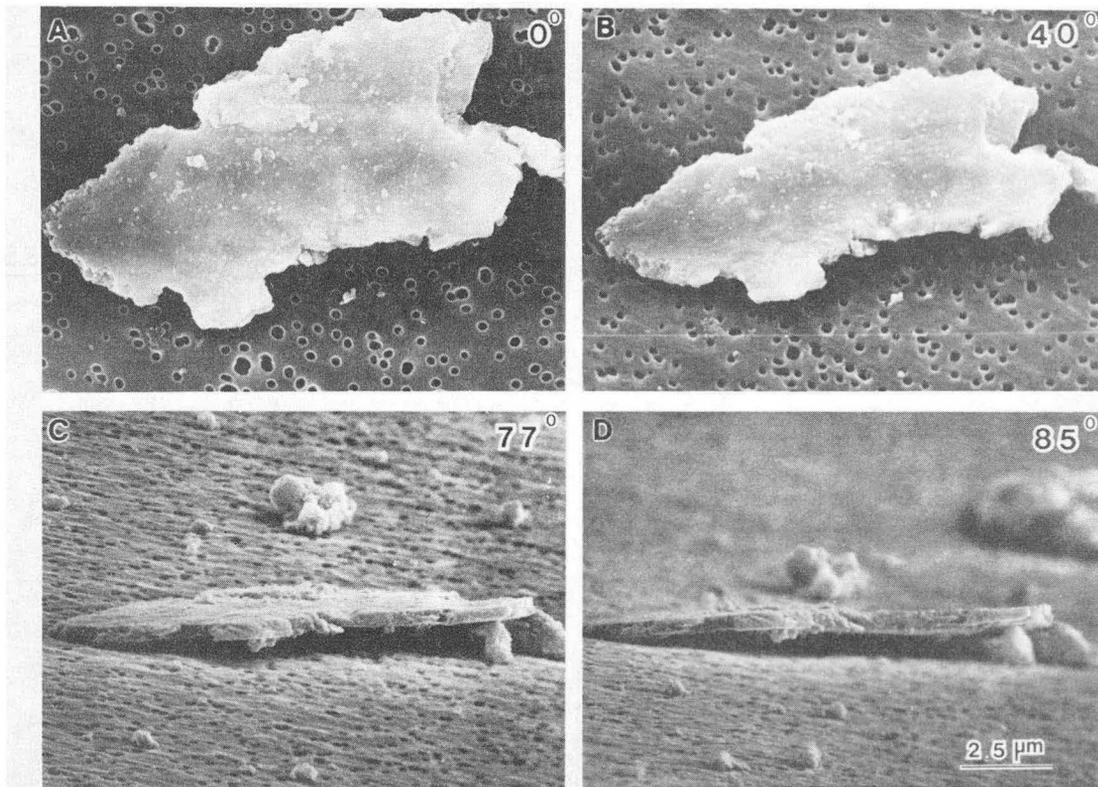
XBB 826-5754A

Figure 4: Typical ferrite wear debris examined in the SEM at oblique angles to reveal its plate-like character. The thickness measured in (d) is 300-400nm.

Examination of debris particles at different viewing angles by tilting the specimen in the SEM revealed the debris thickness to be 250-400 nm (2500-4000 \AA). A typical particle tilted on edge, as shown in Fig. 4a-d, appears to be a flat sheet. All of the debris from specimens worn in air or in controlled environments exhibit this plate-like character.

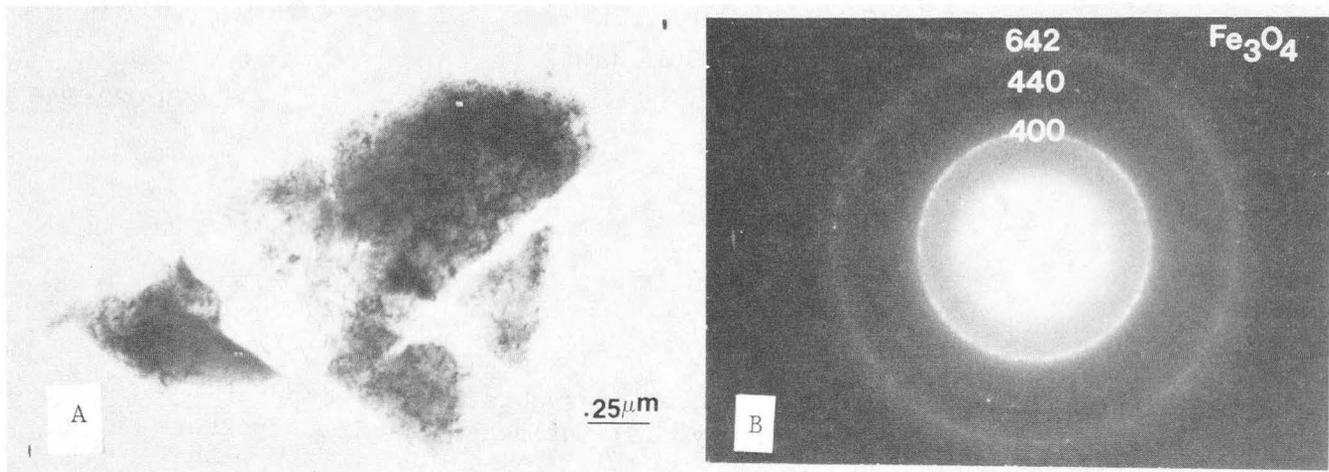
XBB 823-2872

Figure 5: TEM micrograph A and selected area diffraction pattern B showing that small particles are fully oxidized to Fe₃O₄.

Electron diffraction and Auger analyses of debris particles (Figs. 5 to 7) revealed that they are partially or fully oxidized depending on their thickness and the testing temperature and environment. Exposure of iron or steel to air at room temperature results in the formation of a 5-10 nm (50-100 Å) film of Fe_3O_4 in a few days. The much thicker oxide thickness observed for

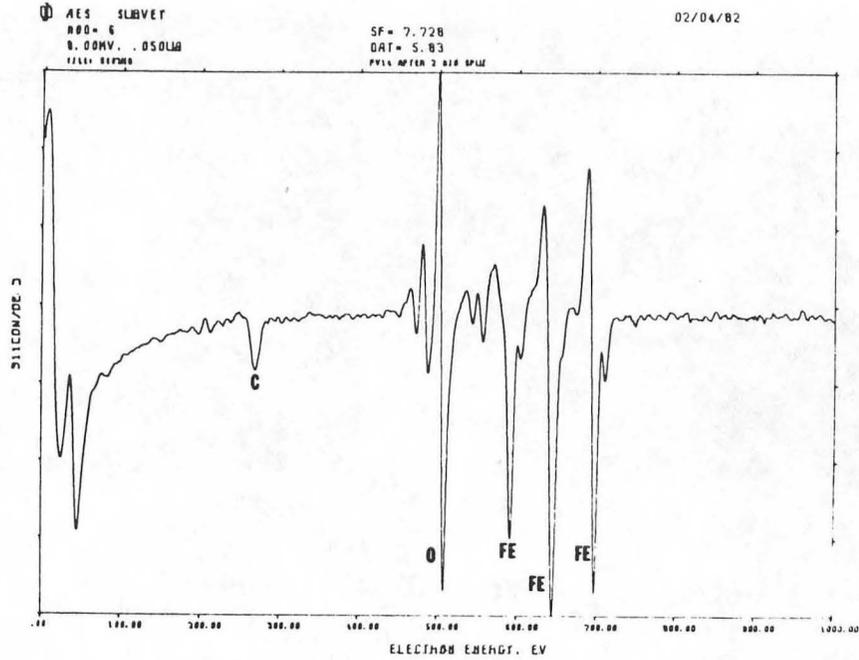
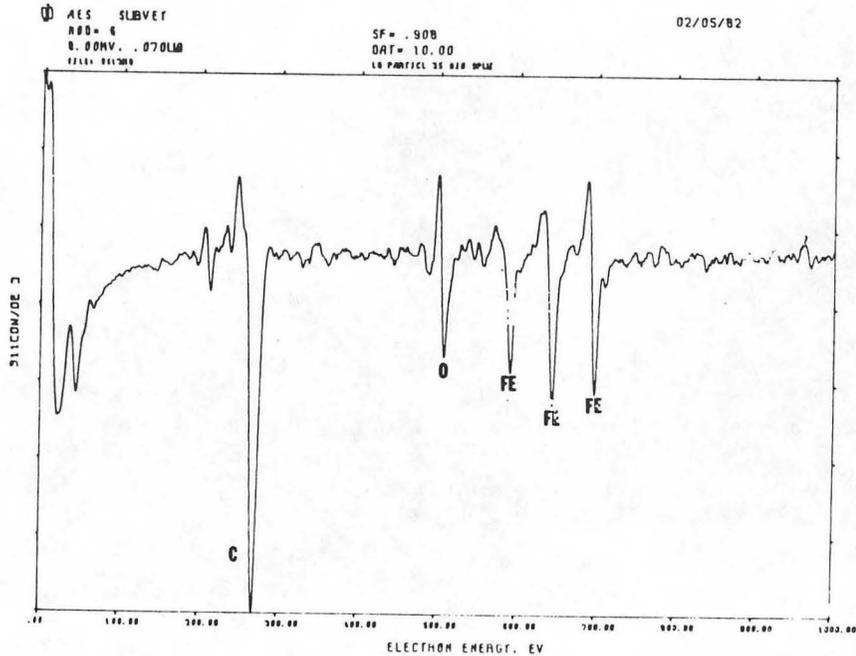
XBL 824-8843

Figure 6: Auger Spectroscopy data from debris formed in air
a) After 2 minutes sputtering the iron oxygen stoichiometry revealed the surface to be hematite. b) Survey after 20 minutes sputter, the oxide appears to be magnetite. The large carbon peak is due to the polycarbonate substrate.

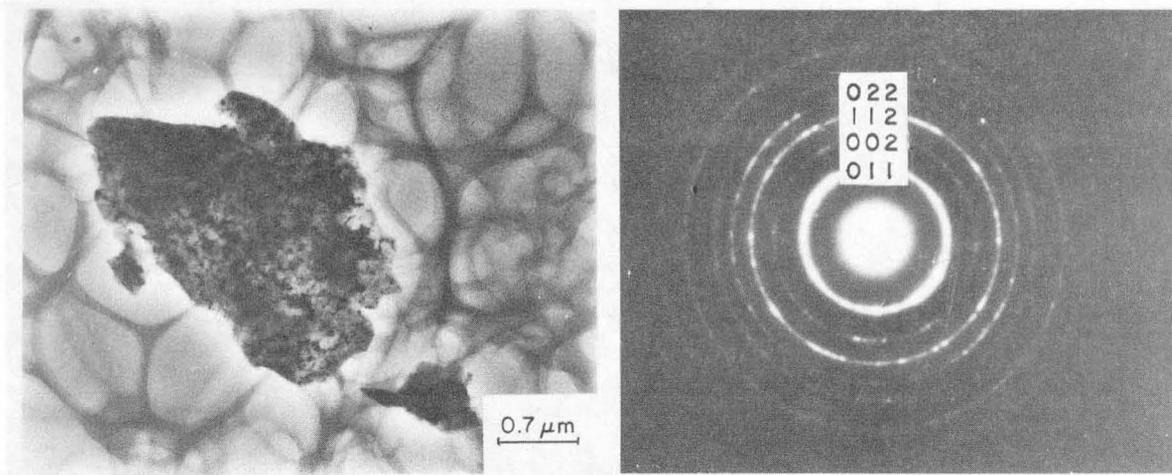
XBB 827-6395A

Figure 7: TEM micrographs. a) Wear debris formed in helium atmosphere. b) SAD of the debris in (a) reveals a wholly metallic structure. Note the intense broad (011) reflection indicating extremely fine slightly misoriented cells are present.

Wear testing in inert gas atmospheres or at low temperature produces metallic particles. TEM electron diffraction studies revealed that a (001) reflection was typically observed suggesting a preferred orientation texture in debris particles (Fig. 7b). Dark field micrographs using this reflection revealed that

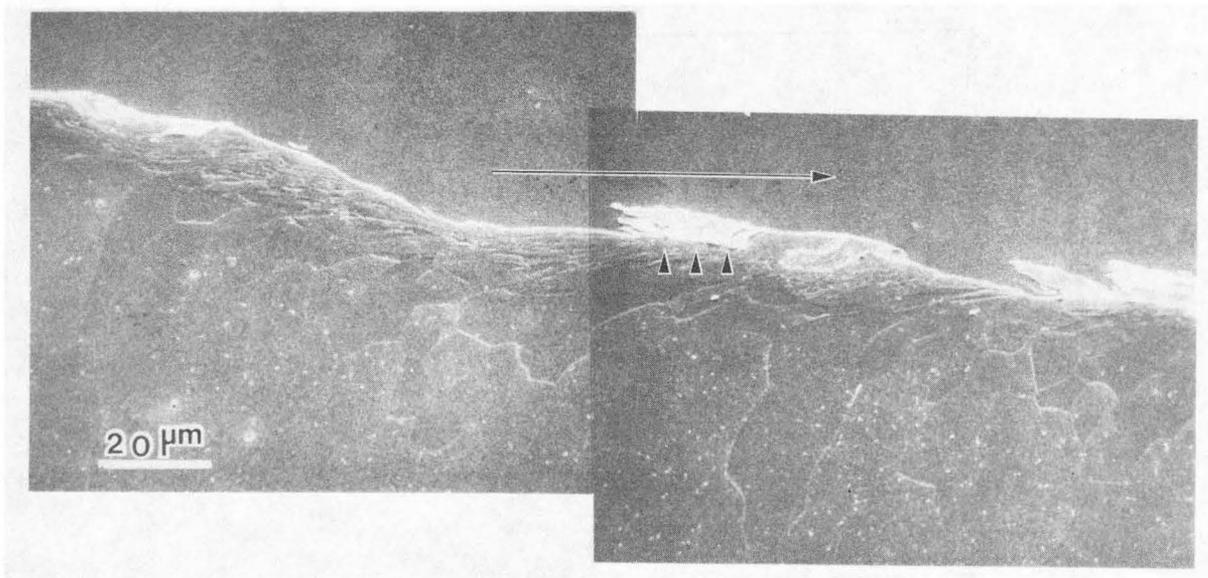
XBB 817-5978A

Figure 8: SEM micrograph. Plastic replica of a cross section of a nickel plated ferritic iron. Notice deformation of grains into sliding direction (arrowed). The deformed zone extends 14-19 microns from the surface. Subsurface cracks parallel to the wear surface are shown by arrow heads.

Cross-sections perpendicular to the wear surface and parallel to the sliding direction indicated the occurrence of extensive subsurface plastic strain and subsurface cracks (marked by arrows) as shown in Fig. 8. The thickest heavily deformed layer was usually found in ferrite structures and there were about 20-30 μm thick.

The formation of wear debris clearly require subsurface crack nucleation and propagation in that the small particles (Figs. 8 and 13a) can flake off from the surface (30). There are a number of possible mechanisms for crack initiation which are primarily related to the microstructure of the material under test and the effects of the interaction of that microstructure with the very severe plastic strain that is encountered in wear. These are illustrated schematically in Fig. 15 and have been subdivided into mechanisms pertaining to microstructures where particles are important or less important. With respect to the non-particle induced crack initiation mechanisms, one very likely mechanism is where sliding along cell walls can lead to the formation of triple point cracks at cell boundary intersections (Fig. 15a). The mode of strain required to generate such triple point cracks is not known, but by analogy to the formation of wedge cracks during high temperature creep testing where substantial grain boundary sliding occurs, it is clear that such a crack initiation mechanism would be promoted by large shear strains and a large strain discontinuity (which produces a tensile stress across the boundary). As shown in Fig. 14, such conditions are met at the interface between the heavily dislocated and recovered zones, which is exactly where the TEM observations indicate that cracks are formed (Figs. 12 and 13a).

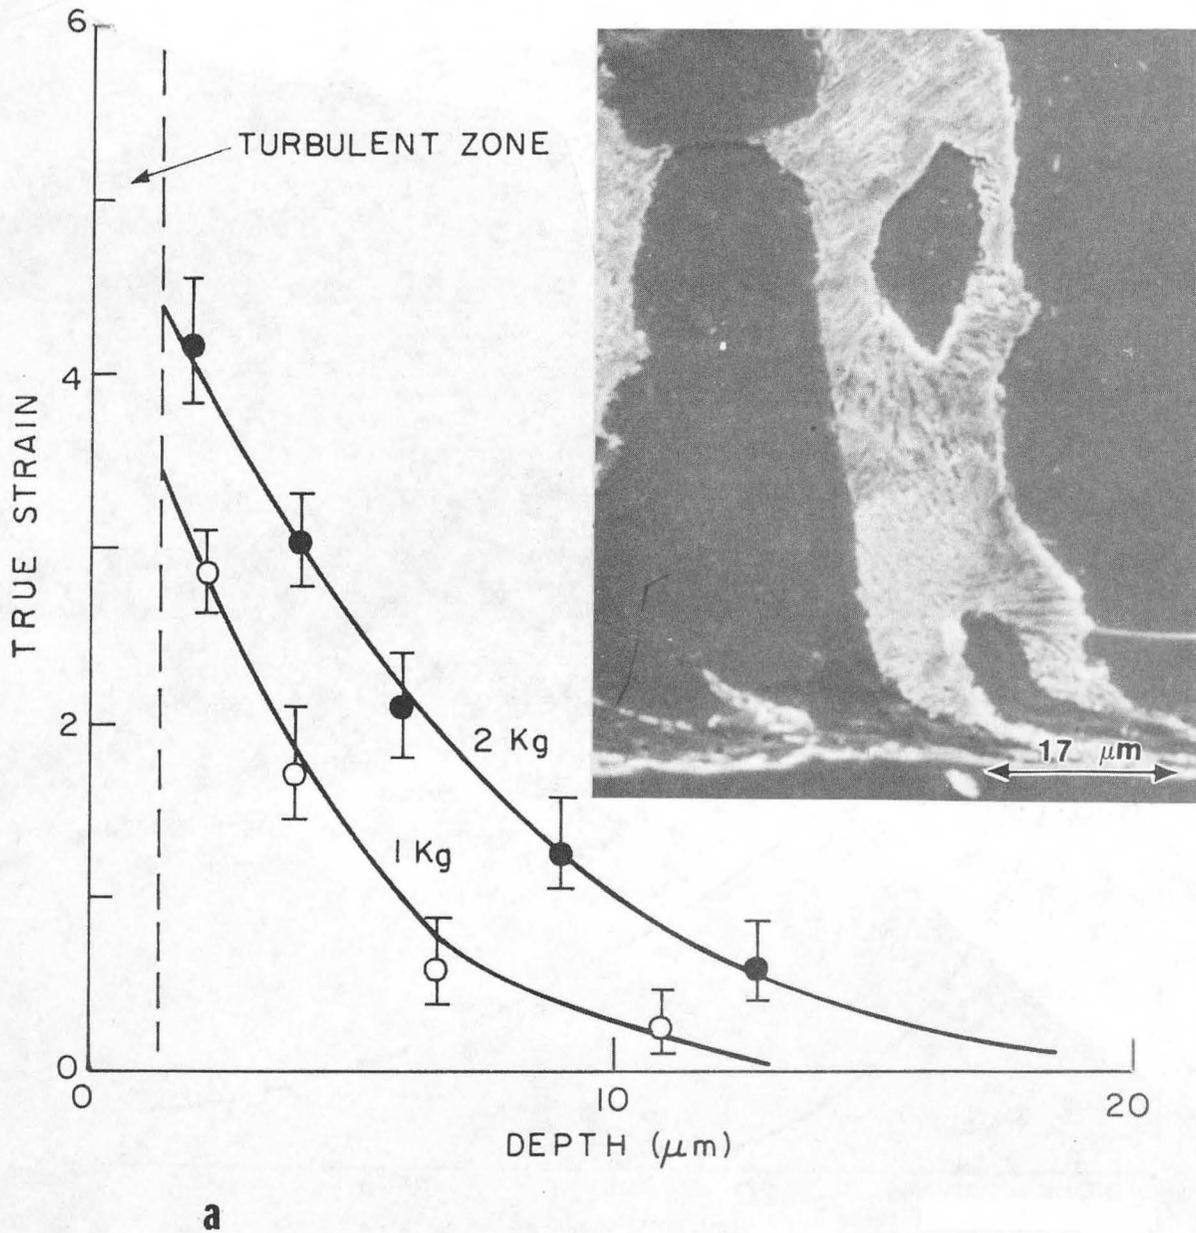
XBB 827-5917A

Figure 9: Strain distribution in 1020 steel as a function of distance beneath the wear surface. a) Strain distribution from distortion of pearlite colonies. Inset shows representative area from aligned pearlite. Near surface strains are indeterminate. b) Strain distribution derived from dislocation cell size measurements. Inset is representative of a dislocation structure 2.0-6.0 microns from the interface

From measurements of the bending of microstructural features (18) (e.g., grains, grain boundaries, etc.) the shear strain in the heavily deformed region was estimated to exceed a true strain of 4 (Fig. 9). Although the use of banded pearlite aided in the measurement of the plastic strain (Fig. 9a, inset), disturbance of the structure of pearlite colonies made it impossible to define their boundaries to determine the amount of strain within 2 μm of the surface. Since the wear debris is formed within this 2 μm region, its characterization was important.

During wear rate measurements, the steel test pins are subjected to intervals of rather large shear forces due to friction against the rotating steel disk. The resulting subsurface deformation strain appears to be a dominant factor in wear. Since the wearing surface will work-harden with repeated straining, the region of deformation will extend below the surface to a distance depending upon the applied load, and flow stress of the material (Fig. 9).

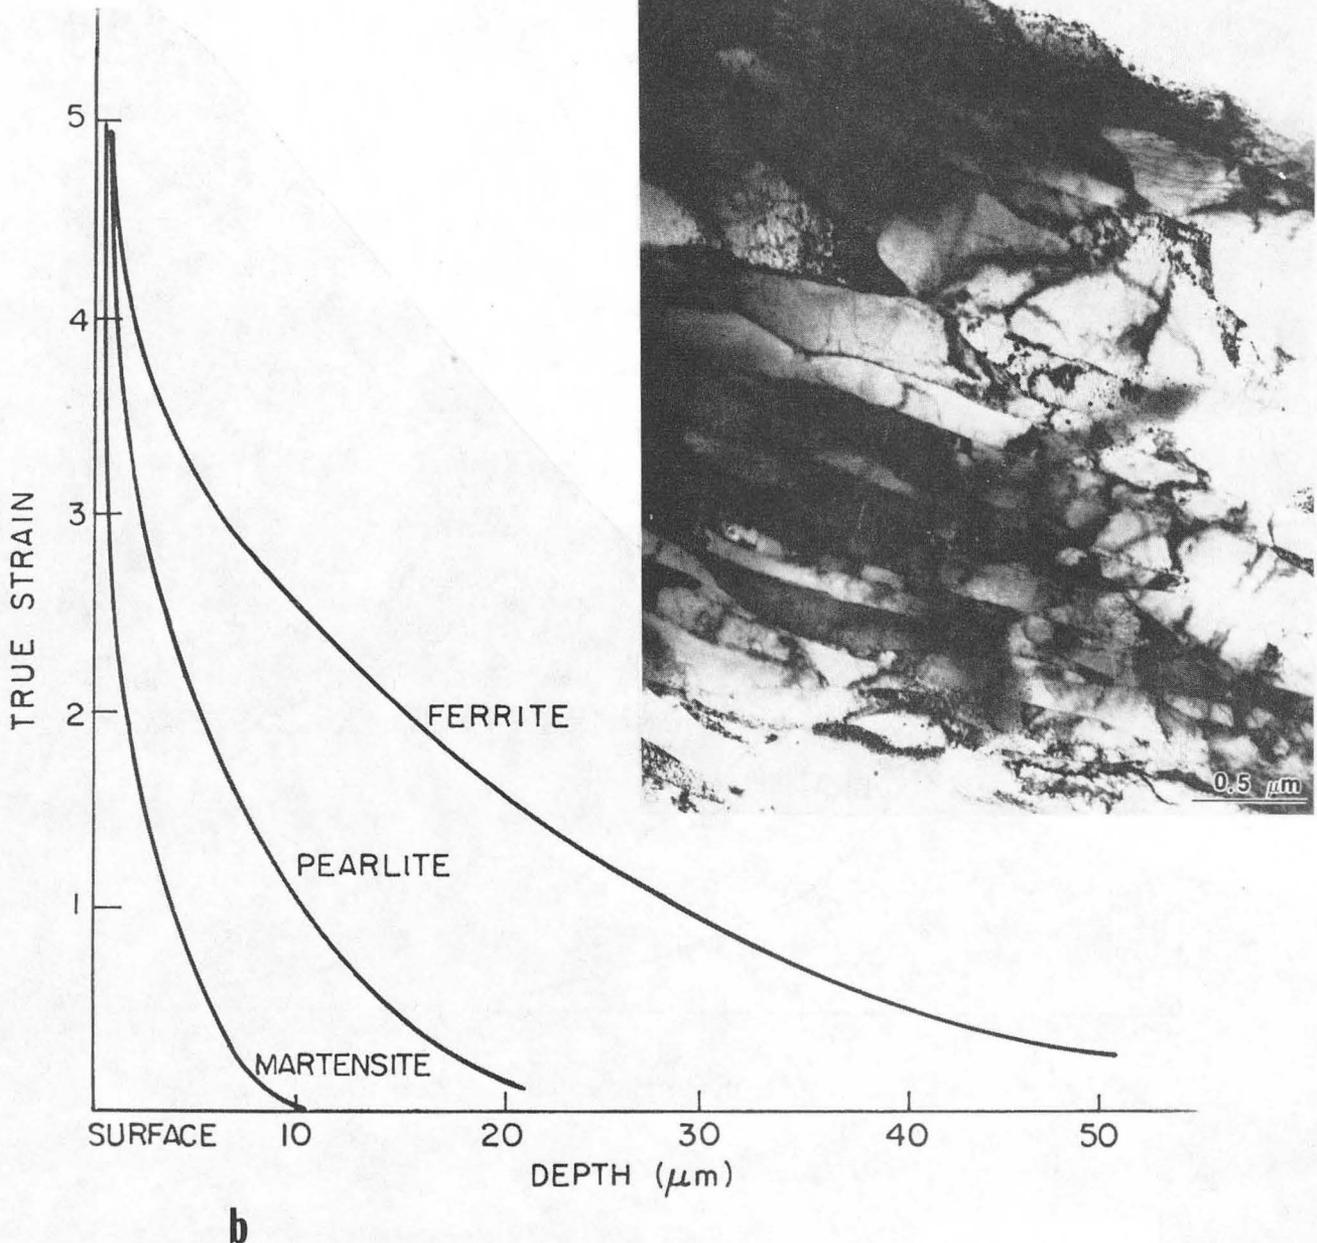
XBB 823-2868A

Figure 9: Strain distribution in 1020 steel as a function of distance beneath the wear surface. a) Strain distribution from distortion of pearlite colonies. Inset shows representative area from aligned pearlite. Near surface strains are indeterminate. b) Strain distribution derived from dislocation cell size measurements. Inset is representative of a dislocation structure 2.0-6.0 microns from the interface

Well defined dislocation cell structures were commonly observed in TEM cross-sections of the wear surface (Fig. 9b, inset). Similar structures had been observed by previous investigation (19-23). Due to the similarity of rolling and wire drawing textures in BCC materials, estimates were made of the subsurface strain using the data of Embury, Keh, and Fisher (24) to relate the dislocation cell width to degree of strain. Details of the method can be found in Ref. 20. These data together with previous measurements are presented in Fig. 9b and

indicate similar estimates of the sub-surface strain distribution. The plastic shear strain at the worn surface was estimated to exceed 5.5. It should be noted that these strains are far greater than those involved in any conventional mechanical test and further that a corresponding very high strain gradient also develops during the wear testing.

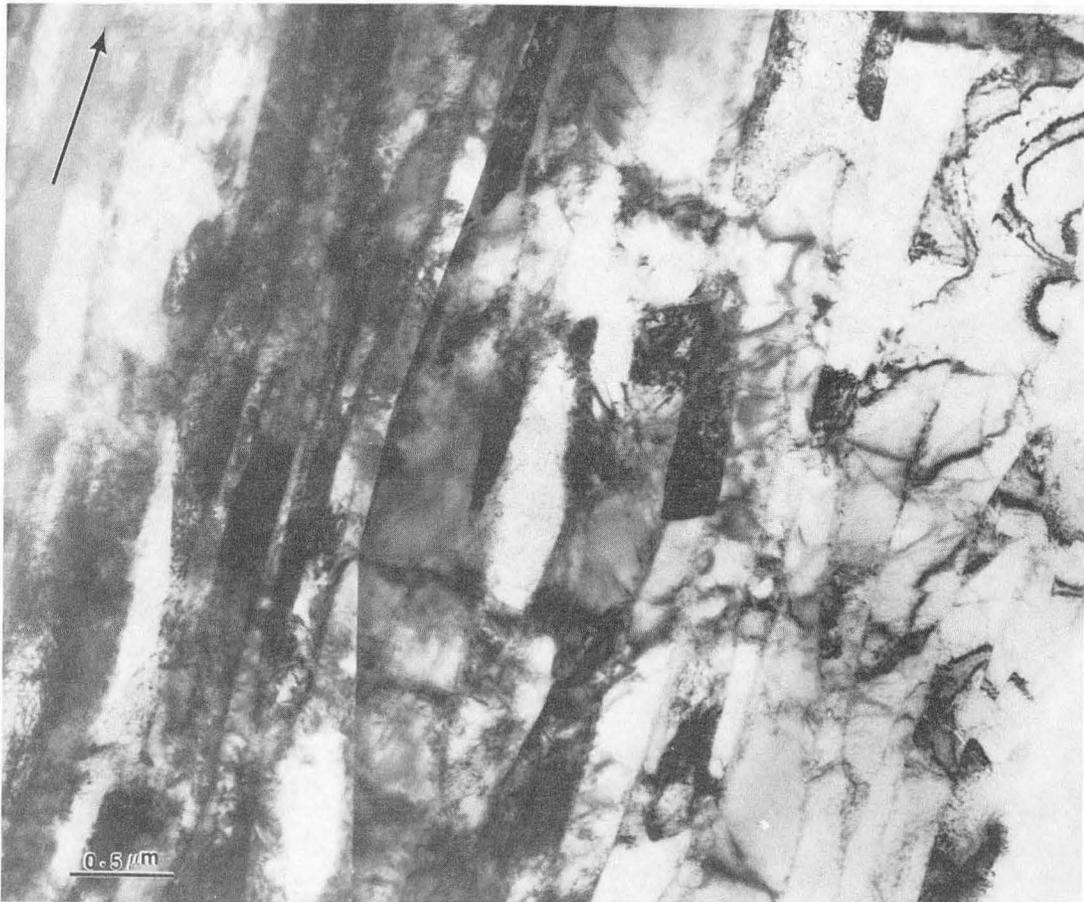
XBB 819-11945

Figure 10: TEM micrograph. Longitudinal cross section of ferritic iron reveals the characteristic dislocation cell structure. Arrow indicates the direction of sliding.

As described above, well defined dislocation structures typical of large strain plastic deformation of metals were observed in TEM for longitudinal (parallel to the sliding direction but perpendicular to the worn surface) cross-sections of ferritic, pearlitic, and spheroidized structures, an example of which is shown in Fig. 10. The dislocation structures within 1 μm of the wear surface ranged from 10-60 nm (100-600 \AA) wide by (80-2000 \AA) long. Sections transverse to the sliding direction revealed the dislocation cells to be equiaxed in section and 10-60nm (100-600 \AA) across. Thus, the dislocation cells tend to have a three-dimensional plate-like character.

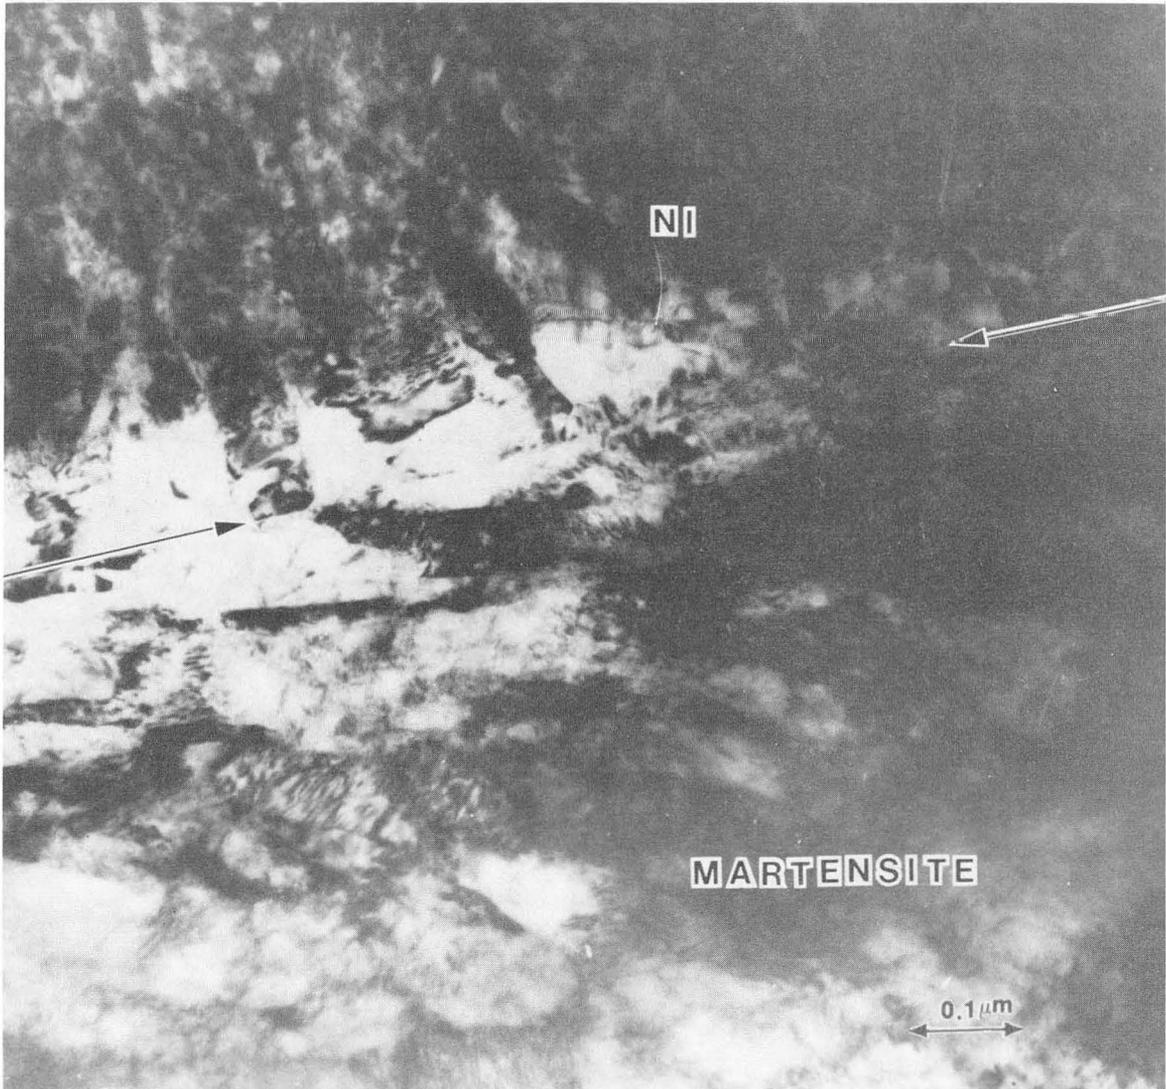
XBB 827-5916A

Figure 11: TEM micrograph of longitudinal cross-section of martensitic steel. Sliding direction is from right to left. Arrows denote the wear interface where martensite laths appear to have necked down 100% from their original size.

Since lath martensite is already similar to a heavily deformed metal in its initial state, it was difficult to separate plastic deformation from transformation structures except for shape changes. The martensite lath was observed to neck down from an initial width of $0.5 \mu\text{m}$ (26,27) to less than $0.05 \mu\text{m}$ near the wear interface (Fig. 11). Dislocation cells $0.025 \mu\text{m}$ wide were observed within the laths adjacent to the surface.

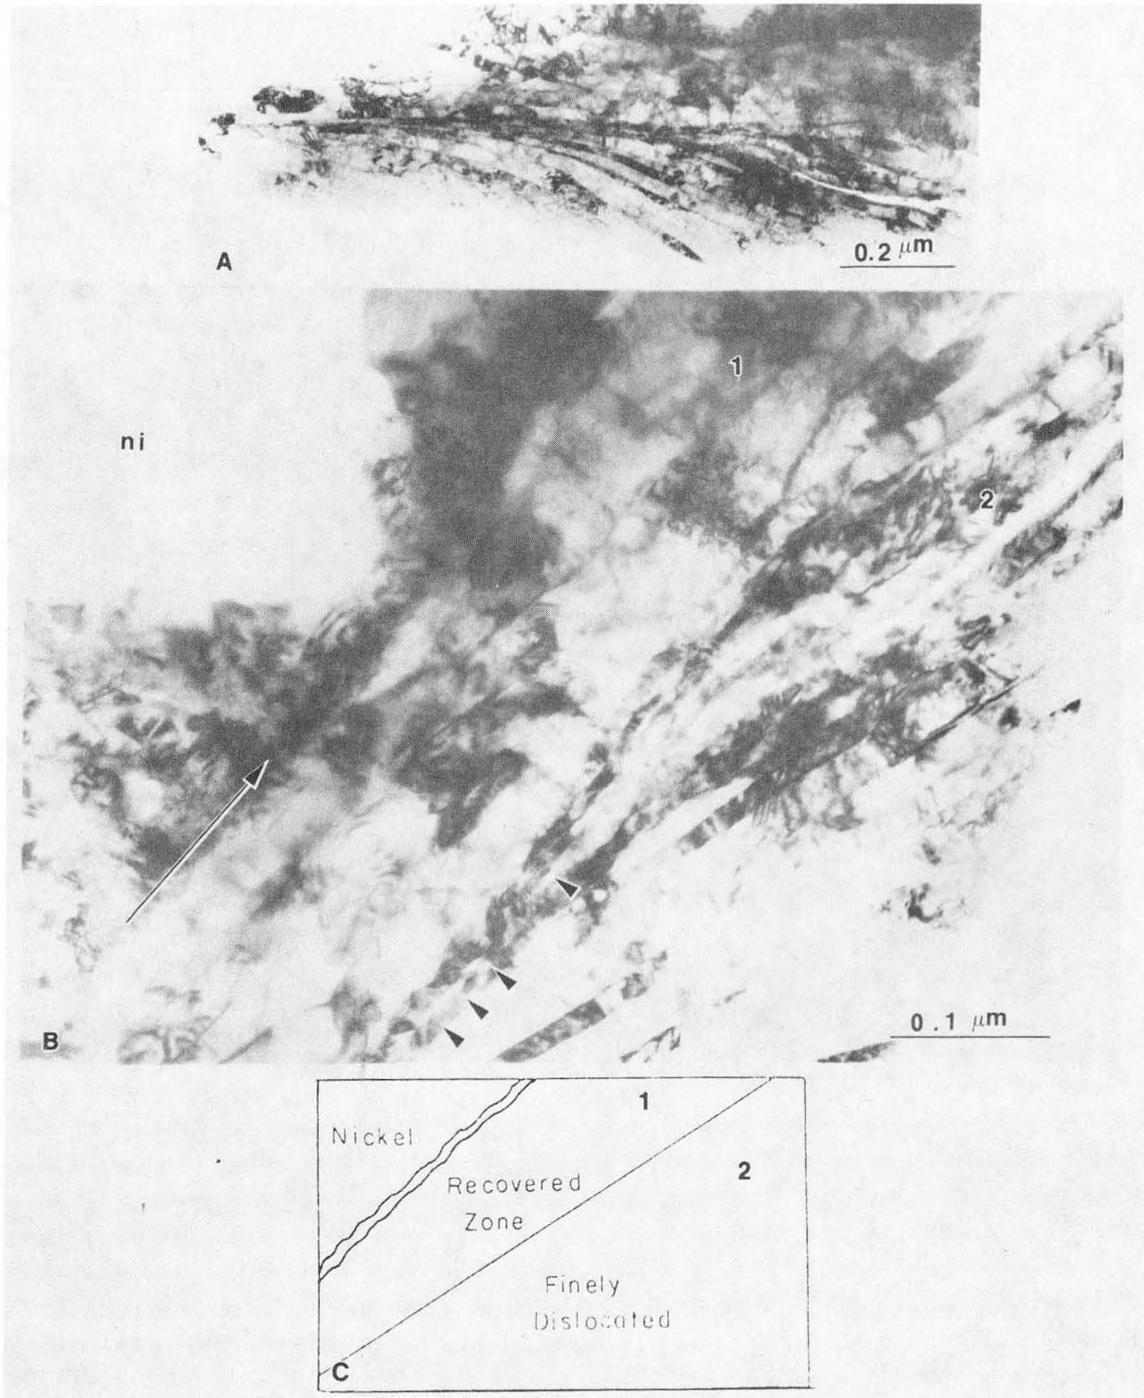
XBB 823-2869

Figure 12: TEM micrograph of longitudinal cross-section of pearlitic steel. a) Low magnification of the interface region. Arrows denote the wear interface b) Enlargement of (a) showing coarser cell structure indicating recovery below the interface. The heavily dislocated fine cell structure is below. Cracks are indicated at the junction of these regions. c) Schematic diagram of the micrograph in (b)

Immediately beneath the wear interface in worn ferritic and pearlitic steels, the dislocation cell size was observed to be approximately 60 nm (600 \AA) wide by 80 nm (800 \AA) long (Fig. 12). This region, however, only extended $0.2\text{--}0.3 \mu\text{m}$ from the surface (Fig. 12b). In the underlying region, the dislocation cell width was smaller, $10\text{--}30 \text{ nm}$ ($100\text{--}300 \text{ \AA}$), and longer $200\text{--}300 \text{ nm}$ ($2000\text{--}3000 \text{ \AA}$). The regions immediately beneath the surface were suspected to have undergone recovery as the result of sliding wear. Cracks appear to have formed near the boundary of the recovered zone and the underlying heavily dislocated layer as indicated by arrows in Fig. 12b. The cracks appear to form along the cell boundaries, consistent with the SEM observations indicating crack

be envisaged through the formation of super-dislocations in the very high angle tilt boundary. For a misorientation of 15° in such cell walls, the dislocation spacing in the boundary need only be of the order of 4 Burgers vectors. Observations suggest that this type of decohesion boundary will occur where extremely high residual strain gradients occur, again inferring the crack initiation should preferentially occur at the interface between the heavily dislocated (unrecovered) and recovered zones, as seen experimentally in Figs. 12 and 13a.

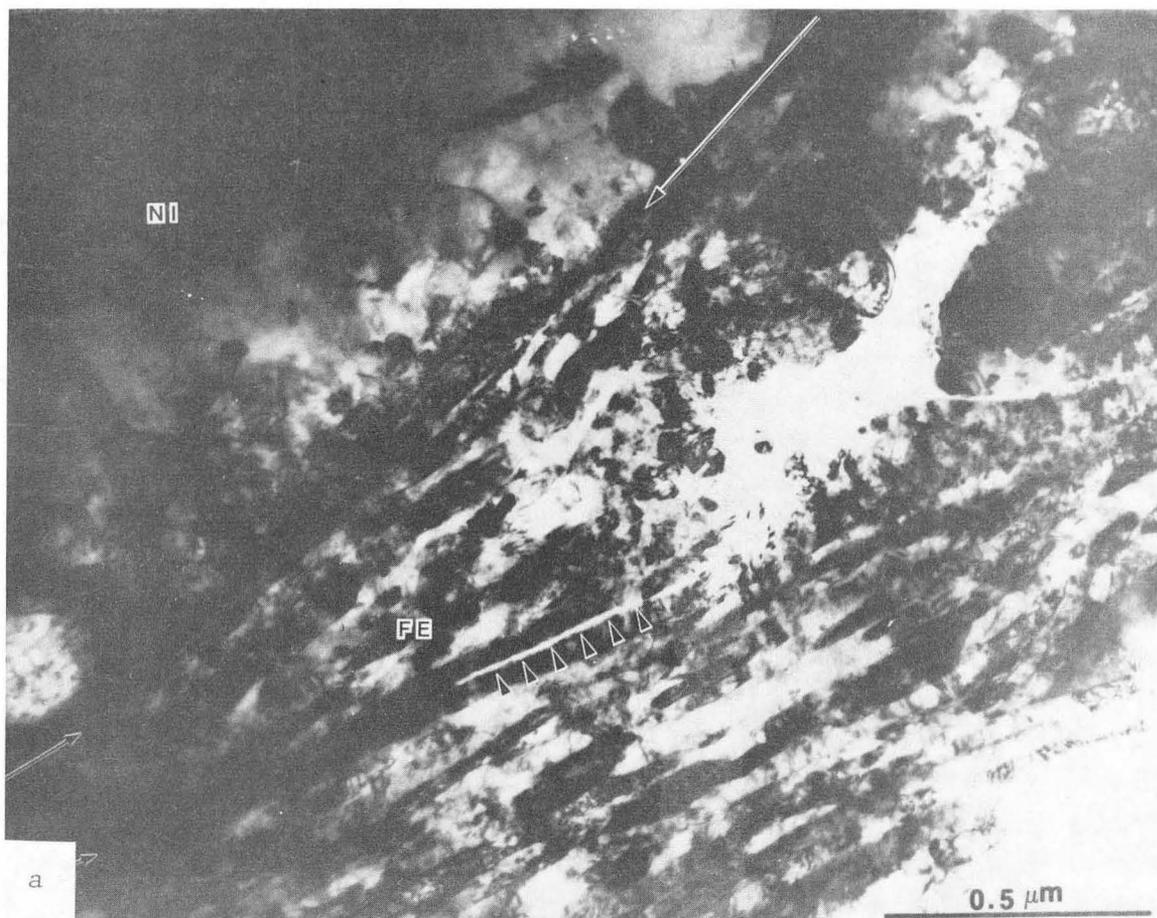
XBB 821-895A

Figure 13: a) Crack initiation associated with dislocations. TEM micrograph. Longitudinal cross section of pearlitic steel, showing apparent formation of a debris particle. Long arrows indicate the Fe-Ni interface. b)c) Crack initiation and decohesion (arrowed) associated with carbides.

This is consistent with other observations of subsurface wear cracks along dislocation cell walls. An apparent example of a wear particle of the early stage of formation is shown in the TEM of a cross-section (Fig. 13a). Energy dispersive X-ray analysis was used to confirm the location of the interface. The long arrow denotes the sliding direction and the iron-nickel plate interface. A crack was observed to have formed along the dislocation cell boundary as denoted by the arrows. The particle soon to be formed was denoted by "FE". Note that the thickness of the feature is equivalent to the recovered zone width as well as the typical wear particle thickness. Also note the dislocation cell structure within the "particle" is similar to that of the recovered zone in Fig. 12.

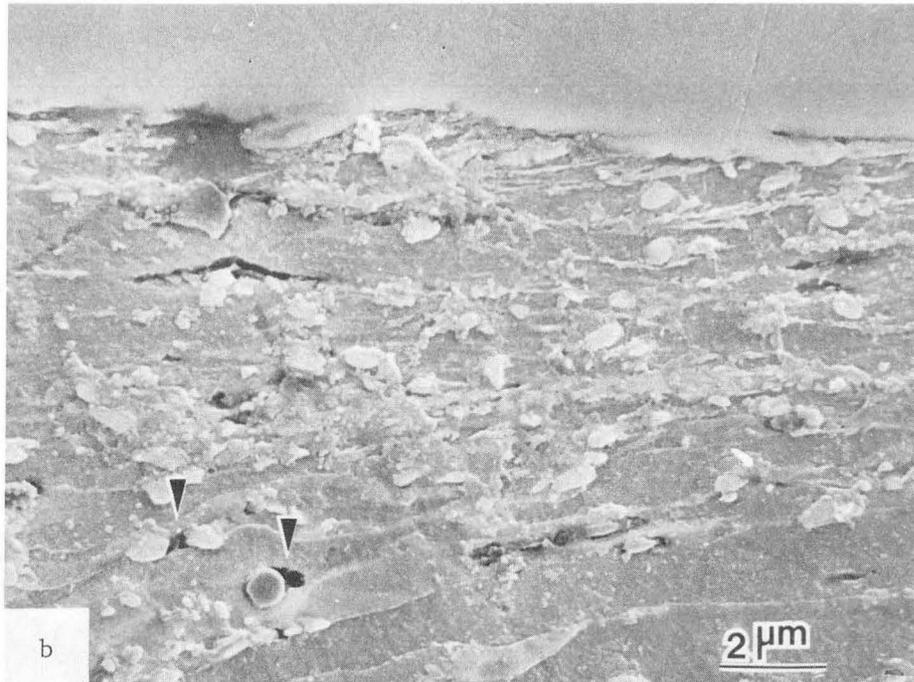
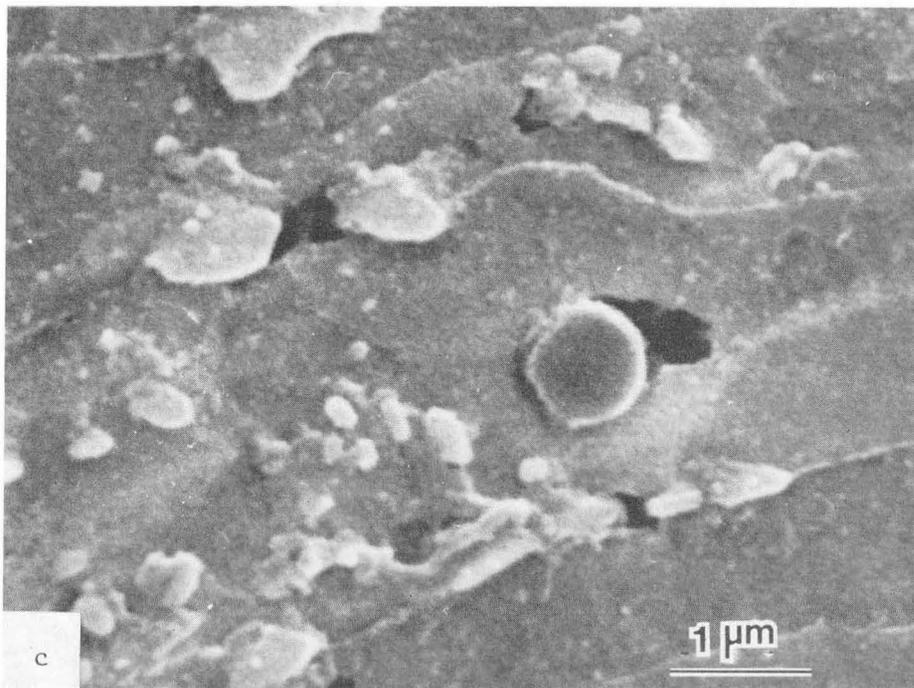
XBB 826-5045

Figure 13: a) Crack initiation associated with dislocations. TEM micrograph. Longitudinal cross section of pearlitic steel, showing apparent formation of a debris particle. Long arrows indicate the Fe-Ni interface. b)c) Crack initiation and decohesion (arrowed) associated with carbides.

In contrast, crack initiation in the spherodized steel was observed to be associated with carbide particles as indicated in Fig. 13b. Matrix decohesion and crack formation between carbides were observed to be the principal modes of initiation. Thus the TEM and the SEM observations demonstrate that cracks may initiate near particles or dislocation cell boundaries depending on the microstructure of the steel being tested.

Mechanisms for subsurface wear crack formation in the presence of particles, e.g., for spherodized structures, are illustrated in Fig. 15c and d, together with experimental TEM observations in Fig. 13b,c. Two mechanisms are envisaged and both involve particles in the form of carbides or inclusions where voids are created either by cracking of the particle or decohesion at the particle matrix interface. For isolated particles in region of intense shear strain, the process of void formation will be similar to that in the cone portion of a uniaxial tensile cup-and-cone fracture in that the void will elongate by shear of the matrix at the forward and trailing edge of the particle (Fig. 15c). For closely spaced pairs of non-deformable particles in a deforming matrix subjected to shear, the incompatibility of strain between the matrix and particles will induce a void connecting the particles. This is illustrated schematically in Fig. 15d, and has been discussed in detail elsewhere (31). Cracks of both types are readily observed in the case of the spherodized steel samples, as shown in Fig. 13b,c.
