Materials & Molecular Research Division

To be presented at the International Conference
on Wear, Reston, VA, April 11-14, 1983

THE NATURE AND ORIGIN OF SLIDING WEAR DEBRIS
FROM STEELS

W.J. Salesky, R.M. Fisher, R.O. Ritchie, and
G. Thomas

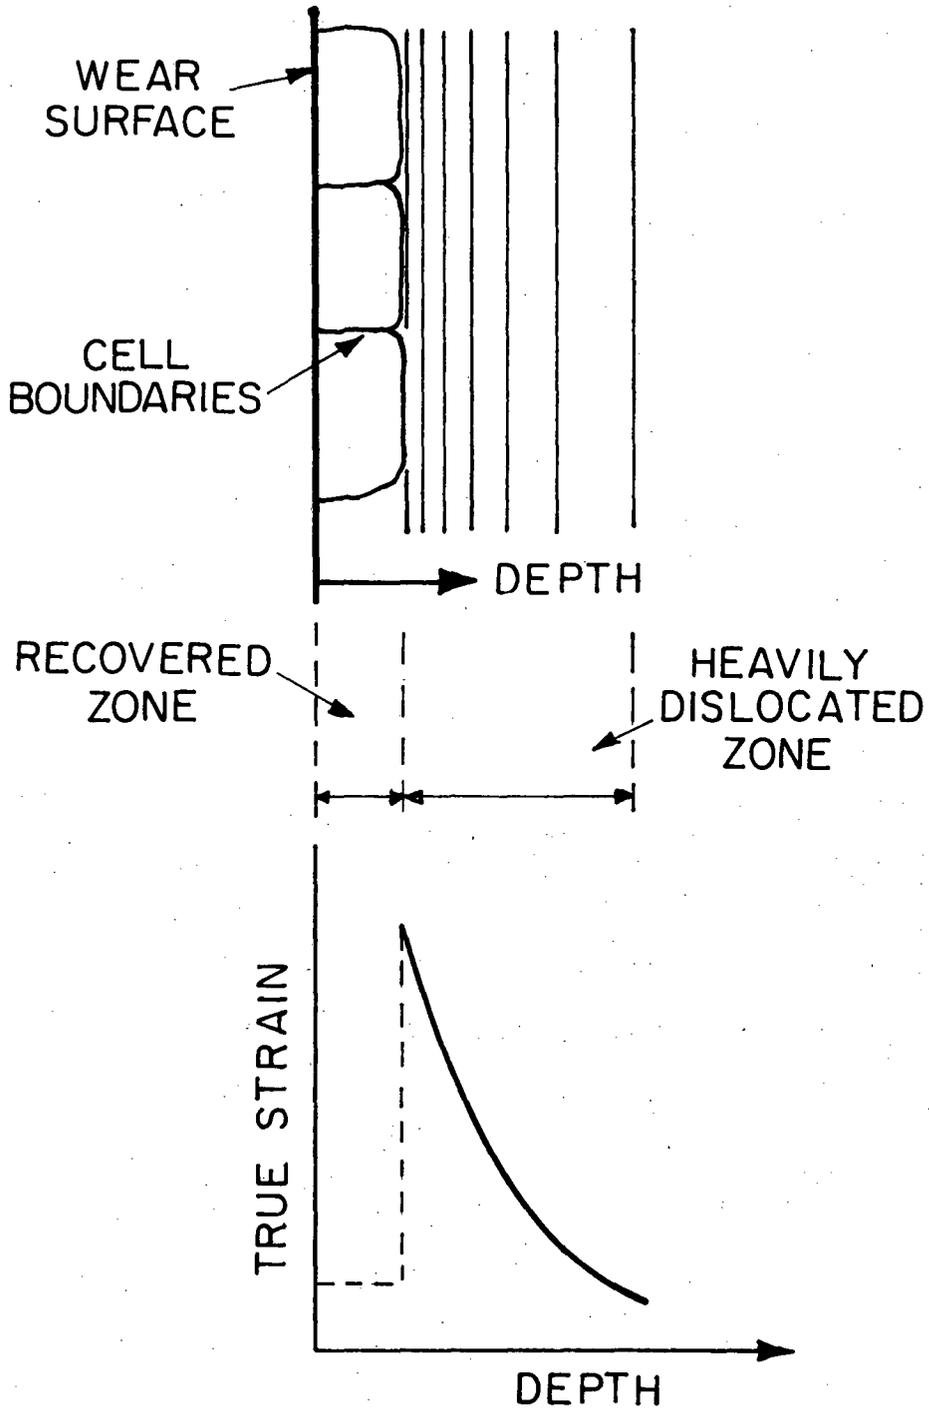
XBL 829-6465

Figure 14: Schematic representation of shear strain gradient generated in close proximity to wear surface

A further consequence of recovery is an abrupt change in stored energy, i.e., strain density, near to the surface as illustrated schematically in Fig. 14. A steep strain gradient, such as that indicated in the sketch, and the corresponding internal stresses that result, will result in a tensile component perpendicular to the surface, which clearly has some bearing on the nature of crack initiation, as outlined below.

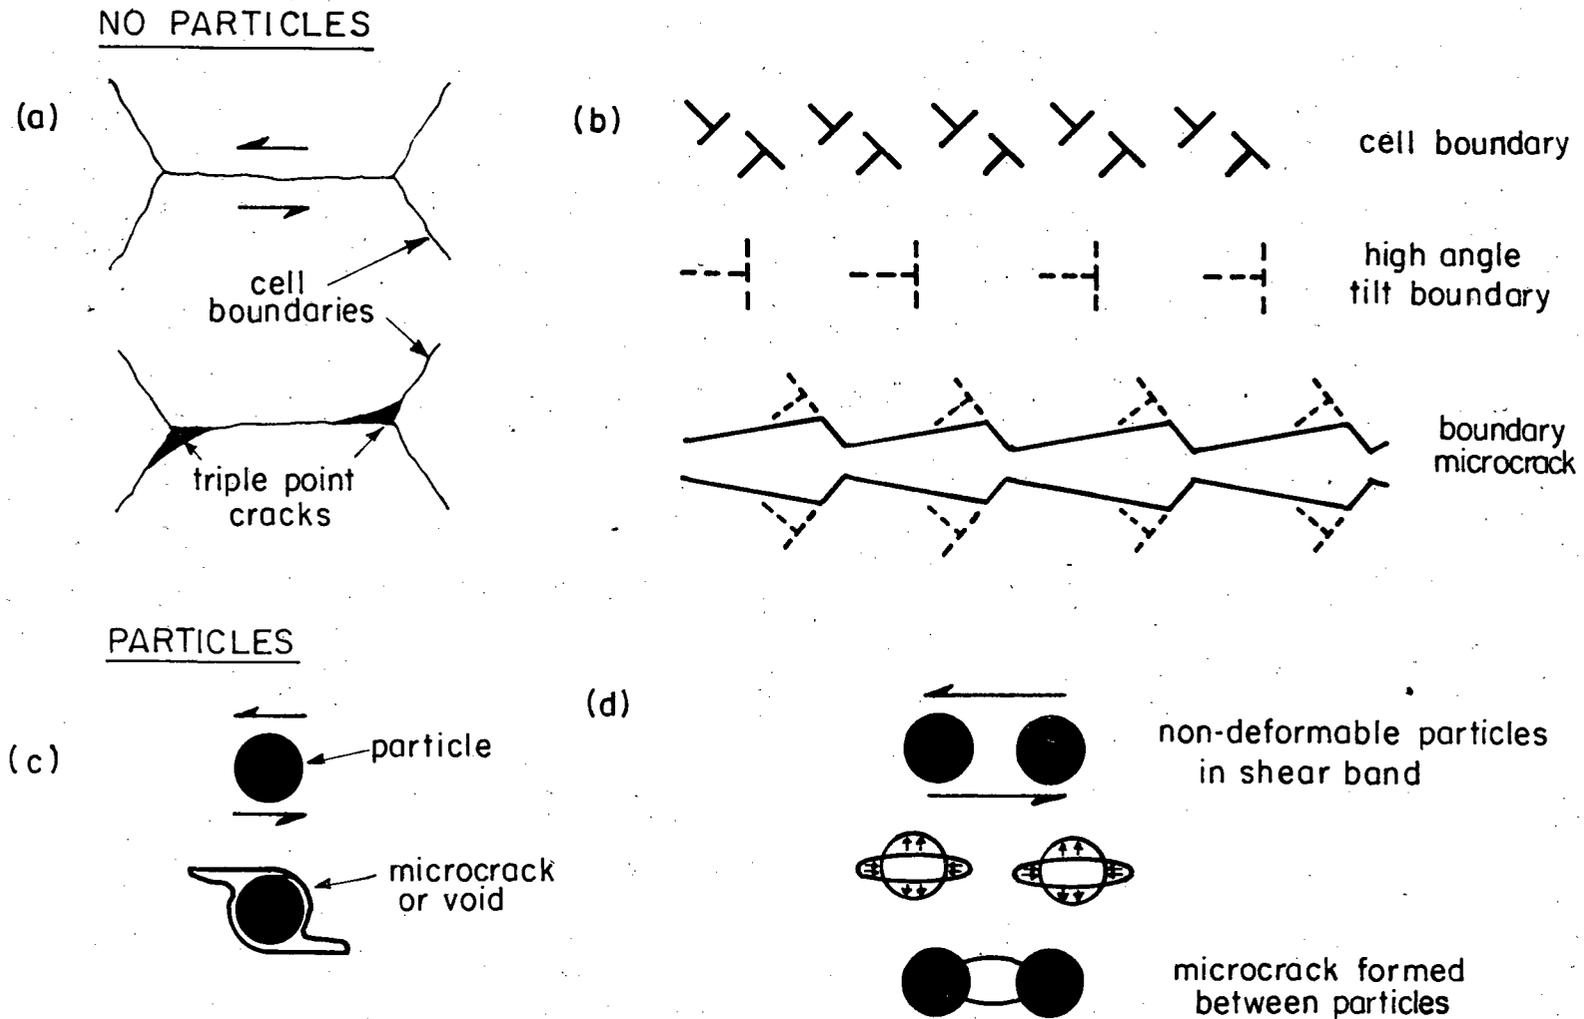
Figure 15: Mechanisms of sub-surface initiation of wear cracks, a) b) for microstructures containing no particles where cracks preferentially nucleate within the cell boundaries at the interface between the heavily dislocated and recovered pores, and c) d) for microstructures containing particles where cracks preferentially nucleate at the particle interfaces.

Another possible crack initiation mechanism in the absence of particles is illustrated in Fig. 15b. In this case, dislocation accumulation in the cell wall and the corresponding increase in misorientation reaches a point where boundary decohesion can

Mechanisms for subsurface wear crack formation in the presence of particles, e.g., for spherodized structures, are illustrated in Fig. 15c and d, together with experimental TEM observations in Fig. 13b,c. Two mechanisms are envisaged and both involve particles in the form of carbides or inclusions where voids are created either by cracking of the particle or decohesion at the particle matrix interface. For isolated particles in region of intense shear strain, the process of void formation will be similar to that in the cone portion of a uniaxial tensile cup-and-cone fracture in that the void will elongate by shear of the matrix at the forward and trailing edge of the particle (Fig. 15c). For closely spaced pairs of non-deformable particles in a deforming matrix subjected to shear, the incompatibility of strain between the matrix and particles will induce a void connecting the particles. This is illustrated schematically in Fig. 15d, and has been discussed in detail elsewhere (31). Cracks of both types are readily observed in the case of the spherodized steel samples, as shown in Fig. 13b,c.

Large shear forces imposed by repeated contact with the harder surface result in very large shear strains near the surface of 5-6 or more. Cracks develop at different critical strains for different features in the microstructure, i.e., single or clusters of inclusions or cell boundaries or junctions as illustrated in Fig. 15. Dynamic recovery may also occur in

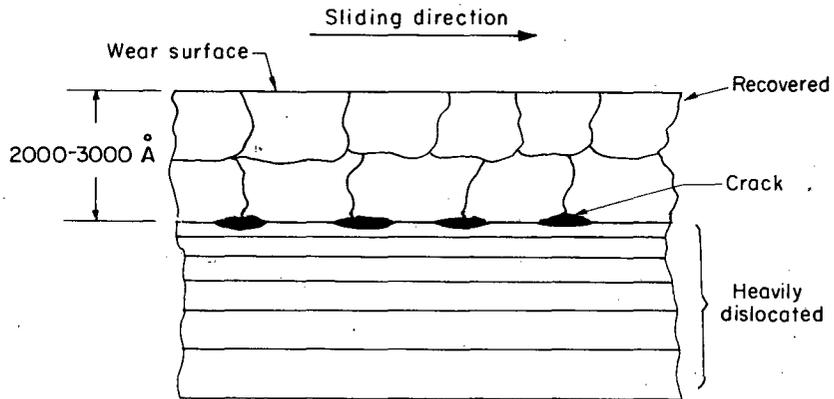
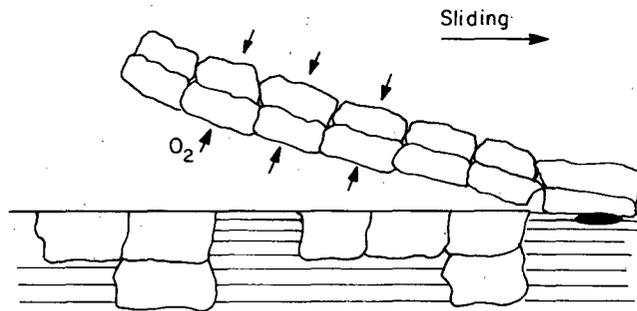
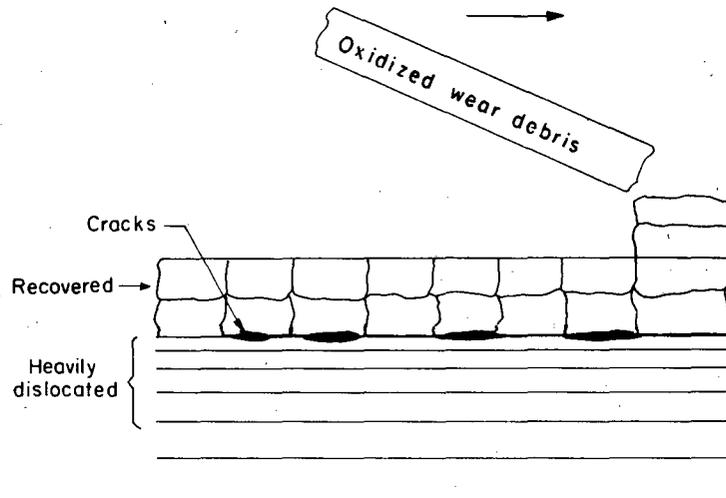
XBL 824-5509

Step A

Step B Wear particle in process of formation.

Step C

Figure 16: Schematic overview of the unlubricated sliding wear process.
