Longevity of duct tape in residential air distribution systems: 1-D, 2-D, and 3-D joints

# **Longevity of Duct Tape in Residential Air Distribution Systems: 1-D, 2-D, and 3-D Joints**

**Bass Abushakra**

December 2002

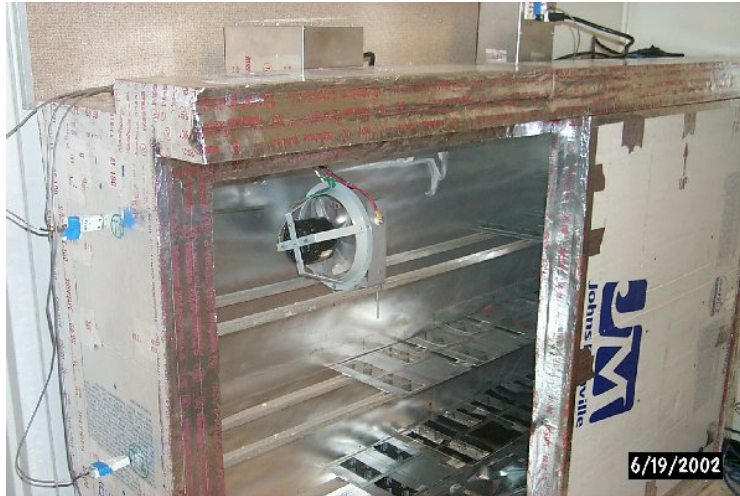
Figure 3 shows the baking test oven that provides constant circulating air temperature of 212°F (100°C) for the baking specimens following the UL 181B “temperature test” protocol. All walls of the oven are made with 4” (100 mm) thick foil-faced foam sheathing. The bottom of the oven, sitting on the floor, is made thicker (6” (150 mm)) for added insulation. The oven is 44” (112 cm) high, 72” (183 cm) wide, and 10” (25 cm) deep. It contains four racks made of two strips of aluminum that hold the testing specimens. Six temperature sensors equidistantly placed on both sides of the oven provide readings of the temperature profile inside the oven. Measured results show that the temperatures do not vary by more than 5°F (2.5°C) from the average temperature of 212±5°F (100±3°C). The oven has an electric heating unit controlled by a relay box to turn off at 214°F (101°C) and on at 210°F (99°C), and also protected by a safety snap thermostat rated at 250°F (121°C). The temperature values are recorded at a one-minute interval. The air circulation inside the oven is insured by a thermally-protected ball-bearing 115 volts.

**Figure 3. The high temperature baking apparatus.**

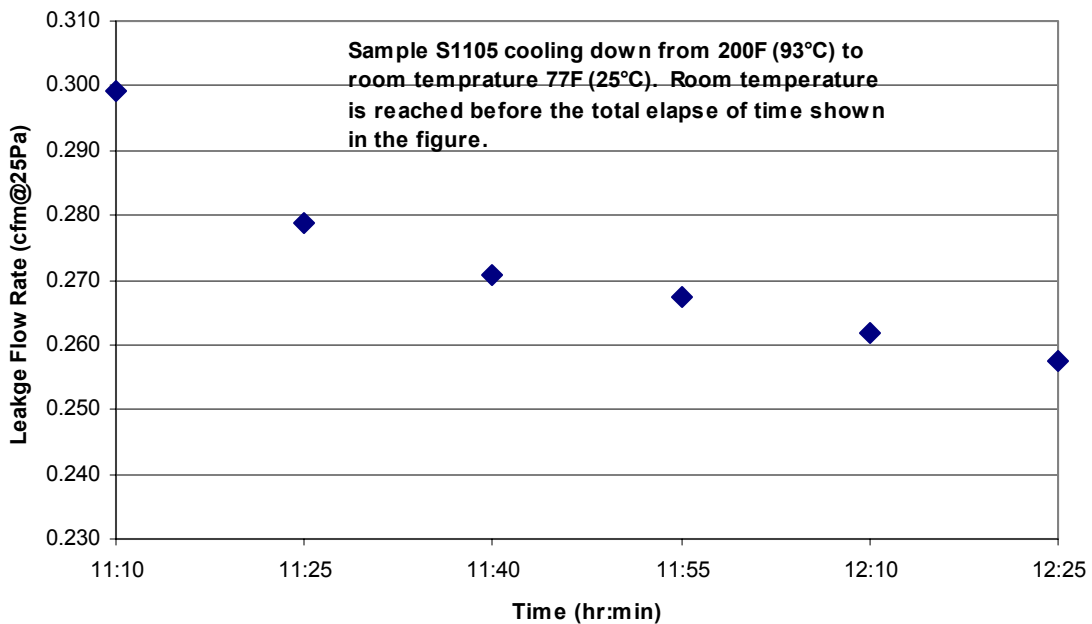
Because the aging test involves heating the specimens continuously at 200°F (93°C), it takes some time for the specimens to return to room temperature. Therefore the elapsed time between removal from the test chamber and measurement of leakage could have an effect on the results. To examine this effect, a specimen was tested six times at 15-minute intervals, with the first measurement taken at its highest temperature (200°F (93°C)). The experiment took place in the laboratory where room temperature is 77°F (25°C). Figure 4 shows the decay in the leakage flow as a function of cool-off time. The leakage flow at the highest temperature is 16% higher than the last value taken 1 hour and 15 minutes later. The difference in leakage is attributed to the “re-sealing” of the joint as it shrinks and hardens at lower temperatures. For consistent results the samples need to cool to room temperature before being leakage tested. However, for some of these results discussed here we did not wait a uniform time, which resulted in additional uncertainty in measured sample leakage.

**Figure 4. Decay in the measured leakage as the specimen cools down from 200F (93°C) to room temperature.**

stabilization and tested the samples at some intermediate temperature, thus leading to higher measured leakage. The magnitude of the changes in leakage with time and therefore sample temperature shown in Figure 4 indicate that the negative leakage shown in Figures 13a and b is of a similar magnitude to this effect. In addition, a general observation of the core-to-collar joints undergoing an aging test is that the shrinkage of the duct tape can have a positive effect as it tightens up around the joint, unlike the case of a collar-to-plenum joint where the shrinkage of the duct tape makes it peel off and pull away from the surface it is applied to, thus exposing the leaks.

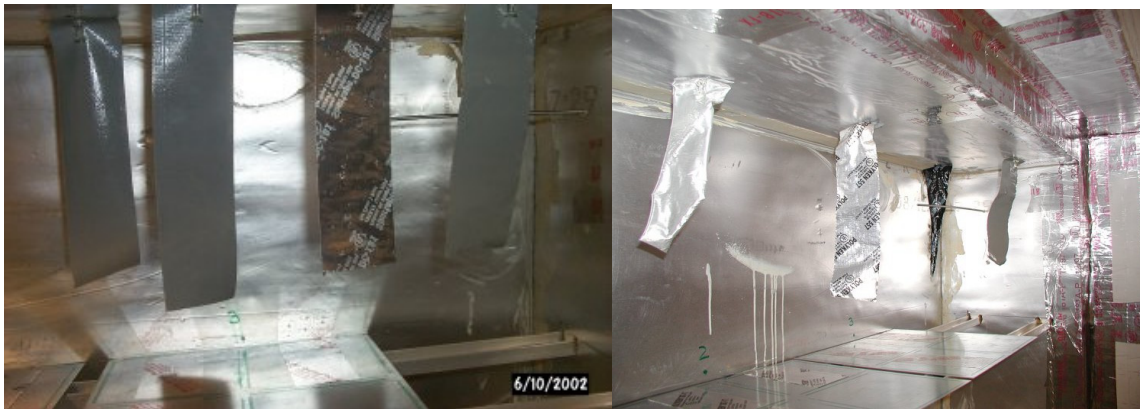
In addition to the specimens following the UL 181B temperature test protocol, we included “hanging specimens” (Figure 8) of all four tapes in the oven to examine their deterioration in isolation from the substrate they are applied to.

**Figure 8. Hanging specimens of Tapes 1 to 4 in the high temperature baking apparatus before testing and after three weeks of testing.**

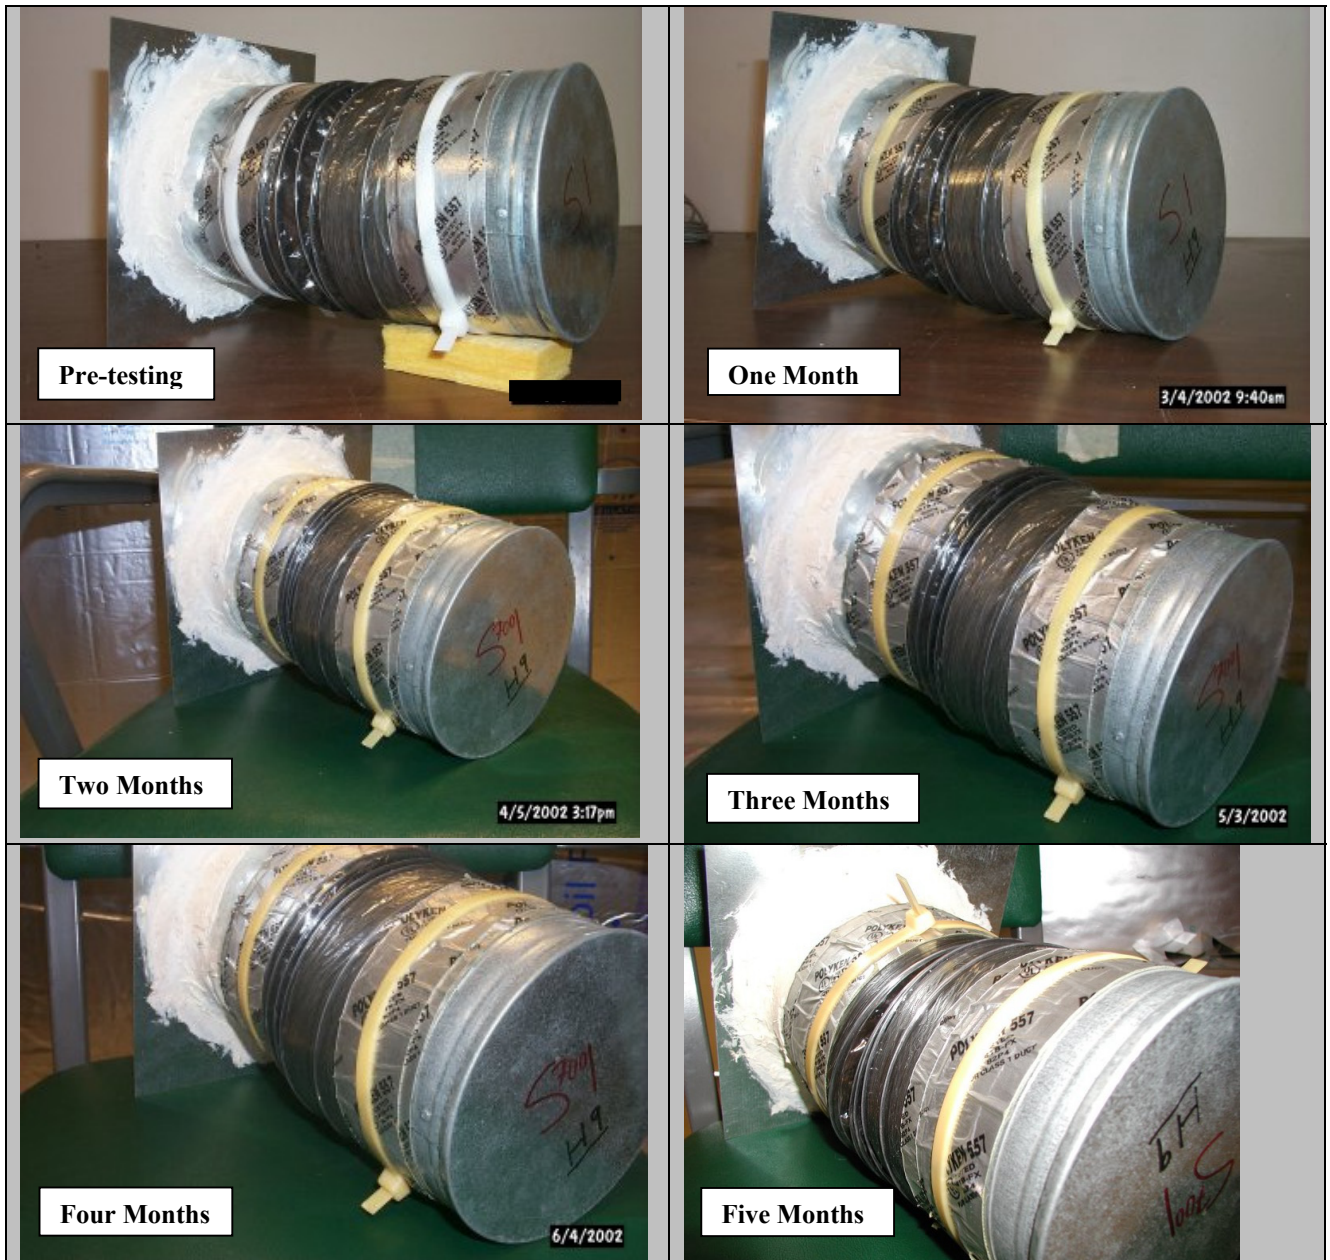
In order to systematically record the visual deterioration of the samples, monthly pictures of all 18 specimens were taken. Typical minor deteriorations were observed as discoloration, wrinkling, and oozing, and major deteriorations were shrinking, peeling, delamination, and cracking. Figure 9 shows the deterioration of one of the specimens with clamping, and 2 continuous wraps of duct tape.

**Figure 9. Deterioration of flexible duct core-to-sheet metal collar joint during the six months of the aging test at 200 F (93°C) temperature.**

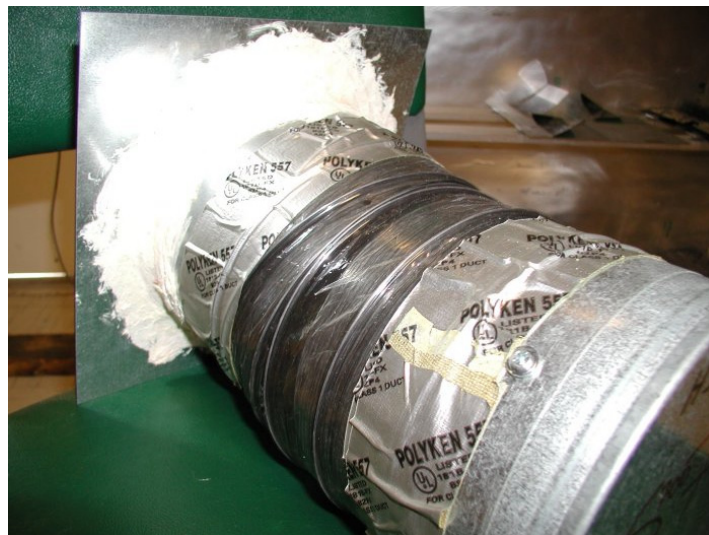
- shrinkage and delamination among the unclamped specimens (Figure 10)
- oozing of the adhesive layer in the foil-butyl tape (Tape 4) specimens (Figure 11)
- little shrinkage and delamination in the strapped specimens
- discoloration of the plastic strapping in the clamped specimens

**Figure 10. Shrinkage and delamination among the unclamped specimens (showing here result of 5 months of aging)**

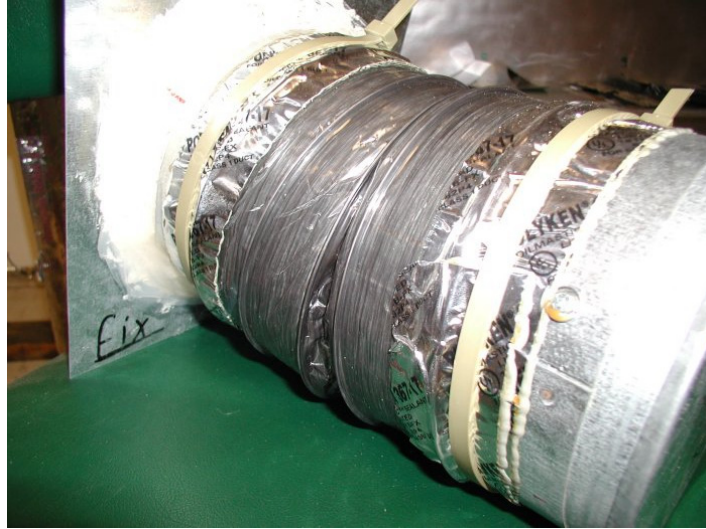
**Figure 11. Oozing of the adhesive layer in the foil-butyl tape (Tape 4) specimens (showing result of 5 months of aging).**

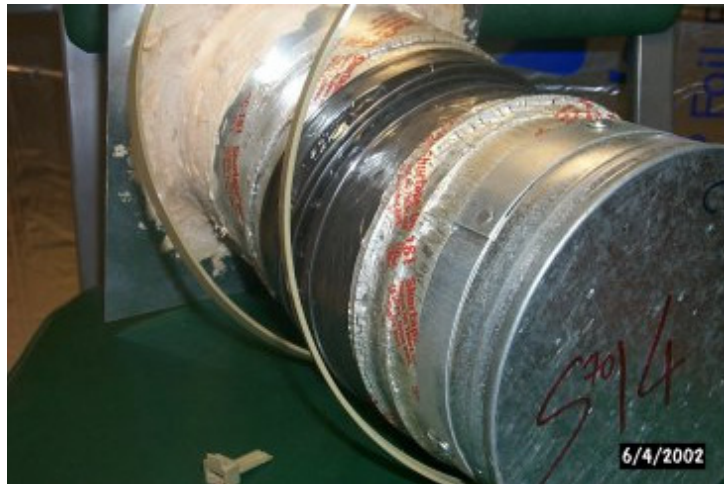
The discoloration of the plastic strapping was an indication of its deterioration which basically lead to a total failure afterward in one case (specimen S7014) after four months of aging. The plastic clamp cracked open due to the increased brittleness of the plastic (Figure 12).

**Figure 12. The failed plastic strapping on one of the flexible core to sheet metal collar specimens after four months of aging.**

Lastly, we found that plastic straps became discolored and brittle during the tests, and a couple of straps broke completely. Therefore, we recommend that clamping the duct-taped flexible core-to-collar joints should be done with metallic adjustable straps.

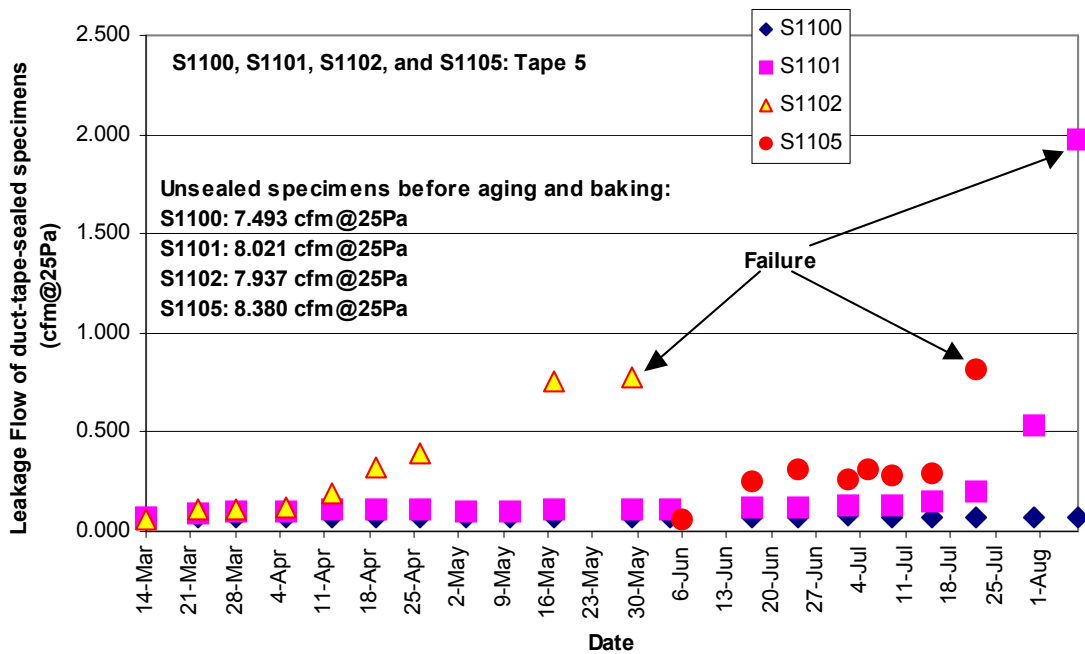
**Collar-to-plenum joints aging test.** In addition to the aging tests of the flexible duct, core-to-collar joints, we also repeated the tests of the collar-to-plenum joints aging tests that were conducted in previous studies. These tests were performed for a new duct tape product that has been developed to have improved high temperature performance (Tape 5) as well a sample of Tape 1. The tape new failed in 9 days (using the >10% of unsealed leakage criteria), showing shrinkage and pulling away from the sheet metal plenum. Figures 14 and 15 show the results of these tests. Because they were mounted in a different location on the test apparatus, these collar-to-plenum were exposed to different temperatures than the core to collar samples. These samples were placed between the left and right chambers (shown in Figure 2) where in previous phases of longevity testing the samples experienced cycling temperatures. Table 4 shows the temperatures the specimens were exposed to during the test, and the corresponding elapsed time before failure. Specimen S1102 failed after 2.5 months, and was replaced with specimen S1105. Specimen S1105 appeared to leak at a faster rate at the beginning, then leveled off, then showed a catastrophic (sudden) failure, contrary to the gradual failure of S1002). It took specimen S1105 only one month and three weeks to fail.

**Figure 14.** The measured leakage of the collar-to-plenum joint Tape-5 specimens.

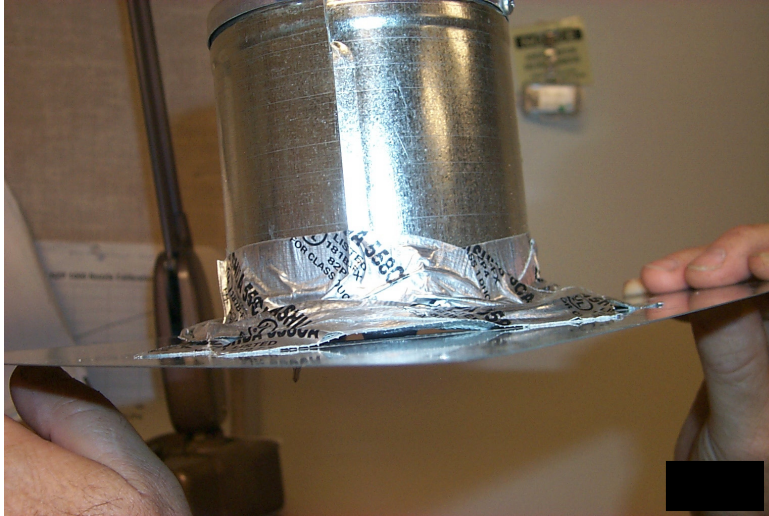
Figure 16 shows the failure of the 3-D joint as the duct tape tends to pull away from the sheet metal, thus uncovering the series of overlapping fin-joints.

**Figure 16. A typical failure of the 3-D collar-to-plenum joint.**
