First-Level Analysis of Phase 1 Heavy Vehicle Simulator and Laboratory Testing on Four RHMA-G Mixes to Investigate Nominal Maximum Aggregate Size, Layer Thickness, and Performance with Aggregate Replacement from Reclaimed Asphalt Pavement

Partnered Pavement Research Center (PPRC) Project Number 4.75 (DRISI Task 3760):
RHMA-G Thickness Limits

University of California
Pavement Research Center
UC Davis and UC Berkeley

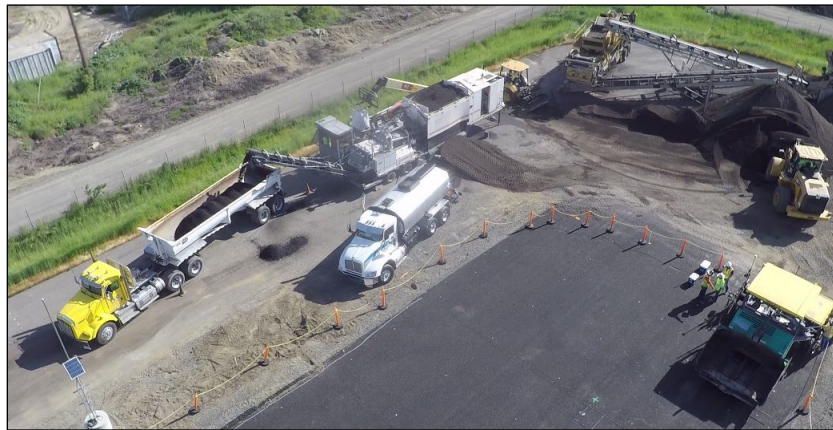
The cold central plant (CCP) was set up next to the crushing plant (Figure 4.22). Recycling agent was fed from a tanker. Active filler (cement) was fed from a super sack directly into the CCP hopper. Compaction and foaming water was sourced from the onboard tank and replenished as required from a water tanker. Samples for quality control and other testing were sampled from the belt. Issues with foaming water content for the CCPR-FA mix were noted in the early stages of production of this mix (mix placed on Lane 3 on Cell D and then Cell C). This was corrected for the mix placed on Lane 2 and Lane 1.

Figure 4.22: CCPR: Central plant setup.

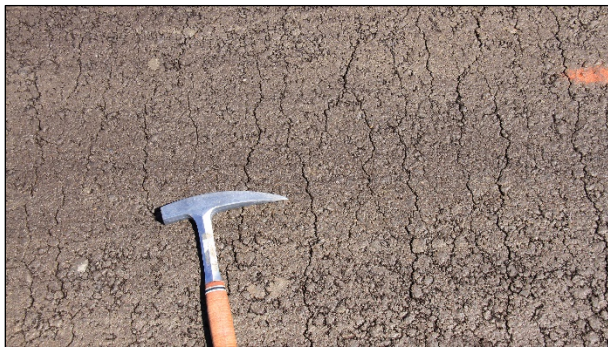
Placement of the CCPR layers was completed with no major issues that might have influenced later performance of the structure. Some shearing of the recycled layer was observed during compaction with the pneumatic tired roller (Figure 4.27), which was attributed to deflection of the underlying aggregate base under the weight of the roller. Shear cracks were not observed after completion of final compaction with the finish roller (Figure 4.28).

Figure 4.27: CCPR: Shear cracks after pneumatic tired roller passes.

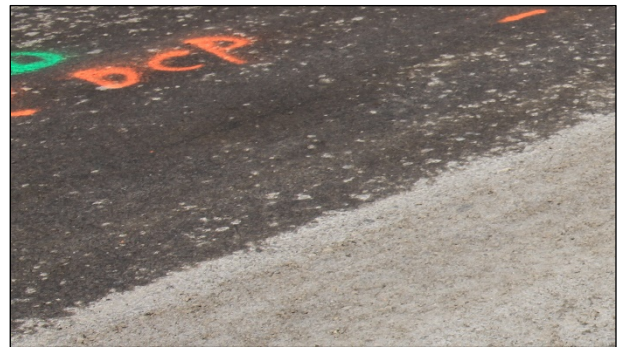
Figure 4.28: CCPR: Crack-free surface after final compaction.

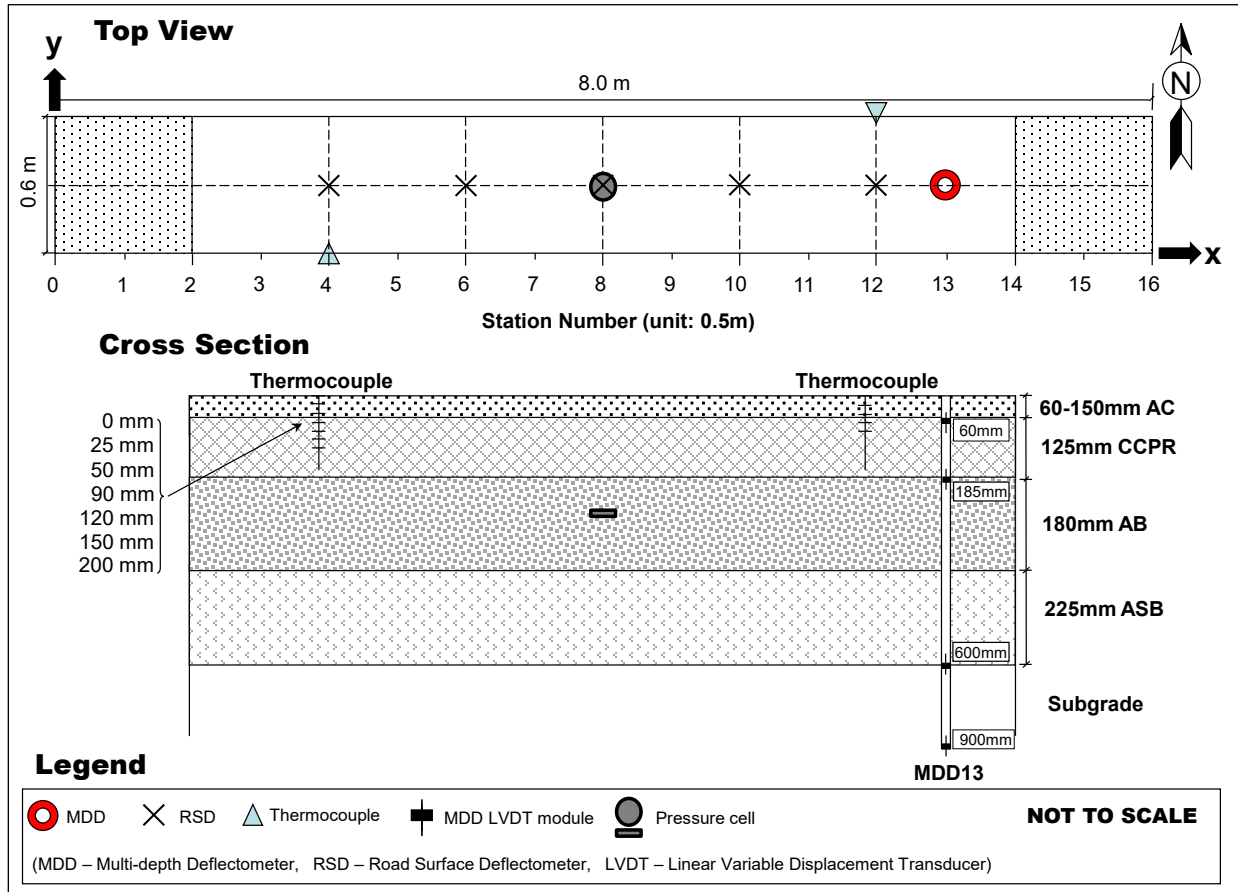
Figure 5.2: Schematic of an HVS test section layout.

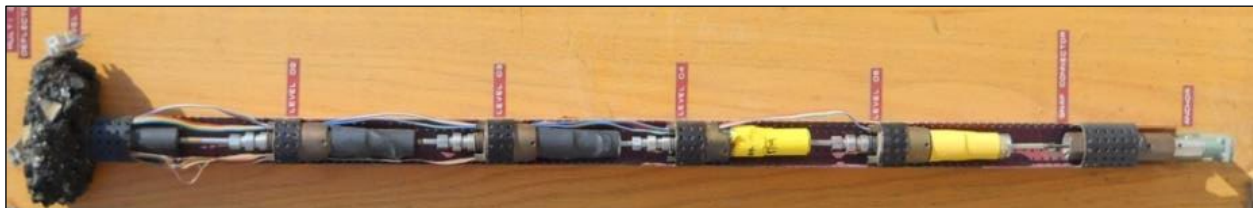
- One multi-depth deflectometer (MDD) was installed on each Phase 1 test section. An MDD is essentially a stack of linear variable differential transformer (LVDT) modules fixed at different depths in a single borehole. The LVDT modules have non-spring-loaded core slugs that are linked together into one long rod that is anchored at the bottom of a 3.3 m (≈ 10.8 ft.) borehole. The LVDT modules are fixed to the pavement layer, which allows permanent vertical deformations at various depths to be recorded, in addition to measurement of the elastic deformation caused by the passage of the HVS wheels. The borehole is 38 mm (≈ 1.5 in.) in diameter. A model MDD with five modules is shown in Figure 5.3. In this project, the MDD was installed at Station 13 between the two wheelpaths of the dual-wheel configuration, with modules 10 mm below the top of the CCPR layer, 10 mm below the top of the aggregate subbase layer, and 10 and 300 mm below the top of the subgrade layer. On one section, a second MDD was installed in the wheelpath at Station 3 to assess differences in results between data collected between the wheelpaths of the dual wheel and data collected in one of the wheepaths, as well to assess upgrades to the device and changes to the installation procedure.

Figure 5.3: A model multi-depth deflectometer (MDD), showing five modules.

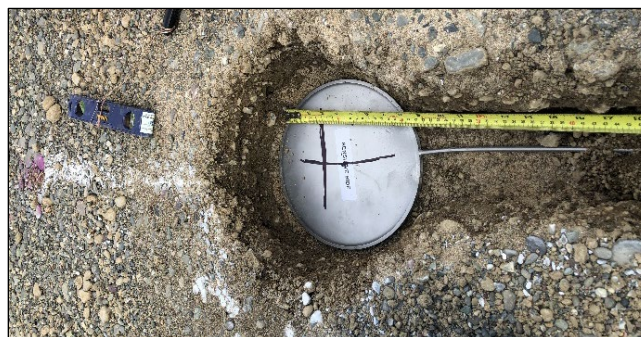
- One RST LPTPC09-S pressure cell was installed at mid-depth in the aggregate base layer (Figure 5.4) on each Phase 1 test section to measure vertical pressure (stress) under the moving wheel.

Figure 5.4: Pressure cell installation.

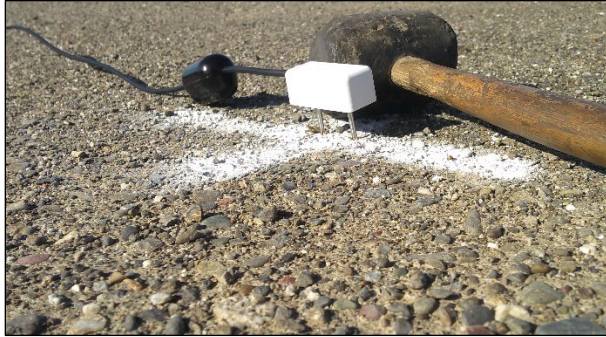
- Multiple moisture sensors (Decogon GS1) were installed in the subgrade, subbase, and base layers (Figure 5.5), positioned next to and between select sections, as shown in Figure 5.6 and Figure 5.7.

Figure 5.5: Moisture sensor installation on top of subbase.

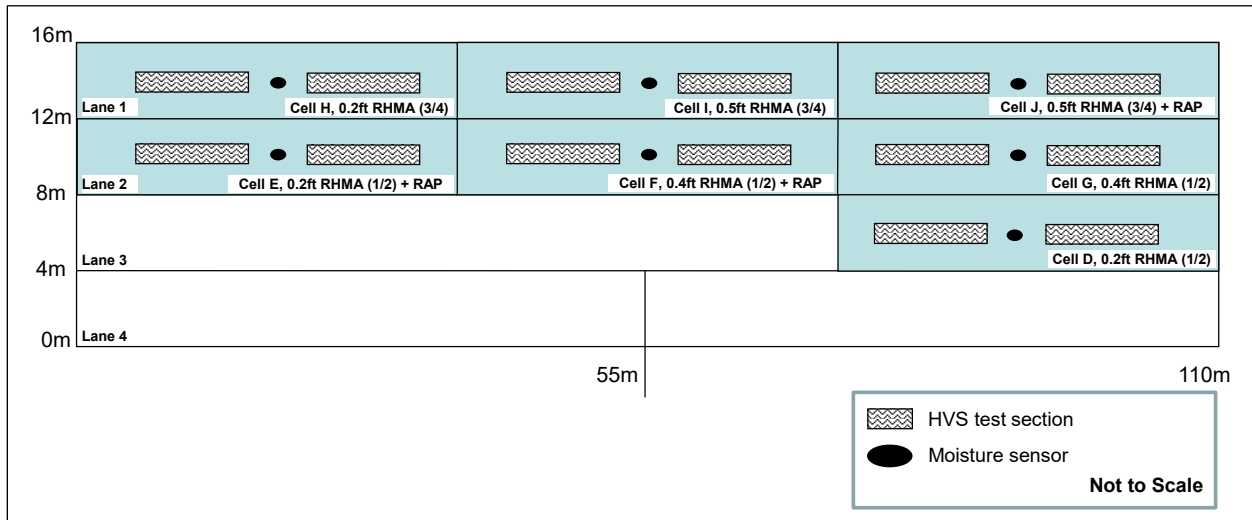
Figure 5.7: Moisture sensor locations.

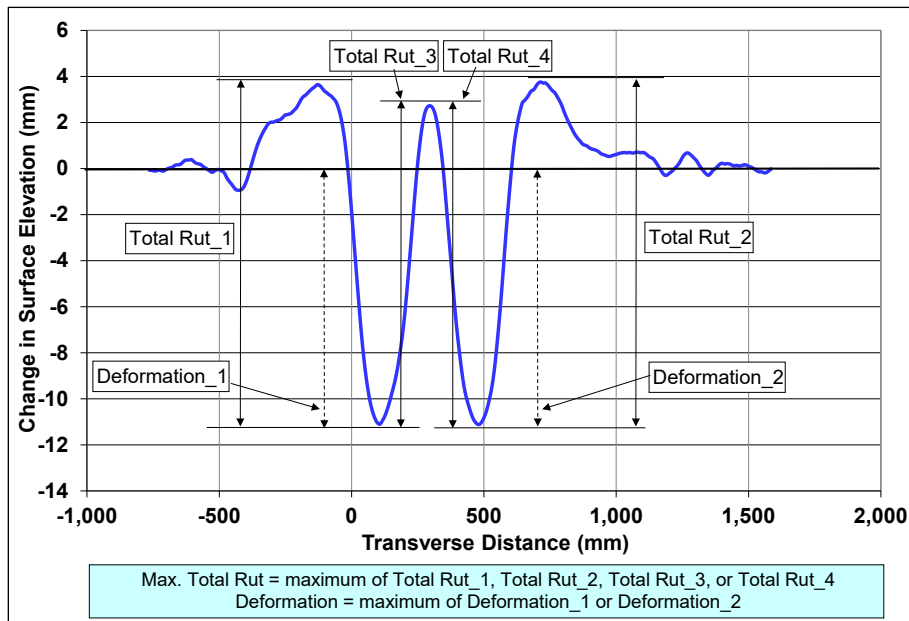
The difference between the surface profile after HVS trafficking and the initial surface profile before HVS trafficking is the permanent change in surface profile. Based on the change in surface profile, the maximum total rut is determined for each station, as illustrated for a dual wheel configuration in Figure 5.8. The average maximum total rut for the section is the average of all of the maximum total ruts measured between Stations 3 and 13.

Figure 5.8: Illustration of maximum rut depth and deformation for a leveled profile.

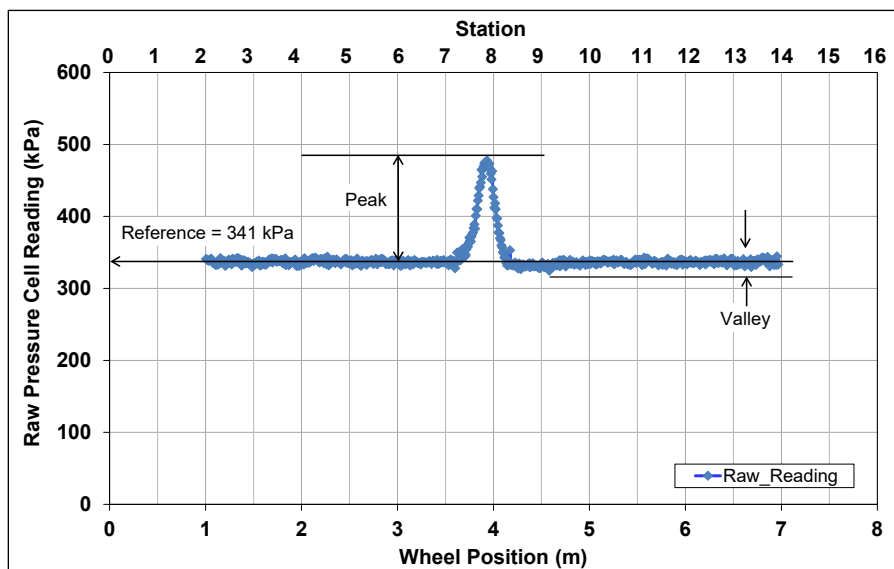
Example data recorded from a pressure cell is shown in Figure 5.10, which shows the variation of the cell reading versus wheel position as the wheel travels from one end of the test section to the other. Several quantities are summarized based on the raw readings. The peak pressure reported is the difference between the maximum value and the reference value, defined as the value of the first reading recorded at the point furthest away from the instrument (i.e., Station 2).

Figure 5.10: Example pressure cell reading and definition of summary quantities.

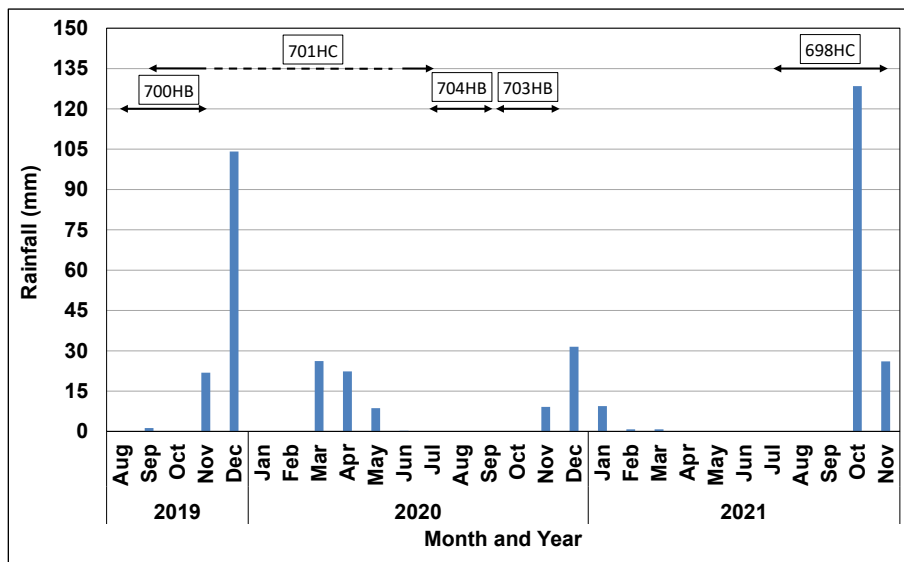
Figure 6.1 shows the monthly rainfall data from August 1, 2019, through November 31, 2021, as measured at the weather station next to the test track. All sections were tested predominantly during dry conditions, with small amounts of infrequent rainfall recorded during four of the five tests (no rainfall was recorded during testing on 704HB and only trace amounts were recorded during testing on 703HB). Only three significant rainfall events (i.e., more than 25 mm [≈ 1.0 in.] in 24 hours for this study) occurred, with one event recording 112 mm (≈ 4.5 in.) in 24 hours (698HC).

Figure 6.1: Measured rainfall during Phase 1 HVS testing.

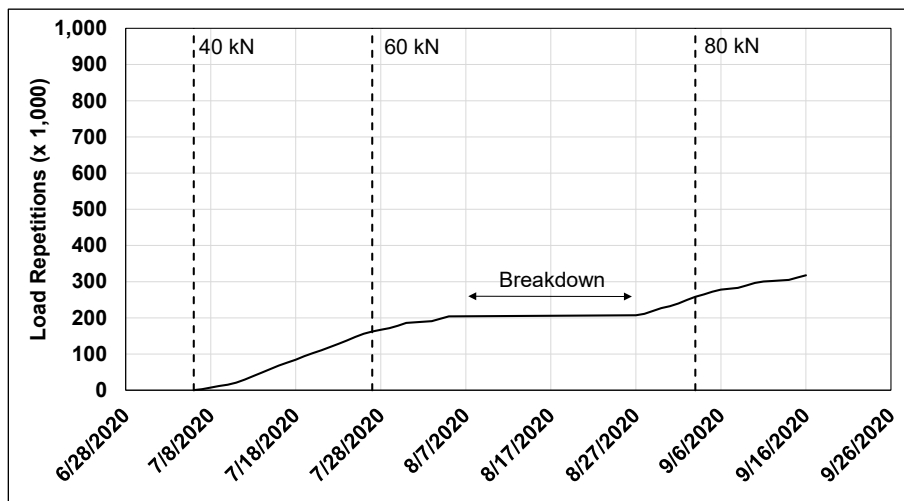
Loading commenced with a 40 kN half-axle load on July 6, 2020, and ended with an 80 kN load on September 18, 2020. A total of 320,000 load repetitions were applied, and 36 datasets were collected. Load was increased from 40 kN to 60 kN after 160,000 load repetitions, and then to 80 kN after 260,000 load repetitions. The HVS loading history for Section 704HB is shown in Figure 7.1. A 21-day breakdown resulting from a hydraulic system failure occurred between August 6 and August 26.

Figure 7.1: 704HB: HVS loading history.

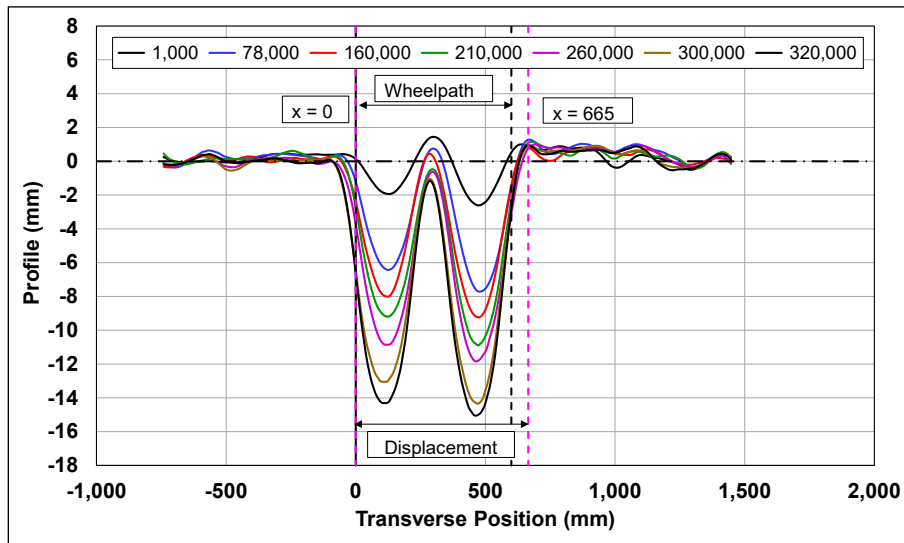
Figure 7.5 shows the average transverse cross section measured with the laser profilometer at various stages of the test. This plot clearly shows the initial high rate of rutting and the increase in rutting and deformation over time and that most of the deformation was in the form of a depression (i.e., deformation was below the zero elevation point at the surface [see Figure 5.8]) rather than upward and outward displacement of the material above the zero elevation point.

Figure 7.5: 704HB: Profilometer cross section at various load repetitions.

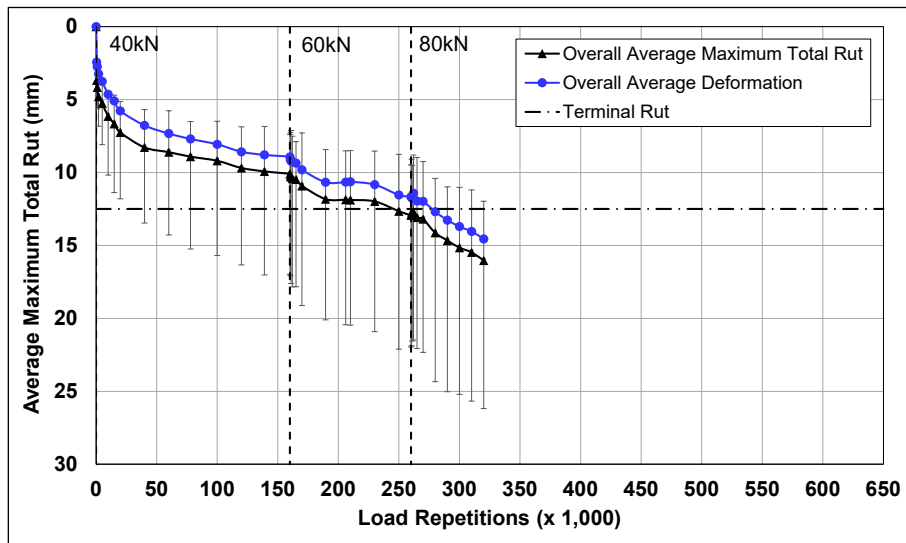
foaming water content during early stages of CCPR material production, which may have affected the CCPR layer performance. Poor aggregate interlock in the aggregate base may also have contributed). The rate of increase of the rut depth after the embedment phase slowed considerably. The increase in the applied load to 60 kN resulted in a short embedment phase before stabilizing to rates similar to those recorded during the 40 kN testing. After the load increase to 80 kN, the rate of rut depth increased and did not change significantly until the end of the test.

Figure 7.6: 704HB: Average maximum total rut and average deformation.

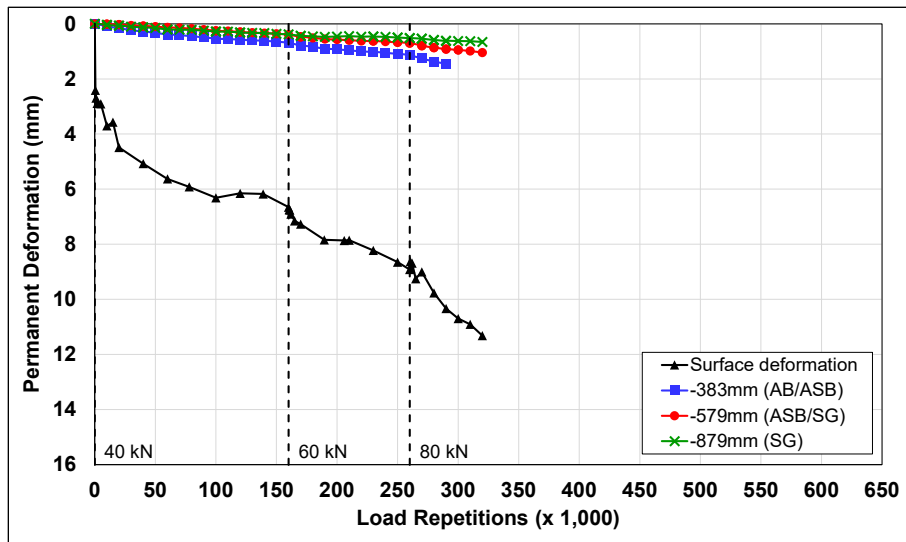
section cannot be directly compared with those from the laser profilometer because the MDD was installed in the untrafficked area between the two wheelpaths of the dual wheel on this section. This instrument location can therefore only provide an indication of which layer or layers the permanent deformation occurred in and not the actual deformation in each layer, which will be assessed during forensic investigations when all testing is completed.

Figure 7.10: 704HB: Permanent deformation in the underlying layers.

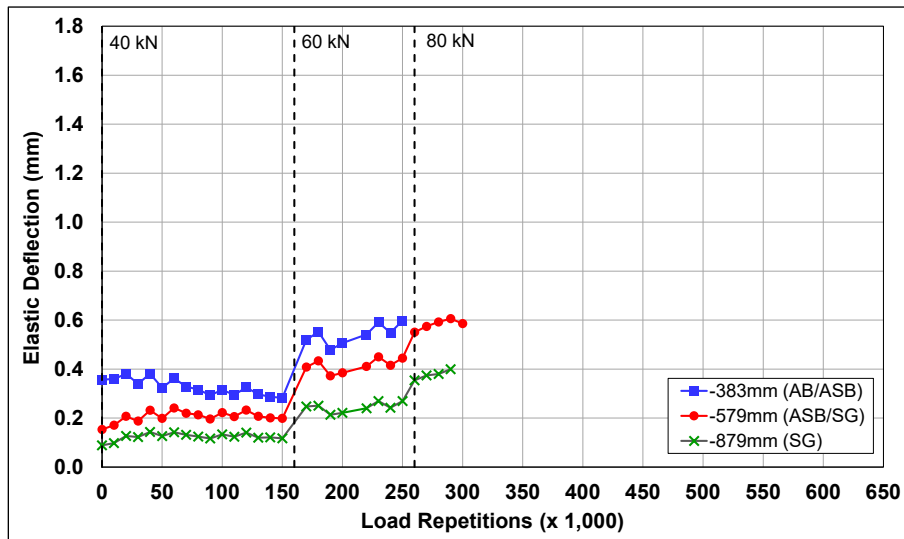
Figure 7.13 shows the history of in-depth elastic deflections measured by the LVDTs in the multi-depth deflectometer. These readings are consistent with the surface deflections measured with the RSD shown in Figure 7.12. Deflections remained stable for the duration of testing under a 40 kN wheel load.

Figure 7.13: 704HB: Elastic deflection in the underlying layers.

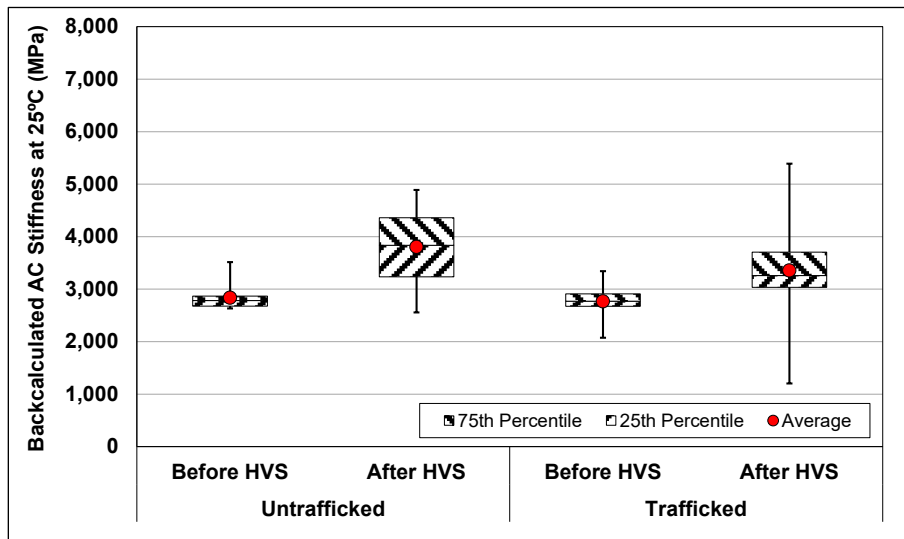
summarized in Figure 7.15. Error bars represent the lowest and highest values. The average backcalculated stiffness of the RHMA-G layer (2,770 MPa) at the start of testing was lower than those recorded on RHMA-G layers tested in previous projects (around 4,300 MPa). Average stiffness increased (about 590 MPa) after HVS trafficking, with a notable difference along the length of the section (1,200 MPa to 5,400 MPa), confirming the damage at the one end. The average stiffness of the untrafficked areas at either end of the test section also increased, consistent with the deflection measurements.

Figure 7.15: 704HB: Backcalculated stiffness of the RHMA-G layer (FWD).

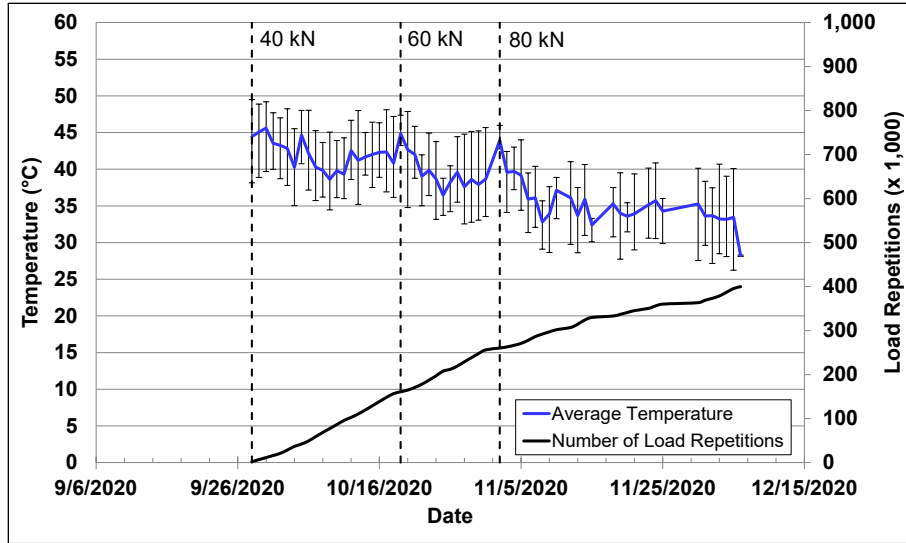
Daily 24-hour averages of the air, surface, and in-depth temperatures of the RHMA-G and recycled layers are shown in Figure 8.3 and listed in Table 8.1. Pavement temperatures were constant and in the target range ($50 \pm 2^{\circ}\text{C}$ at a pavement depth of 50 mm) in the RHMA-G layer. Temperatures decreased with increasing depth in the underlying layers, as expected.

Figure 8.3: 703HB: Daily average air temperatures inside the environmental chamber.

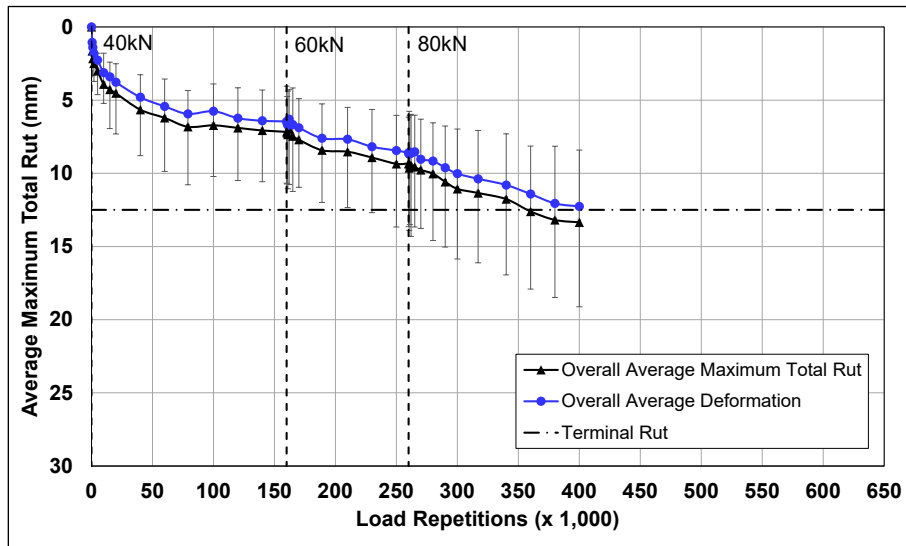
Section 704HB was attributed in part to the thicker RHMA-G layer (120 mm [0.4 ft.] on this section compared to 60 mm [0.2 ft.] on the control section).

Figure 8.6: 703HB: Average maximum total rut and average deformation.

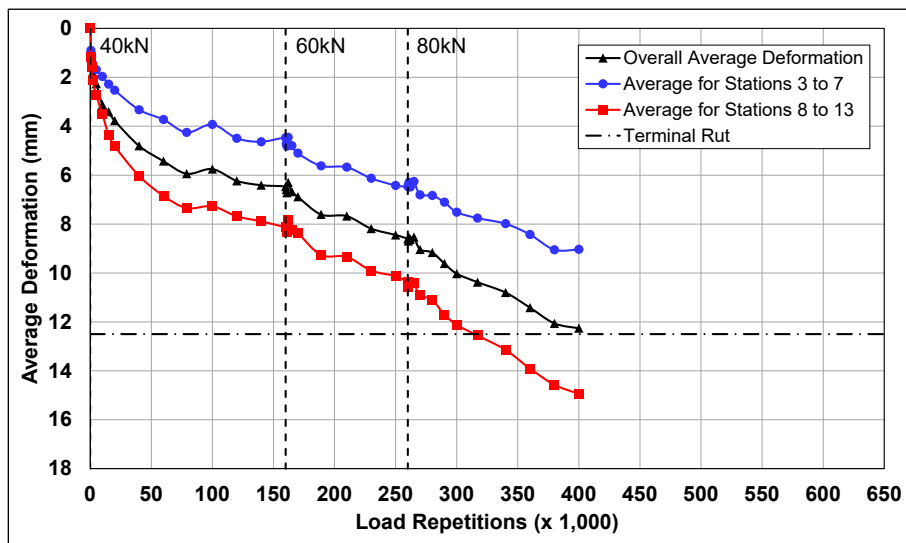
Figure 8.7 shows the average deformation and the deformation measured between Stations 3 and 7 and between Stations 8 and 13. The average rut depth was deeper between Stations 8 and 13, opposite to Section 704HB, but the difference between the rut depths on the two subsections was similar, indicating similar variability along the length of the section.

Figure 8.7: 703HB: Average deformation.

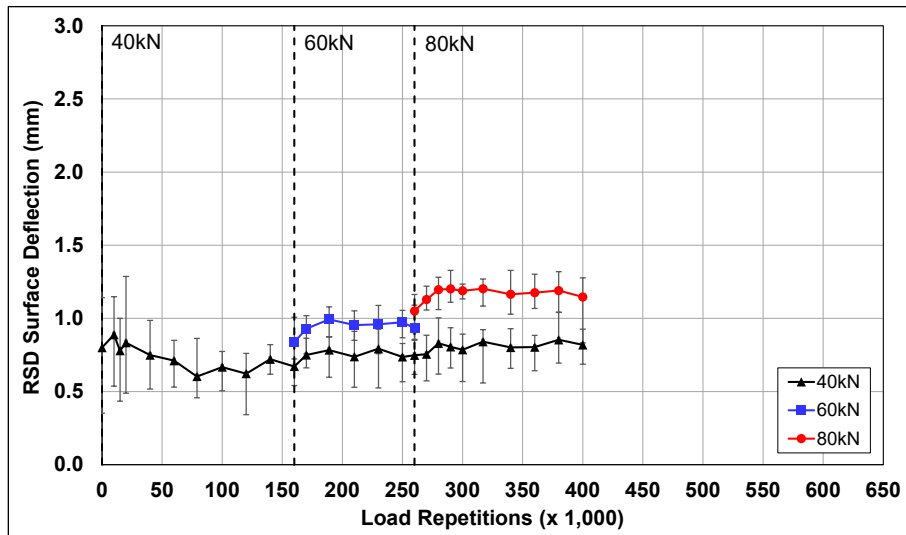
Figure 8.11 compares elastic surface deflections measured with a road surface deflectometer (RSD) under a 40 kN half-axle load. Deflections under the 60 kN and 80 kN loads are also shown.

Figure 8.11: 703HB: Surface deflection (RSD).

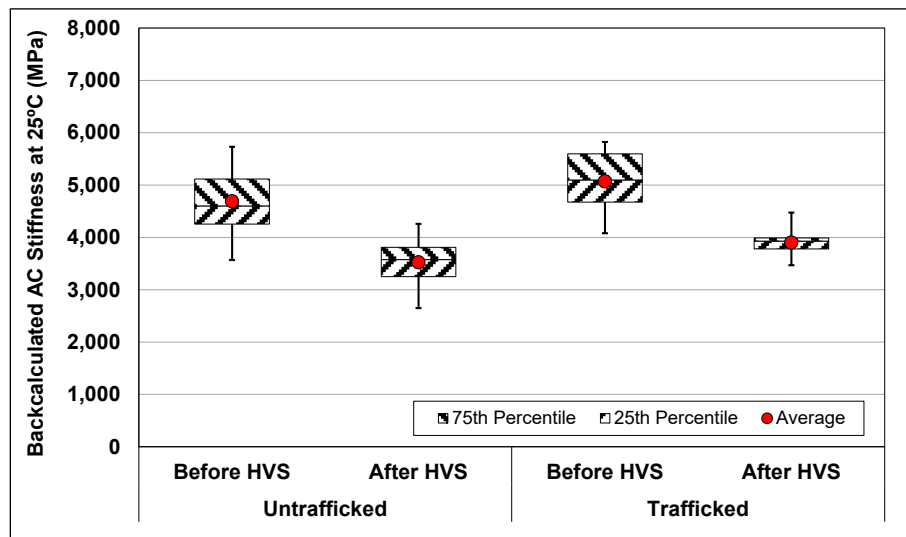
The RHMA-G layer stiffness was backcalculated from the deflection measurements using the *CalBack* software package (see Section 5.5.5 for method followed), and the results are summarized in Figure 8.13. Error bars represent the lowest and highest values.

Figure 8.13: 703HB: Backcalculated stiffness of the RHMA-G layer (FWD).

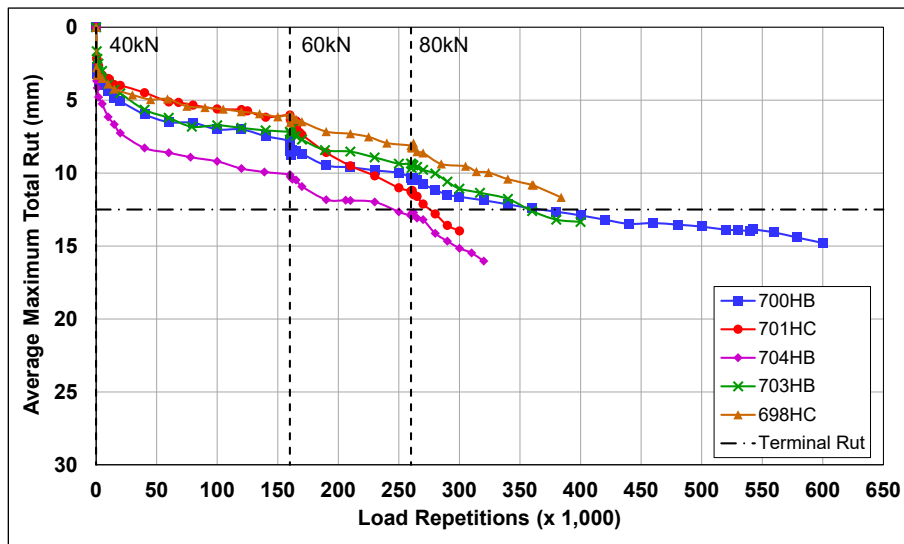
Figure 12.1: Average maximum rut for all sections.

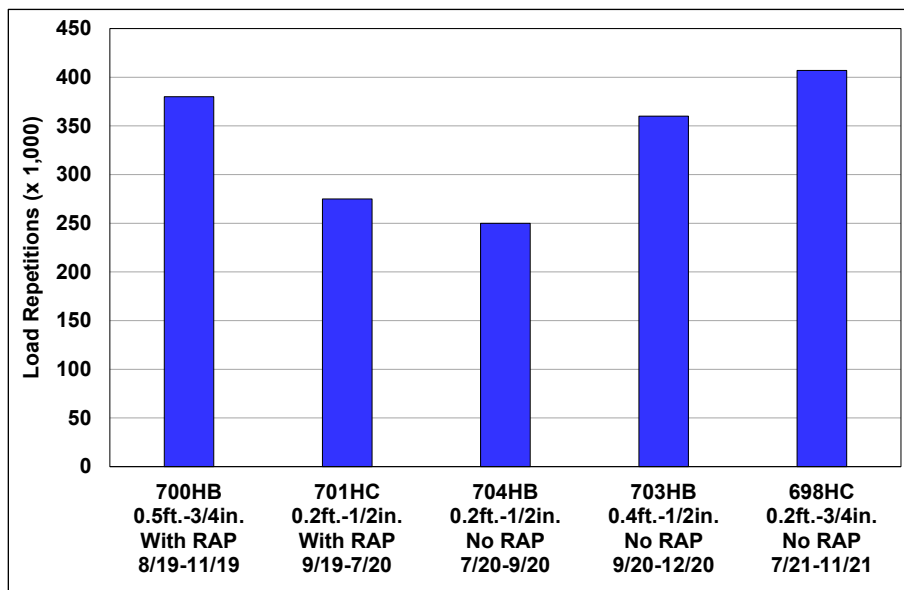
Figure 12.2: Load repetitions to terminal rut (12.5 mm [0.5 in.]).

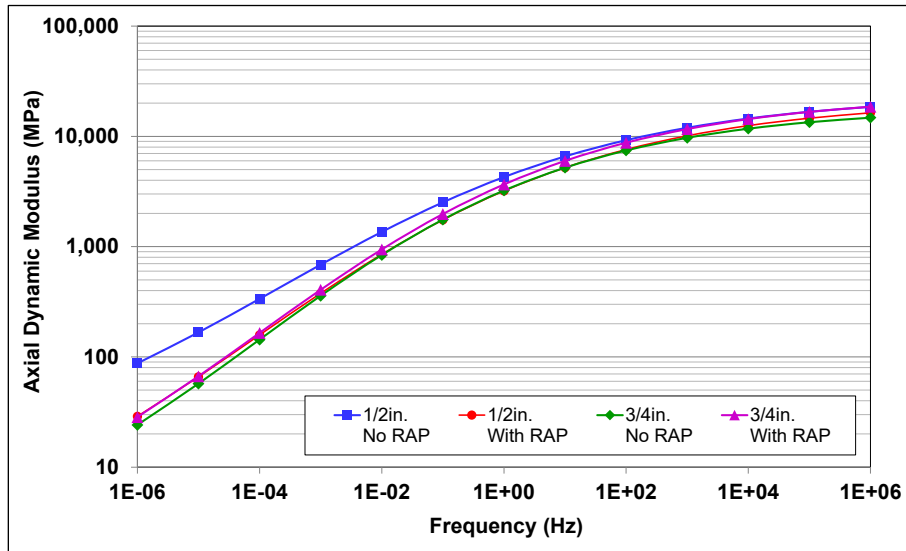
Figure 13.2: Axial dynamic modulus master curves.

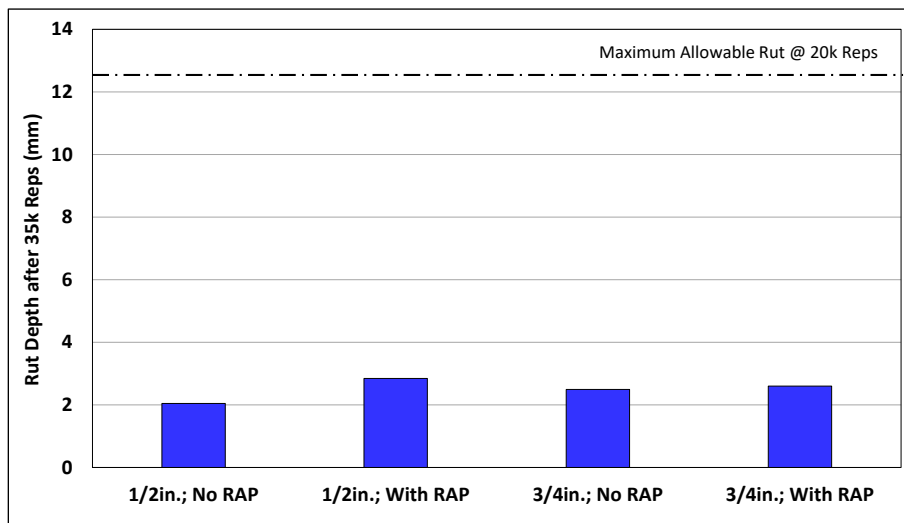
Figure 13.4: Hamburg wheel track results.

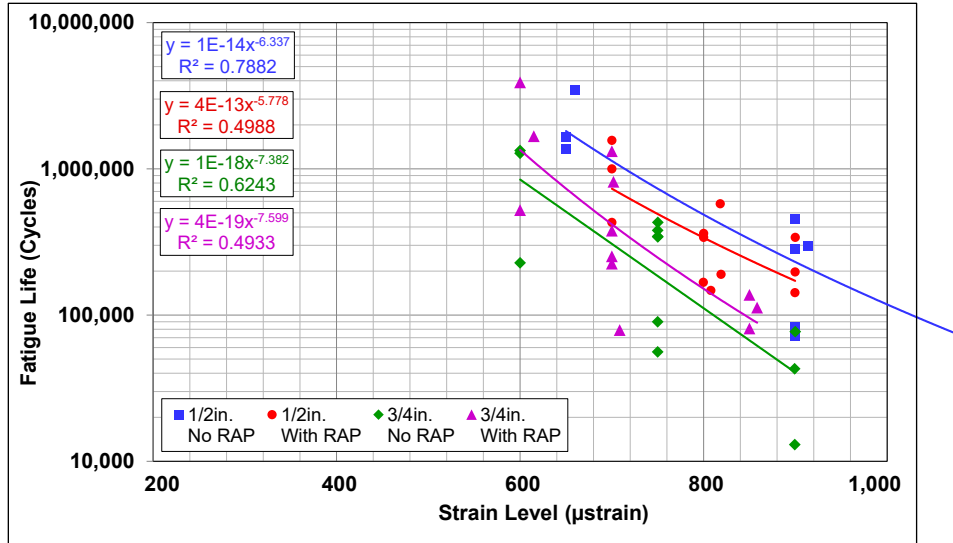
Figure 13.7: Fatigue regression models.

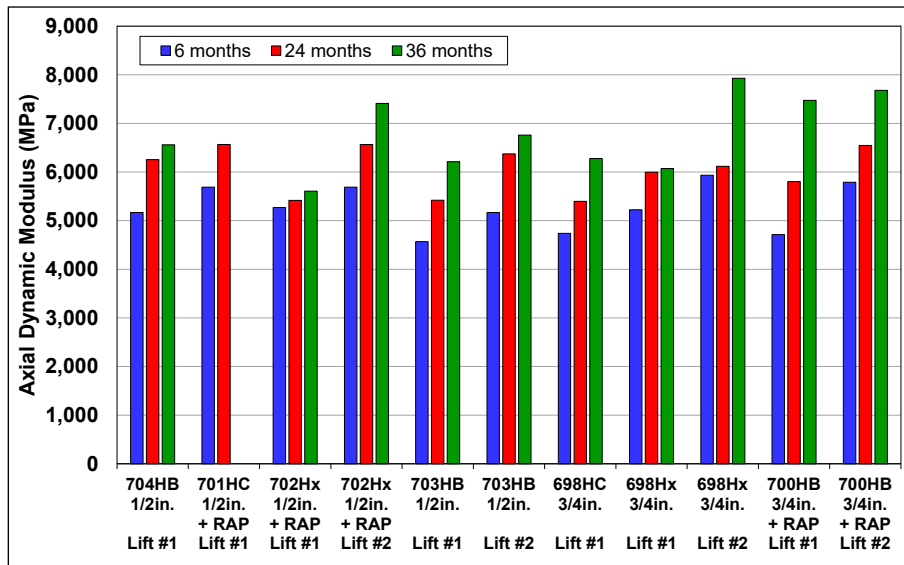
Figure 13.11: Axial dynamic modulus over time at 10 Hz from test track cores.
(Note that Section 702Hx and Section 698Hx were not tested with the HVS.)
