Re-cementation of Crushed Material in Pavement Bases

California Department of Transportation (Caltrans)
Office of Roadway Research and Division of
Maintenance
Office of Pavement Preservation

University of California
Pavement Research Center
Davis and Berkeley

DOCUMENT RETRIEVAL PAGE		Technical Memorandum No.: UCPRC-TM-2009-04			
Title: Re-cementation of Crushed Material in Pavement Bases					
Authors: L. Chai, C. L. Monismith, and J. Harvey					
Caltrans Technical Lead and Reviewer: D. Maskey					
Prepared for: California Department of Transportation Division of Research and Innovation Office of Roadway Research		FHWA No.: CA131890A	Date Work Submitted: March 30, 2010	Memorandum Date: October 2009	
Strategic Plan Element No: 3.1.4		Status: Stage 6, final version		Version No: 1	
<p>Abstract: When recycled crushed concrete and crushed cement-treated materials have been used in pavement bases and subbases, increases in stiffness have been observed. This stiffness increase has been attributed to re-cementation of these materials. To evaluate this phenomenon, four projects that used these recycled materials and for which data are available have been studied. Two of the projects are p

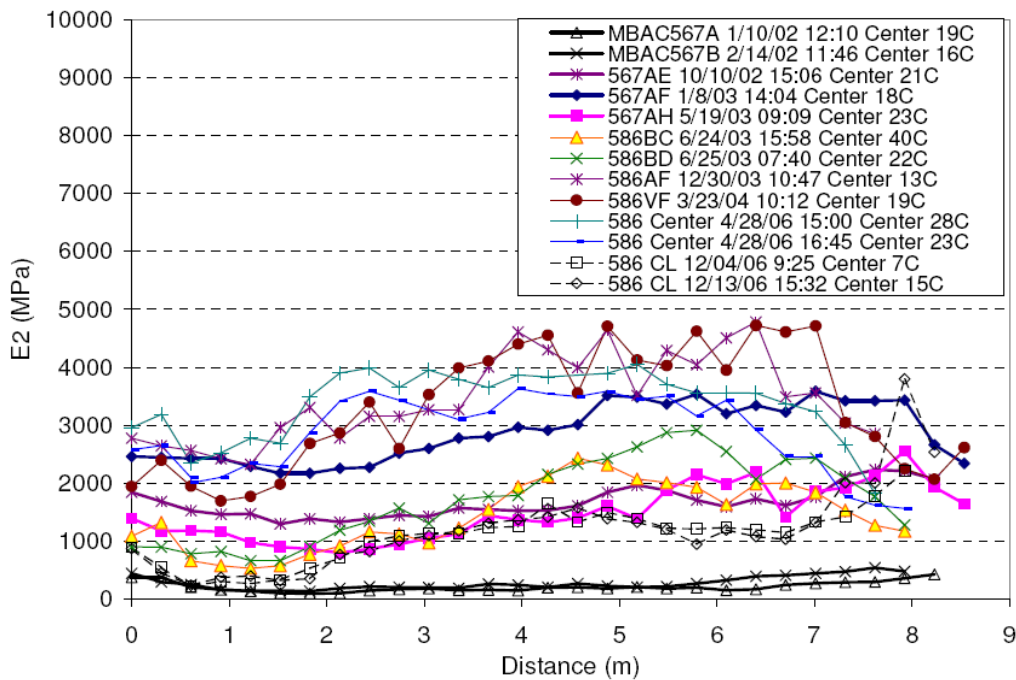
Very little time passed between the initial construction and the initial HVS testing on Section 567/586RF, and during that period no FWD tests were conducted. Backcalculations show that the moduli of the base changed between 1,000 and 4,000 MPa (145,000 and 580,000 psi) during the approximately five years that passed between the initial and the second HVS trafficking; Figure 3.5 and Figure 3.6 show that changes especially occurred during the first two years. During this time there was almost no truck traffic and only light car traffic. This would indicate that while some of the stiffness increase is likely due to curing (drying out causing suction) of the base, much of the stiffness gain should be attributed to re-cementation of the recycled concrete aggregate particles used in the base material (12). Most virgin Class 2 bases have stiffnesses that generally do not exceed 500 MPa (73,000 psi), while this base material had stiffnesses that were 2 to 8 times higher than most virgin Class 2 AB materials.

Figure 3.5: Moduli of aggregate base from FWD measurements over a period of about five years; Sections 567RF/586RF (center of wheelpath).

Some of the increases can be attributed to thixotropic recovery and aging of the asphalt which provided some more confining stress to the aggregate base, but it is highly unlikely that stiffnesses as high as those measured would have occurred without a significant contribution from ongoing re-cementation after construction and each round of HVS testing. The HVS testing was heavy enough that it appears to have broken nearly all of the re-cementation that occurred up to that time, with the moduli of the aggregate base after HVS loading typical of virgin aggregate base. The increased stiffnesses are not as high as on 567/586RF probably because 572/590RF did not have as long before the HVS was put on it. It appears that the re-cementation occurred at a decreasing rate over time, with the improvement after the first HVS testing being less than after construction, and the improvement after the second HVS less again. This makes sense based on the assumption that a finite amount of previously unhydrated cement was exposed during manufacture of the base material, which was being continuously consumed by hydration.

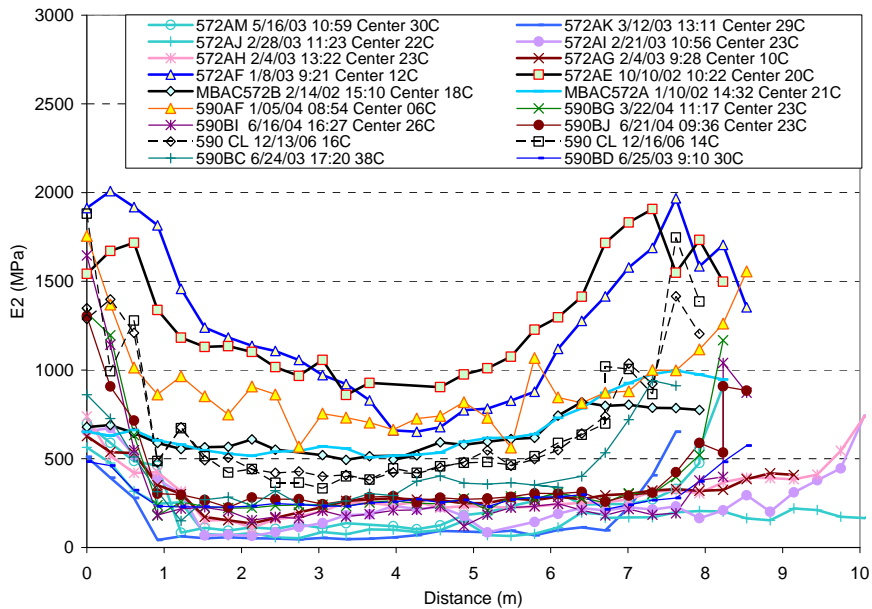
A similar trend can be seen for Section 572/590RF which was constructed at the same time with materials from the same source (Figure 3.7 and Figure 3.8). Section 572/590RF had approximately 18 months of light traffic between initial construction and initial HVS trafficking, another year between the two HVS tests, and another two years between measurements after the second HVS trafficking. It can be seen in Figure 3.8 that in the 18 months after initial construction the stiffness increased to approximately 1,000 MPa (145,000 psi). The very heavy loading of HVS trafficking then reduced the stiffness to approximately 150 MPa (22,000 psi), after which it increased over the next year to approximately 750 MPa (108,000 psi). The second round of heavy loading from the HVS brought the stiffness down to about 250 MPa (36,000 psi), which then increased over the next two years to about 500 MPa (73,000 psi).

Figure 3.7: Modulus of aggregate base from FWD on Sections 572RF/590RF (center of wheelpath).

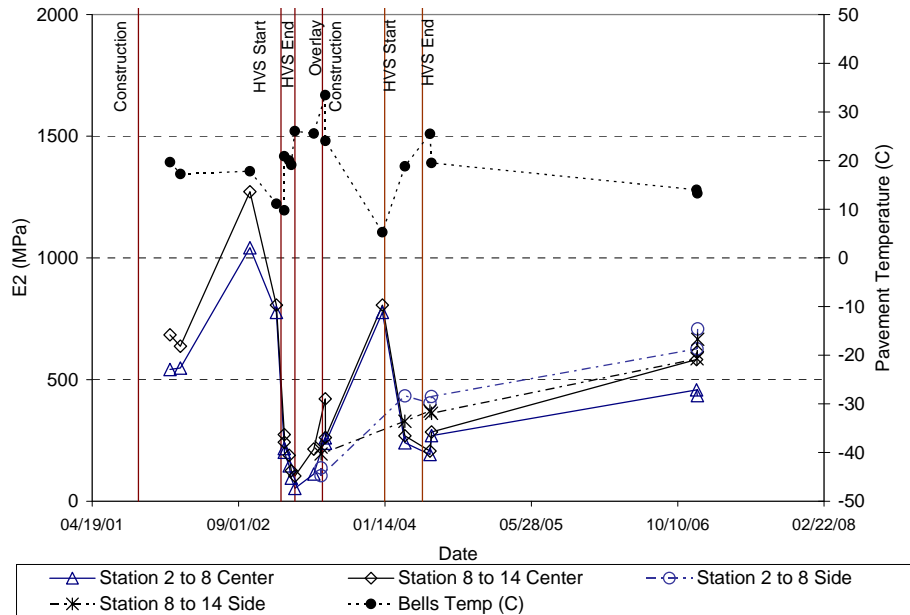
Figure 3.8: Modulus of aggregate base from FWD versus time on Section 572RF/590RF.

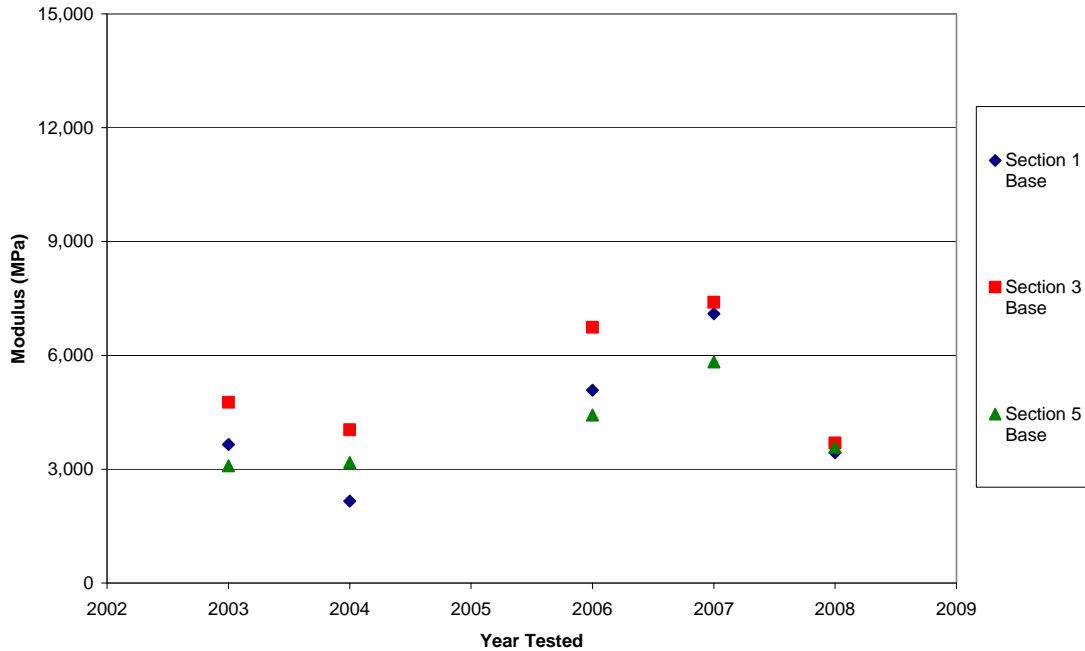
Figure 3.10 through Figure 3.12 show the backcalculated base moduli for the three full-depth sections. Average moduli values for the crushed concrete base section in the full-depth sections were of the order of 4,000 MPa (580,000 psi) with a range of about 1,200 MPa to 7,000 MPa (174,000 to 1,016,000 psi). These values are higher than observed values for conventional crushed aggregate base material. It is suspected that significant cementing must have taken place in the base layer to account for the high levels determined through backcalculation even though no cores were obtained that could be used for strength measurement or to provide evidence of cementation in a laboratory study. Nevertheless, although the computed values might not precisely represent the in-situ characteristics of the material, increased stiffness was evident.

Figure 3.12: I-710 Northbound Lane 3 full-depth sections—layer moduli with time.

It is apparent from these results that over the five-year period of evaluation after construction the stiffness of the base did not decrease significantly, while it did decrease to values typical of aggregate base with no cementation under the HVS loading. The wheel loads on the I-710 pavement do not include many loads over the legal limit,

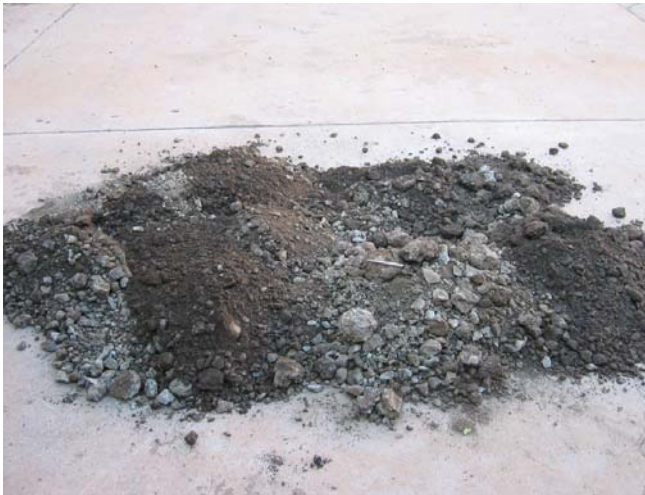
In Figure 3.13, lumps of cemented base from the original road were noted. Freshly exposed faces reacted to phenolphthalein turning a dark red color, indicating the presence of cement (Figure 3.14). A reaction was also obtained when hydrochloric acid was sprayed onto the material, indicating the presence of carbonate.

**Figure 3.13: Base course material from test pit.
(Note large cemented lumps.)**

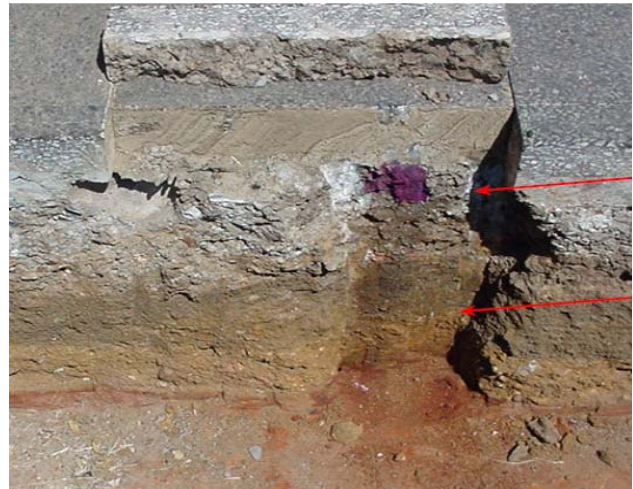
Figure 3.14: Phenolphthalein reaction on base.

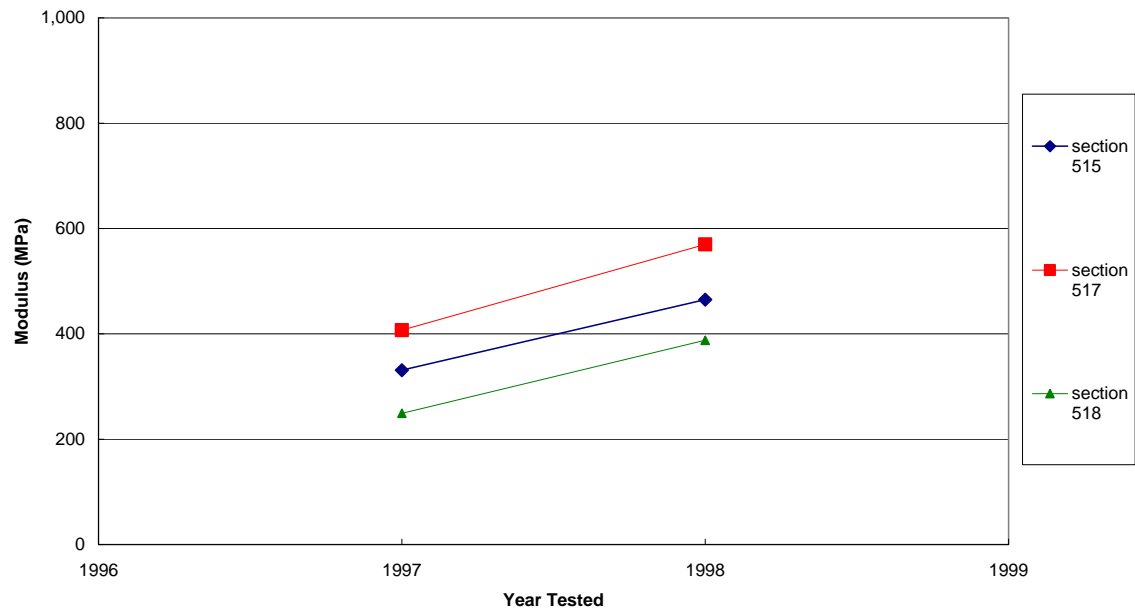
FWD testing and backcalculations performed in 1997 and 1998 showed some increase after 1995 on areas that were not subjected to any trafficking from the HVS, as shown in Figure 3.18, with stiffness ranging between 250 and 400 MPa (36,000 and 58,000 psi). For each of three sections examined (RF 515, 517, and 518), the computed stiffness moduli of the granular base layers increased again with time between 1997 and 1998 as seen in Figure 3.18. This increase was about 45 percent for each section over the year.

Figure 3.18: Backcalculated moduli from FWD deflections.

Observation of the cores of the aggregate base obtained from at least 3 m (10 ft) outside the trafficked areas indicated that some degree of cementation existed, although the results were variable across the entire pavement area. The cementation was sufficient to permit extraction of a complete core from the aggregate base from some locations using a wet coring drill. Cores taken under the HVS-trafficked areas were not cemented, after being subjected to more than a million traffic repetitions with double the legal load.
