Structural evaluation and design procedure for wood beams repaired and retrofitted with FRP laminates and honeycomb sandwich panels

Ayman S. Mosallam

Department of Civil & Environmental Engineering, University of California, Irvine, USA

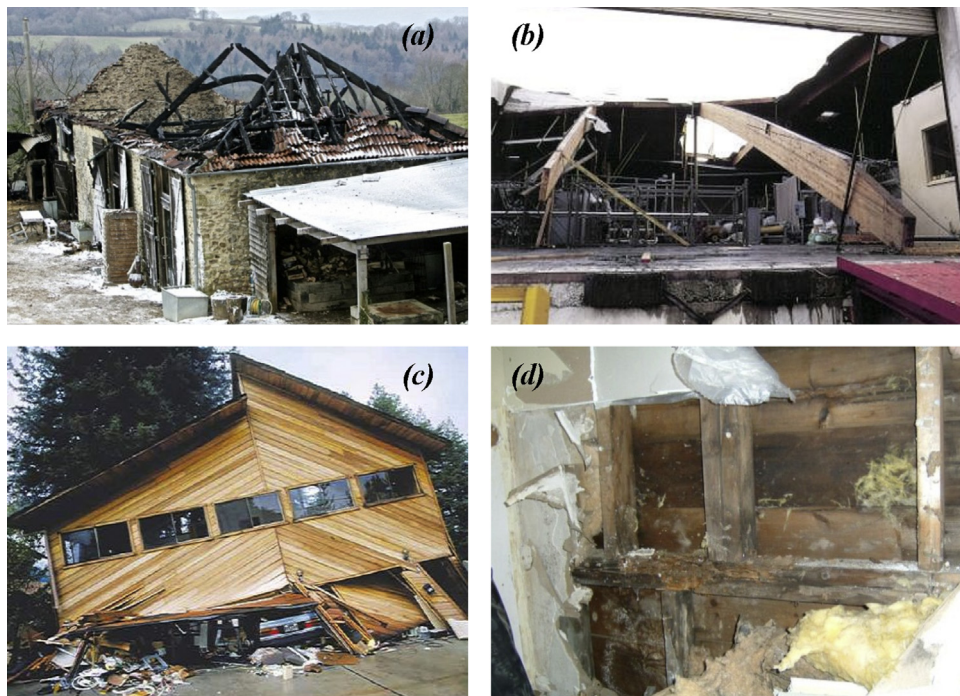
Fig. 1. Examples of Potential Damages of Wood Structures: (a) Fire Damage, (b) Inaccurate Connection Details and Design Faults, (c) Seismic Capacity Deficiency, (d) Environmental Deterioration.

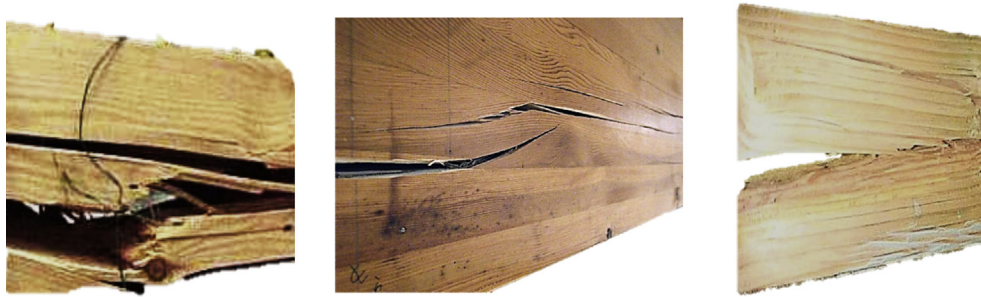
Fig. 2. Interlaminar shear failure of wood members subjected to flexure.

of wood members externally reinforced with polymer composites. In order to successfully introduce this application to the construction industry, more analytical and experimental verification studies are essential. In addition, there is need for developing reliable simplified design procedures for this potential application. In this study, a total of eight large-scale tests were conducted to assess the flexural behavior of wooden members repaired and retrofitted with external composite laminates and to identify the predominated failure mode of such hybrid structural members. One of the major objectives of this study is to highlight the importance and advantages of adopting the proposed “flexure/shear” strengthening protocol for wood flexural members. As known, wood is an orthotropic material with mechanical properties dependent on grains orientation of the flexure member. Wood members subjected to flexural stresses with grains parallel to the member's longitudinal axis have limited interlaminar shear strength, and hence, the amount of additional external flexural reinforcement (e.g. using E-glass/, carbon/or Aramid/epoxy laminates) must be proportional and limited to such strength, otherwise, interlaminar shear failure is unavoidable (refer to Fig. 2). For this reason, and in order to take full advantages of the composite laminates placed at the tension side of the strengthened wood member, it is important to adopt what is referred to in this paper as “flexure/shear” strengthening scheme. In this scheme, a bidirectional $[0^\circ/90^\circ]$ U-shaped composite laminate is proposed. The fiber volume fraction in each orthogonal direction is controlled by the target flexural strength enhancement capacity. Once this capacity is identified, the “parallel-to-grain” fiber volume fraction (0° -direction) can be calculated. Consequently, the resulting interlaminar shear stresses are determined that are used in calculating the “perpendicular-to-grain” fibers volume fraction (90° -direction). The use of this protocol will eliminate or minimize the potential premature interlaminar shear failure prior to reaching the full-capacity of the composite laminate placed at the tension side of the flexural wood member leading an optimum use of composites (see Fig. 2). In

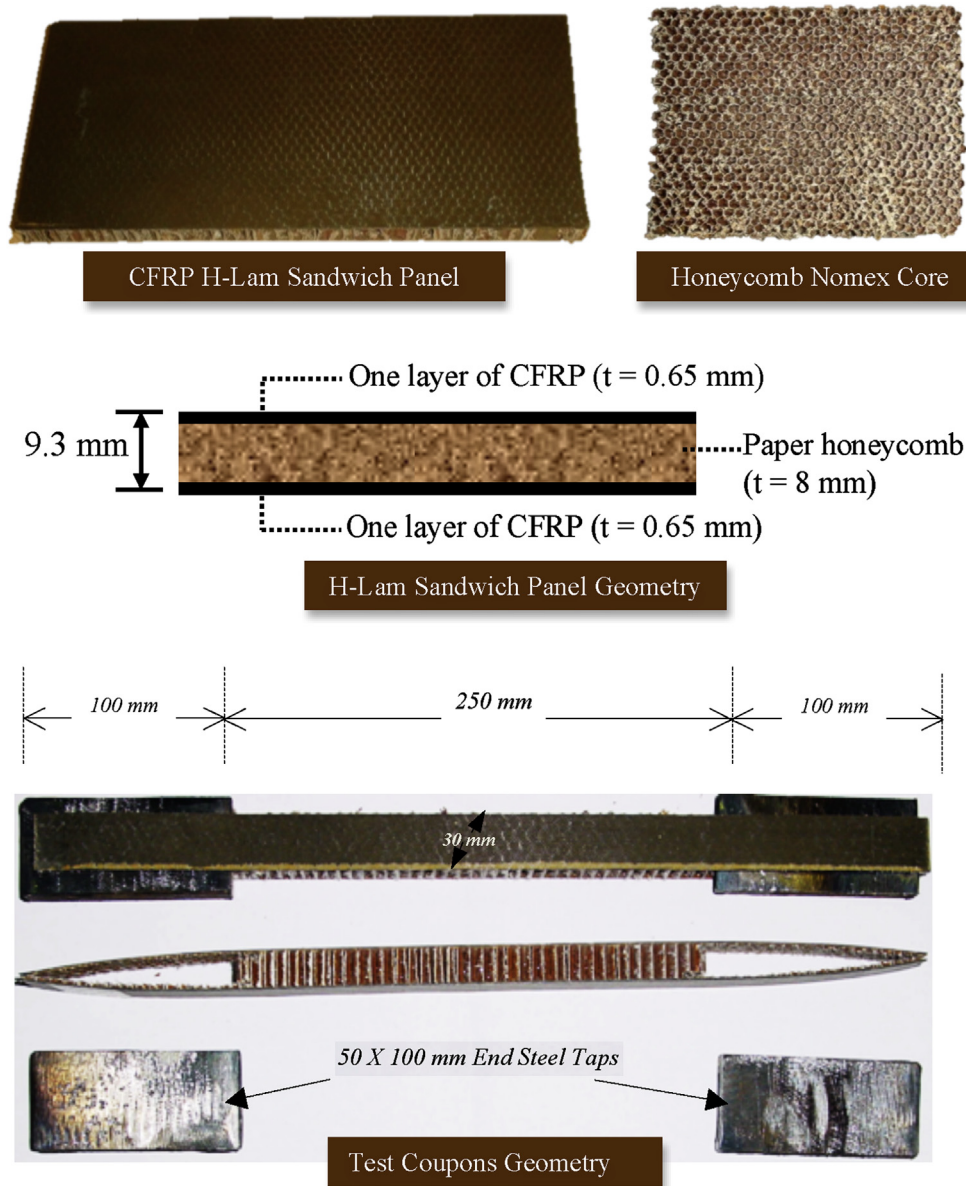
Fig. 3. Geometrical and mechanical properties of cfrp sandwich composite h-lam panels with low-density honeycomb nomex core used for Group “B” specimens.

both face sheets and core materials, and (vi) overall all economic advantages. It should be noted that this study took the advantages of phenolic resins with its excellent fire properties for wood members strengthening applications. The sandwich panels used in this study are fabricated from a low-smoke carbon/phenolic facings bonded to an aramid honeycomb core using high-temperature, high-pressure manufacturing process. The fiber architecture of the two face sheets were in the form of cross-ply $[0^\circ/90^\circ/c]_s$ ($c = \text{half of the core thickness}$) thin-laminates with a unit face laminate thickness of 0.75 mm (0.03"). Equal fiber volume fractions for both longitudinal and transversal directions was used, with an overall fiber volume fraction for both directions equal to 70% for face sheet laminates, assuming a zero void ratio. Table 1 presents geometrical and mechanical properties of the H-Lam system used in this study. The typical H-Lam CFRP panels' details and coupons used for extracting the mechanical properties of these sandwich panels are presented in Fig. 3.

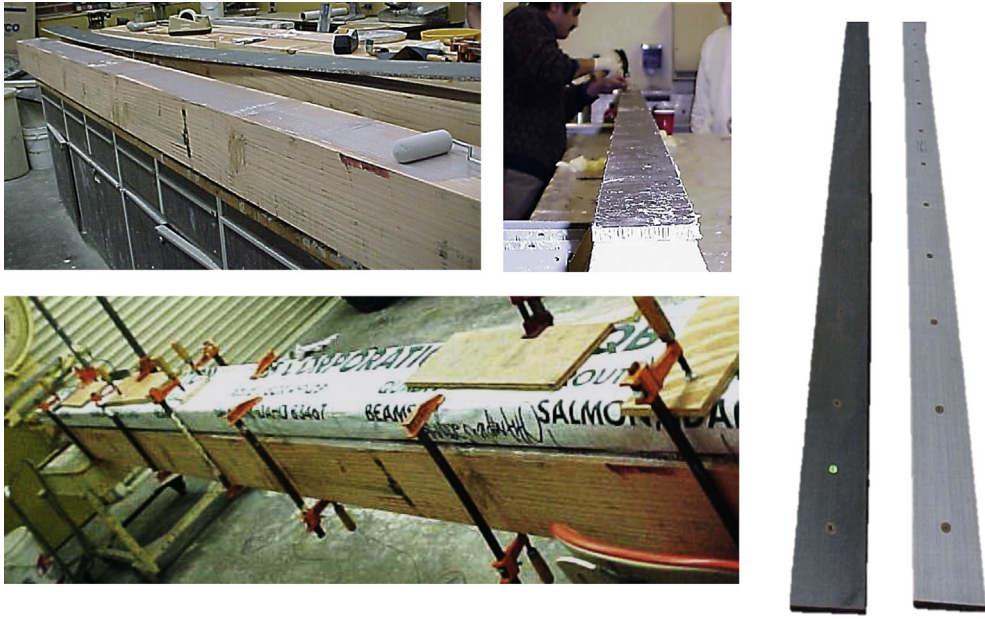
Fig. 4. Application of H-Lam sandwich composites panels on dug-fir beams.

In developing this Honeycomb system (see Fig. 4), several design parameters were considered including: (i) resin compatibility with wood, (ii) pre-treatment of the composite surface to be bonded to wood, (iii) providing self-clamping mechanisms to hold the H-Lam in place during the anti-gravity application at the site, (iv) fire resistance, (v) economic considerations and (vi) strength and stiffness requirements. These design targets were achieved by optimum design of face sheets and core; pretreatment of the face sheets, selection of fire retardant matrix and core materials, introduction of central through-the-thickness stiffeners and holes at equal spacing of 25.40 mm (1.00") along the span of the panel. With this arrangement, the applicator is able to use nails or screws to hold the H-Lam in position after applying the low-viscosity primer and the high-viscosity adhesives in addition its partial role as mechanical shear connectors (refer to Fig. 4). The width of the H-Lam is 152.0 mm (6.0") and the total thickness of the H-Lam is 10.0 mm (0.40") with an average face laminate thickness of 0.74 mm (0.029"). The depth/width (d/b) ratio used for evaluating

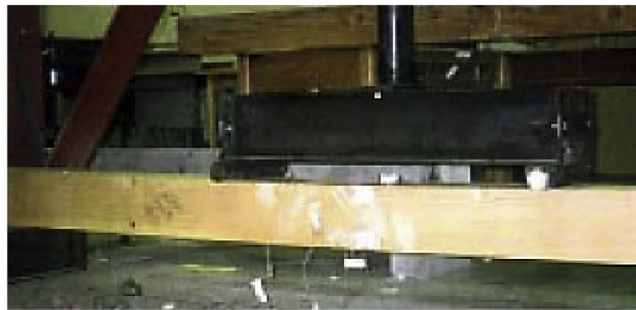
Fig. 5. Wood beams typical dimensions and four-point flexural test setup.

and beam specimens’ dimensions and geometry are presented in Fig. 5. The unidirectional mechanical properties of the carbon/epoxy wet layup materials, used in this study, were tested in accordance to ASTM 3039 standards (refer to Table 2).

The overall dimensions of Group “A” beam specimens were 20.30 cm (8.0”) X 20.30 cm (8.0”) X 3.45 m (11.33 feet) [Width × Depth × Span] Dug Fir Larch No. 1 wooden beams. All specimens were tested under four-point load regime up to failure (see Fig. 5).

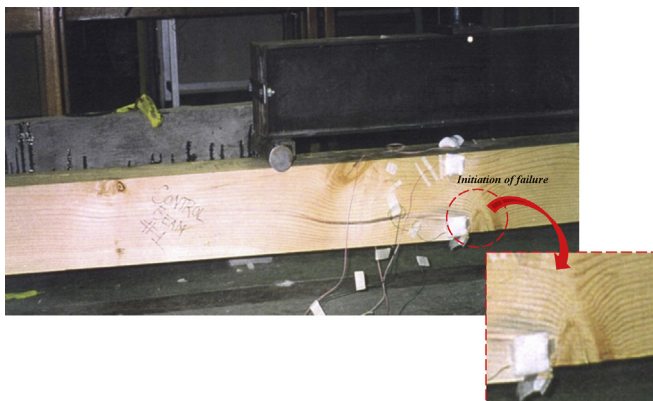
Fig. 6. Failure initiated at a knot located at the bottom side of the mid-span loading zone of the as-built control wood specimen (Group “A”).

were used similar to those for the control specimen. As the load was applied, large deflection was observed. This was expected due to the fact that by slotting the bottom area under the loading points (*maximum constant moment zone*), the effective resisting depth was about 65% of the corresponding depth in the control test. The deflection continued to increase and longitudinal cracks propagated in a faster rate. The ultimate failure load was 31.49 kN (7.08 kips) with a corresponding deflection of 39.37 mm (1.55”). Fig. 9 shows the ultimate failure of the pre-cracked specimen. The load/deflection relation is presented in Fig. 10. As shown in this figure, the behavior was linear up to a load of approximately 13.34 kN (3 kips), after which the behavior exhibited non-linearity with a rapid rate up to failure. One interesting observation is that the ultimate load of the pre-cracked specimen was higher than the ultimate load of the control specimen. This can be attributed to the variation of the wood materials, locations and number of knots (*failure of the control specimen started at a knot location as shown in Fig. 6*).

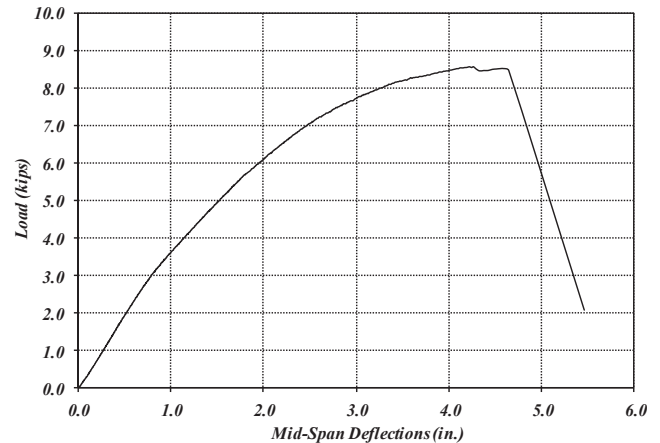
Fig. 7. Load/deflection relation for control (undamaged) dug fir wood specimen [1 inch=25.4 mm, 1 kip= 4.448 kN].

Initially, two control (as-built) Group “A” specimens were tested under quasi-static loading conditions. The first undamaged, unstrengthened “control” specimen was tested to determine the ultimate moment capacity, flexural stiffness, and failure mode of unreinforced wood. The load was applied via a calibrated 245-kN (55-kip) hydraulic actuator in the form of a linear force-controlled ramp with a loading rate of 8.9 kN/min (2 kips/minute). As the load increased, longitudinal cracks with an average length of 19 mm ($\frac{3}{4}$ ”) were observed. The first local crack was initiated at a knot located at the bottom side of the Douglas-Fir wood beam below the loading zone (see Fig. 6). The ultimate mode of failure was a combination of interlaminar and tensile failure of wood at the maximum flexural stress region between the two line load application areas. The ultimate load was 31.36 kN (7.05 kips) with a maximum mid-span vertical deflection of 38.00 mm (1.50”). As shown in Fig. 7, this wood beam specimen exhibited linear behavior until a load level of about 22 kN (5 kips), after which the behavior became non-linear up to the failure load. The ultimate load of this control beam specimen was 37.67 kN [8.47 kips] with a corresponding deflection of 118.0 mm (4.65”).

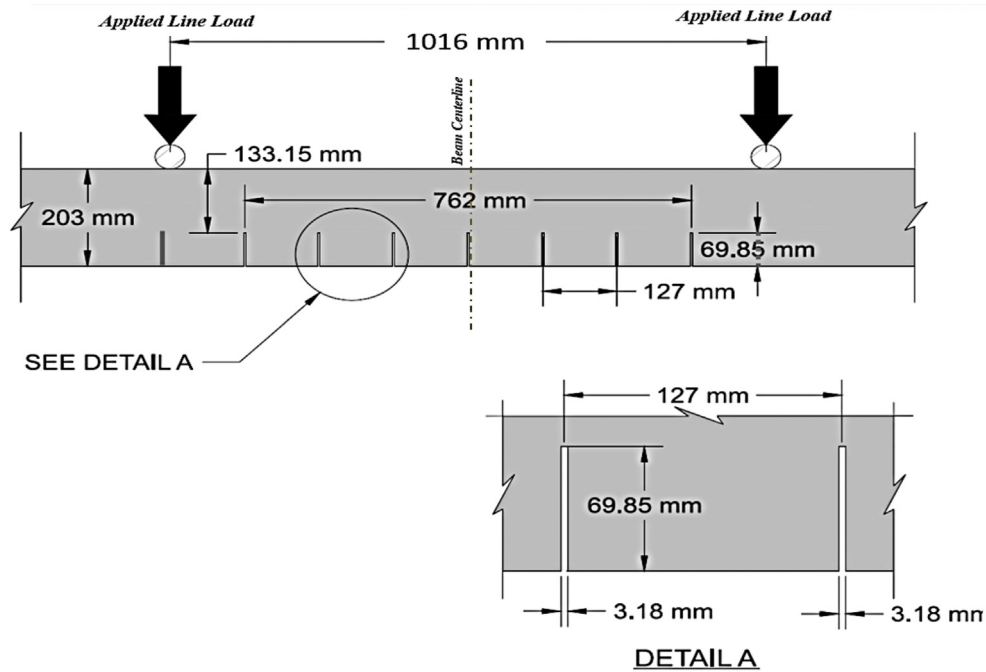
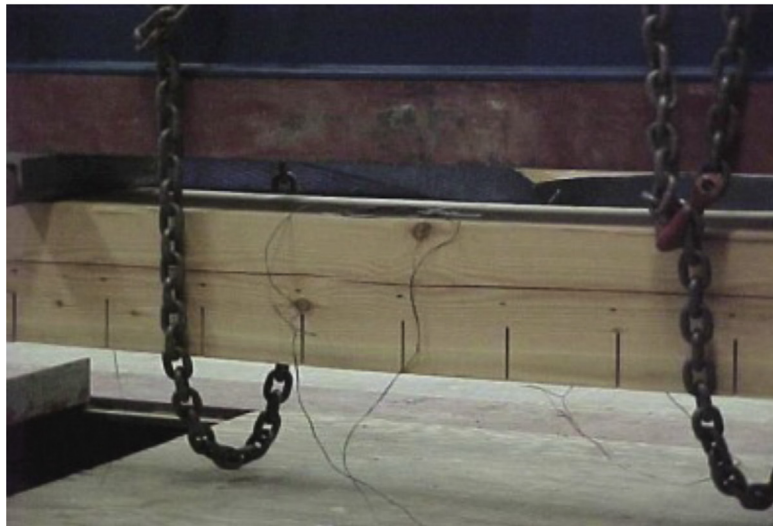
Fig. 8. Mid-span cracks details of the pre-damaged wood beam of Group "A".

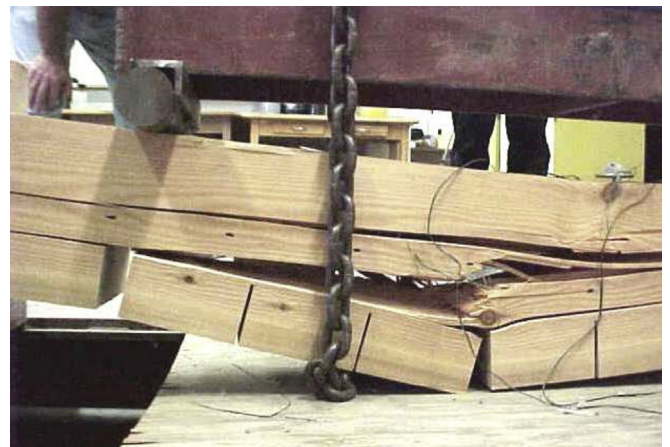
Fig. 9. Ultimate failure of pre-cracked beam specimen.

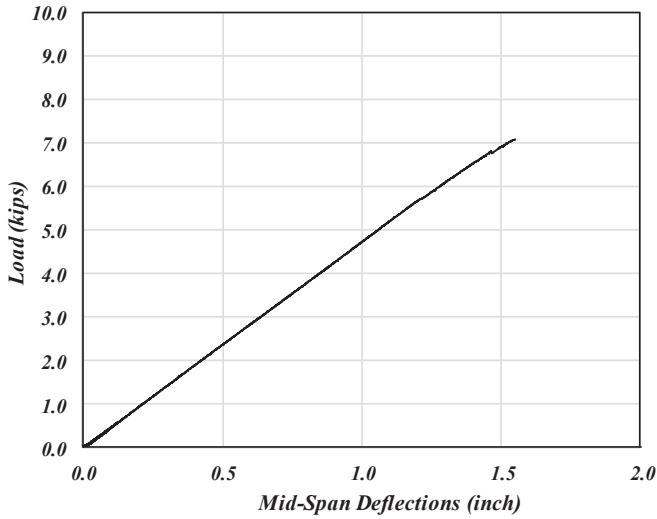
Fig. 10. Load/deflection relation for pre-cracked wood specimen (Group “A”) [1 inch=25.4 mm, 1 kip = 4.448 kN].

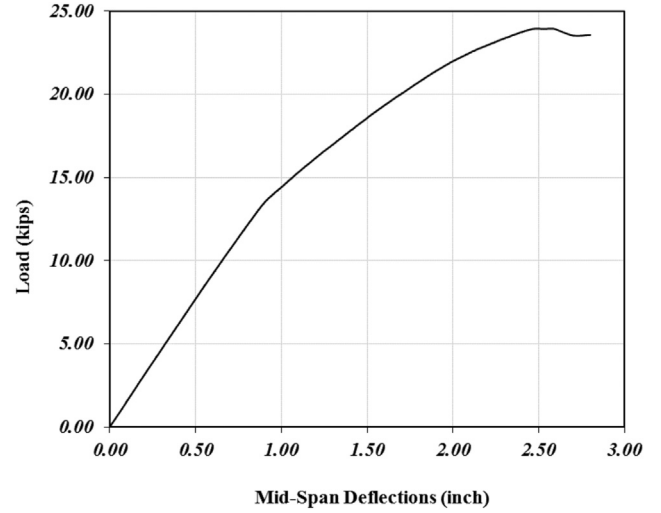
Fig. 12. Load/deflection relation for pre-cracked CFRP repaired wood specimen [1 inch=25.4 mm, 1 kip = 4.448 kN].

Fig. 12). The associated failure mode was less sudden and more ductile as compared to the one observed for the control specimen. The ultimate failure mode was initiated by a cohesive failure of the wood at the specimen side exactly under the left point load, followed by a local of the composite laminate at the same location as shown in Fig. 13. The stress/strain curves for pre-cracked, repaired, and the retrofitted wood members are presented in Fig. 14. Based on the test results, the gain in the strength of the retrofitted members as compared to the control members is in the order of 238.27%.

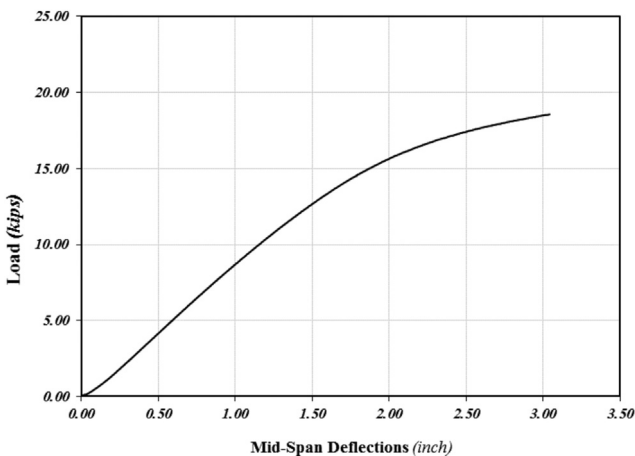
Fig. 11. Load/deflection relation for pre-cracked cfrp repaired wood specimen [1 inch=25.4 mm, 1 kip = 4.448 kN].

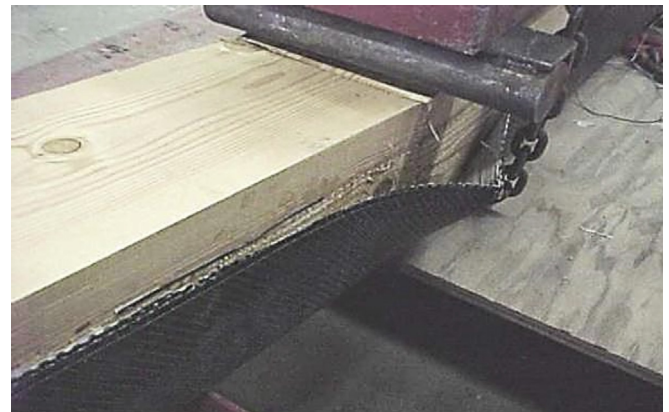
Fig. 13. Failure of Group “A” retrofitted beam specimen.

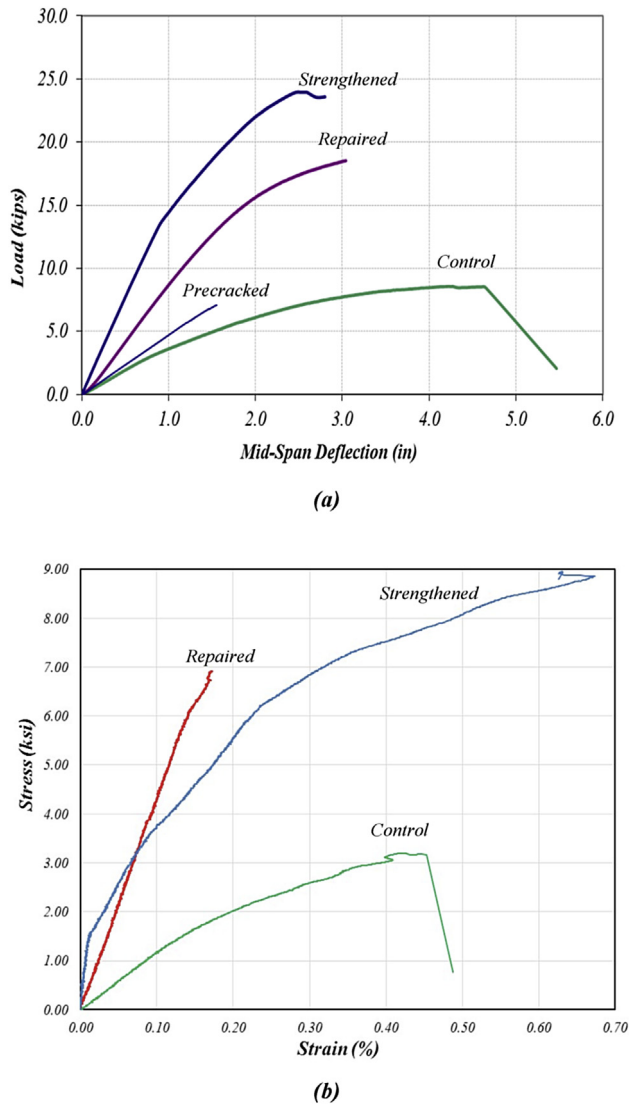
Fig. 14. (a) Load/deflection and (b) stress/strain behaviors of unstrengthened, repaired and retrofitted beam specimens of Group "A".

Load, deflection, and strain data were collected, analyzed and load/deflection (P/δ) and stress/strain ($\sigma-\epsilon$) curves were developed and the modes of failure for each beam was identified. The ultimate capacity of the unreinforced wood member was 31.60 kN (7.10 kips) with a mid-span deflection of 38.00 mm (1.5") at failure. The load carrying capacity of the retrofitted specimen has increased to 260% and the stiffness was increased by about 90% as compared to the control specimen. The associated failure mode was sudden and was initiated by a cohesive failure of the wood at the specimen side exactly under the left point load. Instantaneously, a local buckling of the side composite thin-walled bidirectional laminate occurred as shown in Fig. 13. Experimental results also indicated that adding external plies of polymer composites to the damaged "pre-cracked" specimen resulted in an increase in the loading carrying capacity up to 180%, with a stiffness upgrade to about 150%. Table 3 presents a summary of the experimental results of Group "A" unstrengthened and strengthened wood beams.

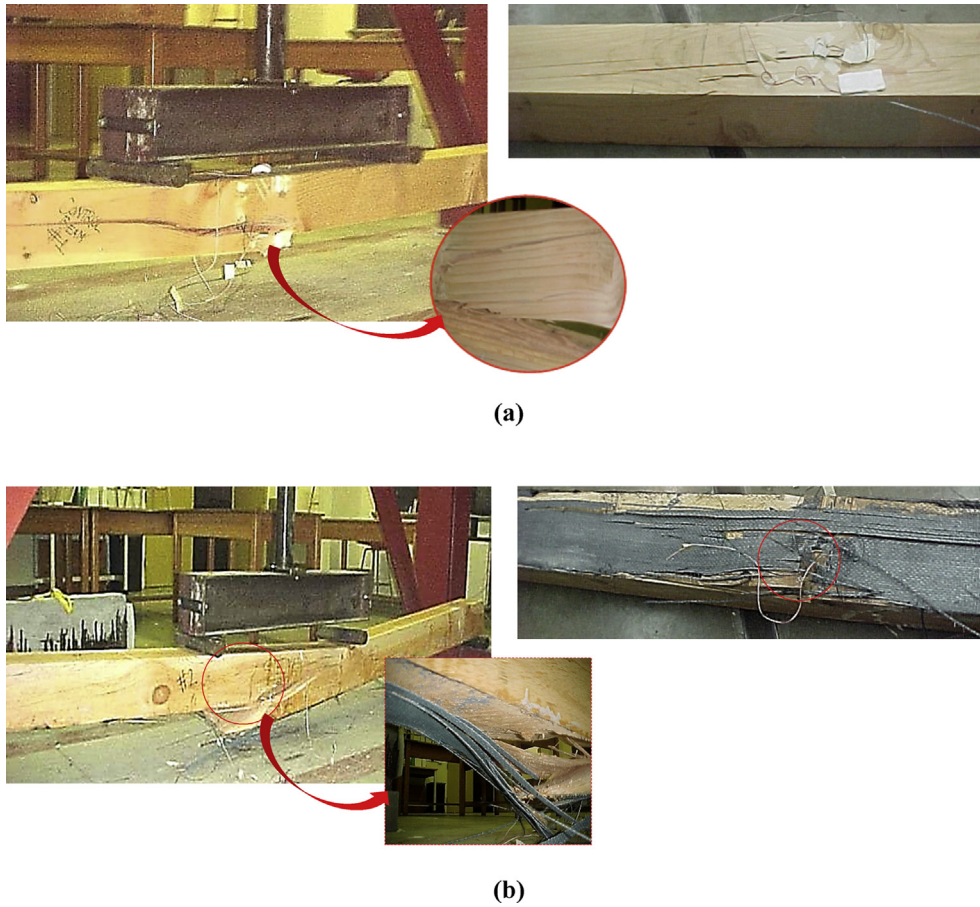
Fig. 15. Ultimate failure modes for Group “B” specimens: (a) unstrengthened beam, (b) beam strengthened with flat unidirectional carbon/epoxy laminates.

rupture of the carbon/epoxy laminate at the bottom face of the beam occurred as shown in Fig. 15-b. The ultimate load of this composite strengthening protocol was a 48.00 kN (10.80 kips) with a mid-span deflection of about 38.00 mm (1.80"). The ultimate capacity of strengthened wood beams with flat CFRP unidirectional laminate $[0^\circ]_2$ increased by 53% as compared to the as-built unstrengthened beams.

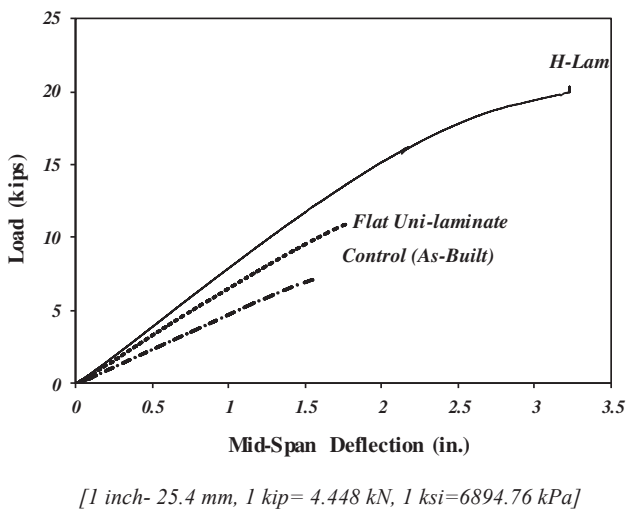
Fig. 16. Load/deflection behavior for unstrengthened (as-built), beams retrofitted with flat unidirectional Laminate and beams retrofitted with H-Lam sandwich panel Group “B”.

The behavior of this specimen was linear up to about 62.00 kN (14.00 kips), after which, non-linearity was noted (refer to Fig. 16). This specimen performed exceptionally well as compared to other specimens. The ultimate load was about 98.00 kN (22.00 kips), as compare to only 31.00 kN (7.00 kips) ultimate capacity for the as-built unstrengthened beam specimen. This gain in strength can be translated to an increase of over 300% over the strength of the control, as built specimen. The mid-span vertical deflection at the ultimate load was about 76.0 mm (3.0") as shown in Fig. 16. The failure was initiated by a local interlaminar shear failure close to the left loading point and at about half the depth of the beam (at the maximum shear load location and at a depth of where maximum shear stresses, near the neutral axis, occur). This failure propagated rapidly following the path of least resistance, and generated an impulse load, which resulted in a premature shear failure of the H-Lam at near the loading point as shown in Fig. 17. The composite sandwich face laminates and the wood failed as one piece and at the same time (cohesive failure and not adhesive failure) as shown in Fig. 18. Fig. 19 shows a sketch describing the failure modes of the wood beams strengthened with "flexure-only" protocol.

For Group "B" beams (flexure-only) strengthened with flat unidirectional wet layup and sandwich honeycomb composites, similar results were achieved. Based on load/deflection curves for the as-built, unidirectional and the H-Lam strengthened beam specimens that were presented in Fig. 16, one can see that distinct high strength, stiffness of the wood beam strengthened with the innovative H-Lam sandwich system. In addition, it is clear from this

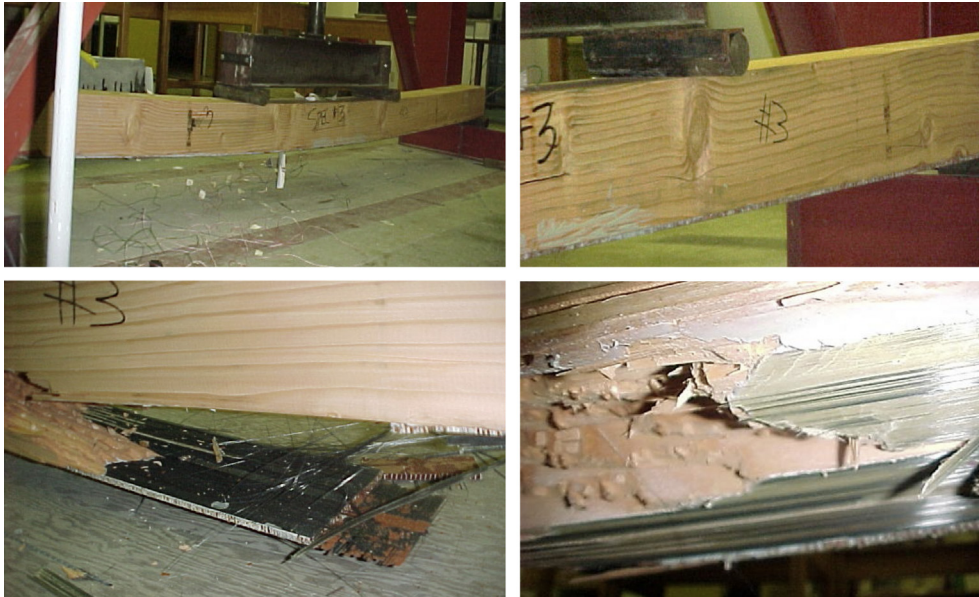
Fig. 17. Ultimate failure of the wood beam strengthened with honeycomb sandwich panel (H-Lam).

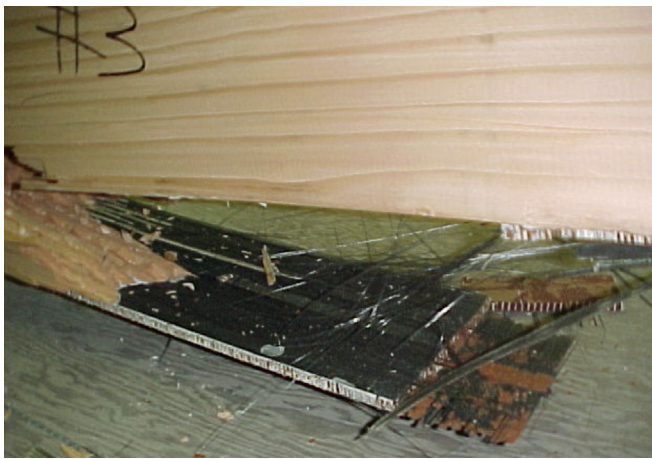
Fig. 18. Cohesive failure of beams retrofitted with sandwich composite laminates indicating proper interfacial bond between wood and composites.

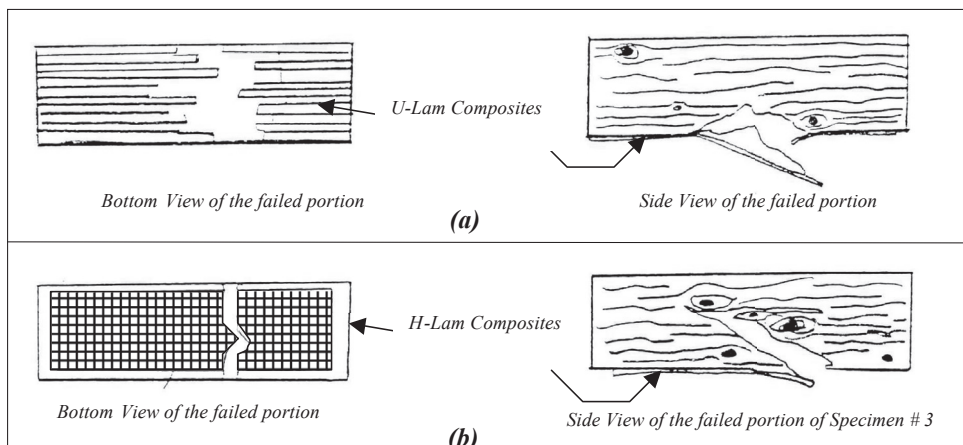
Fig. 19. A sketch illustrating failure modes of wood beams strengthened with (a) unidirectional flat laminate, and (b) H-Lam sandwich panel.

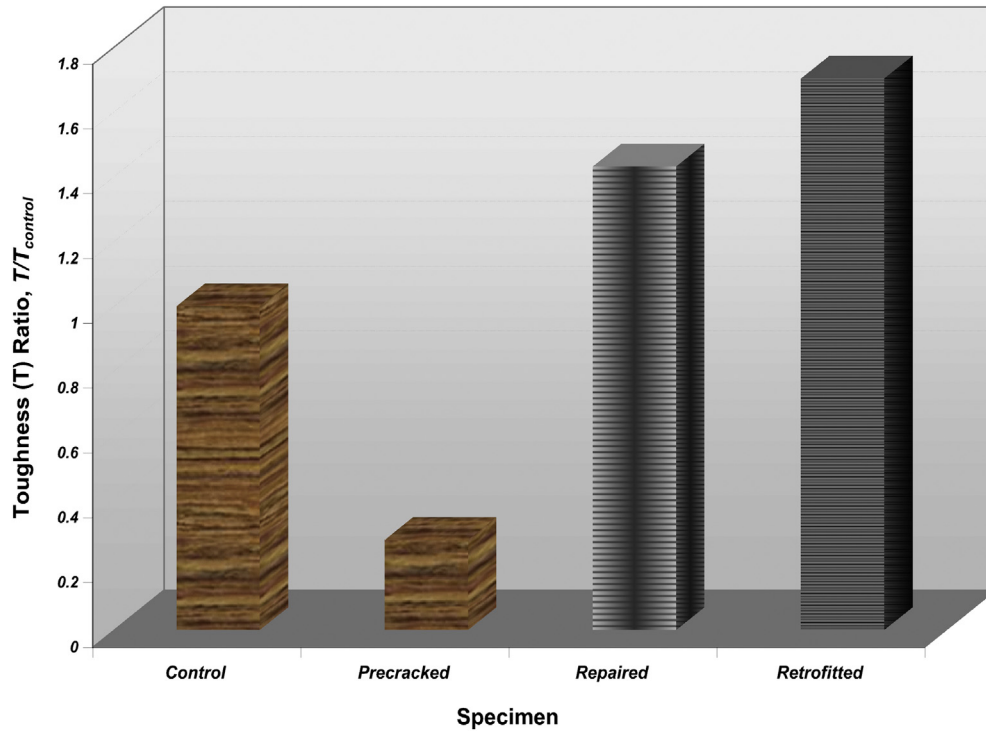
Fig. 20. Toughness comparison relative to control "unstrengthened" wood beam specimen.

figure and Fig. 20 that the toughness of the wood beams strengthened with H-Lam was about four times of the unidirectional flat laminate strengthened specimens and seven times the as-built (*unstrengthened*) beam. A comparison of flexural capacity of as-built and the two FRP strengthened beams is presented in Fig. 21. As shown in this figure, the capacity of the H-Lam

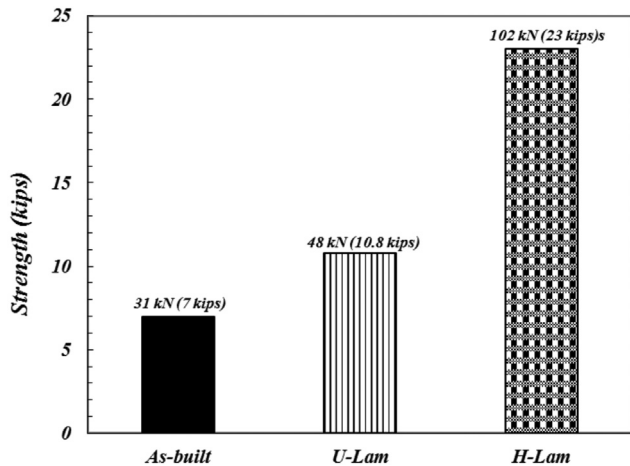
Fig. 21. Flexural strength comparison between for unstrengthened (as-built), beams retrofitted with flat unidirectional laminate and beams retrofitted with H-Lam sandwich panel **Group "B"**.

strengthened wood beam is over three times the as-built specimen and twice as much as the capacity of the wood beam strengthened with unidirectional flat laminate. The failure of the H-Lam strengthened beam was more ductile than both the flat unidirectional laminate and the as-built specimen. In particular, cohesive failure was observed in the case of the H-Lam specimen where chunk of wood was attached to the top face sheet at the failure. In contrast, the failure of the beam with unidirectional flat laminate was a predominantly in the form of adhesive failure.

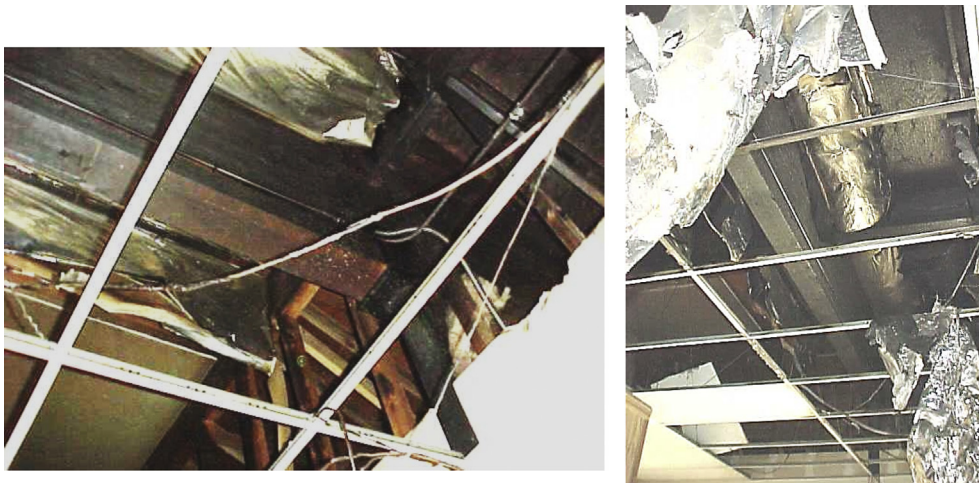
Fig. 22. Fire damages of the Glulam girder (case study).

An over-hanged Glued Laminated (Glulam) timber girder was a part of the roof structural system of a commercial facility in southern California that was exposed to a fire event. Some portions of few glulam girders were partially due to exposure to direct flames (see Fig. 22).

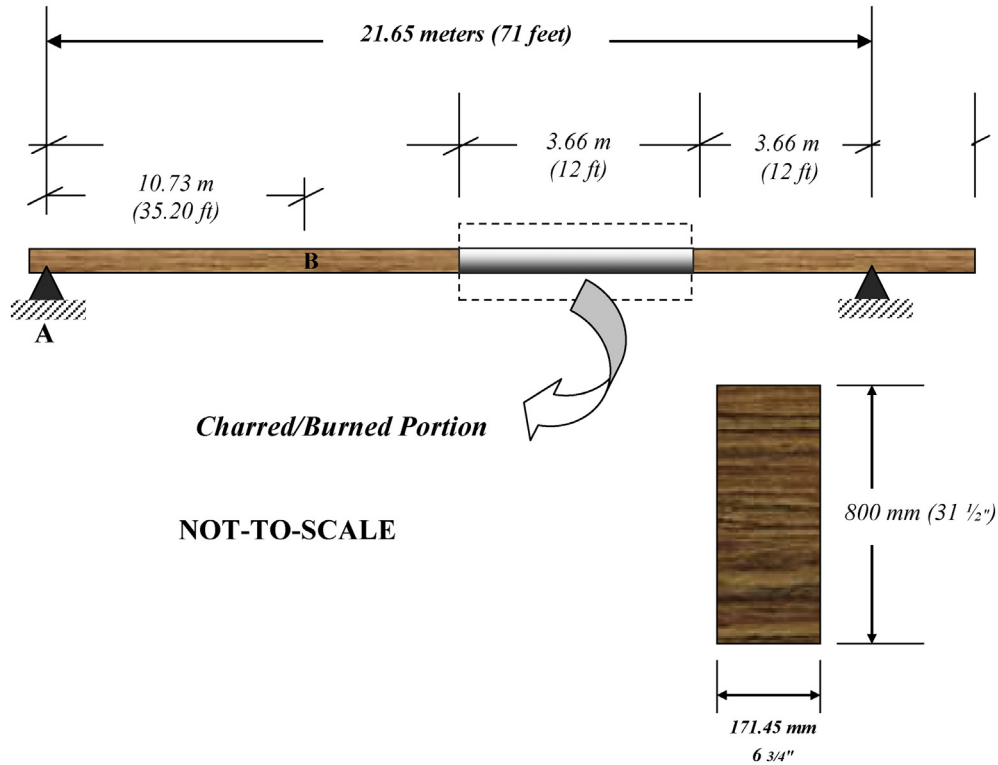
Fig. 23. Dimensions and idealized support conditions for the Glulam girder.

The typical glulam girders analyzed in this case study has a simply supported span of 21.64 m (71.00') with an overhang cantilever span of 2.14 m (7.00') as shown in Fig. 23. The figure also shows the reduced section of the Glue-Lam girder based on visual

6.1.2.3. Geometrical information of the structure. Fig. 23 describes the statically system, idealized boundary conditions and geometry of the Glue-Lam Girder under consideration.

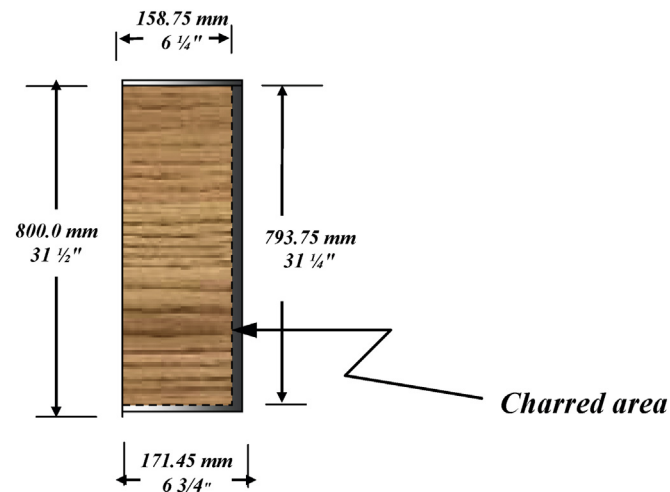
Fig. 24. Dimensions of the reduced section at the charred portion of the Glulam girder based on site inspection.

inspection at the site. As shown in Fig. 24, the reduced section is 79.375 cm × 15.875 cm (31 1/4" × 6 1/4"). The original dimensions before fire damage were 80.01 cm × 17.145 cm (31 1/2" × 6 3/4").

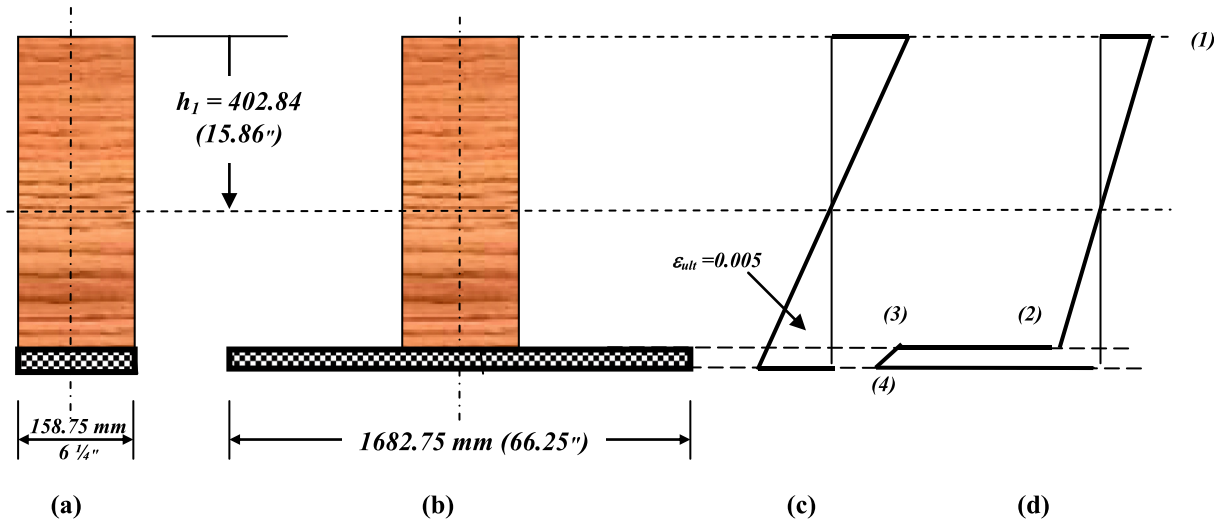
Fig. 25. Transformed section analysis: (a) Original section, (b) Transformed section, strain diagram, and (d) Stress distribution.

[(Point 4 in Fig. 25-d)]

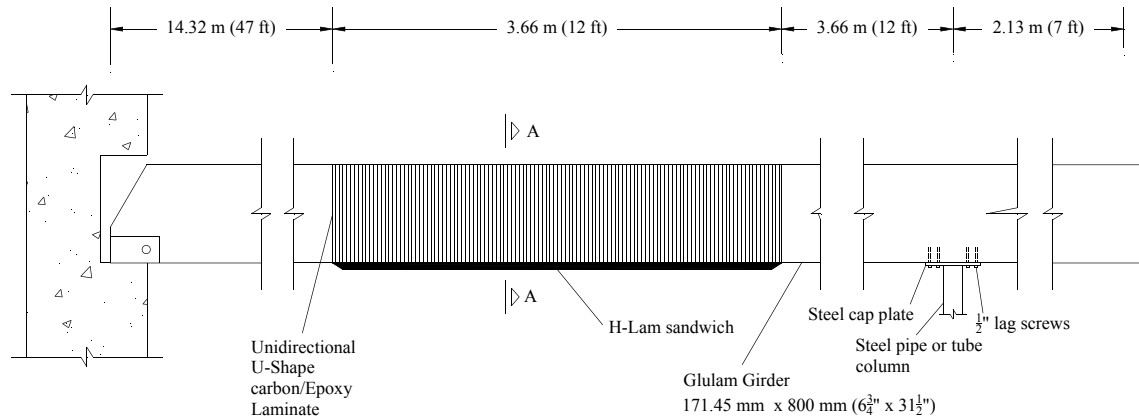
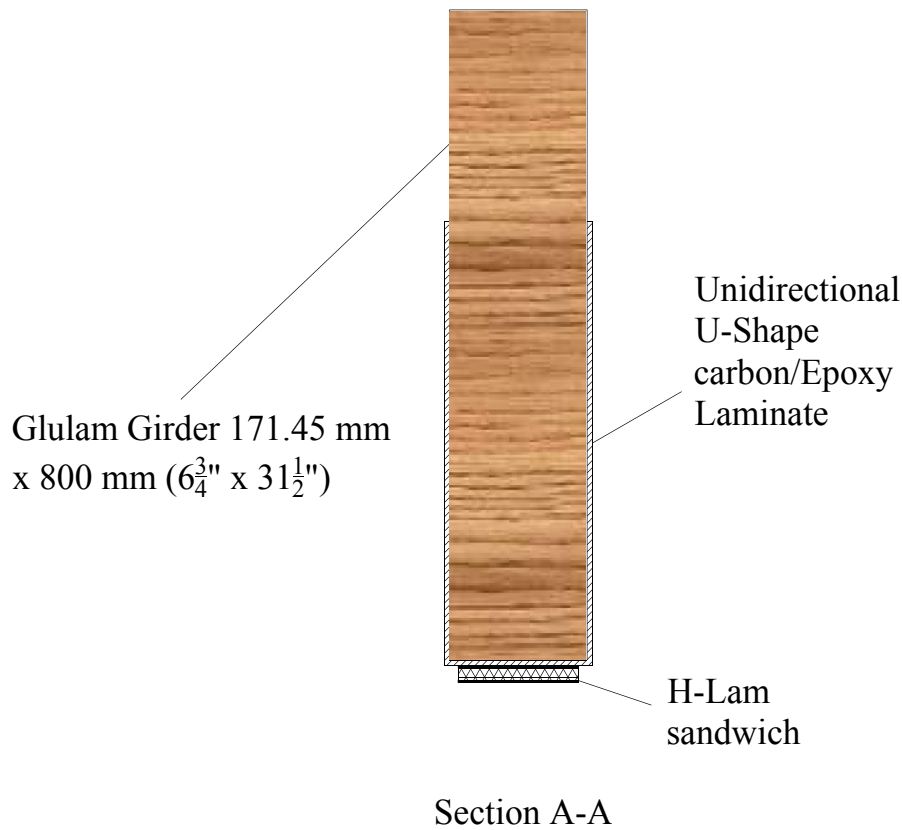
Fig. 26. FRP composite retrofit details of fire partially-damaged glulam girder.

upgrade the interlaminar (*horizontal*) shear strength parallel to the grain (*or to the glue-lines*). This can be accomplished by adding high-strength unidirectional carbon/epoxy laminates bonded to each side of the girder covering 2/3 of the girder's depth which is 53.40 cm (21.00") from the bottom side. Fig. 26 shows the details of the composite repair system used in this case study.

The final details of the CFRP H-Lam repair system is shown in Fig. 26.
