UTILIZATION OF METALS IN OIL SHALE RETORT COMPONENTS

Alan V. Levy

November 1982

LBL-16018

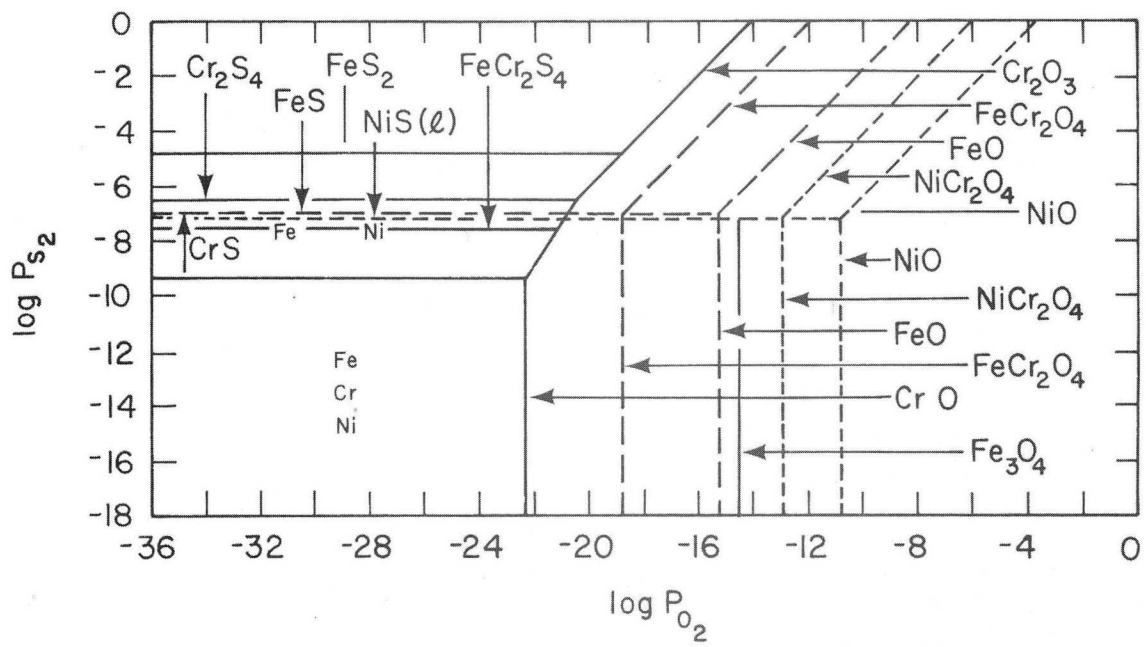
Fig. 13 Thermodynamic equilibrium stability diagram for Fe-Cr-Ni at 980°C

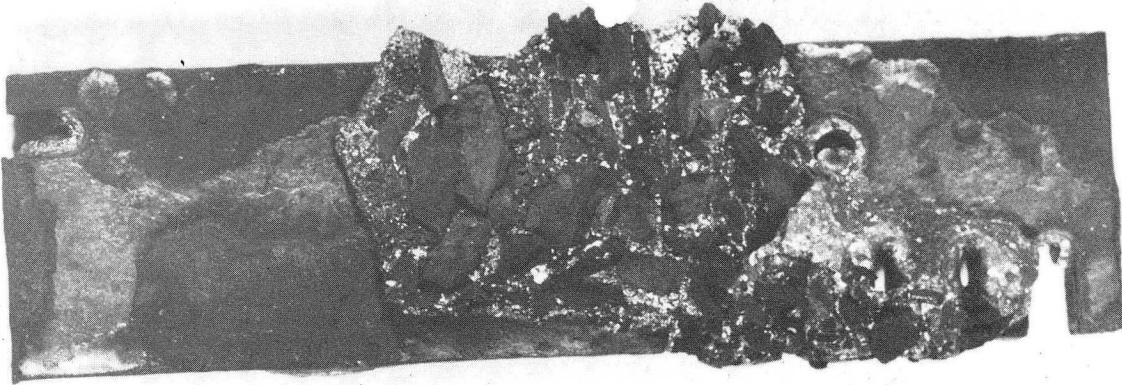
Fig. 50 310SS specimen from level 2

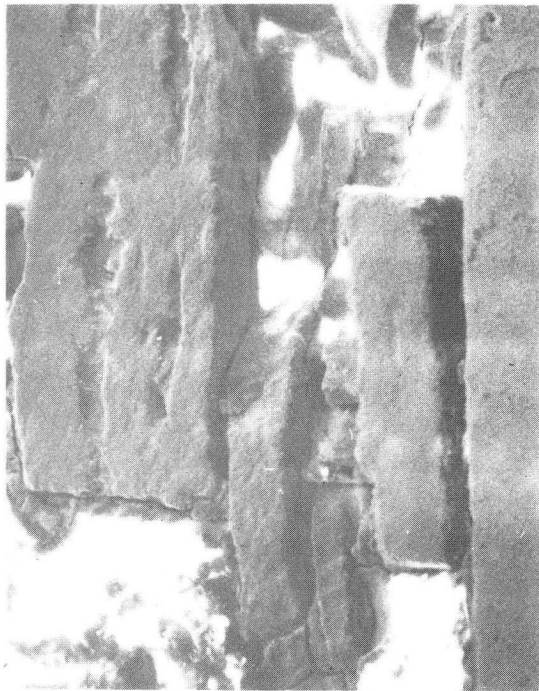
Fig. 82 Corroded 1Cr1/2 steel from retort  
CS79

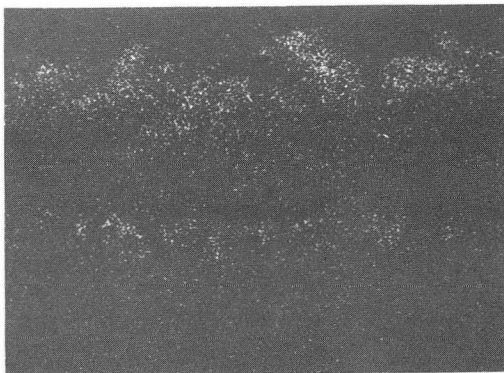
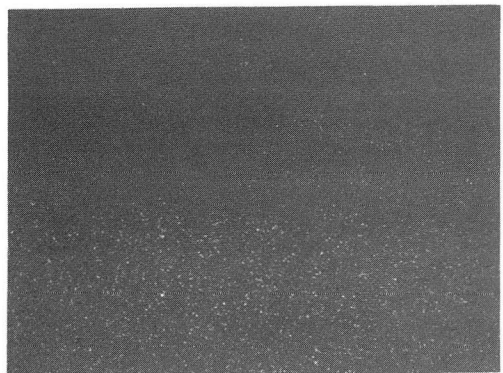
Fig. 83 Corroded Incoloy 800 from retort CS79
