Construction of a Highway Section Within a White-Tailed Deep Winter Yard Near Quebec City, Canada: Mitigation Measures, Monitoring, and Preliminary Results

# CONSTRUCTION OF A HIGHWAY SECTION WITHIN A WHITE-TAILED DEER WINTER YARD NEAR QUÉBEC CITY, CANADA: MITIGATION MEASURES, MONITORING, AND PRELIMINARY RESULTS

**Abstract:** The construction of a new 10.4 km (6.5 mi) section of HWY Robert-Cliche (73) south of Québec City, Canada, integrated an unprecedented number of mitigation measures to maintain connectivity between a bisected white-tailed deer winter yard and minimize apprehended deer-vehicle collisions. In this paper we present mitigation measures planned and complete as well as the monitoring approach to document deer use and movements in the winter yard before, during and after the construction. Some preliminary results regarding the impact of this project on the deer winter use of the project area also will be presented and briefly discussed.

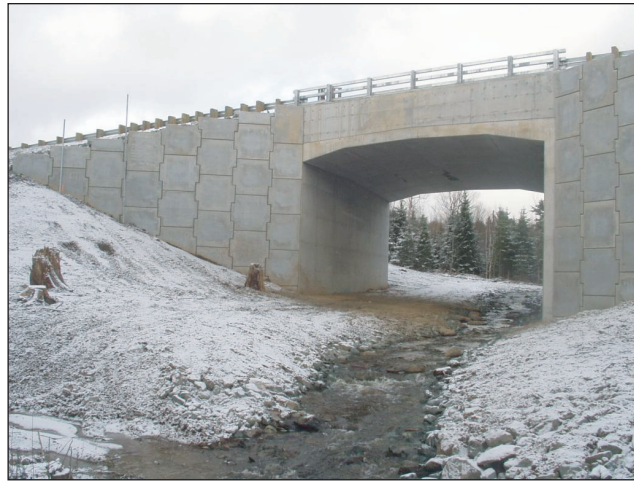
Figure 2. Doyon Creek concrete box culvert before tree and shrub planting.

The construction of one of the two primary deer crossing structures started at the Doyon Creek (fig. 2). Part of the deer-proof fence (2.4 m or 8' high and constructed of woven wire) was installed at the northern end of the deeryard and on each side of this structure for a total length of 1.8 km (1.1 mi). Eight escape ramps were also built within the fenced section for deer. Construction of the Calway River Bridge started but stopped in late fall. This open-span bridge is considered at the heart of deeryard and is the second primary deer crossing structure. The construction of the Calway road bridge also started during the summer. This structure is considered a secondary deer crossing underpass because deer often use this very low-used gravel road during winter to travel within the deer yard. In early fall, the completed section of the highway was paved and roadsides seeded for a length of 5 km. No vehicular traffic was allowed except for construction workers.

Kilometer marker	Structure	Type	Year completed	Span (m)	Rise (m)	Length (m)	Openness ratio
3+920	Doyon Creek	Concrete box culvert	Fall 2005	10 (32.8')	5.0 (16.4')	13.4 (44.0')	3.7
5+300	Calway River	Open-span bridge	Summer 2006	120 (394')	10.9 (35.8')	14.3 (46.9')	91.5
5+600	Calway road	Open-span bridge	Summer 2006	27.5 (90.2')	5.0 (16.4')	14.3 (46.9')	9.6
7+340	Carrière road	2 open-span bridges	Fall 2006	12.6 (41.3')	5.1 (16.7')	12.6 (41.3') each	5.1
8+800	Des Plantes River	2 open-span bridges	Fall 2007	177 (581')	14 (45.9')	12.6 (41.3') each	196.7

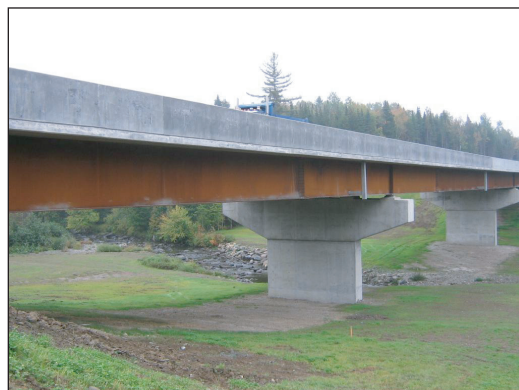
Figure 3. Calway River open-span Bridge before tree and shrub planting.

The Calway River Bridge was completed (fig. 3) and deer-proof fences were tied into the bridge abutments. Another section was cleared, graded and paved with an average right-of-way width of about 100 m. Deer-proof fences were installed on another 3.3 km (2.1 mi) section adjacent to the previous fenced section. A total of 13 escape ramps were also put up. Construction of the Carrière road bridge started and was completed by fall 2006. This underpass is considered a secondary deer crossing structure. The Carrière Road is a privately-owned gravel road and is seldom used during winter when deer are using the Calway deeryard. Clearing and grading started for the third and last section of highway. Construction of the open-span Des Plantes River bridges also started and some drilling operations lasted until early March 2007. Adjustments were made on previously built escape ramps during spring and summer 2006. Again, no vehicular traffic was allowed on paved surfaces except for construction. Two primary and two secondary crossing structures combined with deer-proof fencing funnelling deer toward the underpasses were therefore available at the onset of fall migration into the deeryard for winter 2007.

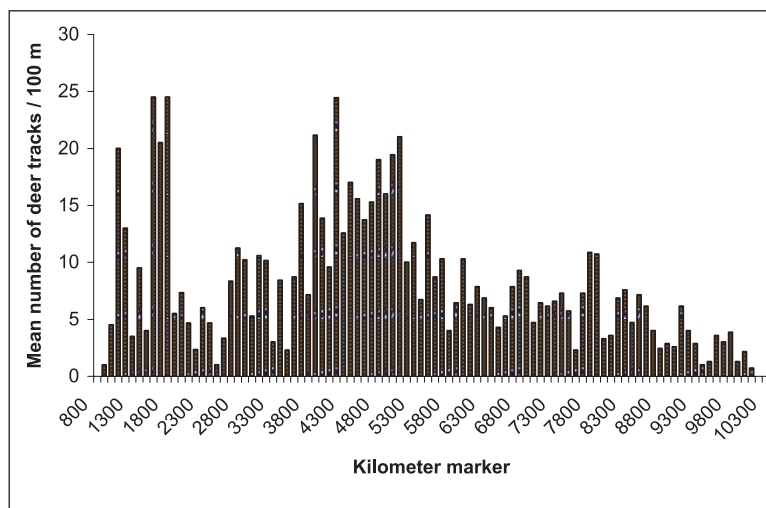
Figure 5. Mean number of tracks per 100 m recorded over 7 surveys from mid-December 2001 to early April 2002 along the projected centreline of the new section of HWY 73 before construction.

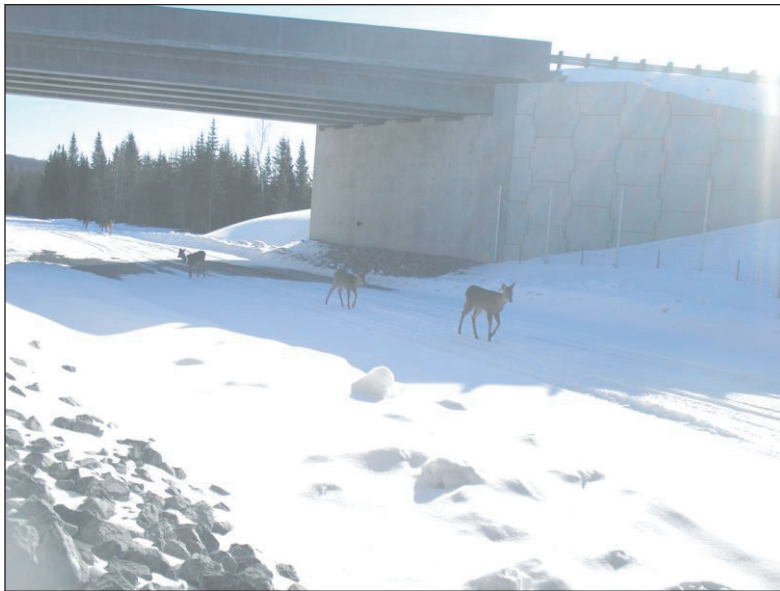
Figure 10. Six deer passing under the Carrière Road bridges, a secondary deer crossing underpass on 10 April 2007.
