## **San Joaquin Rail Corridor Crossing Survey**

**California PATH Research Report  
UCB-ITS-PRR-2008-6**

# Final Report San Joaquin Rail Corridor Crossing Survey

Caltrans Task Order #6201: San Joaquin Rail Corridor Crossing Survey

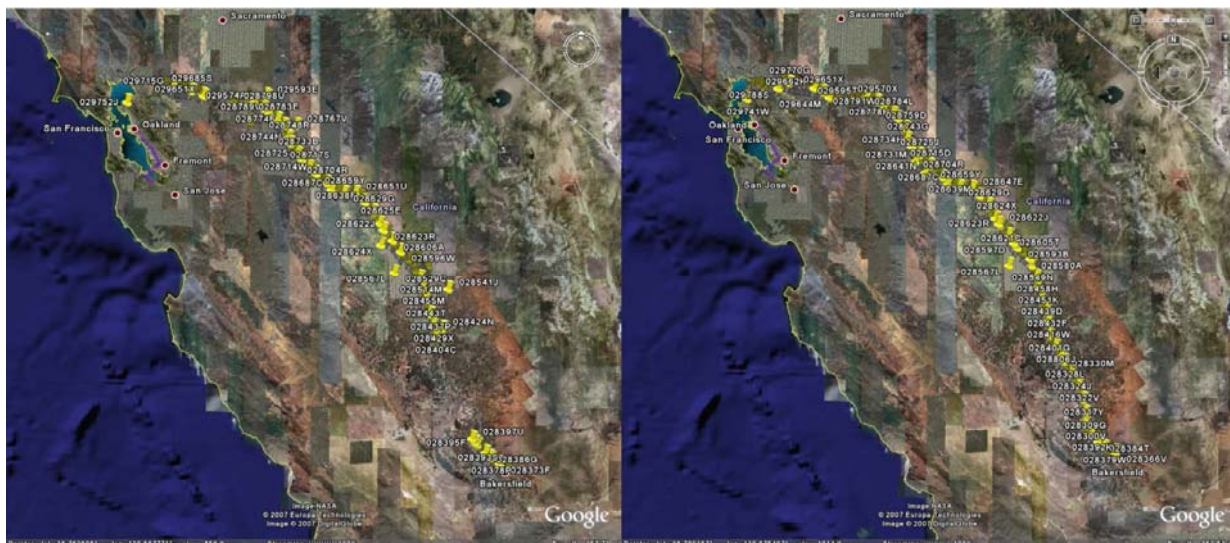
**Figure 1: Plot of original crossing database locations (left) and final database locations (right). The leftmost picture has several “gaps” compared to the one on the right. On this scale, however, the gap that can most clearly be seen is in Kings County in the southern portion.**

The current staff of the Visual Detection Laboratory were supplied a database (in spreadsheet format) that had over 500 crossing entries but we subsequently discovered that, while the number was a good deal higher than the 397 crossings quoted in the original proposal, the database was still very incomplete. We discovered this by extracting the latitude and longitude from the original database and plotting the results in Google Earth. See Figure 1 below.

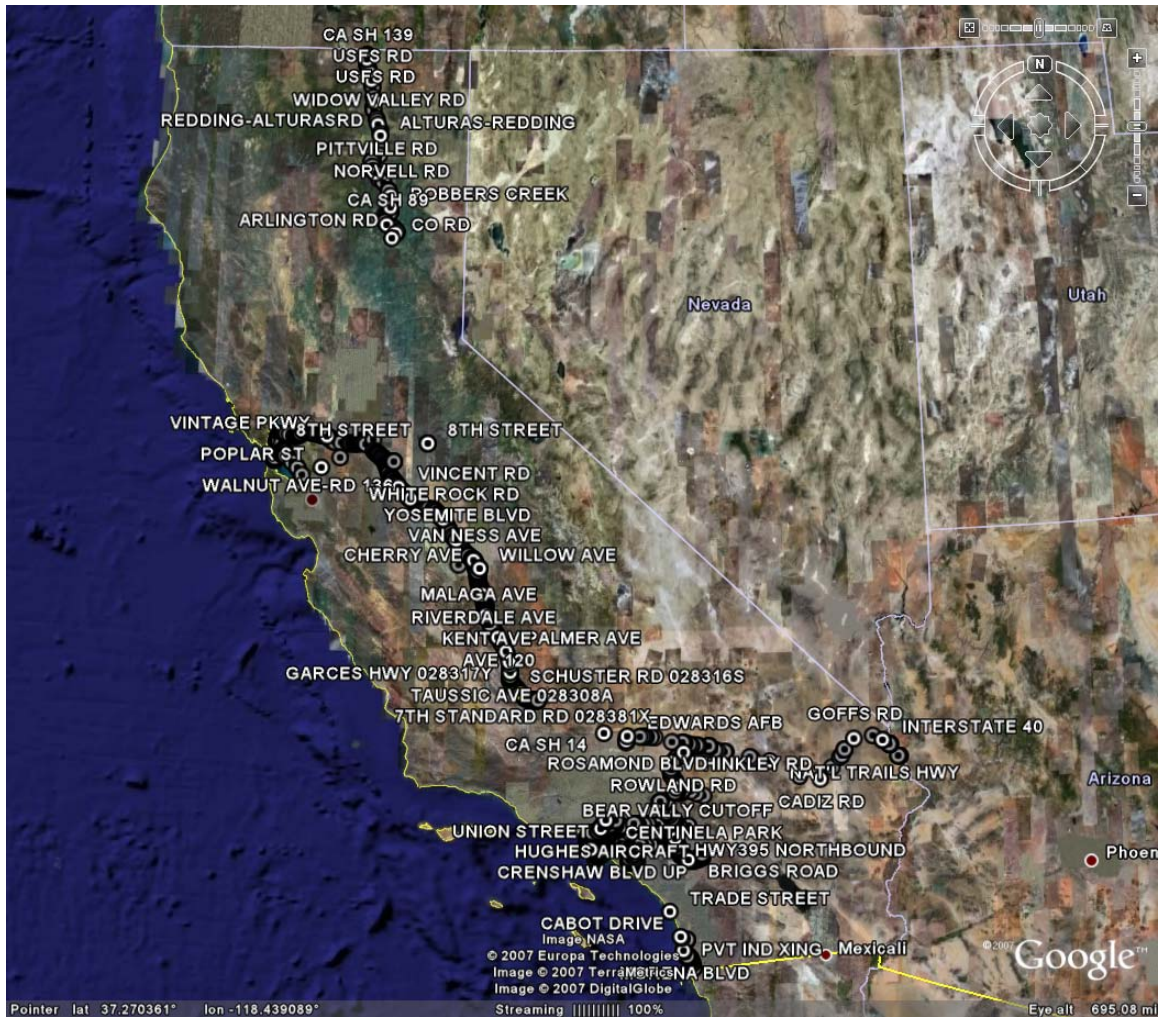
**Figure 2: Major rail corridors in the state of California as seen in Google Earth.**

To aid in this reduction, Ken Galt, the chief of the Railroad Crossing Safety Branch at Caltrans’ Division of Rail, sent us a kmz file with place markers showing, among other rail lines, the SJRC. This is seen in Figure 2, on the following page.

Still the kmz file sent by Mr. Galt, at least when used in Google Earth, was a substantial help. The markers in Figure 2 could be overlaid with those, say, in Figure 1 and the routes compared. Searches and sortings were then done on the state database by latitude and longitude read off of Google Earth. The crossings falling within a small rectilinear box were extracted and were put (tentatively) into the SJRC database. This was then re-plotted and locations that didn’t match up with Ken Galt’s kmz file were either removed or marked for later verification. In this tedious, step-by-step manner, the SJRC was built up “by hand”.

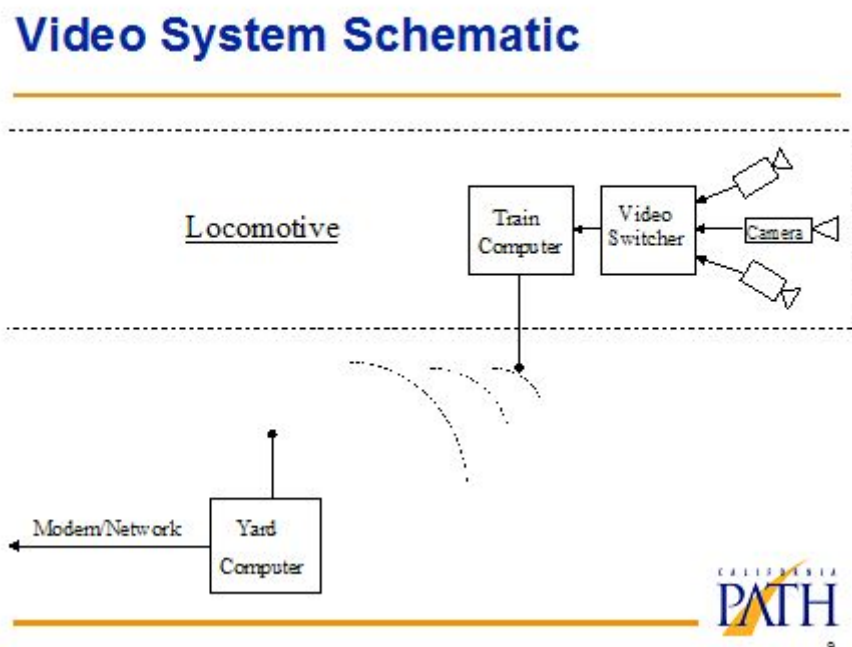
**Figure 4. Schematic representation of Locomotive Video Data Acquisition System (LVDAS). Note the three cameras so as to be able to record images not just in the forward direction but toward the sides as well, in order to capture full details of events at each crossing. For downloading data, the train computer can communicate with the yard computer via a wireless connection, or the hard drive can be easily removed from the train computer.**

In this task, we employed the Locomotive Video Data Acquisition System (LVDAS) previously installed by us at Caltrans' request in their locomotive #2008, and fully describe in the Final Report to the California PATH project titled "Innovative Grade Crossing Safety Measures for the San Joaquin Rail Corridor" (contract #65A0089). A schematic representation is shown in Figure 4.

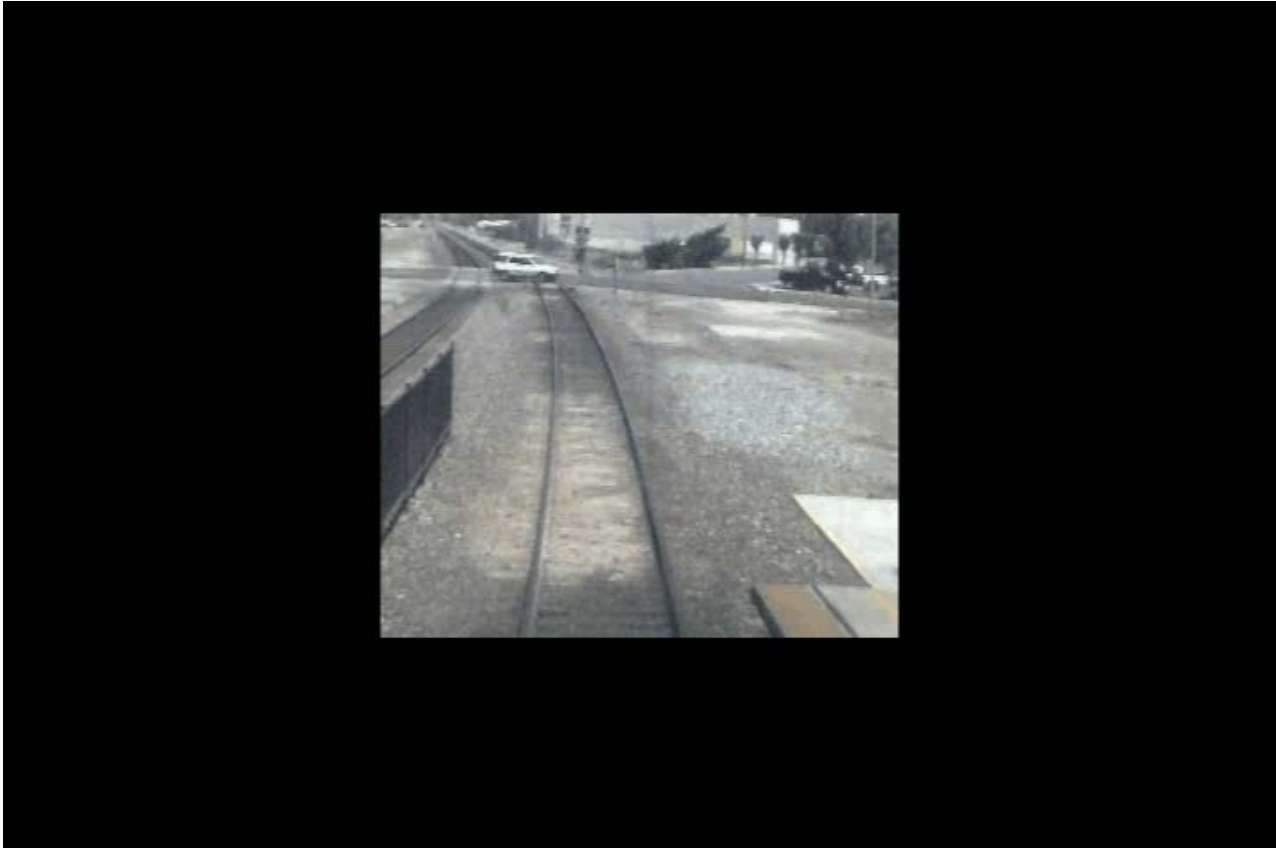
**Figure 5. Captured frame from video produced by LVDAS in moving locomotive.  
A crossing violation by a vehicle is clearly seen.**

A captured frame (from the forward facing frame camera only) of one of these incidents is shown in Figure 5 below. A video which shows the five crossing violations can be seen or downloaded at this URL: <http://path.berkeley.edu/~zuwhan/railroad/incidents.avi>.

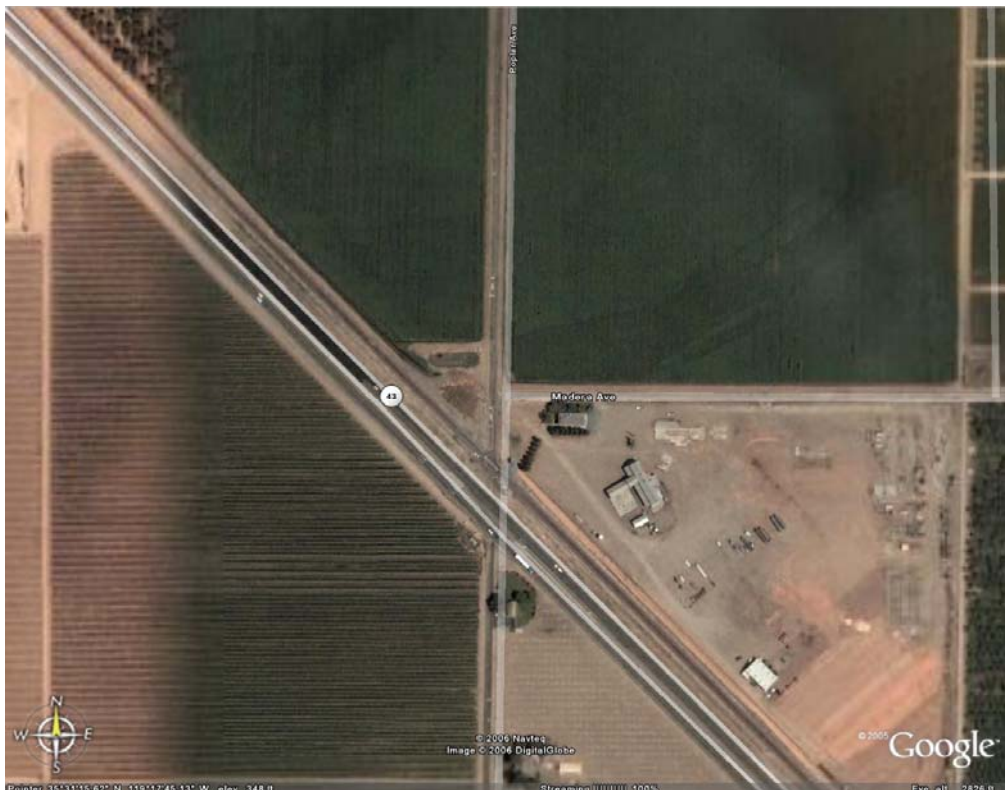
**Figure 6: An aerial view of the project site (with superimposed road labels) using *Google Earth*. Poplar Avenue runs north-south (vertical) while Madera Avenue runs east-west. The railroad track is the uppermost diagonal track running parallel to the two sides of highway 43 (near Shafter, CA).**

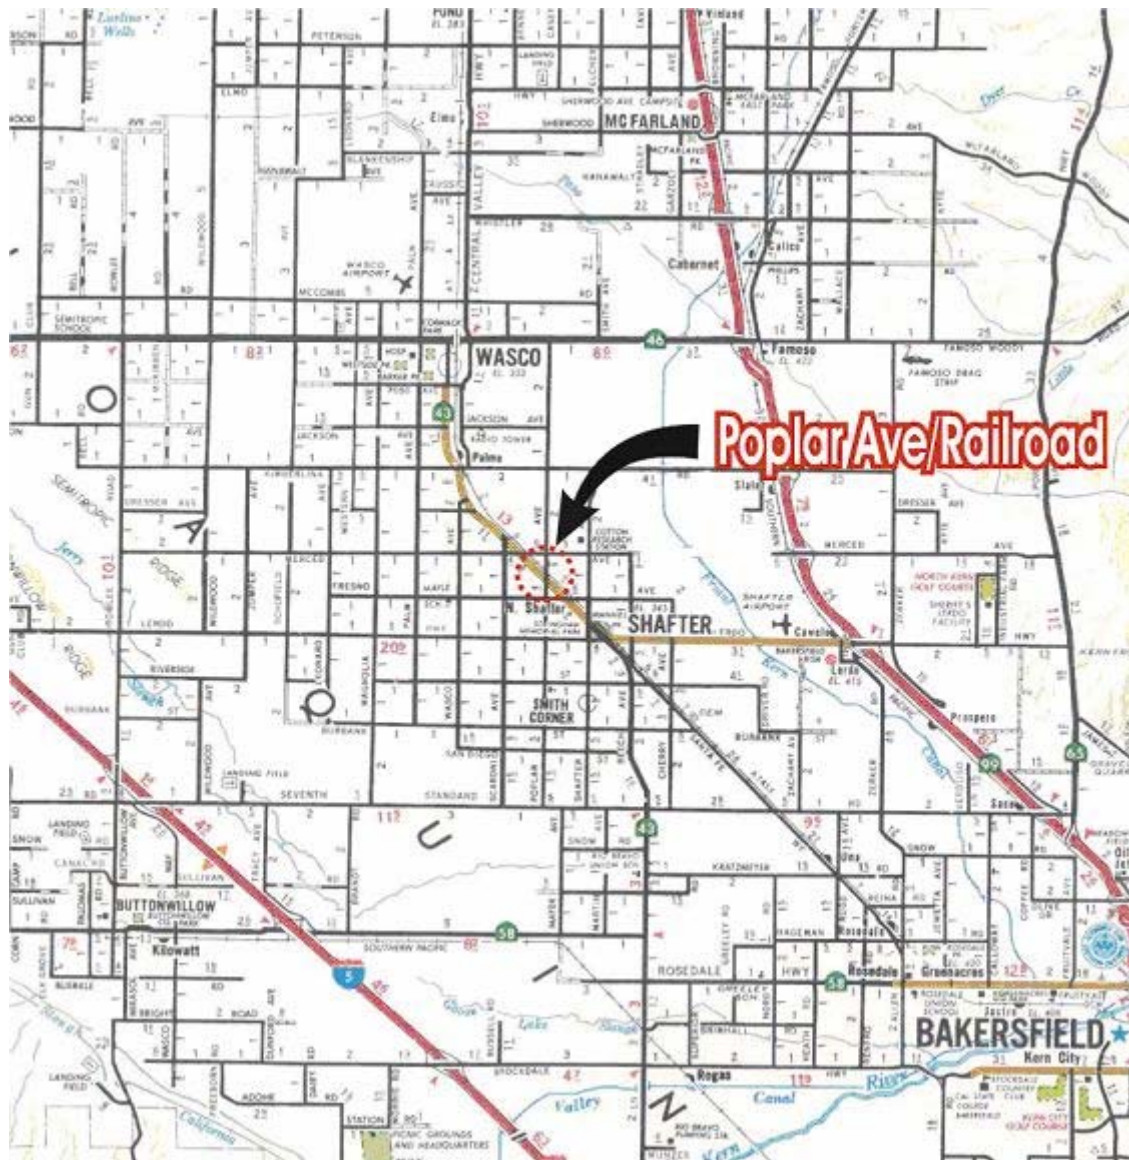
**Figure 7: A map showing the site of the field test.**

The portion of Mr. Lai’s project used in this investigation consisted of five lights embedded in the pavement across southbound Poplar Avenue just north of the grade crossing. The light housings protruded just enough, on the order of a centimeter, to allow the lights themselves (a horizontal string of LEDs) to be visible above the pavement. While this allows the easy passage of vehicles over the lights, their small luminous area, a consequence of the short height, was perceived to be a problem, as described later in this section.

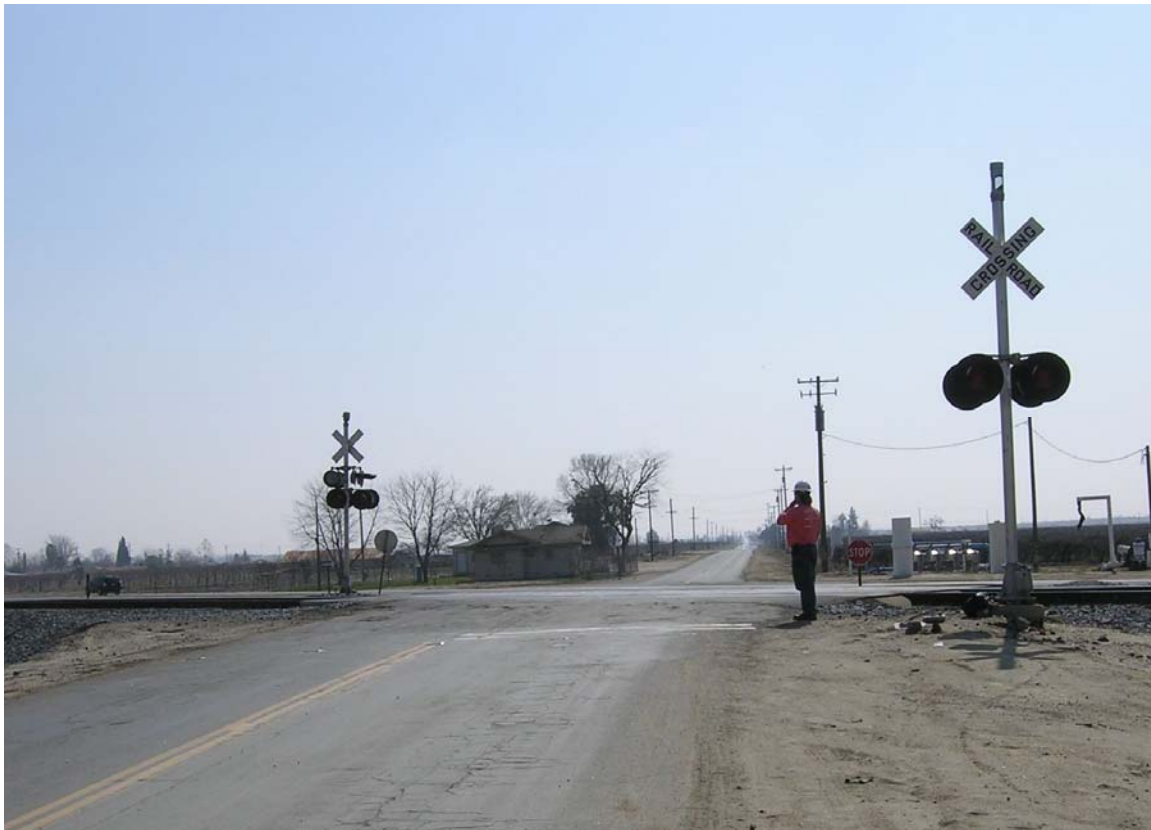
**Figure 8: Grade crossing at Poplar Avenue looking south. The (five) embedded lights under test run across the width of the road parallel to the white limit (double) line and just north (foreground) of it. Other than being too far to the right, the perspective of this photograph is approximately that of a driver approaching the grade crossing.**

The actual layout can be seen in the next two figures. The pictures were taken looking south along Poplar Avenue just north of the railroad tracks and Highway 43. The light housing at the end of the double yellow centerline just short of the left end of the white limit (double) line can be seen fairly easily in the first picture. The two lights to the left of this one (northbound side of Poplar) are less easily seen and the two to the right (southbound side) just before the white limit line are just barely visible in the photograph.

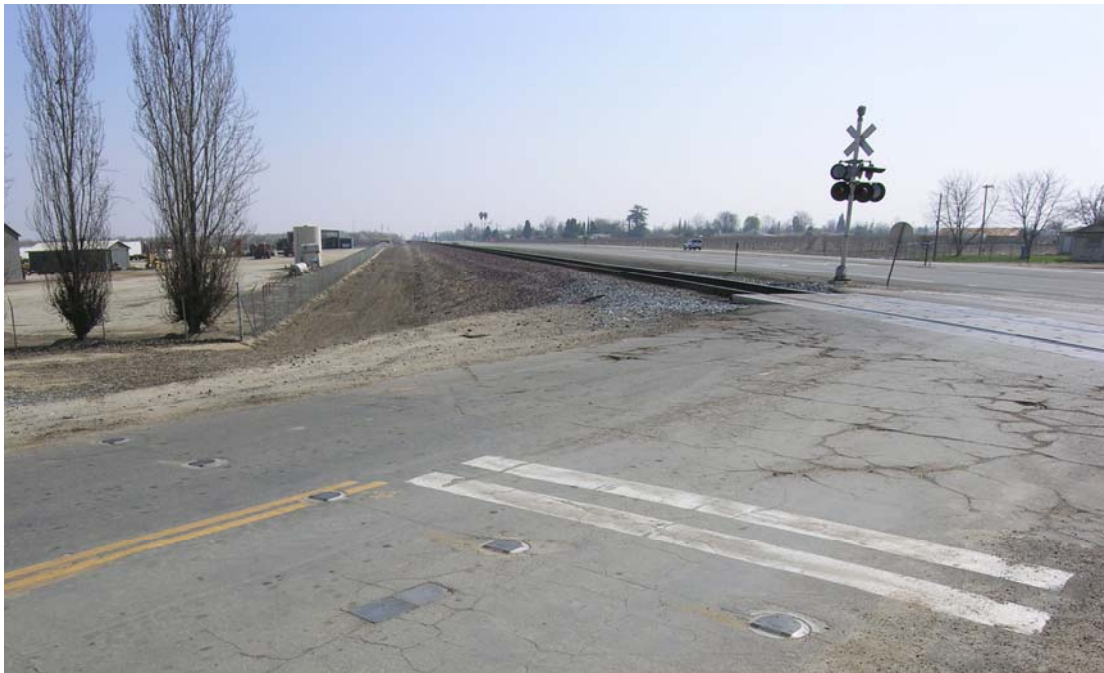
**Figure 9: The same five embedded lights as seen from above and looking more easterly.**

Figure 9 gives a better idea of the layout. The metal rectangle near the light in the middle of the southbound lane is the lid to a box containing an embedded magnetometer that was used in Mr. Lai's project.

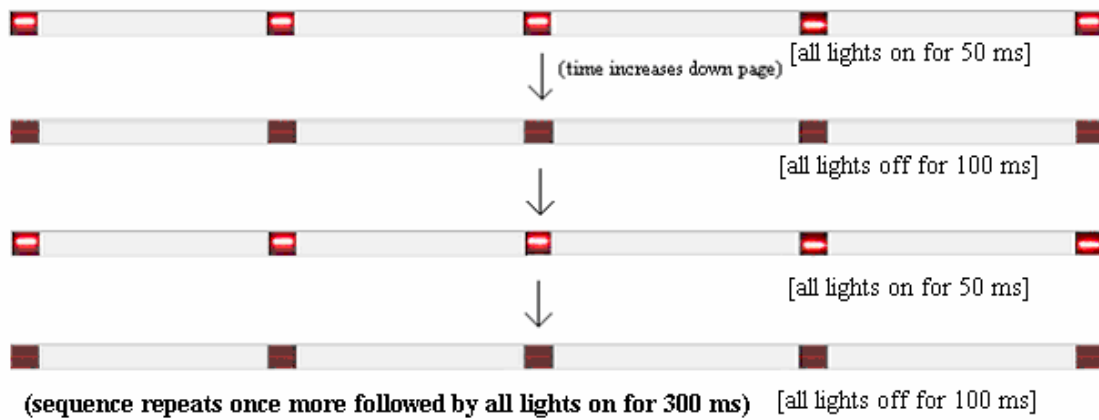
**Figure 10: "Standard" flashing sequence used during the CPUC experiment.**

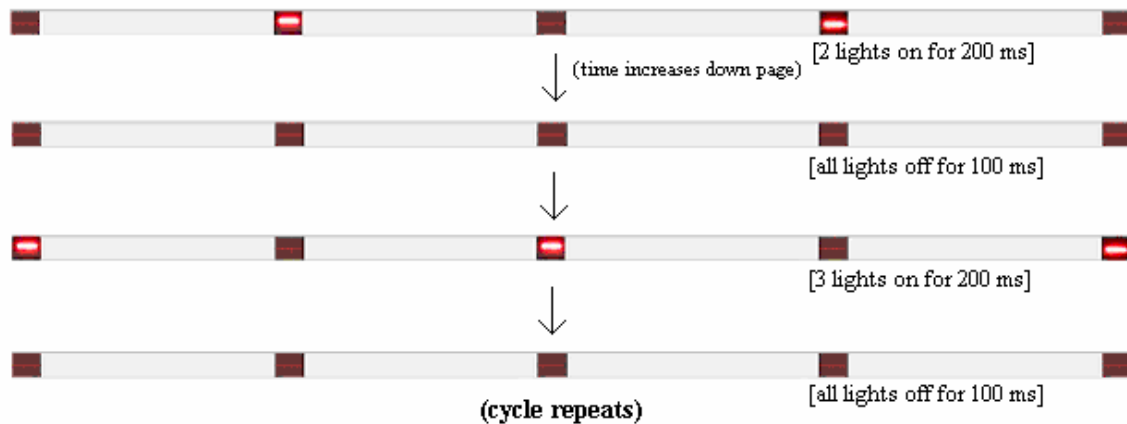
**Figure 11: Pattern and timing for field-deployed lights**

Based on previous laboratory experiments, the Visual Detection Lab felt that the signal pattern of the embedded lights could be changed so as to improve the signal’s effectiveness. The laboratory experiments had tested the reaction time of a number of observers who hit a response button upon seeing a given light pattern fire. Several patterns were tested. The best overall responses came from a pattern similar to that shown in Figure 11. (“Similar” because the lab test used four lights not five as shown here and the lighting sequence times were rounded off to those shown in the figure.)

We called the lighting pattern in Figure 11 the “Alternating Flashed Pair” (even though it consists of five lights) because it is very much like the flashing light pair used as the standard warning at railroad crossings. If the lights in this picture are thought of as being numbered from one to five as one moves left to right, then the pattern is basically the even numbered lights firing followed, after some “dead time”, by the odd numbered lights firing. The cycle then repeats.

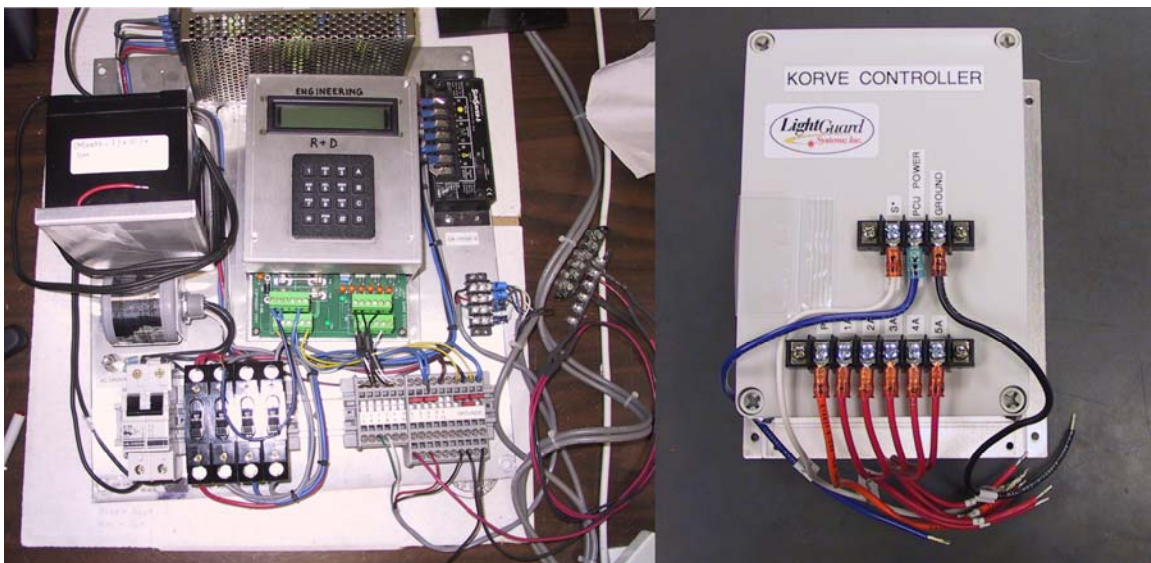
**Figure 12: The alternate controller (right) and the rig used to test it (left). [“Korve” is the name of the engineering firm that the Lai project used.]**

Thus the Visual Detection Lab designed our own replacement controller to signal the lights. To ensure compatibility with the embedded lights and the railroad equipment, *LightGuard* agreed to the actual construction of our design. The result is shown in Figure 12.

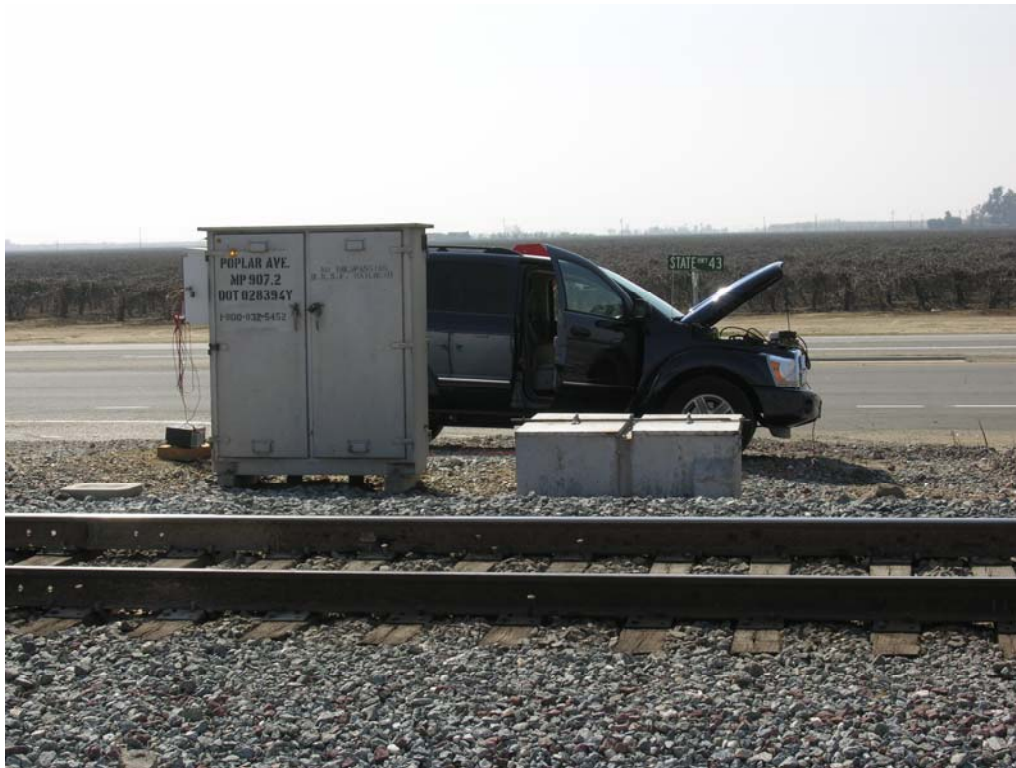
**Figure 13: The inverter used to supply AC power is seen resting above the grill on the vehicle. This allowed complete isolation from the AC power in the railroad control box seen on the left.**

To simplify the procedure, we used a commercially available inverter running off of a car battery to supply power to the system and obviate the need to use of the AC power within the railroad control box. This is shown in the Figure 13.

The inverter then supplied AC power to a heavy-duty DC power supply that in turn powered the low voltage (12 V) controller. The car battery was not used directly as a source of power because its output voltage, closer to 14 V under fully charged conditions, was outside the range allowed for the circuitry in the controller. Employing the inverter and DC power supply was simpler than constructing voltage regulation circuitry to reduce the 14 V output of the car battery to the 12 V required by the controller.

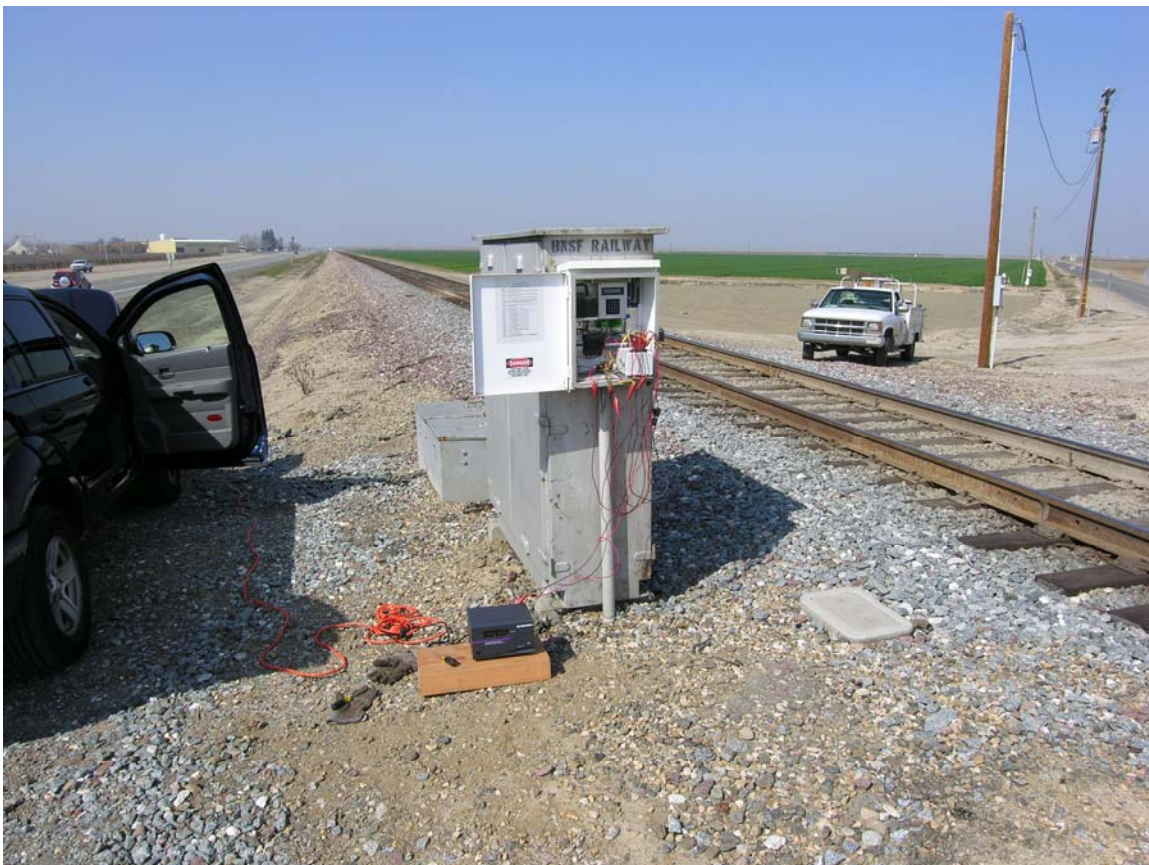
**Figure 14: The heavy-duty DC supply rests on the board in the foreground. It is powered via the orange extension cord that comes from the inverter. Alligator clip leads were used to make the remaining connections. The new controller rests near the lower right-hand corner of the open white control box.**

Alligator clip leads were used to connect the (low voltage) light wires to the new controller, which we placed adjacent to the original controller for this short-duration test (see Figure 14).

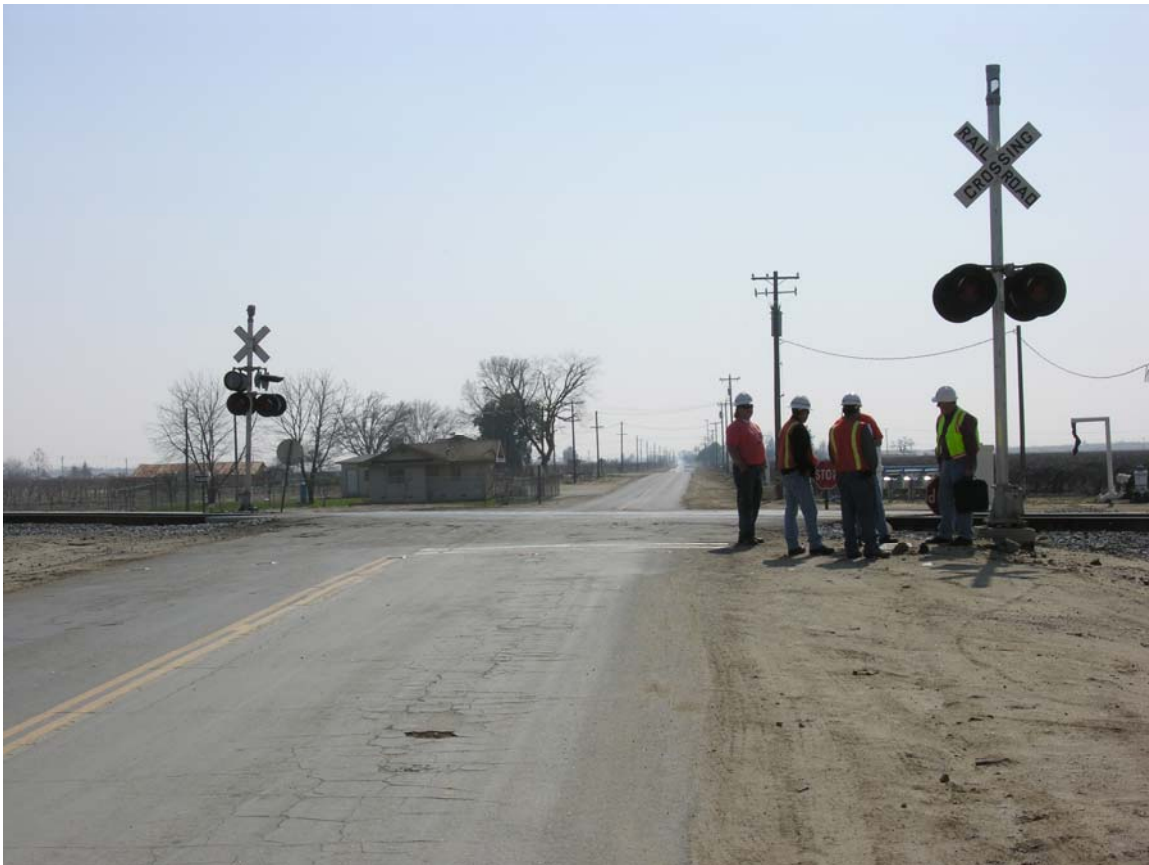
**Figure 15: The embedded lights firing the alternate pattern. Numbering the lights from left to right from one to five, lights two and four are firing when this photograph was taken.**

A still photograph of the new pattern is shown below in Figure 15—embedded lights 2 and 4 are firing. The perspective is not too different from that of a driver approaching the grade crossing (perhaps a little closer to that of a passenger on the right). The lights are a little difficult to discern in the photograph printed in this report. While the dynamic nature of our experimental firing pattern improved upon the conspicuousness of these lights in relation to what can be conveyed in a still photograph, the improvement was not enough to make the embedded lights an effective signaling tool during daylight hours. The relatively low intensity of the embedded lights was a product of the installation carried out in the PUC experiment and thus beyond the control of the Visual Detection Laboratory.

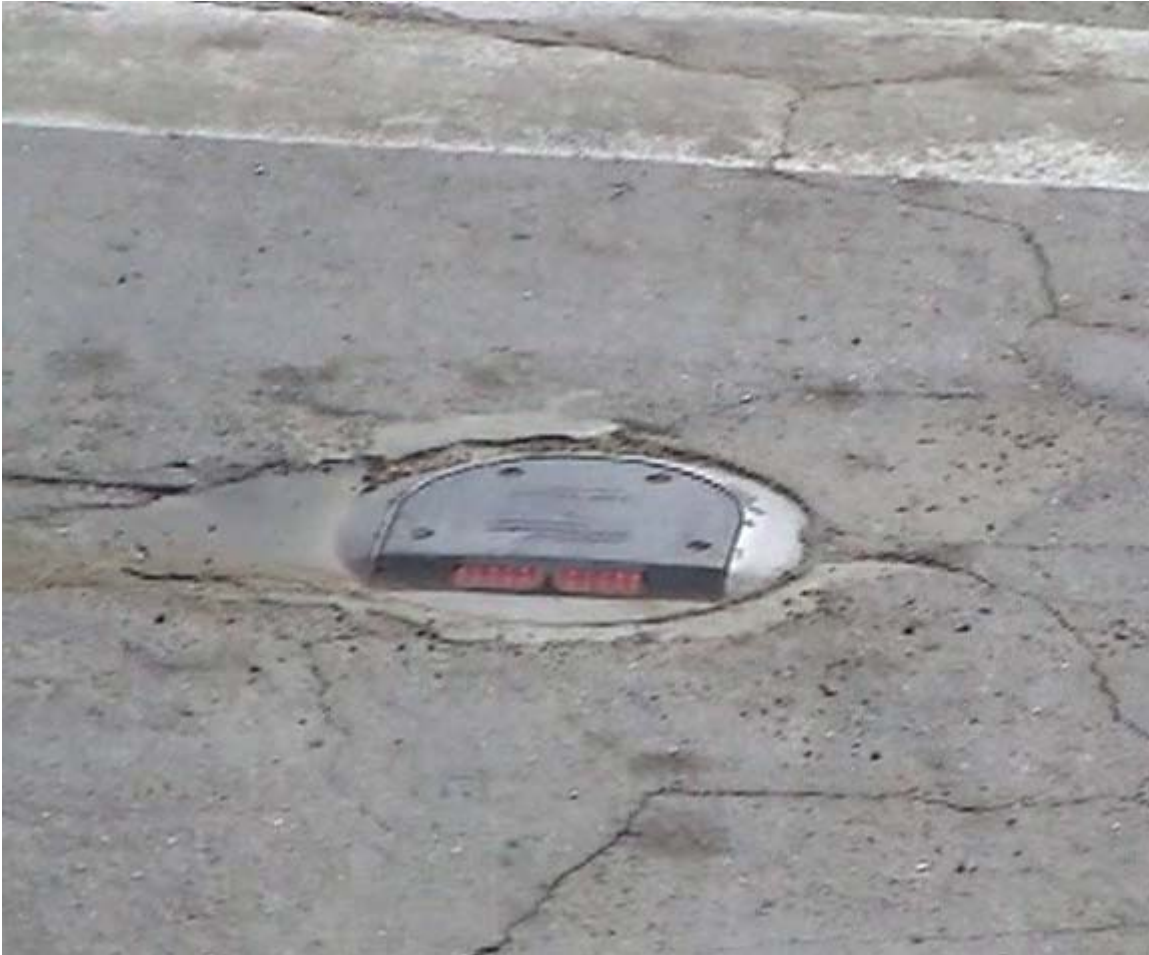
**Figure 16: A close-up of one of the embedded lights as it is firing.**

In Figure 16 a close-up of a firing embedded light can be seen. Even though these lights use high brightness LEDs they can be difficult to see in direct sunlight. In comparison, the typical LED traffic lights are much more visible because 1) the number of LEDs is much greater and occupies a much greater area and 2) the traffic lights typically have a sunshade.

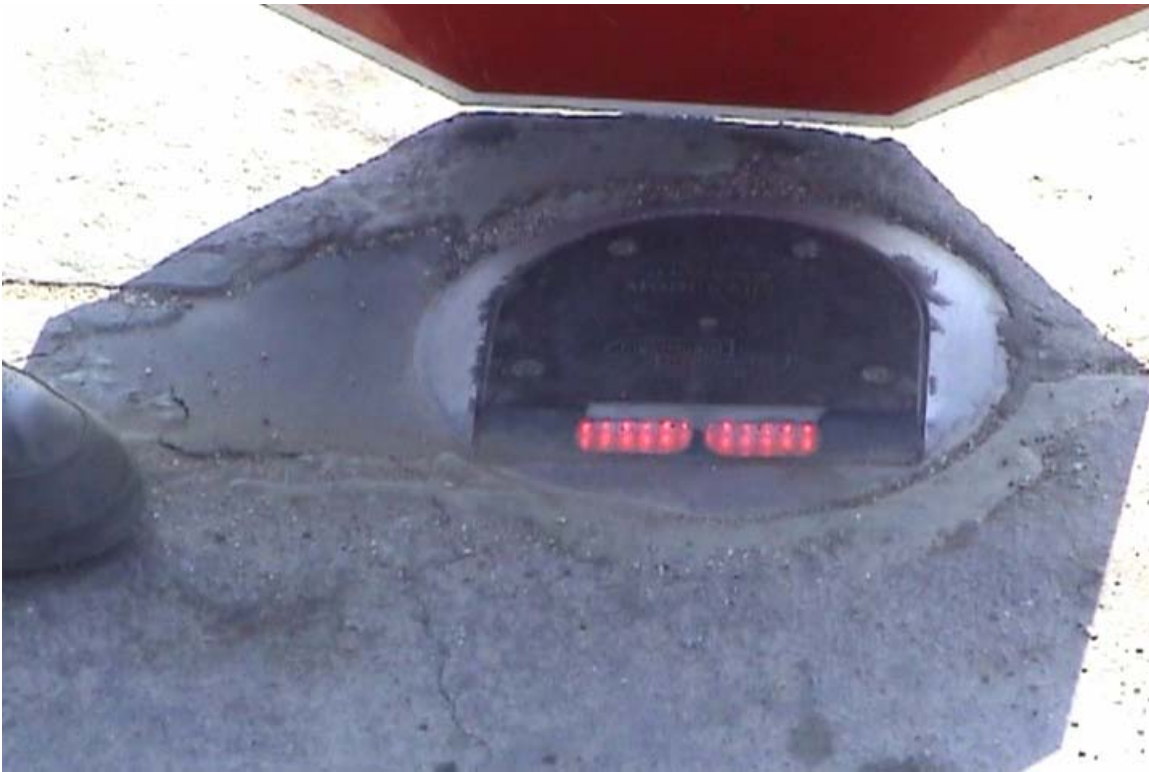
**Figure 17: The conspicuousness of the firing light improves markedly when not in direct sunlight.**
