Rapid Erosion of a Southern California Beach Fill

Coastal Engineering, 52(2005)

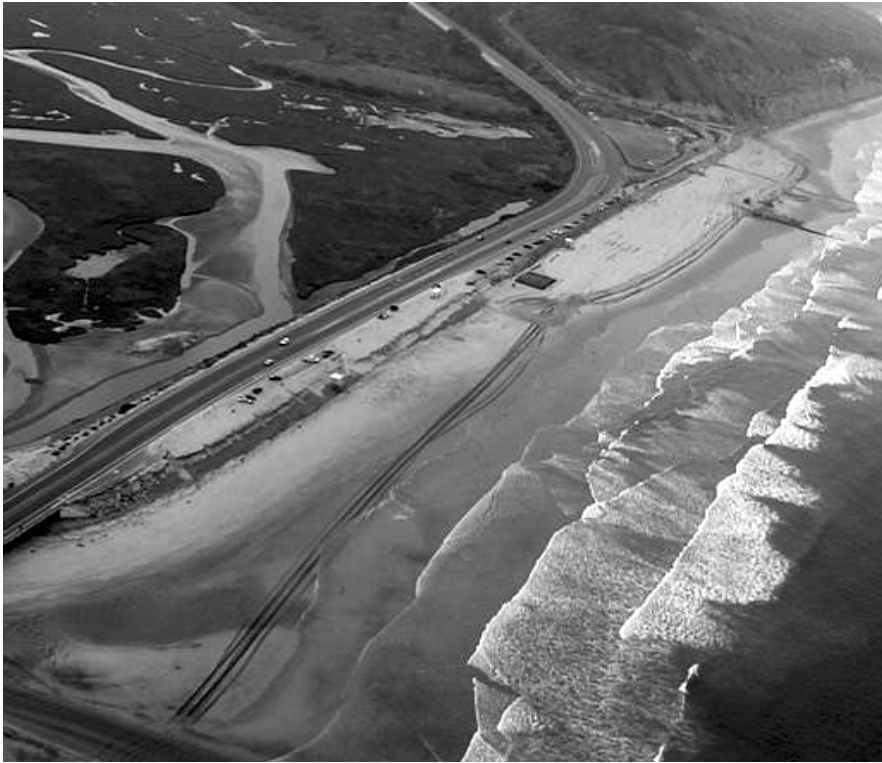
Figure 2. View of the beach fill site showing the Torrey Pines cliffs to the south and the lagoon mouth to the north.

area of low relief (see Figure 2.) The California Resources Agency and the Department of Boating and Waterways selected Scripps Institution of Oceanography (SIO) to undertake a detailed monitoring investigation of the Torrey Pines site. Surveys, as described in the following sections, were begun just prior to the fill construction and were continued biweekly for approximately one year and then monthly for an additional year. Sediment analyses of the native beach material and periodic sampling of the nourishment material were accomplished by others.

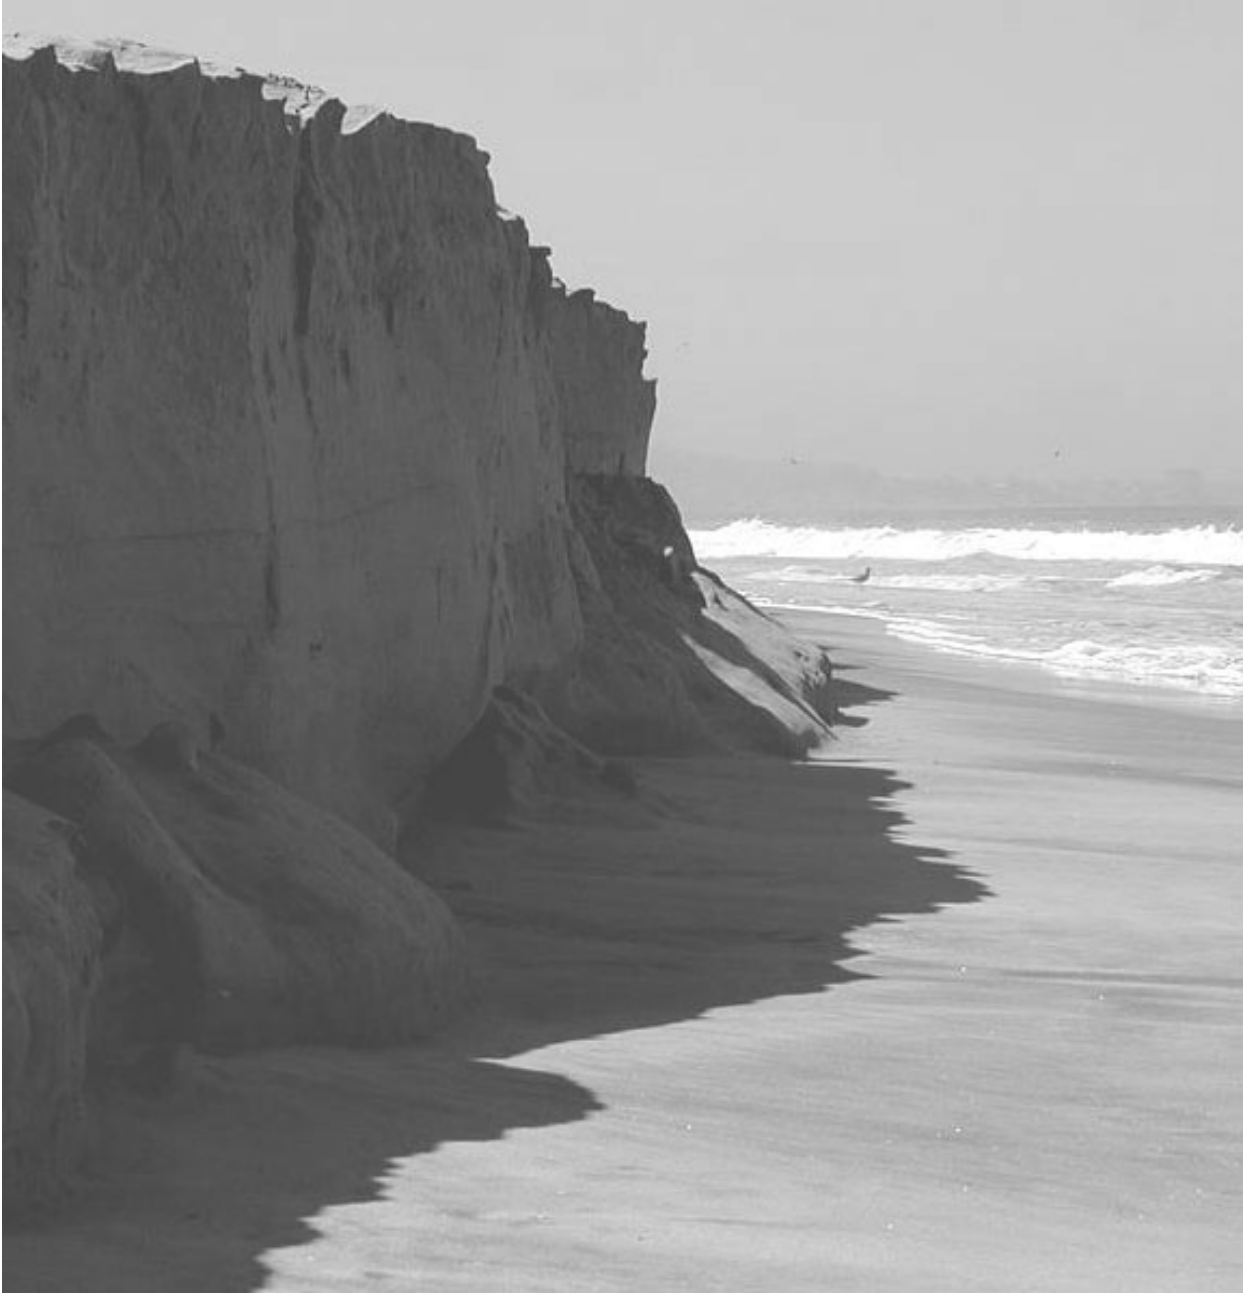
Figure 3. Post-construction scarp at Torrey Pines beach fill.

The Torrey Pines nourishment contained approximately 140,000 m³ of sediment with a median diameter (D₅₀) for the various samples that ranged from 0.15 to 0.25 mm. The native beach D₅₀ was xx mm, such that [comments on suitability]. The alongshore extent was approximately 750m and the width about 70m. This volume is relatively small compared to many East Coast beach fills. For example, in 1992 Florida constructed almost 200 km of nourishment in a total of 33 projects or an average of about 6 km per project (Clarke, 1992.) Because of its short length this project could be expected to suffer large end losses (Dean and Yoo, 1992.) Beach nourishment initial or as-built geometries typically result in slopes much steeper than the native beach slope so that construction operations can be accomplished in the dry, for the most part. At Torrey Pines, the native beach was very narrow – less than 80 m from a riprap seawall protecting the adjoining highway to the mean sealevel line. Rather than burying the riprap wall and sloping the fill to the shoreline, the contractor elected to level the fill material such that a steep, almost vertical scarp almost 2m high was formed near the shoreline (see Figure 3.) The construction required about 2 weeks and was completed in the last week of April, 2001. The scarp was maintained with very little modification by waves and tides for a period of about 7 months.

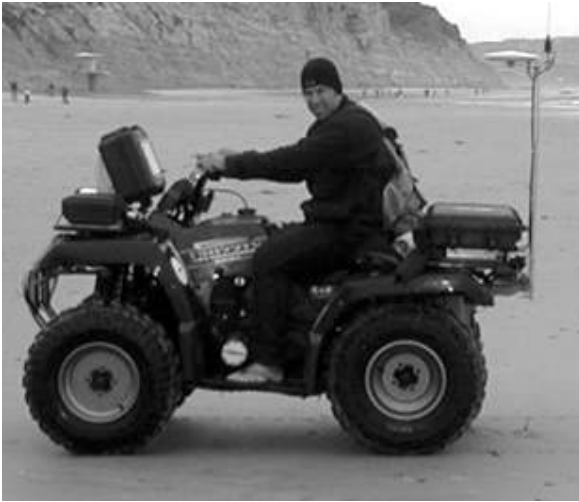
Figure 6. GPS-navigated all-terrain vehicle for dry beach surveys.

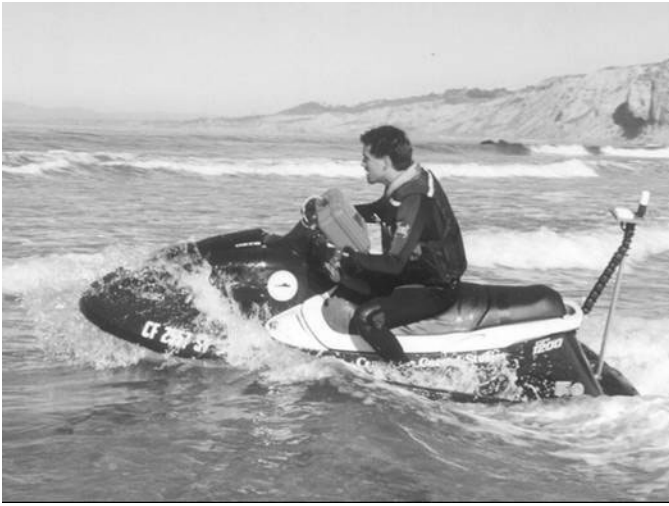
Figure 7. GPS-navigated JetSki for underwater surveys

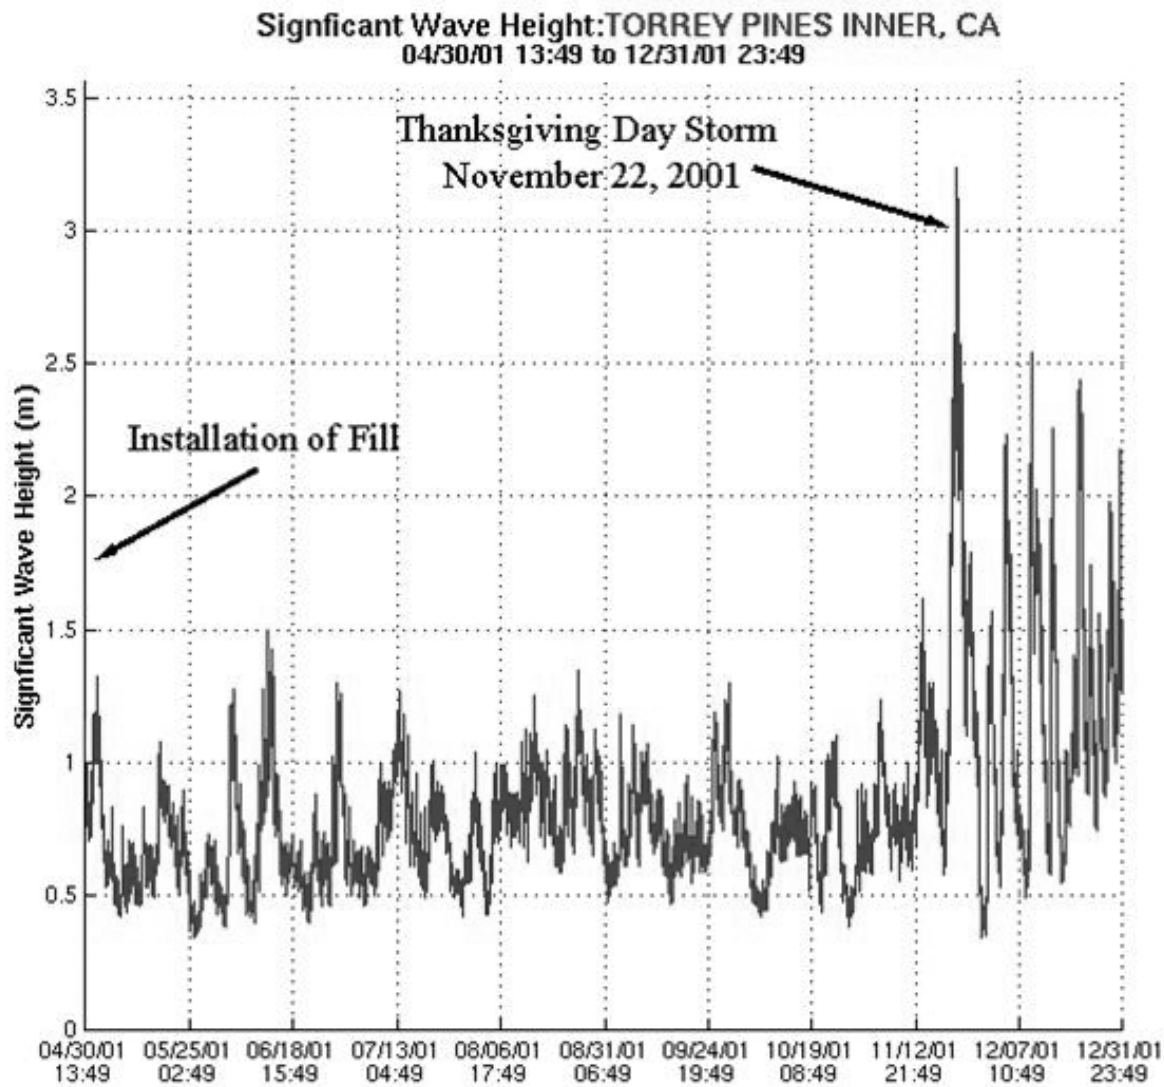
Figure 9. History of significant wave heights at Torrey Pines beach fill

In the approximately seven month interval between the completion of the construction of the fill in April, 2001 and a moderately severe storm in November of that same year, the significant wave height (H_s) seaward of the surf zone varied between about 0.4 and 1.5 m. During this time there were 15 episodes where H_s exceeded 1m, as shown in Figure 9. This wave climate is typical for the summer season in this location. During the same period in 2002 the wave record was essentially identical and in 2003 the H_s range was slightly higher -- 0.4 to 2.1m -- with three episodes over 1.5m. The annual tide range at this location is about 1.6m.

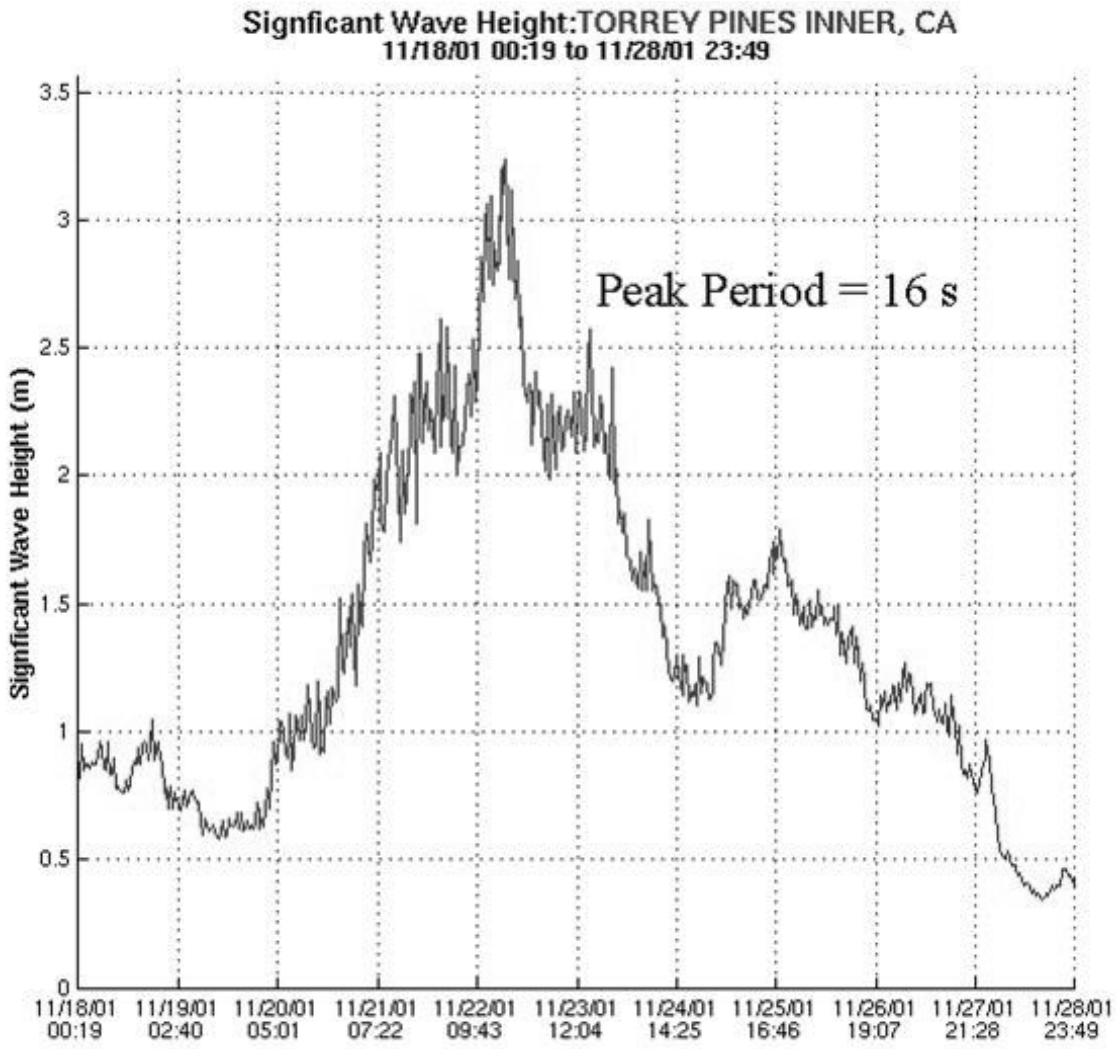
Figure 10. Significant wave heights at Torrey Pines during the Thanksgiving Day Storm

About midnight on November 20, 2001, the H_s exceeded 1.5m and continued to increase, reaching a peak of 3.5m on the afternoon of Thanksgiving Day, November 22. It remained above 1.5m until the morning of November 24, as shown in Figure 10. The period of peak energy at the height of the storm was 16 seconds. The storm peaked at about 9AM on the 22nd. Figure 11 shows the predicted tide elevations for the last half of the month. The high tides (1.2m) bracketed the storm peak, remaining at a level of 1m or above. However, Figure 11 shows clearly that the storm coincided with the neap tides for that period.

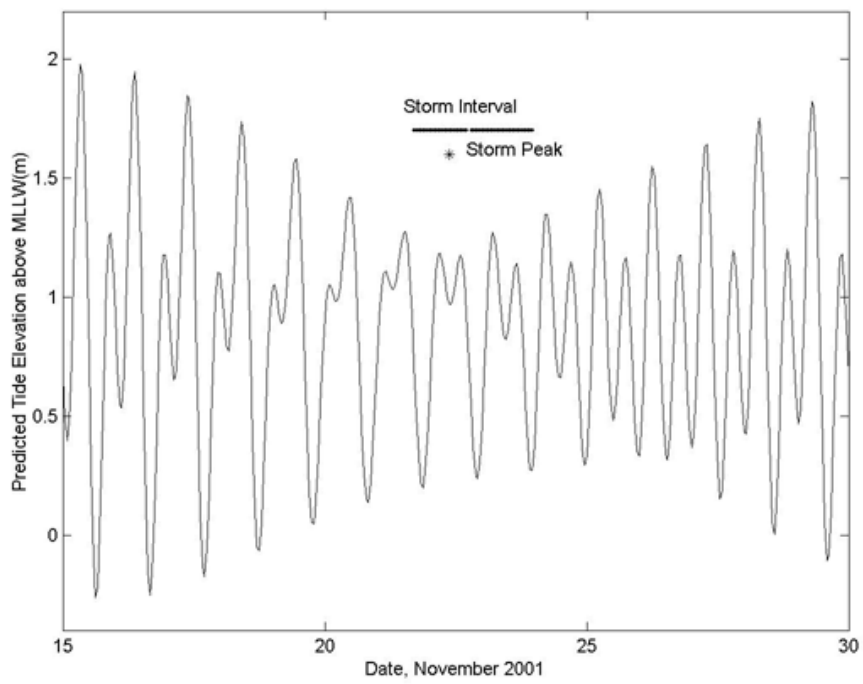
Figure 11. Tide elevations at Torrey Pines during the last two weeks in November, 2001

The astronomical tide appeared to have only a small influence on the erosion of the fill as its elevation during the event was only slightly greater than one half of the annual maximum.

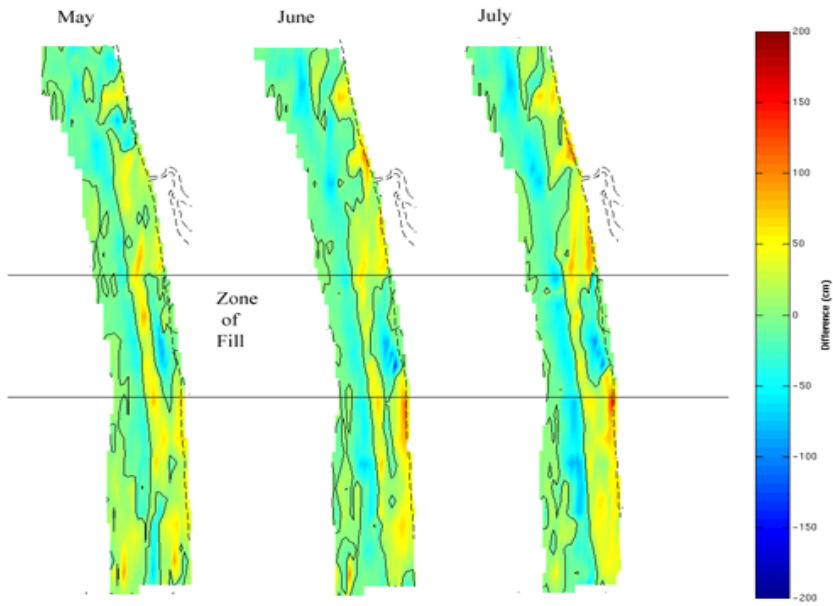
Figure 12. Sequence of differences between elevations following construction and mid-month surveys in May, June and July, 2001.

During the post-construction period and prior to the peak of the Thanksgiving Day storm, there were a variety of changes to the region of the fill. Figure 12 shows a sequence of elevation changes, each relative to the post-construction survey. All of the neighboring beaches within the survey area showed the typical migration of the winter bar onto the beach, with the exception of the fill region, where it appears to have stalled offshore. One possible explanation for this anomaly is that the steep berm face had a very high reflection coefficient compared to the adjacent natural beaches and that the reflected energy inhibited the onshore sediment transport in front of the fill.

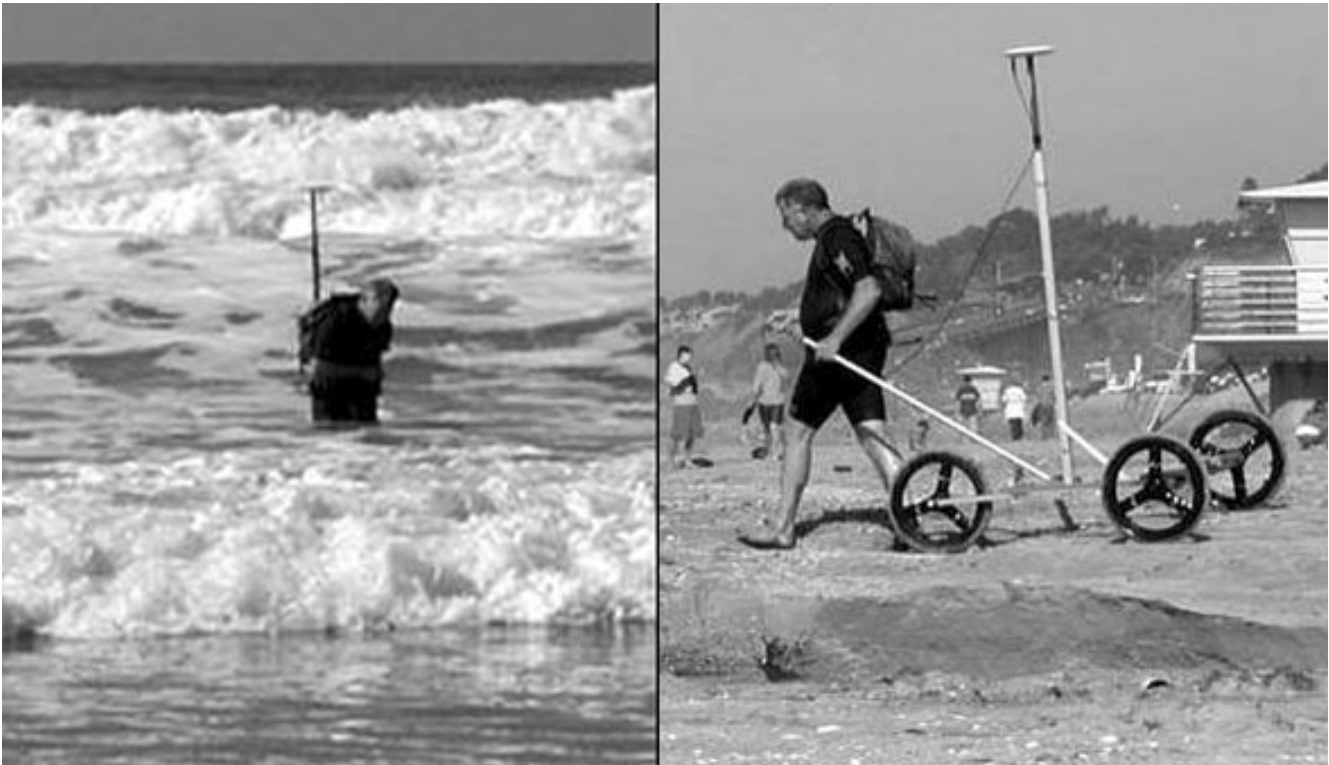
Figure 14. Survey activities during the storm using backpack (left) and dolly (right)

The beach fill began significant erosion early on Thanksgiving Day, November 22, 2003 – although the first visual observation by project personnel was not until the afternoon. The combined tide and runup overtopped the fill berm. Profile lines were run during daylight hours that day using GPS survey equipment contained in a backpack or mounted on a hand-propelled dolly (see Figure 14.) A full post-storm survey was completed a week later using the conventional equipment described above. As shown in Figure 15, the erosion was marked by a series of embayments which were spaced roughly 50m apart. Erosion of the intervening cusp-like material occurred at a slower rate than observed in the embayments. Figure 16 shows a sequence of pictures illustrating the erosion of one of the projecting features during a single wave uprush event. Although similar patterns of berm erosion have been observed elsewhere (Inman, 2002), there is no available theory to explain the quasi-periodic character of the embayment

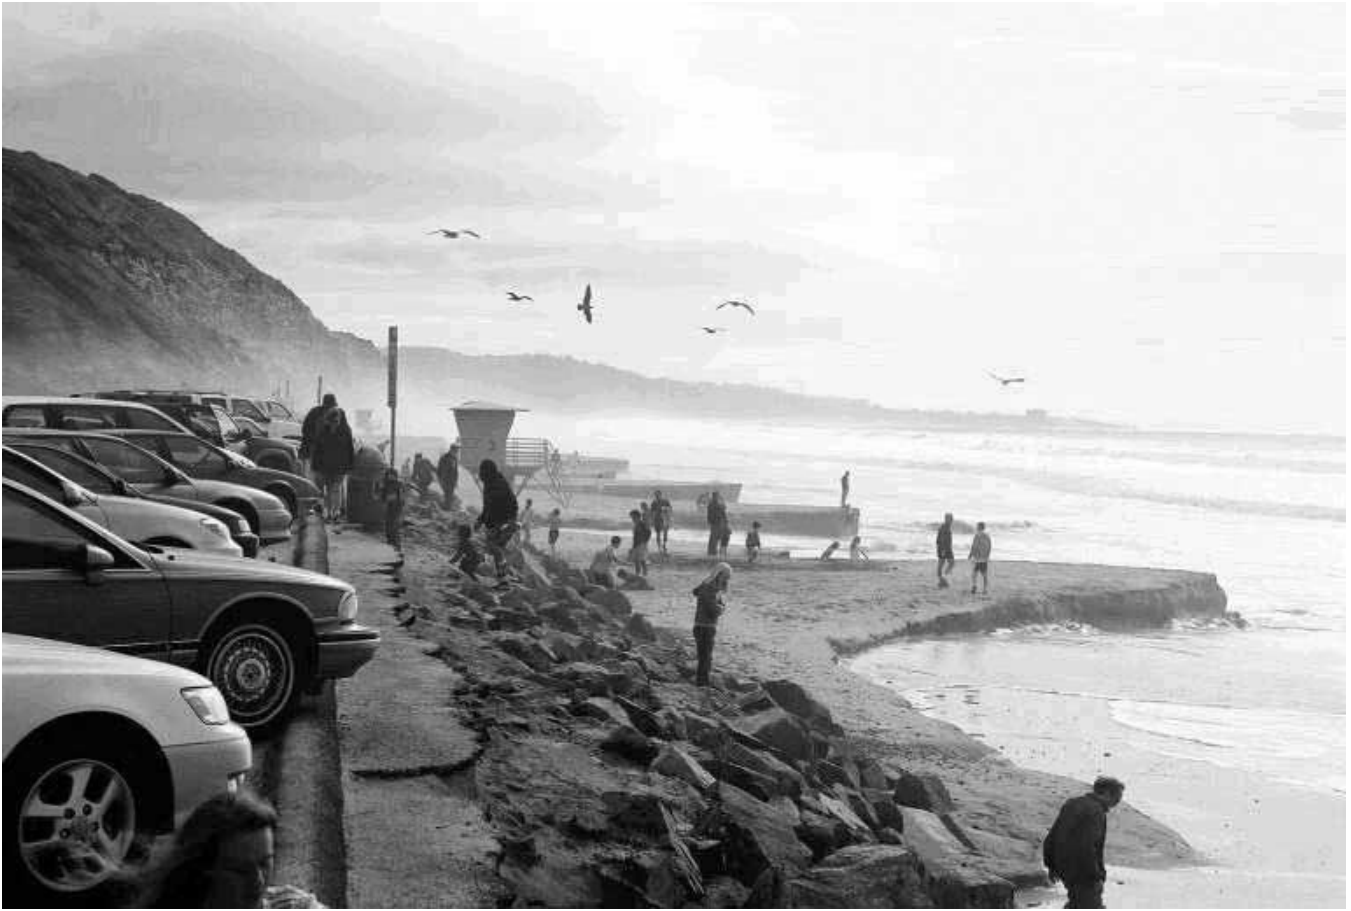
Figure 15. Beach fill erosion as a series of embayments

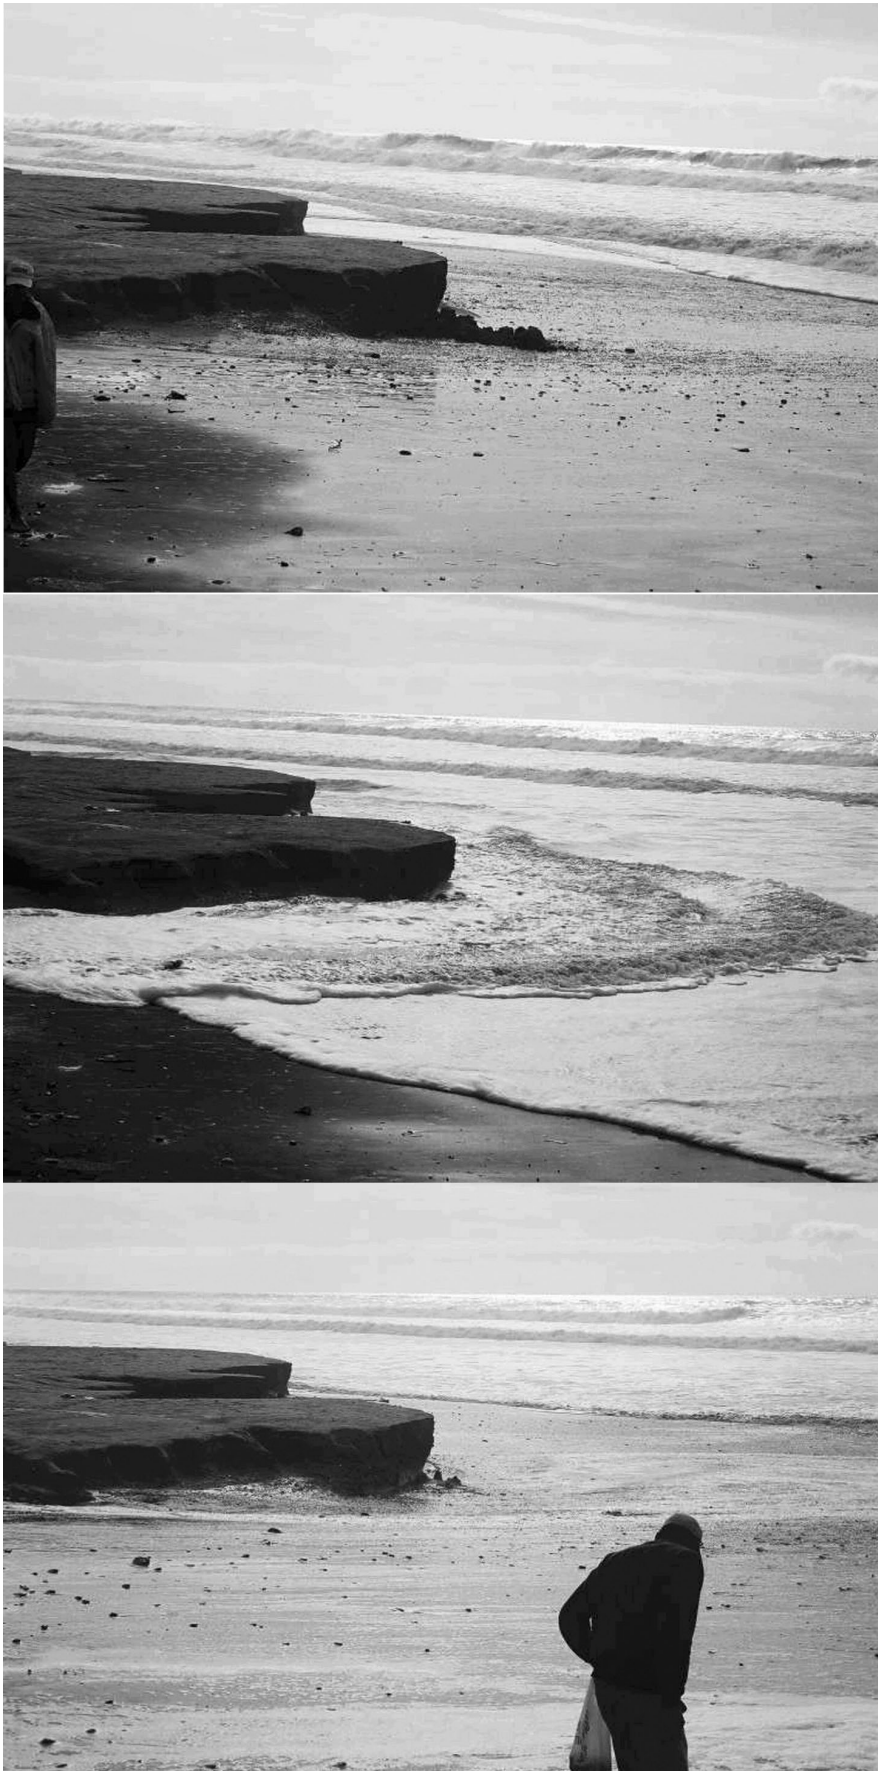
Figure 16. Sequence over one wave period showing erosion of the tip of a cusp

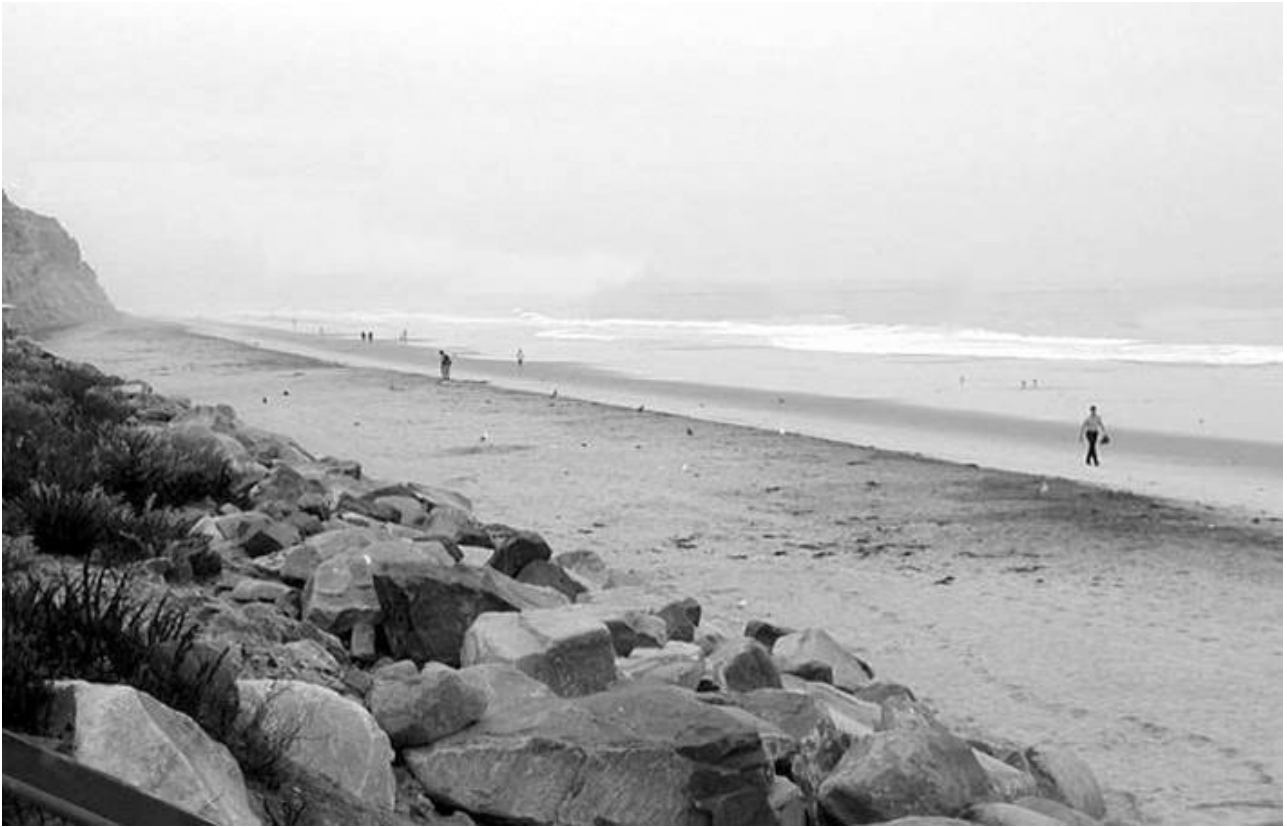
Figure 18. Summer beach at the site of the fill in 2002, the year following the storm

formation. By daylight on November 23, the fill had been almost completely eroded to the riprap revetment at the back of the beach. Figure 17 shows the changes in the beach elevation that occurred between the surveys of 17 November, 2001 (pre-storm) and 30 November, 2001. Beach erosion exceeded 3m and the offshore accretion exceeded 1m. The location of the center of mass of the bar southward of the center of the fill is consistent with wave direction during the storm. The second offshore bar to the north of the fill is probably from the lagoon delta erosion. Figure 18 shows a view of the fill site during the following summer of 2002. Although the beach recovered to a near-normal configuration, there was essentially no visual evidence of the fill location.
