Reflective Cracking Study: First-Level Report on HVS Testing on Section 589RF - 45 mm MB4-G Overlay

D. Jones, R Wu, J Lea and J. Harvey

Partnered Pavement Research Program (PPRC) Contract Strategic Plan Element 4.10:
Development of Improved Rehabilitation Designs for Reflective Cracking

University of California
Pavement Research Center
UC Davis, UC Berkeley

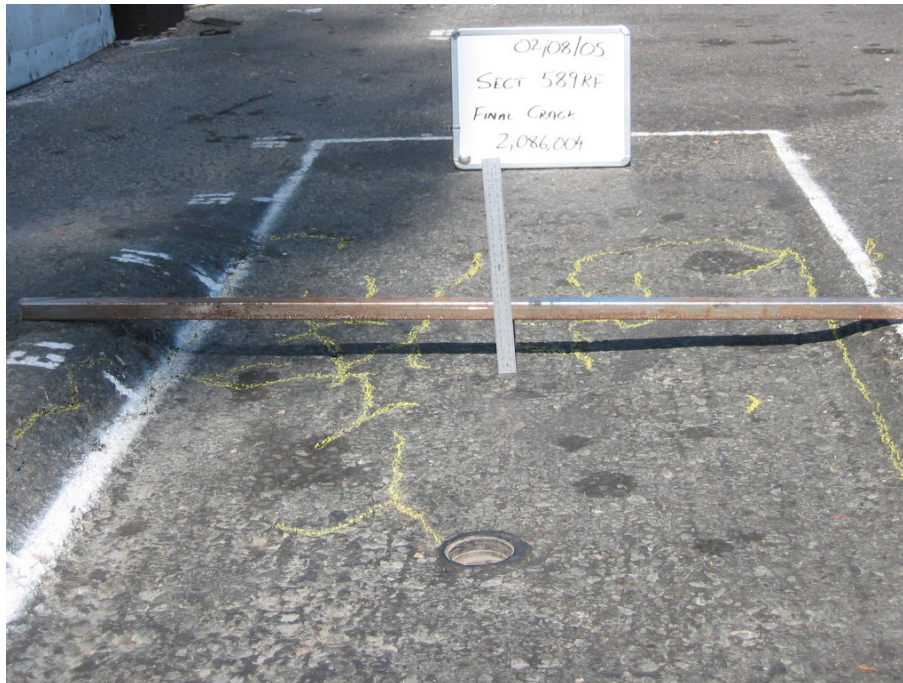
Regular crack inspections were made from the time that the first crack was detected through to the end of testing. The first cracks appeared between Stations 12 and 14 after about 1.5 million repetitions and were considered to be associated with the permanent deformation (rutting and shoving) discussed in the previous section. Cracks continued to appear for a short period until about 1.6 million repetitions, after which no further cracking was noted. The observed cracks were less than 1.0 mm wide and difficult to detect visually. They did not spall or increase in width during testing. Most cracking was longitudinal and did not mirror the cracking in the underlying layer. At the end of testing, 29 cracks were identified with a total length of 4.51 m and an average spacing of 200 mm. This equates to a crack density of 1.55 m/m², considerably lower than the failure criterion of 2.5 m/m² set for the experiment. Figure 3.36 shows the surface between Stations 12 and 14 at the end of testing, with cracks highlighted. The deformation is also clearly visible.

Figure 3.36: Surface cracks marked with crayon between Stations 12 and 14 at end of test.
