Performance Documentation of the Longard Tube at Del Mar, California, 1980-1983

## PERFORMANCE DOCUMENTATION OF THE LONGARD TUBE AT DEL MAR, CALIFORNIA 1980–1983

REINHARD E. FLICK and B. WALTON WALDORF

*Center for Coastal Studies, Scripps Institution of Oceanography, La Jolla, CA 92093 (U.S.A.)*

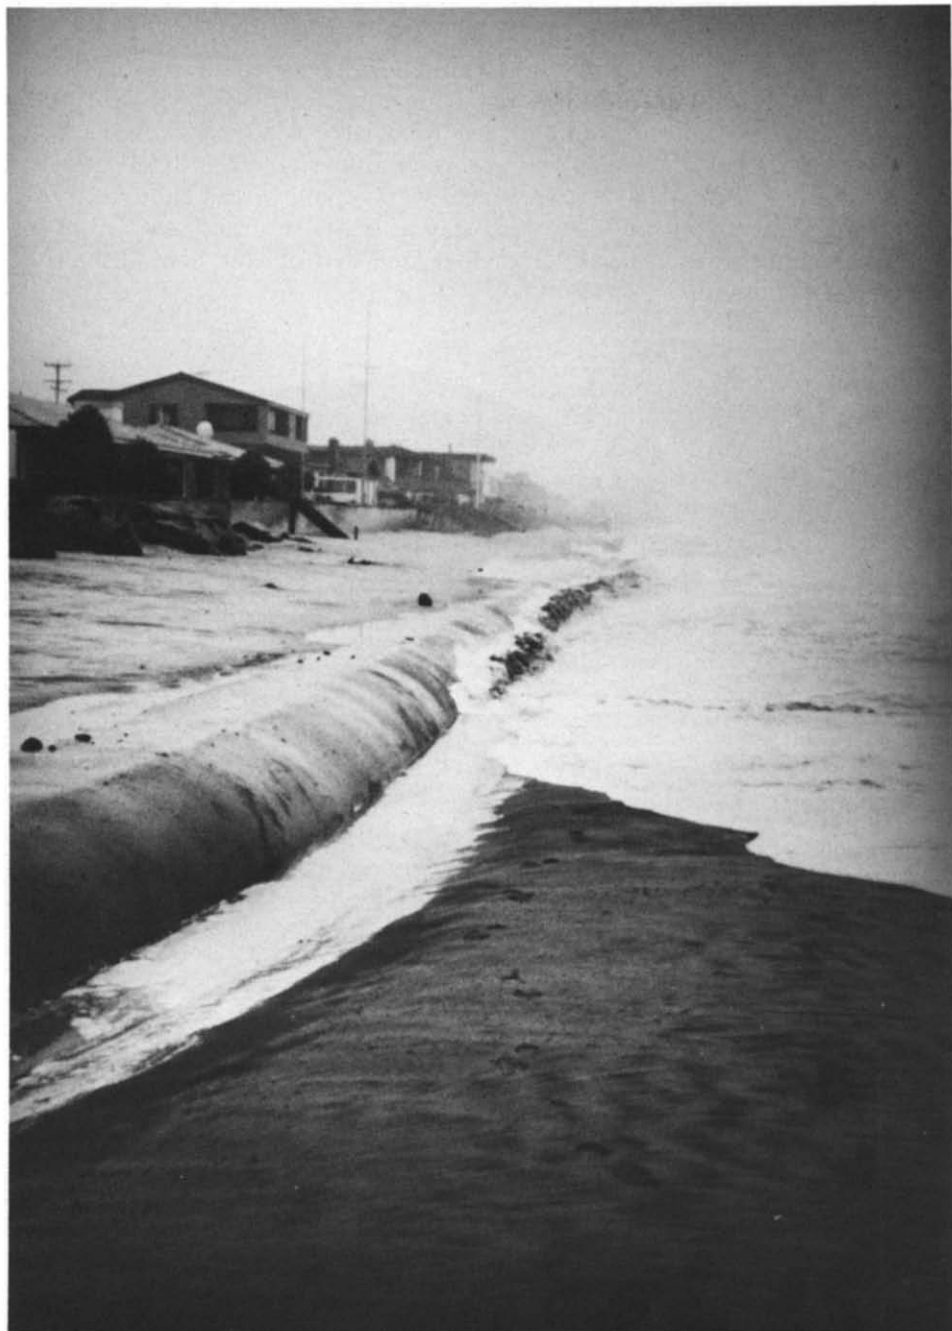
**Fig. 2. Wave interaction with Longard Tube during first winter storm, 22 January 1981.**

(Fig. 2). Wave energy was reflected on the seaward side of the tube, while the tube retained sand in a perched beach, on the shoreward side. It should be noted however that no significant sand loss occurred in the backshore anywhere on Del Mar beach during this winter.

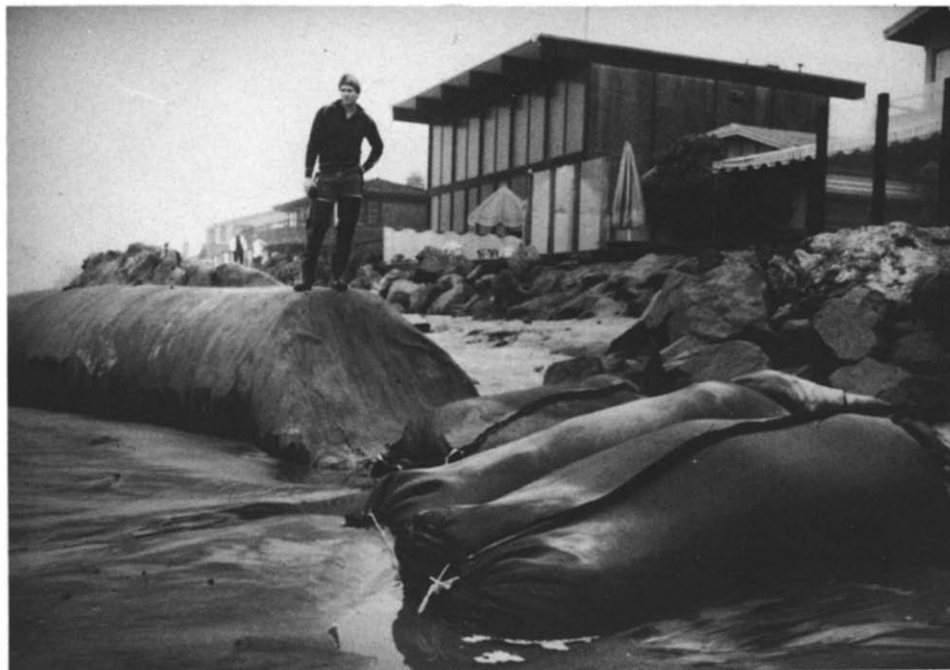
On the extreme southern end of the tube large sand bags placed to tie back the tube to the existing seawalls were undermined and fell seaward (Fig. 3). In this local area further wave overtopping of the tube produced localized sand scour on the shoreward side as water returned seaward in the area of the slumped sand bags. Minor localized loss of sand behind the tube occurred as a consequence.

Fig. 3. South end of Longard Tube showing failure of sand-filled bags used as tie-back to effectively hold sand behind the installation during moderate storm of mid January 1981.

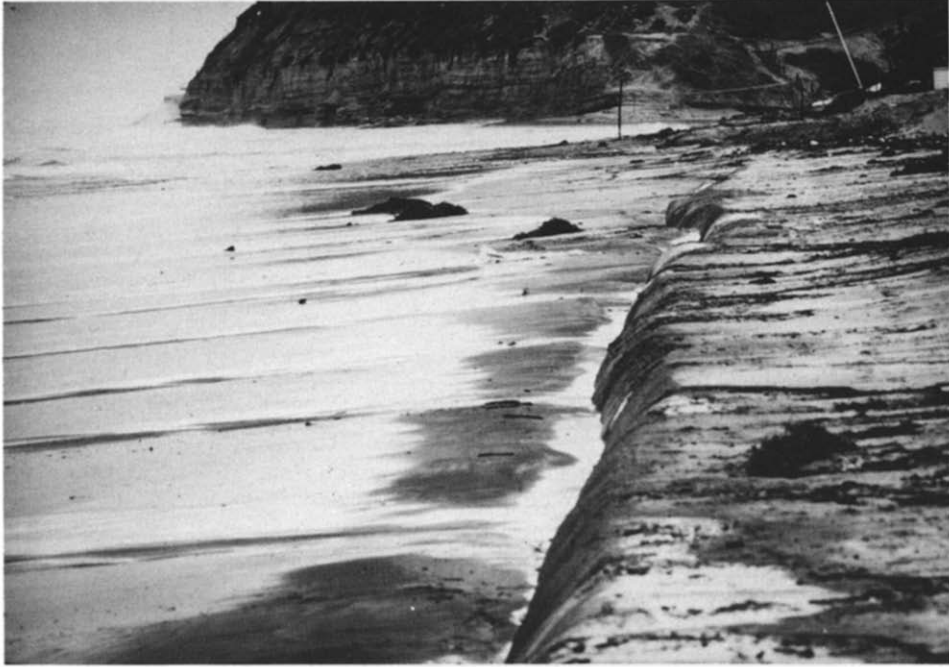
Two more winter storms during the 1980–1981 season produced waves large enough to interact with the Longard Tube. During these periods, observations revealed a problem that eventually contributed to tube failure. During brief intervals when storm waves occurred during high tide, wave overtopping rapidly saturated the sand shoreward of the tube and water returning seaward with the wave backwash poured over the tube top at localized areas of lowest elevation. Water from wave overtopping scoured small longshore channels on the tube's shoreward side, which funneled more water into the areas of low vertical elevation. As the scouring continued the water returning seaward pouring over the tube began to also scour channels

on the tube's seaward side as shown in Fig. 4. This process is self-perpetuating, and continuous exposure eventually caused localized vertical slumping of the tube as it was undermined by local scour. This process contributed to the rapid subsidence of the tube during the severe beach cut and overtopping in winter 1982–1983.

Fig. 4. Photo taken 5 March 1981 showing first stages of localized scour depressions on the seaward side of the tube formed by seaward return flow over tube at points of lowest vertical elevation. This photo taken after the tide had dropped and shows only the remnants of the scour channels which are filled in as over-topping of the tube ceases.

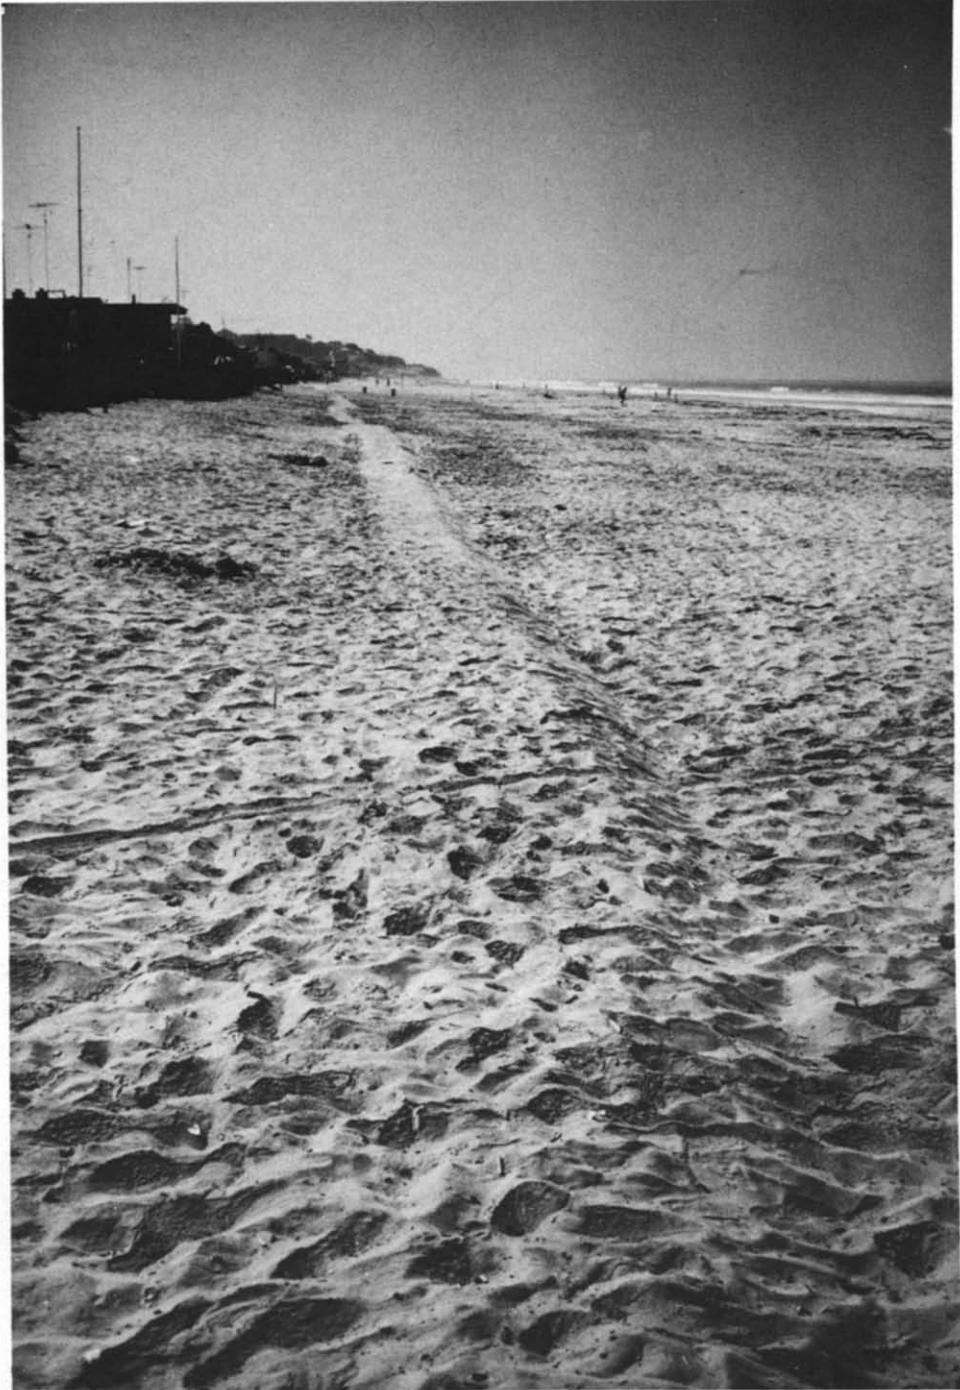
Following the mild winter of 1980–1981, the beach prograded rapidly in a typical accretionary sequence (Fig. 5) removing the tube from wave interaction. By September 1981 the tube was almost entirely buried as shown in Fig. 6. Sand levels at this time were very high as shown by a 10-year time

**Fig. 6.** Accretion of beach during late spring and summer 1981 essentially buried the Longard Tube and removed it from wave interaction. Photo looking south along tube axis taken 2 September 1981. See Fig. 6 for accretionary profile sequence.

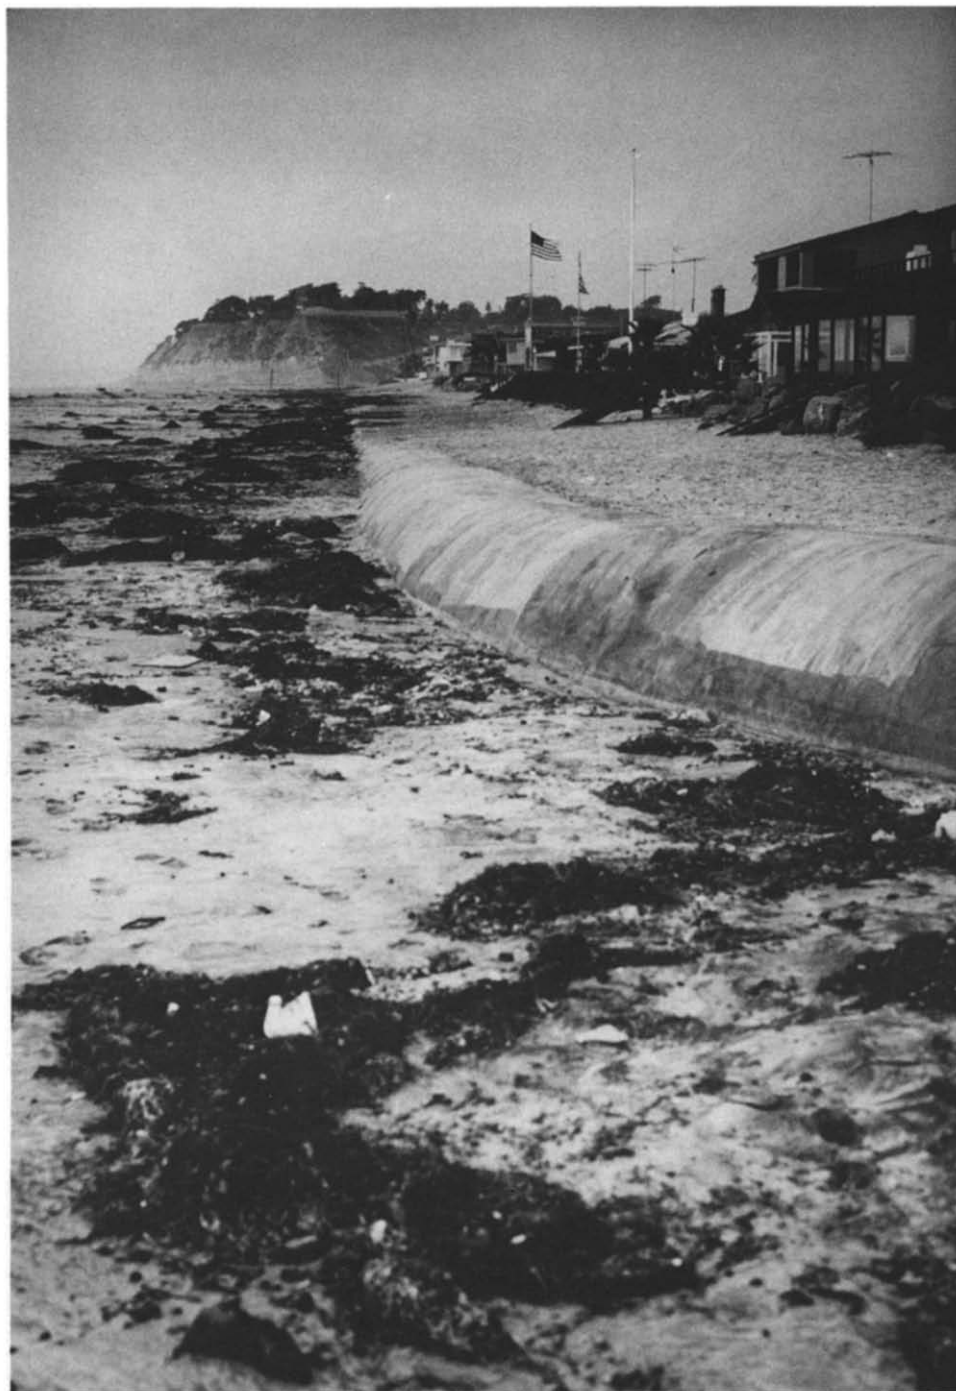
**Fig. 8.** Mild winter of 1981—1982 produced only minor removal of sand near Longard Tube. Photo 12 November 1981.

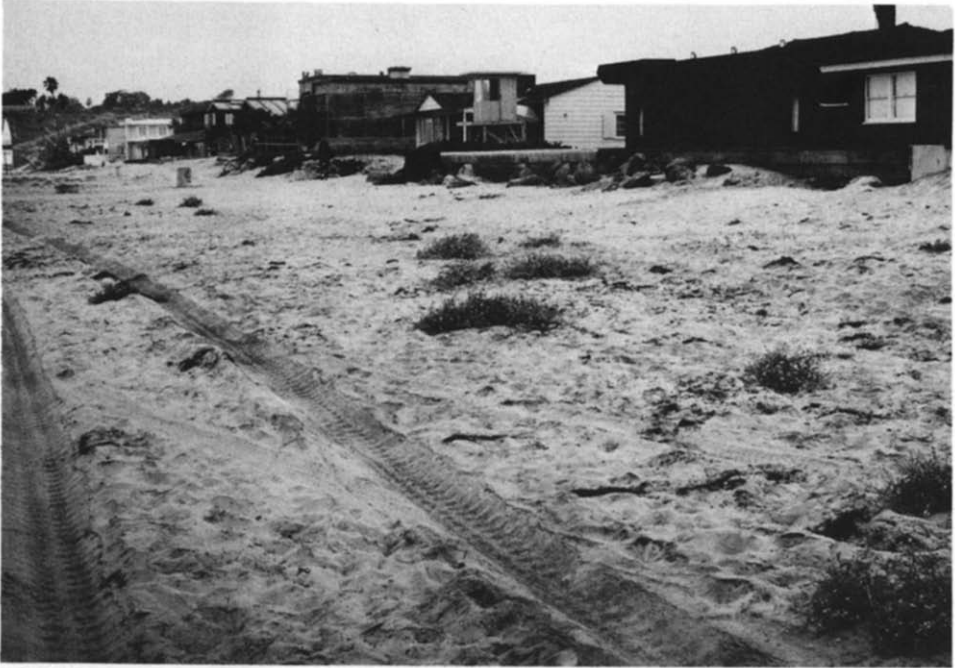
**Fig. 9. Mild winter of 1981—1982 and continuing accretion caused Longard Tube to be completely buried by date of this photo (looking north) 28 June 1982.**

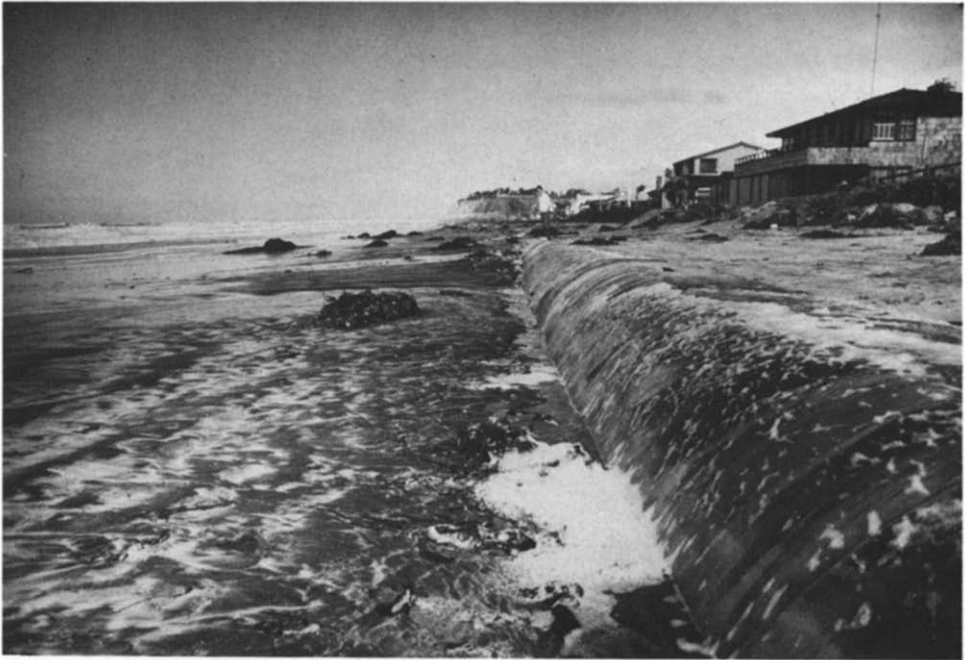
The first major winter storm reached the Del Mar area on 30 November and lasted until 2 December 1982 (Fig. 10). This storm coincided with a spring tide period allowing the waves to act on areas of the beach backshore. This one storm period reduced the foreshore sand volume by about  $45 \text{ m}^3/\text{m}$  to a level lower than it had been during the 1981–1982 winter (Fig. 7), and exposed about one half of the Longard Tube diameter (Fig. 10). While this first storm caused minor localized slumping of the tube, its main effect was to transport large quantities of sand offshore, thereby exposing the tube to the next, even more severe sequence of storm waves (Figs. 11, 12).

**Fig. 10. Photo taken 2 December 1982 showing perched beach and substantial removal of sand seaward of Longard Tube during first winter storm of 1982—1983. Profile change and tube subsidence shown in Fig. 12.**

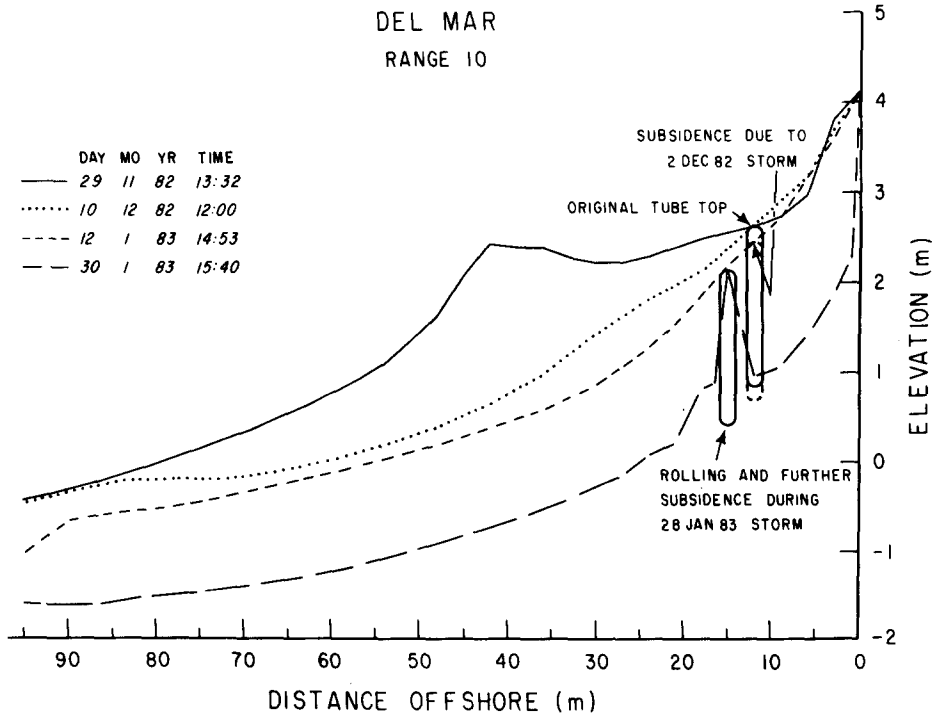
Fig. 11. Beach and tube configuration changes during severe 1982–1983 winter storms at profile Range 10. Note wide beach in 29 November 1982 profile, followed by severe beach erosion, Longard Tube subsidence and offshore rolling in storms of 2 December 1982 and 26–28 January 1983.

During the 27–30 January 1983 storm period, the tube also rolled seaward slightly (Fig. 11). However, displacement in the cross-shore direction was not a significant problem. The subsidence of the tube along with the beach sand level and local scour depressions were the primary cause of tube failure and the magnitude of these are shown in Fig. 15. The tube subsided due to undermining of the beach sand beneath it, and in localized spots sank by as much as 2 m. One point of major subsidence came from a hole punctured in the tube's fabric by a large piece of debris carried by wave action at high tide. The sand near the hole leaked out, leaving the tube deflated in this area. Also, a bulldozer delivering rip-rap drove over the northern 15 m of tube, tearing the fabric and allowing sand to leak out in this section as well. The lowest undulations over the length of the tube actually channeled wave backwash producing temporarily accelerated scour and sand removal from the backshore area.

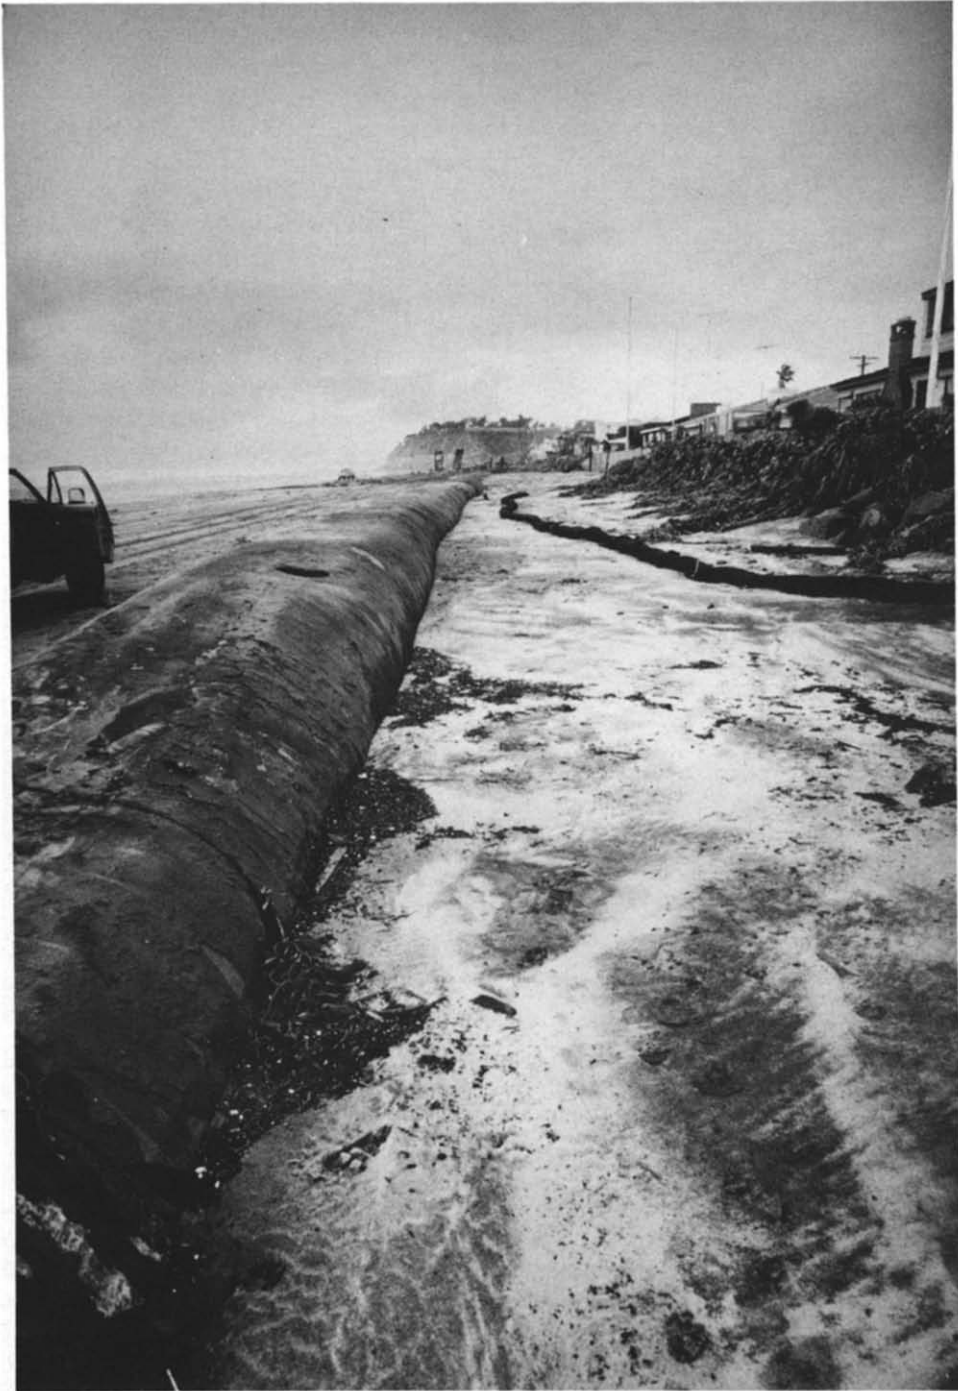
Within one day, on 27 January 1983, the sand shoreward of the tube had been removed by wave action (Fig. 12). The 25-cm diameter tube originally attached to the filter cloth beneath the main tube was ripped from the filter cloth and thrown over to the shoreward side of the main tube. Visual observations indicated that during this time the tube was effective in reflecting a portion of the wave energy during medium tide levels. It is notable that no structural damage occurred to the main tube as a result of wave action during this first day of the storm period. However, during peak tide levels, the

**Fig. 12.** Photo taken 27 January 1983 showing severe beach erosion, particularly sand removed from shoreward side of Longard Tube. Note 25-cm tube intended as toe protection for main tube thrown shoreward.

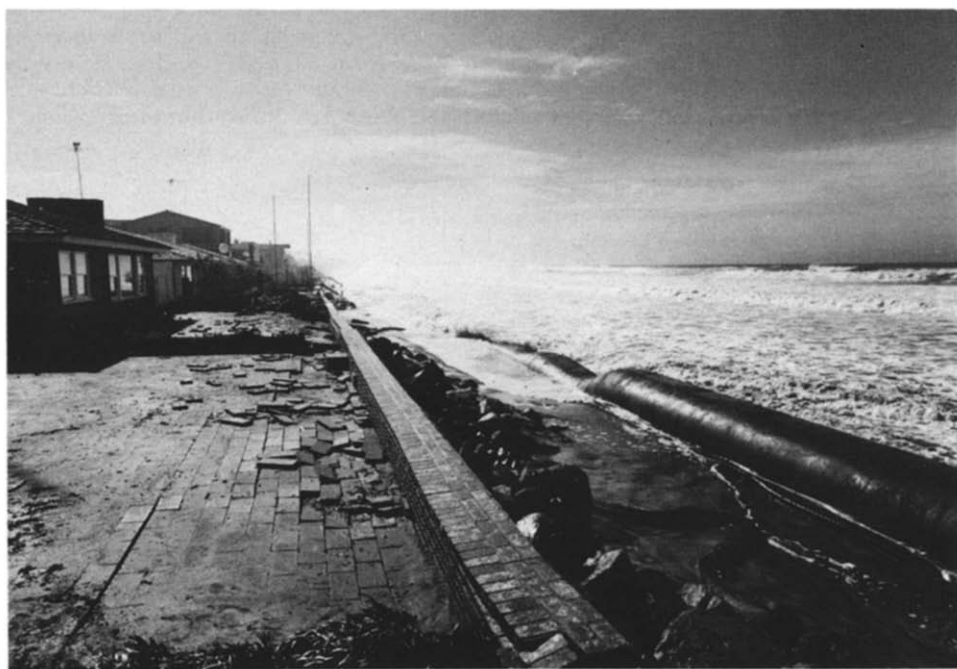
tube was easily overtopped to the degree that it provided an insufficient barrier to the storm waves. Storm waves and high sea level continued the next day, 28 January 1983, and with already reduced sand levels on the beach fore and backshore, waves eroded areas farther shoreward. During the period of high tide, major tube subsidence and localized undulations occurred due to continued wave overtopping (Figs. 13, 14).

**Fig. 13.** Photo taken 28 January 1983 during 2–3 m high tide showing tube subsidence and undulations. Overtopping waves scoured sand from shoreward side of tube. Loose bricks on this patio and other property damage indicated maximum uprush of about 4 m above mean sea level.

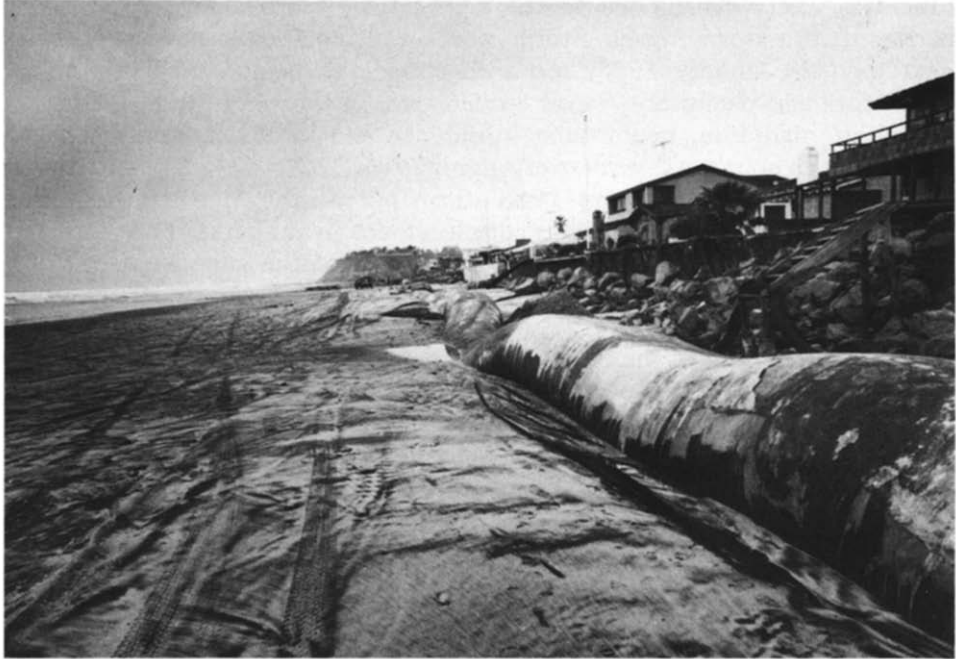
**Fig. 14. Photo taken 28 January 1983 at low tide looking north and showing major undulations and scour depressions in Longard Tube. Note exposed filter cloth previously attached to 25 cm diameter toe protection tube now flung over stair case on shoreward side. Extensive rock rip-rap was placed all along Del Mar beach during the storm episode.**

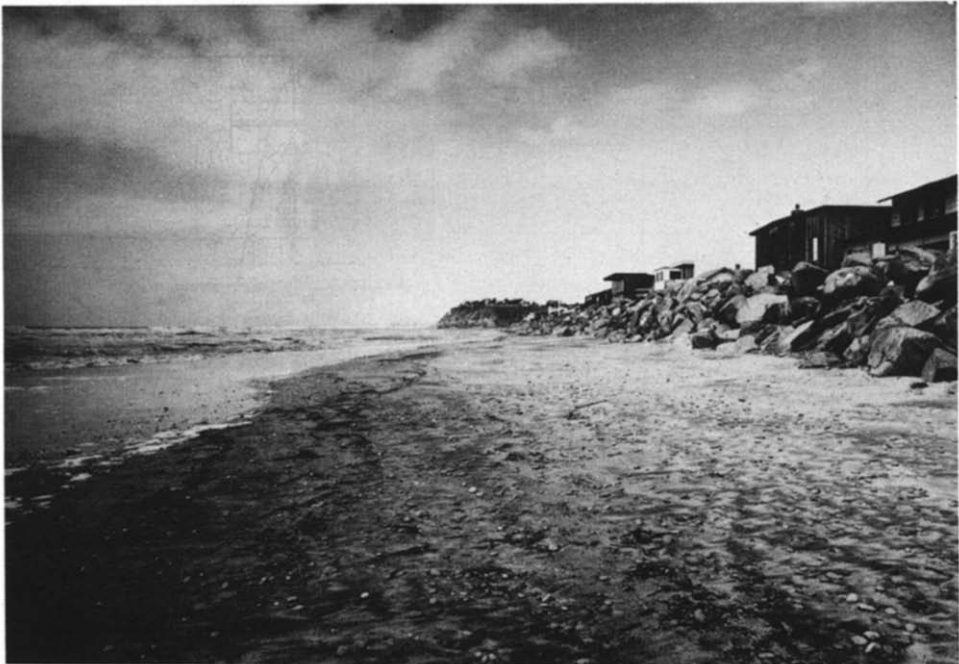
Fig. 17. Photo looking north from Range 2 (foot of 25th Street, see Fig. 15) on 24 March 1983 after removal of Longard Tube. Note rip-rap revetment and very low sand level due to extreme winter erosion.

over the past 10 years. The shorefront public, residential and commercial developments do not require protection from the typical, mild to moderate winter storms and the attendant beach cuts. The winter of 1982–1983 has made clear however, that many beaches and developments do require protection from the much less frequent, severe winter storms, particularly when these are coincident with high sea levels. The Longard Tube and other “low-cost”, alternative revetments used by themselves do not seem to be suitable for this type of protection (Fig. 17).
