COMBINED CORROSION-EROSION OF STEELS IN
OXIDIZING ENVIRONMENTS

A.V. Levy and E. Slamovich

April 1984

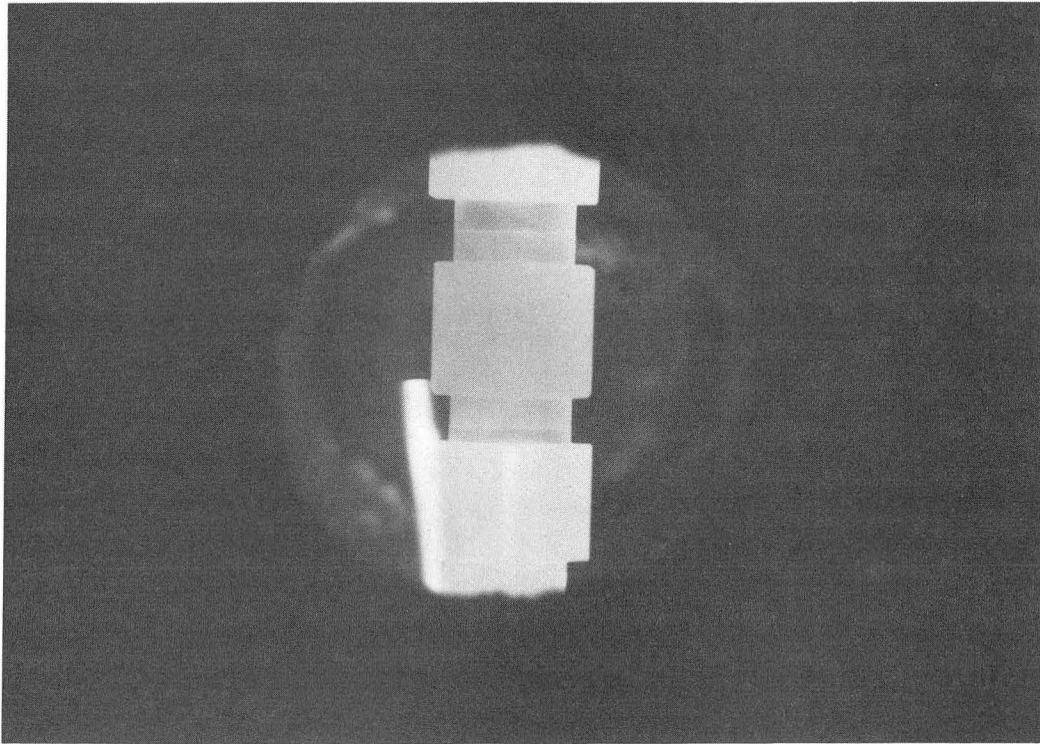
Fig. 1. Specimens in burner duct during testing

The test specimens of each alloy were exposed in the downstream duct of a methane-air burner operating with excess oxygen in the combustion gas. The exact partial pressure of oxygen was not determined. The specimens were 1.25cm on a side cubes with a small hole through their center for mounting on an alumina rod that extended into the 10cm dia. duct perpendicular to its wall. The specimens were exposed so that two of their sides were at 45° cycle to the exhaust gas and the other two sides were shielded from direct gas-particle impingement, thus providing two surfaces that were corroded-eroded and two surfaces that were only corroded. The ACES exhaust gas simulator at the Sandia Livermore National Laboratory Combustion Research Center was used for the tests. The specimens are shown during a test in Figure 1.

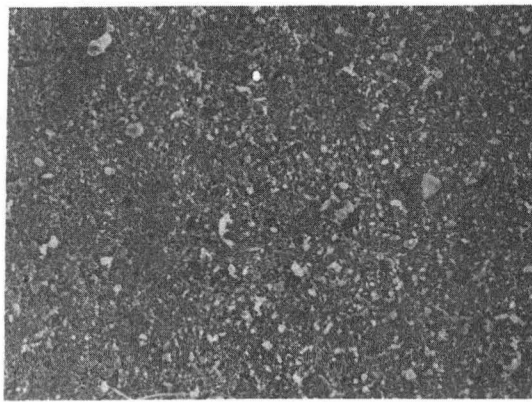
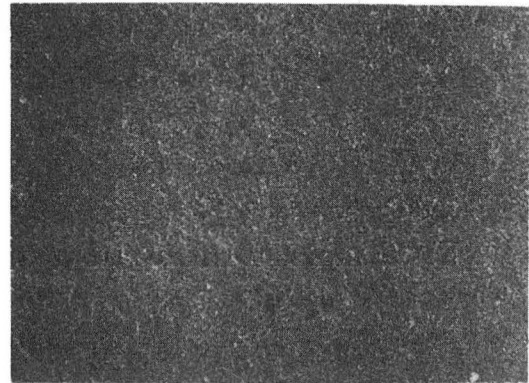
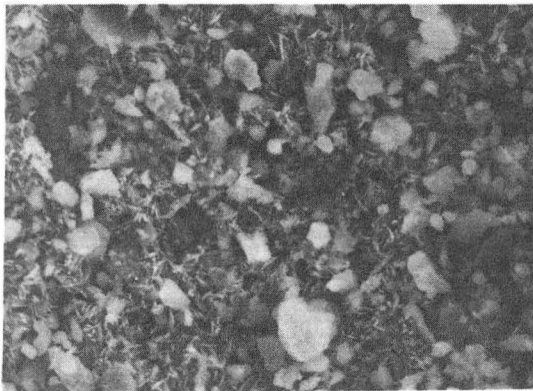
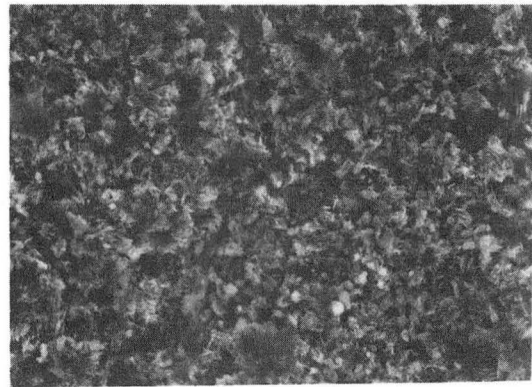
Fig. 3. Corroded and eroded-corroded surfaces of 2 1/4 Cr 1Mo steel at 700°C

Figure 3 shows the surfaces of this alloy after the 700 $^{\circ}$ C test. The appearance of the surface is essentially the same as was seen on the 1018 steel specimen. Figure 4 shows the same alloy after the 800 $^{\circ}$ C test. The morphology of both surfaces has changed somewhat. On the corroded side the Fe₂O₃ needles have formed into an interlaced network with some individual needles of larger diameter also occurring. Very few nodules of Fe₂O₃ are observed along with a very few coal ash

lower, 700°C temperature (Figures 2 and 3). It appears that test temperature and chromium content trade off in the resultant oxide structures. As the chromium content increases, the surface morphology reverts back to that which occurred in the lower chromium content alloys at lower test temperatures.

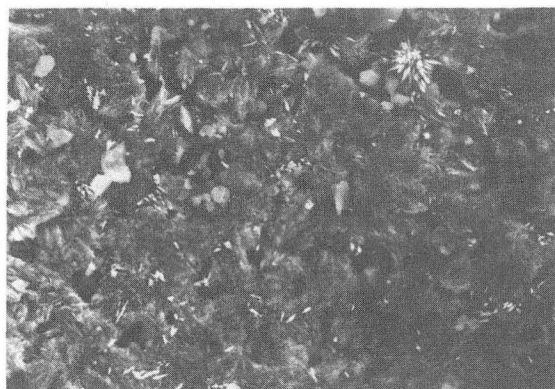
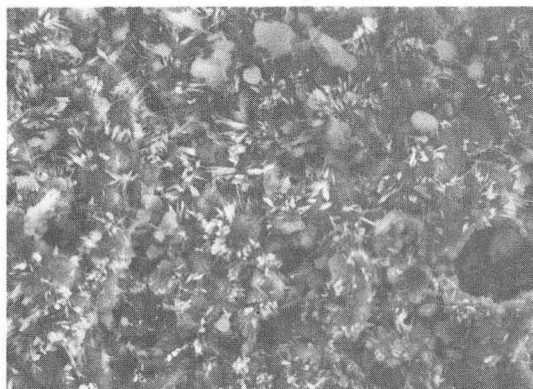
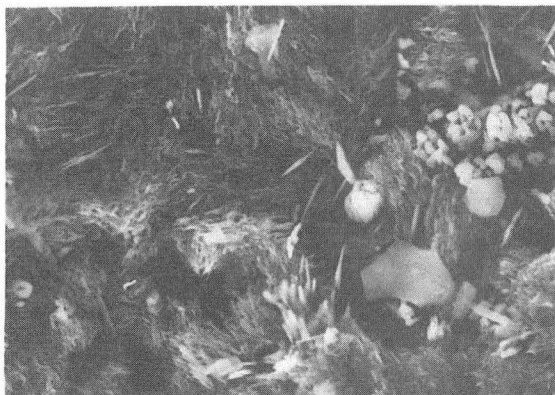
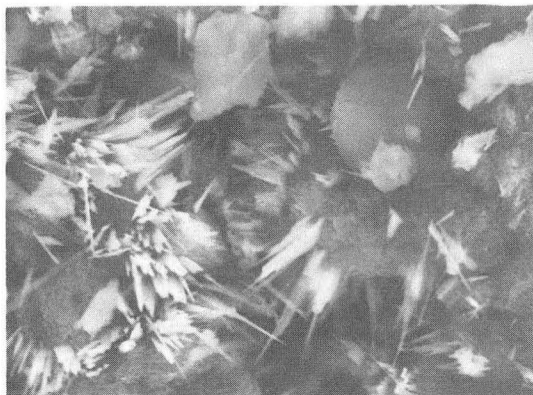
Fig. 4. Corroded and eroded-corroded surfaces of 2 1/4 Cr 1Mo steel at 800°C

particles (the larger, light grey particles in the lower photo).

On the eroded-corroded side, the morphology is somewhat different. The fine needle network appears to have condensed and a number of quite long comparatively large diameter, individual needles of oxide are seen growing out of the scale. Again, a few coal ash particles can be seen in the lower right photo. The delicacy of the long, individual needles on the eroded-corroded side is quite remarkable, considering that this side is being struck by coal ash particles. Note that the two lower photos are at the same magnification. The dynamic corrosion plus erosion that is occurring on the exposed side appears to be enhancing the growth of the oxide needles at this higher test temperature.

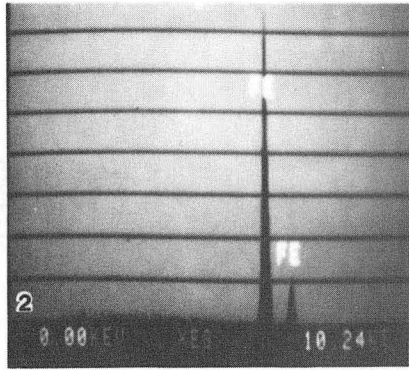
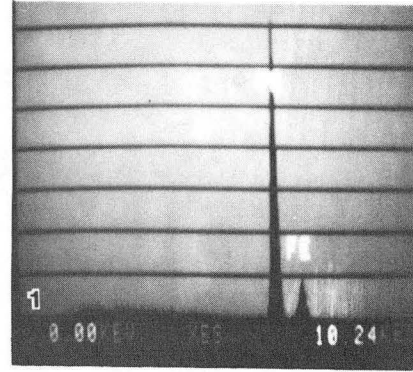
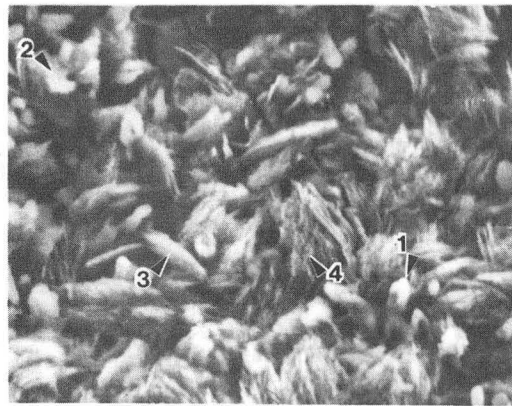
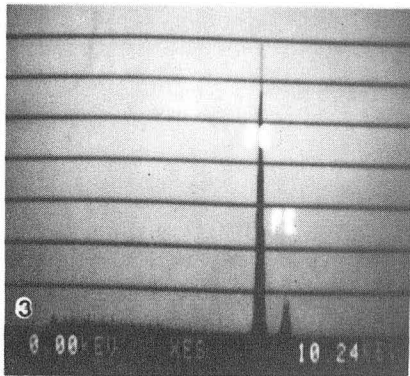
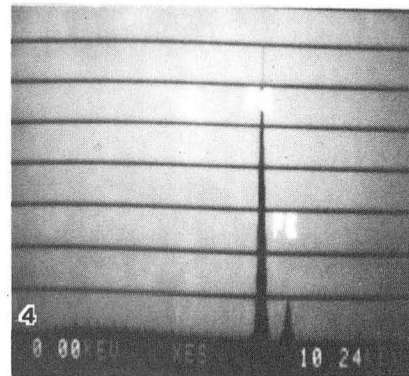
Fig. 5. SEM-KEVEX analysis of scale surface on eroded-corroded side of the 2 1/4 Cr 1Mo steel at 800°C

Figure 5 shows the SEM-KEVEX analysis of the surface scale on the eroded-corroded side of the specimen tested at 800°C. It can be seen that only iron oxide is present. The occurrence of only iron oxide on the surface with no chromium was observed for all of the alloys tested, except for the 304SS.

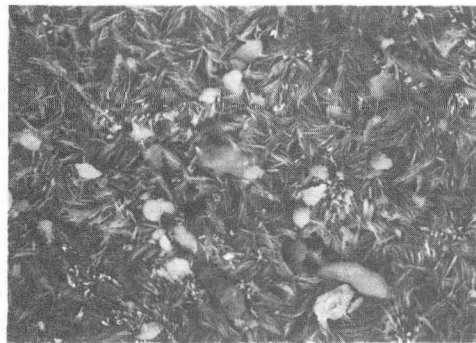
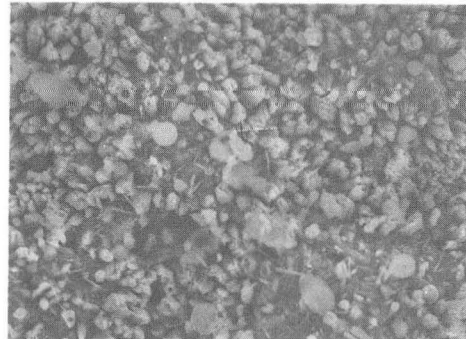
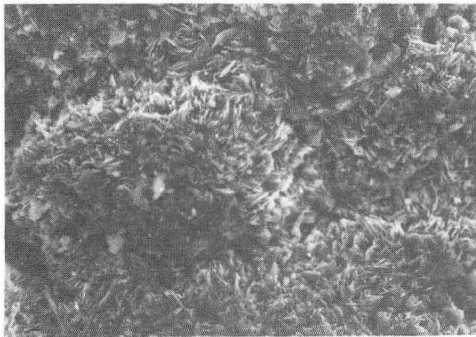
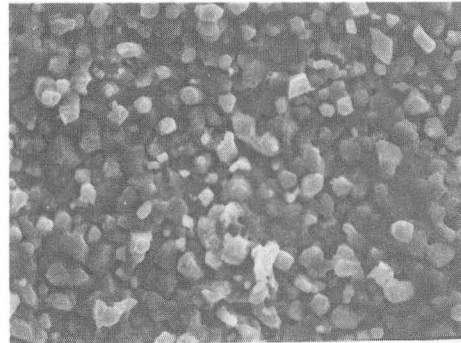
Fig. 6. Corroded and eroded-corroded surfaces of 5 Cr 1/2Mo steel at 800°C and 875°C

As the chromium content of the alloys increased the morphology of the oxide scale surface changed. The beginning of dramatic differences between the corroded side and the eroded-corroded side began with the 5Cr 1/2Mo steel. Figure 6 shows the corroded (above) and eroded-corroded (below) surface at two test temperatures, 800°C and 875°C.

At the 800°C test temperature, the needle-like network of the scale can be seen on both the corroded and eroded-corroded sides. A few nodules appear on the corroded side; none on the eroded-corroded side. The same thing occurred on the 1018 and 2 1/4Cr1Mo steels at the

At the 875°C test temperature, the next major change in the morphology occurred. The needles are almost non-existent on the corroded side (upper right photo) and they are replaced by nodules and columns of Fe_2O_3 . The columns are different from the nodules in that their tops appear to be somewhat pointed and porous or wrinkled on the corroded side. The great difference in the morphology between the corroded and eroded-corroded sides first occurs on the eroded-corroded surface of this alloy. It consists entirely of crystalline columns of significantly greater cross section than the pointed-porous topped columns on the corroded side and their tops do not show any porosity. This intriguing behavior was observed on the higher chromium content alloys at higher test temperatures to an even greater degree, as will be seen.

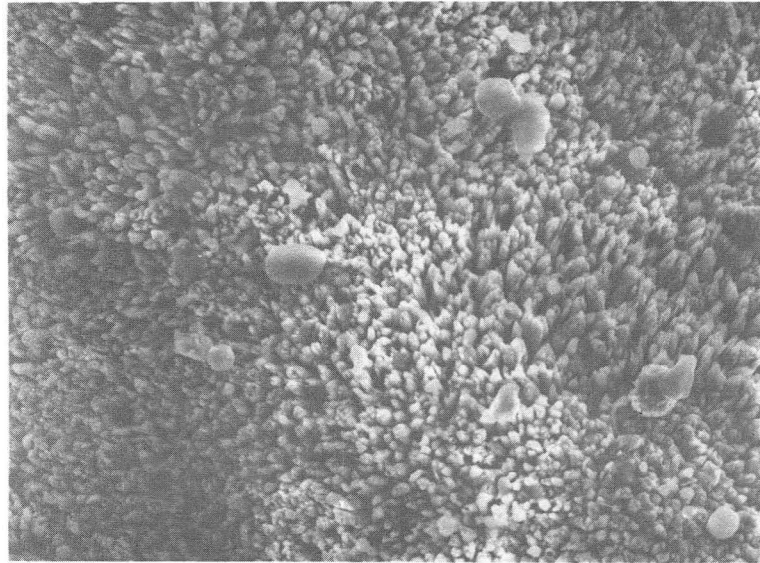
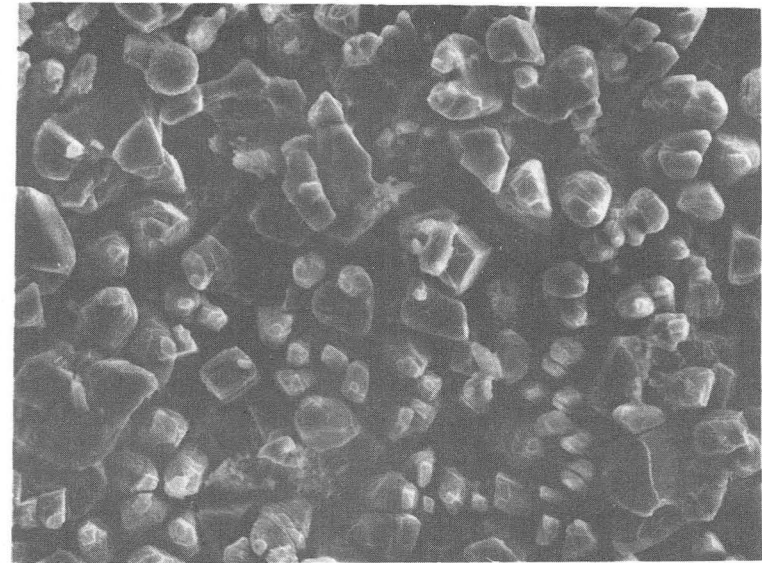
Fig. 7. Corroded and eroded-corroded surfaces of
9 Cr 1Mo steel at 925°C XBB 820-9329

Figure 7 shows the extent to which the great difference occurred in the morphology between the corroded and eroded-corroded sides of the same test specimen. On the left side of the figure is the corroded side with a myriad of small diameter pointed-porous or wrinkled topped columns extending up perpendicular from the metal surface. The few gray globules are coal ash particles. On the right photo is the

eroded-corroded surface. The well defined crystalline columns of iron oxide (no chromium was determined) are many times the size of the columns on the corroded side and are no where near as numerous. Many of their tops have been chiselled away to form more or less points and no porosity or wrinkling can be observed at the tops of the columns. The action of the eroding coal ash particles can be seen to affect individual columns, but do not result in an overall eroding away of the surface. The relatively low density of the columns and their large size seems to reflect a selective thinning of the columns compared to the density of those that occurred on the corroded only side so that the remaining columns could grow to a much larger size. Whether this phenomenon, which is like the selective thinning of trees in a forest to promote the growth of the remaining ones, is the mechanism that is occurring is speculative at this time.

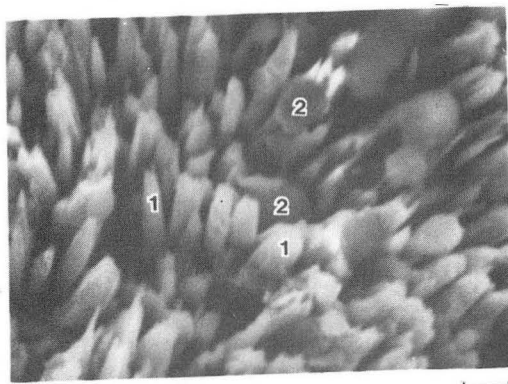
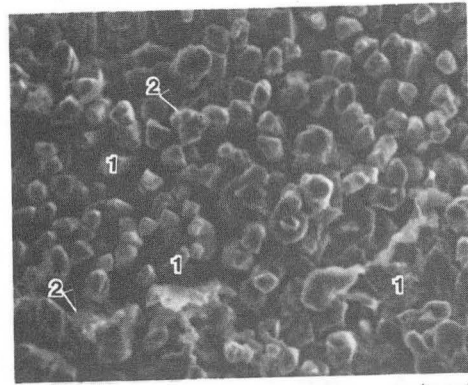
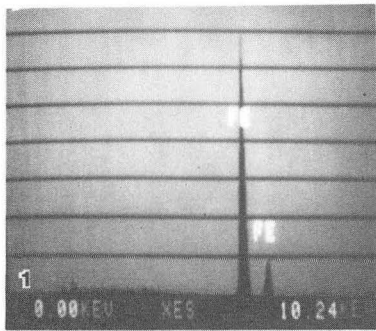
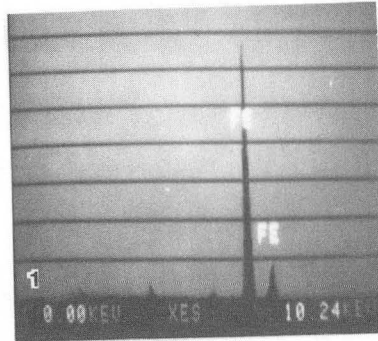
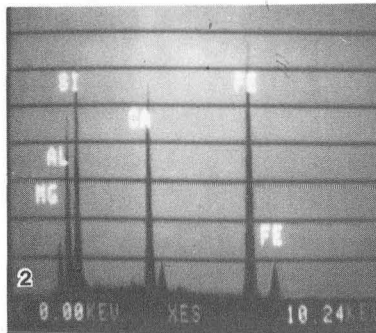
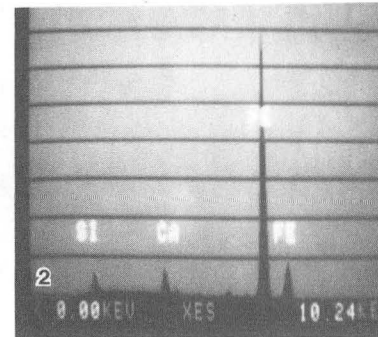
Fig. 8. SEM-KEVEX analyses of the oxide column composition of the 9 Cr 1Mo steel at 950°C

The determination of the composition of the columns on both the corroded and eroded-corroded sides of the 9Cr1Mo steel specimens was made by SEM-KEVEX analysis. Figure 8 shows the analyses of the scales that formed on the 9Cr1Mo steel. It can be seen that both types of columns are iron oxide with no chromium present. The presence of some coal ash is shown by the presence of such elements as Si, Ca, Al and Mg. The reason that the corroded side has more coal ash present is that the velocity of the particles on the back side of the specimens is much slower than on the front side that directly receive the impact of the coal ash at the full 5 m/s. The wafting particles on the back side can more readily get caught in the forest of columns that exists there.

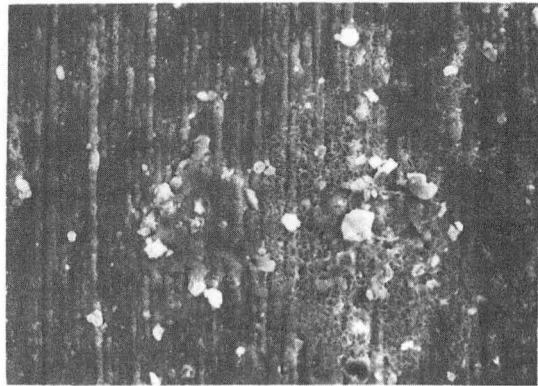
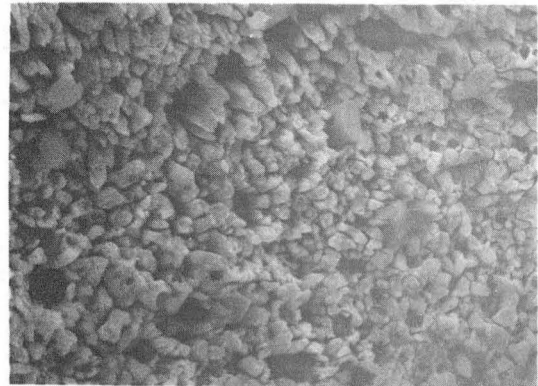
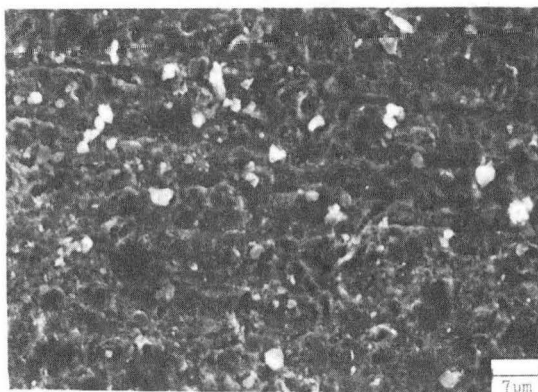
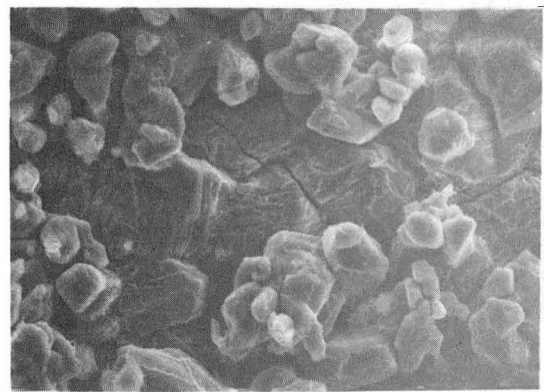
Fig. 9. Corroded and eroded-corroded surfaces of 9 Cr 1Mo steel at 800°C and 950°C

The effect of test temperature on the morphology of the scales formed on the 9Cr1Mo steel are shown in Figure 9. On the left side are shown the surfaces after the 800°C test. Essentially the surface is a continuous Cr₂O₃ scale with some nodules of Fe₂O₃ and a few coal ash particles on the surface. The eroded-corroded side shows a slightly eroded Cr₂O₃ surface. At this lower temperature for the chromium content of the alloy, compared to the 925°C exposed specimen shown in Figure 8, the chromium is present in sufficient quantity to form a typical protective barrier type scale. The eroded-corroded side is still a mild enough overall condition to enable the alloy to maintain the protective scale.

When the test temperature is increased to 950°C (photos on the right side of Figure 9) the same type of behavior as was shown in Figure 7 is evident. In Figure 9 the magnification is higher than in Figure 7 and the nature of the columns can be more readily seen. Also, in the lower right photo another aspect of the erosion process is shown. In some isolated areas the columns had been eroded away, leaving a more continuous scale showing beneath them. The contours appearing on the scale layer is direct evidence of the erosion process. The overall differences between the surface morphologies of both the corroded and eroded-corroded specimens at the two test temperatures is most intriguing.

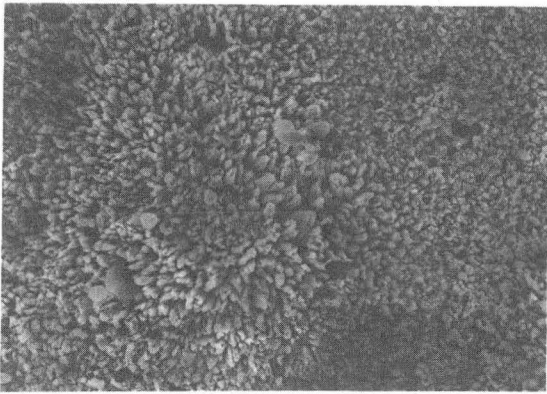
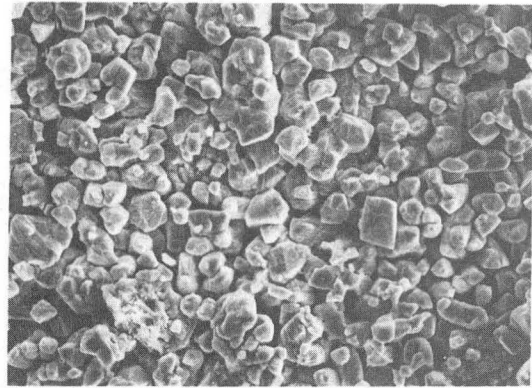
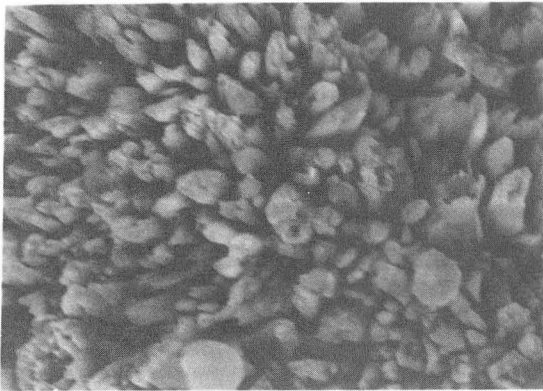
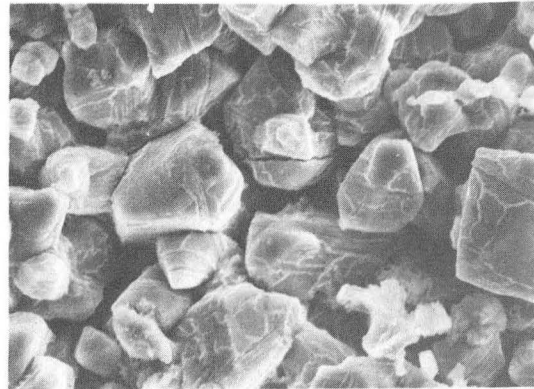
Fig. 10. Corroded and eroded-corroded surfaces of 410SS at 950°C XBB 820-9325

The 410SS specimens showed the same type of behavior as the lower chromium content, ferritic steels that formed columns. Figure 10 shows the two surfaces after testing at 950°C. The chiselled tops of the eroded-corroded side columns toward pointed shapes are clearly evident as are their greatly increased size over the corroded side columns. Note the difference in magnification at both the lower and the higher magnifications. At least one of the columns (lower right side photo) is cracked, providing a short circuit diffusion path.

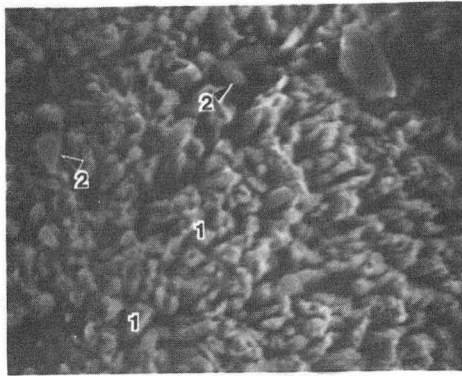
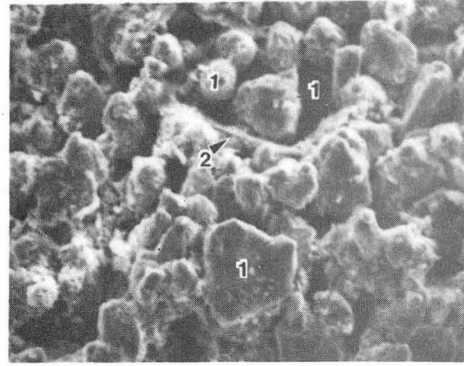
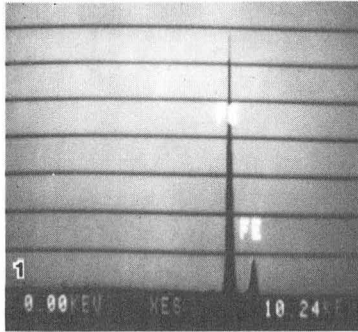
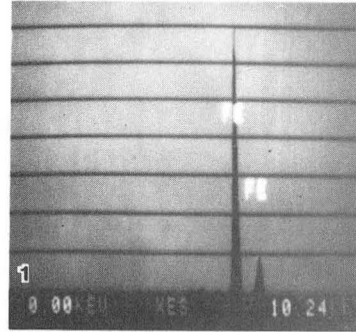
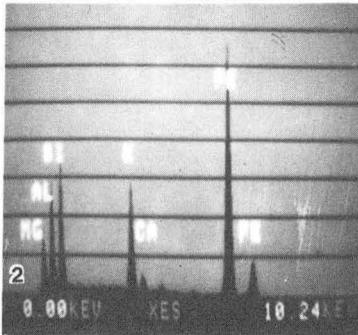
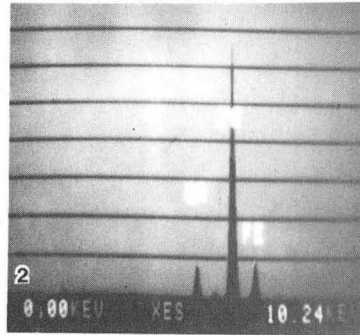
Fig. 11. SEM-KEVEX analyses of columns of scale on 410SS at 950°C

Even with a 12% Cr content in the alloy, the columns of oxide were determined to be pure iron oxide. Figure 11 shows the SEM-KEVEX peak analyses. It is interesting to note, however that the No. 2 peak on the eroded corroded side shows some chromium in a crystallite that appears to be below the general level of the columns. Again, some coal ash was retained on the corroded side of the specimen, peak 2 where the velocities are very low.

are markedly different. The iron oxide scale is much thinner on the erosion-corrosion side, extending only to the base of the columns. This accounts for the occurrence of the chromium peak in the surface side analysis shown in Figure 11. The Fe-Cr spinel layer is much thicker on the eroded-corroded side, essentially constituting the main body of the scale. Also, the interface between the lower layer of the duplex scale and the base metal is quite porous on the erosion-corrosion side. Thus the occurrence of erosion in conjunction with corrosion, with the corrosion process dominant, changes the morphology and the composition distribution of the scale that is formed.

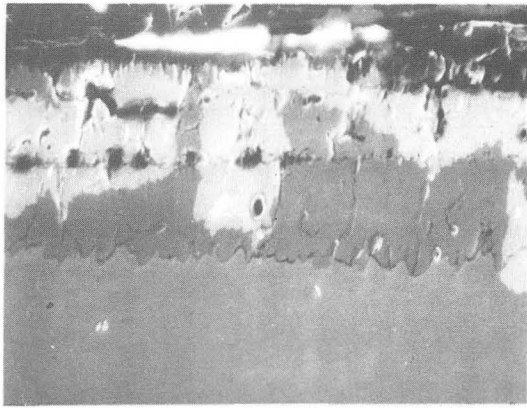
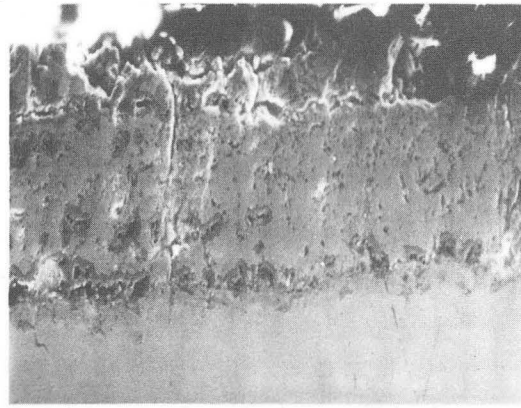
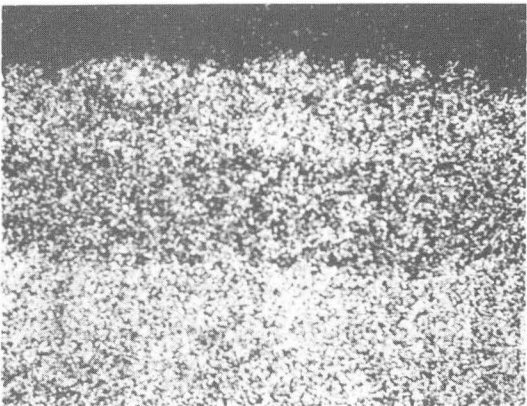
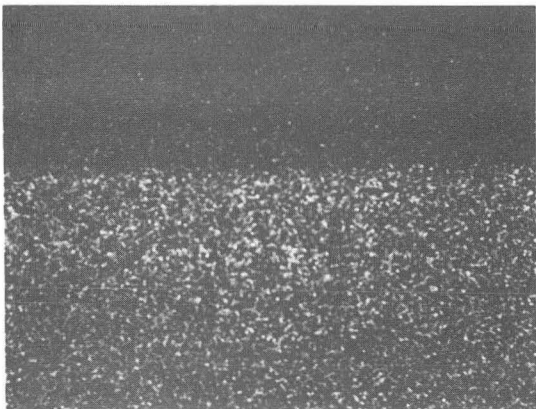
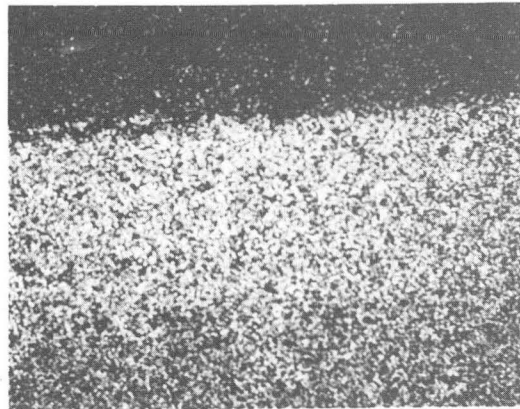
Fig. 12. Cross section of corroded and eroded-corroded surfaces of 410SS at 950°C

of the scale down to the base metal. Cross sectional analyses of the other exposed alloys is in process. Figure 12 shows the morphology of the scales and the distribution of iron and chromium through them. Analysis of the photos indicates that combined erosion-corrosion not only changes the surface morphology of the scale compared to straight corrosion, but also the cross section morphology and composition.

On the corroded side (left photos) the secondary electron image indicates that there is a duplex scale present with a line of porosity separating the two phases. Analyzing the x-ray maps shows that the top layer is iron oxide with no chromium in it, as has been discussed above. However, the second layer of the scale has substantial chromium content and is probably an iron-chromium oxide spinel. This layer has a scalloped, intimate bonded interface with the base metal. The cross sections of the small, pointed columns of surface scales described earlier can be readily seen in the upper left photo.

The morphology of the scale cross section on the eroded-corroded side of the specimen is quite different from that on the corroded only surface. On the right hand side of Figure 12 is the secondary electron image and iron and chromium x-ray maps of the eroded-corroded scale. The cross sections of the much larger columns can be seen at the top of scale cross section, verifying the observations made earlier concerning the morphology differences between the surface of the corroded and eroded-corroded scales.

Referring to the x-ray maps, it can be seen that the total scale thicknesses of the corroded and eroded-corroded sides as well as the distribution of the two phases on each side

The change in the composition as well as the morphology of the surface scale as the result of the combined erosion-corrosion process (Figure 12) is a very interesting phenomenon that requires more work before it is understood. The effects of the gross changes which

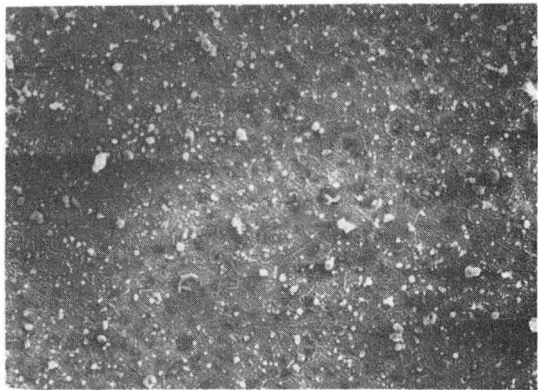
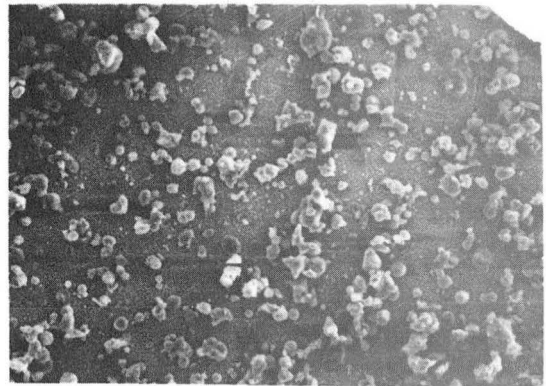
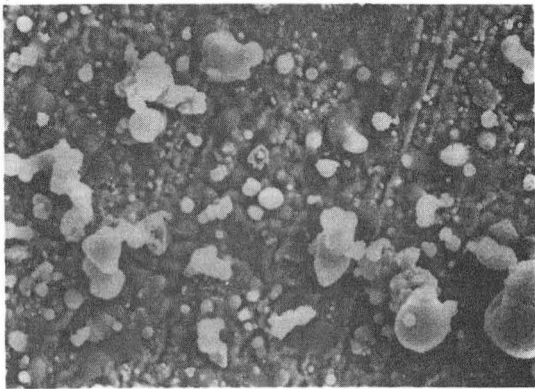
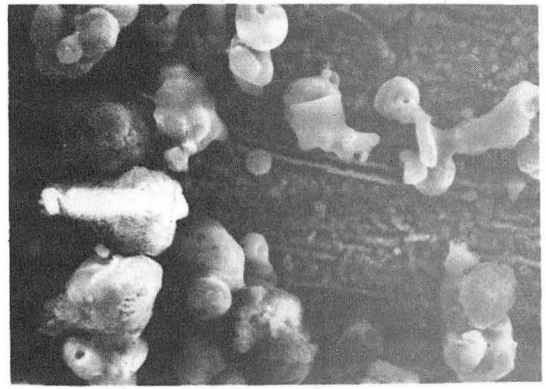
Fig. 13. Corroded and eroded-corroded surfaces of 304SS at 1000°C

The 304SS, an austenitic alloy with a significantly higher chromium content than any of the chromium containing ferritic alloys tested, behaved in a somewhat different manner than the other steels at temperatures higher than were used to test the other steels. Figure 13 shows that the surfaces developed a continuous Cr_2O_3 scale on both the corroded and eroded-corroded surfaces and that the barrier scale was not penetrated by the eroding particles.

On both the corroded and eroded-corroded surfaces, nodules of iron-chromium spinel have penetrated through the Cr_2O_3 scale layer. The size of the nodules is considerably larger on the erosion-corrosion surface than on the corroded surface. This follows the general trend throughout the test series of having combined erosion-corrosion enhance the growth of individual crystallites on the scale outer surface. Some of the nodules present on the surface are coal ash.

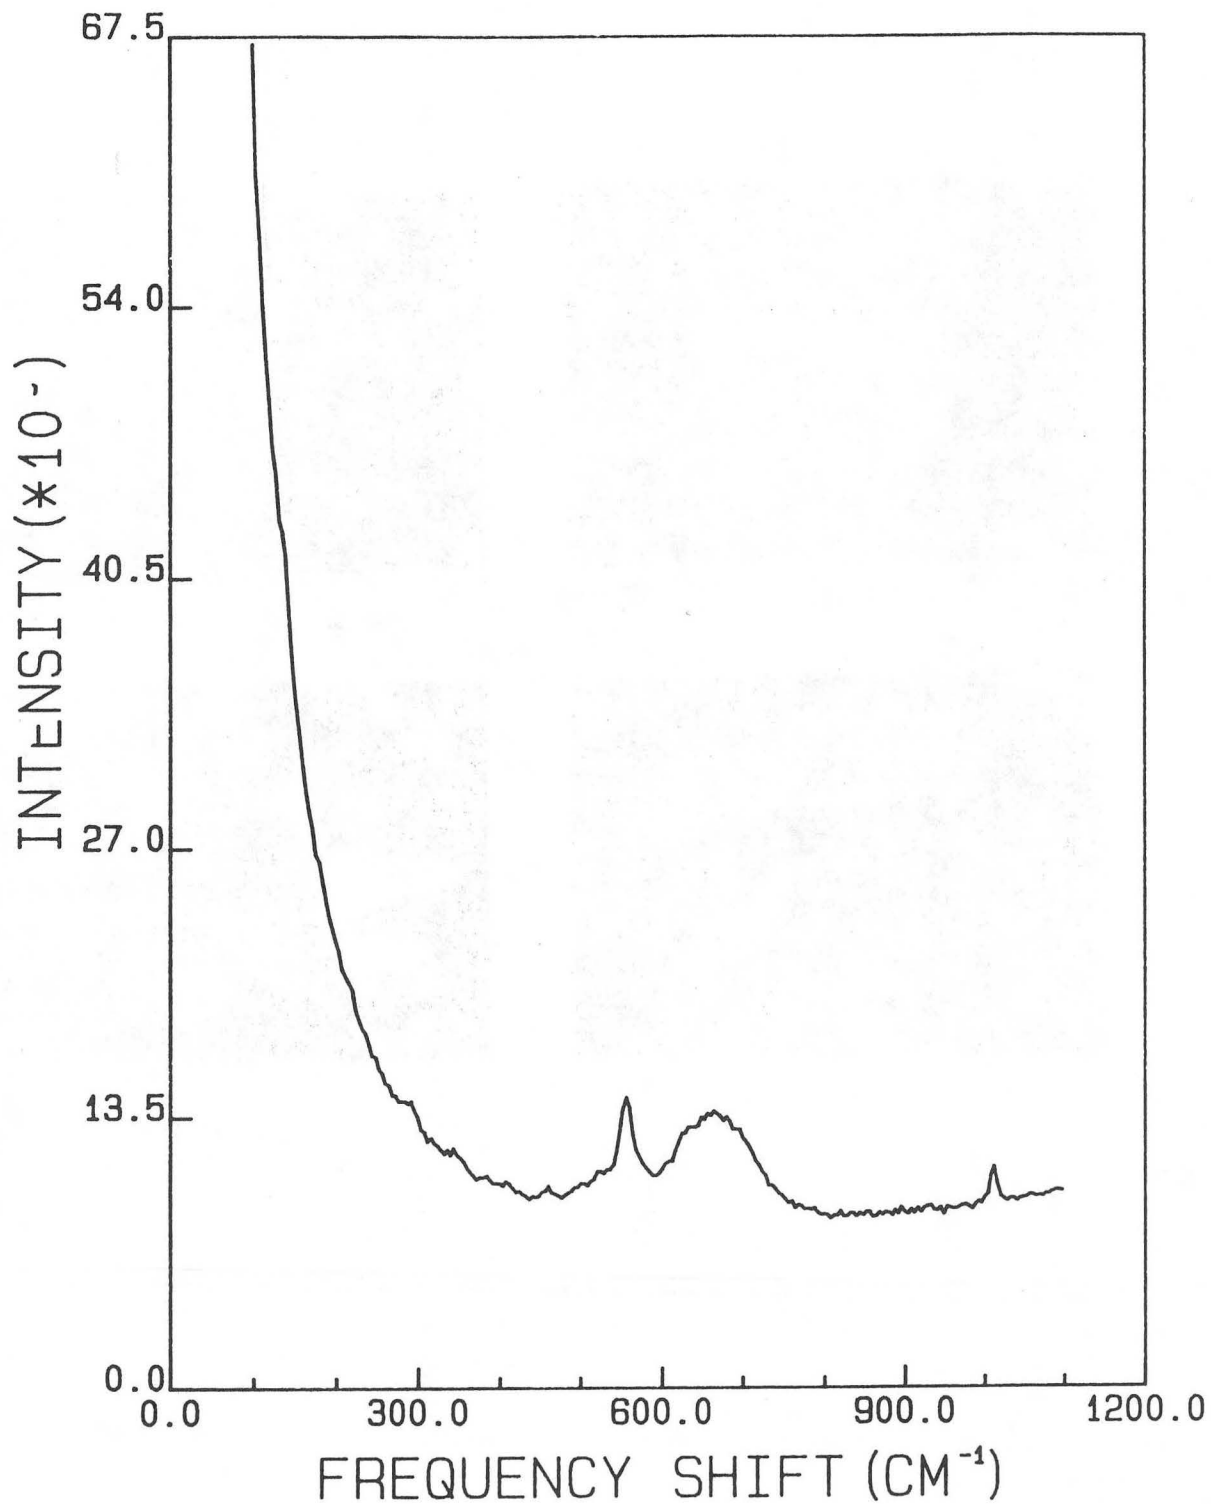
Fig. 14. Raman spectra of corroded surface of 304SS at 1000°C

Laser Raman spectroscopy was used to identify the phases that were present on the surface of the 304SS test samples. Figure 14 shows the Raman spectra for the corroded surface. The peak at 570 is Cr_2O_3 , the peak at 660 is spinel and the small peak at 1010 represents the compounds in coal ash. Figure 15 shows the Raman spectra of an area on the surface of the eroded-corroded side. The additional peaks over and above those that occurred in Figure 14 are due to coal ash particles adhering to the surface. These spectra indicate that iron-chromium spinel individual nodules formed on the iron-chromium-nickel 304SS rather than the iron oxide nodules that formed on the straight iron-chromium alloys.

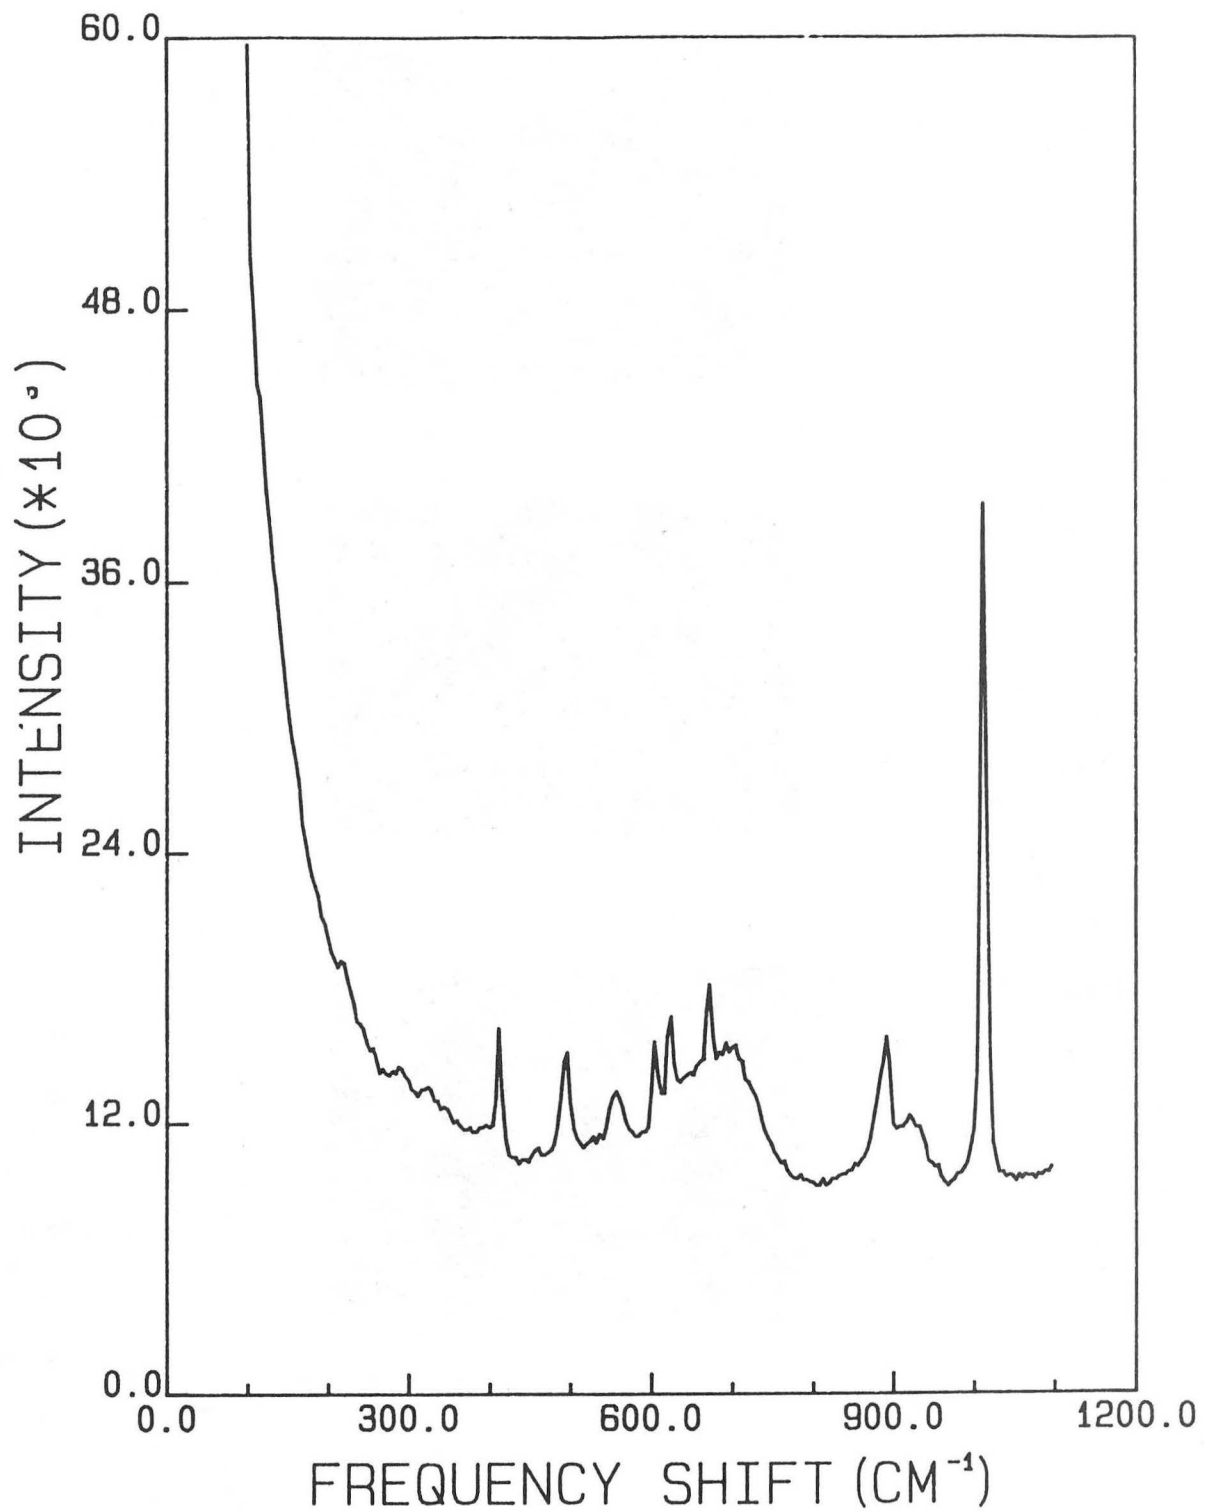
Fig. 15. Raman spectra of eroded-corroded surface of 304SS at 1000°C

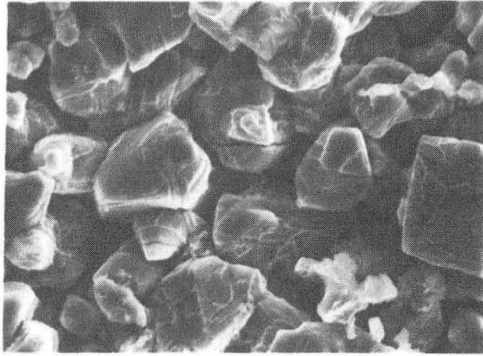
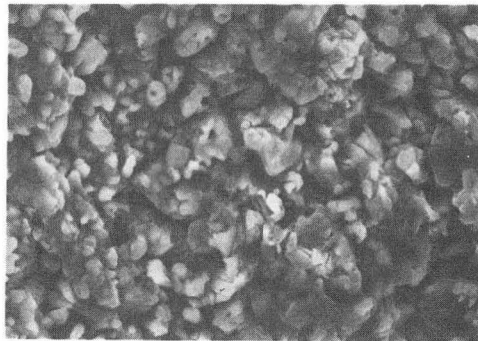
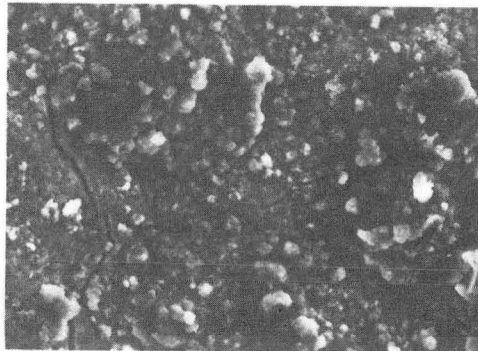
Fig. 16. Effect of eroding particle size on the surface morphology of the eroded-corroded surface of 410SS at 950°C

Figure 16 shows the eroded-corroded surface of the 410SS after exposure to the three different size particles. It can be seen that as the particle size and its resultant impact force increased, the individual columns of iron oxide became smaller, almost disappearing in

the $100\mu\text{m Al}_2\text{O}_3$ erodent particles test. The greater impact force of the $100\mu\text{m Al}_2\text{O}_3$ particles also cracked the scale that had formed, providing excellent short circuit diffusion paths for corrosion.

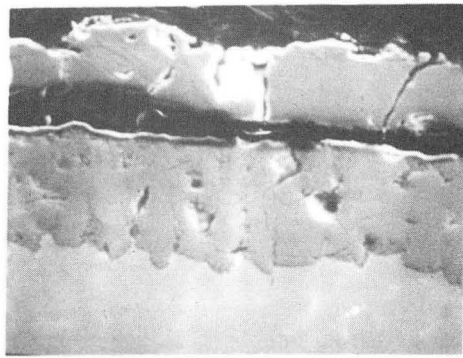
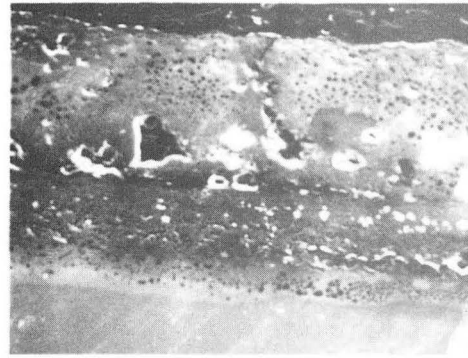
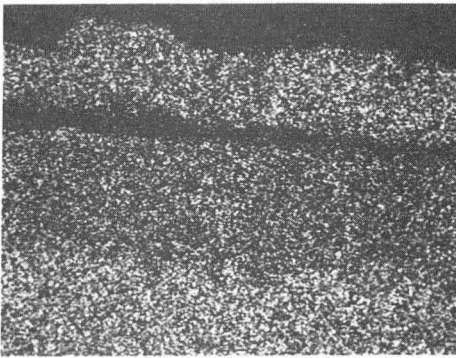
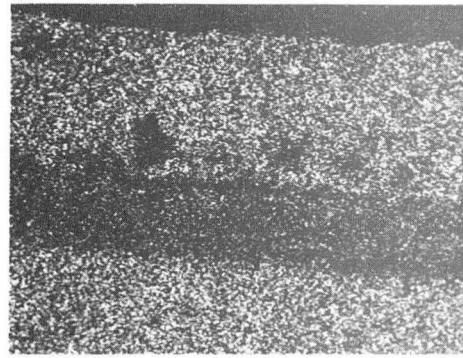
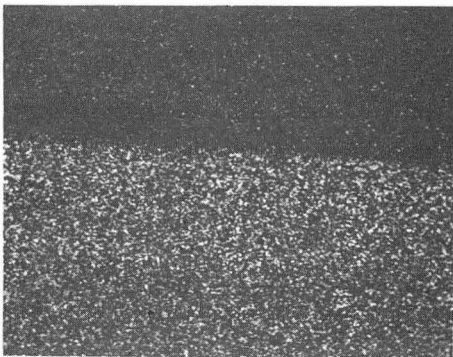
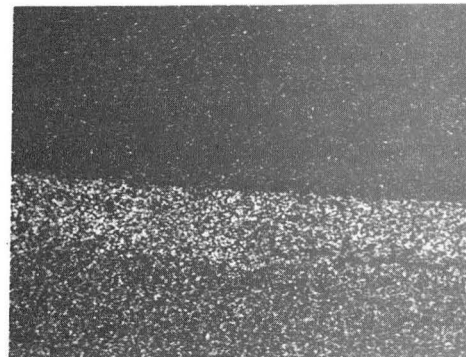
Fig. 17. Cross sections of corroded and eroded-corroded scale on 410SS at 950°C eroded by 100 μ m Al₂O₃ particles

Figure 17 shows the cross section of the scales formed on the corroded and eroded-corroded surfaces of the 410SS. The corroded surface scale is similar to the scale shown in Figure 12. The small diameter columns that can be seen in Figure 12 were probably knocked off by $100\mu\text{m Al}_2\text{O}_3$ particles that lightly struck the back surface of the specimen as the result of eddying of the gas-particle stream. The light impacts could also have caused the relatively large size voids seen in Figure 12 to crack through and result in the separation of scale layers seen in Figure 17.

The cross section of the eroded-corroded side of the 410SS specimen in Figure 17 has three significant differences from the eroded-corroded surface shown in Figure 12. First, the scale is considerably thicker on the eroded-corroded side than it is on the just corroded side. Note the difference in magnification of the micrographs in Figure 17. The scale on both sides of the specimen were much nearer in thickness for the $5\mu\text{m}$ coal ash erosion tests. It appears that the more severe erosion conditions that occurred when the $100\mu\text{m}$ size particles were used enhanced the corrosion rate, maybe as the result of cracking the coating as was shown in Figure 16 which increased the short circuit diffusion which could occur. Definitive metal surface regression rates tests will have to be performed to establish better exactly what is happening.

Second, the iron oxide scale layer is quite thick on the erosion-

corrosion surface compared to the spinel layer in Figure 17. This was not the case for the 5 μ m coal ash tests, as shown in Figure 12, where the iron oxide scale layer became quite thin on the eroded-corroded surface compared to the spinel layer. Third, the major porosity at the scale-metal interface which was observed in Figure 12 did not occur in the 100 μ m Al₂O₃ erodent tests as can be seen in Figure 17. Instead, it appears that areas of very small pores formed in the spinel layer near the scale metal interface.
