HVS Testing of the Palmdale Test Site, North Tangent Sections: Evaluation of Long Life Pavement Rehabilitation Strategies-Rigid

**Summary Report of  
HVS Testing of the Palmdale Test Site, North Tangent Sections:  
Evaluation of Long Life Pavement Rehabilitation Strategies—Rigid**

August 2005

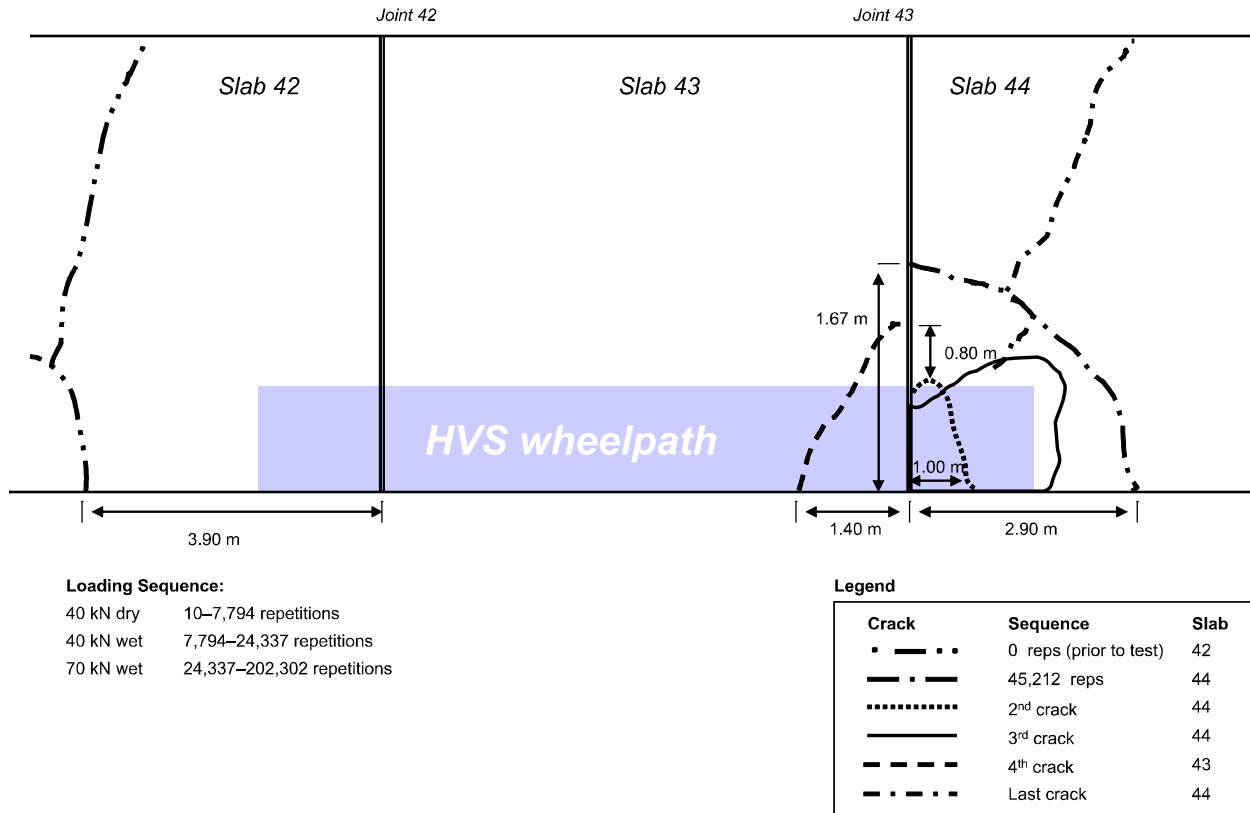
Figure 13. Schematic of crack pattern, Test 532FD.

The crack pattern, as it developed with time, can be seen in Figure 13. The figure shows the outer shoulder at the bottom of the page (the trailer side). The inner shoulder, near the K-rail (the opposing traffic side), is at the top of the figure.

Prior to the start of the test, a mid-slab crack existed right through Slab 42 (See Figure 13). After the first two loading cycles (Phases I and II), no visible cracks could be found. A corner crack in Slab 44 (towards Joint 43) developed after another 20,875 load applications of 70 kN at a total of 45 121 load applications. This crack was immediately followed by a smaller corner crack on the same slab (44) towards Joint 43. The ingress of water had a very detrimental effect on the support of the slab and visible pumping could be seen at Joint 43. This pumping led to the complete loss of support under Slab 44 and a huge chunk of concrete broke loose in the corner of Slab 44. In order not to damage the trafficking wheels, a piece of wood was put in place where the concrete chunk broke loose. Another corner crack developed in Slab 43 towards Joint 43. A composite image of the final crack pattern can be seen in Figure 14.

The number of load repetitions at which each crack appeared was not noted but the sequence was recorded as seen in Figure 13.

The data are also graphically displayed in Figure 15. To properly interpret these values, they should be analyzed together with the crack pattern as displayed in Figure 13.

It seems as if the crack development at Joint 43 (see Figures 13 and 14) had little effect on the deflections measured at the other joint (Joint 42). Even after water was added and the load increased to 70 kN (from 40 kN), deflections stayed relatively constant and no sudden increase was detected.

After about 120,000 repetitions, the area in the proximity of Joint 43 had extensive cracking (see Figure 13). This crack pattern had an effect on the LTE calculated at the right-hand side of Joint 42, which is clearly visible in Figure 16.

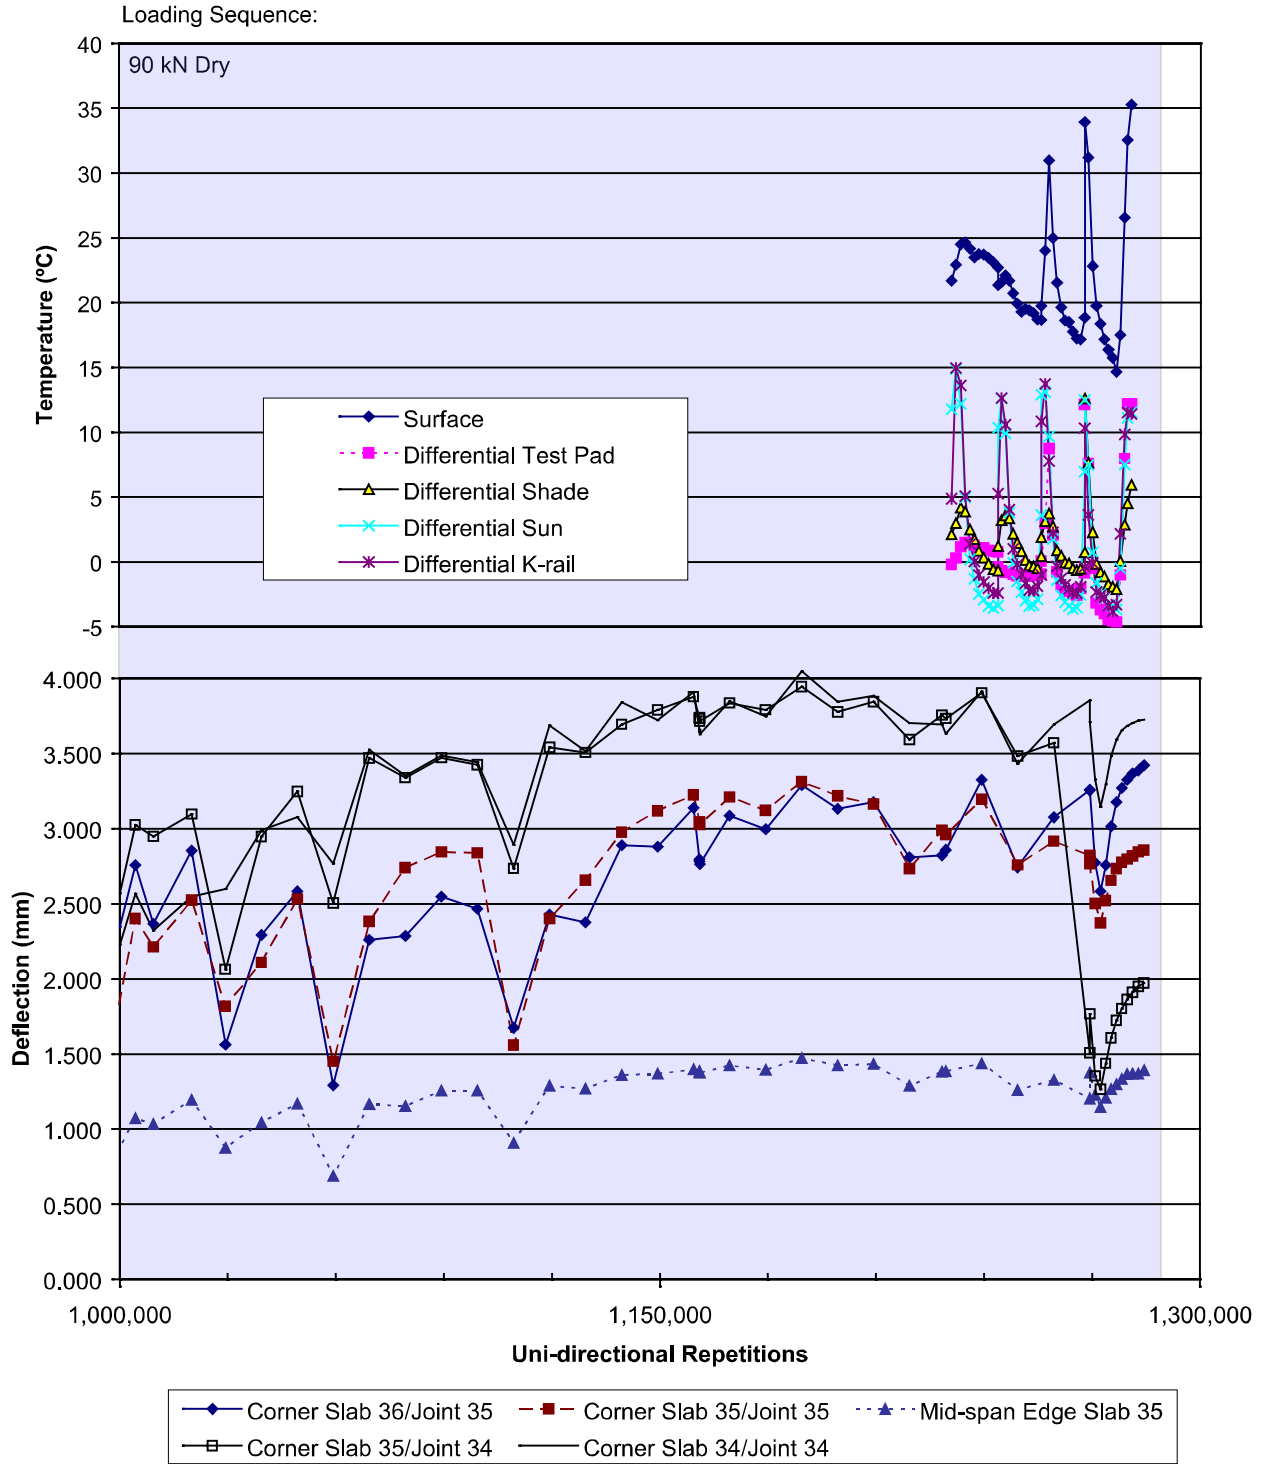
Figure 26. Plot of JDMD deflections and temperature versus load repetitions (1M repetitions to end of test), Test 534FD.

Second, Figure 26 clearly show that after the crack developed, the deflection readings recovered somewhat. Deflections did not return to the same level as before the crack appeared. It is likely that after settlement of the slab and its loose cracked piece, the deflections increased again due to the heavier (90 kN) loading that was applied to the section until the test was stopped.

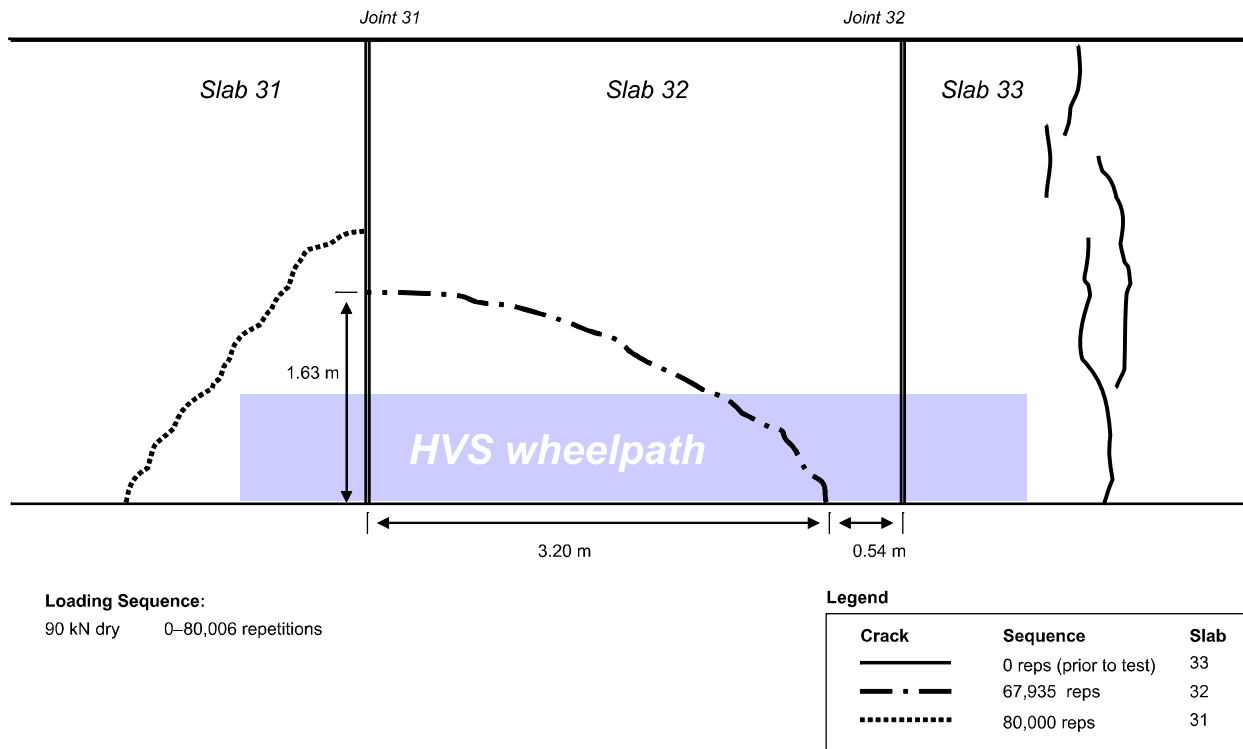
**Figure 31. Schematic of crack pattern, Test 535FD.**

The last crack appeared in Slab 31 at the end of the test after 80,000 repetitions. This was a corner crack, which started at about mid-span of Slab 31 and ended at Joint 31 in the middle of Slab 31.

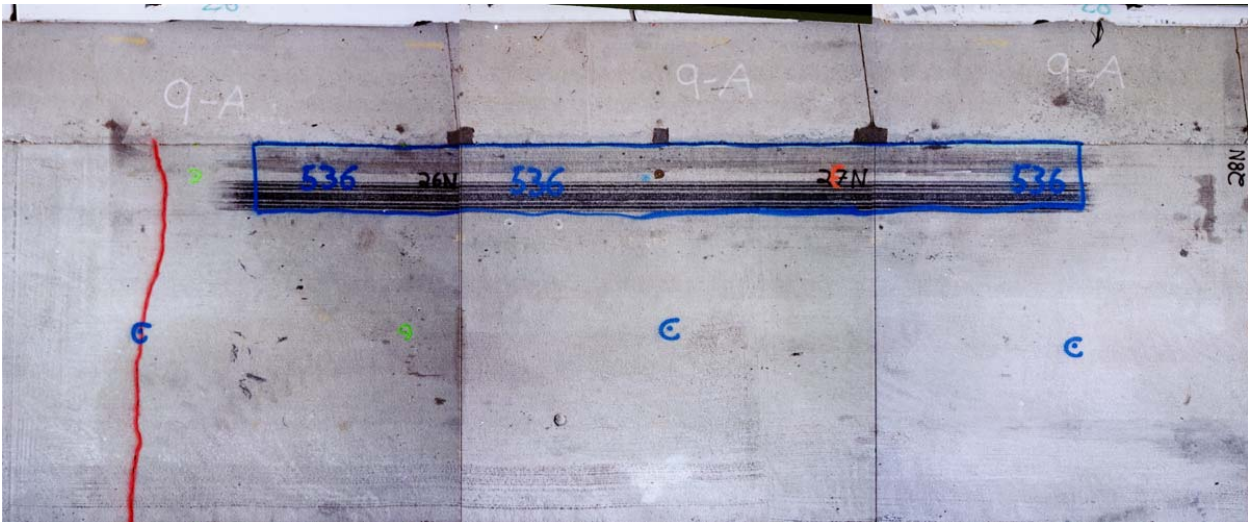
**Figure 37. Composite image of Test 536FD.**

No cracks were observed throughout Test 536FD and no visible changes in condition were reported. This is in keeping with a strong, well restrained, pavement slab configuration that was able to carry almost a million repetitions of heavily overloaded wheel loads (90 and 150 kN for just over 990,000 repetitions of the total number of load repetitions) prior to stopping the test. Figure 37 shows a composite image of the section.

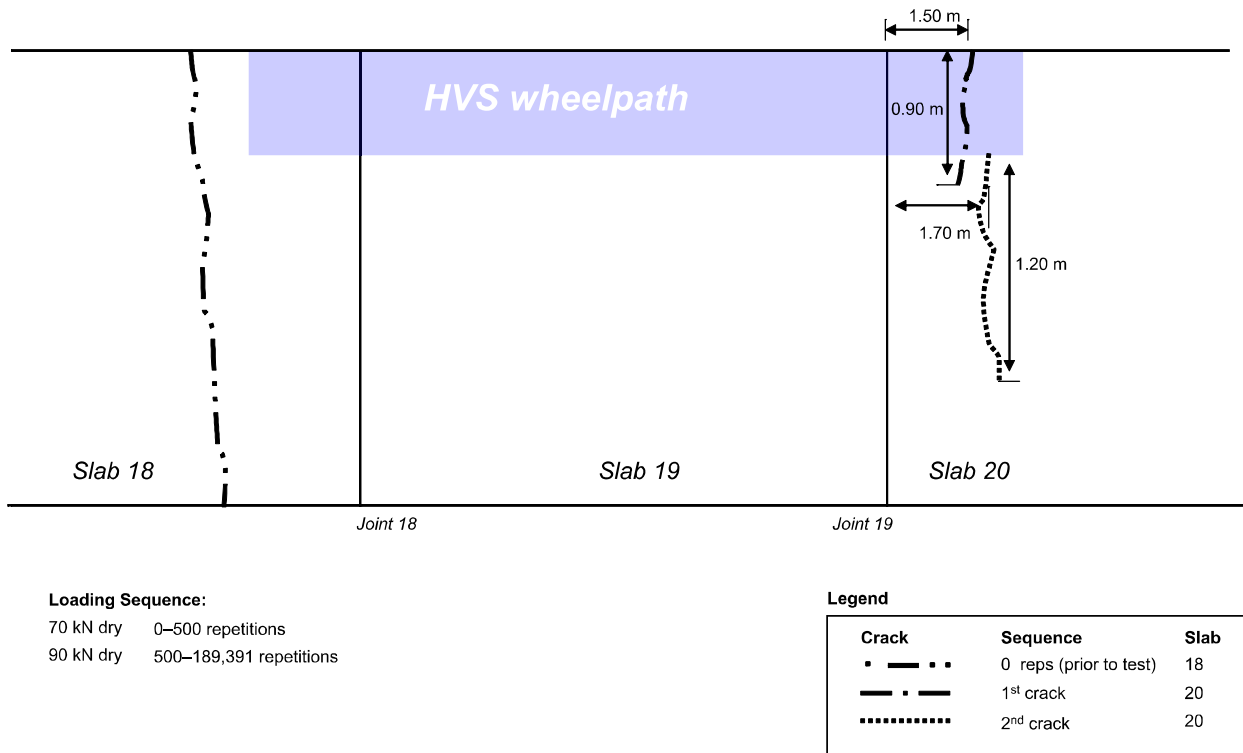
**Figure 71. Schematic of crack pattern, Test 538FD.**

During the test, no cracks were observed on the main trafficked slab (Slab 19) and HVS traffic-induced cracking was limited to a transverse crack on Slab 20 approximately 1.5 m from Joint 19. This crack tended to mirror the existing transverse crack on Slab 18, providing a degree of symmetry on each side of Slab 19, however, it did not run completely across the slab. The crack ended approximately 2.1 m from the originating slab edge, so it still had approximately 1.5 m to propagate to the opposite edge of the 3.66-m wide slab. Although visibly discontinuous, it is apparent that the two observed cracks are part of the same discontinuity.

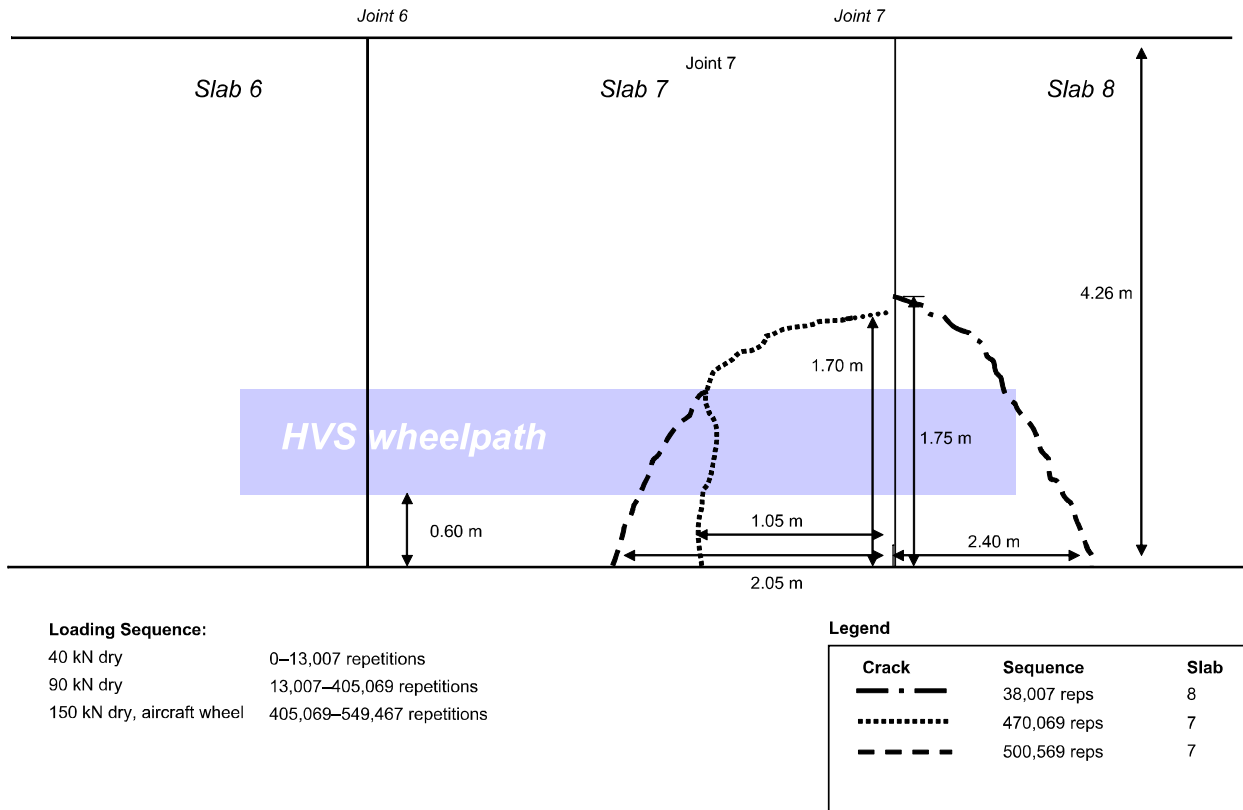
**Figure 91. Schematic of crack pattern, Test 540FD.**

The crack pattern as it developed with time is shown in Figure 91. A composite image of the completed test section is shown in Figure 92. The orientation of the figure is such that the outer shoulder is at the bottom of the figure (the trailer side) and the inner shoulder (the opposing
