The Busayra Cultural Heritage Project's 2025 Season

Kevin McGeough, University of Lethbridge, Canada  
Shawn Bubel, University of Lethbridge, Canada  
Jordan Weitzel, University of California, Berkeley, USA  
Ehab al-Saudi, Department of Antiquities, Jordan  
Benjamin W. Porter, University of California, Berkeley, USA

After an unexpectedly long hiatus, the BCHP resumed its research at the site between 1 and 24 July 2025. This report describes the achievements of the season which focused on the conservation and documentation of the monumental building in Area A.

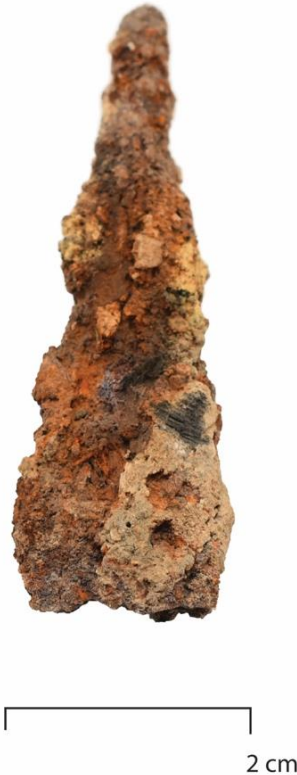
An iron spearhead recovered in destruction debris

This depositional pattern suggests this deposit was created by a destruction event characterized by burning. The presence of iron weapon fragments additionally suggests this destruction may have been instigated by a violent attack. The mudbrick wall that Wall PB.34 had supported collapsed during or soon after the destruction event. Bennett's team identified similar depositional patterns in the eastern courtyard, but the published documentation for the associated evidence is wanting. The evidence documented in AA02 therefore offers a more detailed picture of the courtyard's destruction.

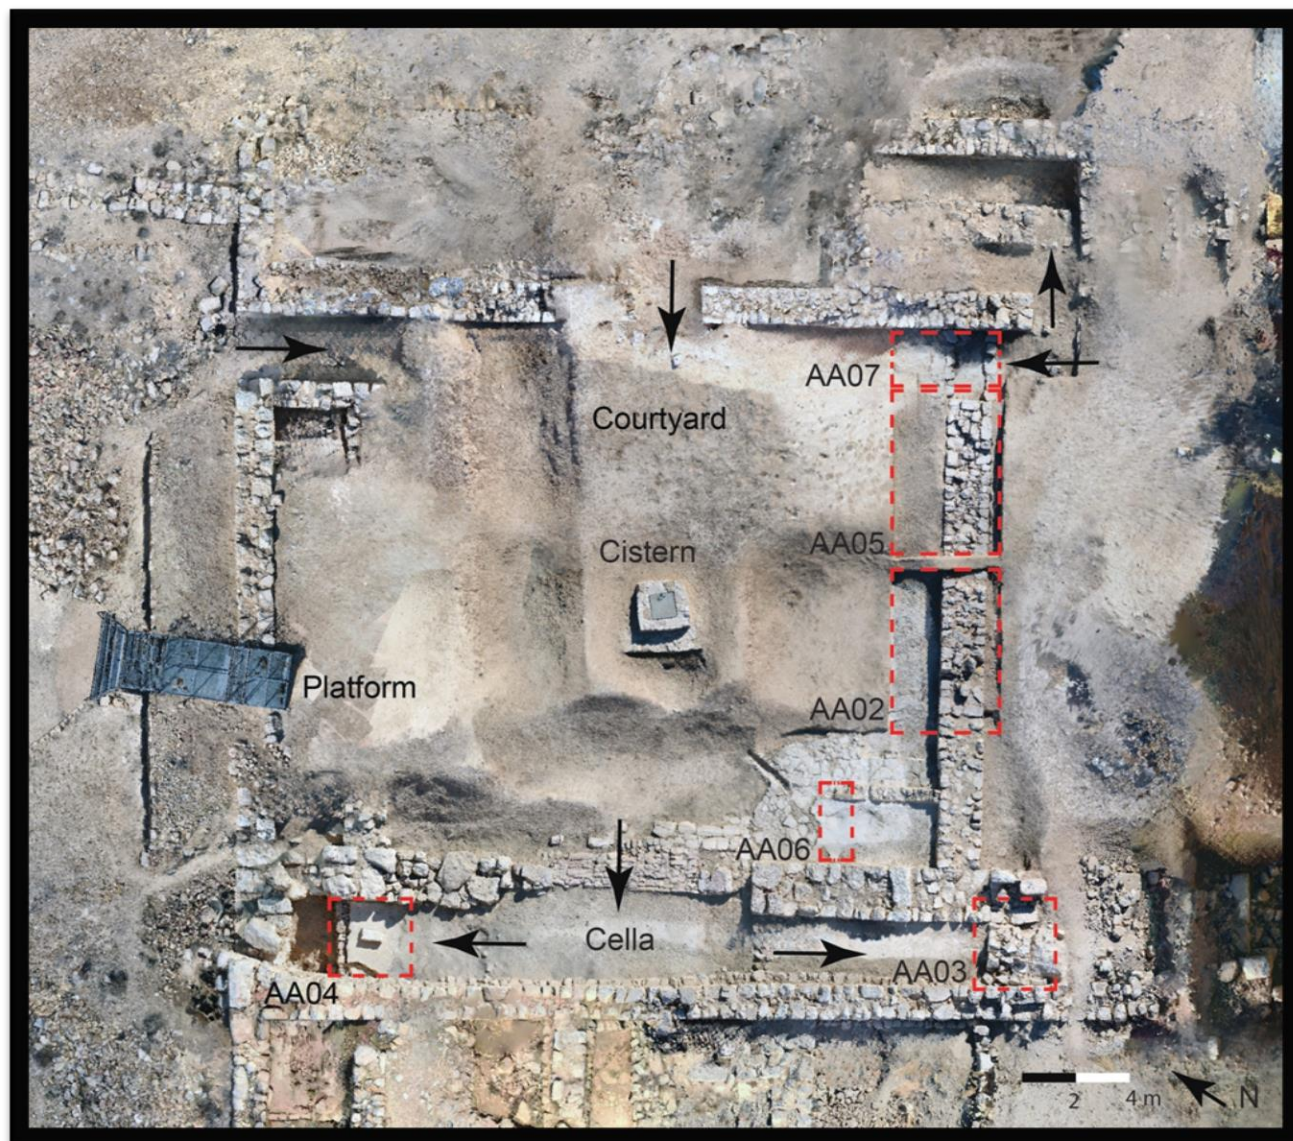
Figure 2. Eastern courtyard of Area A building detailing key features and 2025 excavation units.

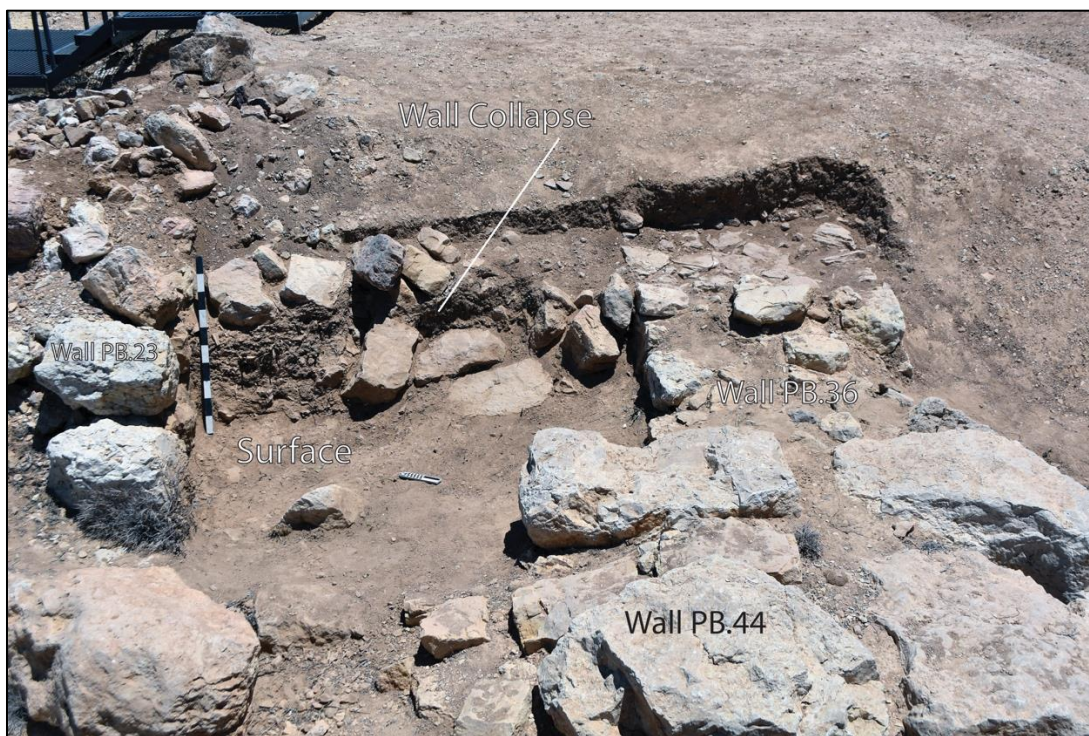
Figure 3. Unit A60 section between Wall PB.36 and Wall PB.23 looking west

These two sections reveal that excavations in this room will require the removal of a substantial amount of collapsed materials before reaching the room's first surface. Excavation will also expose tall sections of Walls PB.23 and 26 that will require extensive conservation to preserve them in place. Therefore, research in this room should proceed carefully with the plan of immediate conservation. Dry-laid reversible buttress walls were constructed against both section profiles after documentation to prevent additional erosion.

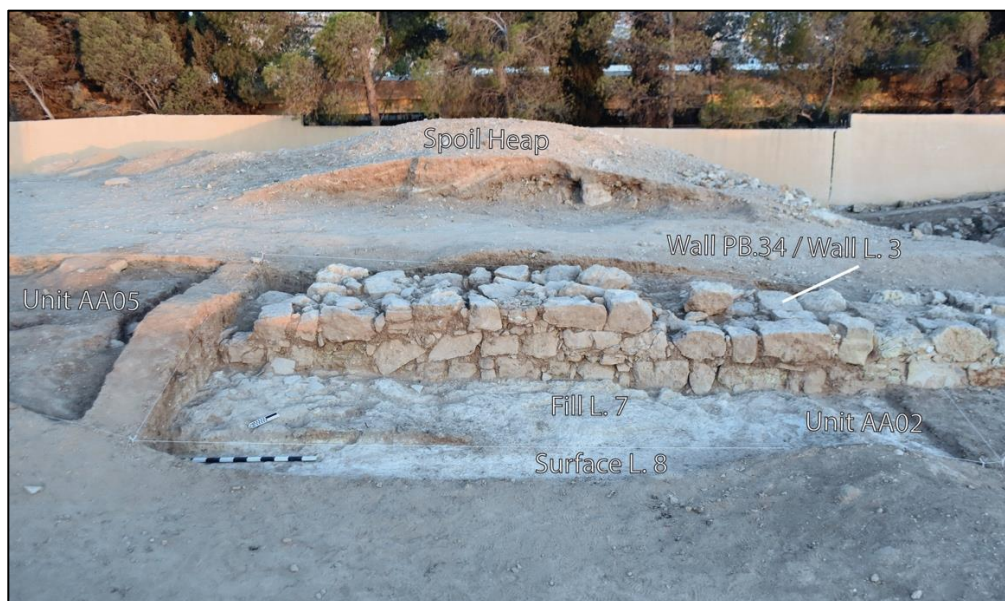
Figure 5. Wall PB.34/Wall AA02.Locus 3 in Units AA02 and AA05. Fill AA02.Locus 7 runs up to Wall AA02.Locus 3 and over Surface AA02.Locus 8.

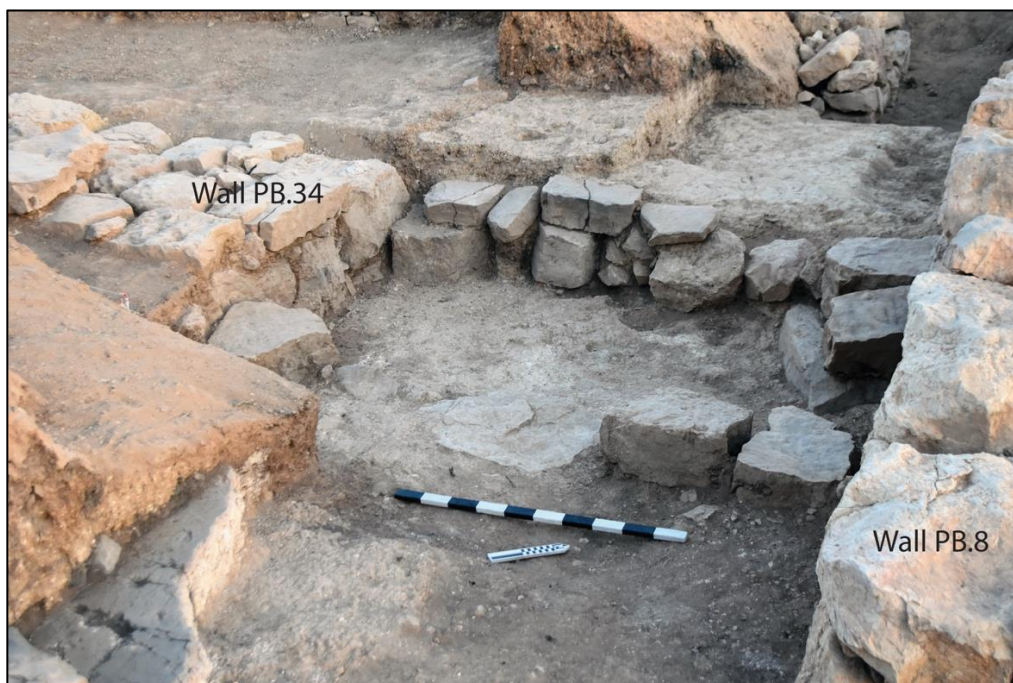
Figure 6. Threshold between Wall PB.34 and Wall PB.8 identified in Unit AA07 after cleaning A1.25. Stones in the threshold are collapse from surrounding walls.

Wall PB.34 ended 2.5 meters before reaching Wall PB.8. Upon this discovery, Unit AA.07 was established to study Bennett's excavations here to determine if this interruption in the wall was a threshold or the result of damage. Bennett's team had documented Wall PB.8 here during their excavation of Unit A1.25. Work in Unit AA07 required extensive cleaning of Bennett's Unit A1.25 to locate the now-buried Wall PB.8 and understand its relationship to Wall PB.34. Cleaning and limited excavation determined that the stones associated with Wall PB.11 and 13 had most likely fallen from Wall PB.34 and Wall PB.8, creating a small feature that had appeared to the Bennett team as a wall. The BCHIP team therefore identified a 2.5-meter wide threshold between the eastern courtyard and the yet-to-be excavated area south of Wall PB.34 (Fig. 6).

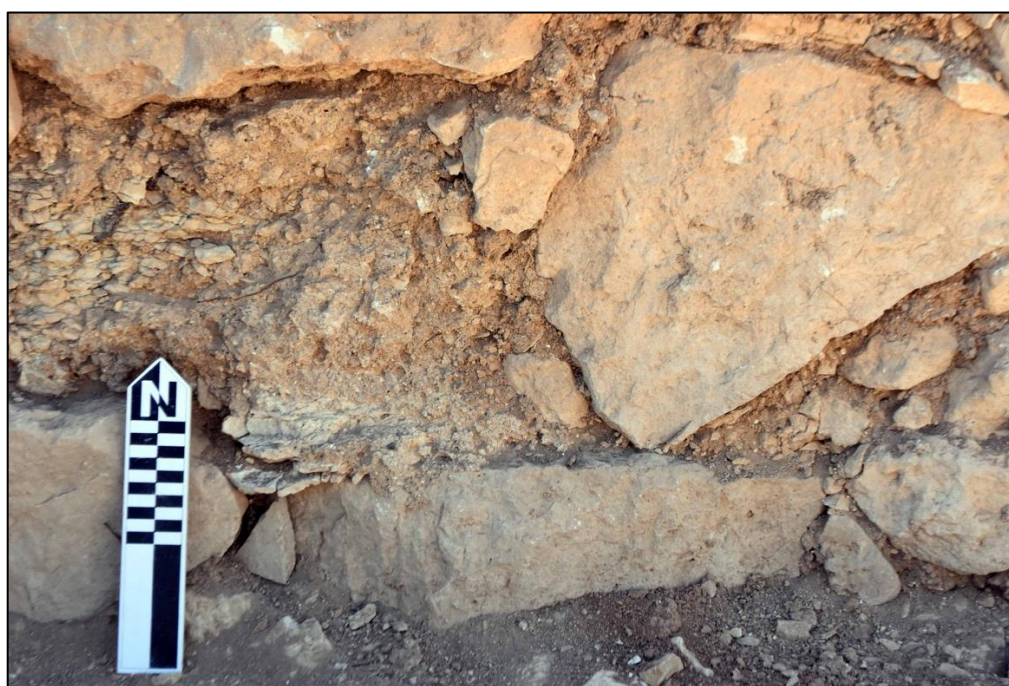
Figure 8. Plaster preserved on the north face of Wall AA02.Locus 3.

Sealing this plaster material was a thick layer of collapsed mudbrick material filled with plaster fragments, mudbrick debris, and burnt materials (AA02.Locus 5, 7). Broken flat-lying ceramic vessels were found resting on and above the plaster debris, suggesting that this material had been located nearby prior to falling on the surface (**Fig. 7**). Iron fragments, including an iron spearhead (**Fig. 9**), were also associated with these materials. More architectural debris was located above these materials (AA02. Locus 4) that included boulders, cobbles, and mudbrick, although few ceramic fragments were recovered.

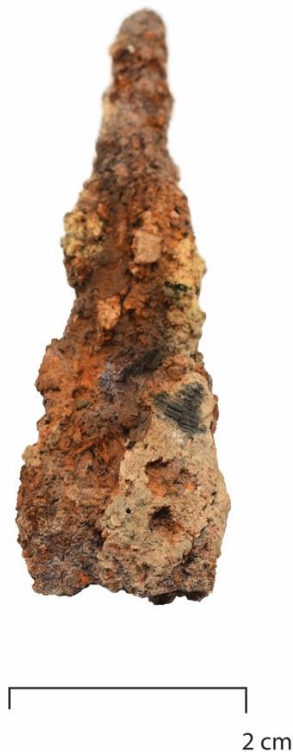
Figure 9. Iron spearhead AA02.Locus 5.30 recovered in destruction debris north of Wall AA02.Locus 3

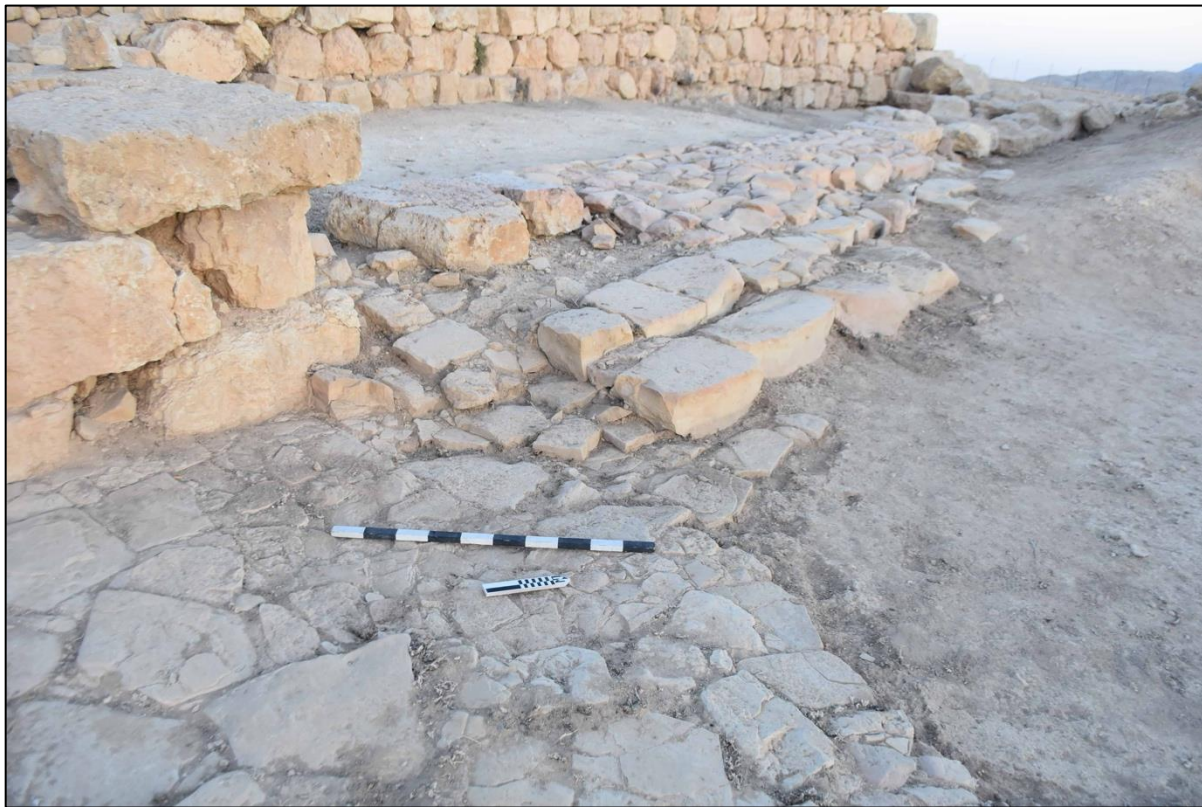
Figure 13. Unit A5.3 was cleaned along Wall PB.31 to determine that the flagstone surface ran up to, and possibly beneath, the shallow stairway leading into the cella.

The BCHP also defined the relationship between the flagstone surface and adjacent features. To some extent, Bennett's archaeological team had done this work, but the documentation was unfortunately thin in the published record and these architectural relationships required confirmation. The BCHP removed soils in Units A5.2 and A5.4 that had accumulated since 1980 to the point where Unit A5.2 ends and Unit A4.1 begins. The thick white plaster surface that likely extends across Area A's eastern courtyard was recovered during the cleaning of these deposits, an indication that the limits of the flagstone surface had been reached. There was an additional interest in linking Unit AA02's Locus 8, the laminated surfaces and sub-surface identified to the north of Wall PB.33 described earlier, with the flagstone surface. Deposits leading up to the small area immediately to the west of AA02 were cleaned and the relationship between AA02 and the flagstone surface was confirmed to be in phase with each other. The relationship between the flagstone surface and the entrance to the cella was also confirmed. Unit A5.3 was cleaned along Wall PB.31 revealing that the flagstone surface ran up to, and possibly beneath, the burnt stones that create a shallow stairway leading into the cella (**Fig. 13**; cf. Bienkowski 2002: 78-80; Plate 4.53).

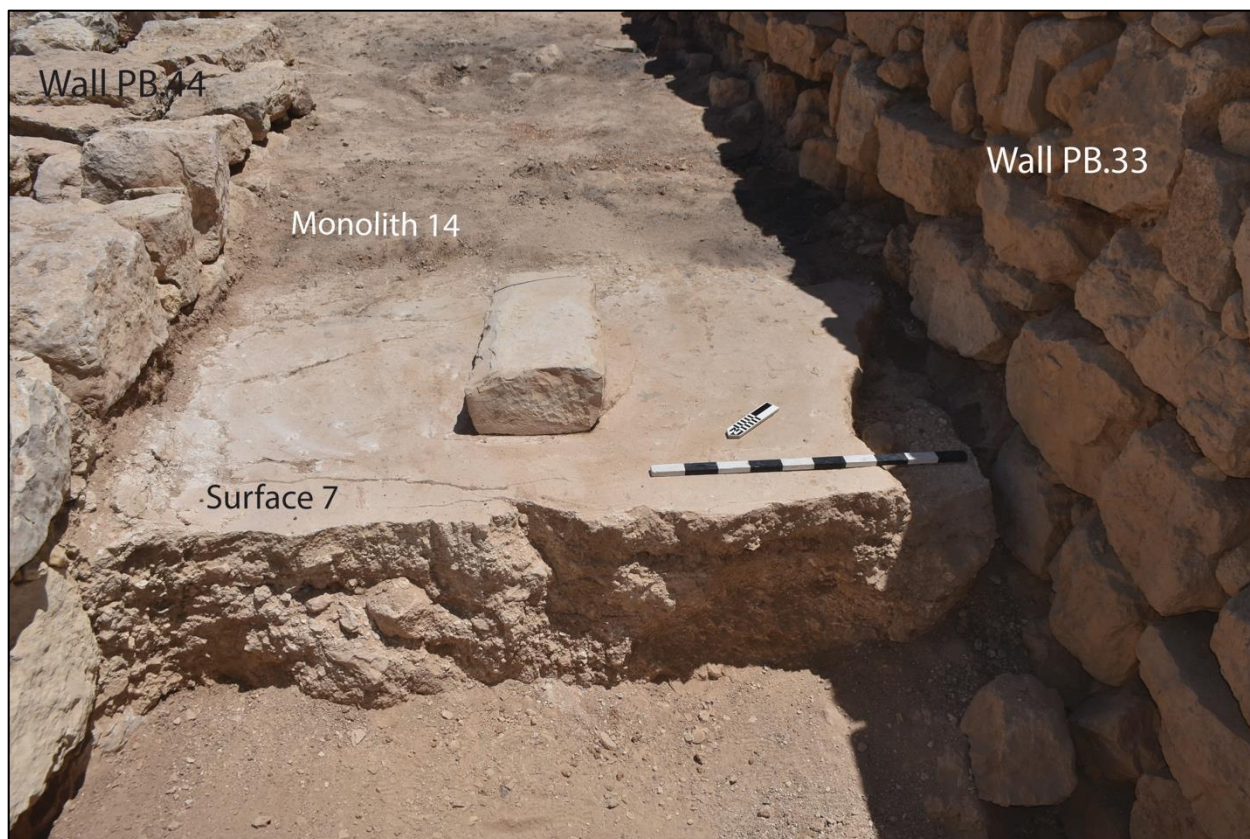
Figure 14. Stone monolith Locus 14 resting on Surface Locus 7 in AA04.

A reexamination of Bennett's section suggests the earliest activity in the unit was the construction of Walls PB.44 and 23, both made of large boulders. A relatively thick fill (AA04.Locus 11) with many lime inclusions was deposited against Wall PB.44 and topped with a thick plaster surface that was composed of a layer of dense plaster (AA04.Locus 7) and a subfloor layer of white plaster with small pebbles (AA04.Locus 12). A rectangular stone monolith (dimensions: 0.8 x 0.5 x 0.3 m), not previously documented by Bennett's team, was found lying flat on Surface 7 (**Fig. 14**). Toolmarks were found on the monolith's edges, an indication that it had been intentionally shaped; the monolith was uninscribed. It is unclear whether or not the object stood upright or not during its use as it was discovered lying flat. The monolith may have been a standing stone that served as the focus of cult practices.

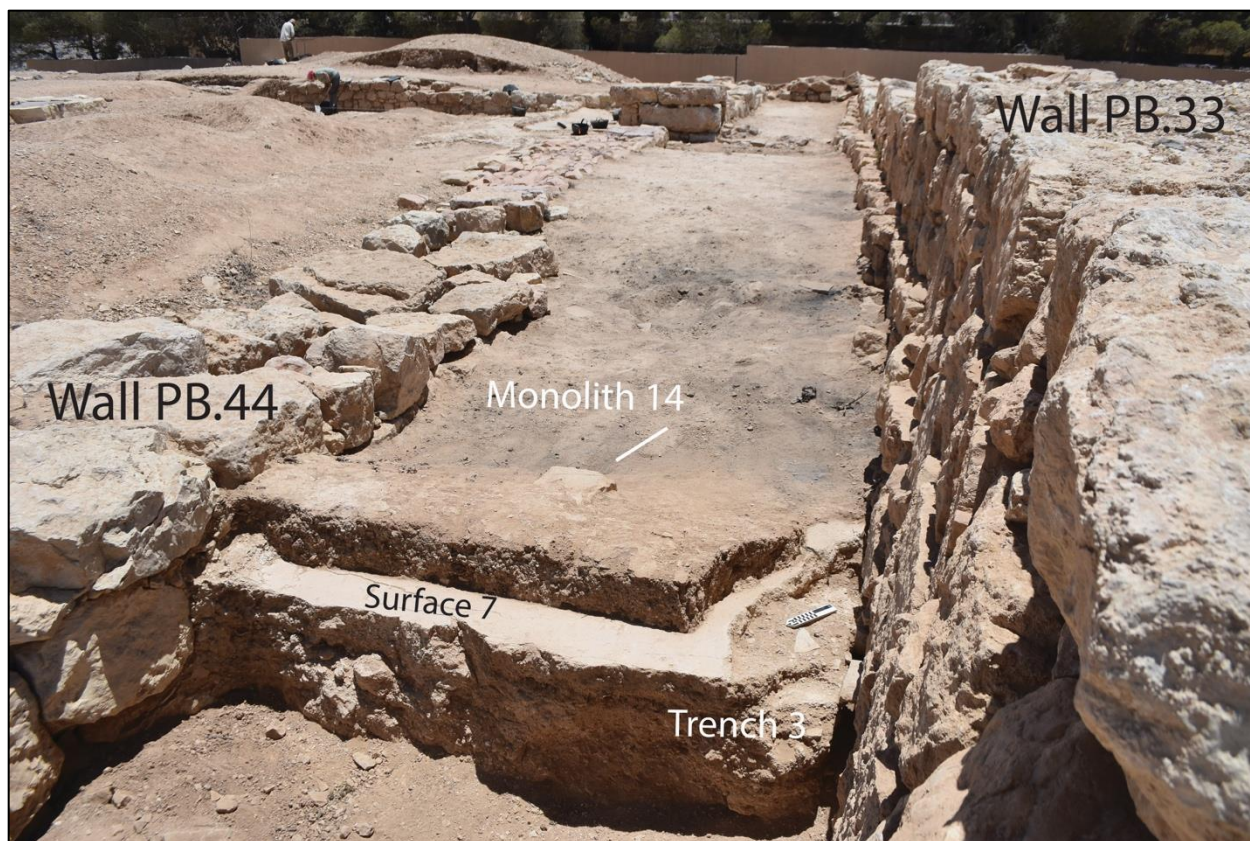
Figure 15. Foundation trench Locus 3 cut Surface AA04.Locus 7 during the construction of Wall PB.33's earliest phase. Stone monolith AA04.Locus 14 is beginning to appear.

In Phase 4, the latest phase observed in the unit, Wall PB.33 was rebuilt. As in Unit AA03, here too the latest phase could be differentiated based on its differing construction style, including the use of less standardized cut stones and heavier use of snecking. This phase of the wall was built over Wall PB.23, offset from the lower courses on the east side, ending at a quoin supported by a monumental buttress made of stepped ashlar blocks (Bienkowski 2002: 85; plates 4.65-4.67). No floor surface could be associated with this phase by either excavation team. This is likely due to Wall PB.33 use in Phase 4 as an exterior east wall for the rectangular building constructed on the western half of Area A Phase 3 walls.
