Development of a Unique Laboratory Scale Fluidized Bed Wear Testing Unit

Presented at the Conference on Wear of Materials — 1989,
Denver, CO, April 9–13, 1989, and
to be published in *Wear*

S. MacAdam and J. Stringer

April 1989

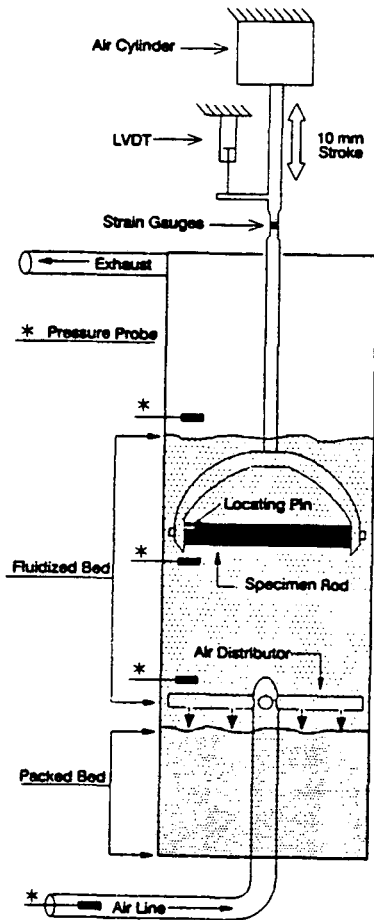
Fig. 1. Schematic diagram of actuated specimen fluidized bed wear testing rig.

A schematic of the fluidized bed wear testing rig is shown in Fig. 1. Dimensions and other characteristics are listed in Table 1. The body of the unit consists of a 155 mm diameter enclosed vertical cylinder that is partially filled with bed material. Quartz with a mean particle diameter of $800\ \mu\text{m}$ was the material chosen in this study because it is often a major constituent of the inert bed material within fbc, and is believed to be primarily responsible for component wear. Air is fed to a distributor within the bed consisting of four tubes extending radially from a central supply tube. Each tube extension has two holes on its underside. When in operation, air enters the bed via the eight distributor holes, flowing first downward and then uniformly upward through the bed towards the exhaust at the top, where it passes through a cyclone that collects escaping particle dust. The bed material, a few centimeters below the distributor, is not penetrated

by the air jets and thus remains in the packed condition. Typical distributors sit at the bottom of the bed and have orifices directed upward. The downward directed orifices of this rig prevent jet streaming, and thus allow the specimen to be situated close to the distributor. This design also helps prevent orifice blockage which can result in preferential bubble paths and uneven fluidization. By adjusting the height of the distributor, the bed depth can be altered.

The specimen is a rod of circular cross-section, held horizontally in a stirrup on the end of an actuator rod within the fluidized portion of the bed. Specimen orientation is maintained with a locating pin. The specimen rod is driven downward within the fluidized bed at high accelerations by a pneumatic air cylinder. The force of the downward stroke is altered by adjusting the air pressure supplying the cylinder. The bed material immediately below the moving specimen is compressed, or defluidized, and therefore behaves like the defluidized material that is thrown against the tube bottom during bubble passage or teardrop void collapse in bubbling fbc. The specimen accelerates at an approximately constant rate from its rest position at the top of the stroke to the stroke end. Typical values for this acceleration range $60 - 170 \text{ m s}^{-2}$. The characteristics of the downward specimen motion were modeled after those of rising bubbles and collapsing teardrop voids. Maximum downward specimen velocities, like those of rising bubbles, are in the range $1 - 2 \text{ m s}^{-1}$. The actuation frequency can be set between 0.27 and 2.8 Hz, similar to the measured pressure and tube force pulses of 0.5 - 3 Hz. The stroke length can be set between 0 and 20 mm. This is in the range of the observed teardrop dimensions of 10 - 50 mm. The return stroke is damped to prevent any significant wear occurring during the upward stroke since the system is meant to simulate particle blocks that impact the tube bottom only. The downward specimen motion typically takes between

Specimen motion is monitored through a linear variable displacement transducer (LVDT) attached to the actuating rod. The force of particle blocks impacting the rod surface is determined via strain gauges that are mounted on a reduced section of the actuating rod. Pressure transducers are linked to probes that can be inserted into the bed through side ports located at intervals along the tube. These probes are used to determine the onset of fluidization and to detect any bubbling that occurs within the bed.

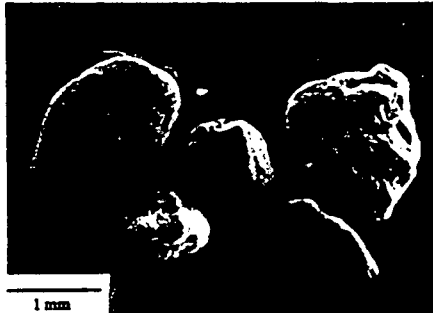
Fig. 2. Collection of typical conditioned quartz particles used in fluidized bed wear study.

During the first several hours of fluidized bed operation with fresh bed material, nearly 20% of the quartz was reduced to fines and elutriated. This was found to be due more to the rounding of particles by the cracking off of corners than to bulk fragmentation. After this initial period, the particles reached a relatively stable shape and size, and further elutriation was reduced to less than 1% over 20 h. Changes in particle shape during testing are undesirable, not only because of the possible changing particle abrasivity, but also because the associated change in particle size distribution alters the state of fluidization. Accordingly, all tests were carried out with bed material that had been preconditioned in the fluidized bed. Furthermore, the finer bed material that had naturally levitated to the top of the bed during fluidization was vacuumed off and replaced with fresh material between test increments. These procedures yielded bed material that was of a satisfactorily consistent size and shape distribution over a time in excess of 1000 h. A typical collection of conditioned quartz particles used during testing is shown in the scanning electron micrograph in Fig. 2.

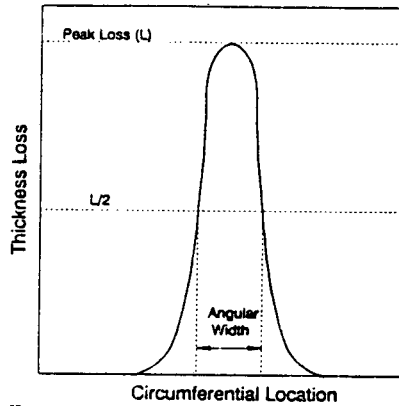
Fig. 3. Schematic of method used to determine the area over which the rod wastage is averaged.

In Task 2, thickness loss measurements were taken in approximately 7.5° intervals around the ^{periphery} ~~periphery~~ of the rods using a diamond stylus profilometer. Measurements were made relative to a small circumferential masked region at the midpoint along the specimen axis. A practical accuracy of 1 μm could usually be guaranteed for small losses. For larger losses, the error was limited to ±5%. The circumferential accuracy was limited to ±2°. Profiles were taken after completion of each incremental series; taking measurements between increments was generally not practical owing to the small losses involved. The profiles obtained were used to determine wear distribution but were not directly used in determining steady state wear rates because the varying incubation behavior of the different materials makes comparisons among them misleading. As will be shown below, losses were generally limited to two reasonably symmetric circumferential regions of between 25° and 35° in width. The quoted thickness loss values were determined by averaging the steady state loss rate, determined from mass loss measurements, over the area encompassed by the circumferential widths of the two loss regions, determined by profilometry. This width was defined as the circumferential width of each loss region at half the maximum peak height. This is shown schematically in Fig. 3. The thickness loss rates determined in this manner were typically between 30% and 50% higher than the peak thickness loss rates determined directly from loss profiles. Much of this difference is due to the inclusion of the incubation periods in the loss rates estimated from the thickness profiles.

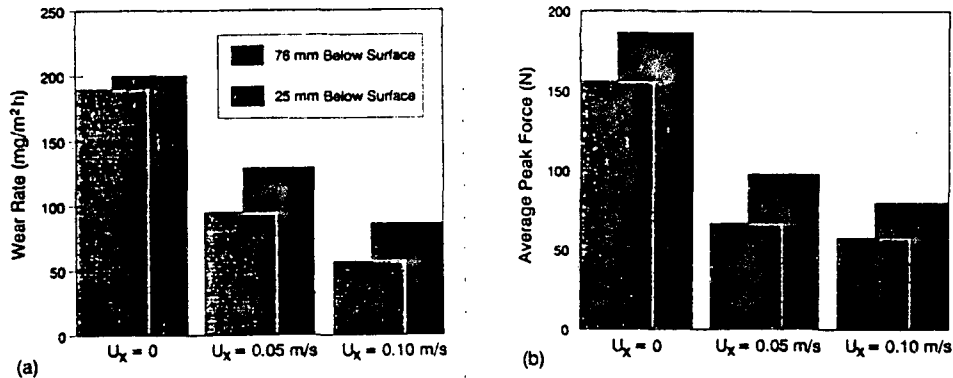
Fig. 4. (a) Task 1 wear rates as a function of excess fluidizing velocity and depth below bed surface. (b) Mean peak force on specimen under the same conditions.

The six steady state loss rates determined from plots of cumulative mass loss as a function of bed exposure time are presented in Table 4 and graphed in Fig. 4(a). Two trends in material wear are clearly evident. First, there is a decrease in the wear rate associated with an increase in excess fluidizing velocity. This is expected since the bed resistance force is greatly reduced with an increase of u_s in the neighborhood of u_{mf} . A second trend is the fractional decrease in wear rate for a specimen situated closer to the bed surface. It is possible that the agglomeration of bursting bubbles close to the bed surface results in a reduced bed density in this region such that on the downward stroke, particles are loaded onto the specimen surface

Both of these trends are directly related to the force of impact of the bed material on the specimen as shown in Fig. 4(b). The basic dependency of the wear rate on the force, as the excess fluidizing velocity and rod location are changed, is apparent. It is interesting to note that the force changed comparatively little with an increase in u_x from 0.05 to 0.10 m s^{-1} . This is probably due to a lack of defluidization at these higher excess velocities. The bed in these cases acts more like a viscous fluid. At values of u_x nearer 0, force pulses showed sudden sharp increases part way through the stroke. This was probably related to defluidization.

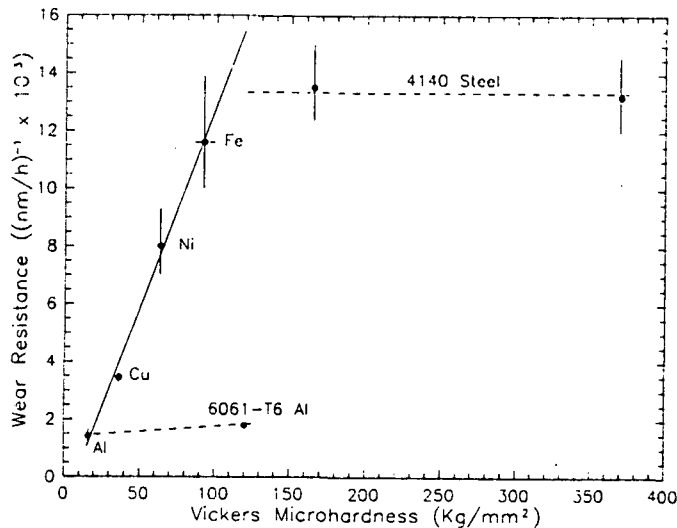
Fig. 5. Wear resistance of Task 2 materials as a function of hardness.

The wear rates for the various materials tested in Task 2 are listed in Table 6 together with their hardness values. The relationship between the wear resistance (1/wear rate) of the metallic materials tested in Task 2 and their hardness is plotted in Fig. 5. Wear resistance is seen to increase linearly with the annealed hardness of pure metals. This relationship was anticipated and has been shown to exist for two-body abrasion (Khrushchov [9], Richardson [10]), three-body abrasion (Misra and Finnie [11]), and erosion

(Finnie *et al.* [12]). It is also indicated in Fig. 5 that increased hardness resulting from precipitation strengthening or heat treatment had comparatively little effect. The thermally hardened 4140 steel showed no improvement in wear resistance over the normalized material. This result was also obtained by Finnie *et al.* for the erosion of 1045 steel [12]. Others have shown a slight increase in wear resistance for similar thermally treated materials tested under abrasive conditions [9 - 11].

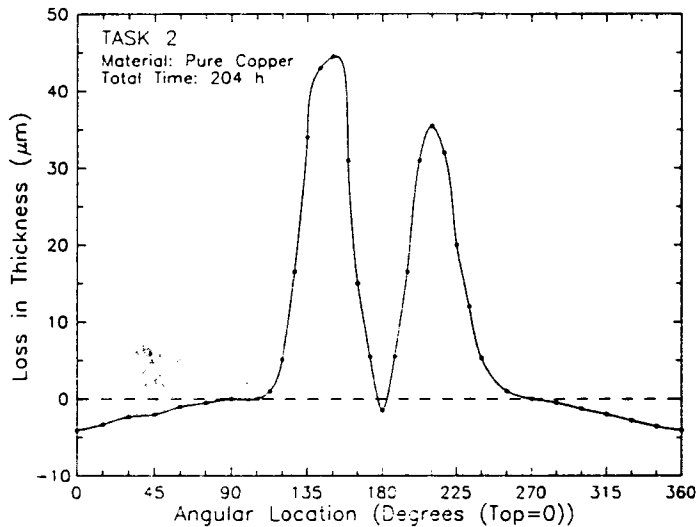
Fig. 6. Circumferential thickness loss profile of Task 2 copper specimen rod at the conclusion of 204 h of testing.

Figure 6 shows the thickness loss profile for the pure copper specimen. It is characteristic of the profiles for all of the metallic materials with the exception of the pure aluminum. The wear patterns of these more typical specimen rods can be divided into four regions of differing behavior and morphology. The regions (referenced to 0° at the rod top) are as follows.

(1) 0° - 80° (280° - 360°). No thickness loss at all was found on the top half of the rods. Instead, there was a gradual increase in thickness with the maximum occurring at the rod top. This is indicative of a layer of deposited bed material covering the surface. This deposit can be seen in the optical micrograph of the 0° location on the 6061-T6 Al specimen in Fig. 7. Shown in the cross-section is part of the continuous layer that is composed of micron-sized quartz particle fragments held in a conglomerate of submicron quartz. The maximum deposit thickness ranged from 2 to 10 μm for the different materials.

(3) 100° - 170° (190° - 260°). These regions were the only locations on the rod to experience any substantial material removal. Maximum loss consistently occurred at 145 and 215° ± 3°. Examination of the worn 6061-T6 Al rod surface in this region revealed many small abrasion tracks, as seen in Fig. 8(a), as well as indentations of the kind shown in Fig. 8(b). The surface surrounding these abrasion scars was covered with a layer of fine quartz particles, probably similar in make-up to that seen on the rod top, though of a different thickness. The basins of fresh scars usually had no quartz layer, indicating that the impacts could penetrate through the layer to deform or remove underlying metal. The wear tracks typically had widths

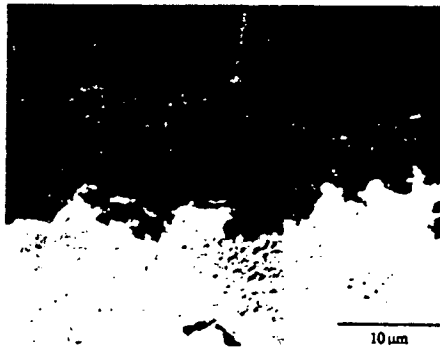
Fig. 7. Optical micrograph of surface cross-section from the 0° rod location of the 6061-T6 specimen from Task 2 showing deposit layer on surface.

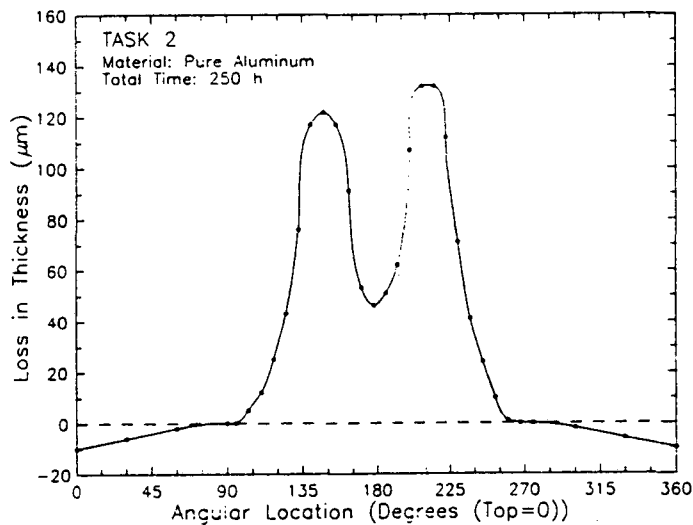
Fig. 11. Circumferential thickness loss profile of pure aluminum specimen rod at the conclusion of 250 h of testing.

ever, the results of the pure aluminum tests indicate that under some conditions mechanical properties do play a role. The pure aluminum rod, in contrast to all other metals and alloys tested, suffered a significant amount of wear at the rod bottom as can be seen in the wear profile in Fig. 11. In other respects, the pattern of loss was the same. This differing behavior was not related to test duration or magnitude of loss. A pure aluminum rod showed significant loss at the bottom when the peak loss was only $33\ \mu\text{m}$ and the test duration was 115 h. The 6061-T6 Al rod had a peak loss of $55\ \mu\text{m}$ after 130 h, but suffered no loss at the bottom.

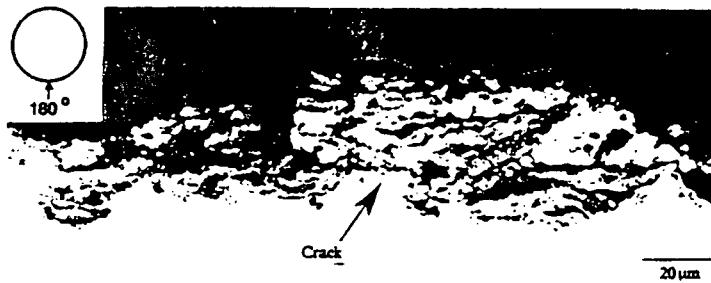
Fig. 13. Optical image of the worn pure aluminum surface seen in cross section near the 180° location showing evidence of failure due to layer cracking.

aluminum layers should be noted. Vickers microhardness measurements revealed this composite layer to be approximately five times harder than the underlying pure aluminum. Many cracks were observed within the layer; in Fig. 13, a crack is seen that has severed a 25 μm thick segment from the surface. Some of the observed cracking was undoubtedly initiated by the metallographic preparation, but many examples were found that indicated segments had spalled prior to specimen preparation. The very low yield stress and high elongation of the pure aluminum allowed the very thick composite to develop with up to 18 or so alternating quartz and aluminum layers. The intermixed region of the pure copper by contrast, was limited to around six component layers and a total thickness of 10 μm . The pure aluminum was probably able to develop a thick enough layer such that the external and internal stresses caused spalling of segments. This layer cracking and spallation may be the sole cause of material removal near the rod bottom and it is likely to have contributed to the loss in the 145° regions as well.
