Towards understanding the environmental durability and corrosion behavior of protected silver mirrors

A dissertation submitted in partial satisfaction of the  
requirements for the degree Doctor of Philosophy  
in Materials Science and Engineering

Kelsey Anne Folgner

2019

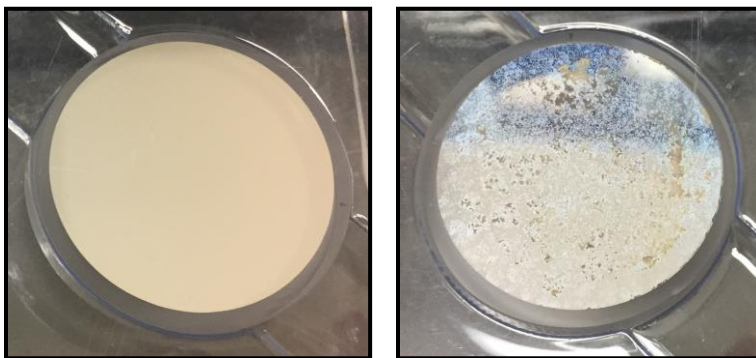
Figure 2. Freshly-deposited silver mirror (left) is smooth and reflective, compared to a degraded mirror (right) that is tarnished and corroded.

Atmospheric corrosion of silver results in the formation of silver sulfide ( $\text{Ag}_2\text{S}$ ), silver chloride ( $\text{AgCl}$ ), silver oxide ( $\text{Ag}_2\text{O}$  or  $\text{AgO}$ ), and silver sulfate ( $\text{Ag}_2\text{SO}_4$ ) tarnish films on the surface [6, 8, 11, 17]. Silver sulfide, a highly absorbing compound, is the most common tarnish observed on silver surfaces, often developing as dark brown markings that significantly degrade silver's outstanding optical properties [5, 6, 9, 10, 14, 18, 19]. Tarnish and corrosion on silver surfaces degrade reflectivity and increase scatter, vastly reducing the optical performance.

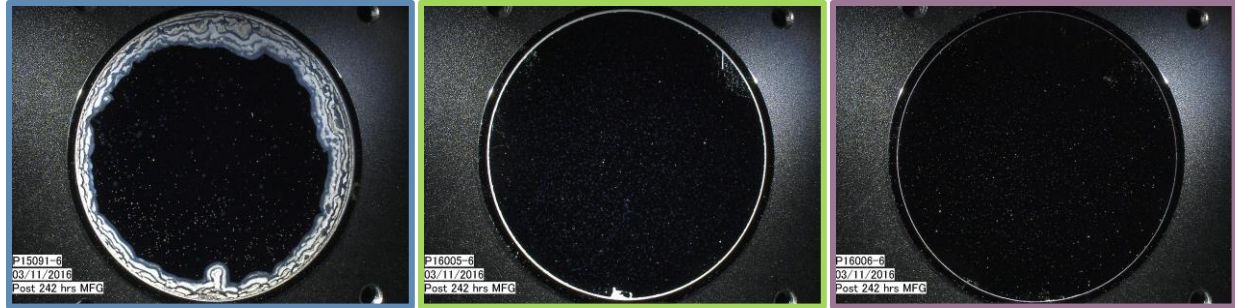
Figure 14. Dark field images after 10 days of MFG exposure of the no adhesion layer mirror (left), CrN<sub>x</sub> adhesion layer mirror (center), and NiCrN<sub>x</sub> adhesion layer mirror (right).

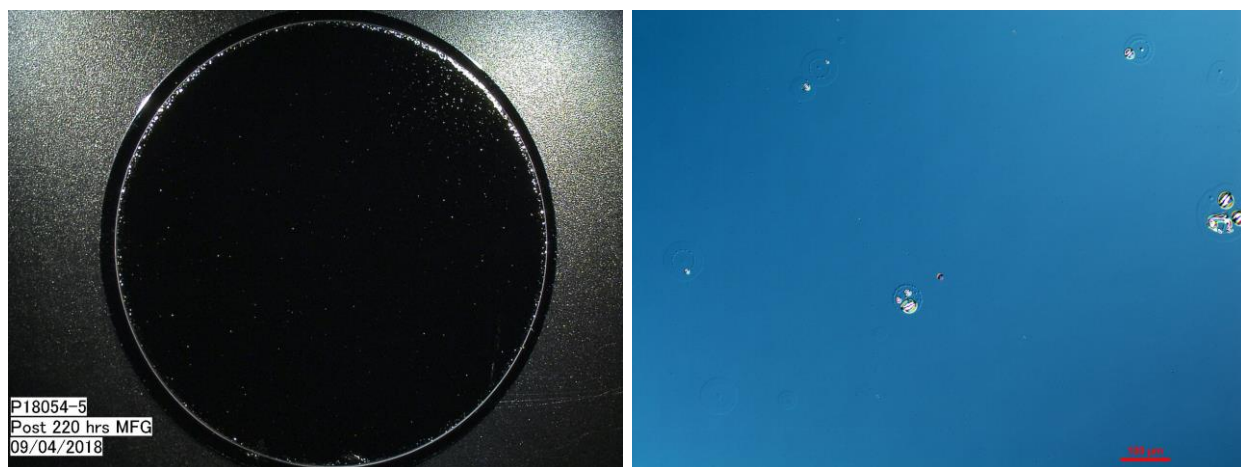
Figure 48. Dark field image of a Cr base layer mirror with corresponding optical micrograph of corrosion features after 10 days MFG exposure.

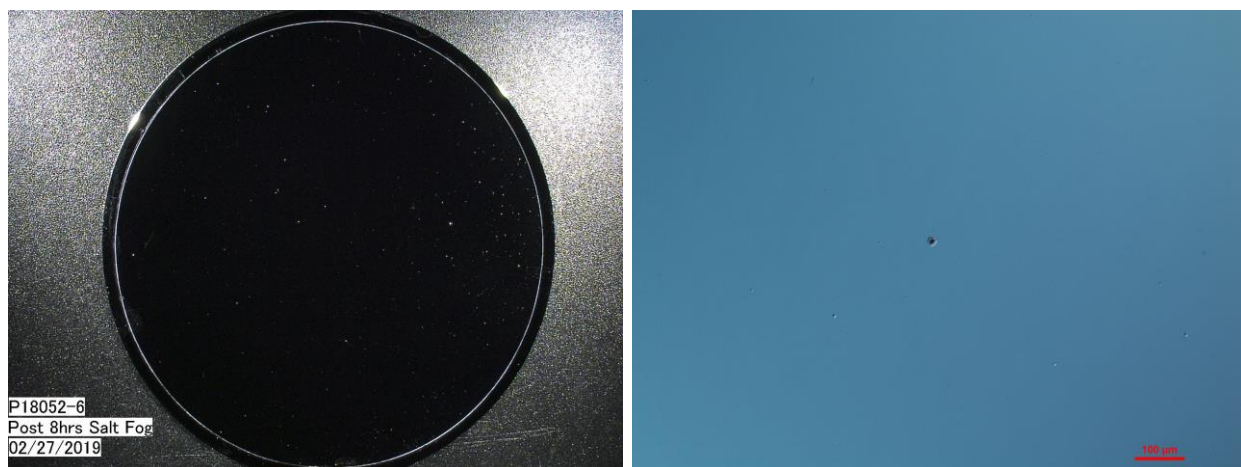
Figure 56. Dark field images of a NiCrN<sub>x</sub> adhesion layer mirror with corresponding optical micrograph of corrosion features after 8 hrs salt fog exposure.

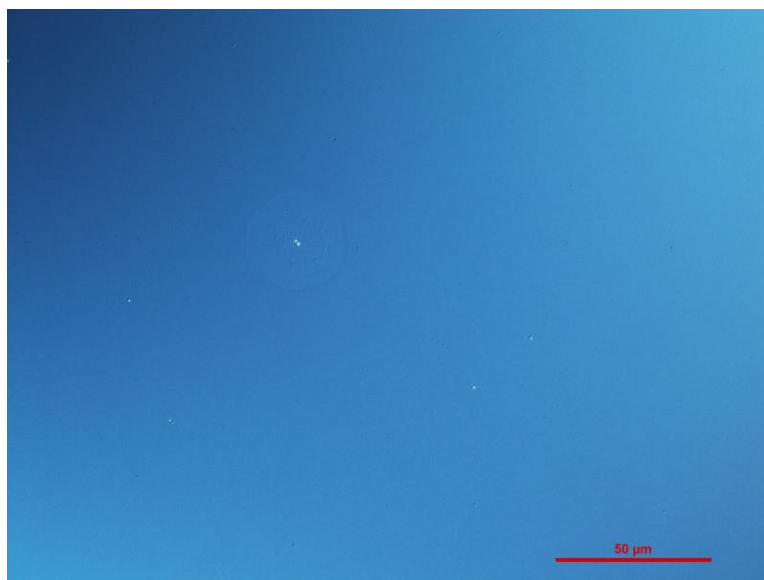
Figure 57. Optical micrograph of a corrosion feature on the  $\text{CrN}_x$  adhesion layer mirror after 6 months of laboratory storage. Note the difference in scale from previous micrographs of this mirror type.

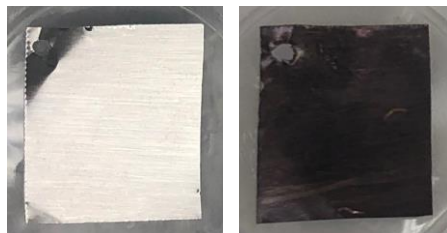
Figure 75. Ag foil sample before (left) and after (right) MFG exposure.

Bare silver mirrors and silver foil samples were exposed to 10 days of MFG exposure and then subjected to coulometric reduction at  $-50 \mu\text{A/cm}^2$  in 0.1M  $\text{Na}_2\text{SO}_4$  adjusted to pH 10. After MFG exposure, the silver foil was covered with dark brown corrosion product (Figure 75), while

the bare silver mirror was similarly brown in appearance (Figure 76). The brown color of the corroded surfaces is likely due to silver sulfide.

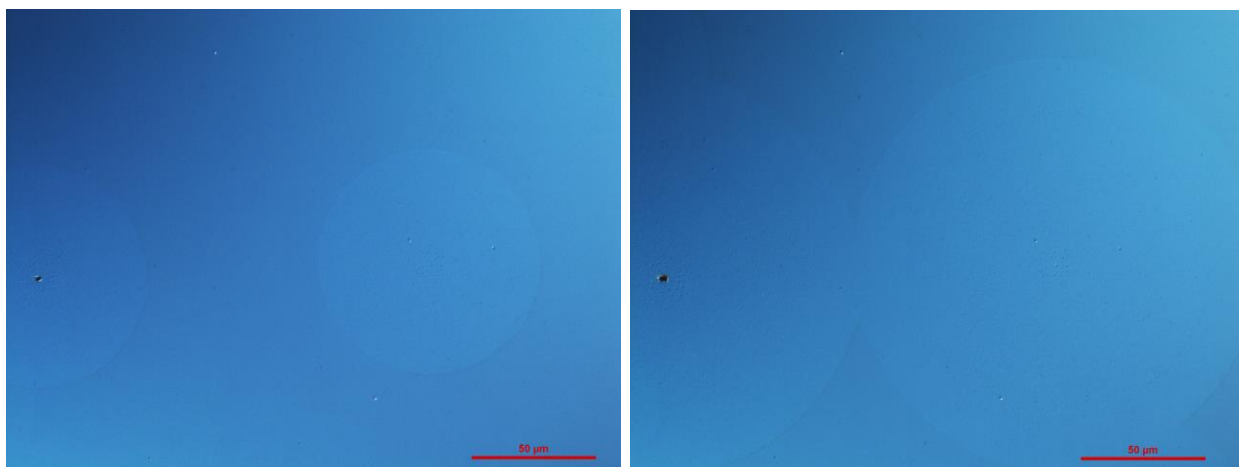
Figure 93. Optical micrographs of circular corrosion regions on the  $\text{CrN}_x$  adhesion layer mirror after 5 days (left) and 10 days (right) of MFG exposure.

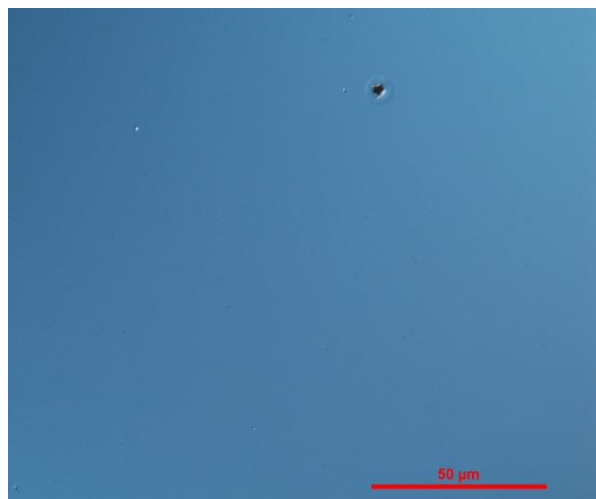
Figure 95. Optical micrographs of a corrosion nodule on the NiCrN<sub>x</sub> adhesion layer mirror after 10 days of MFG exposure.

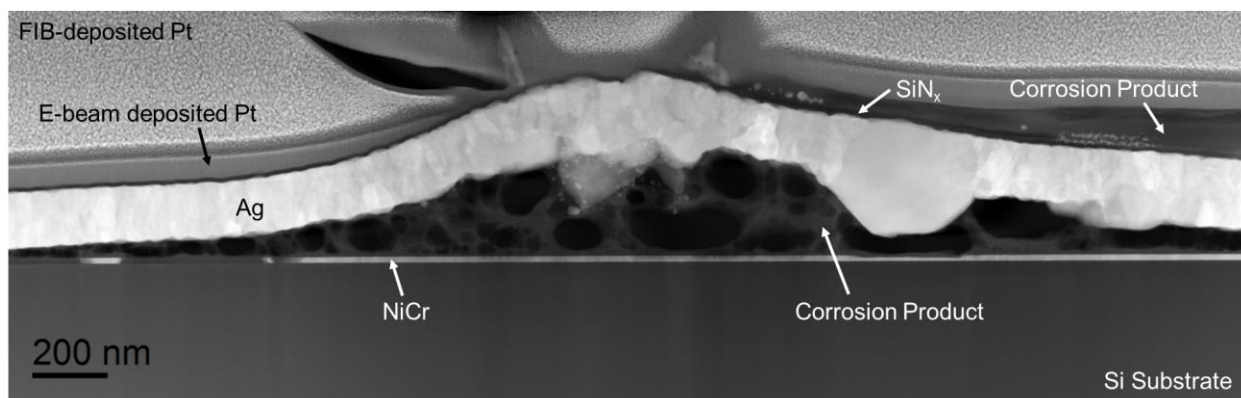
Figure 98. ADF image of cross-section of small corrosion feature on  $\text{NiCrN}_x$  adhesion layer mirror.
