April Burn-in Testing Report for Genentech B35, South San Francisco Campus

## **April Burn-in Testing Report for Genentech B35, South San Francisco Campus**

Andrew McNeil, Eleanor S. Lee

Energy Technologies Area  
June 2015

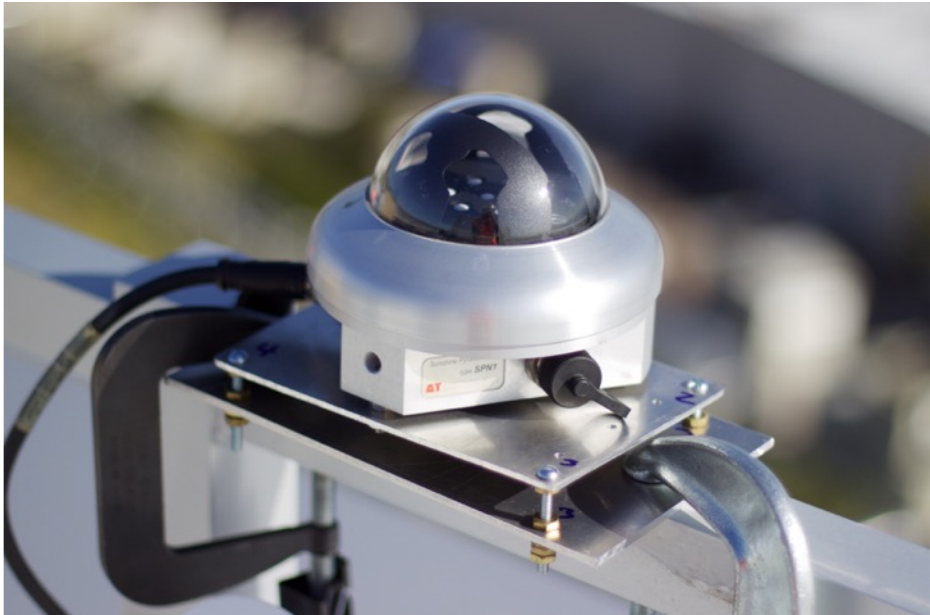
A sunshine pyranometer (SPN-1 by Delta-T Devices) mounted to the railing on the roof measured exterior irradiance conditions for part of the test period. The SPN-1 measures both global and diffuse horizontal irradiance. These measurements allow us to determine the sky conditions (eg, clear, dynamic, or overcast) during the measurement period.

The sunshine pyranometer was installed on April 10, 2015. Unfortunately a problem with the device recording and storing data prevented data from being collected after April 17, 2015. In order to understand sky conditions during the periods without data collect on site, we used historical Meteorological Terminal Aviation Routine Weather Reports (METAR) from SFO airport, located 2.5 miles south of B35. The reports contain hourly sky cover observations reported in octals (fraction of sky coverage in 1/8 increments). The charts below show measured irradiance and reported cloud cover on a clear day (left) and dynamic day (right). These charts indicate that reported cloud cover at SFO gives a reliable indication of sky conditions at B35.

Sunshine Pyranometer installed on the railing of B35 roof.

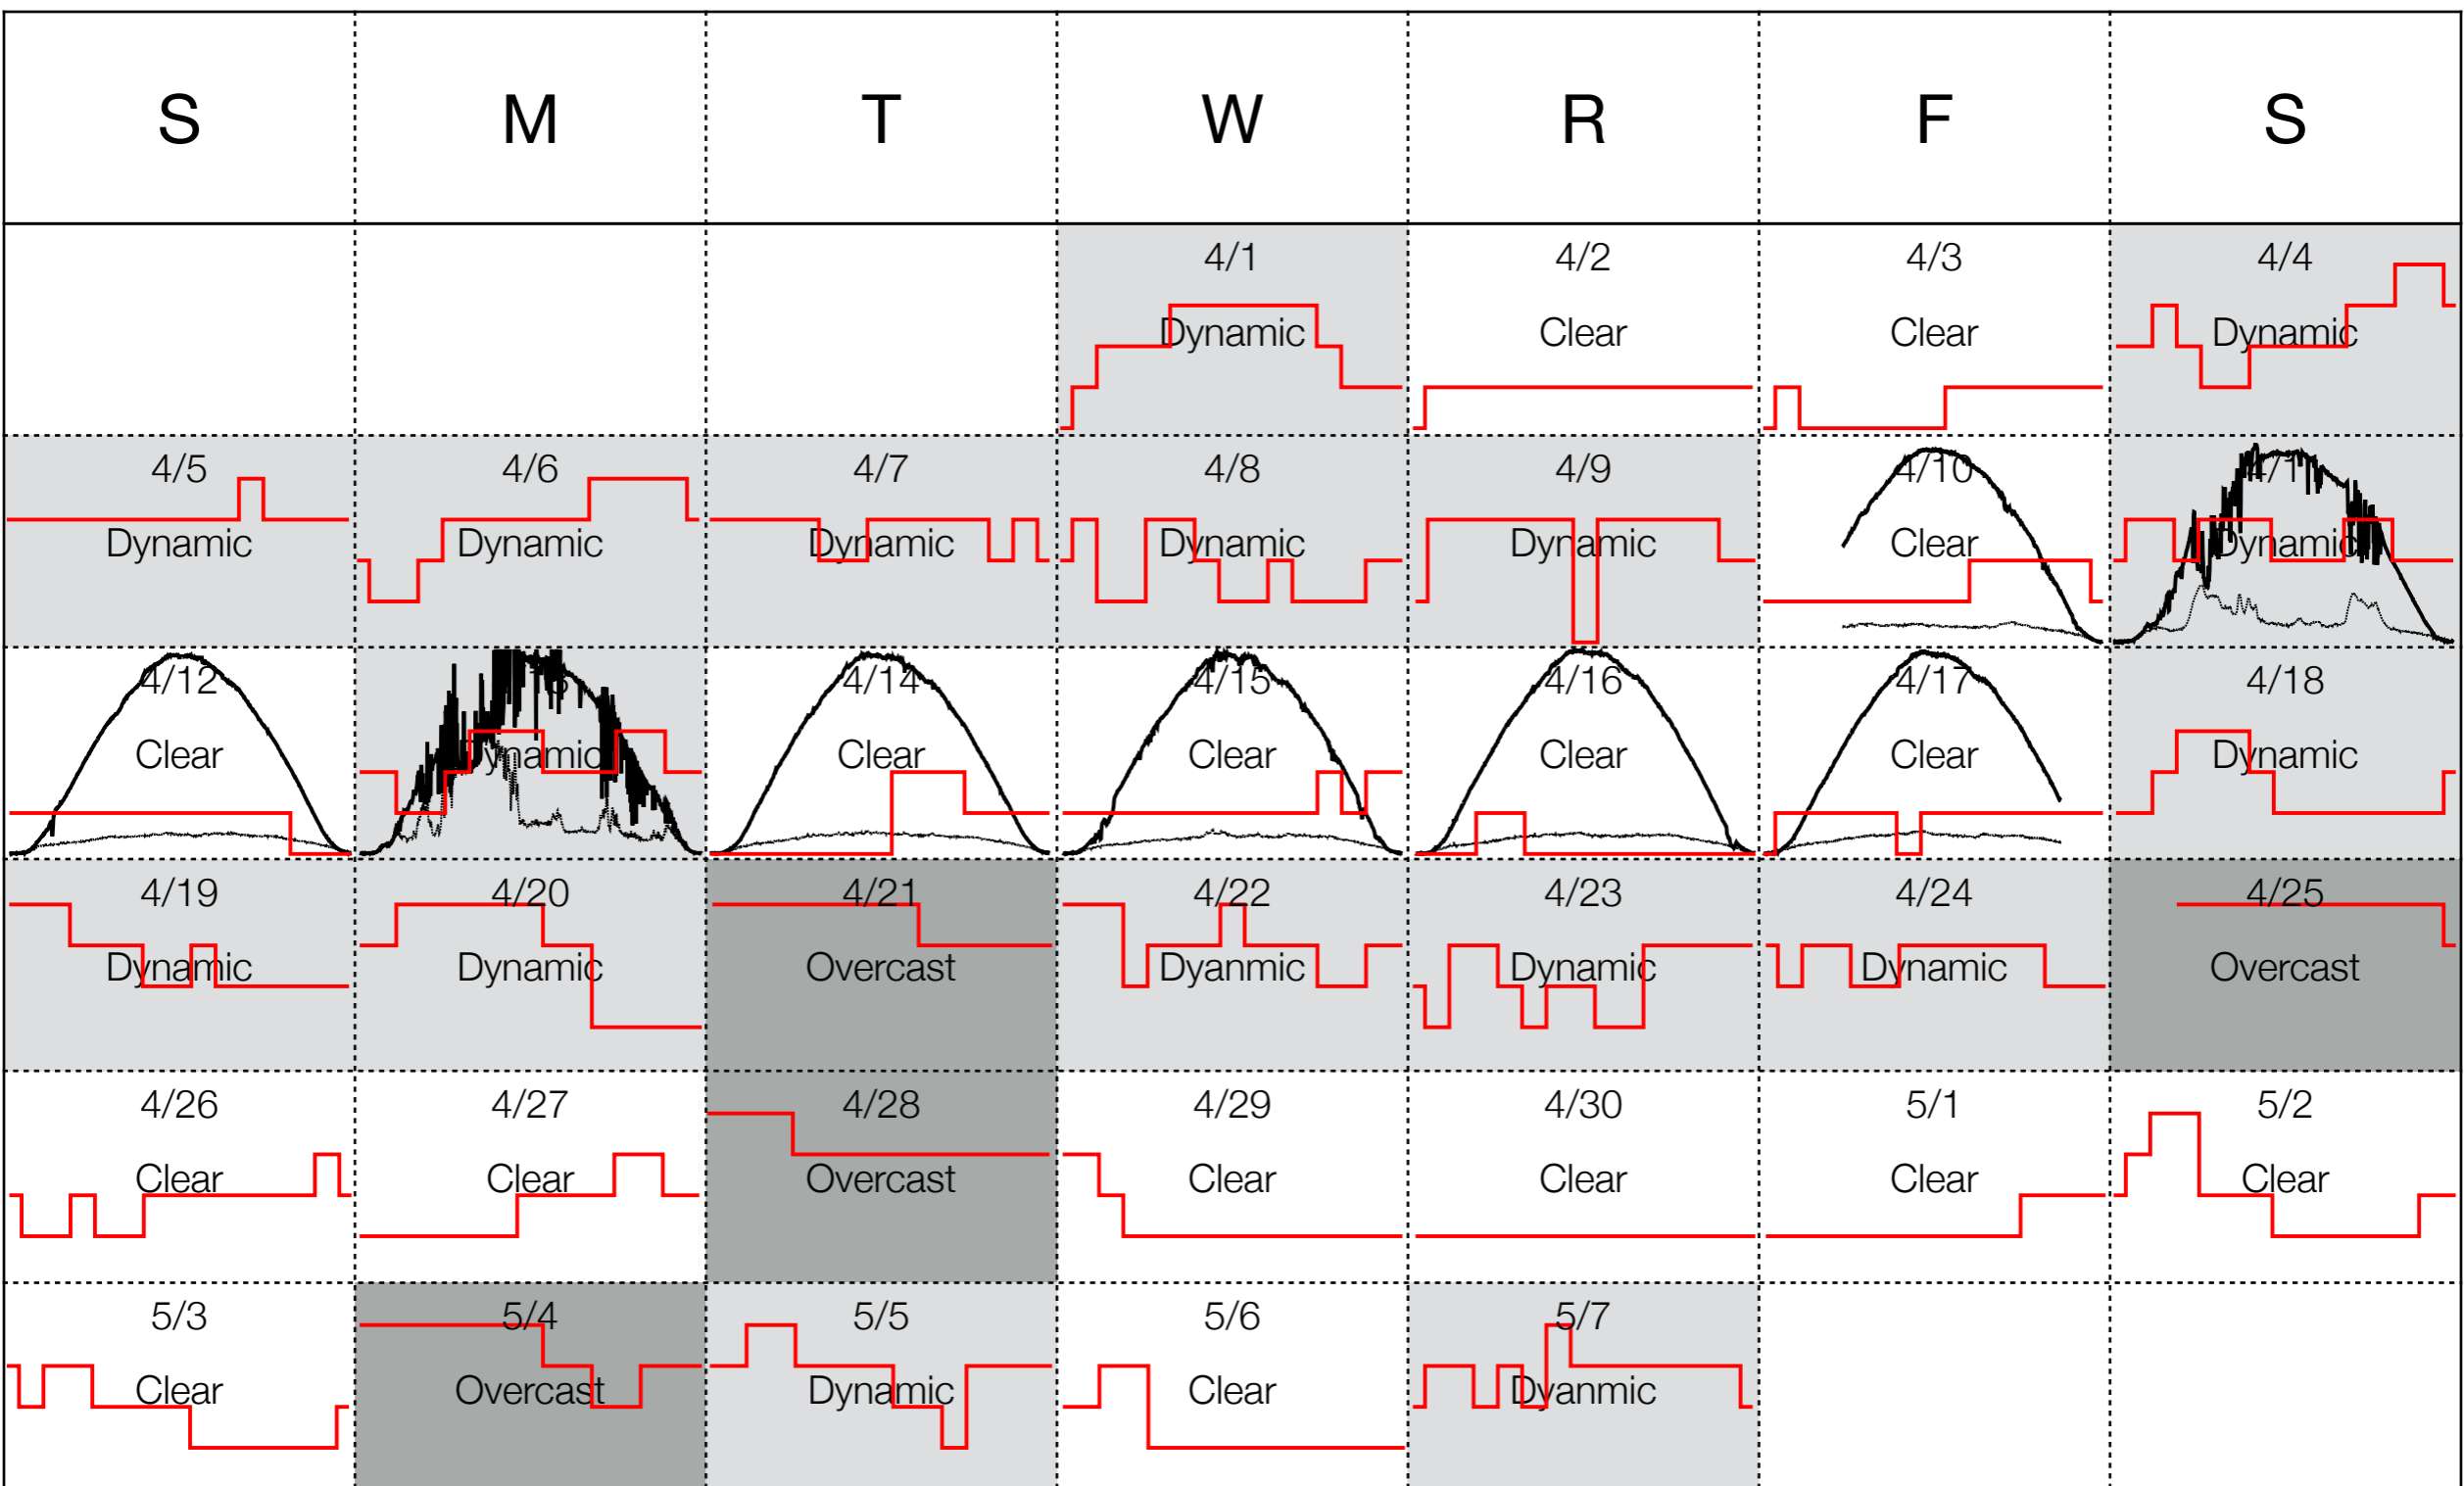
Sparklines plotted in the calendar below indicated cloud cover (red), global horizontal irradiance (black) and diffuse horizontal irradiance (gray). The days are coded as clear, dynamic, and overcast based on data presented and HDR photos taken that day.

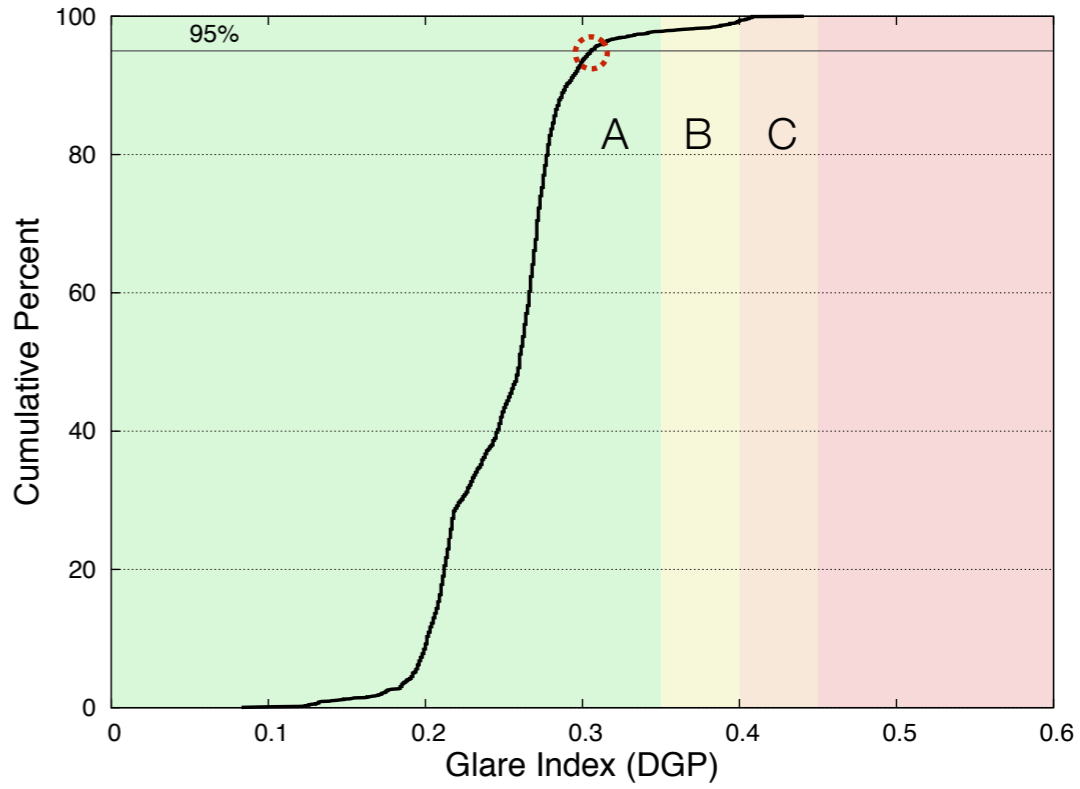
DGP Cumulative Distribution Plot

The cumulative distribution plot depicts all valid measurements for a particular camera position and facing direction (over several days). Days where shades did not operate (due to power outage or similar) are omitted from these charts. The cumulative distribution is used to calculate the visual comfort class ratings according to Jan Wienold’s recommendations (set table below). The color shading depicts the 95% threshold for each comfort class. The location where the CDF plot crosses the 95% line (circled) corresponds to the 95% DGP limit condition.

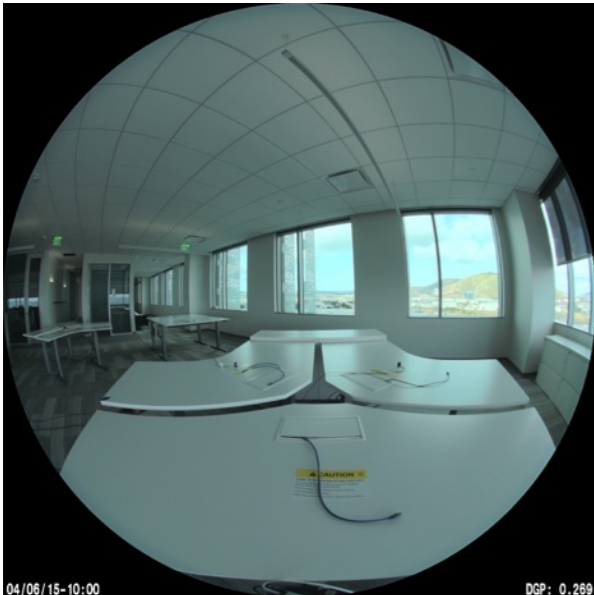
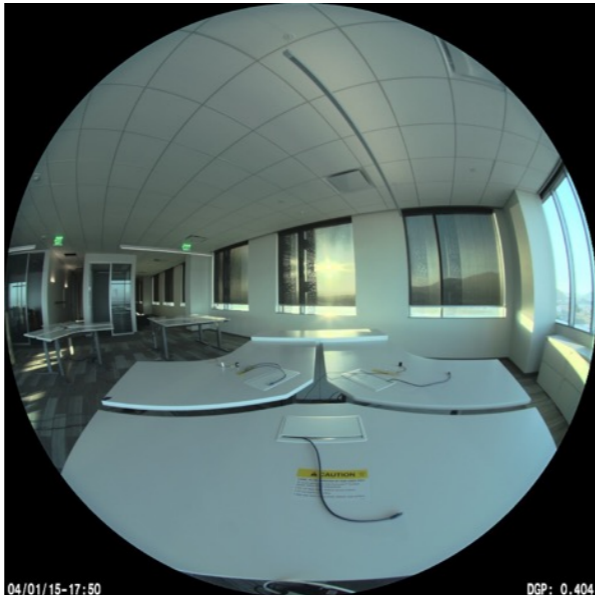
Cumulative DGP Statistics, Position #1, North Area

95% DGP Threshold	0.306
Average DGP within top 5% band	0.354
Comfort Class Rating	A

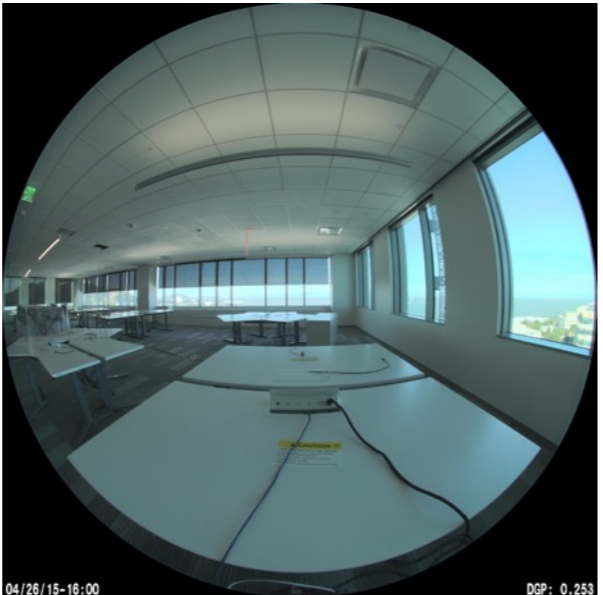
Cumulative DGP Statistics, Position #5, North Area

95% DGP Threshold	0.279
Average DGP within top 5% band	0.290
Comfort Class Rating	A

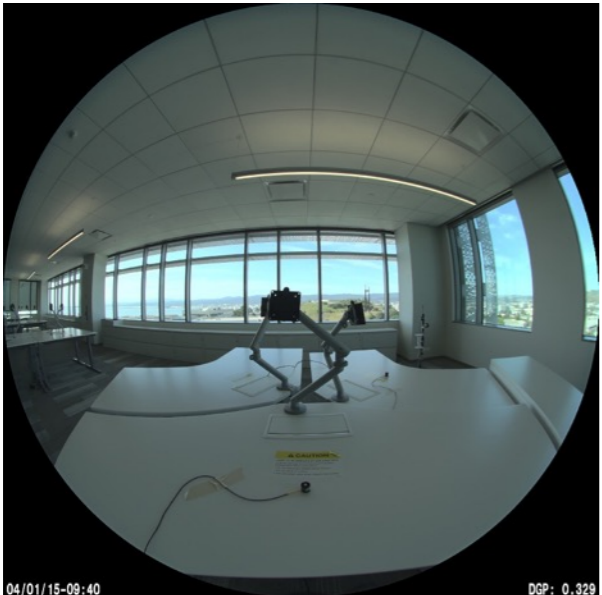
Cumulative DGP Statistics, Position #1, South Area

95% DGP Threshold	0.335
Average DGP within top 5% band	0.346
Comfort Class Rating	A

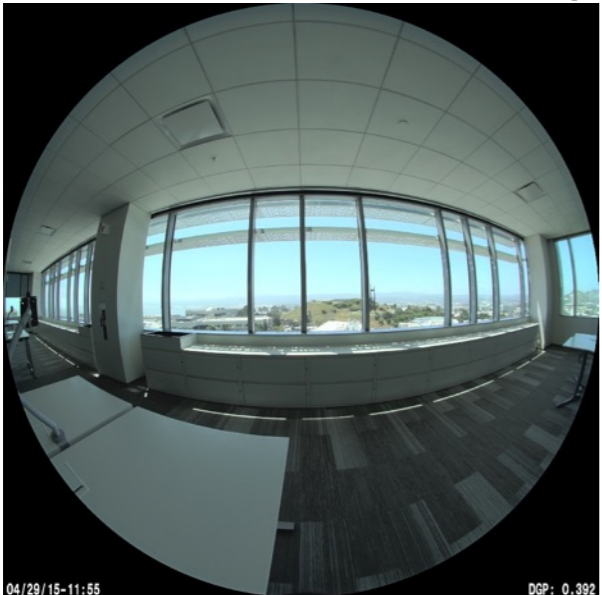
Cumulative DGP Statistics, Position #5, South Area

95% DGP Threshold	0.386
Average DGP within top 5% band	0.397
Comfort Class Rating	B

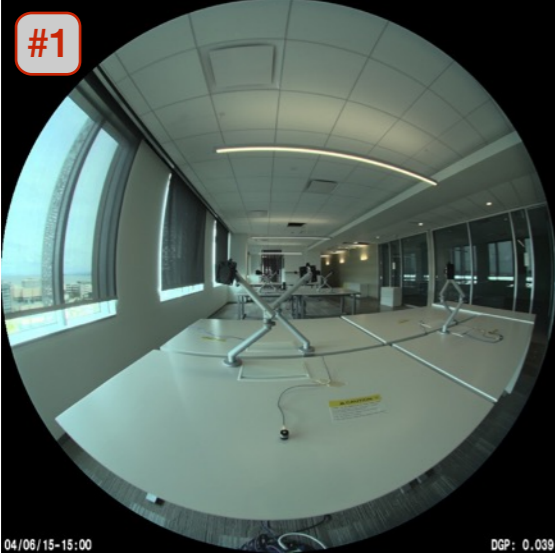
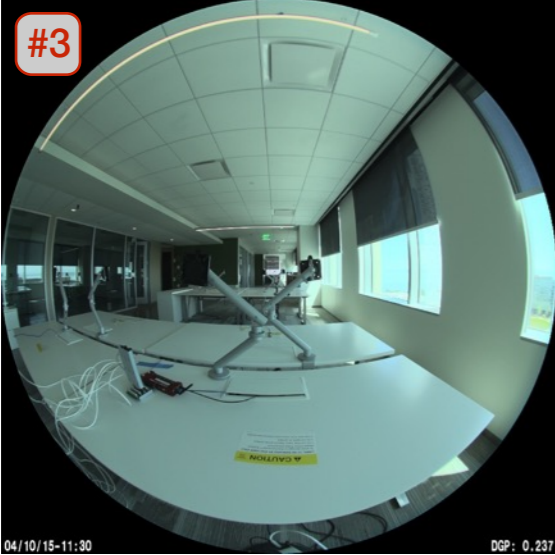
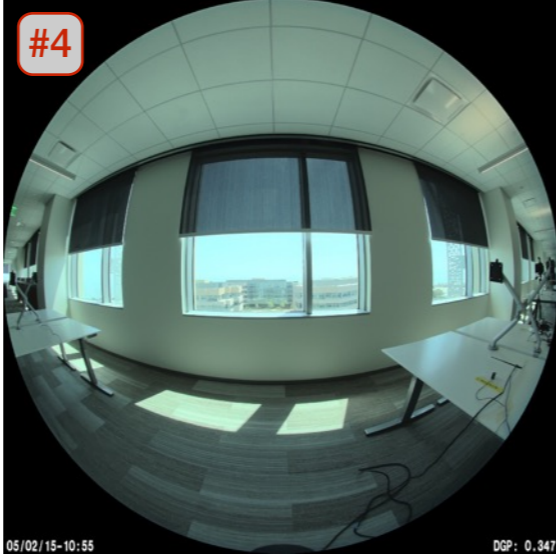
# Glare | HDR Camera Locations, East Area

HDR Camera Position & Direction  
  Shade Group

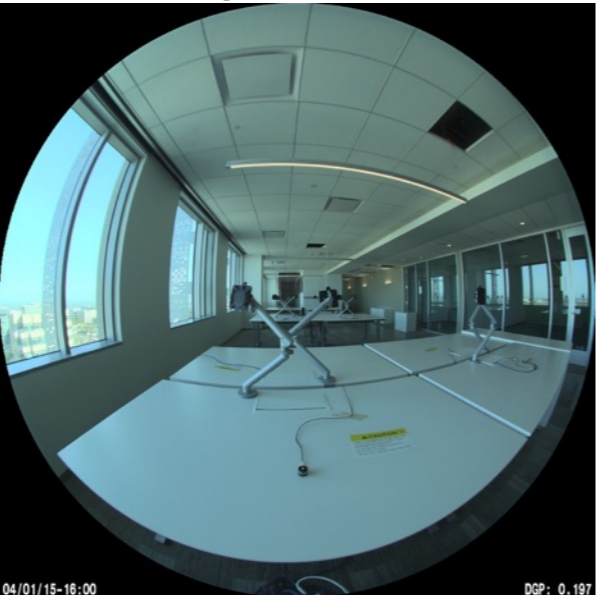
Cumulative DGP Statistics, Position #1, East Area

95% DGP Threshold	0.226
Average DGP within top 5% band	0.236
Comfort Class Rating	A

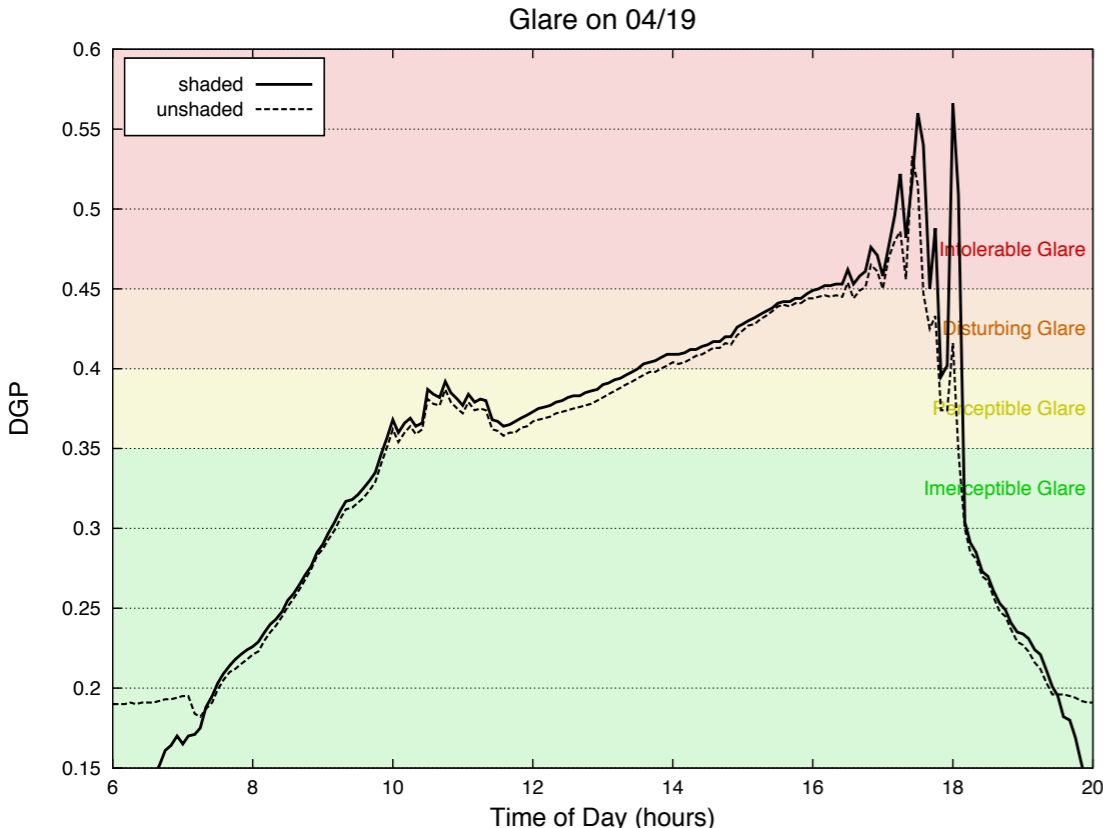
The falsecolor images on the right show a comparison between daylight conditions on the 6th floor (unshaded) and 7th floor (shaded). The plot below shows DGP recorded on a day when shades were raised on both the 6th and 7th floors. The DGP between two floors tracked very closely, demonstrating that the two conditions are comparable.

DGP plot on a day when shades were raised on both the 6th and 7th floor.

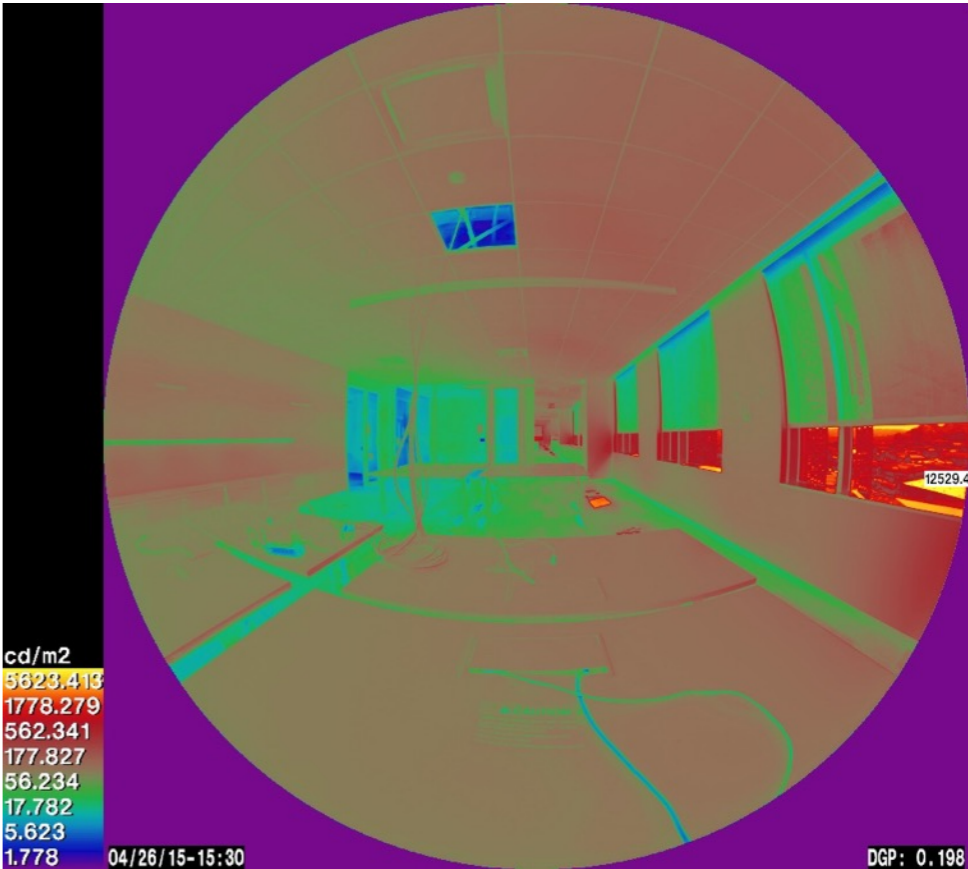
The chart below shows that the DGP on the unshaded floor passes above the 0.35 threshold at 4:40 PM. The shade effectively maintains DGP below the critical threshold, even when the sun is visible through the window from 5:20 until 7:40 PM.

April 26, 16:30  
Unshaded Condition

April 26, 16:30  
Shaded Condition

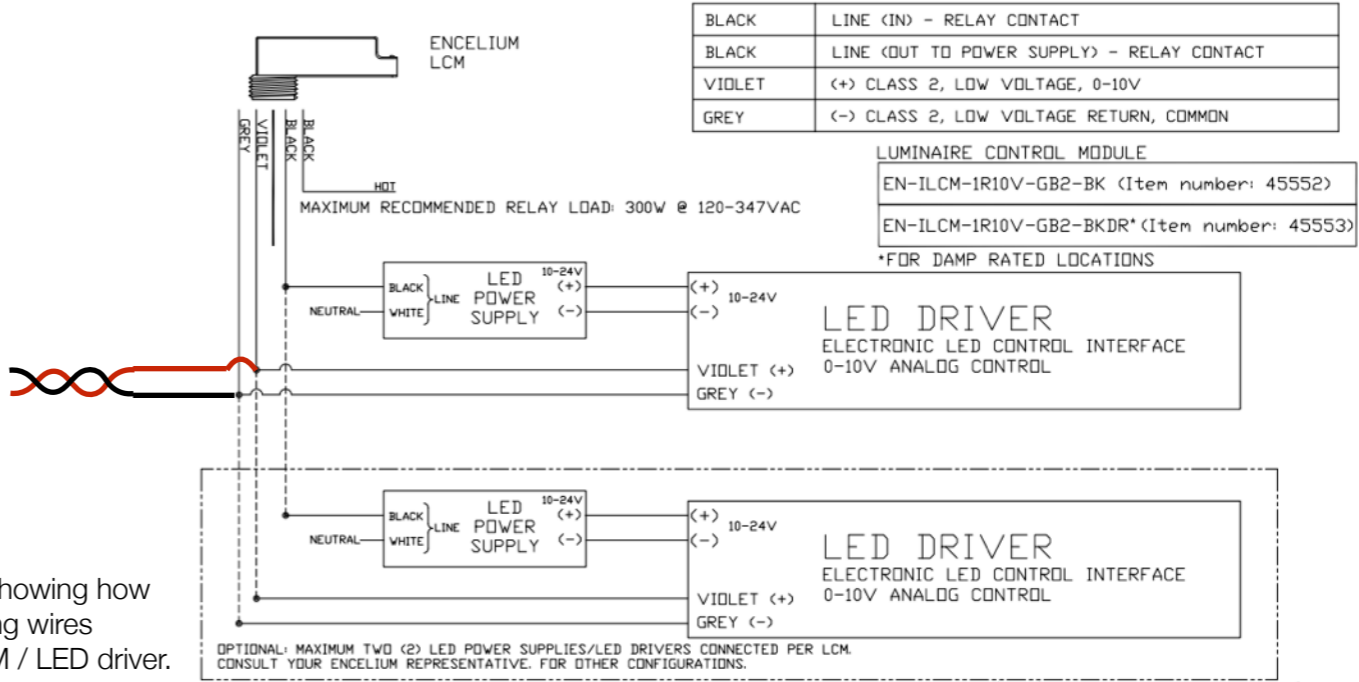
Wiring schematic showing how the dimming sensing wires connect to the LCM / LED driver.

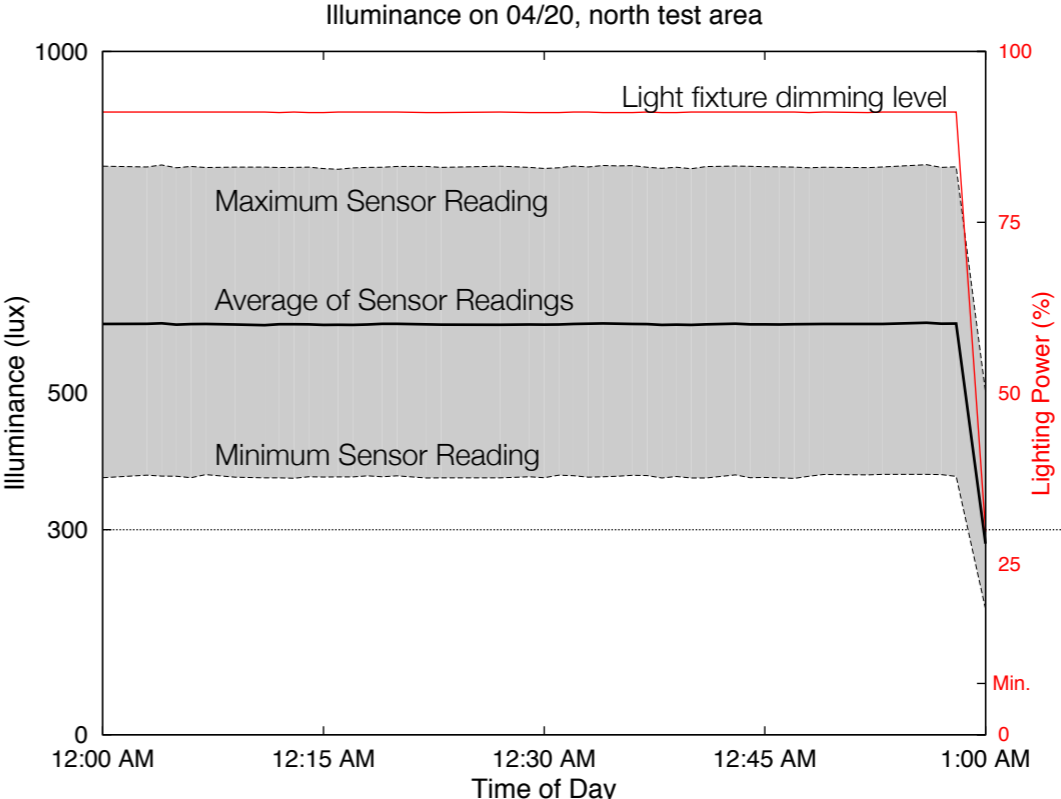
Light fixtures in open office areas turned on for a couple of hours in the middle of each night. During this time we can see the workplane illuminance from electric lighting without daylight contribution. The charts below show the workplane illuminance with the light fixtures at 72% output (left) and with 90% output (right). As you can see the average illuminance measured by the sensors is above 500 lux in both cases. In the 72% output scenario, the minimum illuminance is at 300 lux, while the minimum illuminance is 375 in the 90% output. For this reason, LBNL recommends reinstating the task level tuning for all areas, with the exception of the specific locations identified by the commissioning agent. The tuning level remains at 90%, waiting for information regarding specific locations of under illuminance from the commissioning agent.

Workplane illuminance measured at night with task tuning (left) and without task tuning (right).

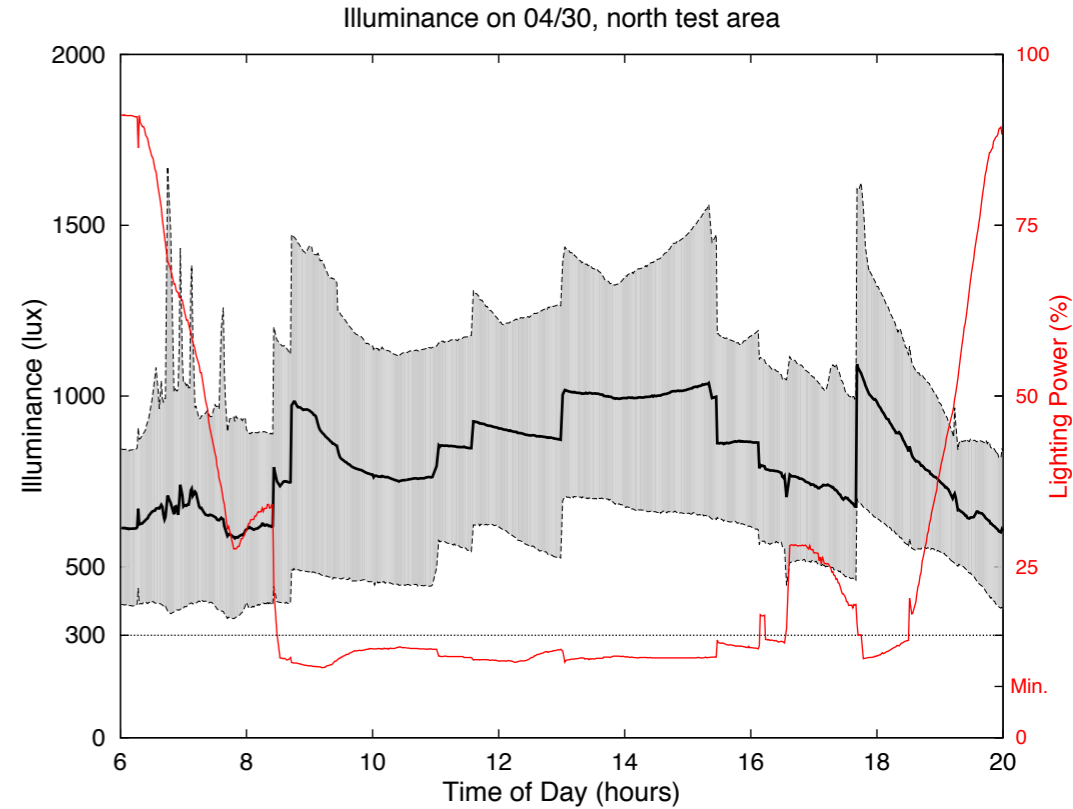
The minimum illuminance histogram shows that the minimum illuminance is in the 300-400 lux range 54% of the time, and above 300 lux 91% of the time. The minimum illuminance measured at a sensor never falls below 200 lux during the study period.

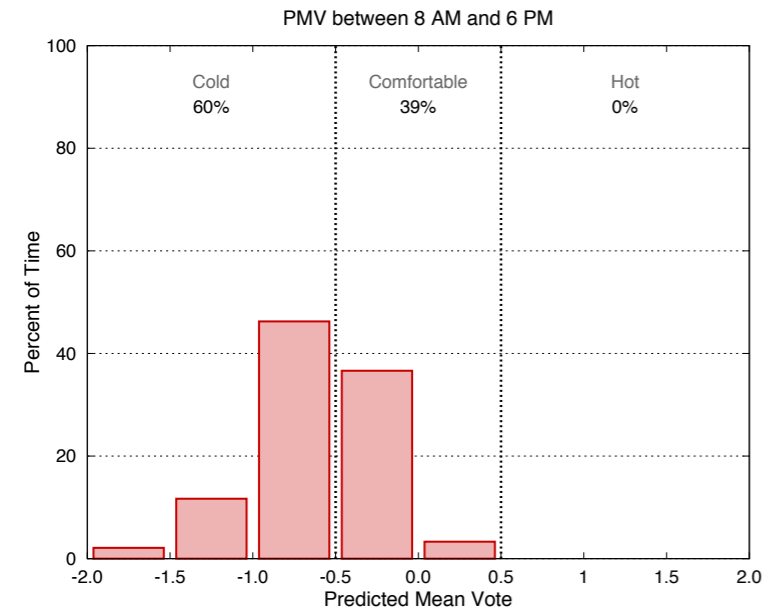
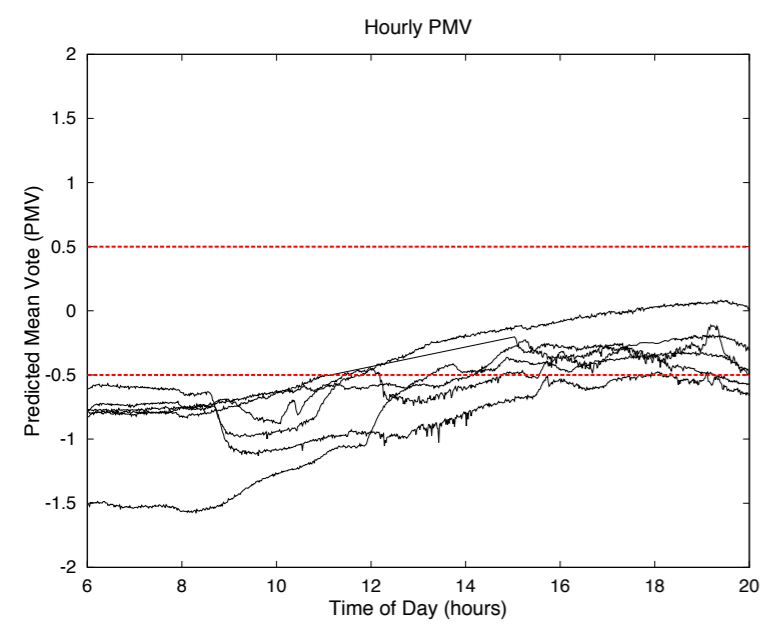
Position #1 4/1-4/6

PMV in the south test area was low during the period 4/1 - 4/10, indicating that occupants are likely to feel cold a substantial portion of the time. However later testing in the south area (4/27-4/30) showed more comfortable conditions. Though PMV regularly falls into the cold range (below -0.5) in the morning and evening.
