In Search of Sand: Debris Flows and Pacific Lamprey Habitat, Salmon River, California

Kim Deniz and Casey Jones

*Department of Landscape Architecture & Environmental Planning,
University of California, Berkeley*

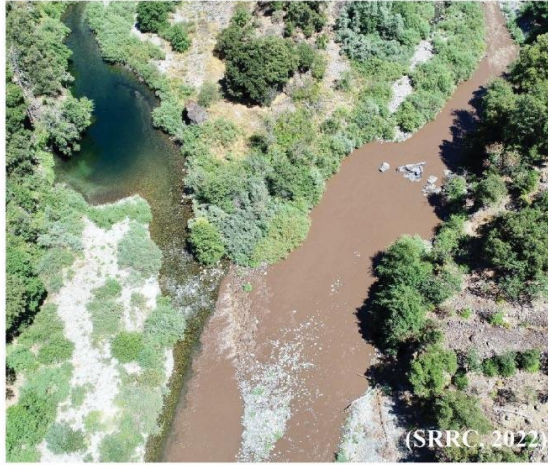
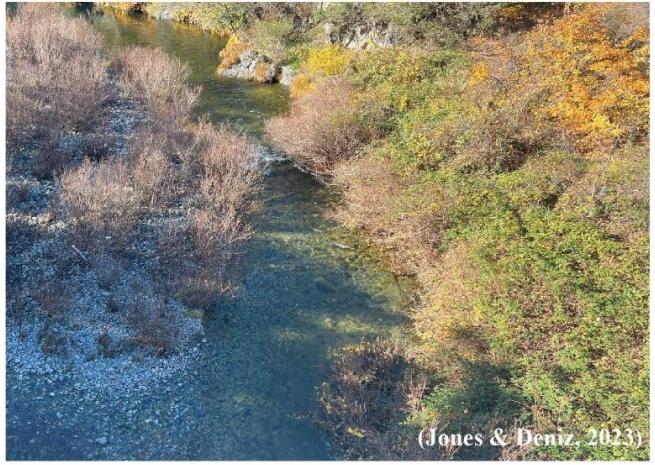
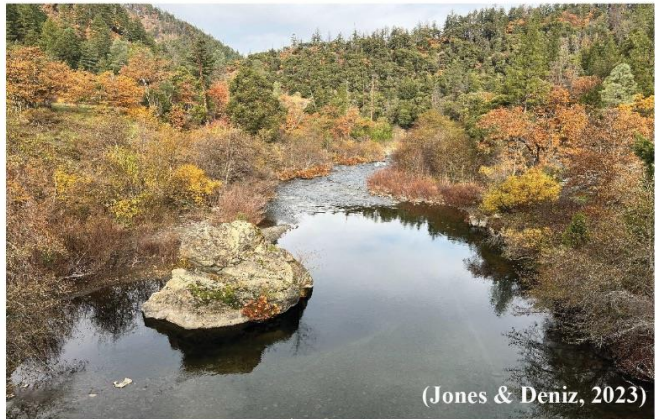
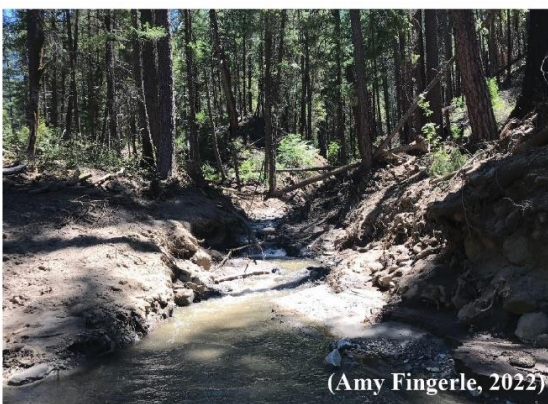
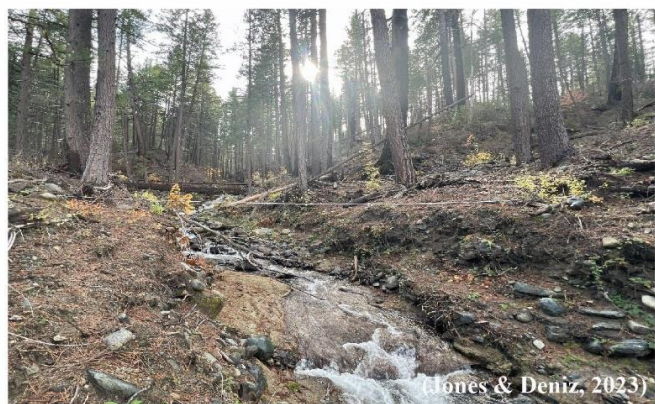
Confluence of the North Fork & South Fork Salmon River. Aerial (left) and looking west (right).

Methodist Bridge: Approx. RM 6, South Fork Salmon River. View looking west from the bridge.

Confluence of Blind Horse Creek, South Fork Salmon River. View looking south, or upstream on Blind Horse Creek.

Figure 3. Photo point recreations, based on Amy Fingerle's photographs from August 2022, as well as aerial photography provided by the Salmon River Restoration Council.

Lastly, we repeated photo points of Amy Fingerle (2022). Fingerle took photos about a week after the storms that caused the observed debris flows at three sites, including the confluence of the North and South Forks of the Salmon River, Methodist Bridge on the South Fork of the Salmon River, and the confluence of Blind Horse Creek and the South Fork Salmon River (Figure 3).

When comparing images taken in the weeks directly after the storms to those we took on site just over a year later, it is clear that much of the suspended fines visible from the earlier images have since washed out. Earlier photos show the dispersal of sediment introduced to the river from overland flow, most likely the fine-grained sediment driving higher turbidity. Recent photographs show residual material left behind both from overland flow inputs and coarser sediment and larger debris that were more likely introduced from the debris flows. We observed areas along the banks of the South Fork Salmon River with up to 26 inches of fluvial deposits, this observed coarse sediment material (gravel and boulders), is evidence of a high rate of transport, suggesting a categorization of the event to be a debris flood, a case of Stage 3 flow, as defined by Church and Jacob (2020, pg. 1):

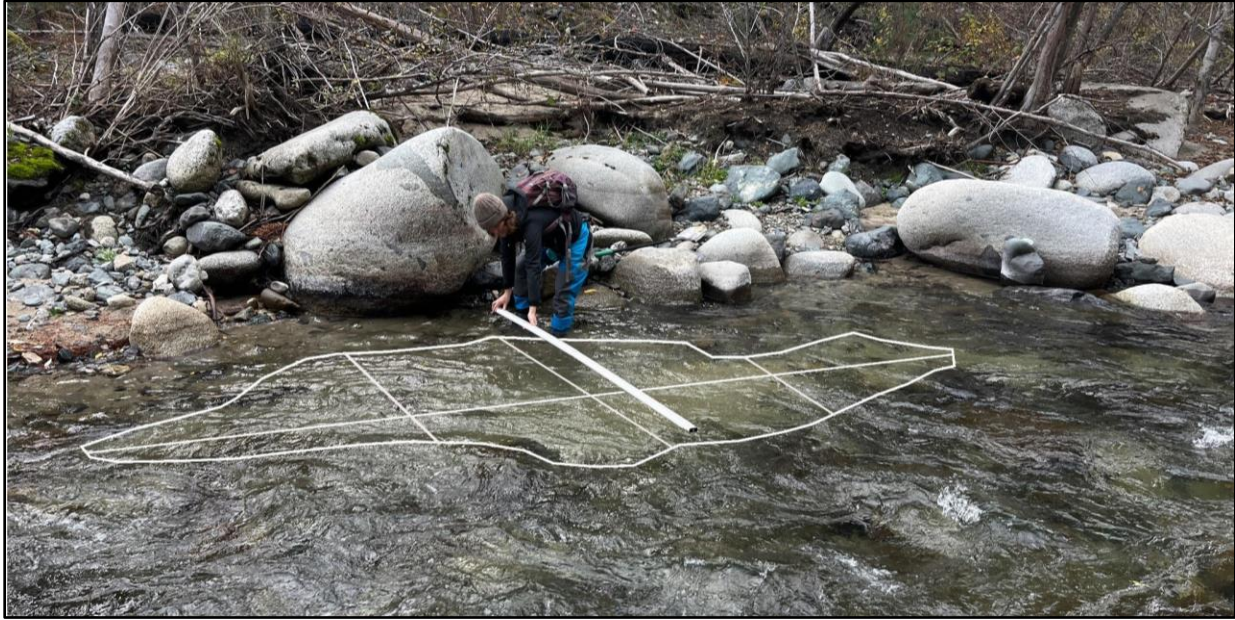
Bar 2

Figure 6. Example of measurements taken for each bar (image of bar 2). The 3 width measurements were averaged and multiplied by the length to determine area estimates.

The dimensions of three of the more substantial deposits we encountered were calculated using a method outlined by Nystrom (2020), with the lengths multiplied by the average of 3 width measurements to yield total area (Figure 6). We measured the depths of the deposits from the surface of the water to the surface of the sand and from the top of the deposit to the original cobble bed material below (Table 1). These measurements allowed us to identify areas where the deposits were deep enough to be considered viable rearing habitat. Not only do lamprey ammocoetes need certain depths of substrate, but dewatering of rearing areas due to low flows can cause high mortality rates, especially early on in the larval stages. (Liedtke et al., 2015). Future surveys during various points of the annual hydrograph will need to occur to

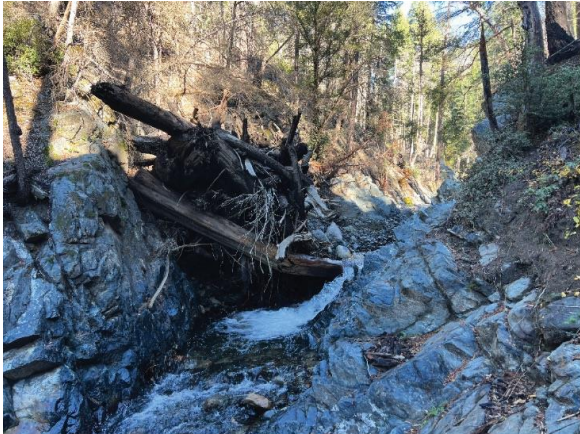
Figure 7a. Large woody debris pile up on Rush Creek. Note the steep bedrock banks with cobbles and small boulders deposited upstream of the log jam. View looking north (upstream).

In addition to Blind Horse Creek, other tributaries within the 2021 River Complex burn scar contributed to the increased sediment loading in the South Fork. On the north side of the drainage, approximately 167 yards upstream from Blind Horse Creek, Rush Creek flows into the South Fork Salmon River. We hiked approximately 300 yards through Rush Creek, after taking the Rush Creek Trail southeast and entering the channel at the trail bridge (41°05'30.26"N, 123°02'52.91"W). While walking southwest towards the confluence of Rush Creek and the South Fork, we observed large accumulations of woody debris (which appeared to be freshly deposited given the state of the finer branches), at the base of standing trees, a layer of mud provided an indication of the floodline, and unvegetated freshly deposited fine to medium grained sand accumulated on the banks. These suggested that another debris flood had occurred

on Rush Creek (Figure 7). Thus, for a comparison of sediment dispersal, we need to go further afield to locate a reach that is less impacted by the 2021 River Complex and 2022 winter storms.

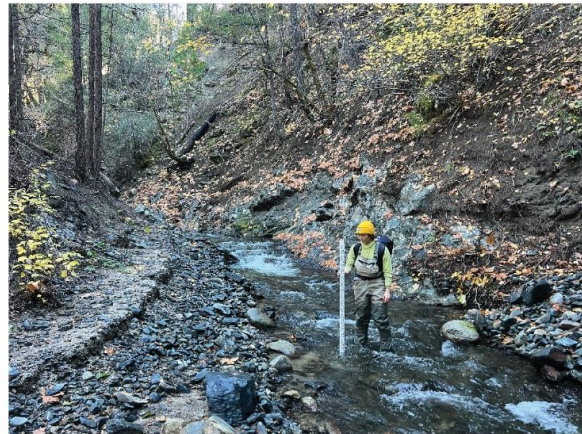
Figure 7b. Active erosion of the noncohesive bed material that makes up Rush Creek's channel and fine grain deposits seen on the outer edges of the active channel, indicates significant transport throughout the tributary. View looking south (downstream)

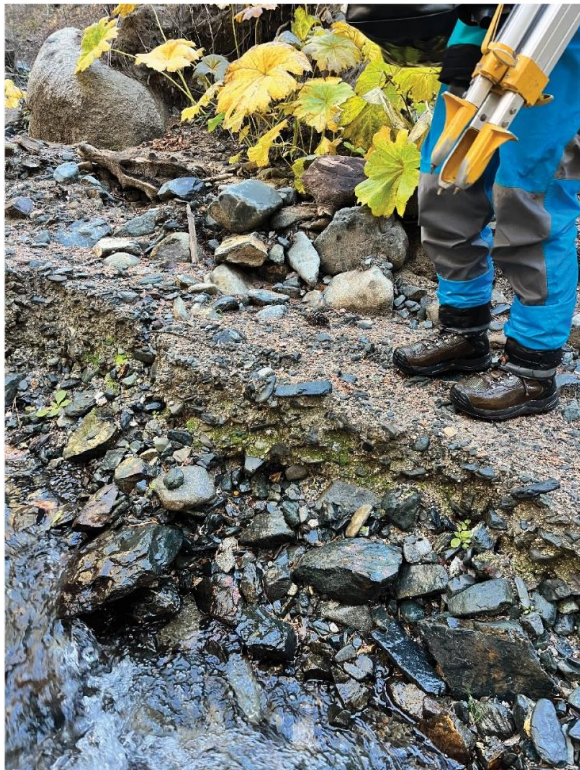
Figure 7c. The channel is made of noncohesive sediments suggesting high rates of bed material transport throughout the incised channel. View of left bank (looking downstream).

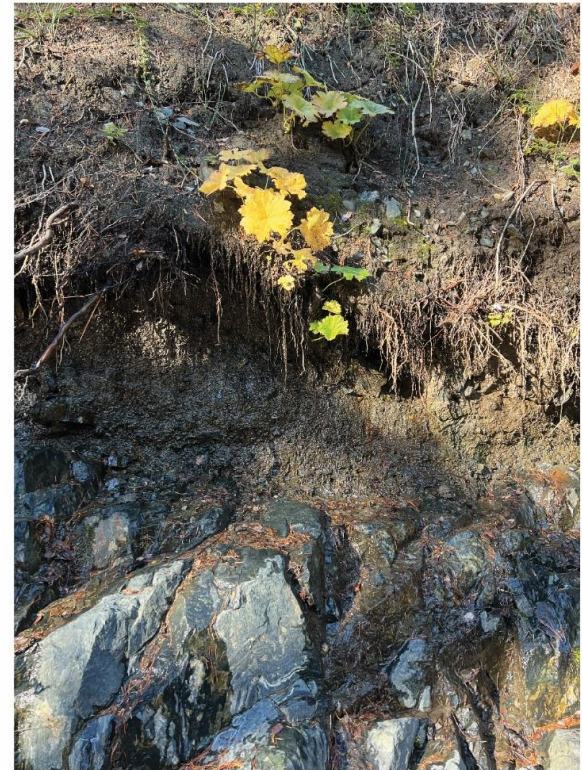
Figure 7d. Evidence of scour on the left bank (looking downstream) from exposed roots.
