### Features and Dimensions of the Hayward Fault Zone in the Strawberry and Blackberry Creek Area, Berkeley, California

P.L. Williams

March 1995

LBL-36852

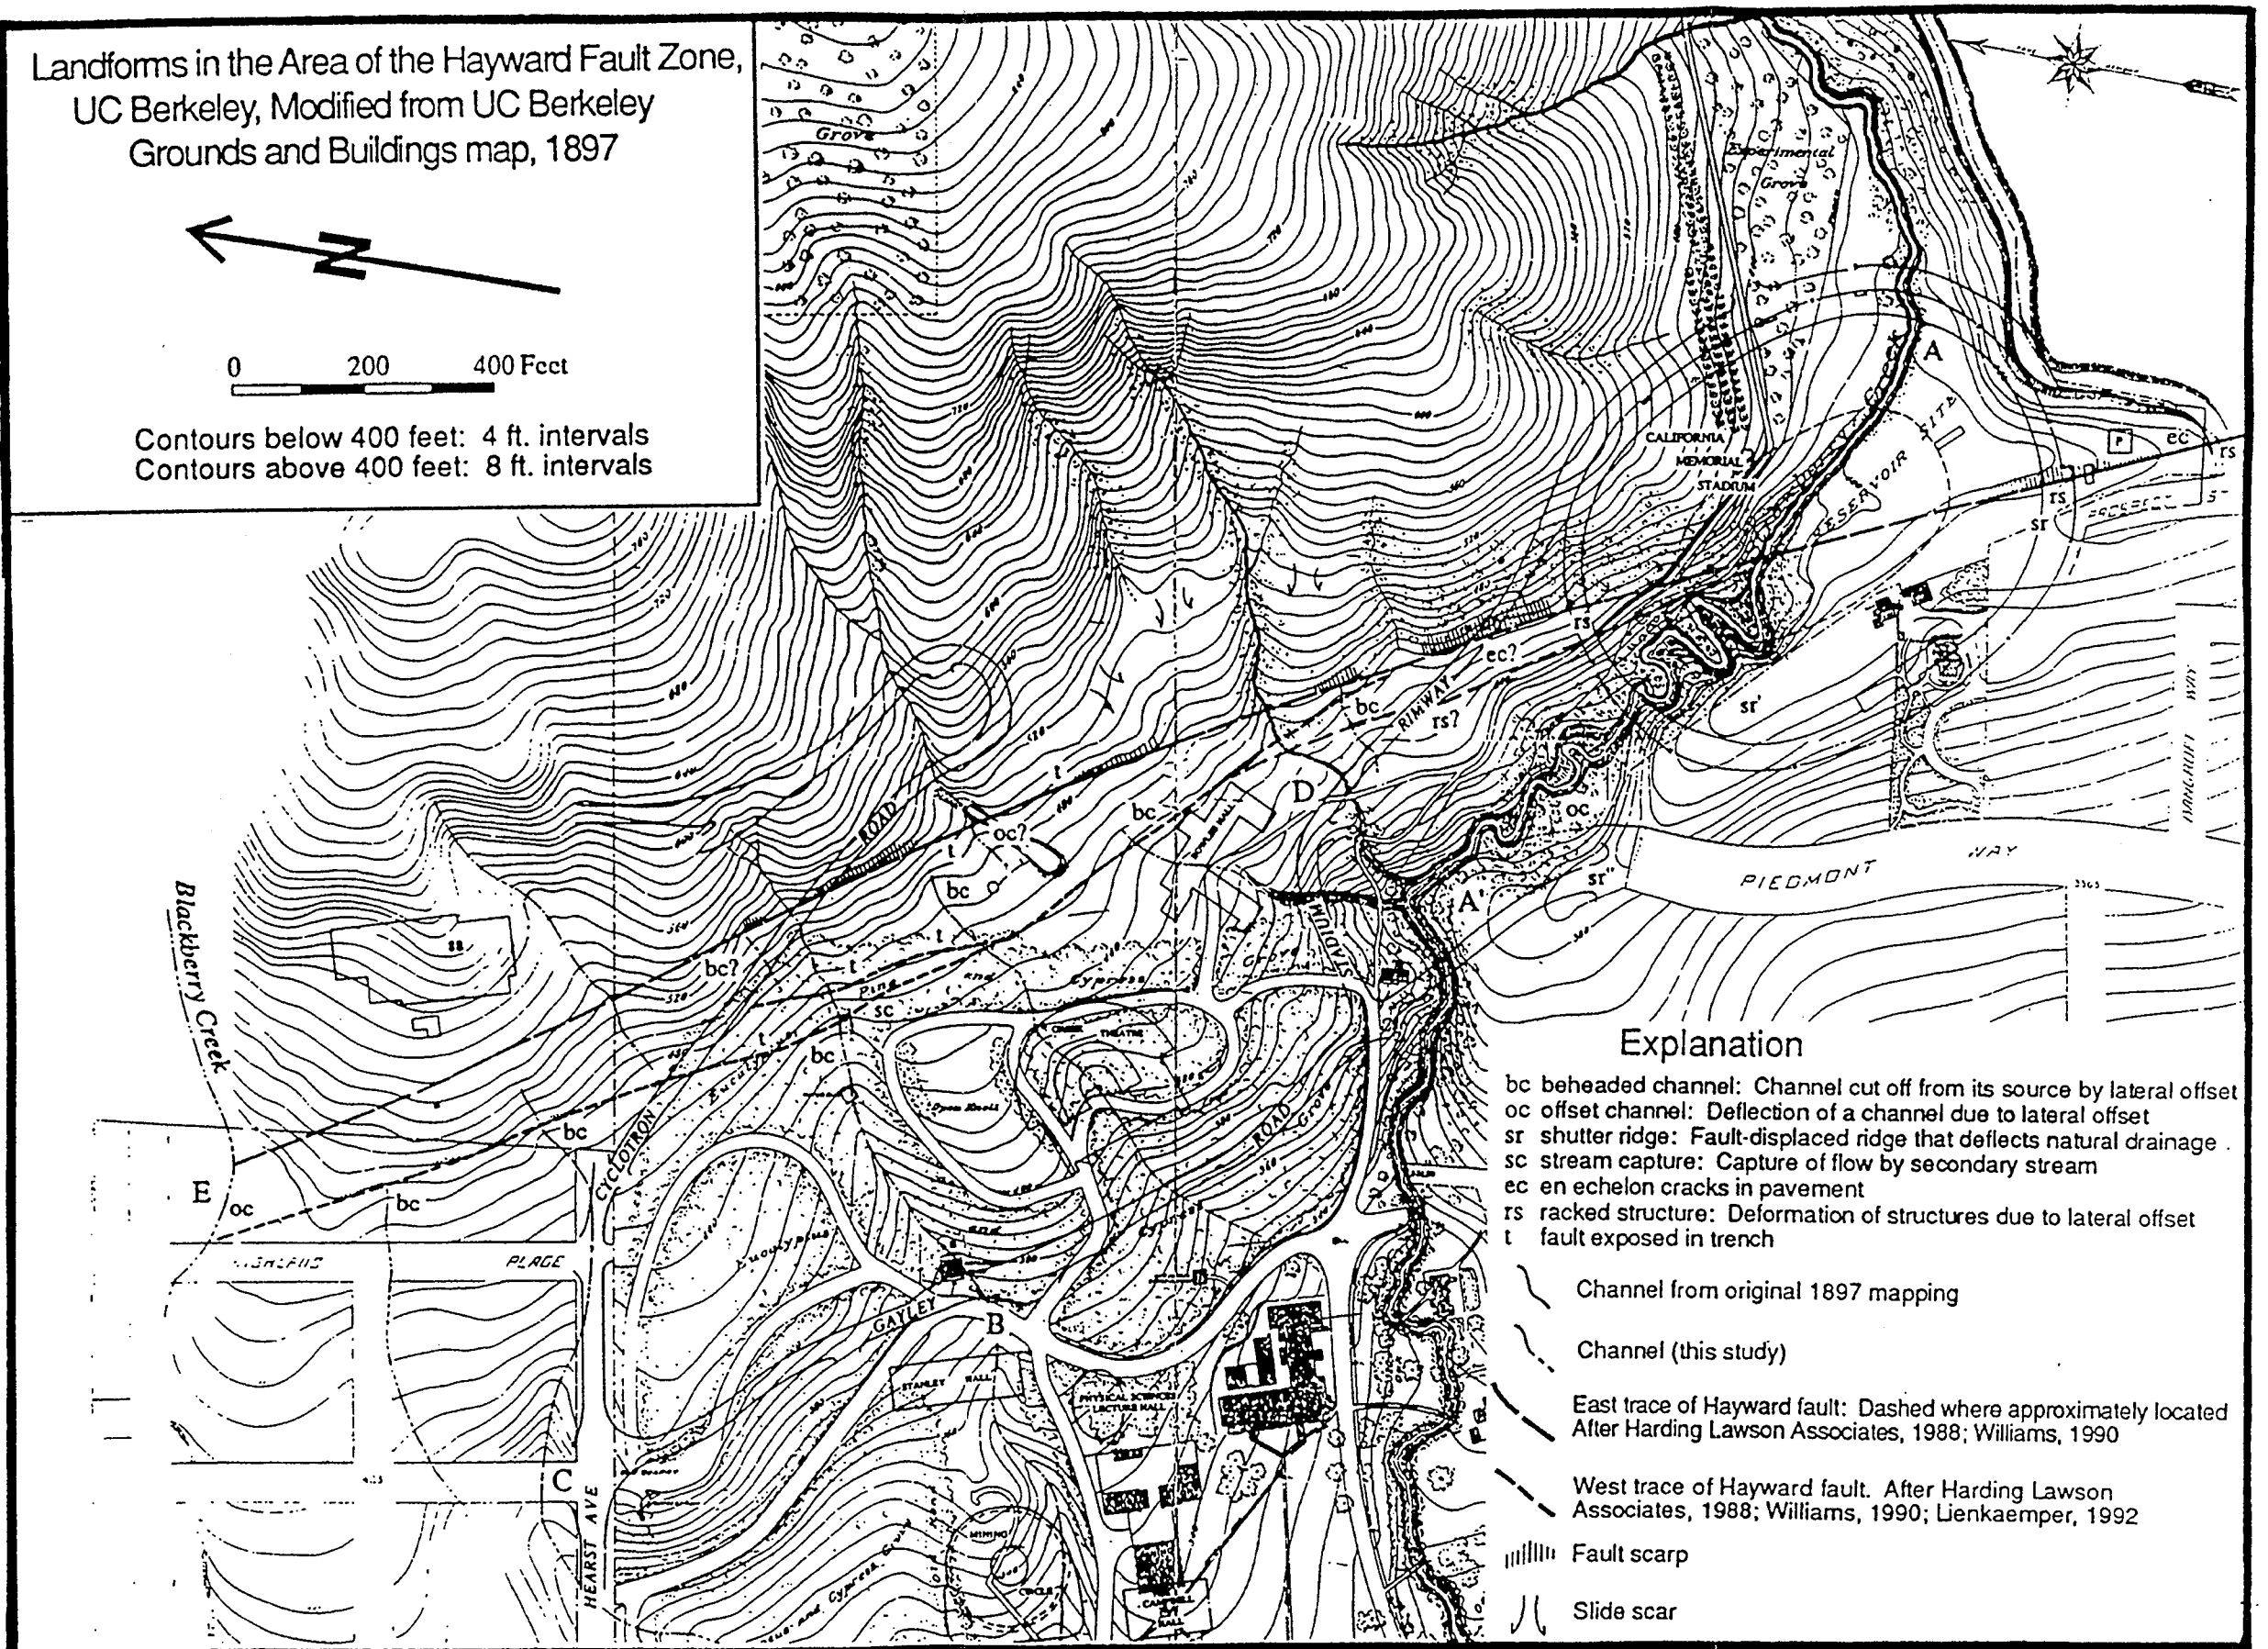
*Offset and beheaded streams.* One of the most direct means of mapping strike-slip (lateral slip) faults is by the identification and alignment of deflected drainages along faultlines. Many drainages are offset by the Hayward fault, and these provide primary evidence of the fault's location. Before construction of the California Memorial Stadium in 1923, the largest intact channel offset along the fault's length was that of Strawberry Creek (Figure 1, location A-A'). This large, competent stream is offset 1100 feet by right-lateral motion. The channel of Blackberry Creek is offset 190 feet by faulting. These two channel offsets are the most prominent evidence of the fault's location adjacent to Lawrence Berkeley Lab. A number of more subtle stream offsets and deflections have been interpreted from the 1897 UC Berkeley Building and Grounds basemap upon which more recent cultural features and the Hayward fault have been superimposed (Figure 1.).

Two former channels of Strawberry Creek cross the Berkeley Campus. These offset channels are termed "beheaded" or "abandoned", since they have been cut off from the Strawberry Creek watershed. The beheaded channels (locations B, C; Figure 1) were described by Buwalda (1929). One is located along a line between the east entrance to UC Berkeley and the Mining Circle. This "Mining Circle Channel" is offset 1900 feet from Strawberry Canyon (Location B, Figure 1). A second (and older) beheaded channel of Strawberry Creek is located beneath Hearst Avenue (Figure 1, location C). The "Hearst

Several additional abandoned and offset stream channels are interpreted on Figure 1. The confidence of these interpretations varies, but where the offsetting fault is also located by additional evidence, the abandoned and offset streams increase confidence in the analysis.

*Shutter ridge.* Buwalda (1929) noted that the course of Strawberry Creek is deflected by a fault-bordering ridge of slope-base deposits, a *shutter ridge* (Located at *sr'-sr''*, Figure 1). The 1000-foot-long shutter ridge ranged in height from 16 to 28 feet. Buwalda documented both the fault's location and lithology of the shutter ridge during construction of the California Memorial Stadium. He found that the ridge contained serpentine fragments. No source of serpentine exists in the Strawberry Creek drainage, but serpentine is present in Hamilton Gulch, 1400 feet southeast. This required that "at a date so recent that the topography of the region was essentially that of today" the ridge deposits had moved at least 1,400 feet from the gulch.

*Fault scarps.* Fault scarps near the foot of the Berkeley Hills appear as abrupt increases in slope angle as shown by tight contour spacing (Figure 1). The crisp definition of several of these scarps indicates the recency of fault movement. The linear trend of these scarps also aids in locating the fault trace. Particularly clear is the east-facing scarp (at *sr*, Figure 1) on the uphill side of the Strawberry Creek shutter ridge

Avenue Channel" is offset 2400 feet from Strawberry Canyon. These landforms, and their deposits, provide clear evidence of the fault's location. Analysis of the morphology and ages of the beheaded and active Strawberry Creek channels also enables the quantification of both vertical and lateral deformation rates across the Hayward fault in Berkeley.
