North Campus Open Space Restoration Project Restoration Plan

# NORTH CAMPUS OPEN SPACE RESTORATION PROJECT

## Restoration Plan

Prepared for  
University of California Santa Barbara  
Office of Budget and Planning

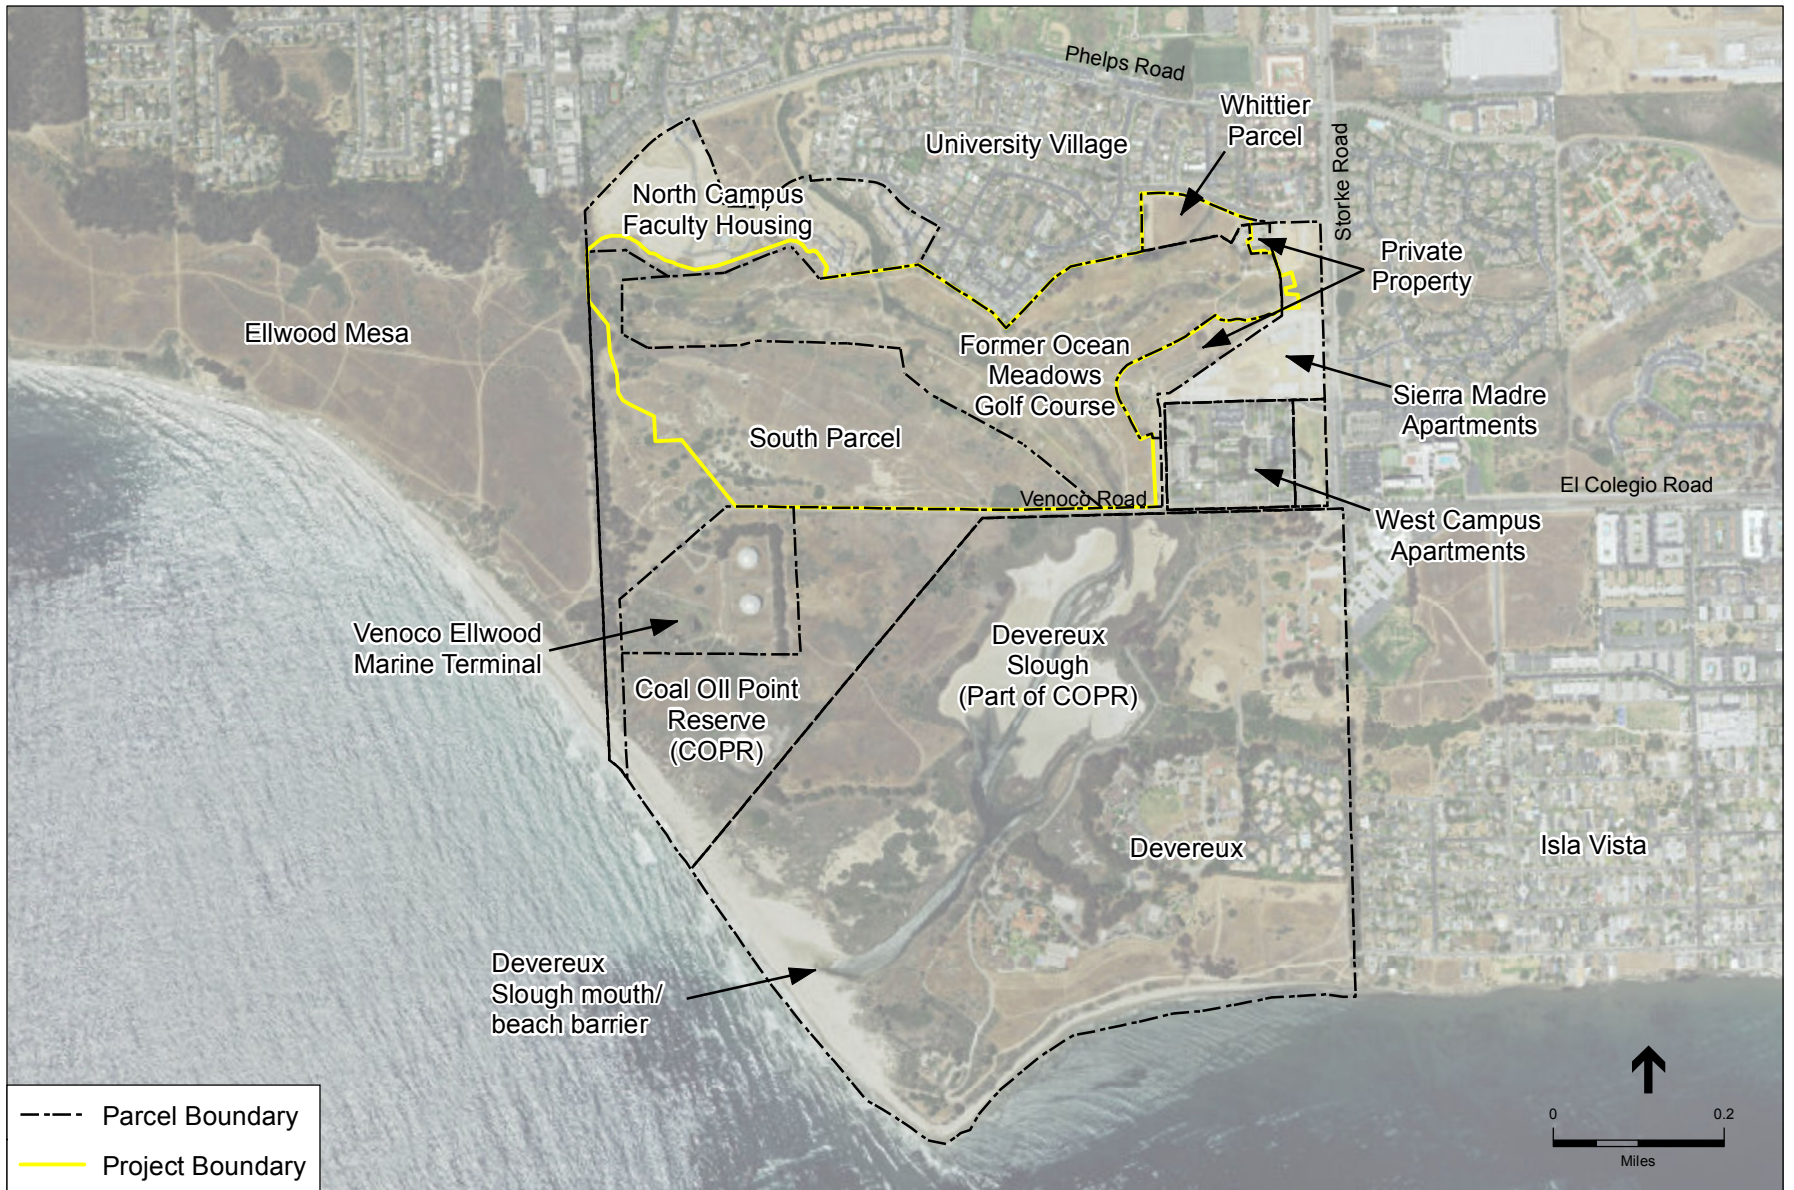
**Figure 1**  
Project Site and Surrounding Area

The Coal Oil Point Reserve (COPR) is located immediately to the south of the project site, and Ellwood Mesa and undeveloped property in the City of Goleta's jurisdiction are located to the west. Venoco Road provides vehicle access along the southern site boundary.

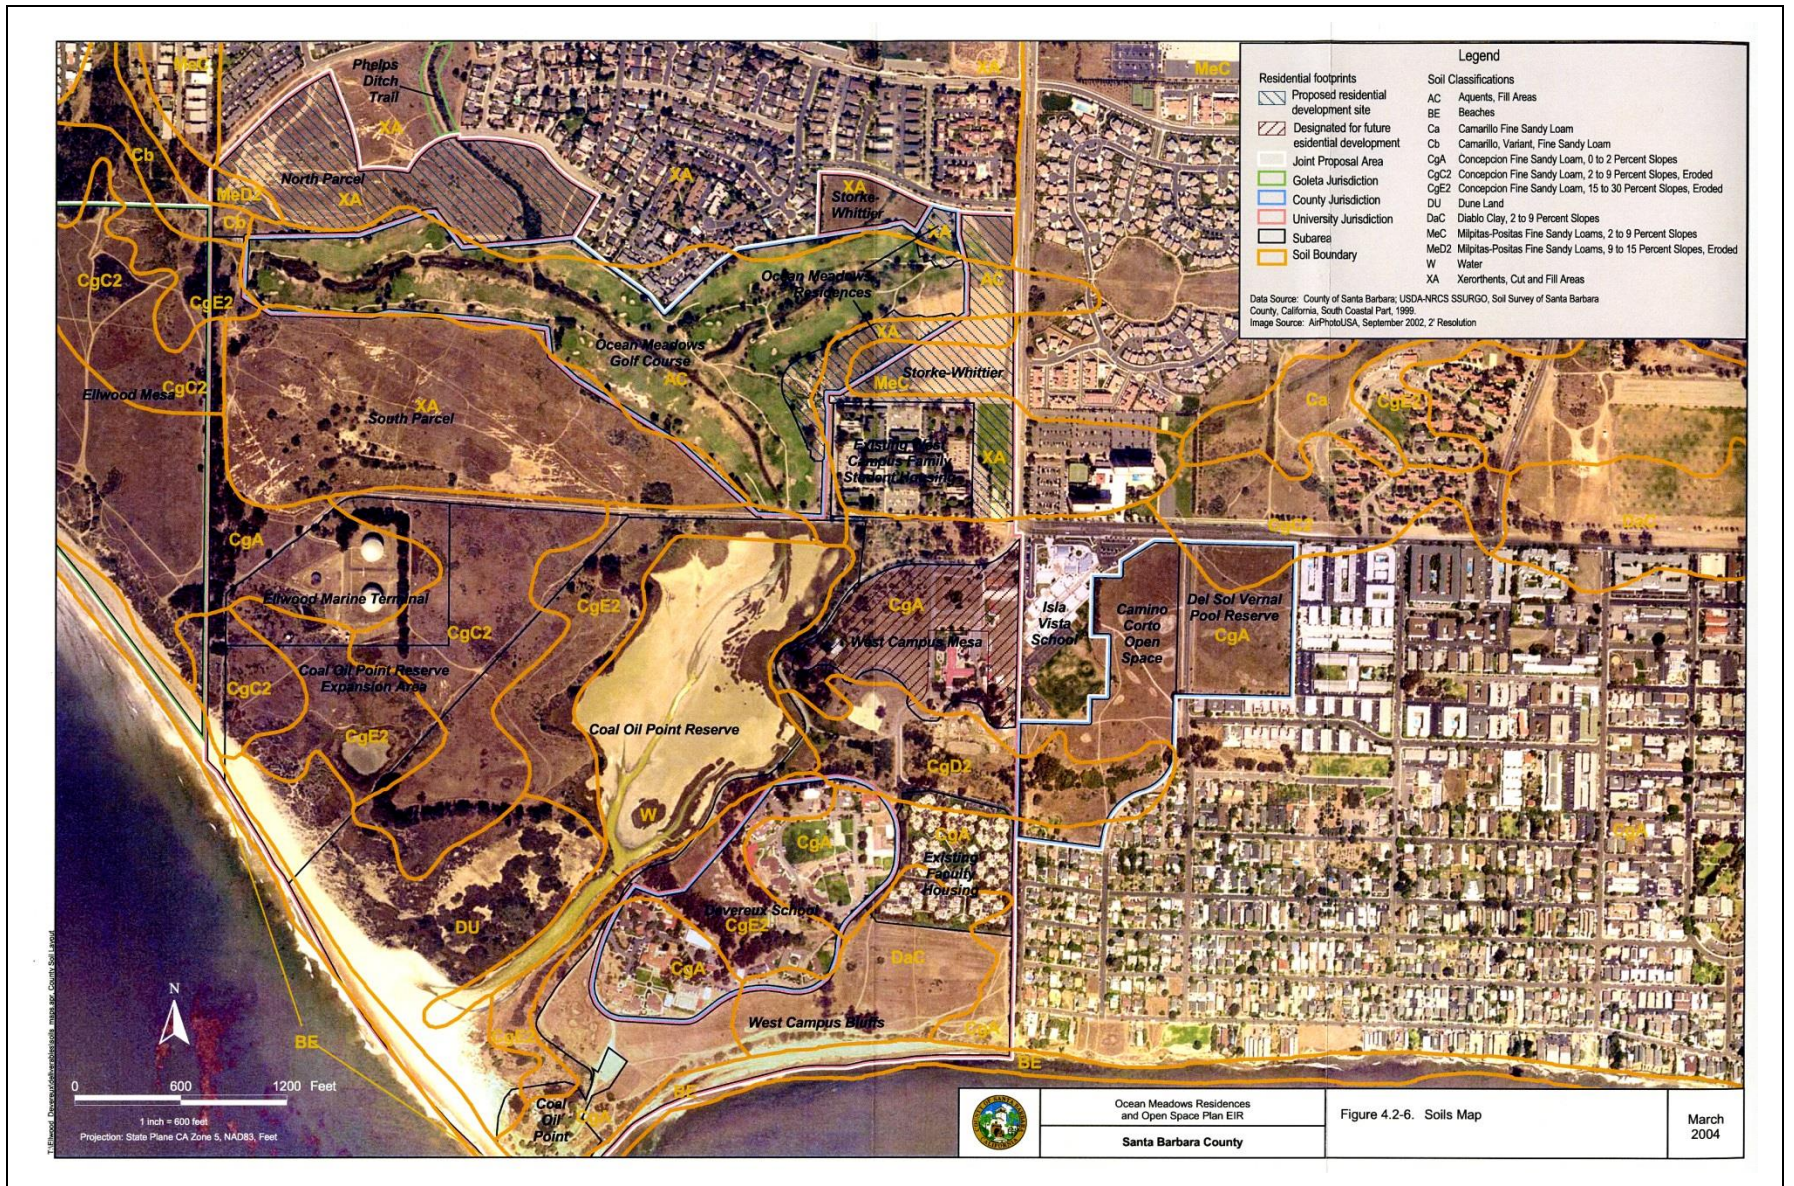
1. The majority of soil in the former golf course has high salinity levels. Salt marsh plants are adapted to high salinity soils, but high salinity is generally not tolerated by upland plant species.
2. There is considerable variability in soil salinity between locations
3. Deeper soils tend to be saltier than soils closer to the surface, but this might be a seasonal effect that will not persist, or could even reverse, through the dry season
4. Approximately two-thirds of the soil in the golf course appears to be very clay-rich (*i.e.*, comprised of 40% or more clay). Soils with such high clay content (and low salinity) support vernal pools and can pond rainwater for months at a time. Heavy clay soils will generally not support coastal sage scrub habitat. Perennial grasslands can be established on heavy clay soils (with low salinity).

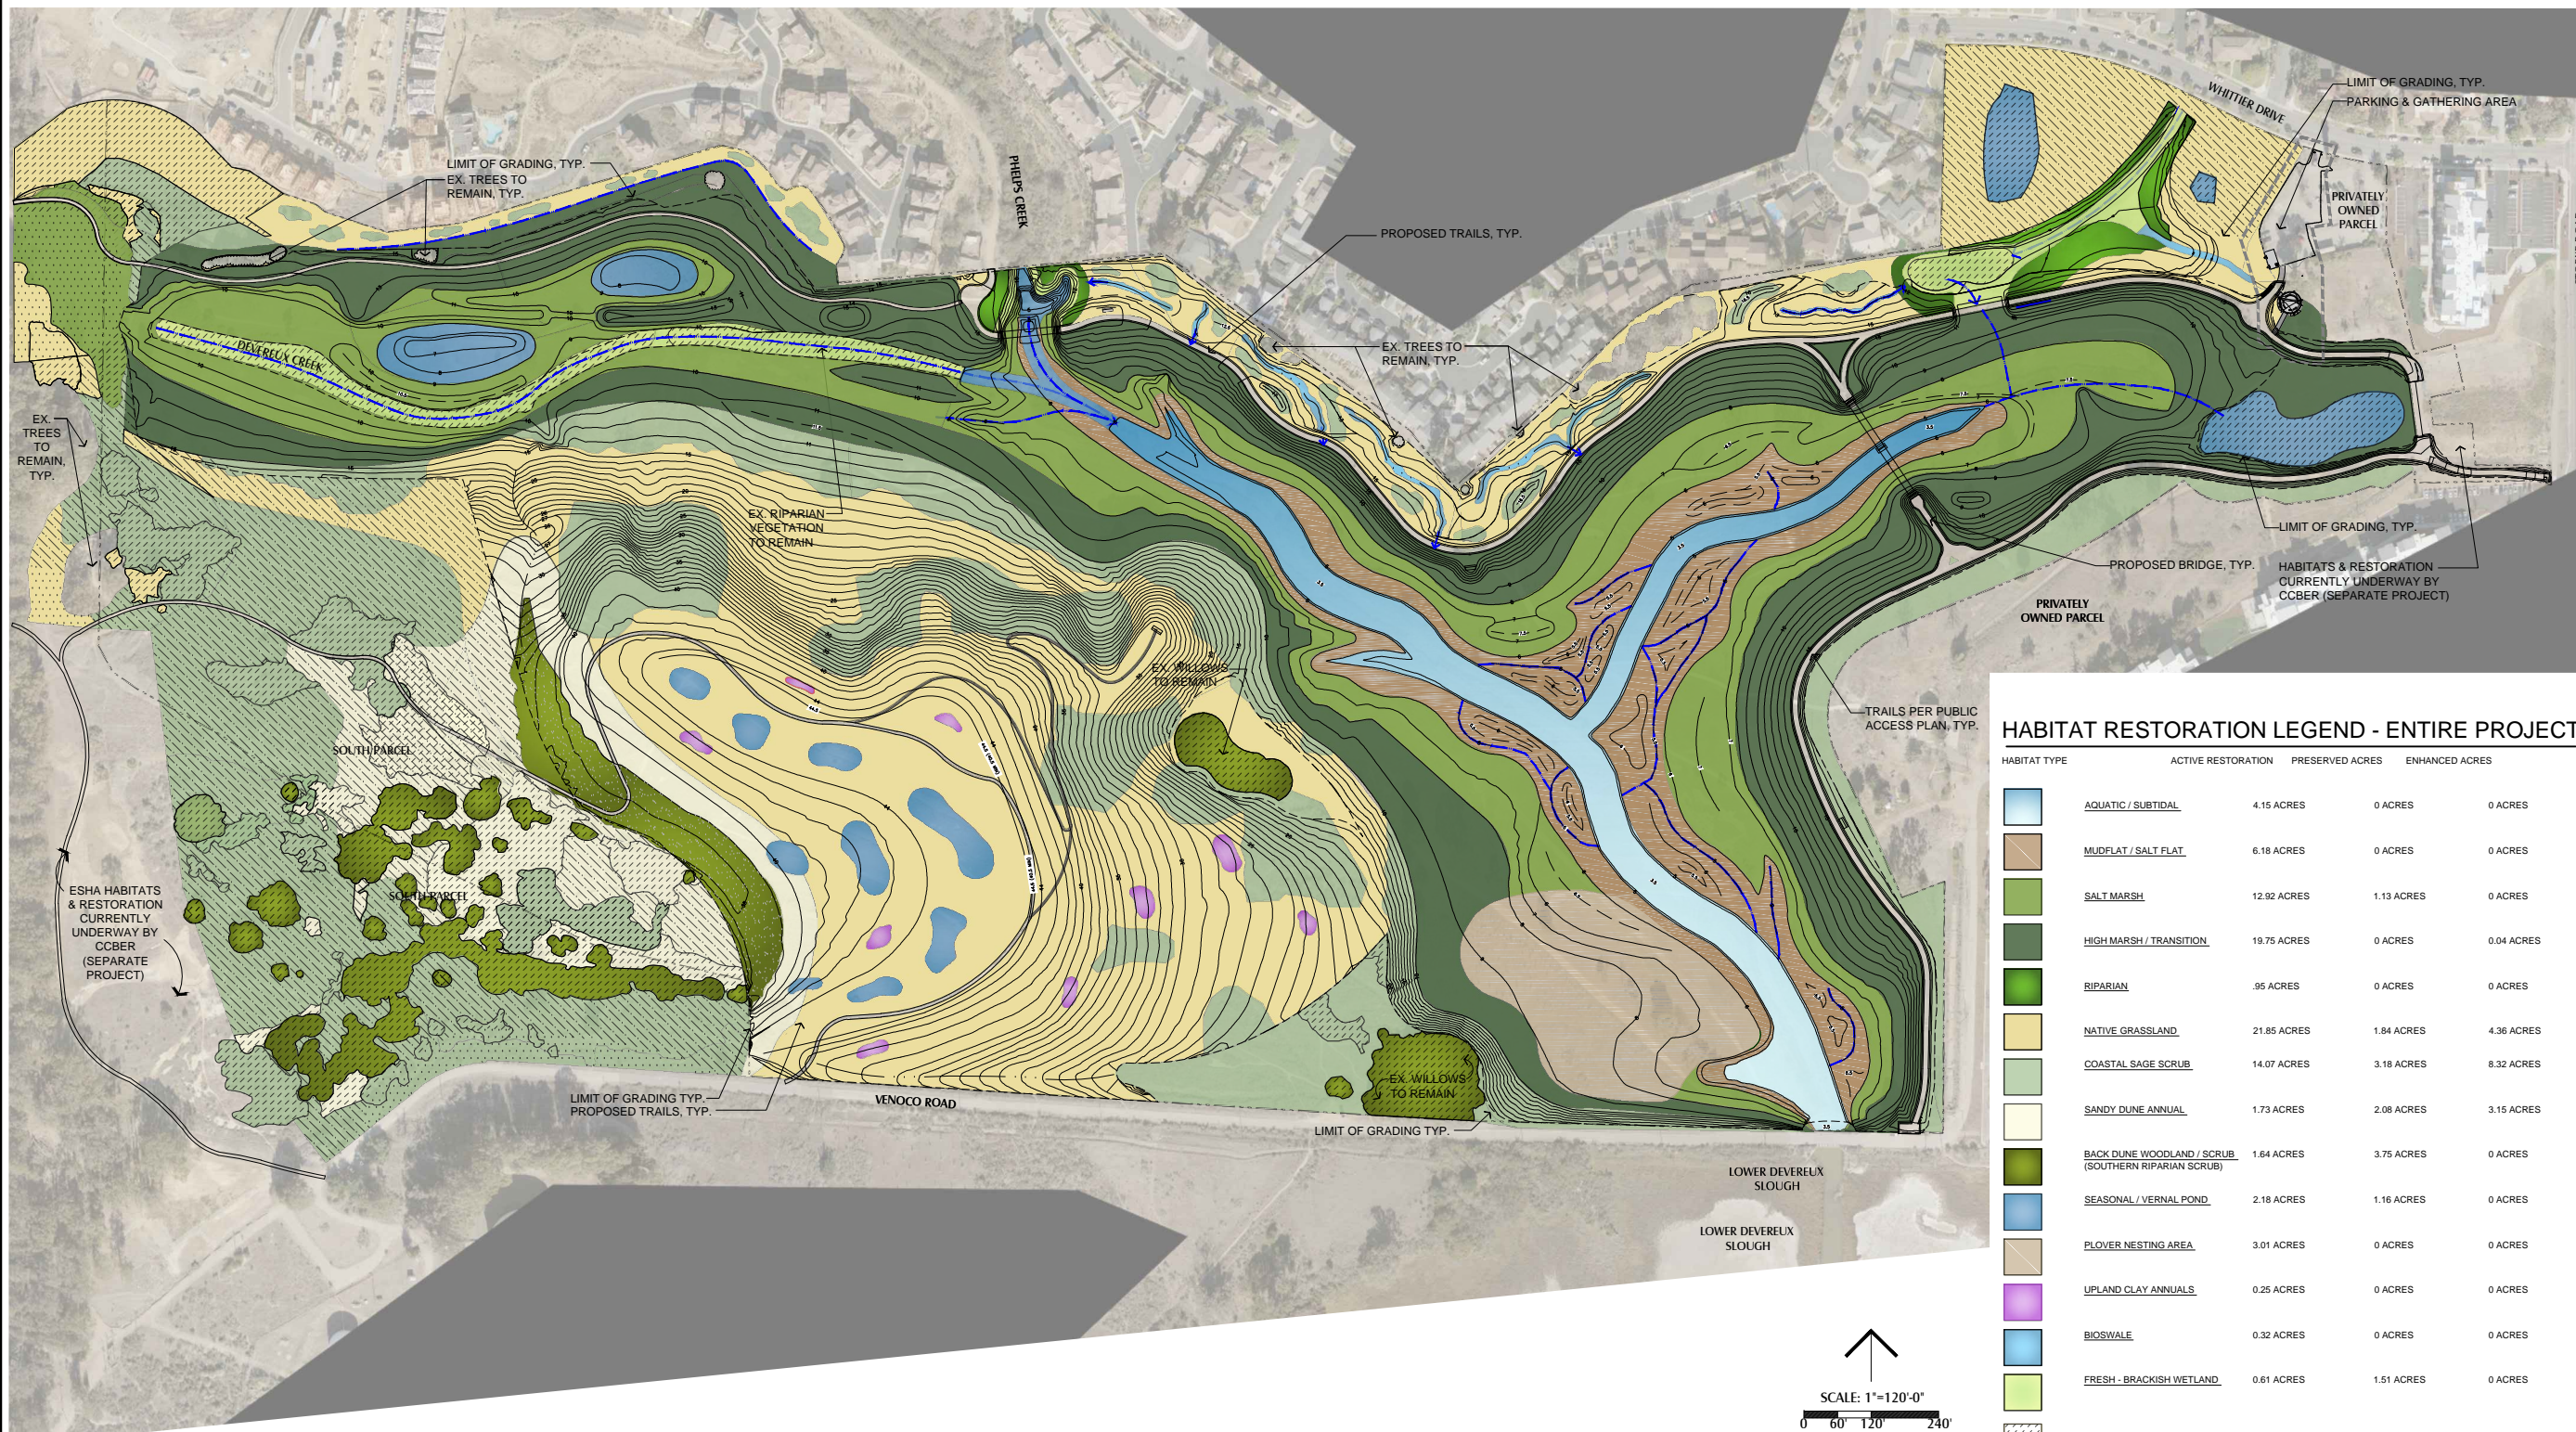
**HABITAT RESTORATION LEGEND - ENTIRE PROJECT**

HABITAT TYPE	ACTIVE RESTORATION	PRESERVED ACRES	ENHANCED ACRES
AQUATIC / SUBTIDAL	4.15 ACRES	0 ACRES	0 ACRES
MUDFLAT / SALT FLAT	6.18 ACRES	0 ACRES	0 ACRES
SALT MARSH	12.92 ACRES	1.13 ACRES	0 ACRES
HIGH MARSH / TRANSITION	19.75 ACRES	0 ACRES	0.04 ACRES
RIPARIAN	.95 ACRES	0 ACRES	0 ACRES
NATIVE GRASSLAND	21.85 ACRES	1.84 ACRES	4.36 ACRES
COASTAL SAGE SCRUB	14.07 ACRES	3.18 ACRES	8.32 ACRES
SANDY DUNE ANNUAL	1.73 ACRES	2.08 ACRES	3.15 ACRES
BACK DUNE WOODLAND / SCRUB (SOUTHERN RIPARIAN SCRUB)	1.64 ACRES	3.75 ACRES	0 ACRES
SEASONAL / VERNAL POND	2.18 ACRES	1.16 ACRES	0 ACRES
PLOVER NESTING AREA	3.01 ACRES	0 ACRES	0 ACRES
UPLAND CLAY ANNUALS	0.25 ACRES	0 ACRES	0 ACRES
BIOSWALE	0.32 ACRES	0 ACRES	0 ACRES
FRESH - BRACKISH WETLAND	0.61 ACRES	1.51 ACRES	0 ACRES
EXISTING MAPPED HABITATS TO BE PRESERVED Indicates habitats to be preserved, selectively weeded, and selectively planted.			
EXISTING NON-NATIVE HABITAT TO BE ENHANCED "Enhanced" indicates habitat to be actively weeded and planted. Any existing native plant material to be preserved.

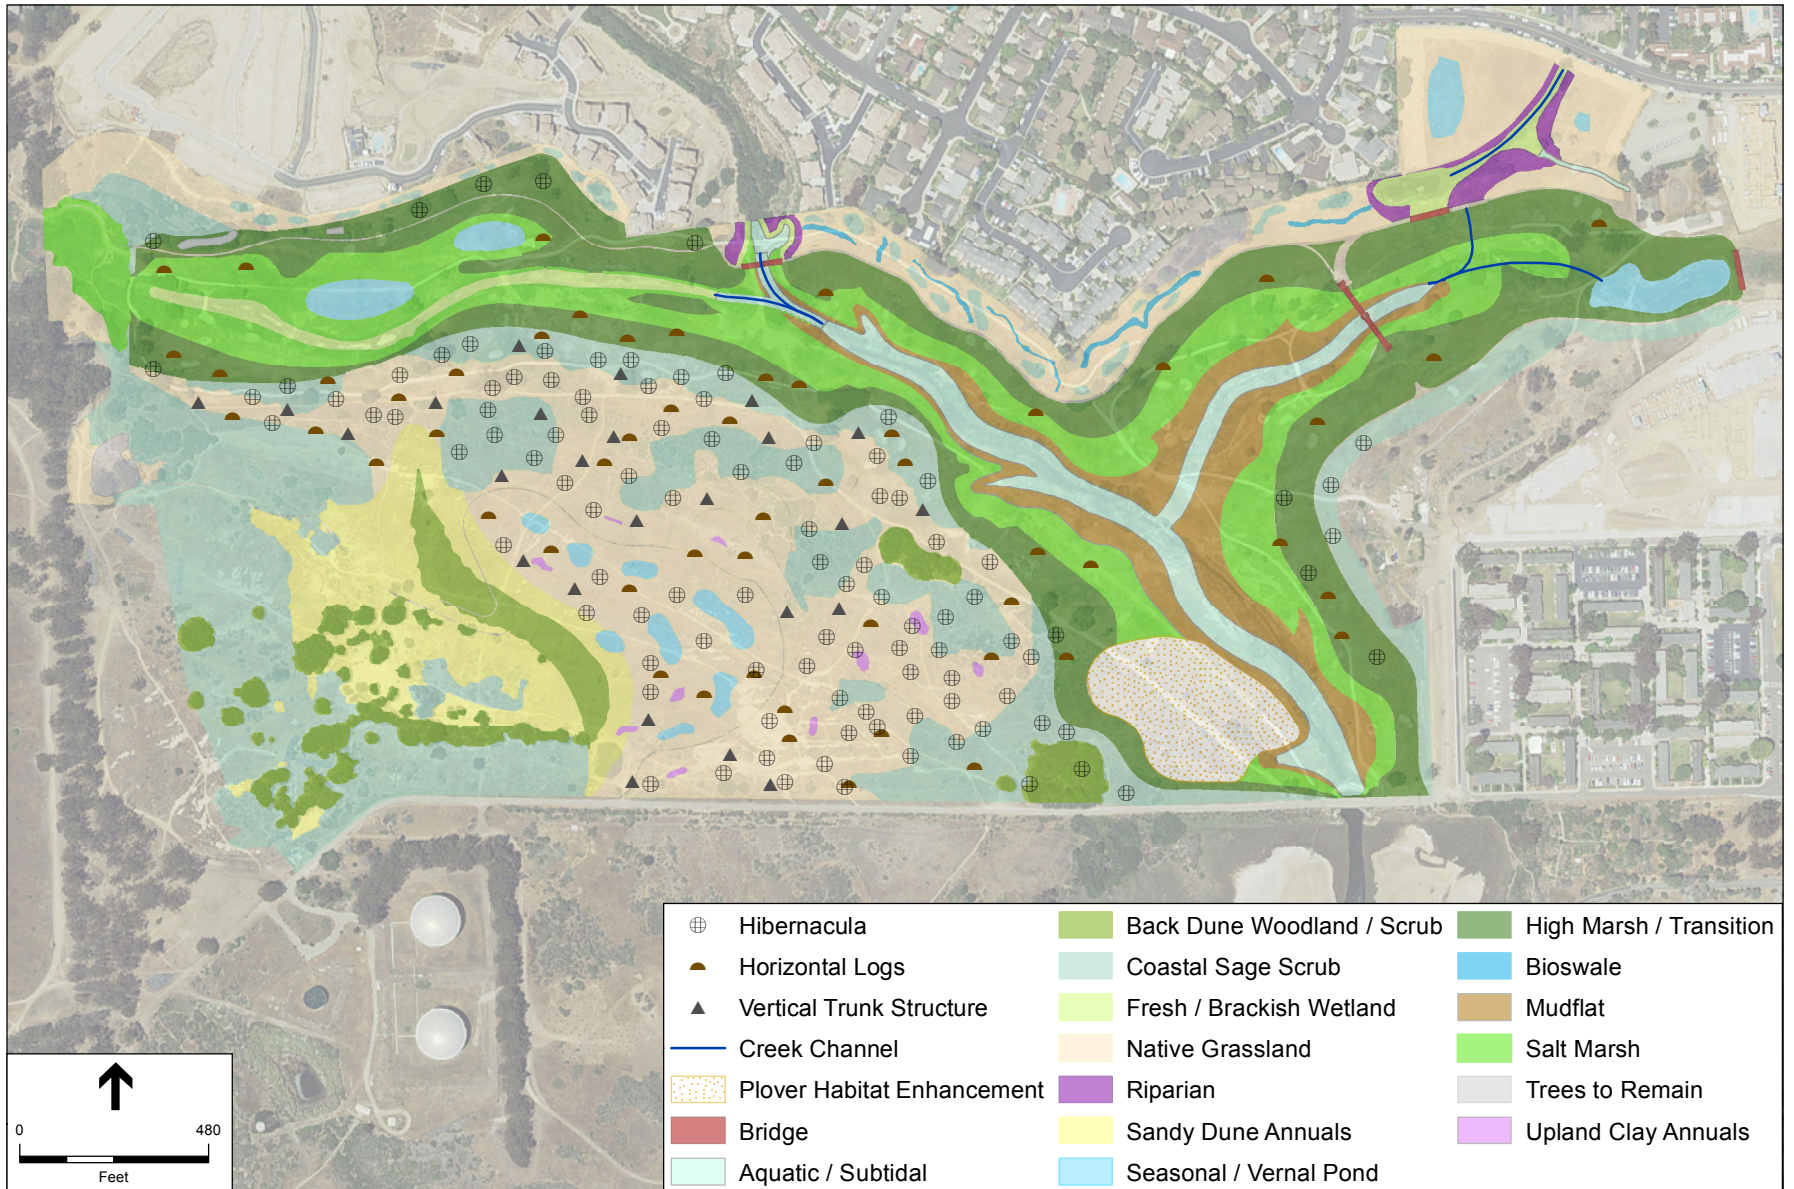
Reestablishment of native plant communities on the restoration site and the creation and enhancement of a variety of freshwater resources in vernal pools and freshwater marsh habitats will provide cover, food (e.g. seeds) and water sources for small and large mammals. Logs, rocks, thatch and hibernacula will be incorporated into the site design to benefit small mammals.

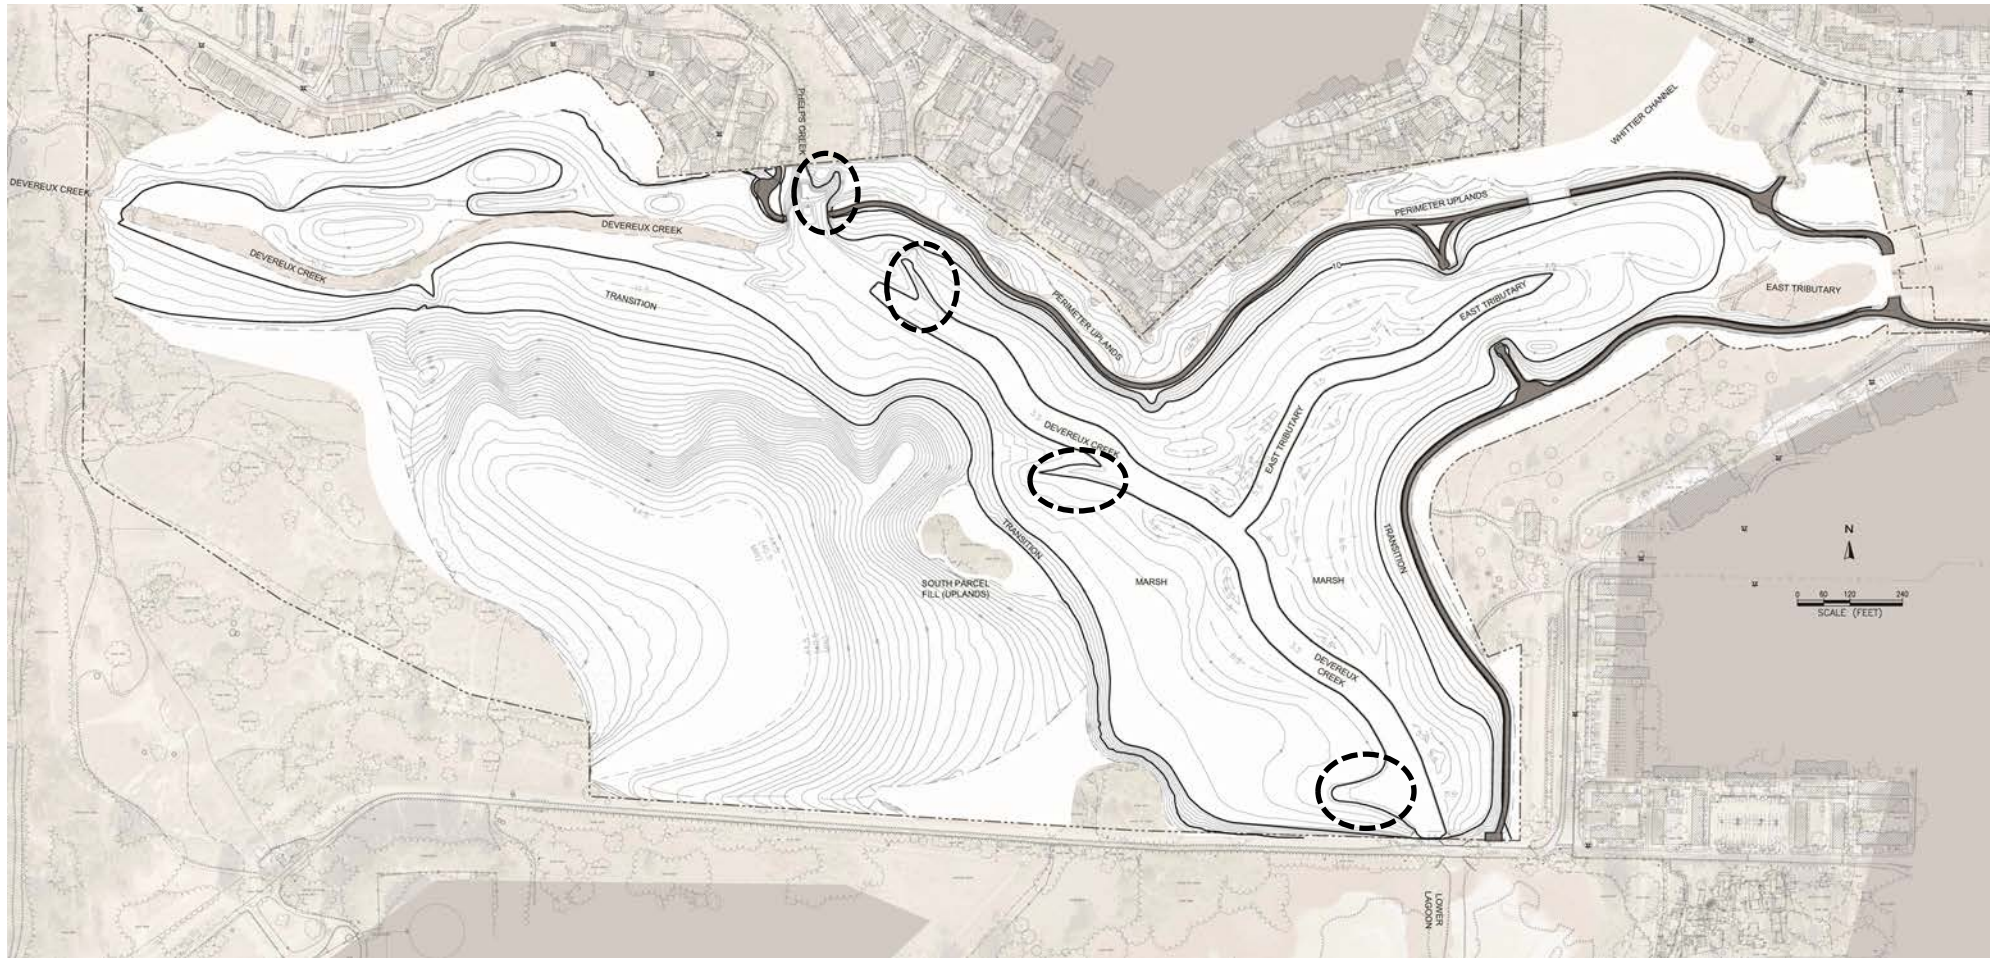
Eddy ponds, incorporated into the project design to provide conditions favorable for tidewater goby, will be approximately 2 feet deep and occur in areas upstream of islands and peninsulas of higher elevation habitat to create refuge during higher flow events, such as when the Slough mouth breaches (Figure 8). At the restored Slough connection to Phelps Creek, a series of two step-pool style grade control structures and an additional armored sill downstream of the new Phelps Creek Bridge will preserve freshwater conditions in Phelps Creek and provide a fresh to saline gradient at the confluence (Figure 9). This control will maintain brackish conditions at the restored Slough confluence, favored by tidewater goby, and preserve freshwater conditions in upstream reaches that currently support freshwater wetland and riparian habitat. Given the regular occurrence of hypersaline conditions in the larger Slough, this feature will provide an important brackish refuge for the goby, similar to ponds in Goleta Slough near Tecolotito Creek. This grade control feature will facilitate connectivity during the 8-10 foot water stage periods that occur with

most rain events and during periods when the Slough mouth is closed, and provide refuge from high velocity flows during storm events.

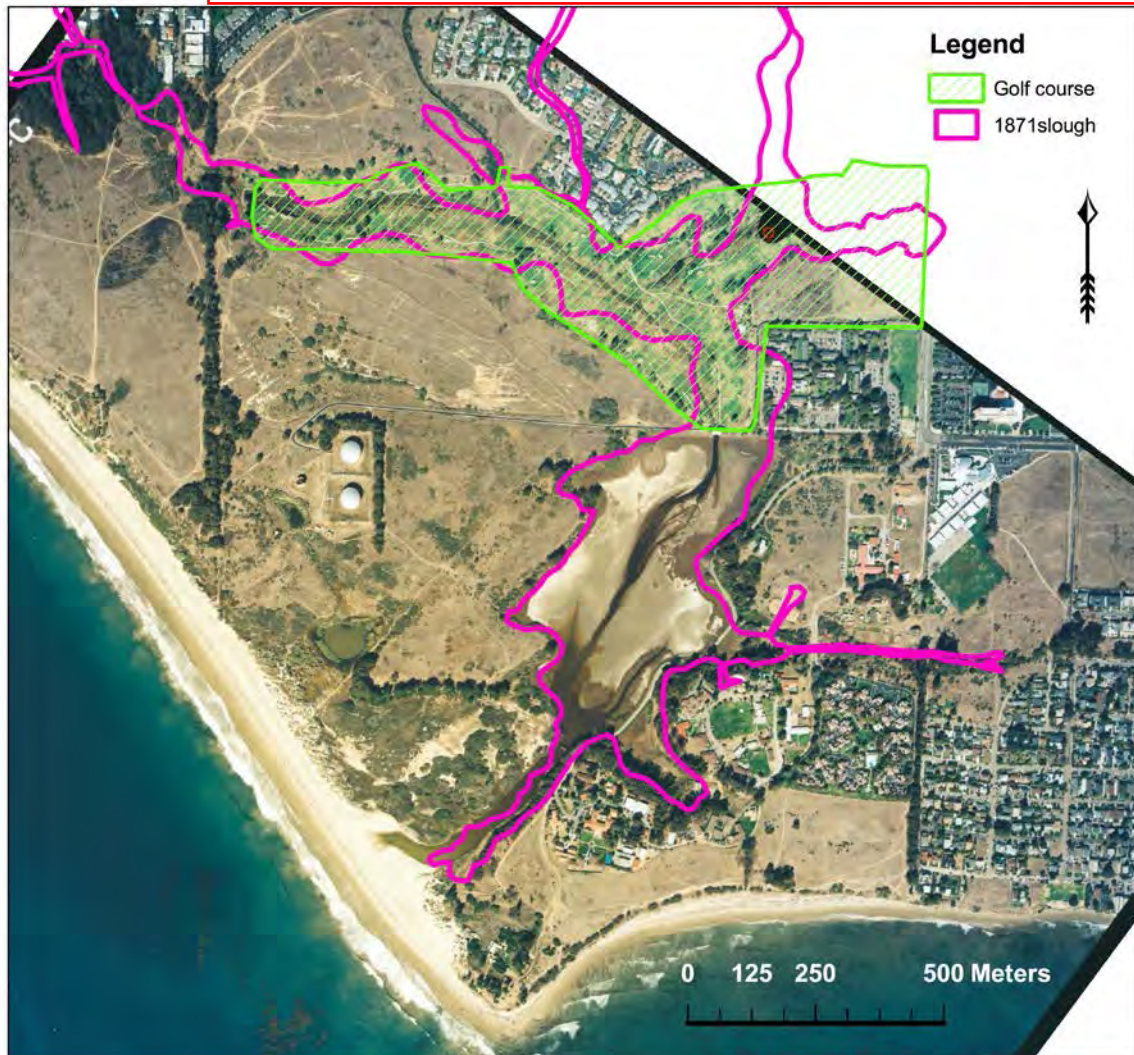
Figure 7. The extent of the golf course compared to the historic extent of the tidal wetland in 1871 over a 2001 rectified air photo.

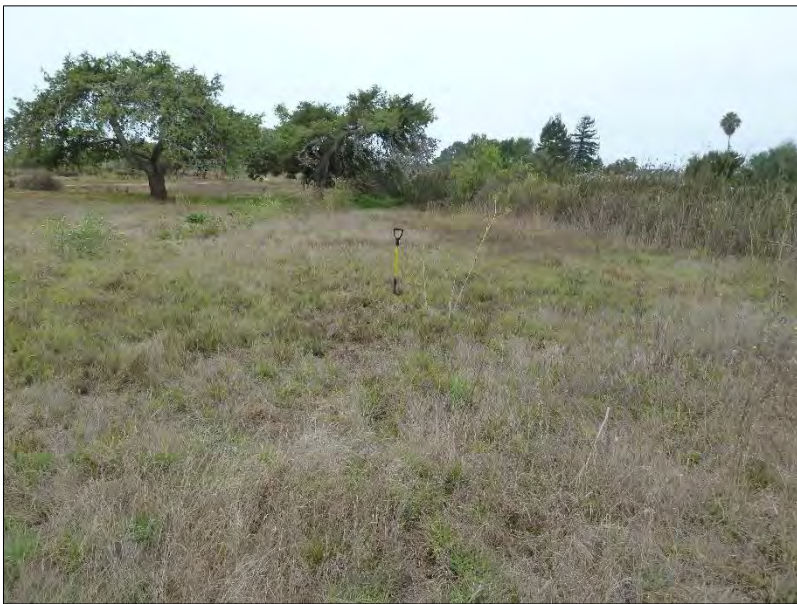
**Photo 1:** DP-1 view west at salt grass patch along Whittier Parcel drainage channel. 9/22/2015

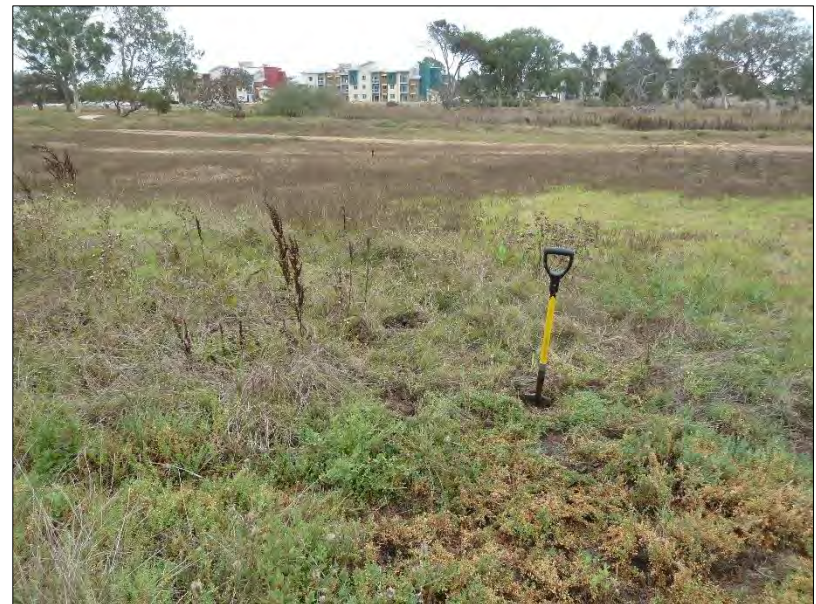
**Photo 2:** DP-2 view south at salt grass and alkali heath dominant patch along Whittier Parcel drainage channel. 9/22/2015

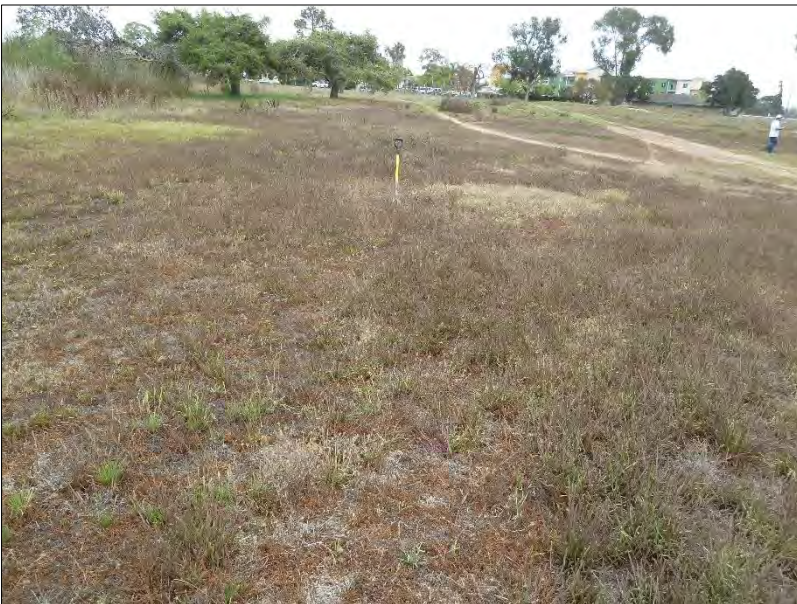
**Photo 3:** DP-3 view east at buck-horn plantain expression in fairway. 9/22/2015

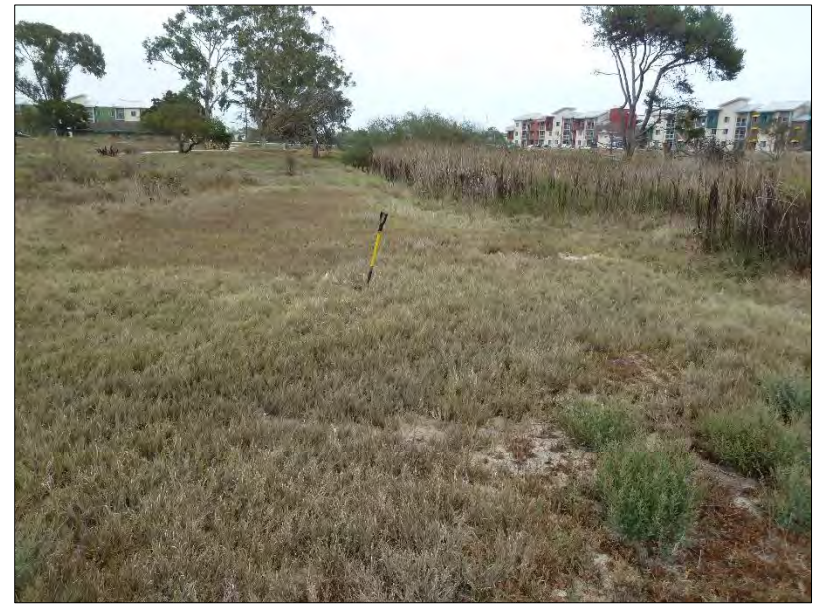
**Photo 4:** DP-4 view east at salt grass flat in fairway rough along Storke Road drainage channel. 9/22/2015

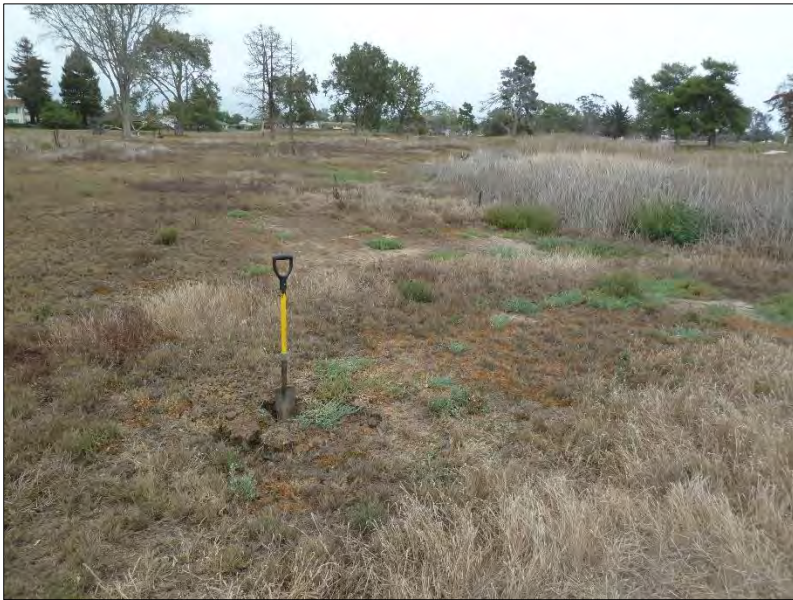
**Photo 5:** DP-5 view east at salt grass flat along Devereux Creek. 9/22/2015

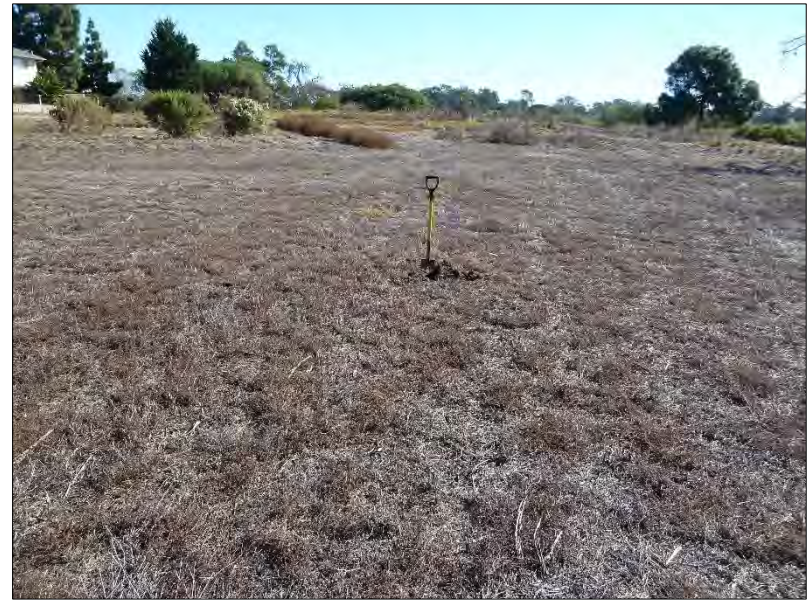
**Photo 6:** DP-6 view east at salt grass flat along Devereux Creek. 11/20/2015

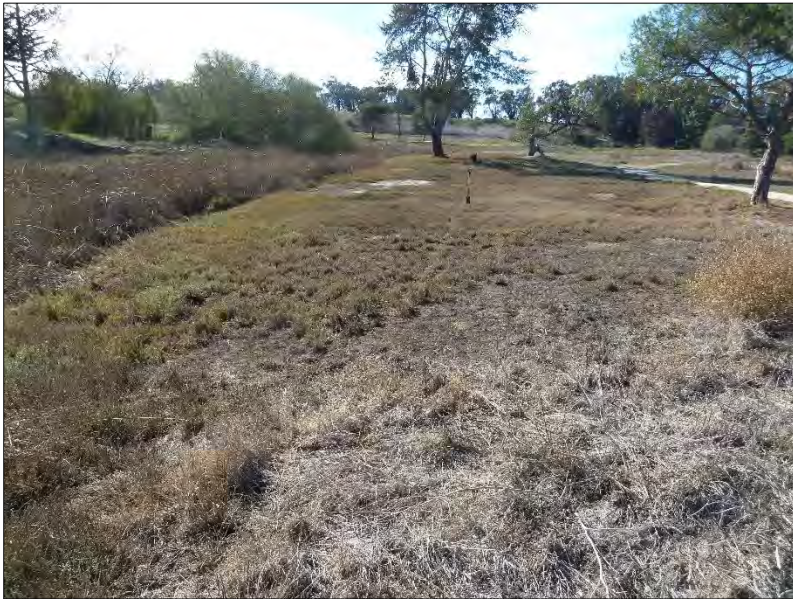
**Photo 7:** DP-7 view west at yard knotweed patch in fairway along Devereux Creek. 11/20/2015

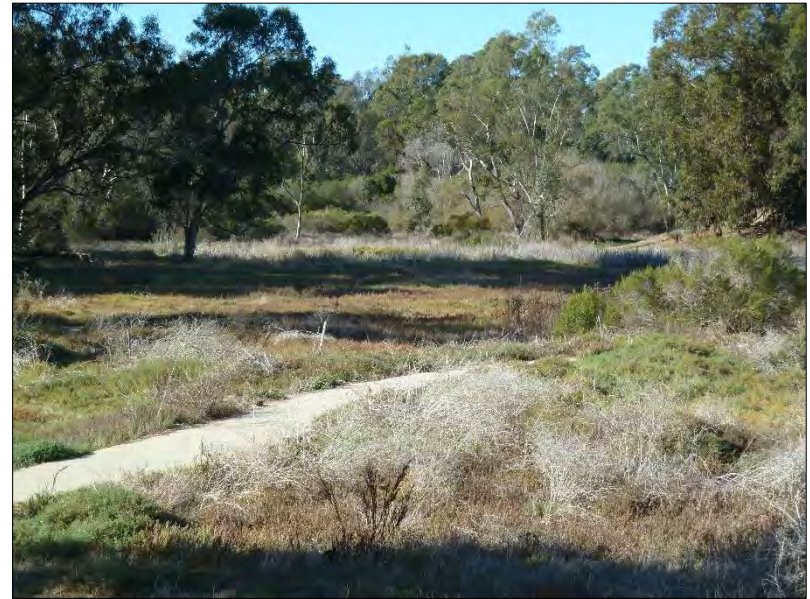
**Photo 8:** View west at salt marsh flat of Devereux Creek in northwest corner of study area outside of former golf course area. 11/20/2015

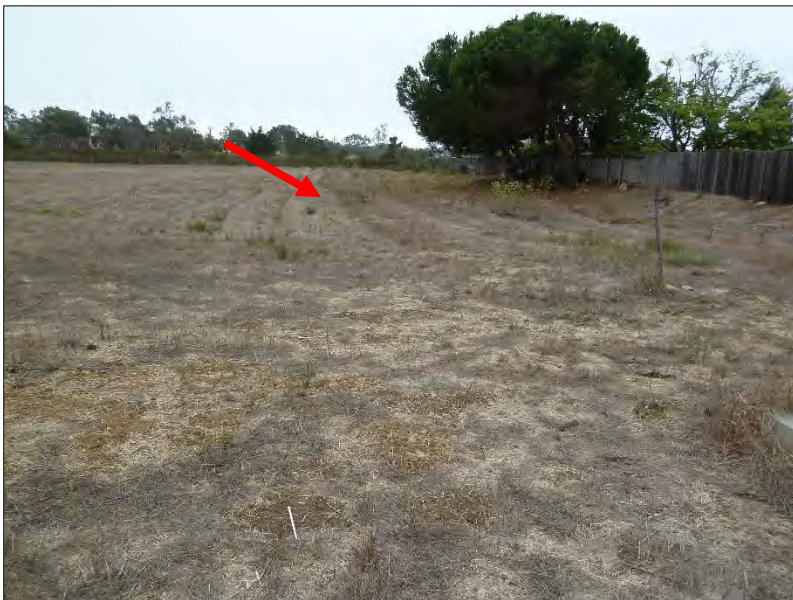
**Photo 9:** View west at larger Whittier Parcel vernal pool (arrow). 9/22/2015

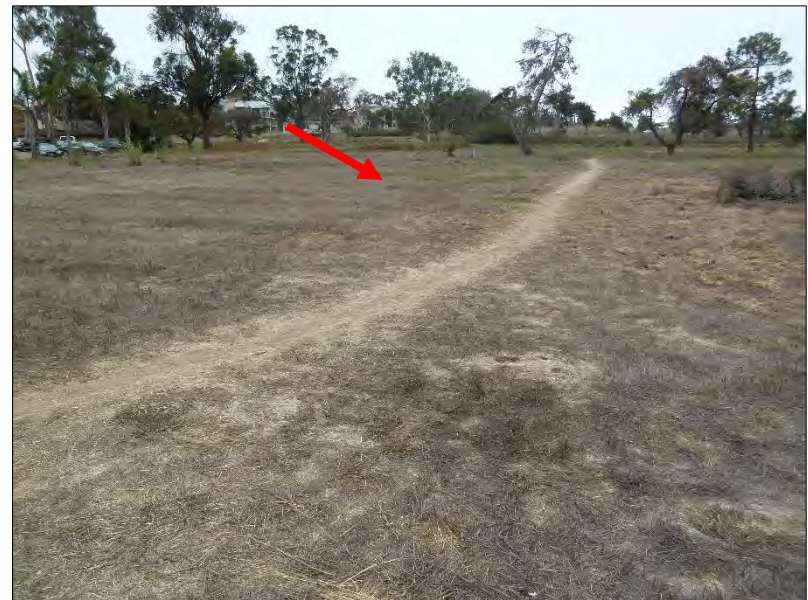
**Photo 10:** View west at smaller Whittier Parcel vernal pool (arrow). 9/22/2015

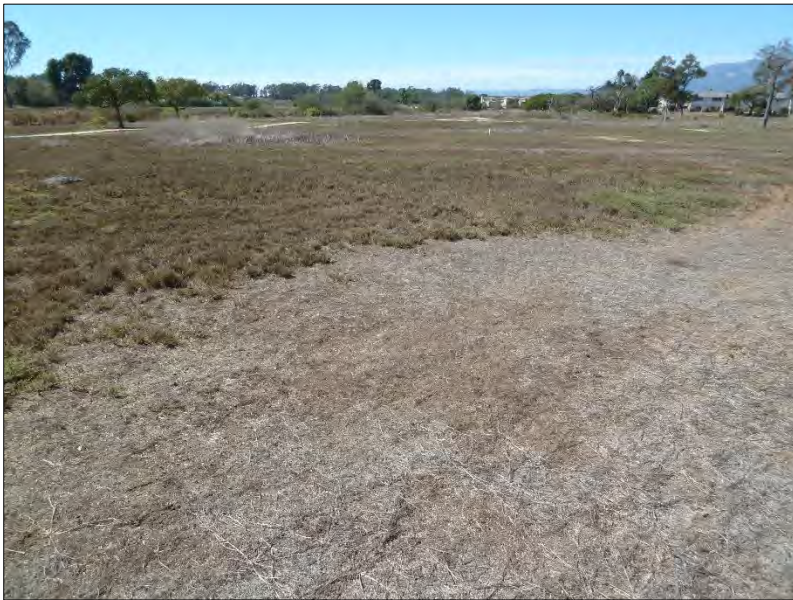
**Photo 11:** View northwest at example salt grass expression in fairway. 9/30/2015

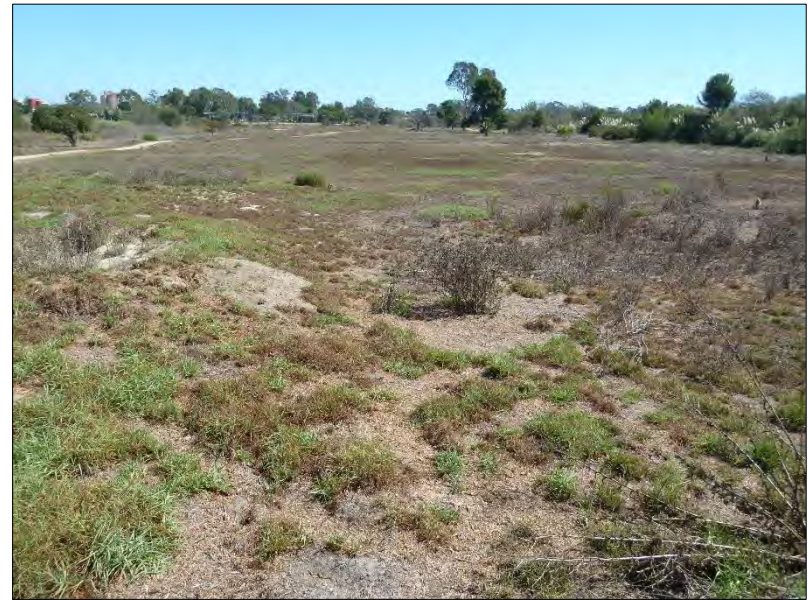
**Photo 12:** View west at example of varied species patchwork mosaic in transitioning golf course fairway. 9/30/2015

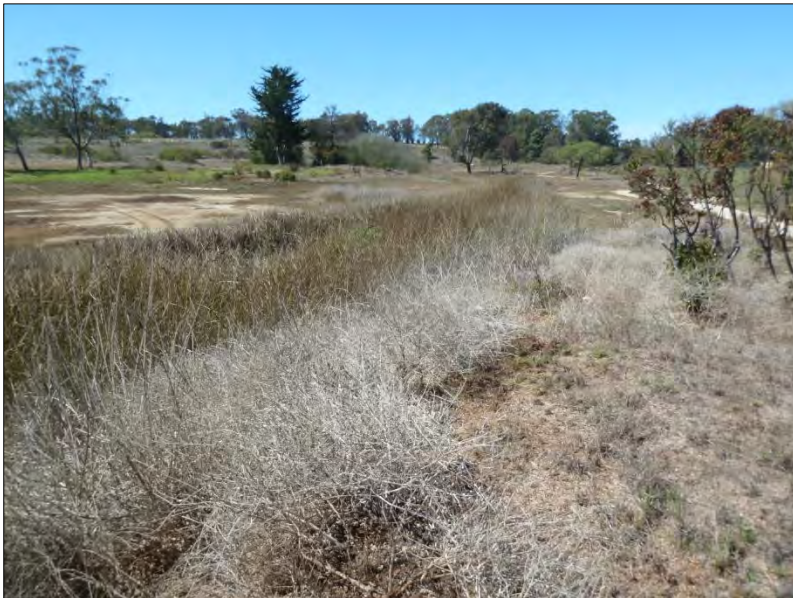
**Photo 13:** View west at confined Devereux Creek and robust wetland vegetation bisecting transitioning golf course fairways. 9/30/2015

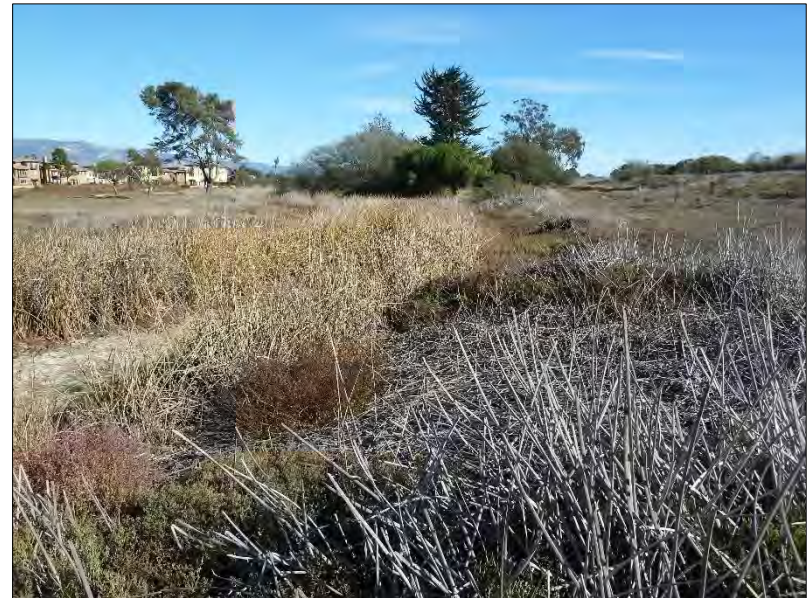
**Photo 14:** View east at confined Devereux Creek and robust wetland vegetation and willows bisecting transitioning golf course fairways. 9/30/2015

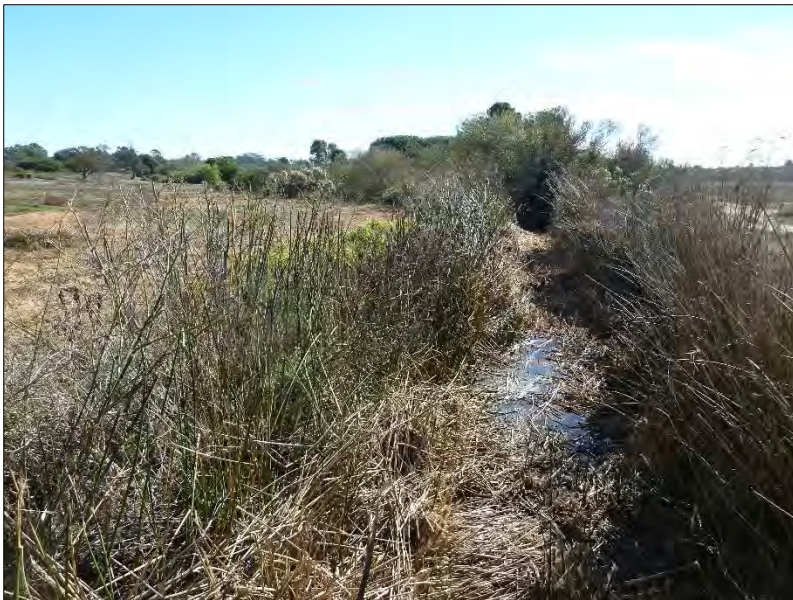
**Photo 15:** View southeast at Devereux Creek incised confined channel and robust wetland vegetation and willows. 9/30/2015

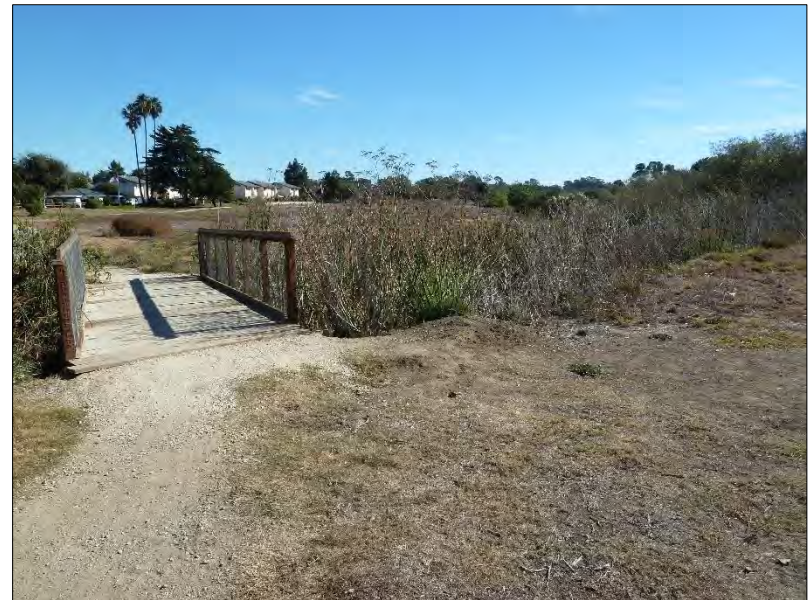
**Photo 16:** View east at Phelps Creek bridge crossing and confined channel. 9/30/2015

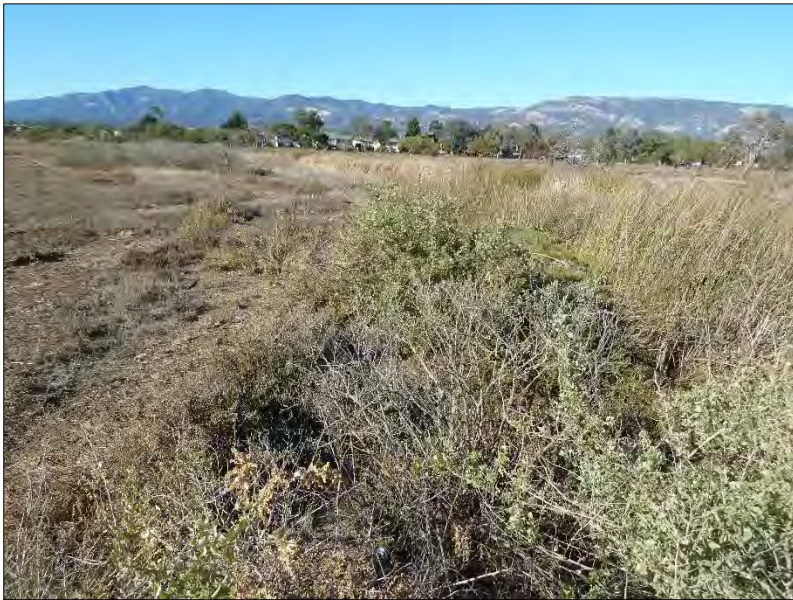
**Photo 17:** View north at Devereux Creek and example adjacent wetland fringe of quail bush, alkali heath, and pickleweed. **11/20/2015**
