North Campus Open Space Restoration Project Restoration Plan

# NORTH CAMPUS OPEN SPACE RESTORATION PROJECT

## Restoration Plan

Prepared for  
University of California Santa Barbara  
Office of Budget and Planning

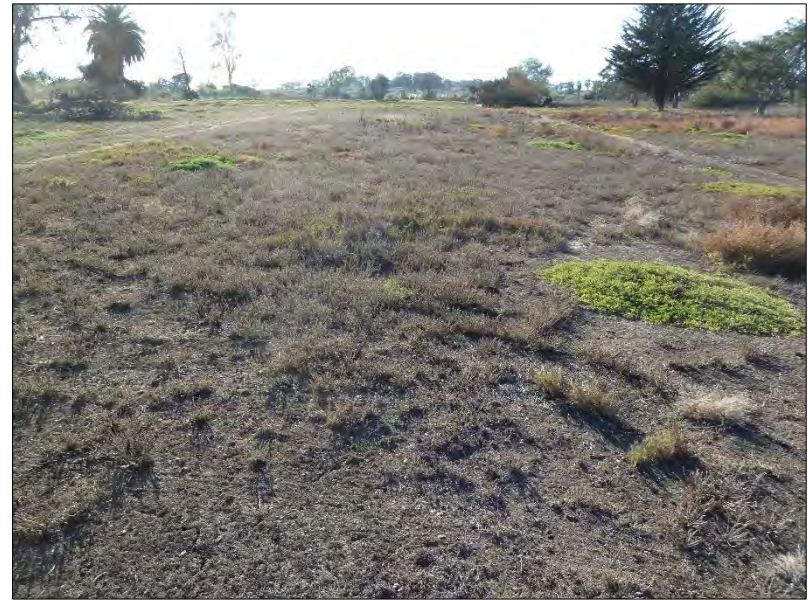
**Photo 18:** View west at transitioning fairway with scattered mat forming Australian saltbush (green mats). **11/20/2015**

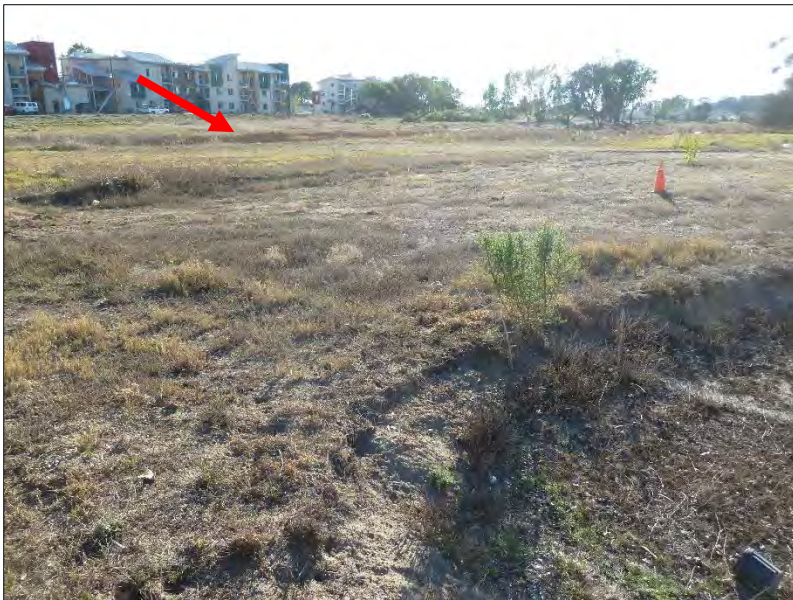
**Photo 19:** View southwest from demolish clubhouse at drainage channel wetlands from Storke Road (arrow). **11/20/2015**

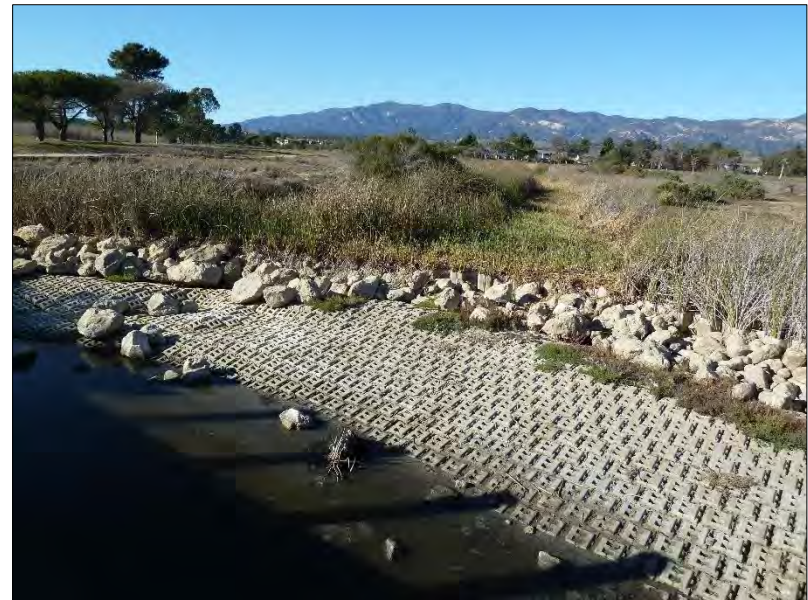
**Photo 20:** View north at Devereux Creek sheet pile sill separation from Devereux Slough tidal influence. **11/20/2015**

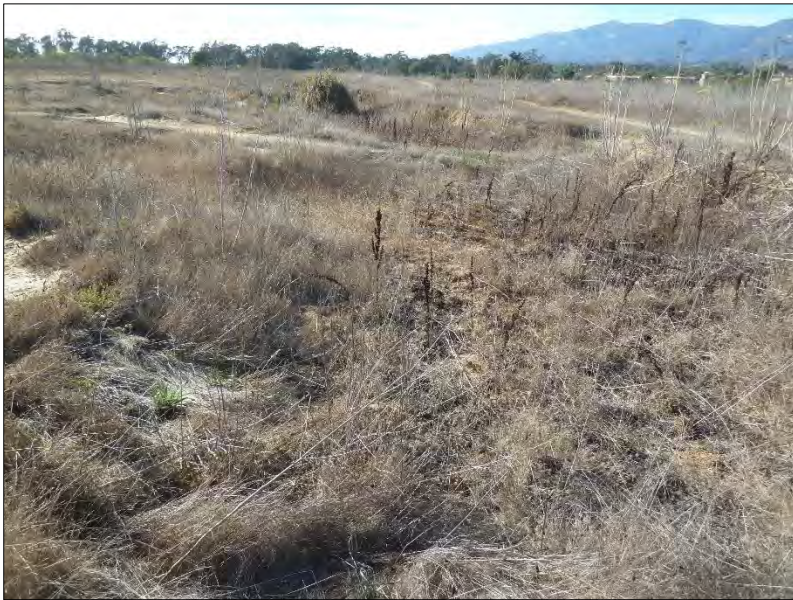
**Photo 21:** View northwest at South Parcel ditch seasonal wetland along created berm from golf course construction borrow operation. 9/29/2015

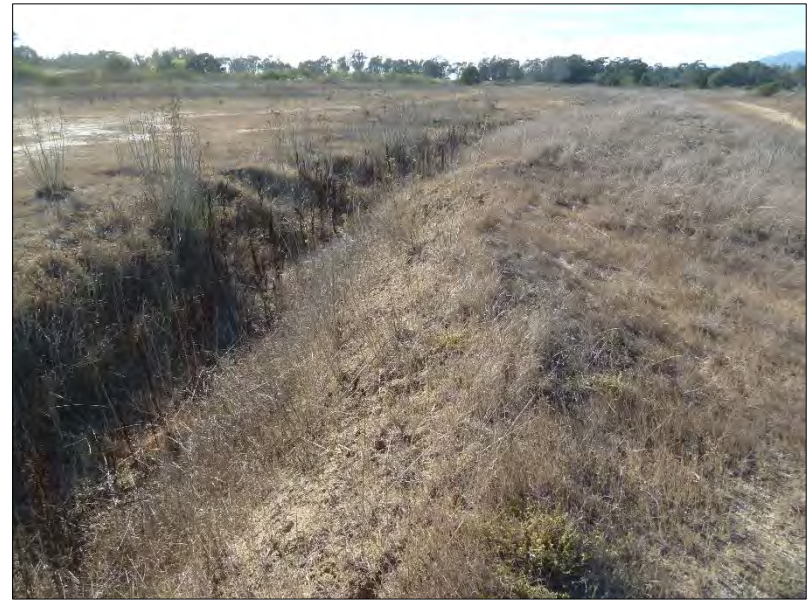
**Photo 22:** View west at South Parcel ditch seasonal wetland along created berm from golf course construction borrow operation. 9/29/2015

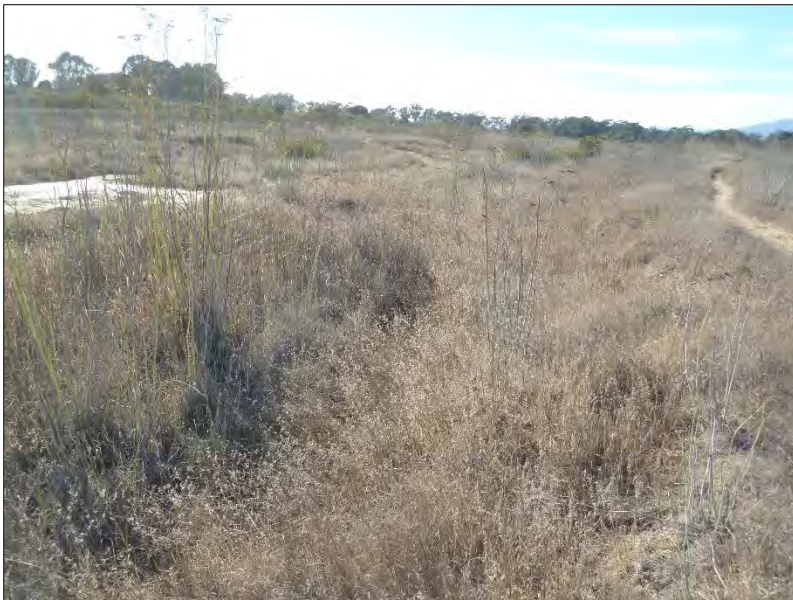
**Photo 23:** View west at South Parcel ditch seasonal wetland along created berm from golf course construction borrow operation. 9/29/2015

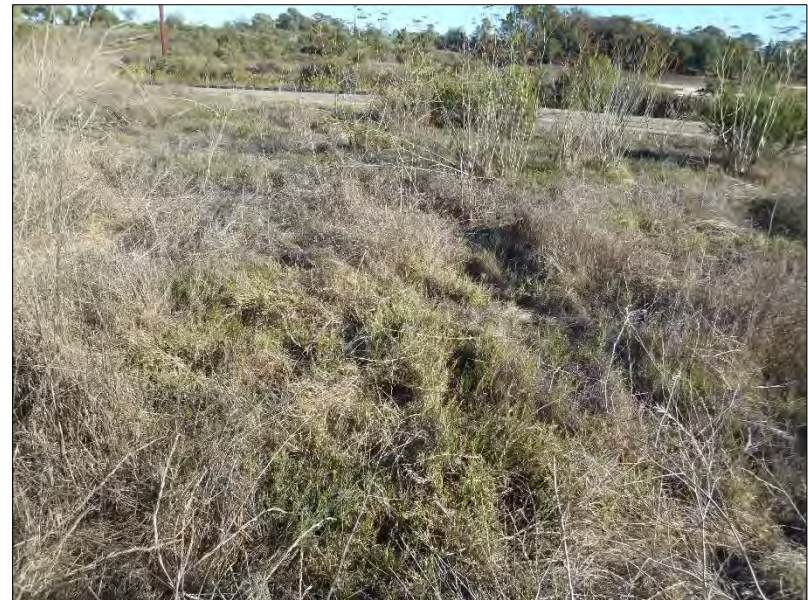
**Photo 24:** View north at salt grass seasonal wetland mapped on South Parcel. 9/29/2015

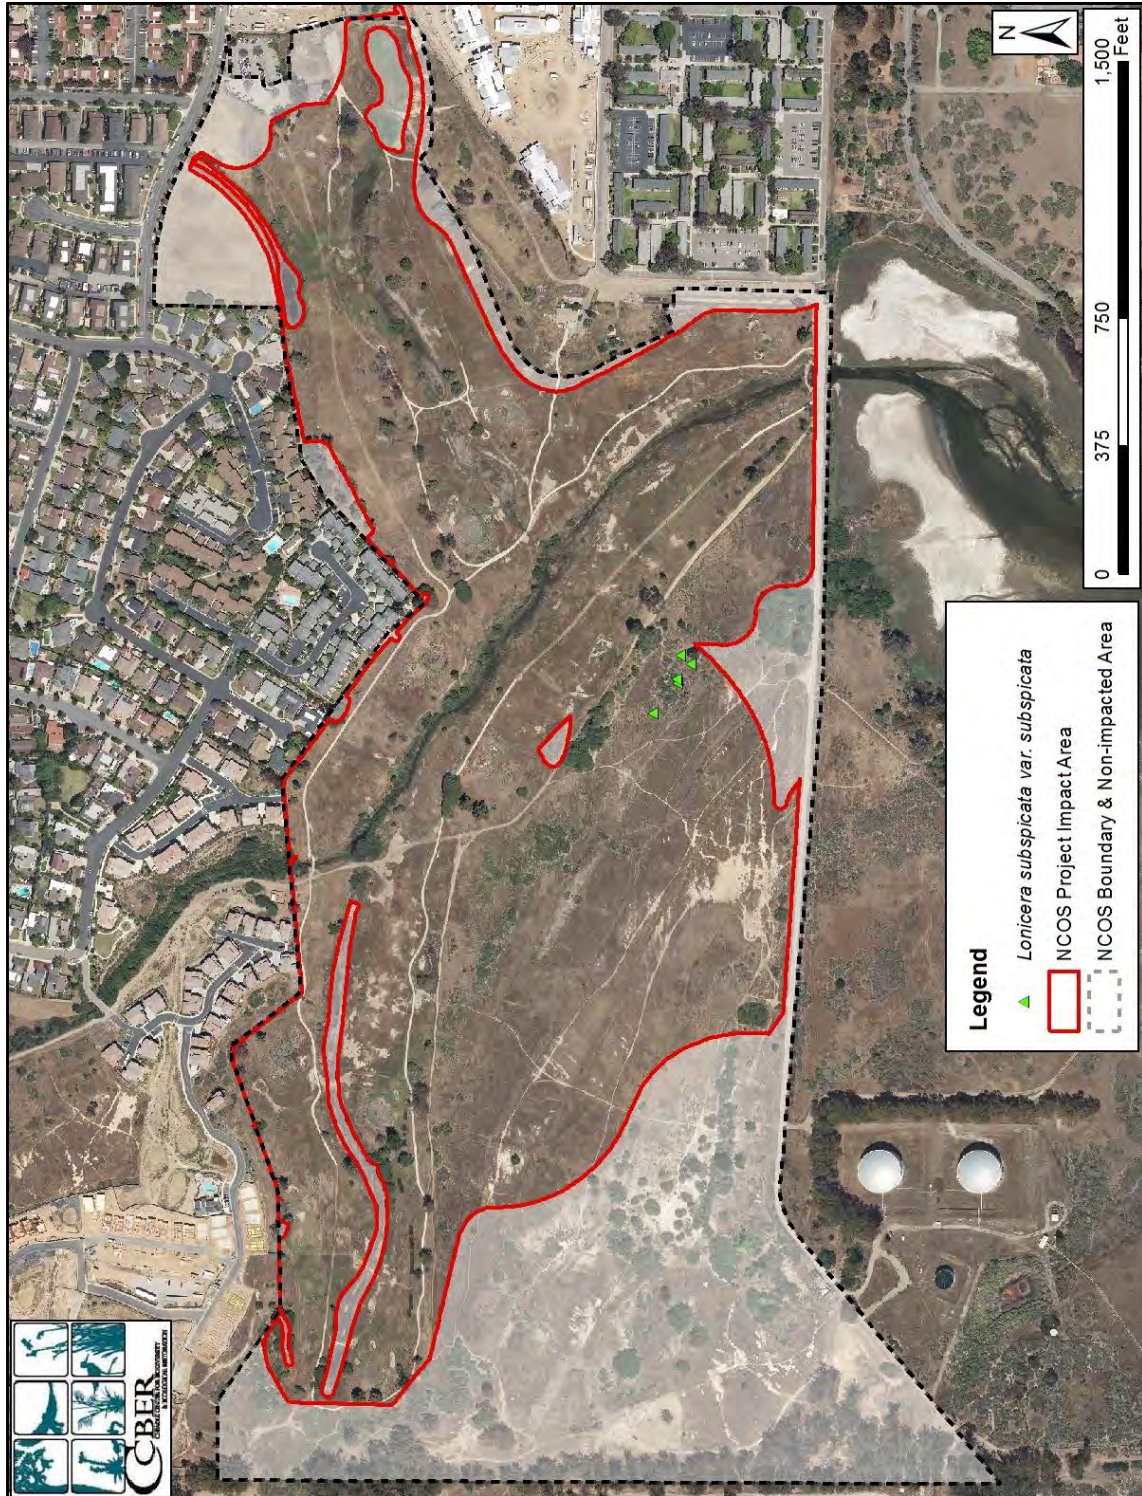
**Figure 1:** Map of North Campus Open Space showing locations of the special status plant, *Loniceria subspicata* var. *subspicata*, within the projected restoration zone.
