Air leakage test report: EPA region 8 headquarters, Denver, CO

## **AIR LEAKAGE TEST REPORT EPA REGION 8 HEADQUARTERS, DENVER, CO**

Fred Bauman, Tom Webster, and Darryl Dickerhoff

Center for the Built Environment (CBE)  
University of California, Berkeley

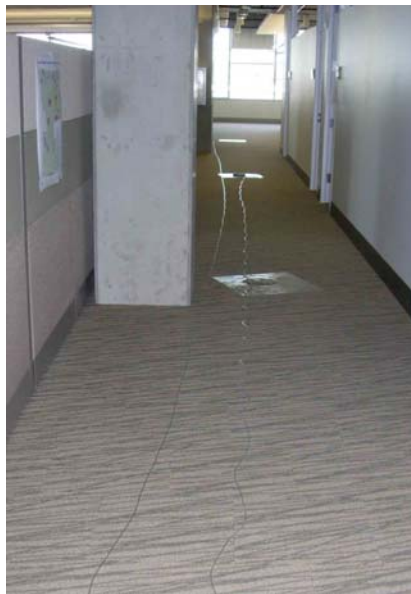
Figure 6: Installation of tubing for plenum pressure measurement

4. Install pressure sensing tubing from command center to eight underfloor plenum pressure measurement locations on the 7th floor to allow multi-point monitoring of plenum pressure distribution during subsequent air leakage tests (see Figure 6 and Figure 7. These eight locations were selected to match the eight installed plenum pressure sensors shown in Figure 2. Also run tubing to the 6th floor (all floor were open (i.e., no return plenum) with "cloud" acoustical ceilings) and to the outside to allow monitoring of pressures in adjacent spaces to 7th floor underfloor plenum.

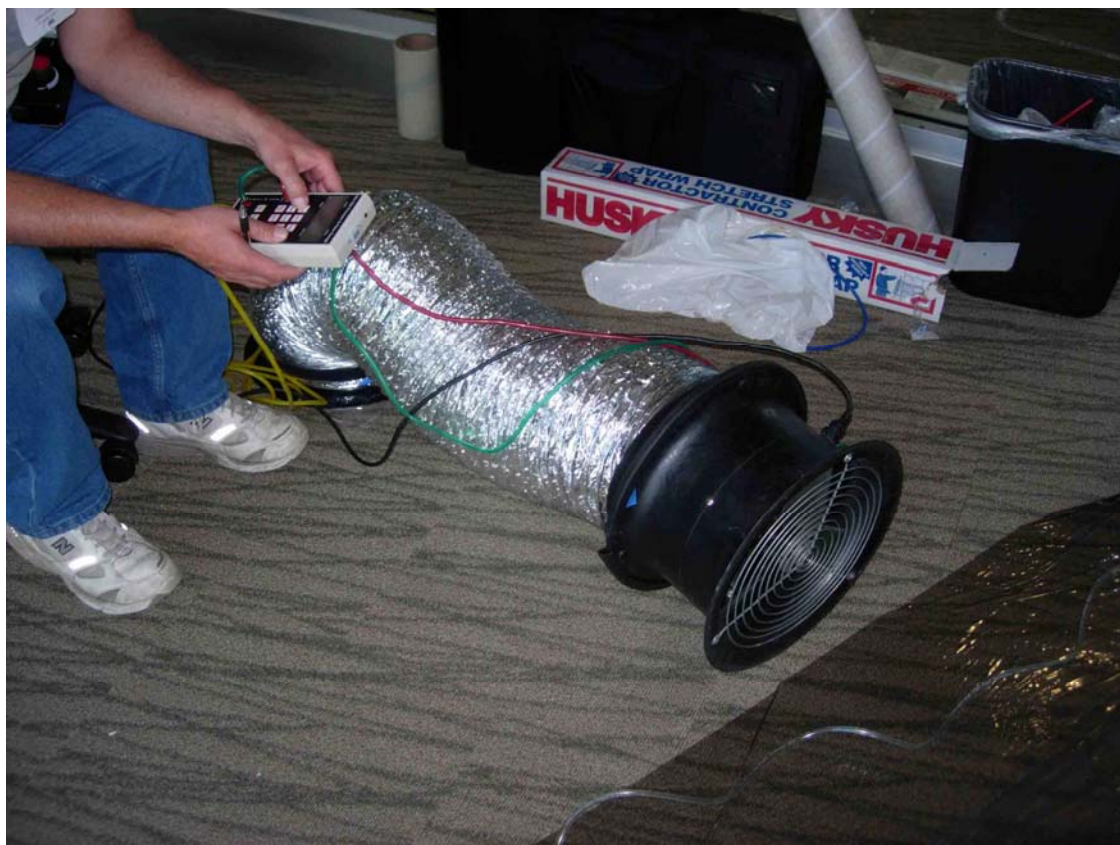
Figure 9: Duct Blaster shown being used as a powered flow hood to measure flow through swirl floor diffuser

3. Conduct airflow measurements of 2-3 swirl floor diffusers. These tests were intended to characterize the airflow through the diffuser for two manually adjusted damper positions: (1) fully open and (2) fully closed. A powered flow hood was used to measure these small flows. A powered flow hood uses a calibrated fan, in this case a Duct Blaster, to measure the flow and to overcome the flow resistance of the relatively small flow sensor necessary for accurate determination of low flows. Flows as small as 10 cfm can accurately be made using a Duct Blaster (see section 13.3 of the Duct Blaster manual).

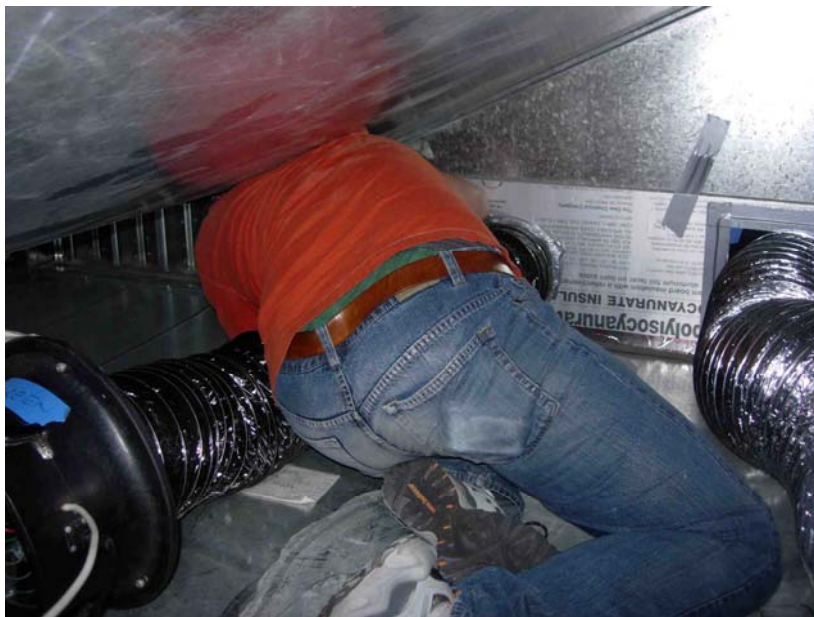
Figure 11: Two Duct Blasters with manifold being installed at entrance to one supply air highway

In the case of the EPA building, each floor served by the UFAD system is configured to have a single open plenum across the entire floorplate (7<sup>th</sup> floor area = 29,892 ft<sup>2</sup>). Due to the large size of this single plenum zone and resulting high range of required airflow for air leakage testing, it was decided to use the building's two AHUs that deliver air down each of the two supply shafts. As described further below, this required calibration of the 8 air highway flow measurement stations serving the 7<sup>th</sup> floor supply plenum.

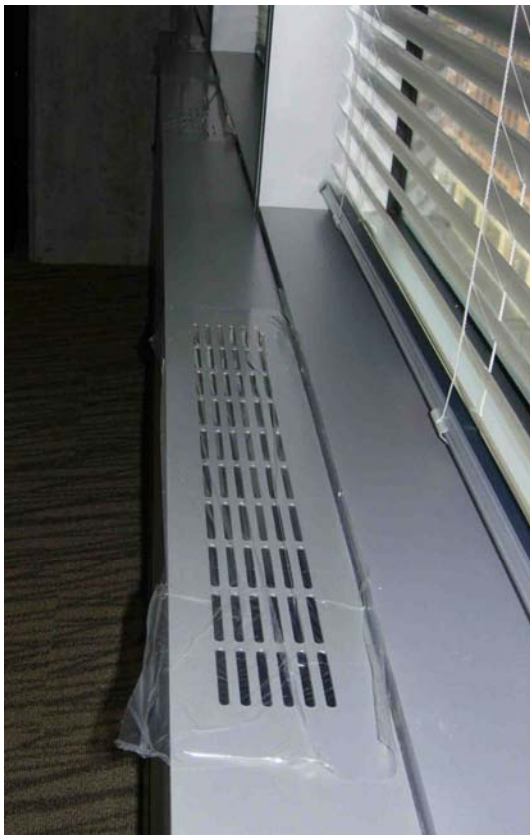
Figure 13: Sealed perimeter linear grilles

significant airflow was still able to leak into the room through these gaps or cracks along the edges of the sill plate. In our testing we discovered this extra leakage and were able to account for it in our analysis. Our testing method included additional measurements when we completely taped and sealed all cracks along the window sills of three of the 21 perimeter fan units. Since this extra leakage was created only when we unsuccessfully taped the perimeter grilles shut during the sealed diffuser test, we recommend that it be subtracted from the total leakage measurement to obtain the true leakage from the plenum.

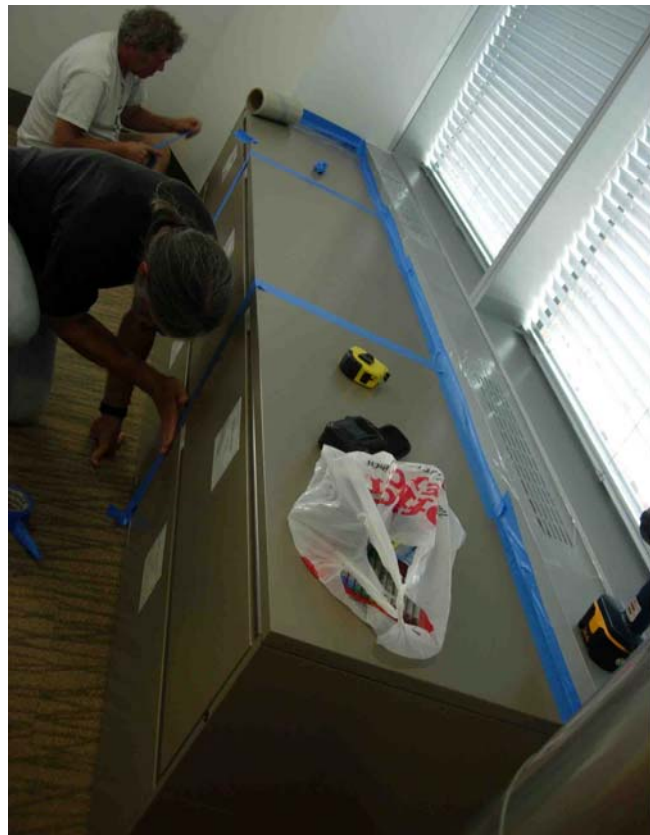
Figure 14: Taping cracks and cabinets at perimeter

**EPA Test Results:** There were two configurations of window sill flow: one where file cabinets partially blocked the flow path and one where the window sill cap overhung the wall. In the former case we measured a leakage rate of 0.37 cfm/inch of perimeter at 0.05 iwc and for the latter 0.80 cfm/inch. Applying this to the total perimeter yields an estimated leakage of 4,420 cfm. We obtained virtually the same leakage with the multi-path pressurization test method at 4,220 cfm (see Test 3). This close agreement of the two methods is an indication of the potential of the multi-path pressurization test method.
