Ultrasonic Guided Waves Test Method for Blunt Impact Damage Assessment on Composite Aircraft Structures

A dissertation submitted in partial satisfaction of the
requirements for the degree Doctor of Philosophy

Structural Engineering

Hyung Suk Kim

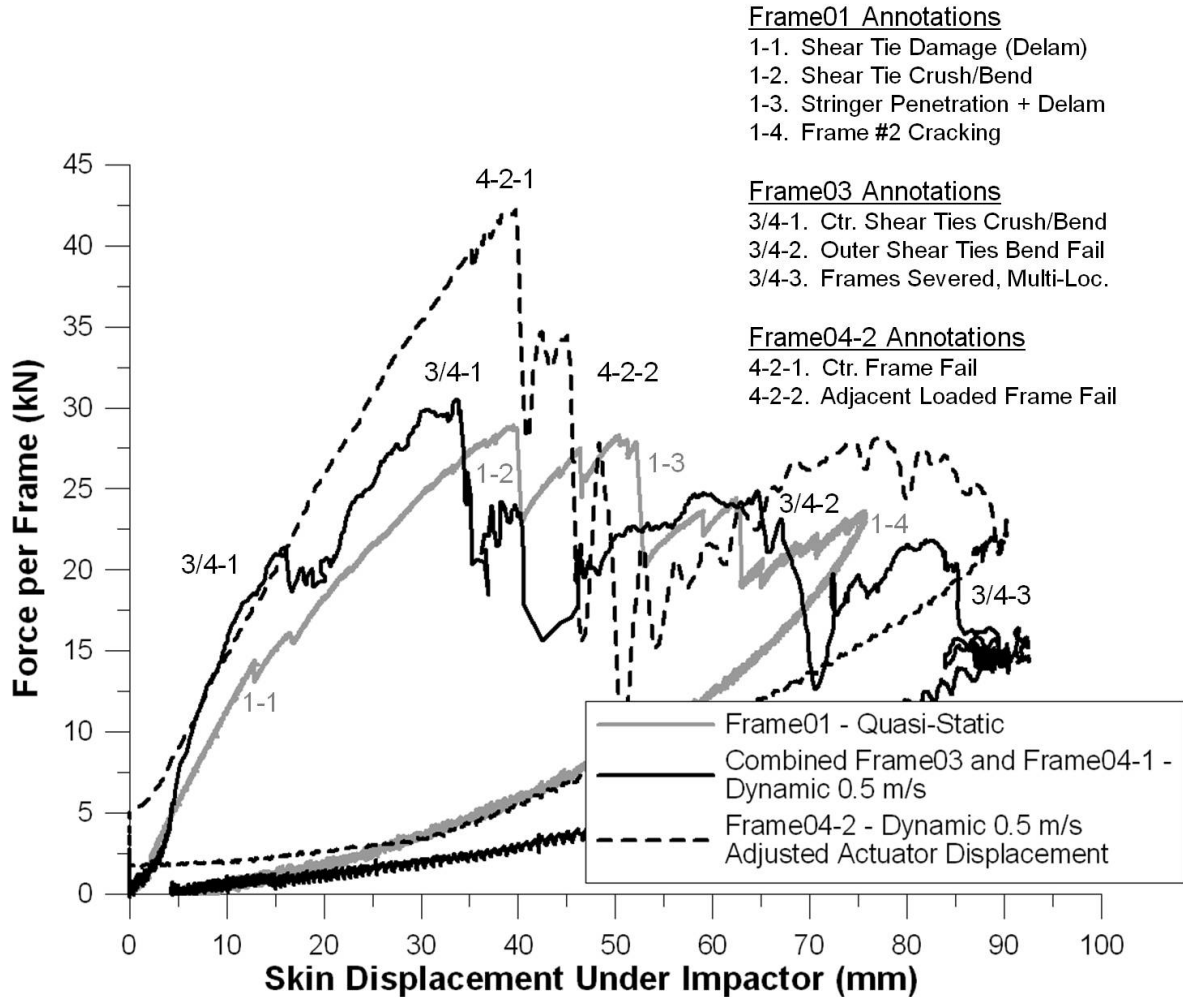
Figure 1.4.1.1 Frame panels load history comparison [4]

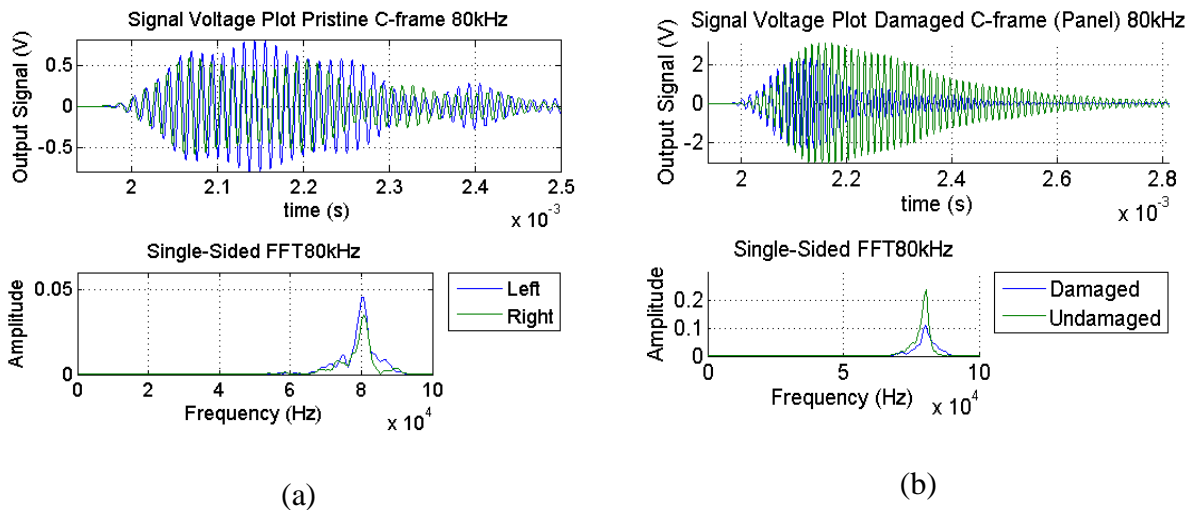
Figure 2.2.2.1. Initial C-frame UGW test result comparison: (a) pristine C-frame and (b) C-frame with through-the-flange crack

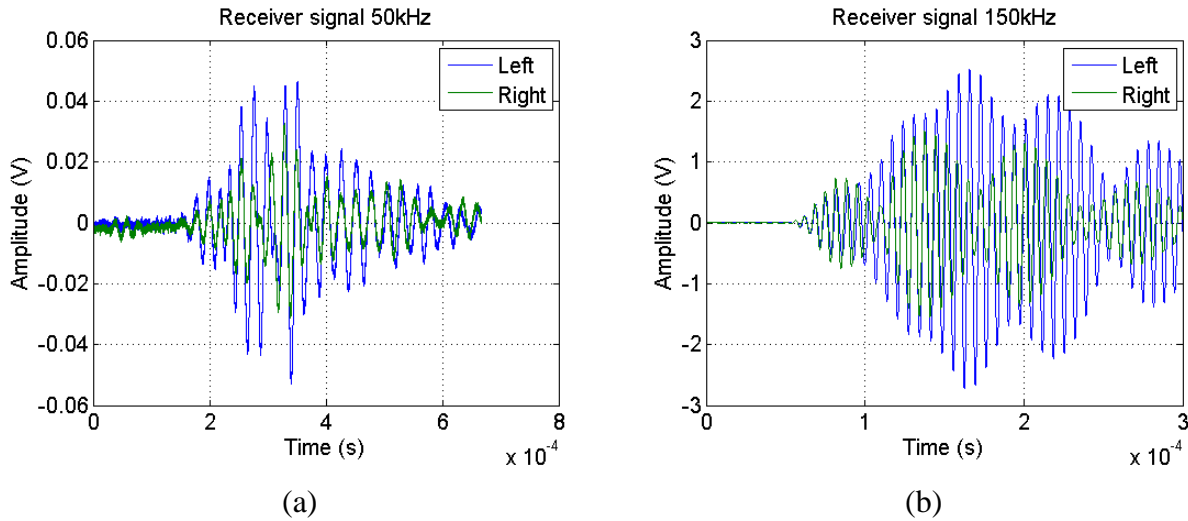
Figure 2.2.2.2. UGW test on C-frame at (a) 50 kHz and (b) 150 kHz

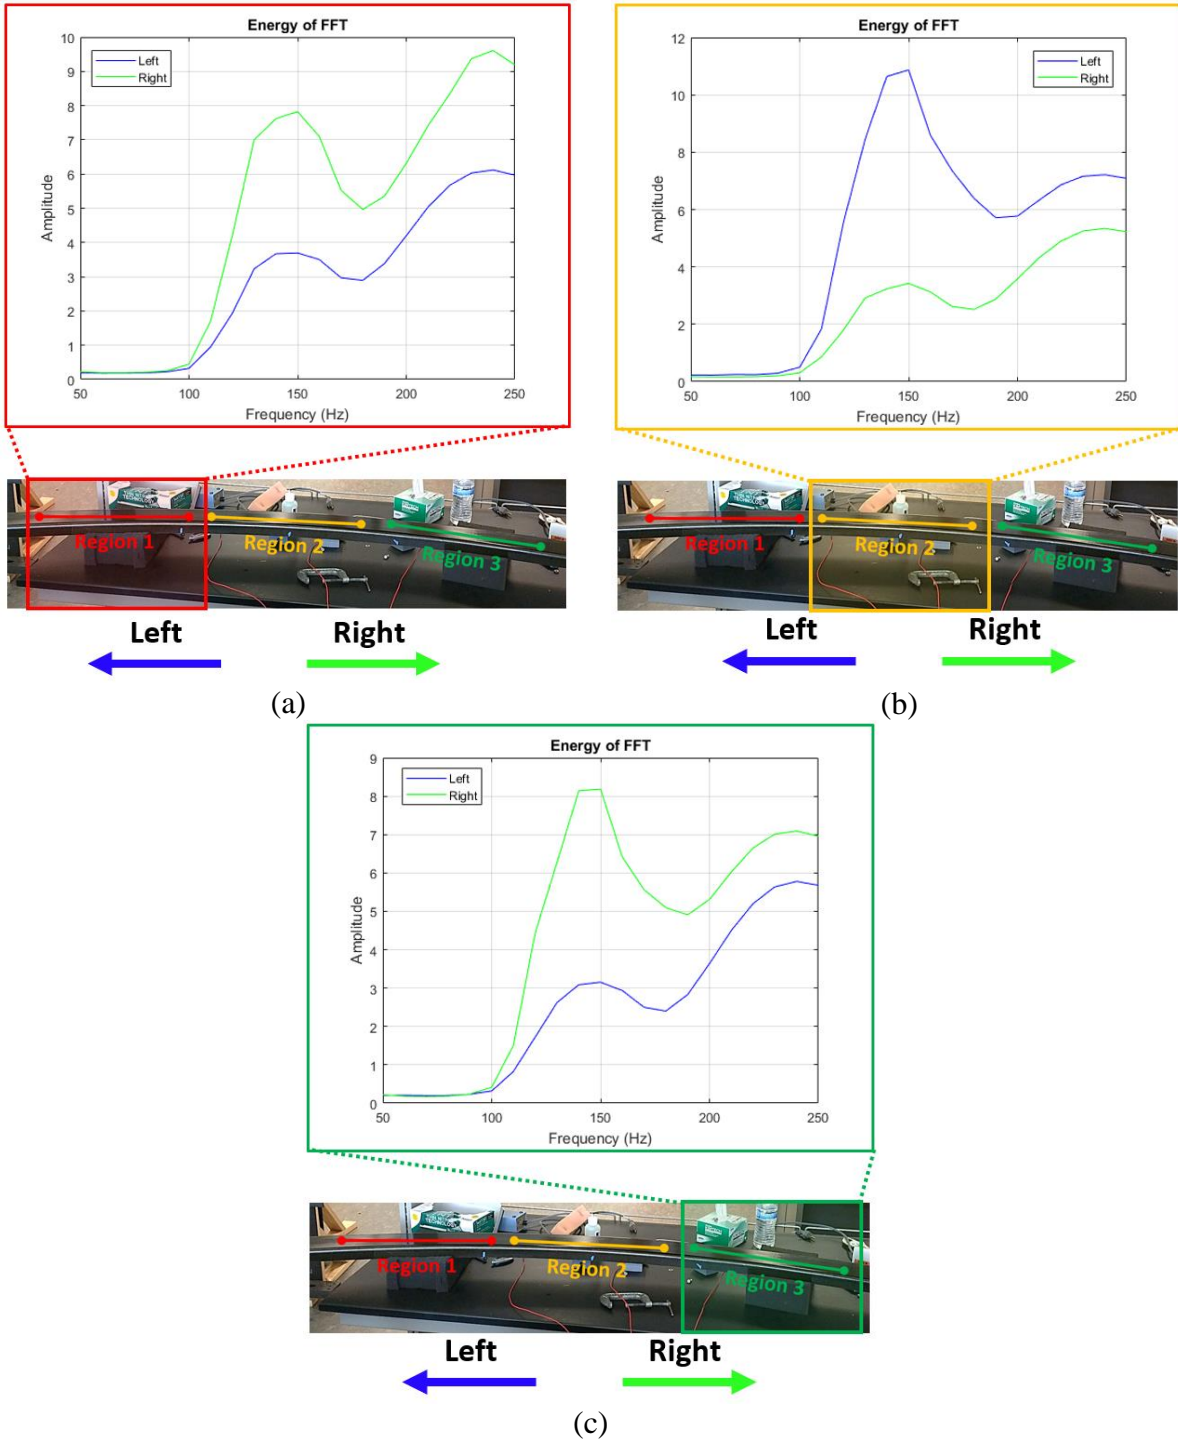
Figure 2.2.2.3. Energy from the frequency response results of UGW test for regions (a) 1, (b) 2, and (c) 3 on C-frame

UGW propagation through symmetrical paths on the C-frame was further examined at three highlighted regions (see Figure 2.2.1.3). UGW tests were performed with R15S transducers with 3D-printed hold-downs and repeated at least three times by re-applying couplant for every re-mounting of transducers to confirm consistency of the test method (results confirmed to not vary from coupling). Experimental results for 50 and 150 kHz test frequencies at center region of the C-frame (Region 2 in Figure 2.2.1.3) show guided waves propagated asymmetrically through the symmetric wave path from the center region of the C-frame, as shown in Figure 2.2.2.2. Frequency response energies for test frequency range from 50 to 250 kHz at 10 kHz increments were extracted from UGW tests of each C-frame segmented region (Regions 1, 2, and 3 for left, center, and right portion of the C-frame, respectively) and were compared in Figure 2.2.2.3. Intensity of transmitted UGWs conflicts strong towards one direction than the other through symmetric waveguide, which was an unexpected behavior based on the energy results seen in Figure 2.2.2.3: transmitted wave energy was not simply stronger towards one direction, left or right (see direction defined in Figure 2.2.2.3).

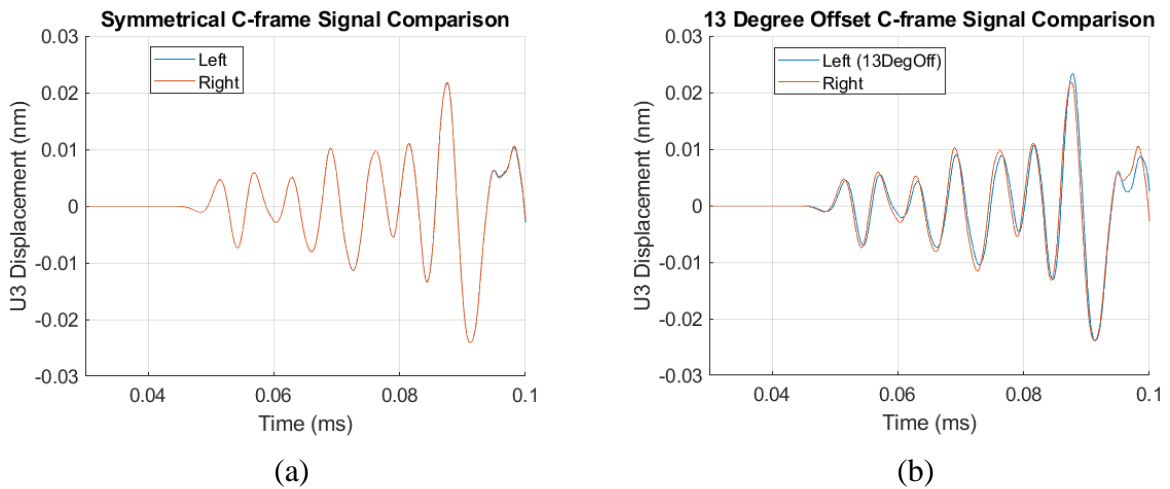
Figure 2.2.2.5. FE model guided wave simulation results of pristine C-frame (a) no angle offset (b) 13 degrees angle offset on a single ply for 150 kHz test frequency

Figure A.1.1.1. Second ply was changed from 0 to 13 degree ply angle at a partitioned region (results shown in Figure 2.2.2.5)

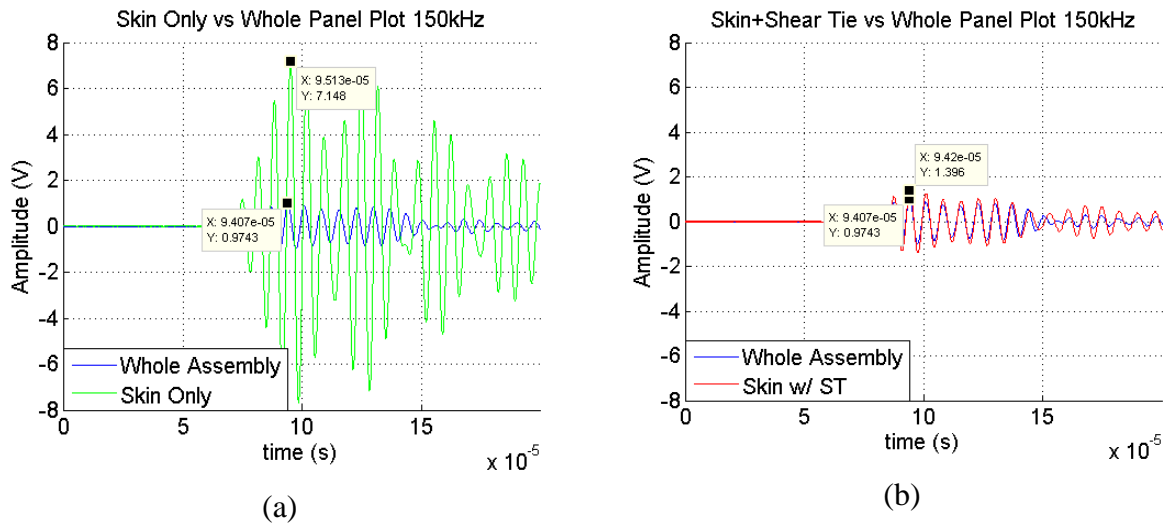
Figure 2.2.2.7. Systematic UGW test results at 150 kHz: (a) Full assembly vs C-frame + Shear Tie disassembled and (b) C-frame disassembly vs C-frame + Shear Tie disassembly

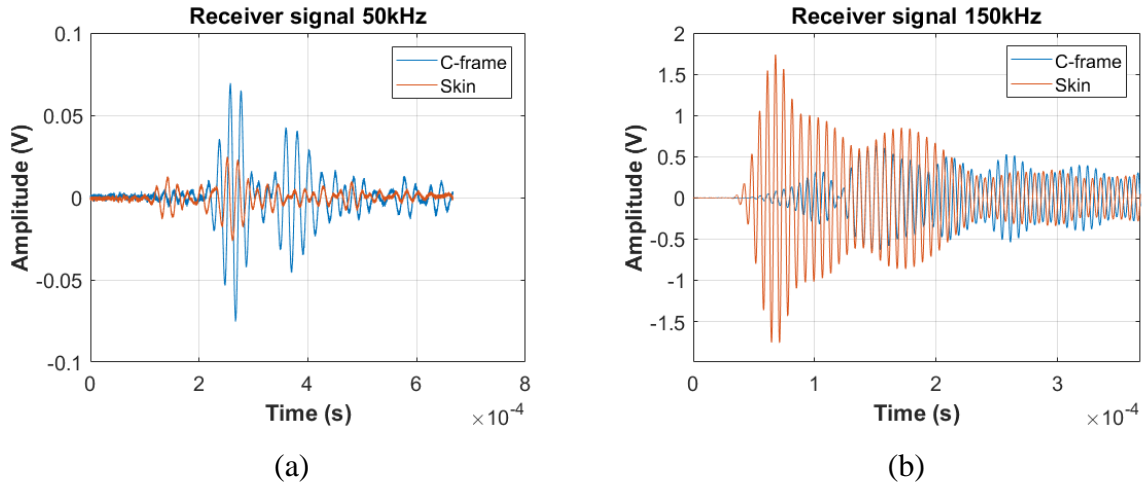
Figure 2.2.2.8. Frame02 Panel UGW test raw signals comparison between receiver on skin surface and on C-frame at (a) 50 kHz and (b) 150 kHz

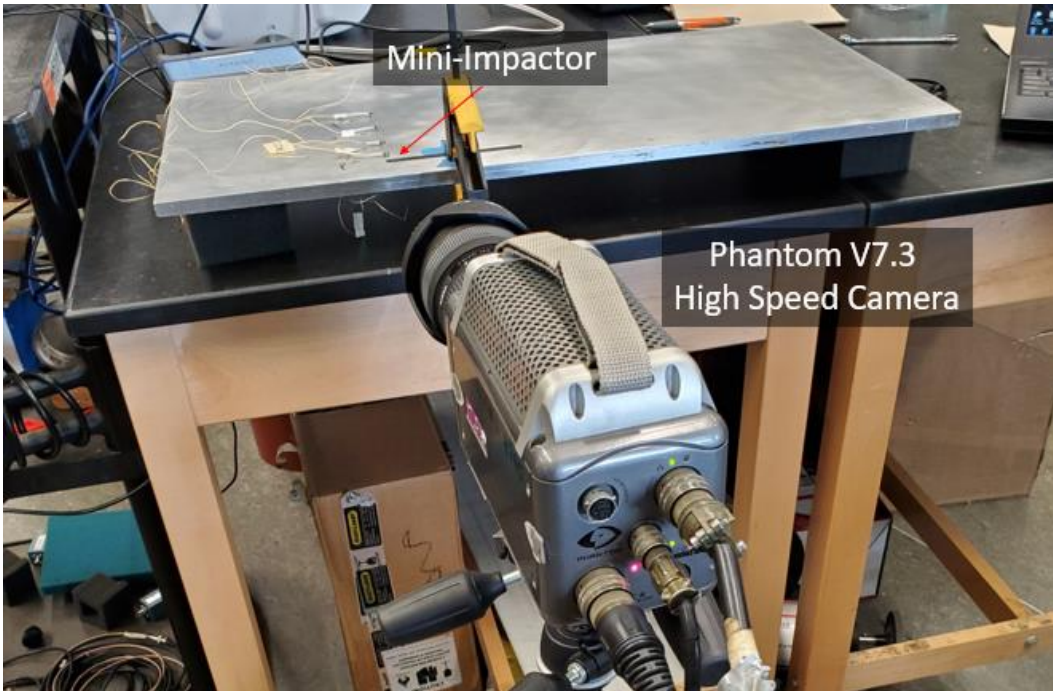
Figure 2.3.1.2. Mini-impactor test with high-speed camera

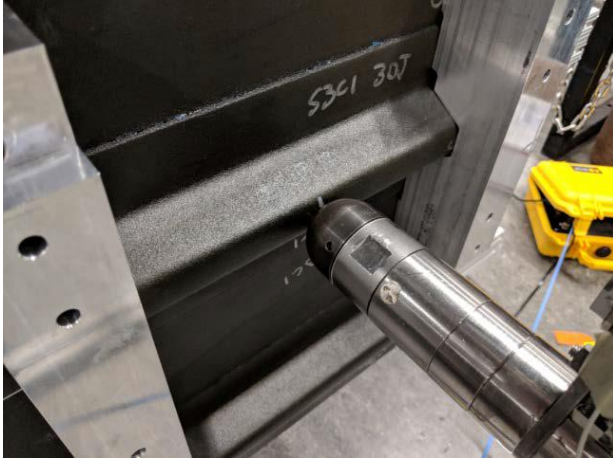
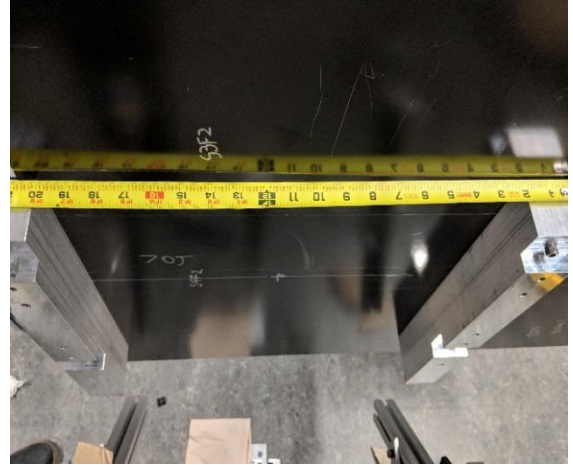
Figure 3.2.1.1. FSPs fixed onto the pendulum impactor for (a) cap and (b) flange impact

FSP1 was blunt impacted on the caps of the stringers at “target” impact levels of 30, 50, and 70 J at the center of 254 mm span distance between fixed inner ends for each designated regions as shown in Figure 3.2.1.1.a. Similarly, FSP2 was blunt impacted on stringers’ flanges at the center of 457 mm span distance of fixture inner ends (see Figure 3.2.1.1.b). Impacts on the stringer flange were performed from external skin-side at “target” impact levels of 70 and 90 J. Total of 12 impacts and 4 impacts were executed on stringer cap of the 12 regions on FSP1 and on stringer flange of the 4 regions on FSP2, respectively.

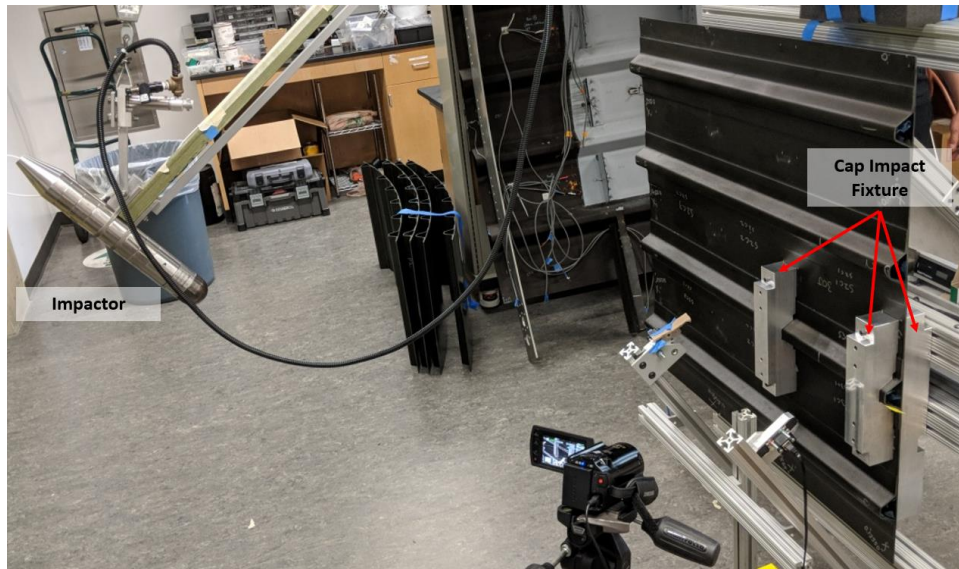
Figure 3.2.1.2. Pendulum impactor setting for the cap impact at region S3C1 for 30 J target impact

Blunt impacts were conducted on the pendulum impactor with a hemispherical metal impactor tip, 50.8 mm in diameter, with stack of masses added to the impactor (Figure 3.2.1.2). Dytran 1060V5 force sensor assembled on the impactor was used to acquire force response. A whole panel was fixed onto the pendulum impact fixture with the clamping-type aluminum bracket fixture on inner and outer skin surfaces [30]. Angular position, α , of the impactor (Equation (3.2.1.1)) was controlled and measured with an absolute encoder to estimate the height required for the target impact levels ($\alpha = 0$ at rest of the pivoting bar, vertical position). Impact levels were calculated from potential energy Equation (3.2.1.2) with effective mass of the impactor, m_{imp} , and length of the pivoting bar, L_B . True impact energies were calculated from the kinetic energy Equation (3.2.1.3) based on the velocity of the impactor, v_{in} , measured using the laser sensor photogate just before the impact. Details about the impact are summarized in Table 3.2.1.1.

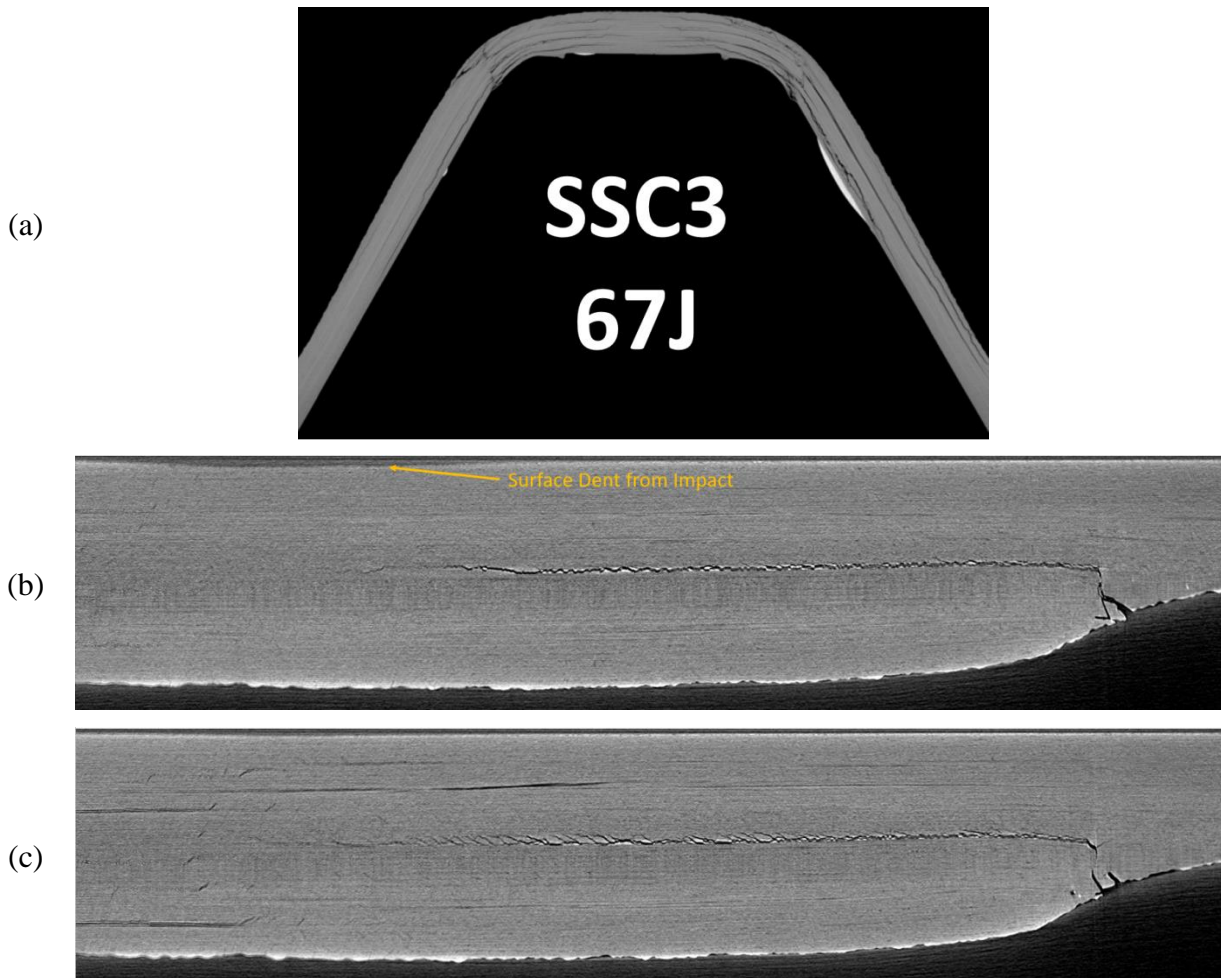
Figure 3.2.2.4. Cross-sectional CT scan image of the (a) 67 J cap-impacted SSC3, and (b) 65 J flange-impacted S4F1 at COI and (c) 1.5 cm away from COI [30]

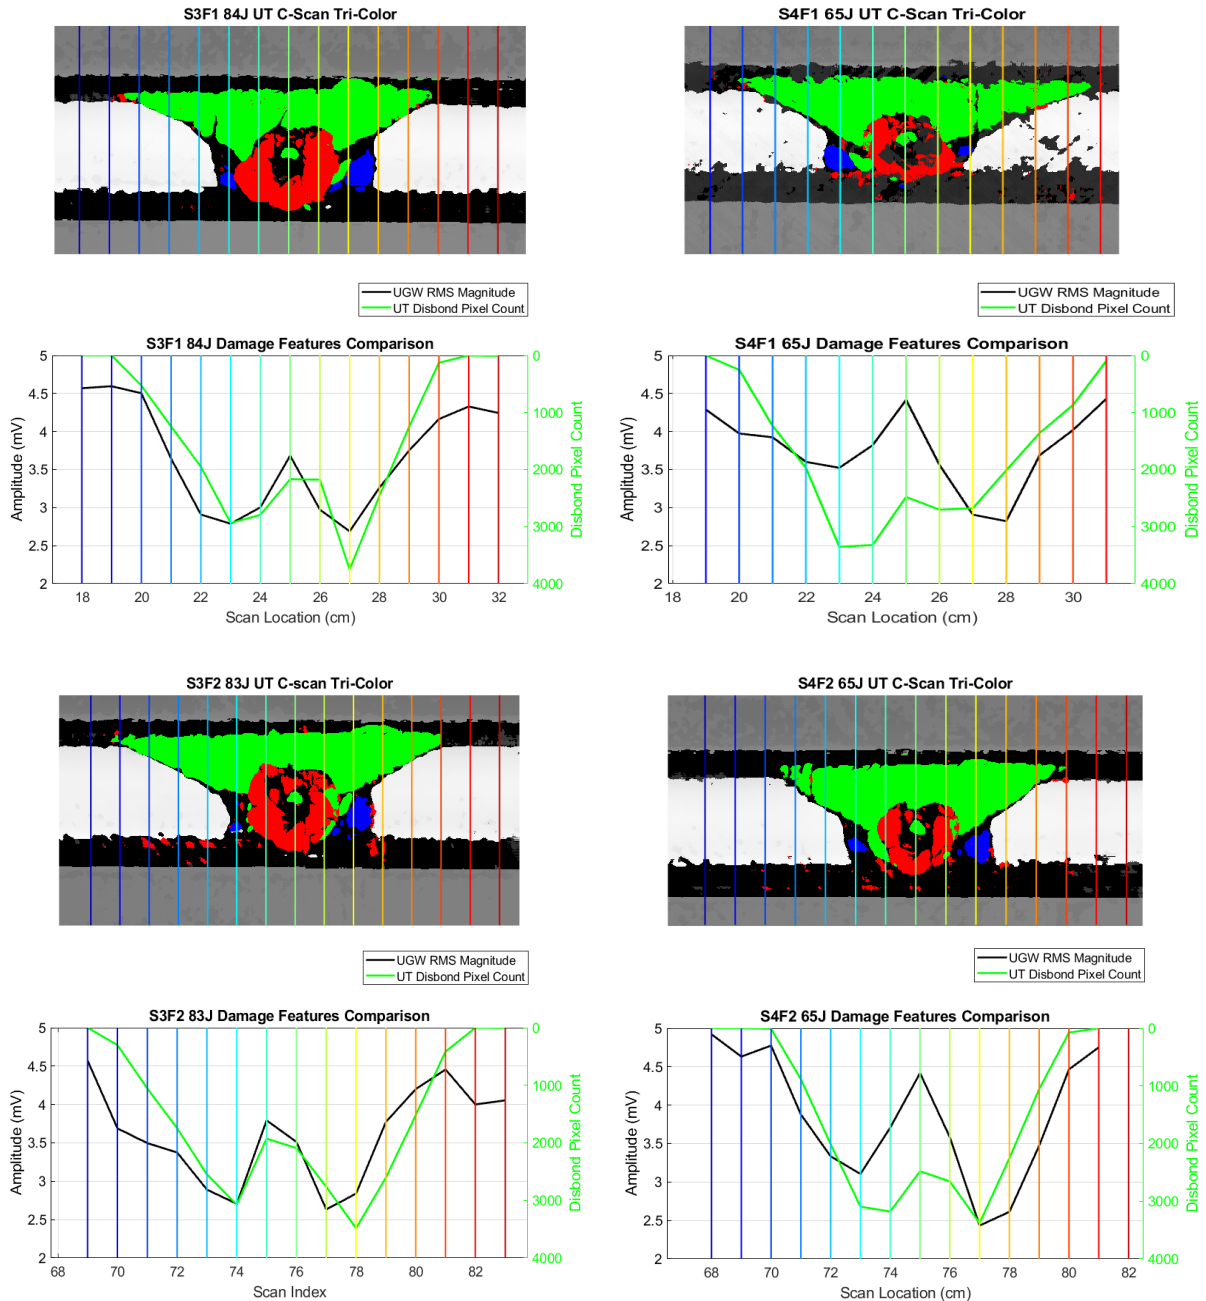
Figure 3.3.2.1.4. UGW RMS compared to UT C-scan disbond damage pixel count

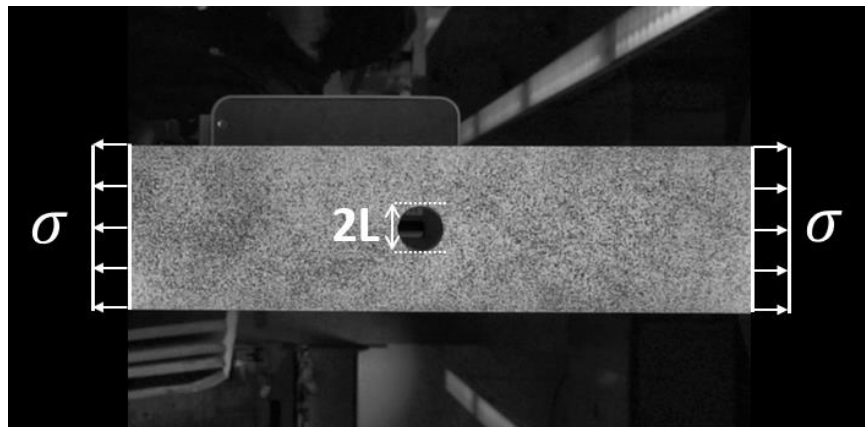
Figure 4.1.1. OHT tension test coupon with DIC speckle pattern

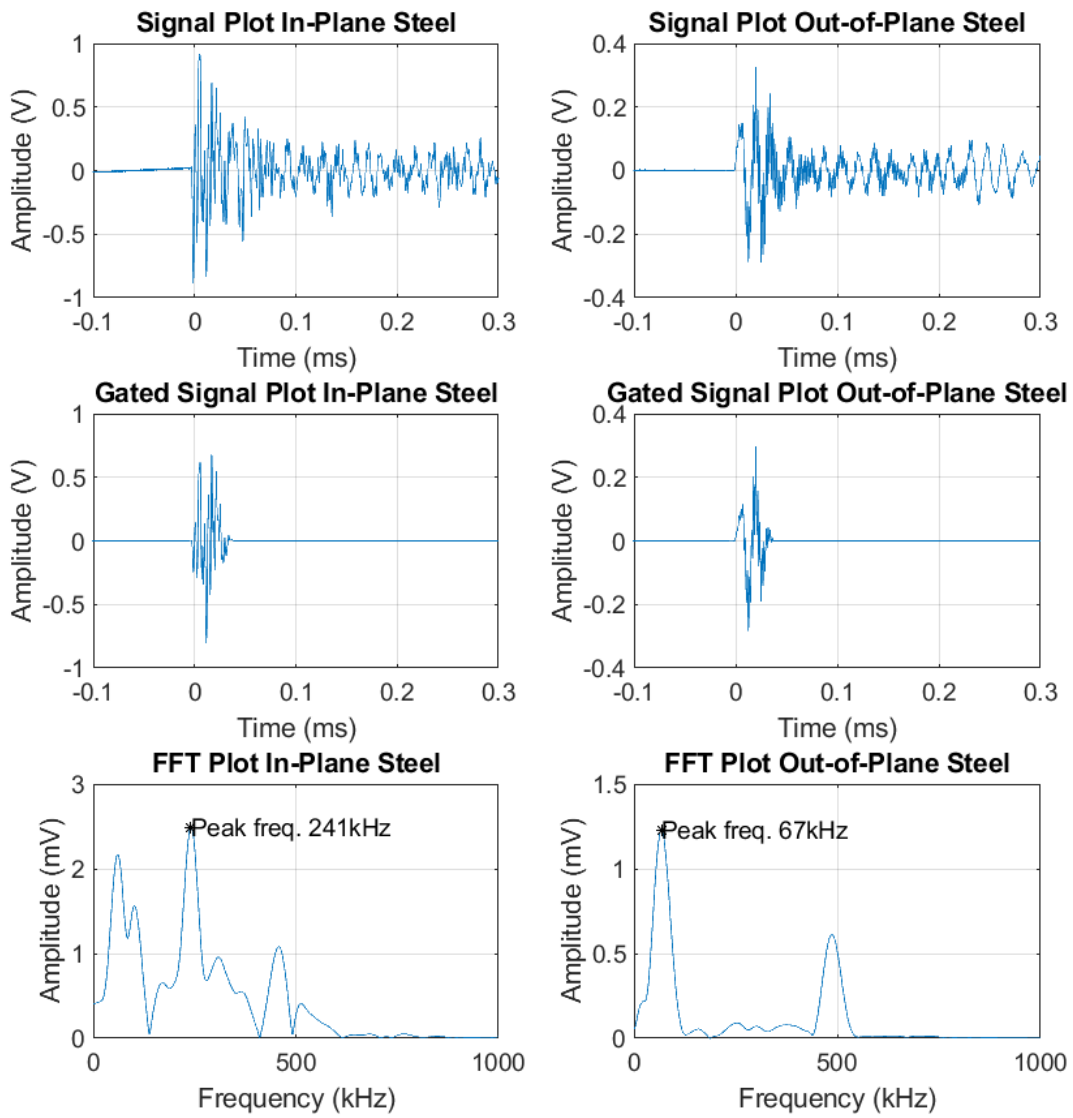
Figure B.2.7. Response on steel plate with the mini-Impactor with 0.5 mm thickness tip
