Laboratory Evaluation of Corrosion Resistance of Steel Dowels in Concrete Pavement

Research Report: UCPRC-RR-2005-10

Work Conducted as part of Partnered Pavement Research Center Strategic Plan  
Element No. 4.8: Dowel Bar Retrofit Rehabilitation of Rigid Pavements

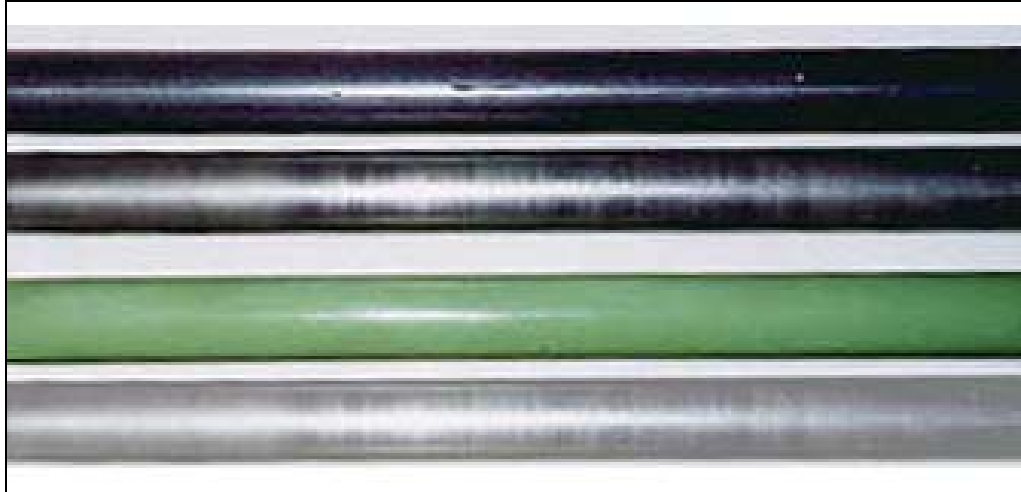
**Figure 3. Steel dowel types investigated in Phase I. From top to bottom: carbon steel, stainless steel clad, carbon steel coated with bendable epoxy, and stainless steel hollow.**

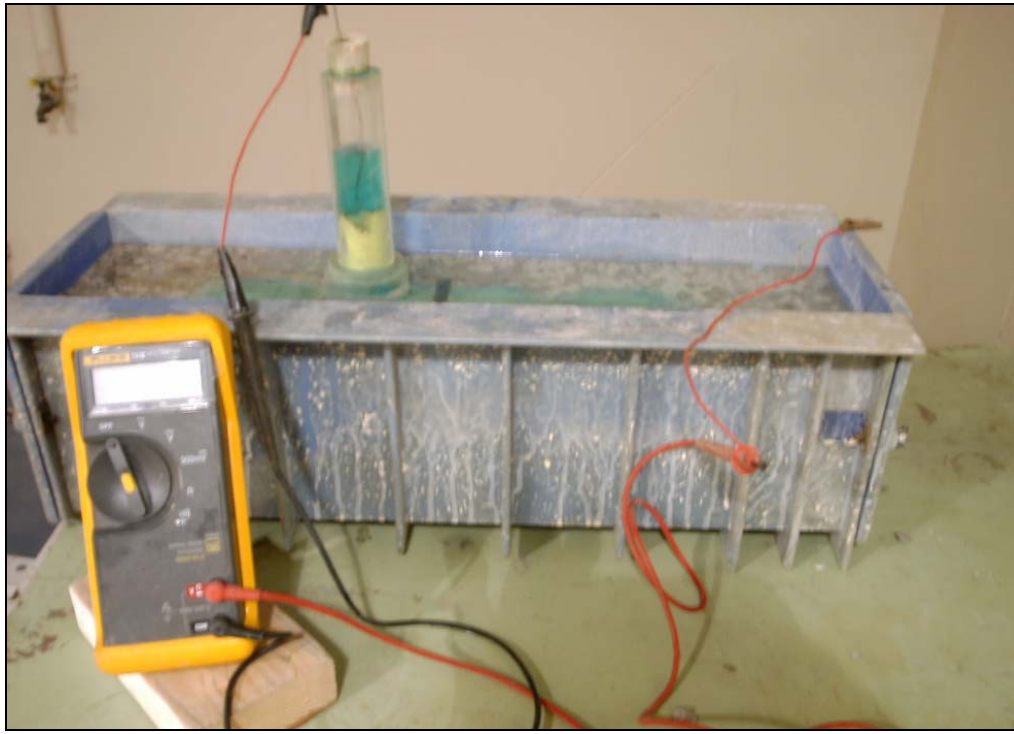
**Figure 5. Half-cell potential test using a high impedance (10 Meg-Ohm) voltmeter, and a copper/copper sulfate reference cell.**

concrete surface before the electrical measurements were performed. As previously noted, three replicates for each type of steel dowel were tested. Figure 5 illustrates the experimental setup. Details of the half-cell potential test are included in APPENDIX A: Detection Techniques.

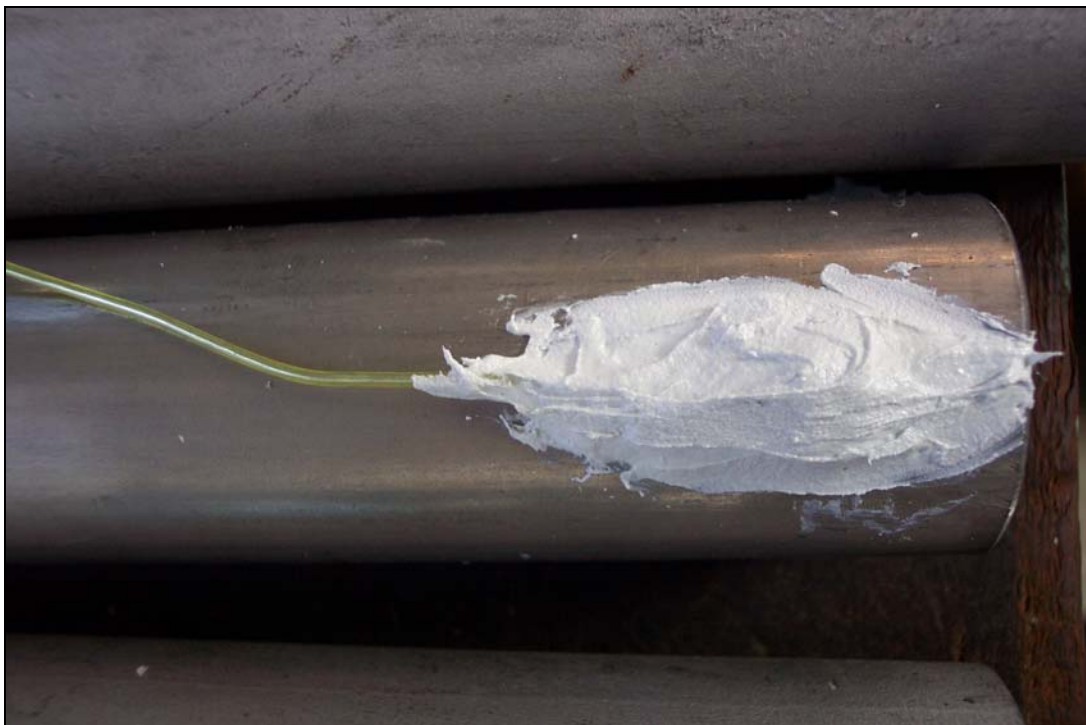
**Figure 8. Electrical connections made to the stainless steel hollow specimens. Connections were made at the side of the dowel (a) and sealed with epoxy (b) before casting.**

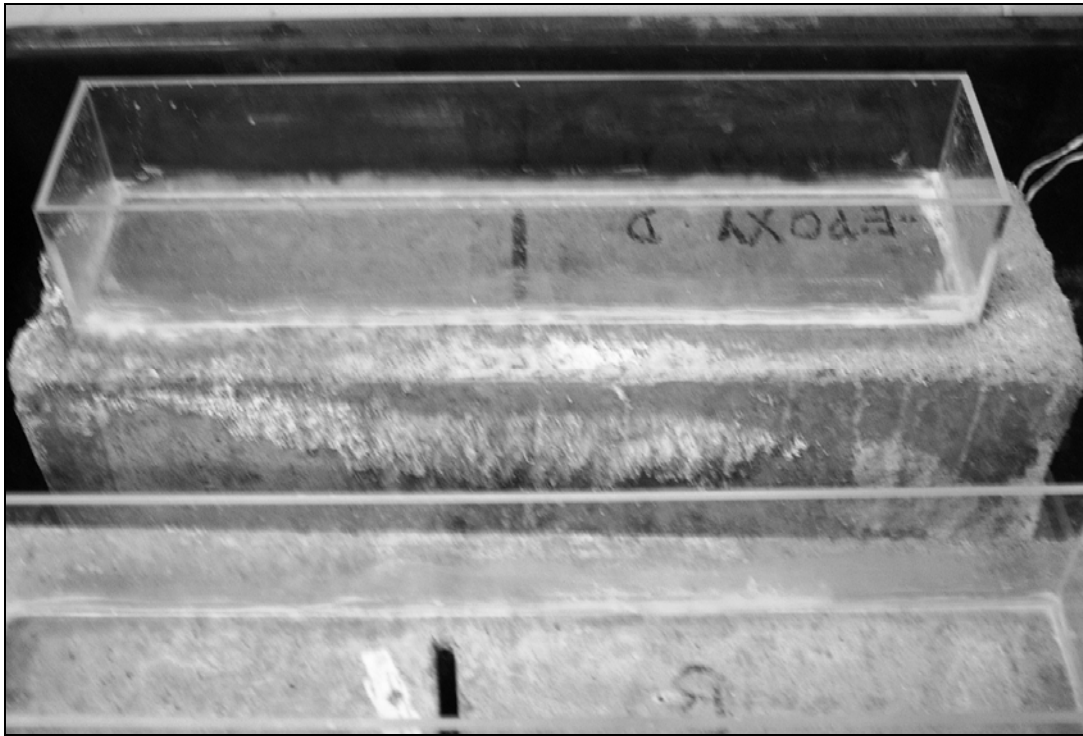
**Figure 10. Picture of the experimental setup illustrated in Figure 9.**

In the Phase II testing, corrosion was accelerated by exposing the samples to weekly wet-and-dry cycles of a 3.5 percent NaCl solution at room temperature for a period of 18 months. Half-cell potential tests, Linear Polarization Resistance (LPR) curves, visual inspections, chloride analyses, and microscopic investigations were carried out to evaluate the corrosion performance of the dowels. Four replicates of each type of steel dowel were tested in this study. Figure 6 illustrates the different types of dowels used. The in-situ corrosion rate was measured in order to permit estimation of the service life of the dowels under the accelerated conditions. Details of the detection techniques are included in Appendix A. Figures 7 and 8 show the electrical connections. Figures 9 and 10 demonstrate the experiment setup.

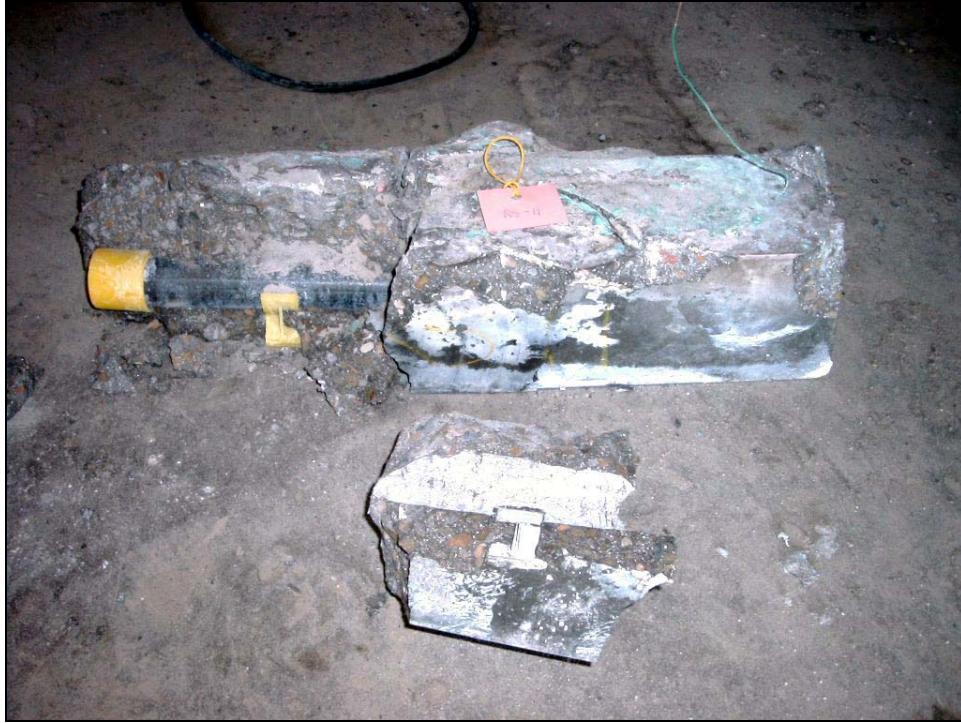
**Figure 21. Extraction of dowels for visual inspection.**

At the end of six months, the concrete beams were broken open and the dowels were retrieved and inspected. Figure 21 shows one of the concrete beams at the moment the dowel was being retrieved.

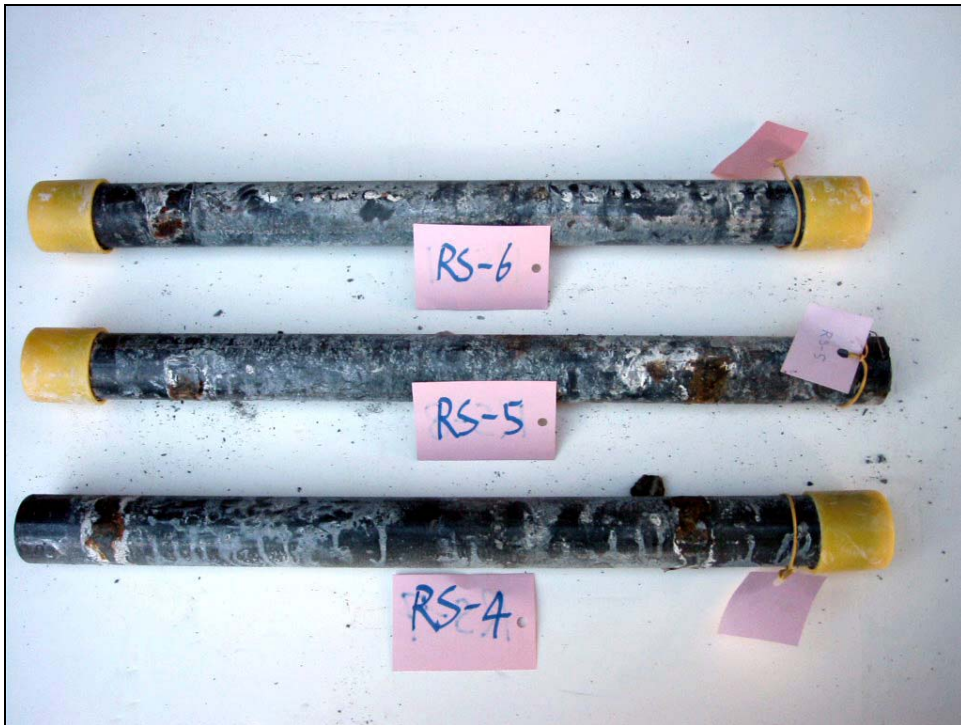
**Figure 22. Corrosion along the carbon steel bars.**

For the carbon steels exposed to chloride ponding, corrosion products were distributed along the length and perimeter of the bars for both the cold and hot conditions, as shown in Figure 22. The epoxy-coated bars had localized corrosion mostly at the ends of the bars where the coating is the most vulnerable to damage. All the epoxy-coated bars exposed to Chloride ponding, except EX-9, were corroded at the ends, as shown in Figure 23. The results matched the half-cell potential in the sense that once corrosion occurred and the coating was lifted, the measured potential was not zero anymore. No visible corrosion was found on either stainless steel hollow bars or stainless clad bars, as can be observed in Figure 24 and Figure 25.

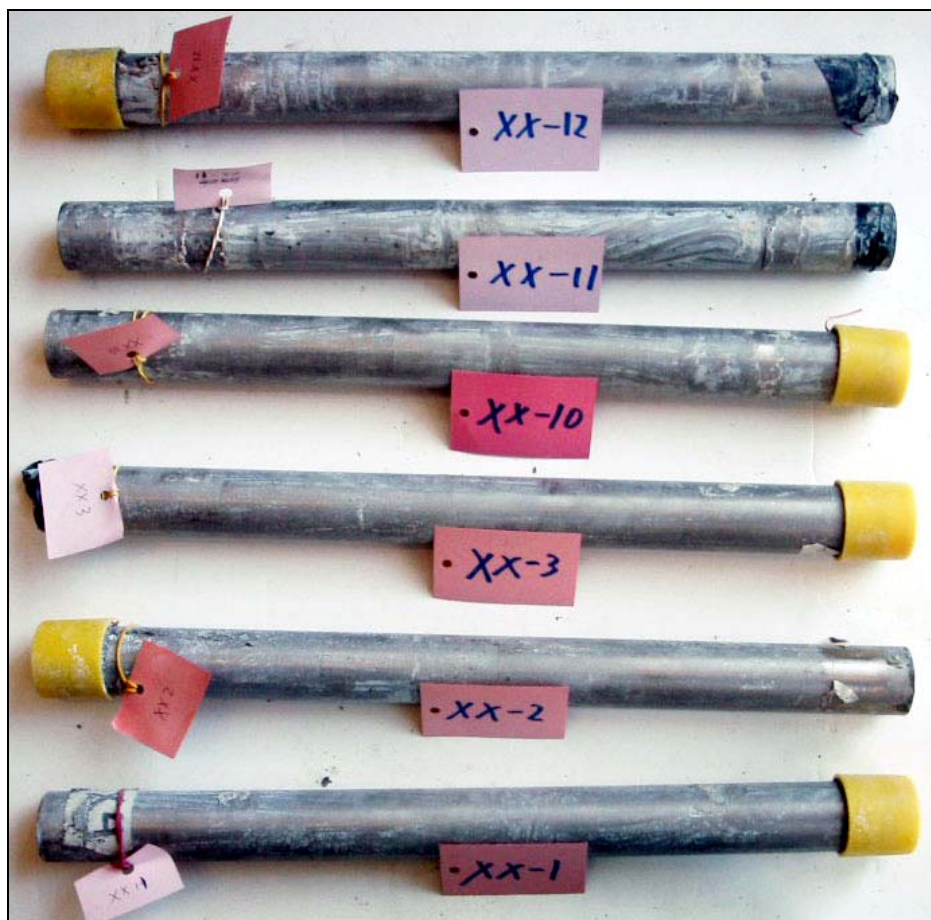
Figure 25. Appearance of stainless clad bars after tests.

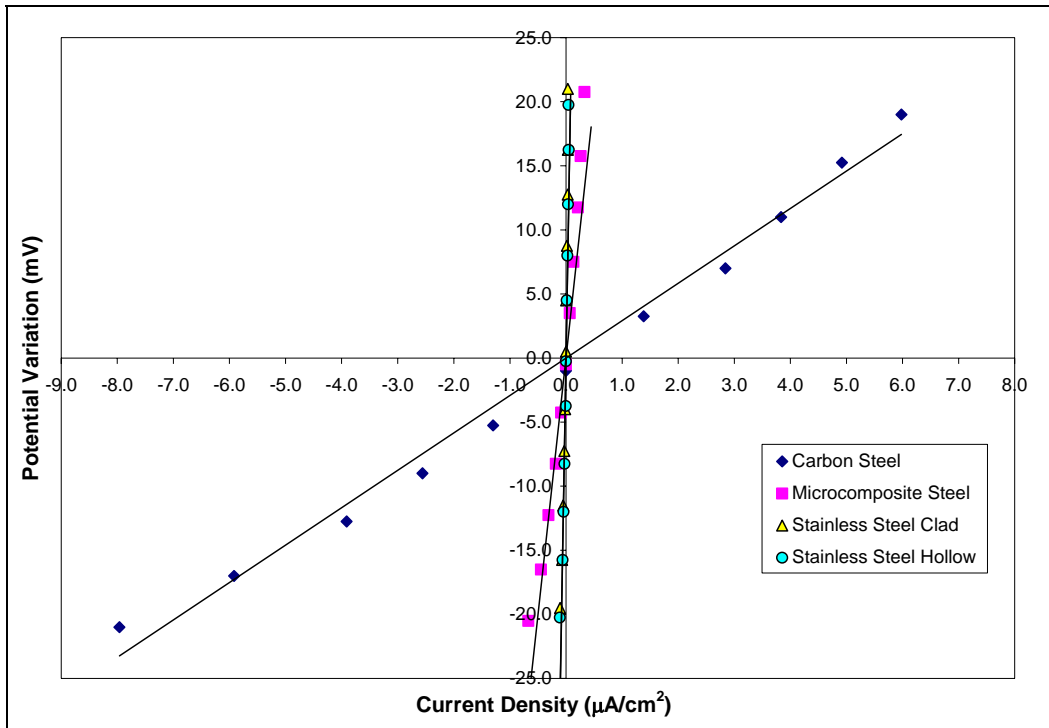
Figure 33. Summary plot showing the variation of potential and current density about the half-cell potential, for different dowels.

Regarding the half-cell potential values, note that the stainless steel hollow and stainless steel-clad specimens are, on average, located in the uncertain corrosion region, while all the other samples are in the active corrosion region (refer to Table 1).

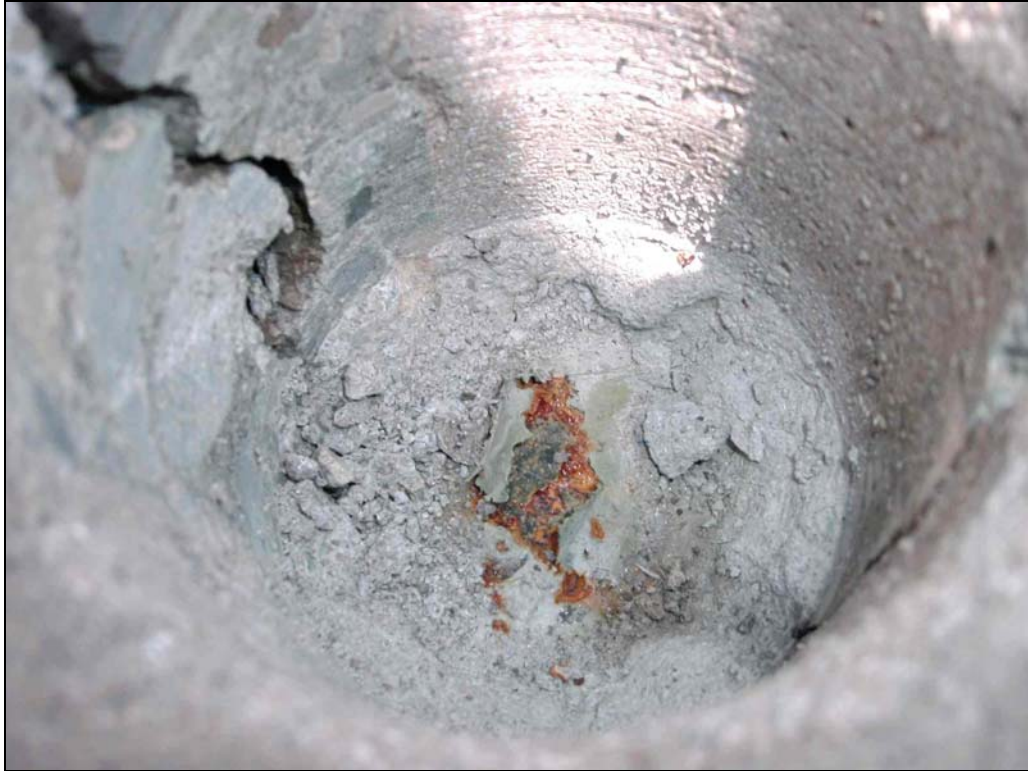
**Figure 55. View of the interior of a recently made core hole showing corrosion products underneath the epoxy coating.**

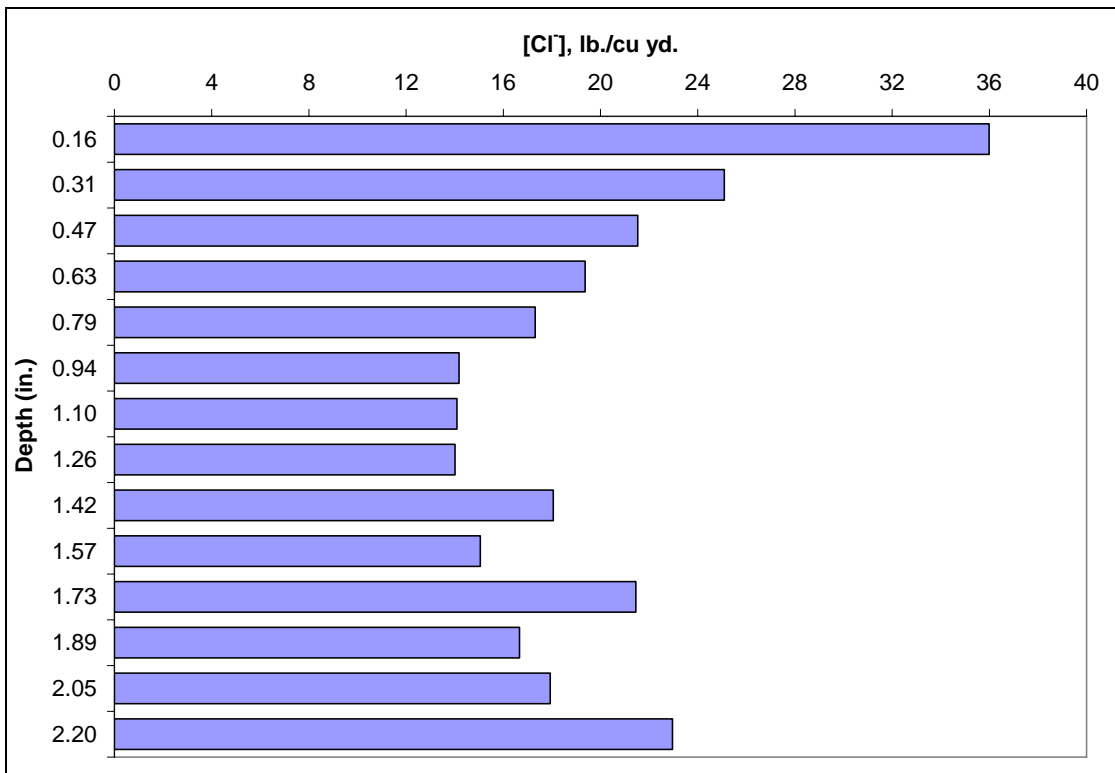
Figure 68. Chloride profile on the concrete of a stainless hollow specimen.

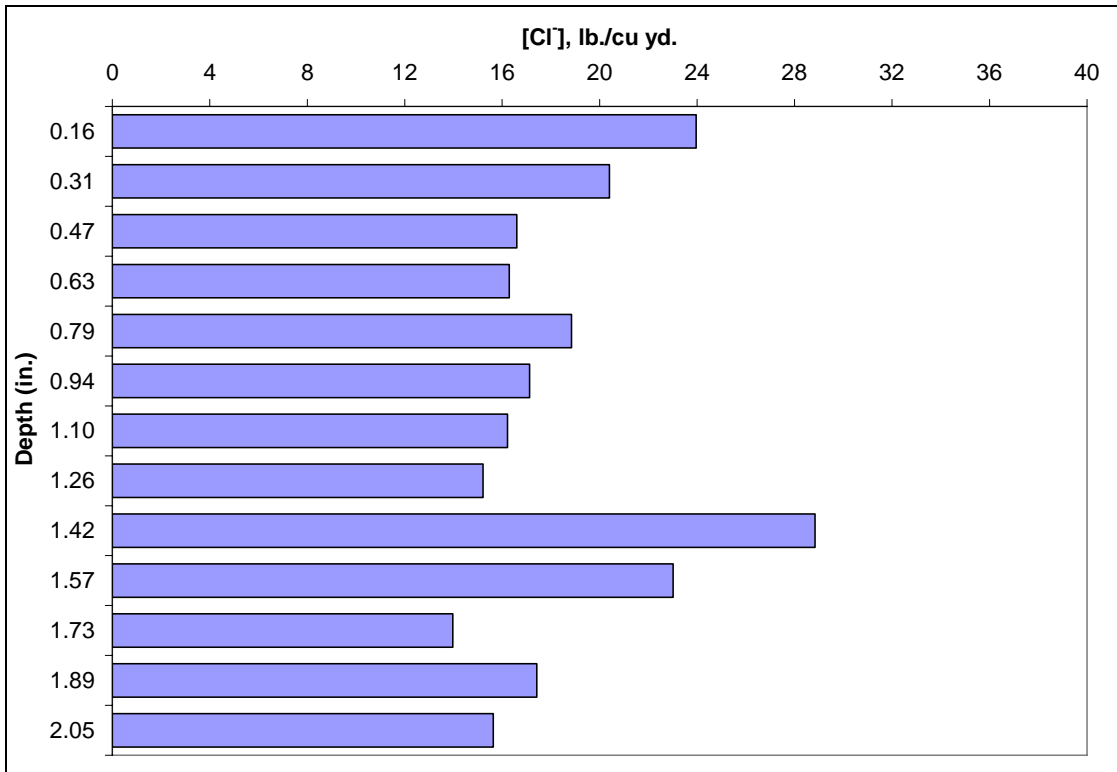
**Figure 69. Chloride profile on the concrete of a flexible (green) epoxy-coated specimen.**
