Warm-Mix Asphalt Study: First-Level Analysis of Phase 2 HVS and Laboratory Testing, and Phase 1 and Phase 2 Forensic Assessments

Partnered Pavement Research Program (PPRC) Contract Strategic Plan Element 4.18:
Warm-Mix Asphalt

California Department of Transportation
Division of Research and Innovation
Office of Roadway Research

University of California
Pavement Research Center
UC Davis, UC Berkeley

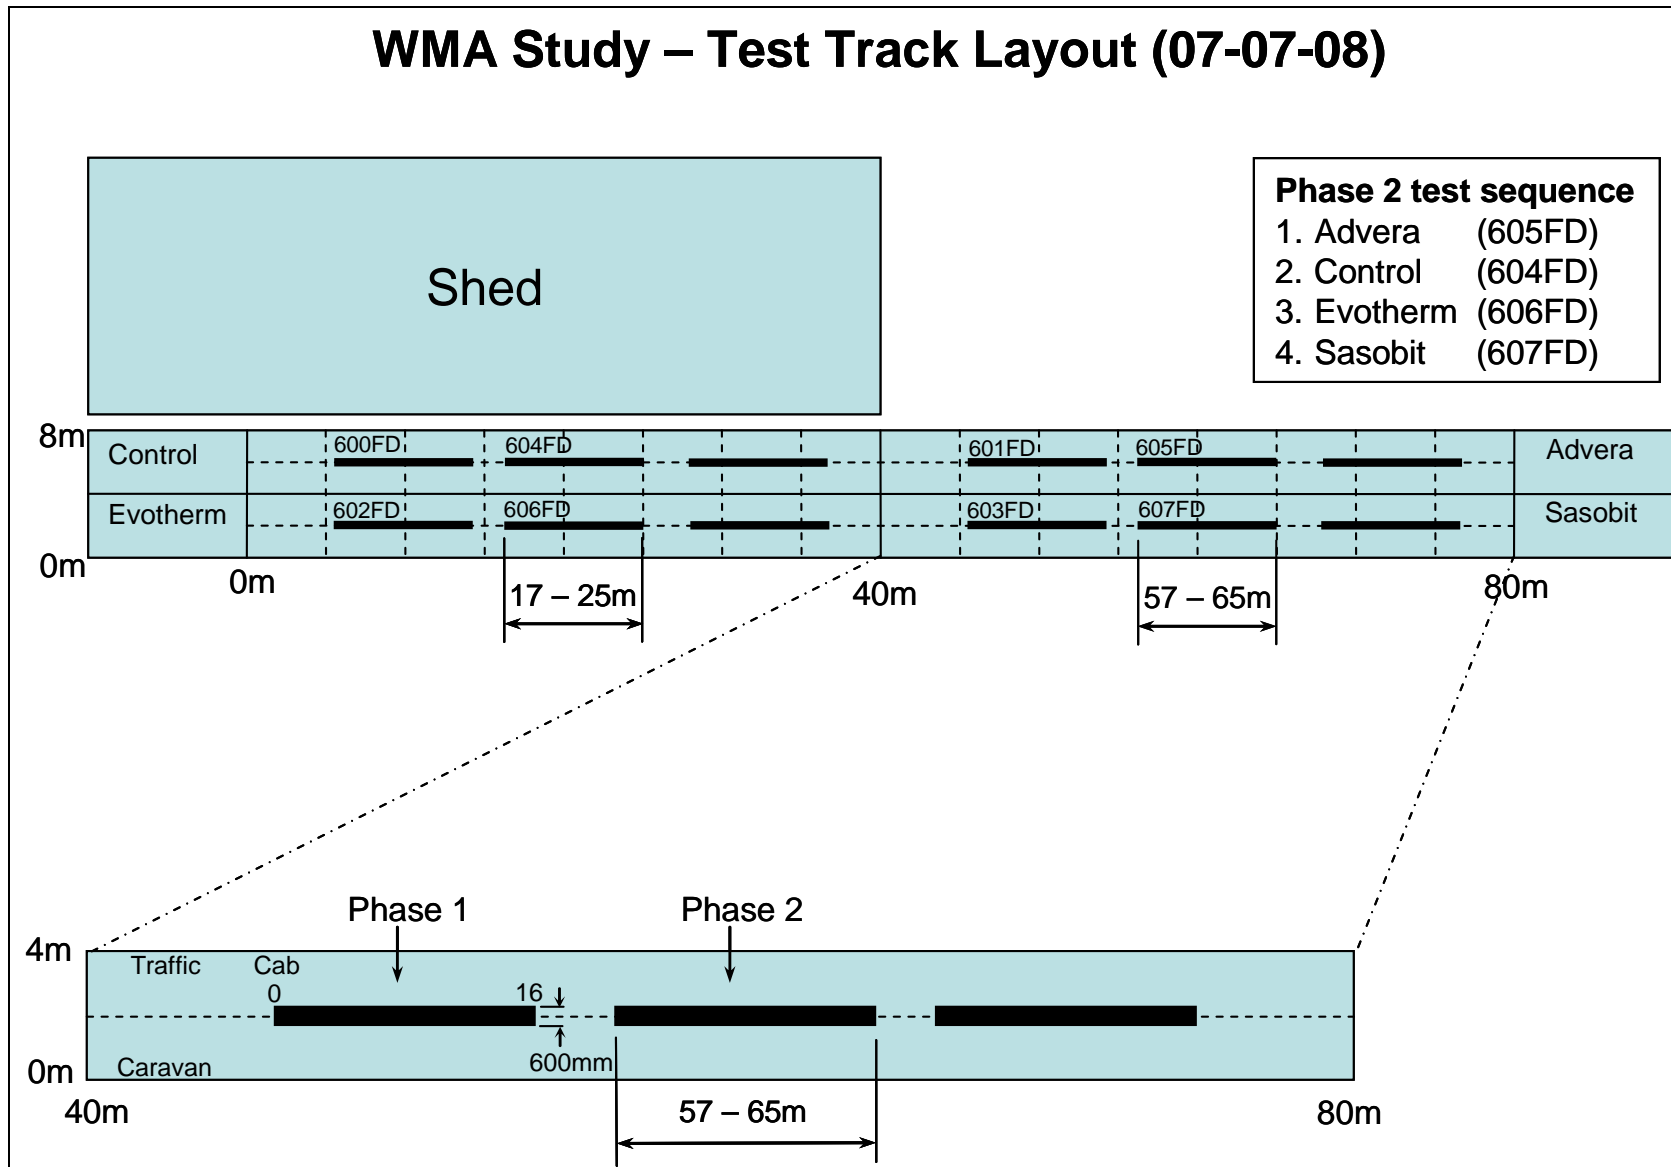
Figure 3.1: Layout of test track and HVS test sections.

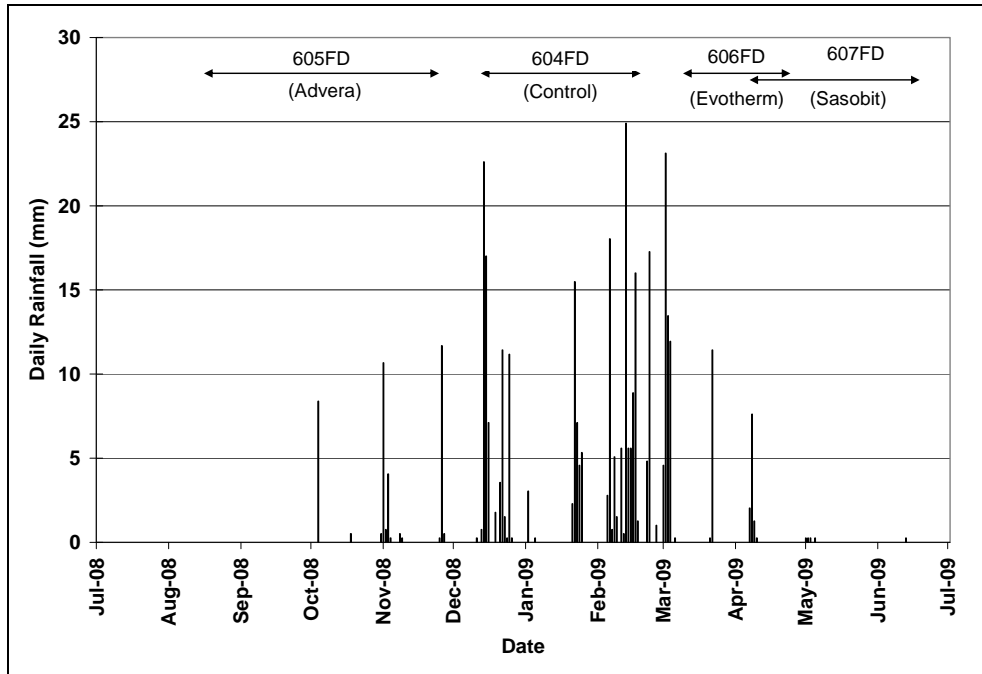
Figure 4.2: Measured rainfall during Phase 2 HVS testing.

Section	Overlay	Rain days	Total (mm [in.])	Highest 24 Hour (mm [in.])
604FD	Control	32	212.4 (8.36)	24.9 (0.98)
605FD	Advera	9	25.9 (1.02)	10.7 (0.42)
606FD	Evotherm	6	22.9 (0.90)	11.5 (0.45)
607FD	Sasobit	9	12.4 (0.49)	7.6 (0.30)

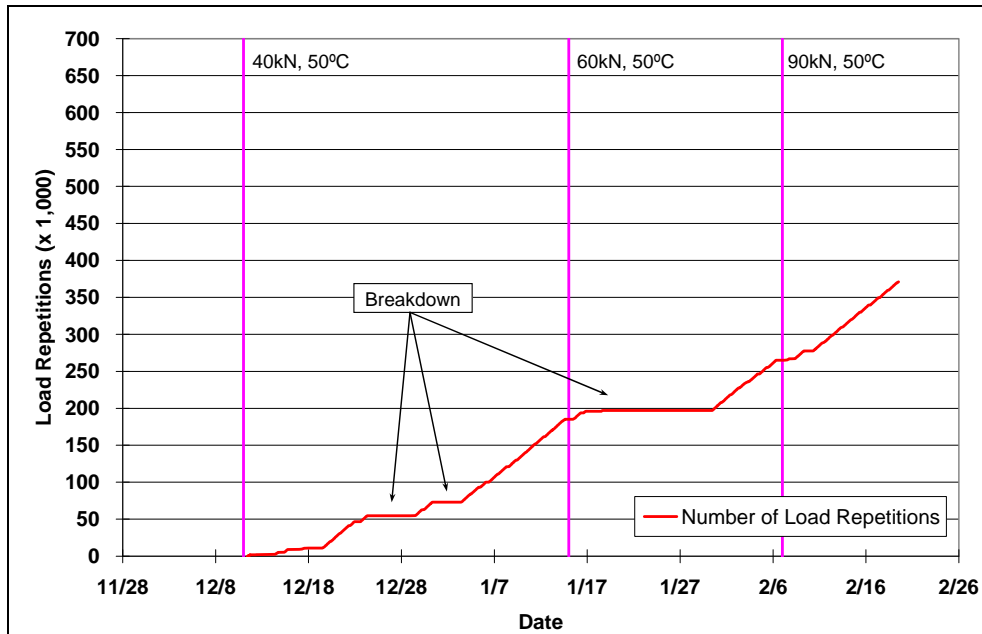
Figure 4.4: 604FD: Load history.

Loading commenced on December 11, 2008, and ended on February 19, 2009. A total of 371,000 load repetitions were applied and 64 datasets were collected. Testing was interrupted on three occasions during equipment breakdowns. The HVS loading history for Section 604FD is shown in Figure 4.4.

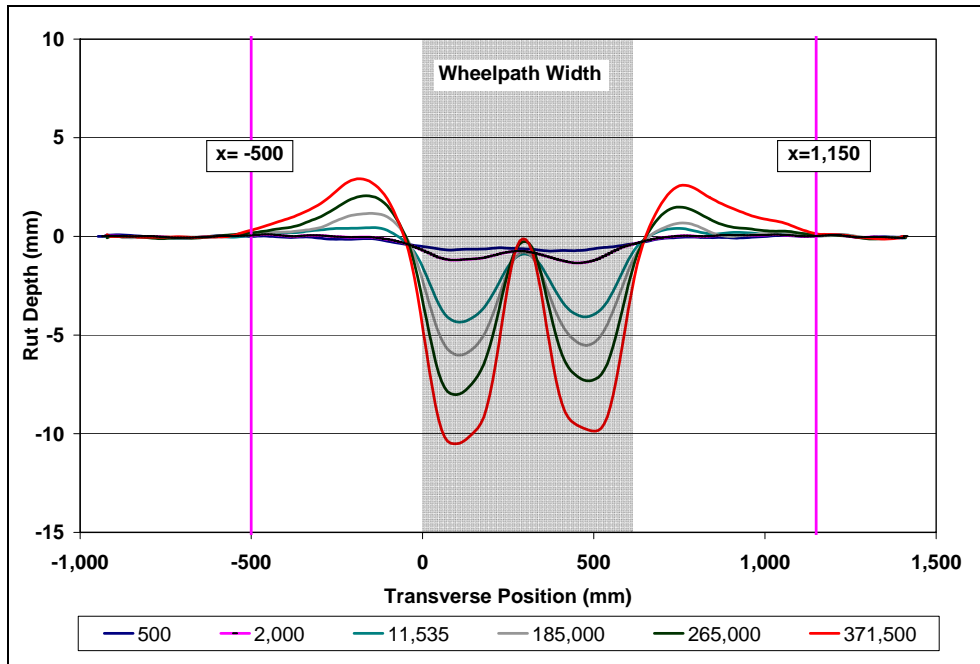
Figure 4.8: 604FD: Profilometer cross section at various load repetitions.

Figure 4.8 shows the average transverse cross section measured with the Laser Profilometer at various stages of the test. This plot clearly shows the increase in rutting and deformation over the duration of the test. The average height of displaced material (i.e., above the pavement surface) was less than 5.0 mm (0.2 in.), while the depth of deformation (i.e., below the pavement surface) was about 10 mm (0.4 in.).

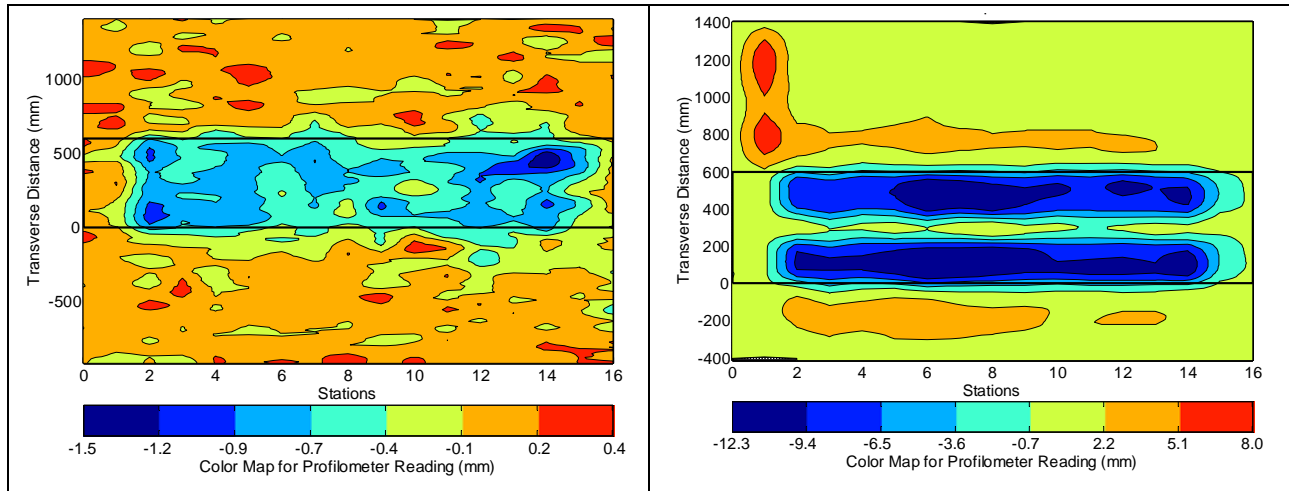
Figure 4.11: 604FD: Contour plot of permanent surface deformation at start and end of test.
(Note that scales are different.)

Figure 4.11 shows a contour plot of the pavement surface at the beginning (after 500 repetitions) and at the end of the test (371,000 repetitions), also indicating minimal variation along the section. After completion of trafficking, the average maximum rut depth and the average deformation were 13.5 mm (0.5 in.) and 8.6 mm (0.33 in.), respectively. The maximum rut depth measured on the section was 16.2 mm (0.64 in.), recorded at Station 6.

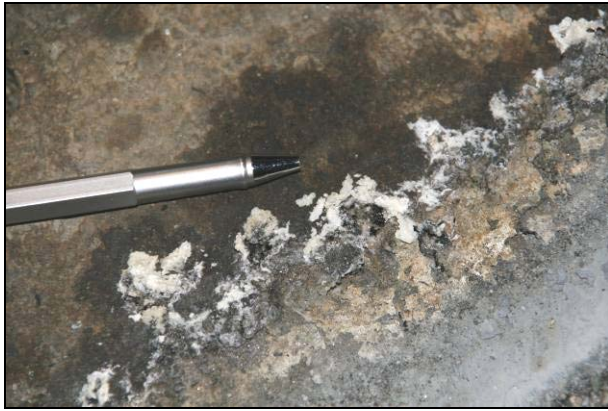
Figure 4.14: 604FD: Crystallized salt on edges of wheelpaths during testing.

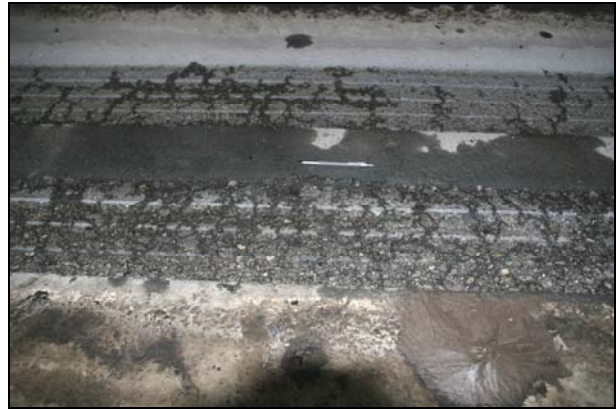
Figure 4.15: 604FD: Cracks in wheelpaths during testing.

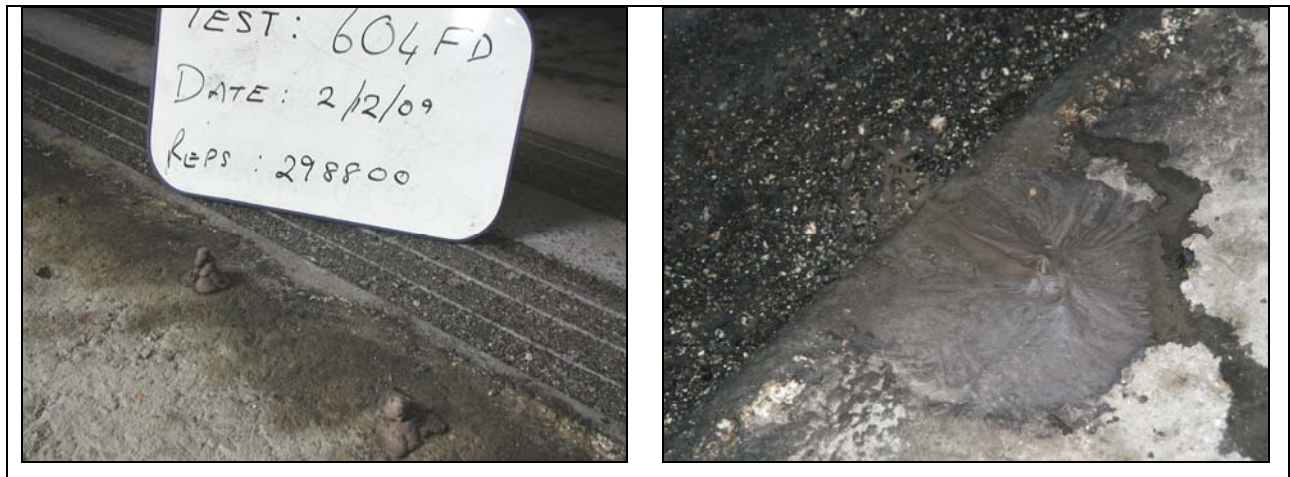
Figure 4.17: 604FD: Fines pumped from holes drilled for presoaking.

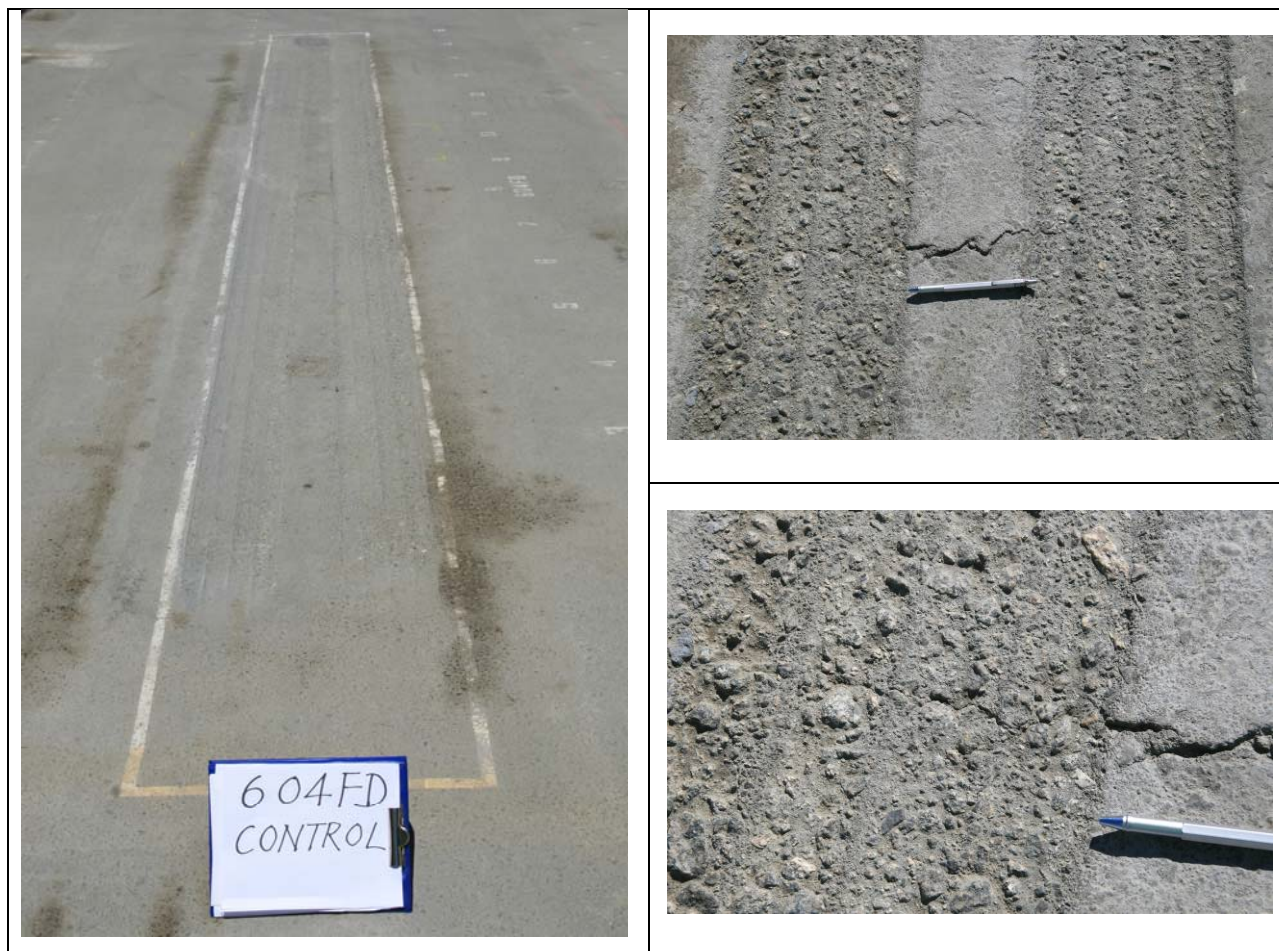
Figure 4.18: 604FD: Section photographs at test completion.

- Although some “wear” (attributed to the channelized traffic and constant water flow) was noted on the surface (Figure 4.18), no aggregate stripping, ravelling or other evidence of moisture damage was noted during or after the test.

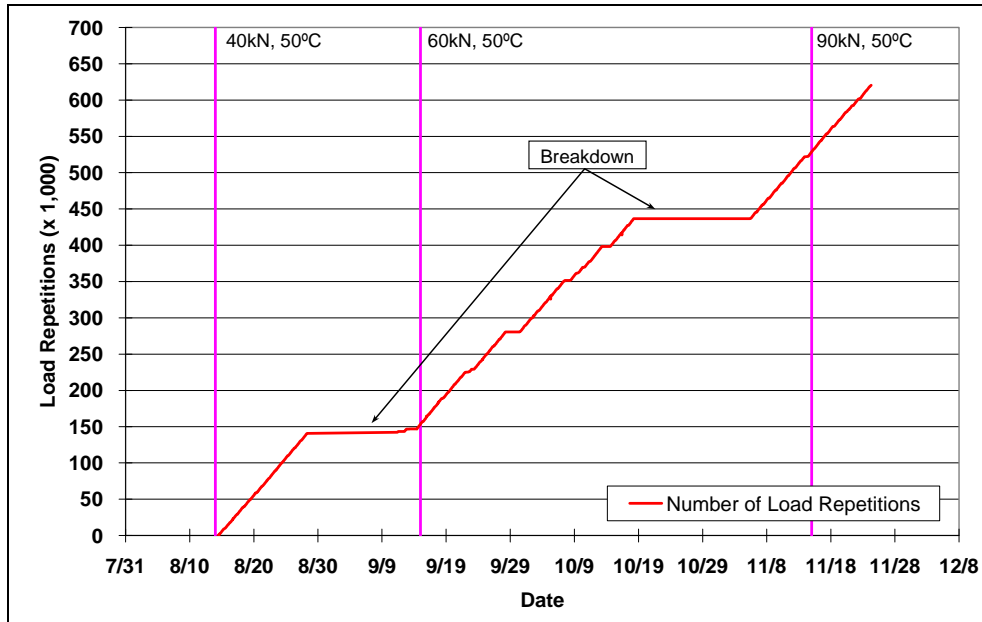
Figure 4.19: 605FD: Load history.

Loading commenced on August 14, 2008, and ended on November 19, 2008. A total of 620,500 load repetitions were applied and 73 datasets were collected. Almost 250,000 more load repetitions were applied compared to the Control. In the interests of completing the project, testing was terminated prior to obtaining an average maximum rut depth of 12.5 mm (0.5 in.). The HVS loading history for Section 605FD is shown in Figure 4.19. Two breakdowns occurred during this test.

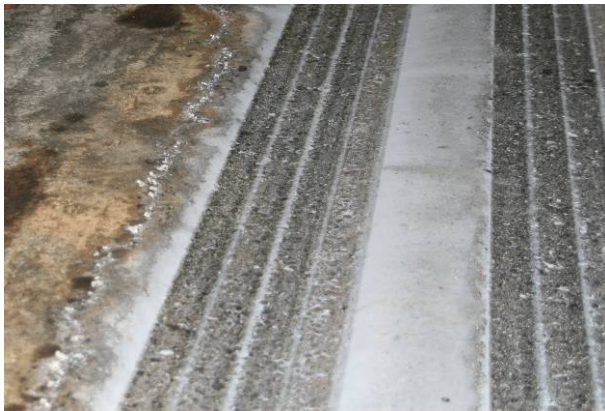
Figure 4.28: 605FD: Crystallized salt on edges of wheelpaths during early testing.

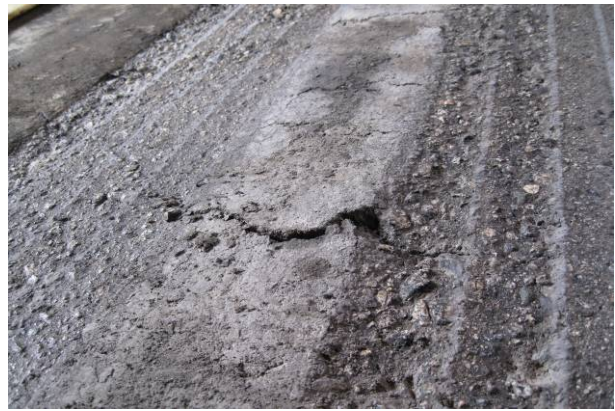
Figure 4.29: 605FD: Cracks in wheelpaths during testing.

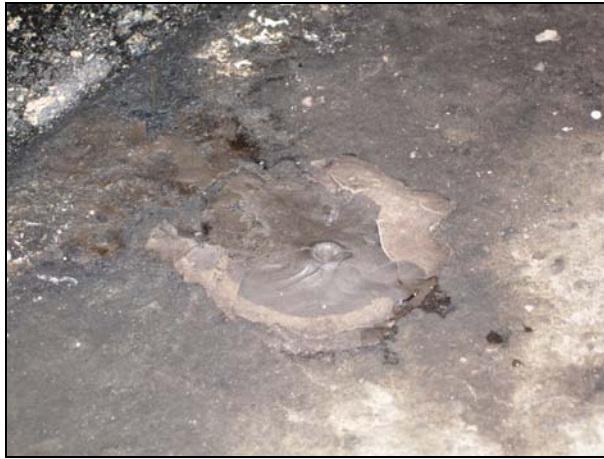
Figure 4.31: 605FD: Fines pumped from holes drilled for presoaking.

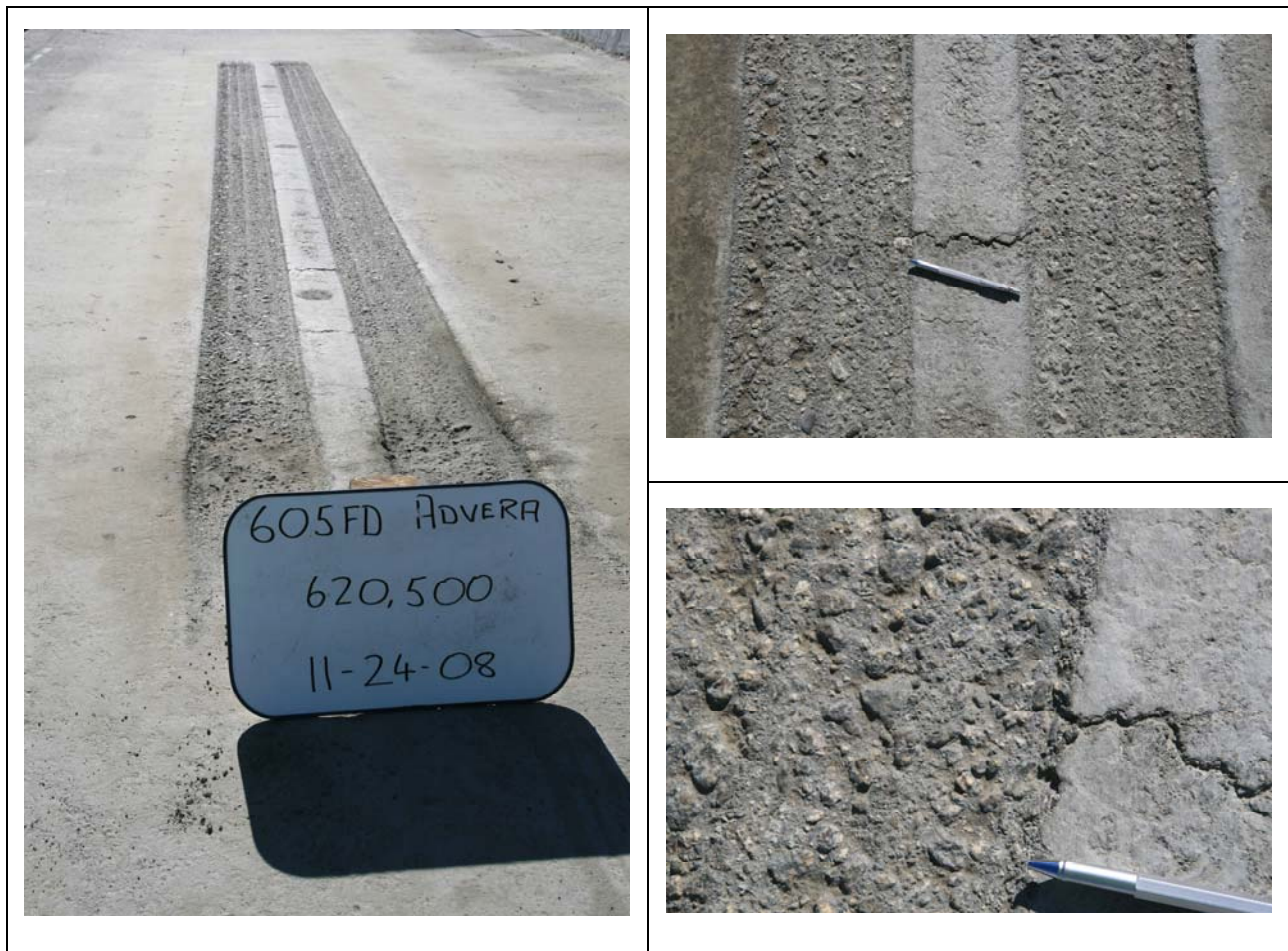
Figure 4.32: 605FD: Section photographs at test completion.

- The rutting pattern after completion of the test was typical of HVS rutting tests (Figure 4.32) and similar to that observed on the Control.
- Although some “wear” was noted on the surface (Figure 4.32), no aggregate stripping, ravelling or other evidence of moisture damage was noted during or after the test.

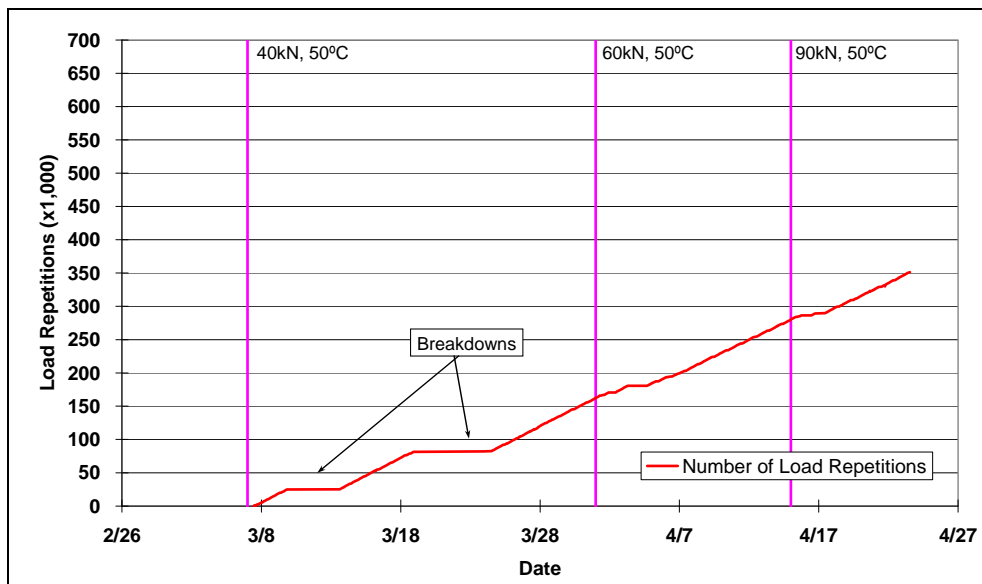
Figure 4.33: 606FD: Load history.

Loading commenced on March 07, 2009 and ended on April 24, 2009. A total of 352,020 load repetitions were applied and 58 datasets were collected. The number of load repetitions applied was very similar to the Control section. The HVS loading history for Section 606FD is shown in Figure 4.33. Two breakdowns occurred during this test.

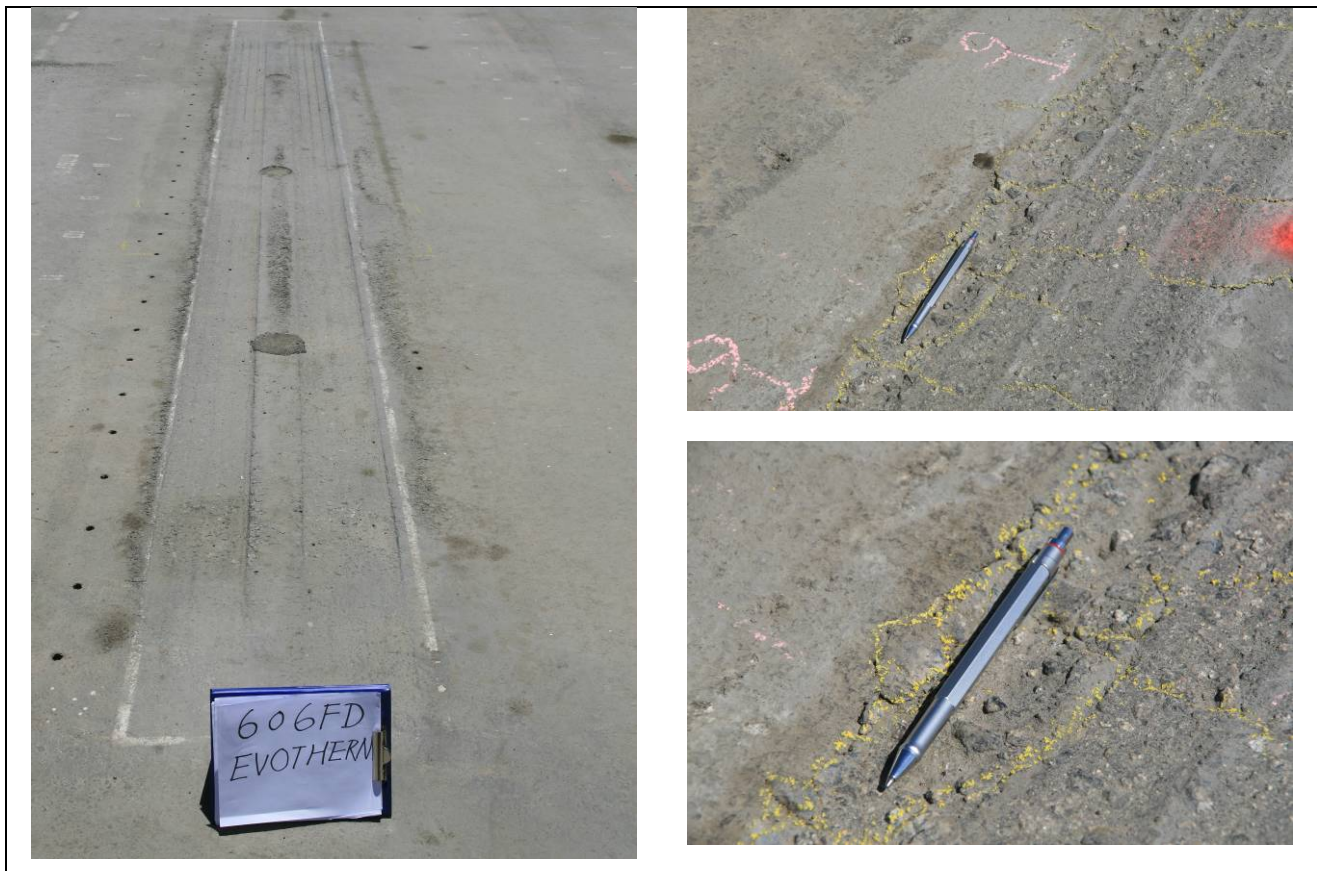
Figure 4.43: 606FD: Section photographs at test completion.

- The rutting pattern after completion of the test was typical of HVS rutting tests (Figure 4.43) and similar to that observed on the Control.
- Although some “wear” was noted on the surface (Figure 4.43), no aggregate stripping, ravelling or other evidence of moisture damage was noted during or after the test.

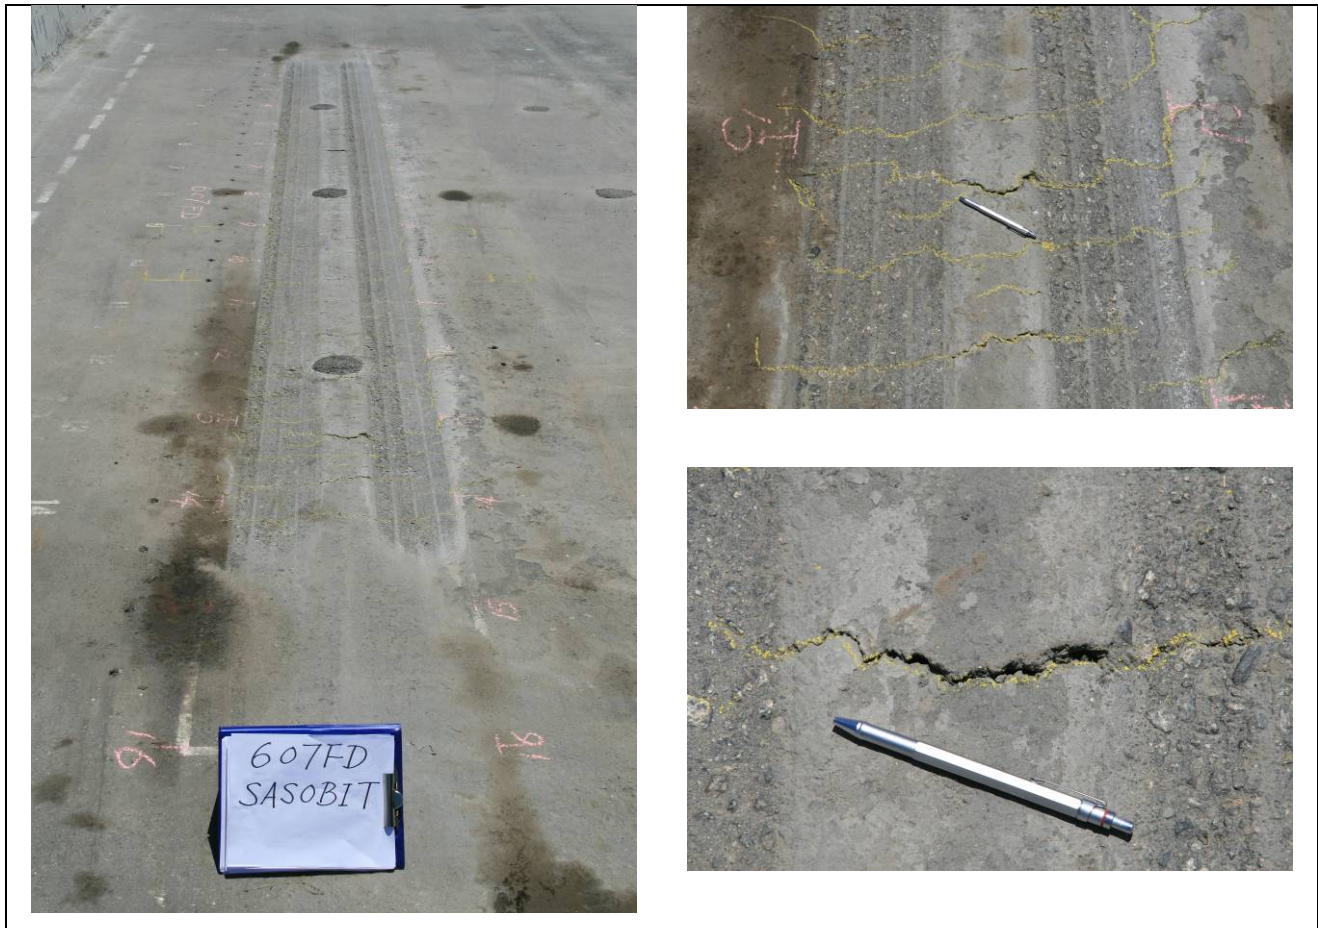
Figure 4.54: 607FD: Section photographs at test completion.

- The rutting pattern after completion of the test was typical of HVS rutting tests (Figure 4.54) and similar to that observed on the Control.
- Although some “wear” was noted on the surface (Figure 4.54), no aggregate stripping, ravelling or other evidence of moisture damage was noted during or after the test.

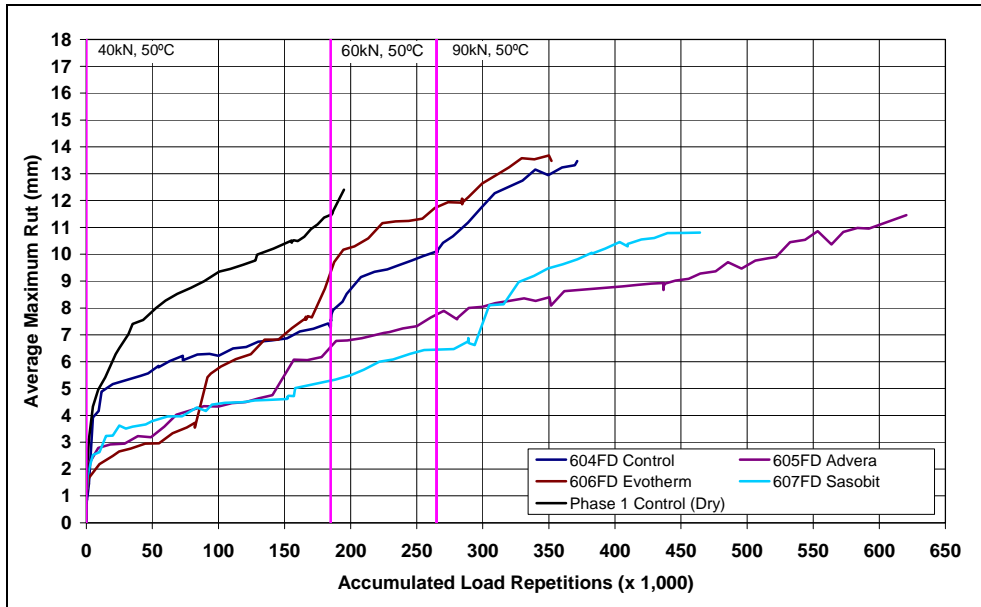
Figure 4.55: Comparison of average maximum rut.

Rutting behavior for the four sections is compared in Figure 4.55 (average maximum rut) and Figure 4.56 (average deformation). HVS trafficking on each of the four sections revealed that the duration and rut depths of the embedment phases (high early-rutting phase of typical two-phase rutting processes) on the warm-mix sections were approximately half that of the Control, a trend opposite that observed in Phase 1 (discussed in Section 4.8). This indicates that the effects of oxidation of the binder at lower production temperatures may only influence rutting performance in the first few months after construction.

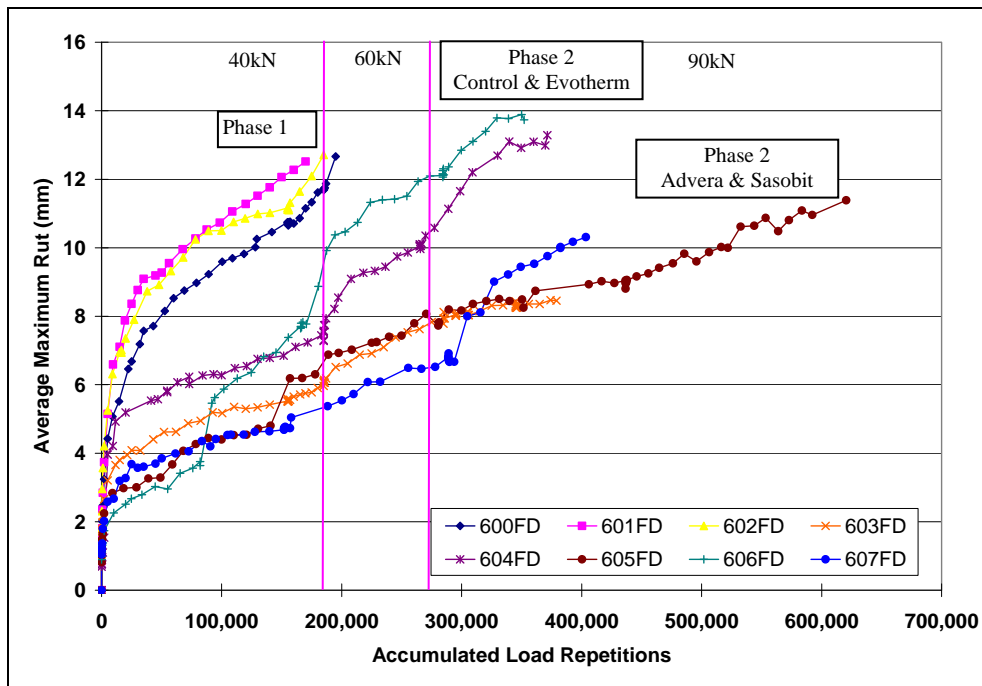
Figure 4.58: Comparison of Phase 1 and Phase 2 rutting performance.

The average maximum rut progression for both phases is shown in Figure 4.58. The plot clearly shows the difference in the embedment phases in terms of duration (number of repetitions) and rut depth and in terms of the difference between the Control and warm-mix sections. In Phase 1, the embedment phases of the warm-mix sections were similar to the Control, but the rut depths were deeper. In Phase 2, the duration of the embedment phase on all sections was again similar; however the rut depth was notably less on the warm-mix sections compared to the Control. The plot also clearly shows the difference in the number of repetitions required to reach an average maximum rut depth of 12.5 mm (0.5 in.), with the Phase 2 sections requiring significantly more repetitions. A significant proportion of the later trafficking on each section in Phase 2 was undertaken at higher wheel loads (60 kN and 90 kN [13,500 lb and 20,250 lb]) than those used in Phase 1.

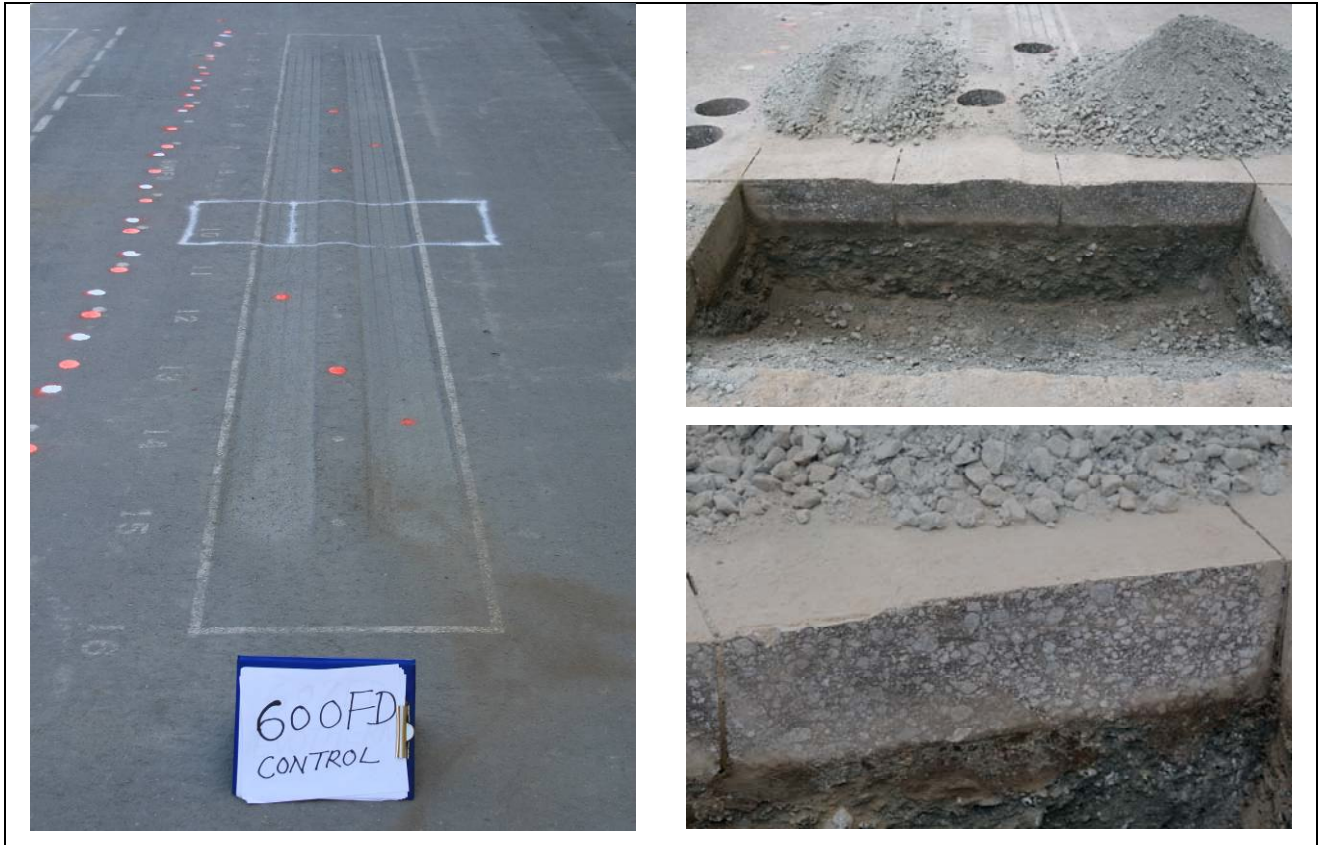
Figure 5.10: 600FD: Test pit photographs.

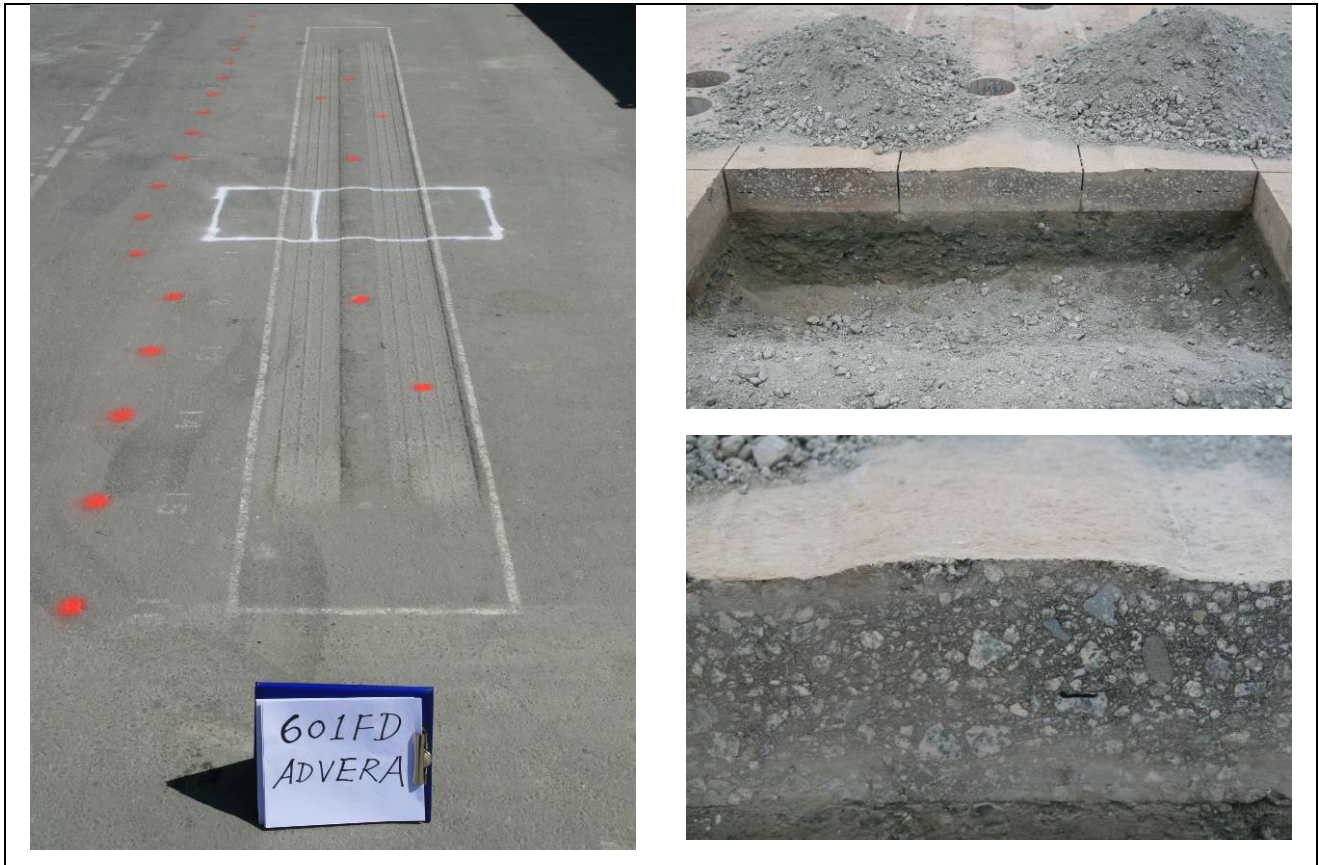
Figure 5.11: 601FD: Test pit photographs.

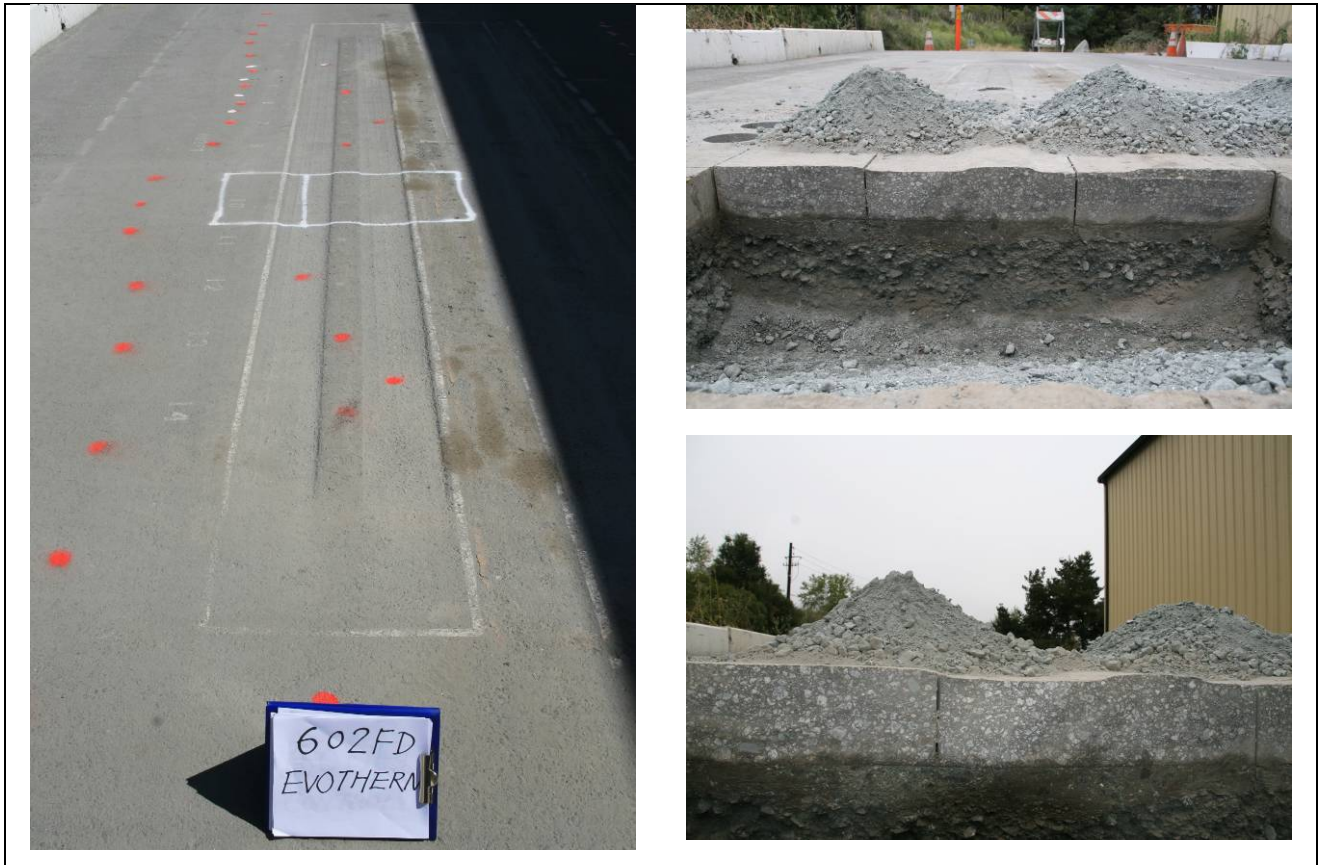
Figure 5.12: 602FD: Test pit photographs.

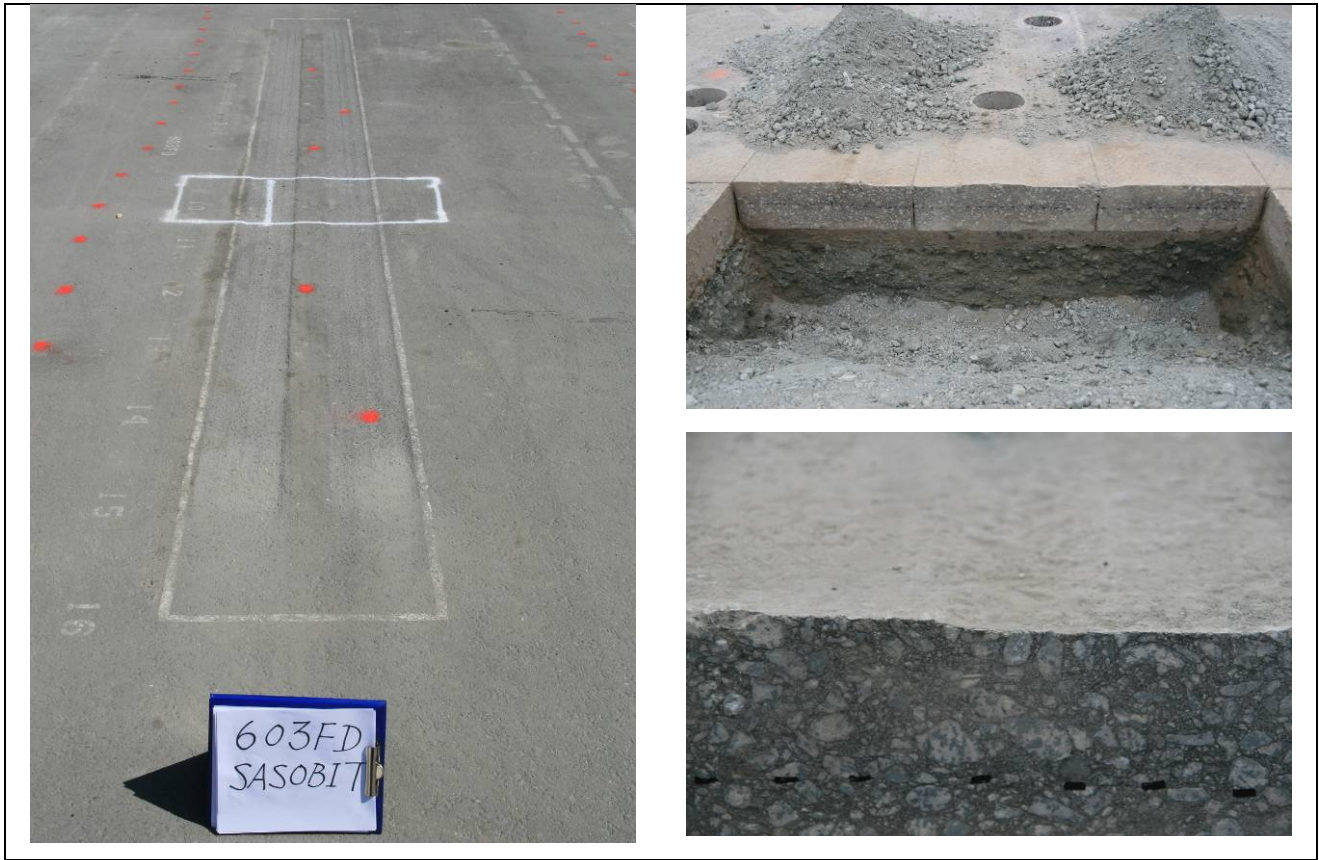
Figure 5.13: 603FD: Test pit photographs.

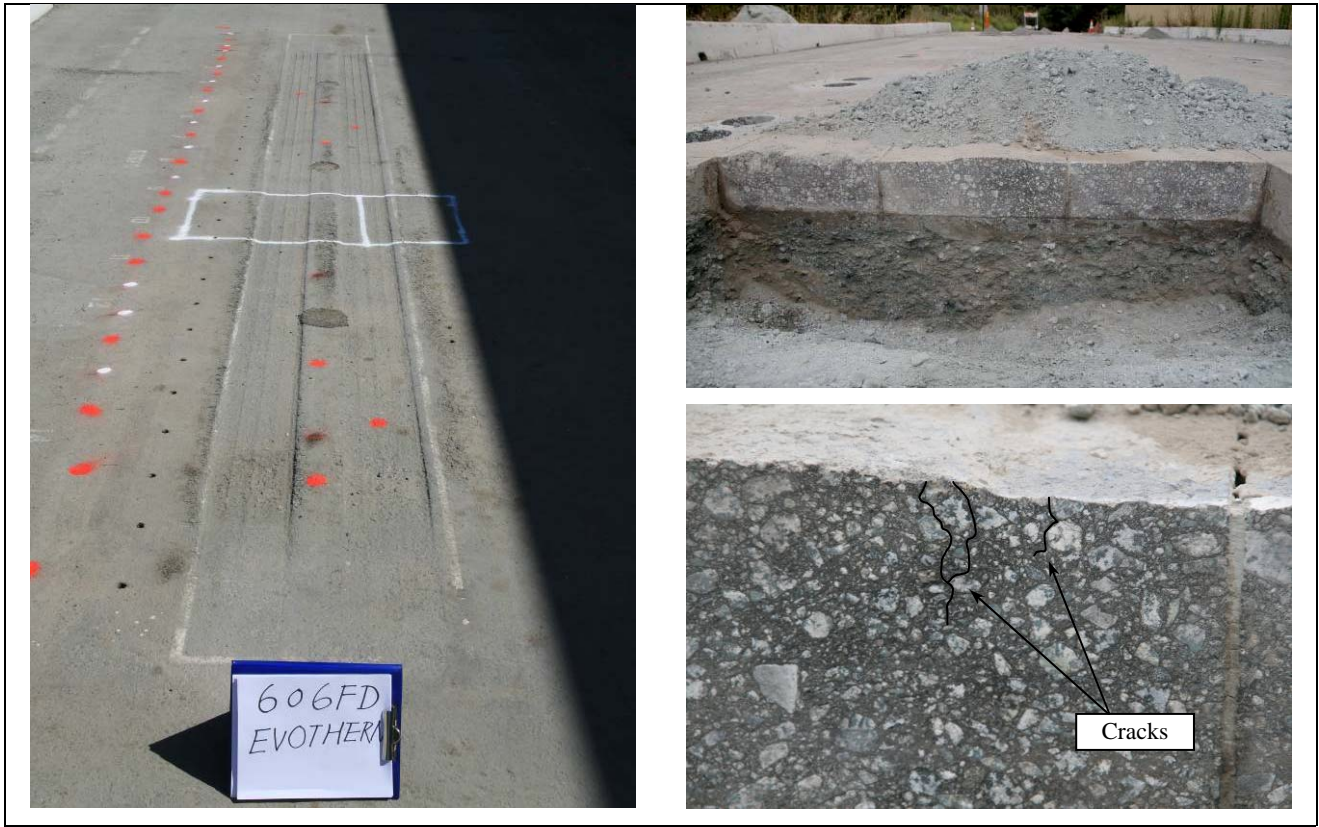
Figure 5.16: 606FD: Test pit photographs.

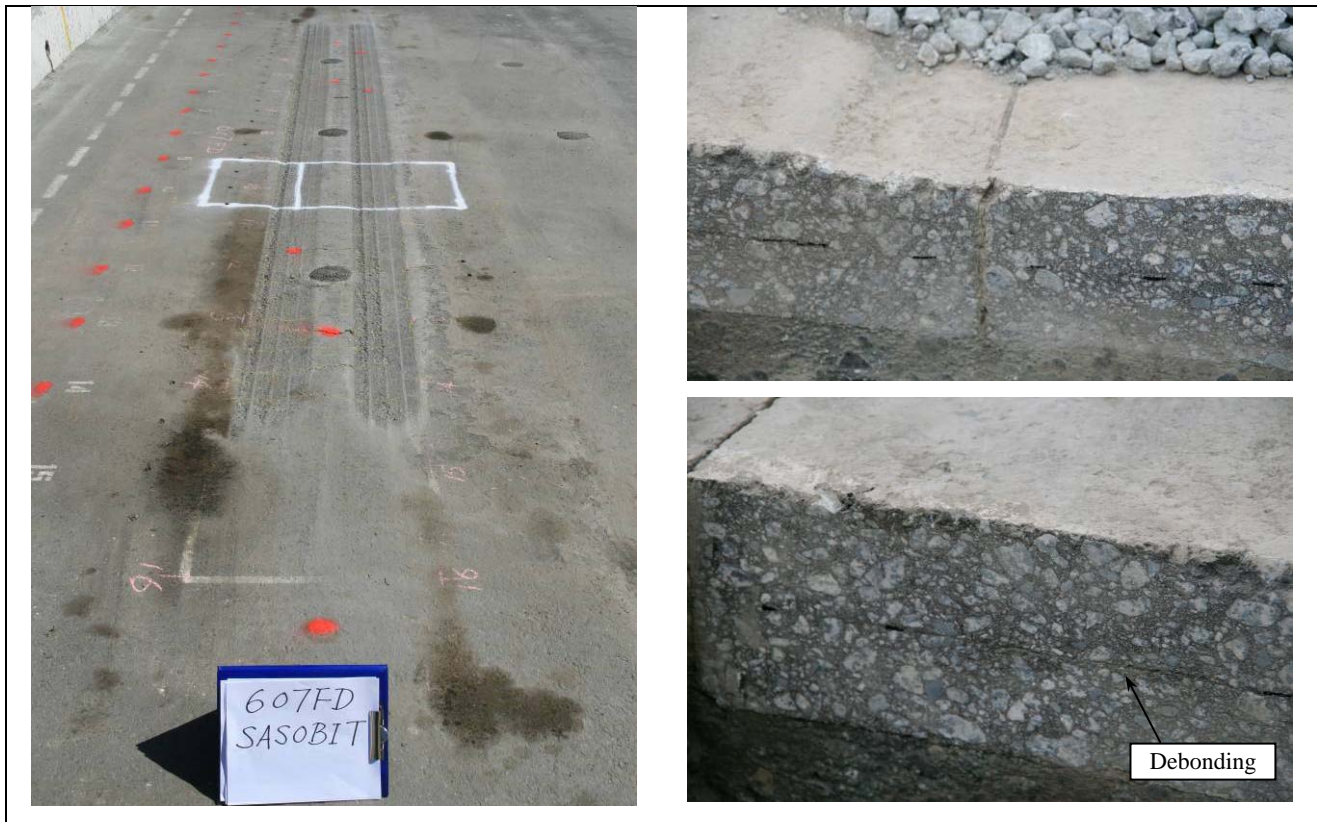
Figure 5.17: 607FD: Test pit photographs.

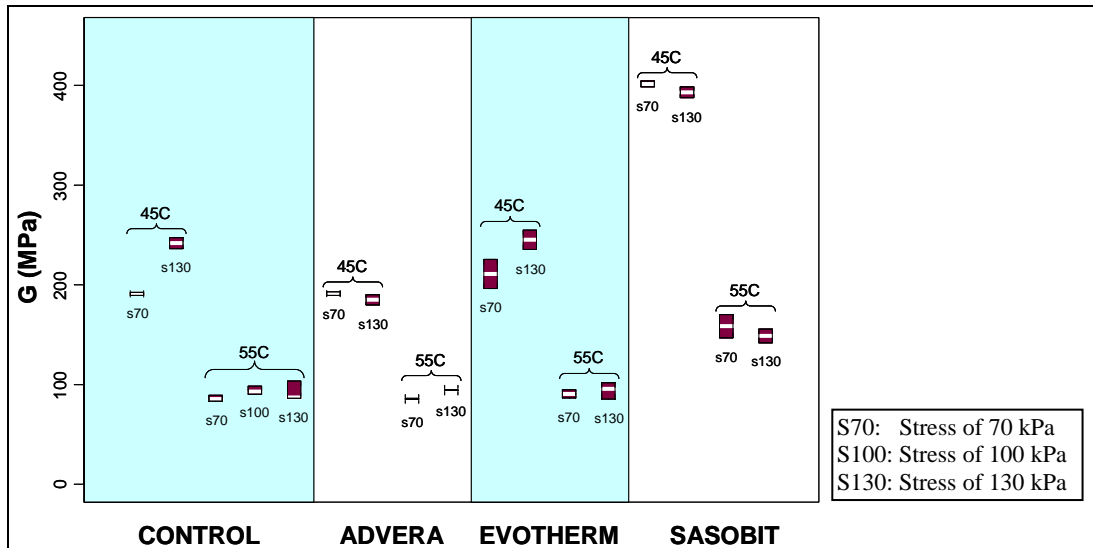
Figure 6.2: Summary boxplots of resilient shear modulus.
