Warm-Mix Asphalt Study: First-Level Analysis of Phase 2 HVS and Laboratory Testing, and Phase 1 and Phase 2 Forensic Assessments

Partnered Pavement Research Program (PPRC) Contract Strategic Plan Element 4.18:
Warm-Mix Asphalt

California Department of Transportation
Division of Research and Innovation
Office of Roadway Research

University of California
Pavement Research Center
UC Davis, UC Berkeley

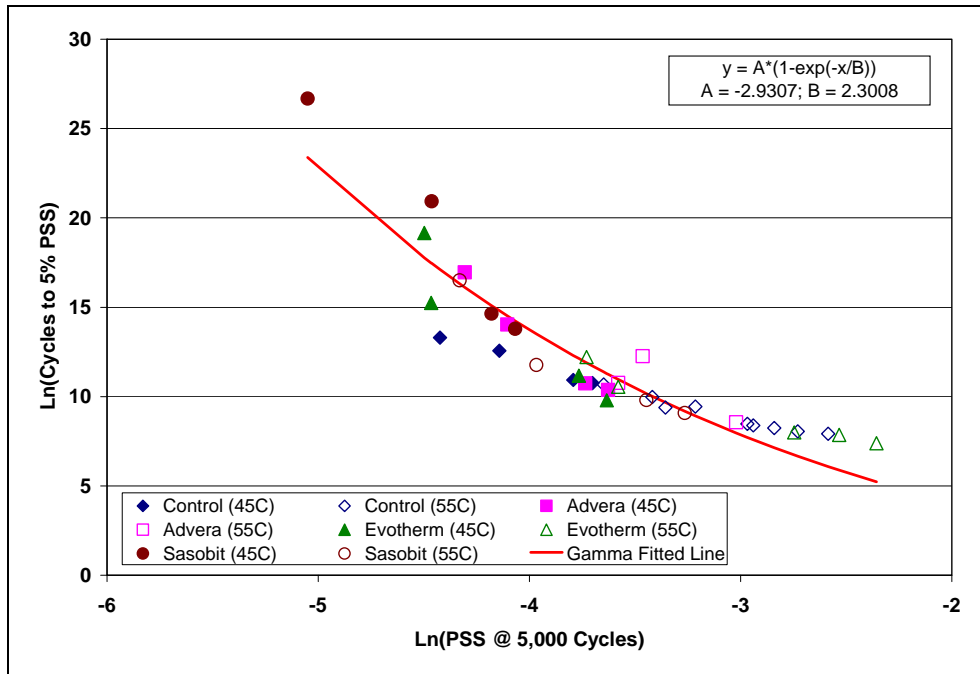
Figure 6.5: Cycles to 5% permanent shear strain versus permanent shear strain after 5,000 cycles. (Double natural logarithm scale)

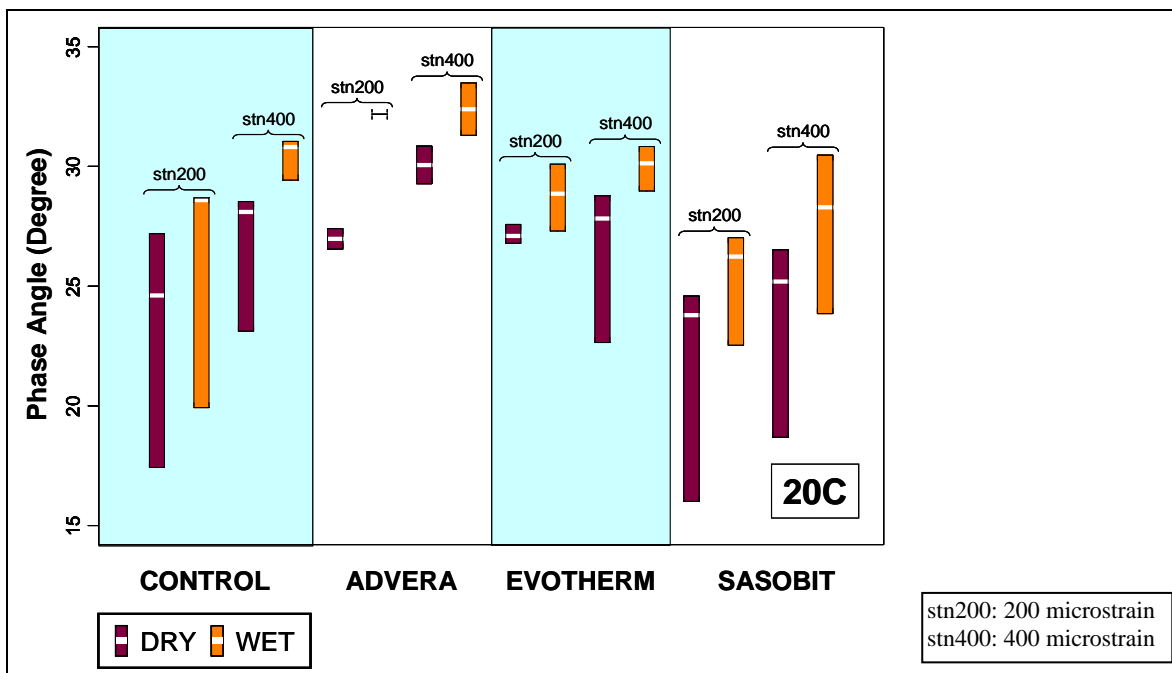
Figure 6.9: Summary boxplots of initial phase angle.

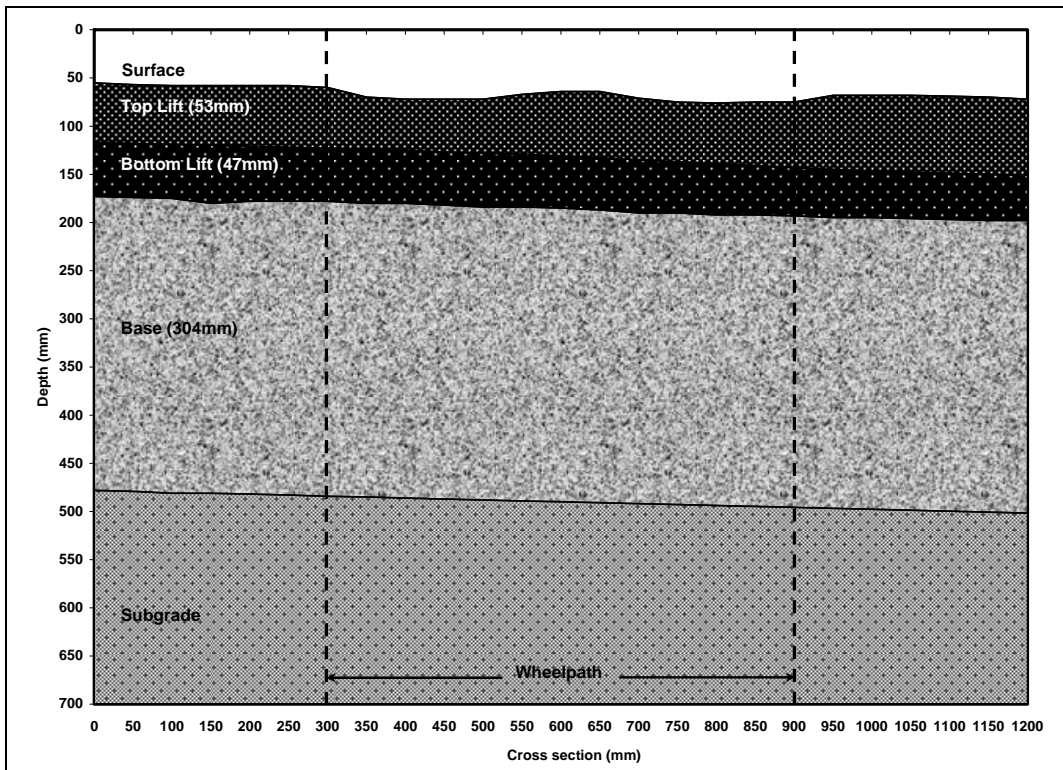
Figure A.3: 602FD: Test pit profile.
