Development of composite renewal systems for rapid rehabilitation and construction of bridge decks

A dissertation submitted in partial satisfaction of the  
requirements for the degree Doctor of Philosophy

Structural Engineering

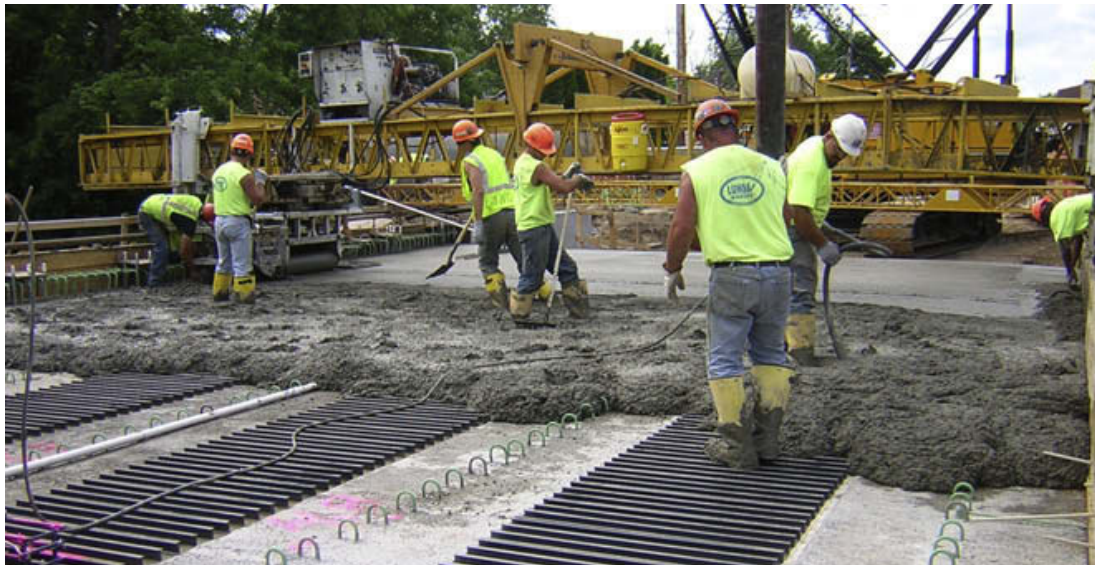
Figure 2.6 Use of commercially available FRP plank as SIP formwork and secondary reinforcement in reinforcement-free deck [66]

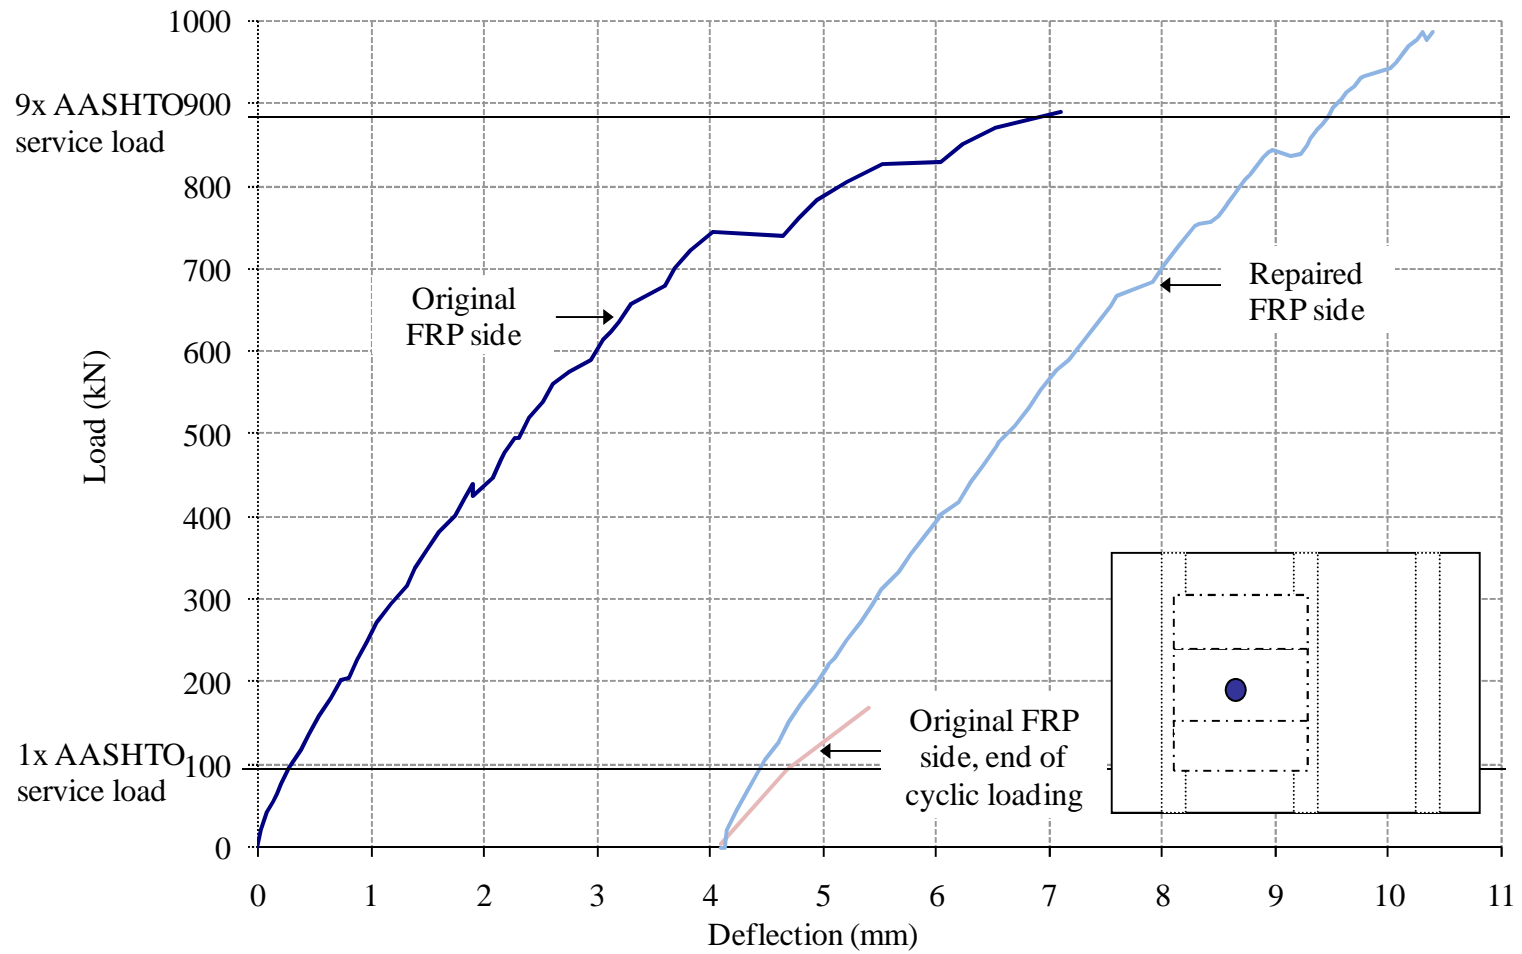
The response of the repaired FRP side under static loading is compared to the response of the original test specimen under static loading and also to the last cycle of the cyclic phase for the original test specimen, which was the last loading experienced by the test specimen prior to the repair. Figure 4.4 shows the overall load versus midspan displacement envelope plots for the FRP side. In order to more easily compare the stiffness of the deck slab before and after the repair, the load-deflection curves for the repaired specimen and the original specimen at the end of cyclic loading were shifted back to the origin by removing the residual deflections, as shown in Figure 4.5.

Figure 4.4 Load versus deflection envelope plots of the original and repaired test specimen for both the FRP and RC slabs

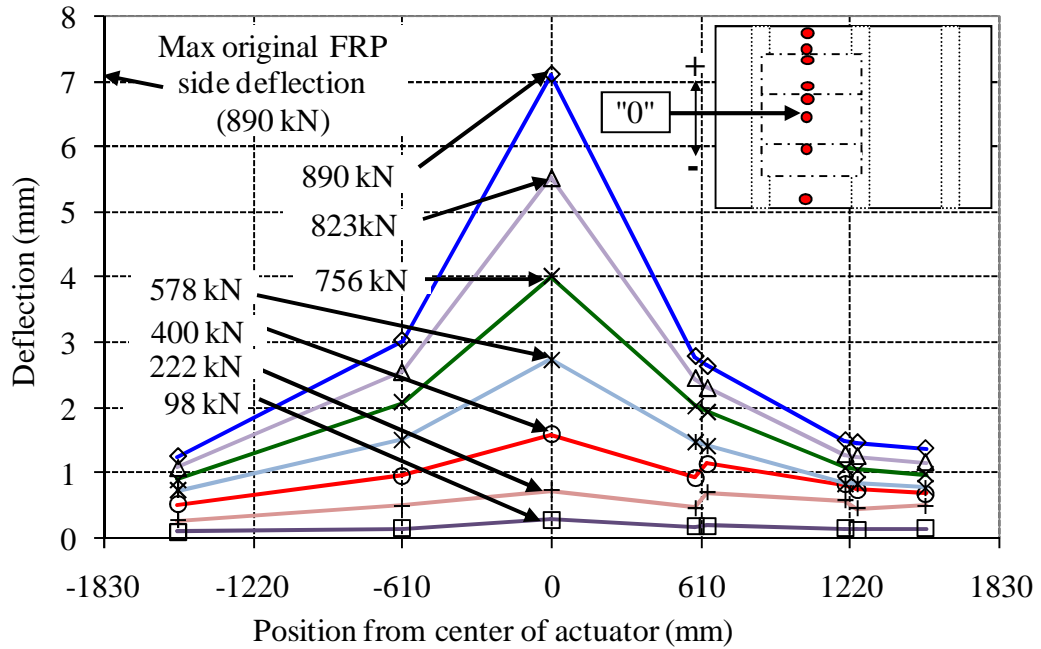
Figure 4.8 Deflection profile along centerline of original FRP side deck

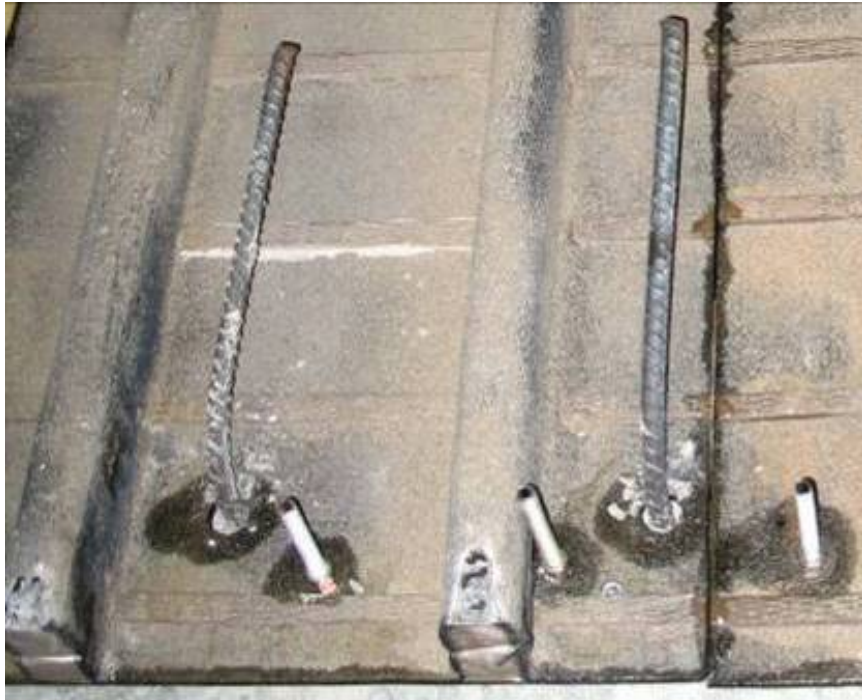
(a) End condition detail from Test Specimen #1.

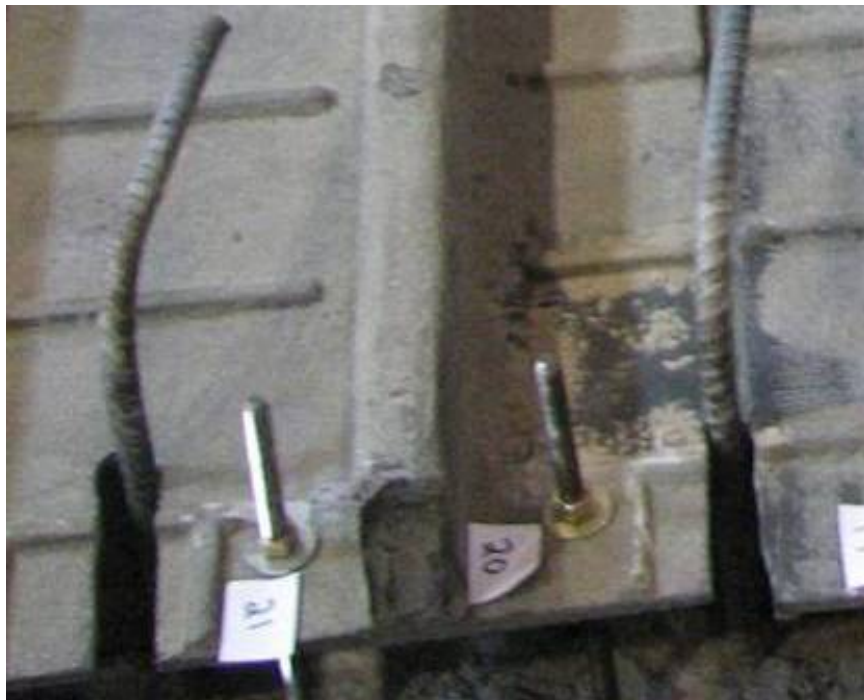
(b) End condition detail from Test Specimen #2

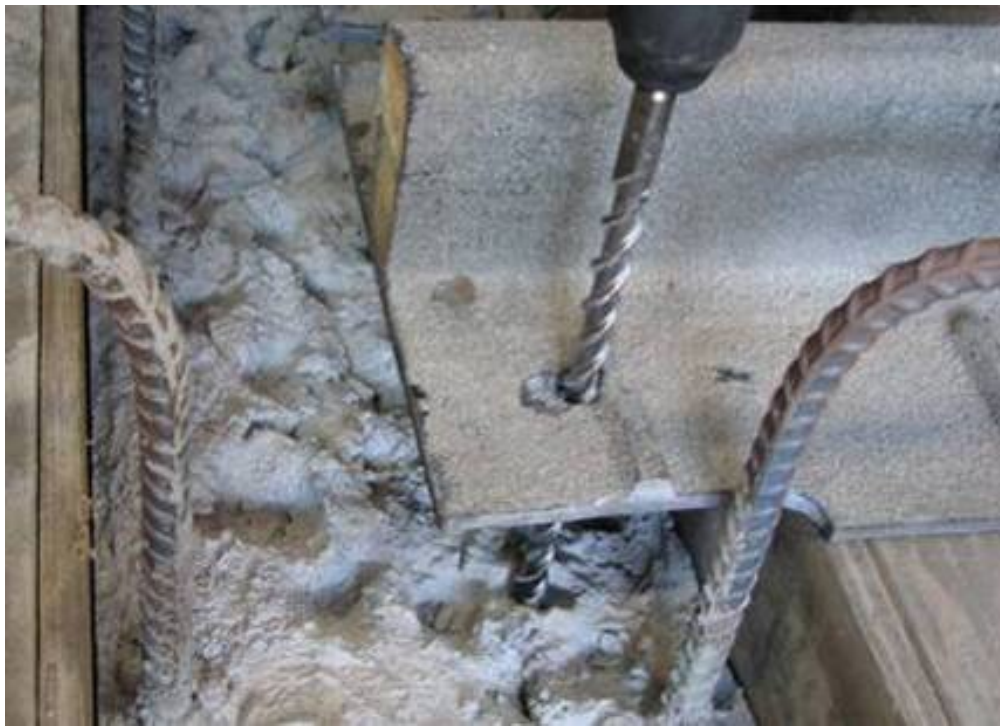
Figure 5.5 Drilling of stem concrete using FRP panels for alignment of holes

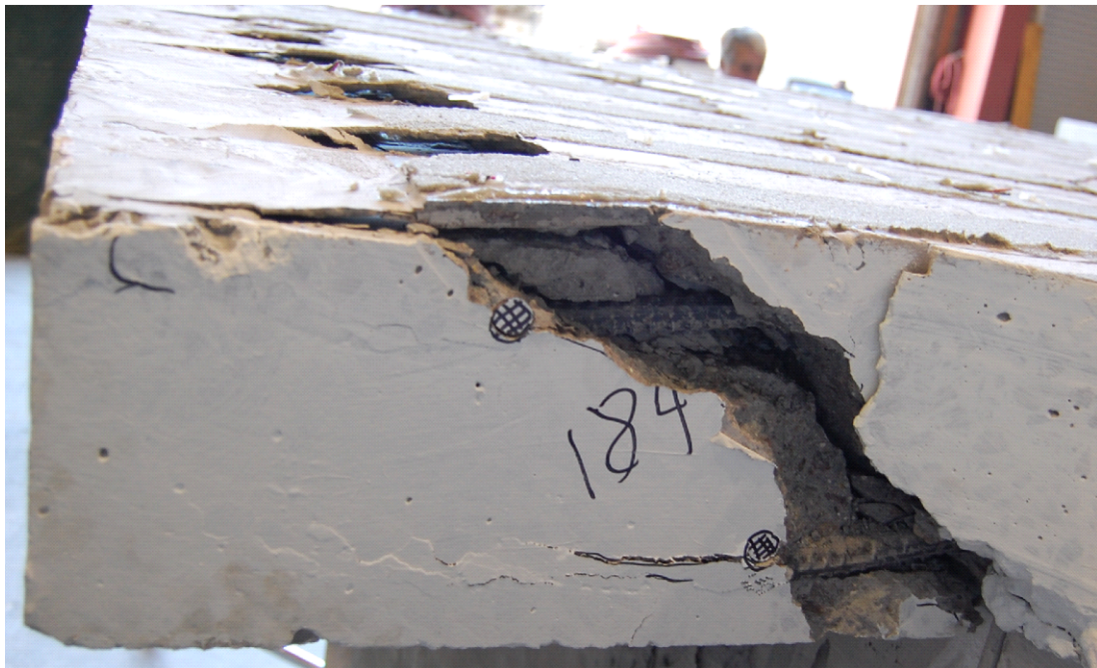
Figure 6.44 Side view of tested FRP rehabilitated specimen after removal of loose concrete

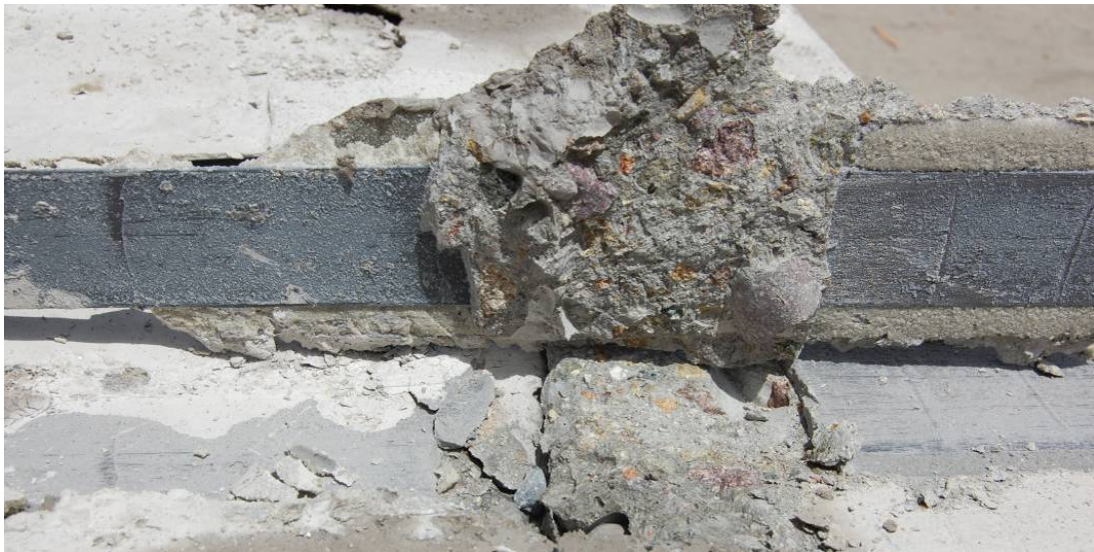
Figure 6.58 Detail of failure surface of FRP strip

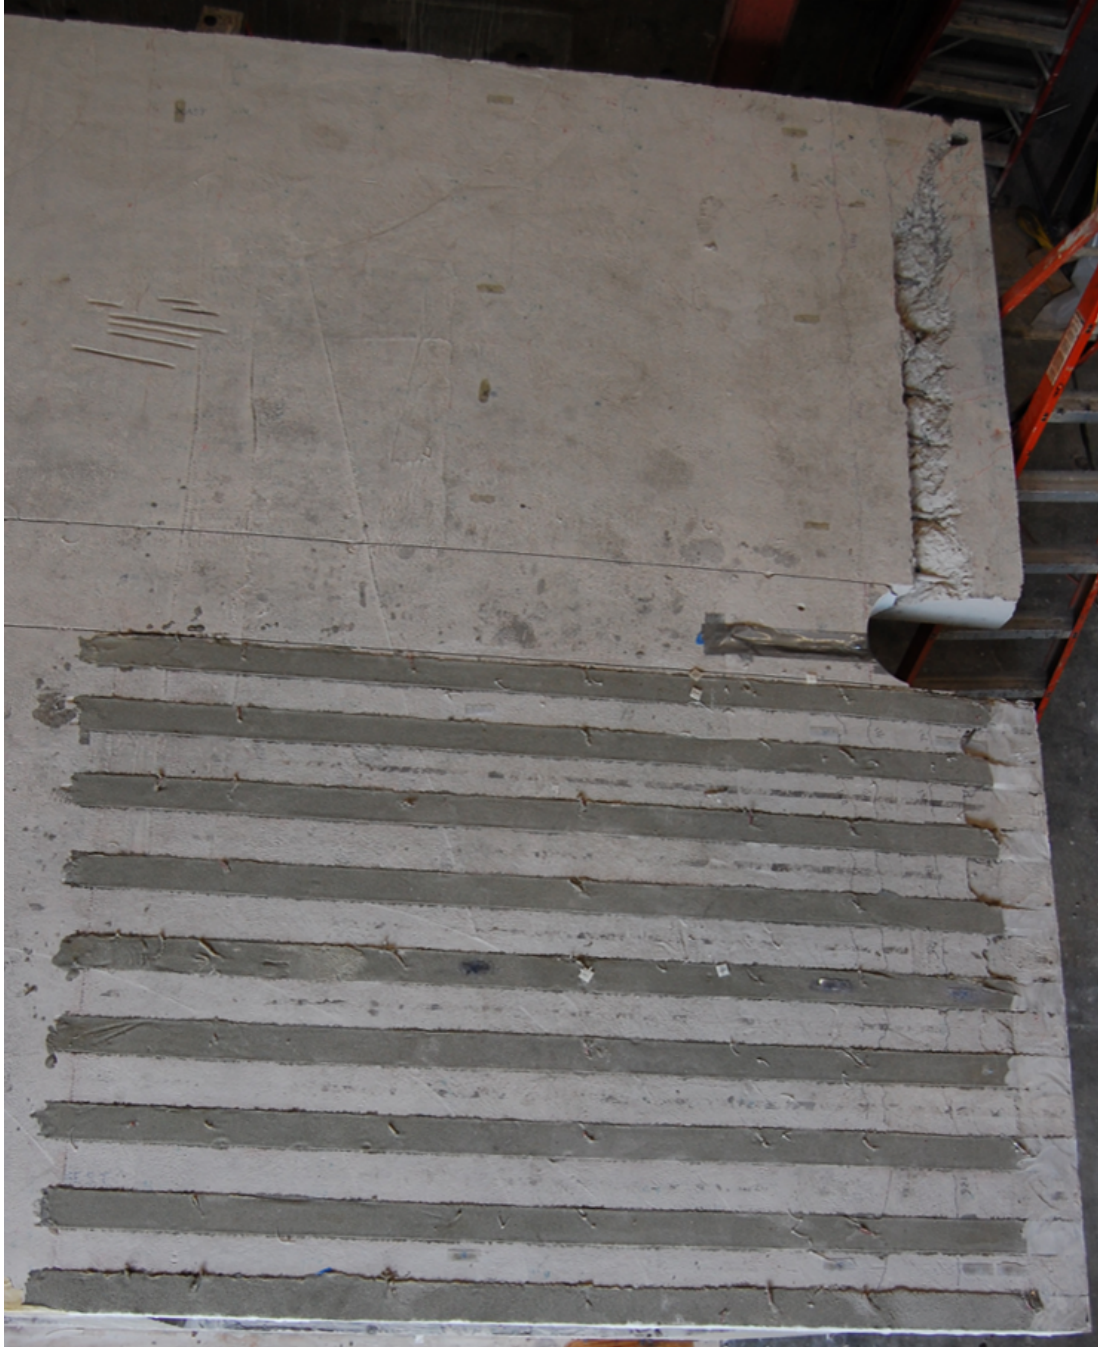
Figure 6.67 Top view of deck slab tested to ultimate capacity after removal of loose concrete
